Building Recording - Ground Floor

External and Internal Doors

Showing existing photos, noted location, frame condition, leaf condition and proposed refurbishment works

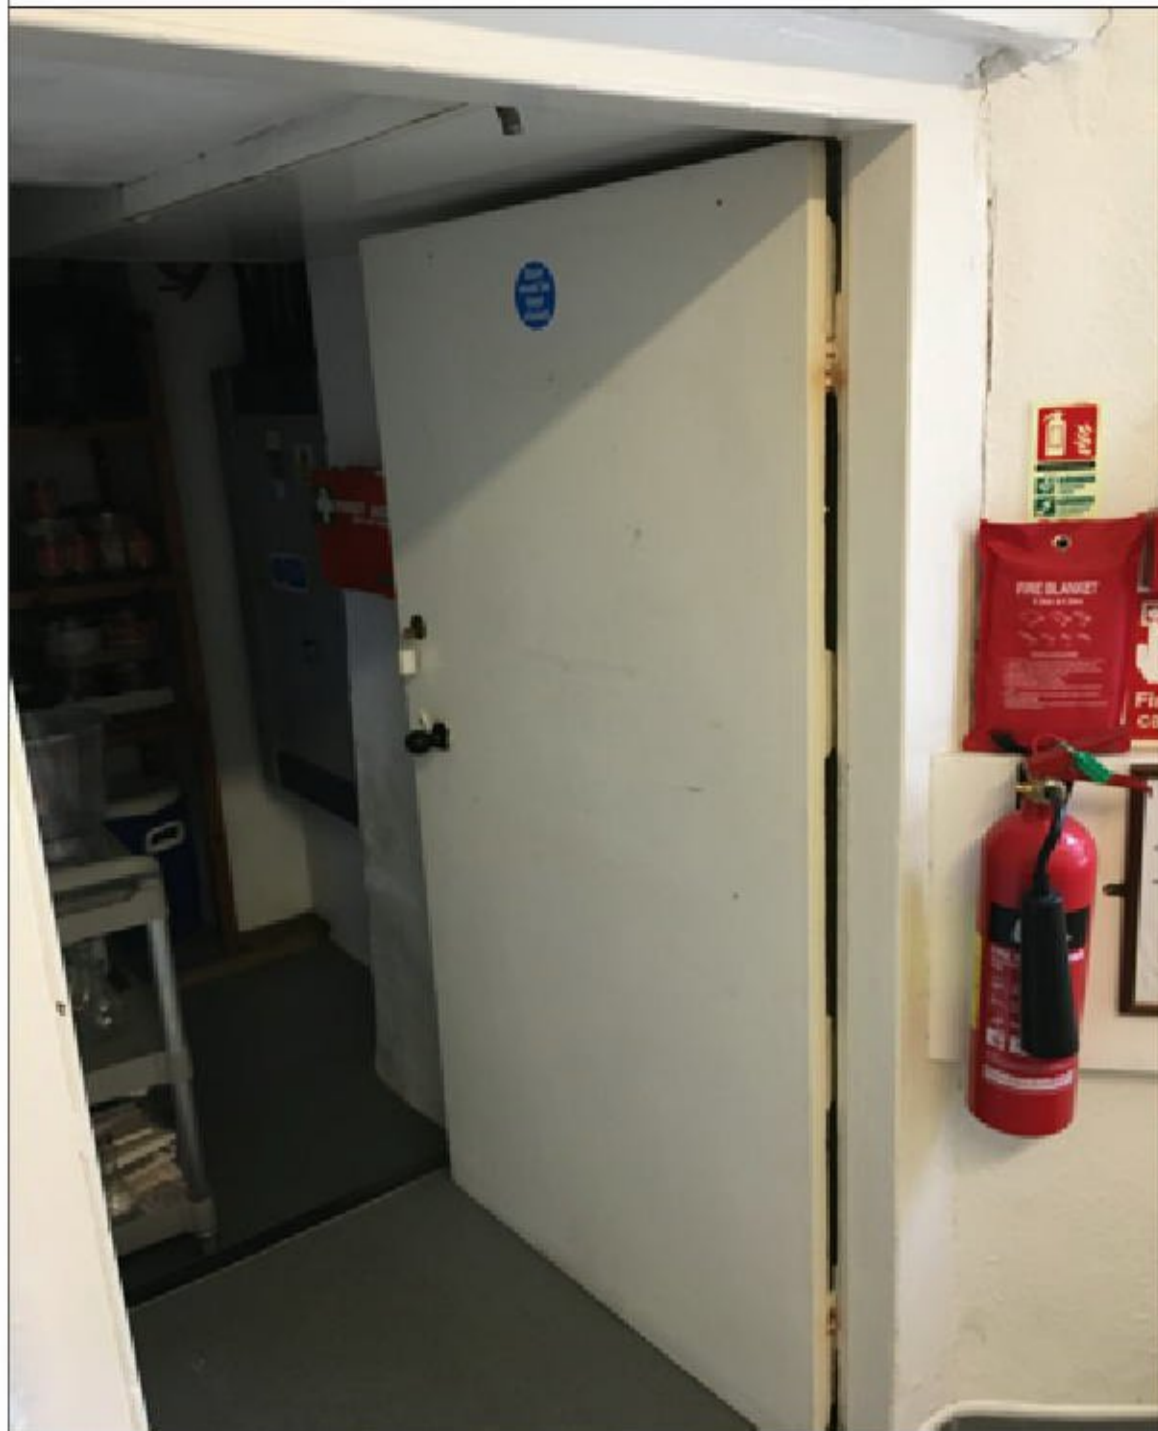
Internal Photo D011i

Photo Location - Kitchen - Door Number **D011** - See floor plans for location

Door leaf - Presumed non original - Good condition

Frame and Architrave - Presumed original - Good condition

- Refurbish and repaint frame
