Building Recording - Ground Floor

External and Internal Windows

showing existing photos, noted location, frame condition, glass condition and proposed refurbishment works.

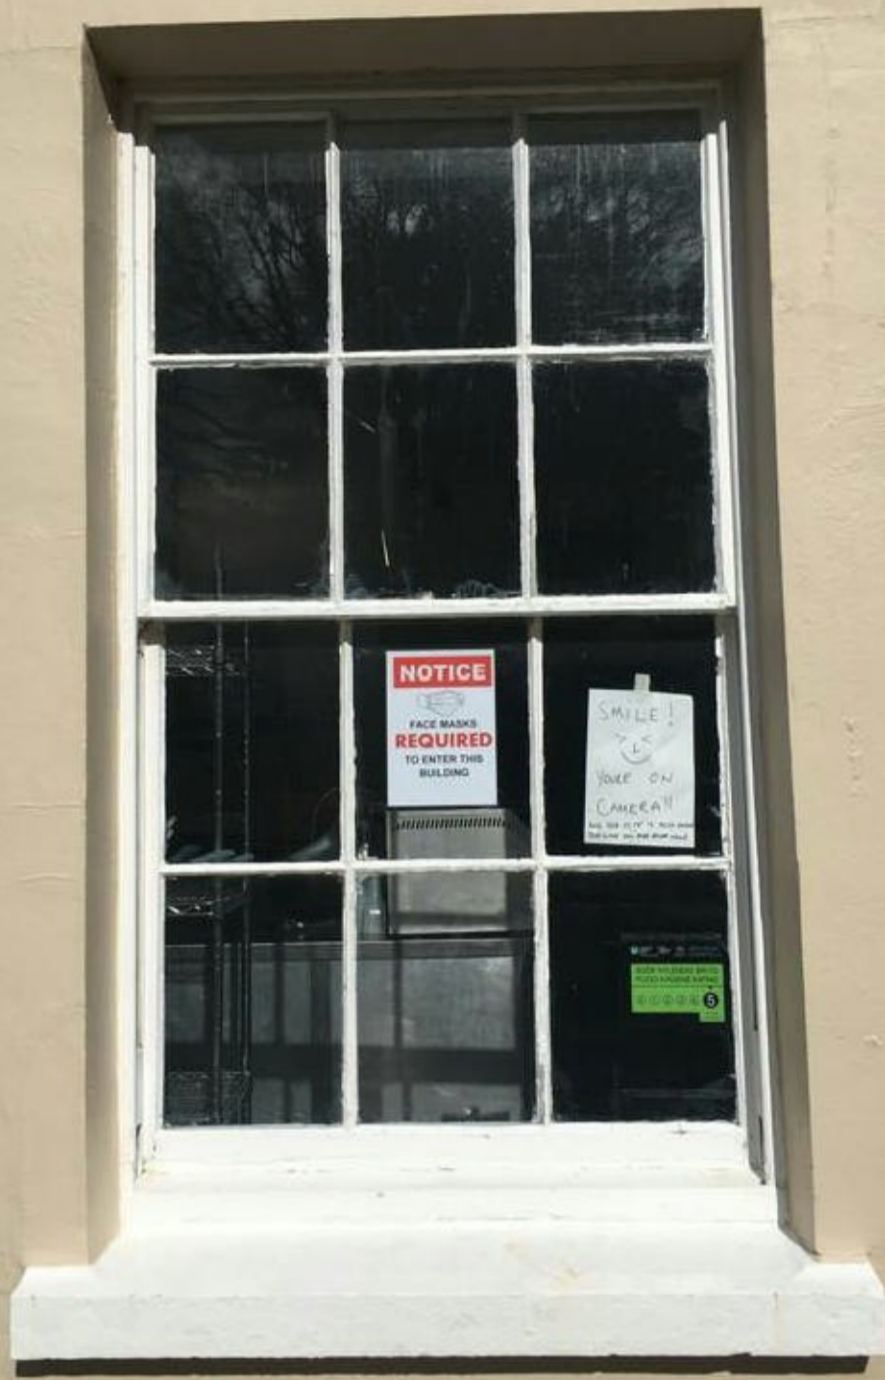
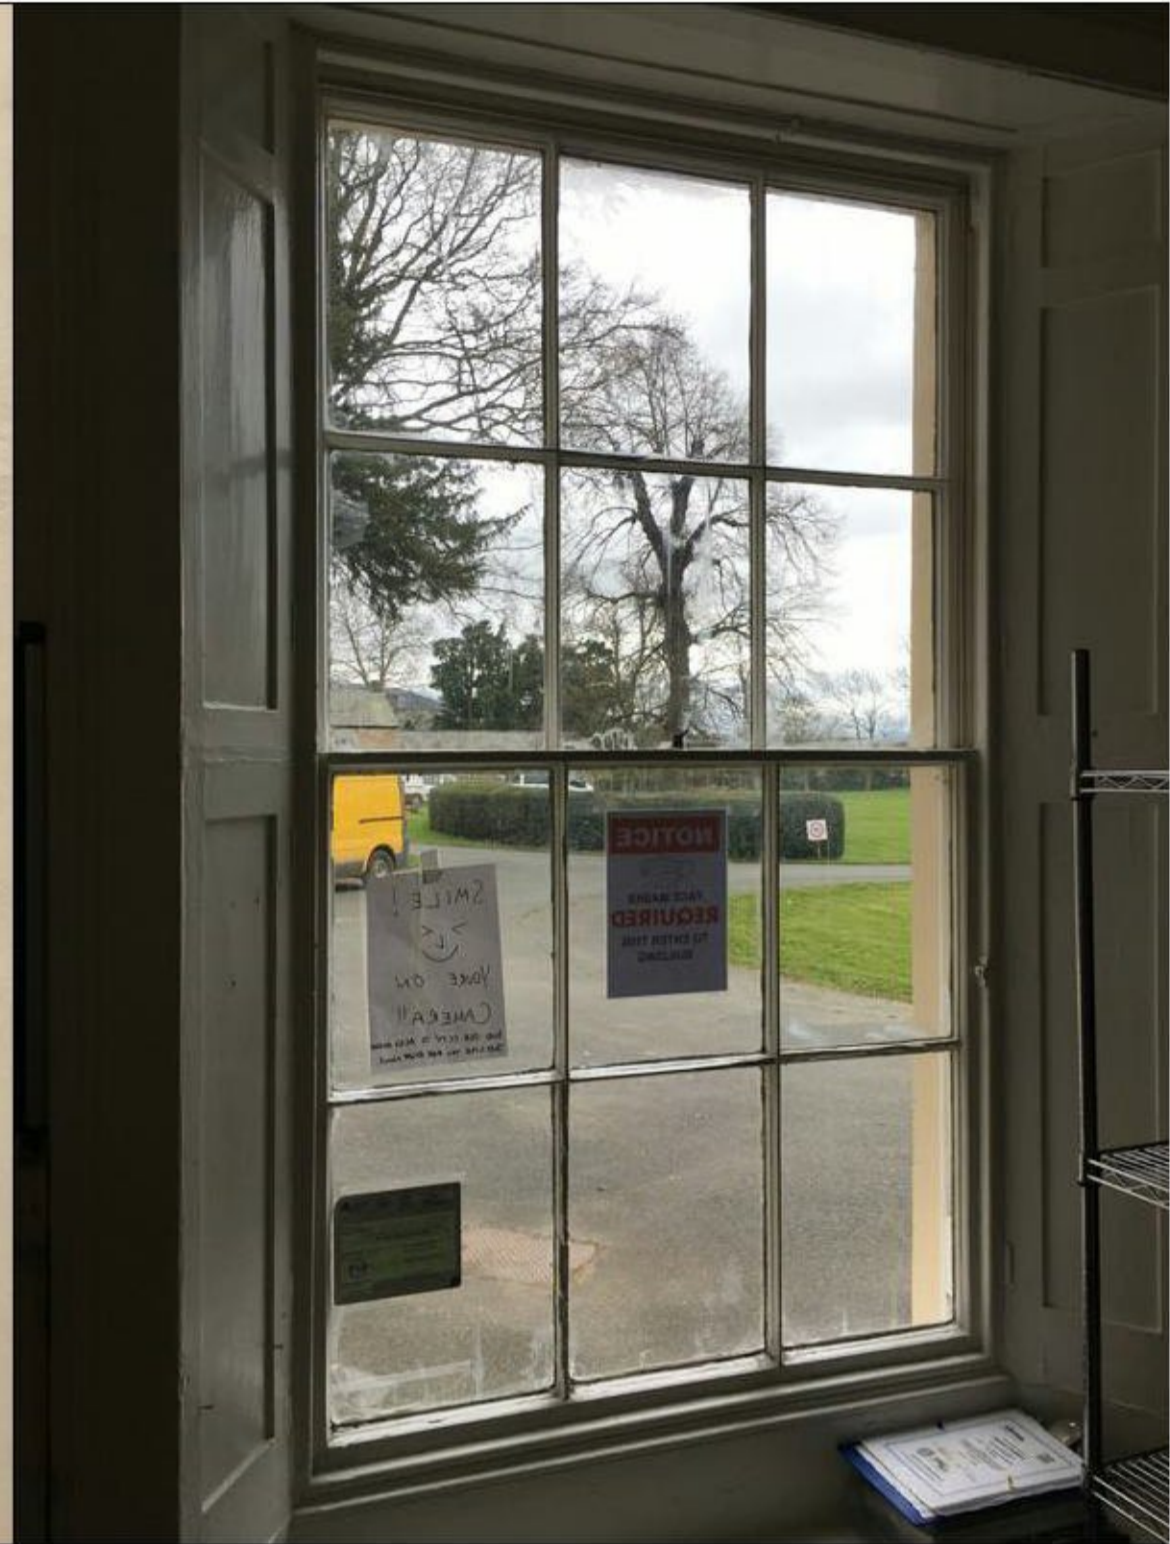
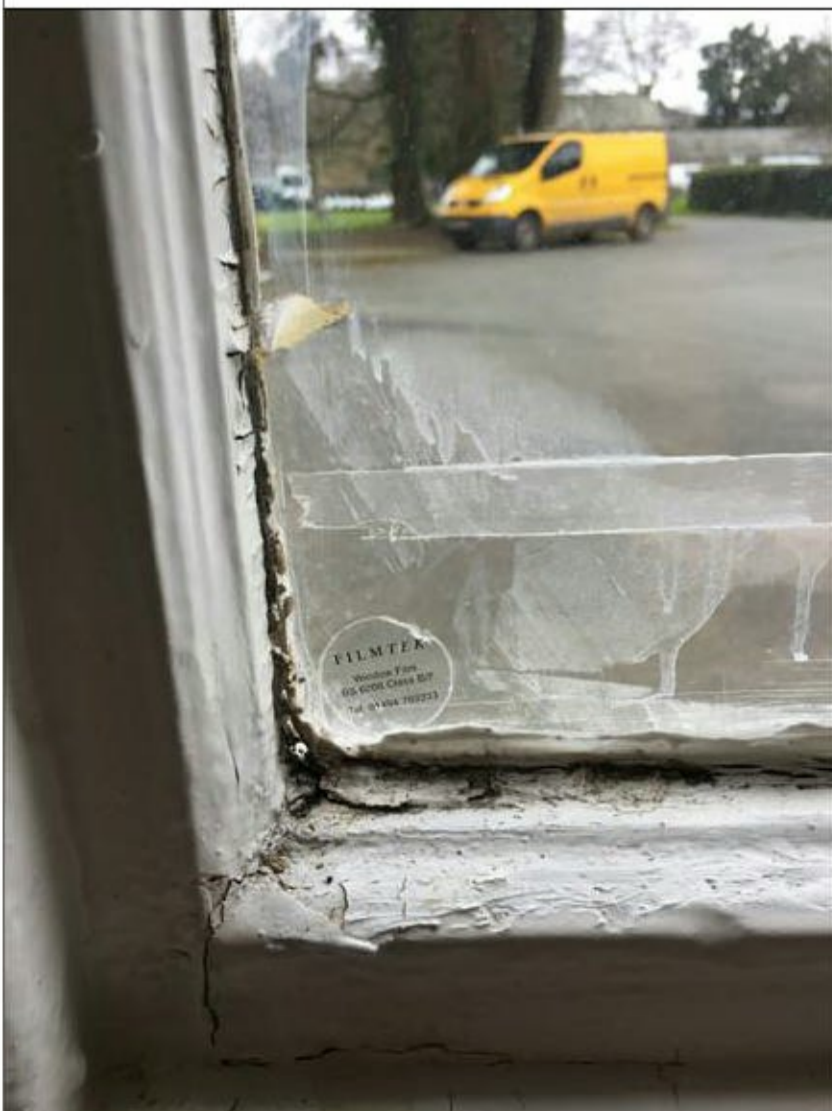
Photo Location - South_Window Number **W001** - See floor plans for location

Located with 1840's section of the building

Condition - Poor in need of refurbishment

Frame - Presumed Non Original

Glass - Presumed Non Original

- Replacement window

it has been advised by a window restorer and fabricator that there is not enough good quality frame left to simply refurbish this window.

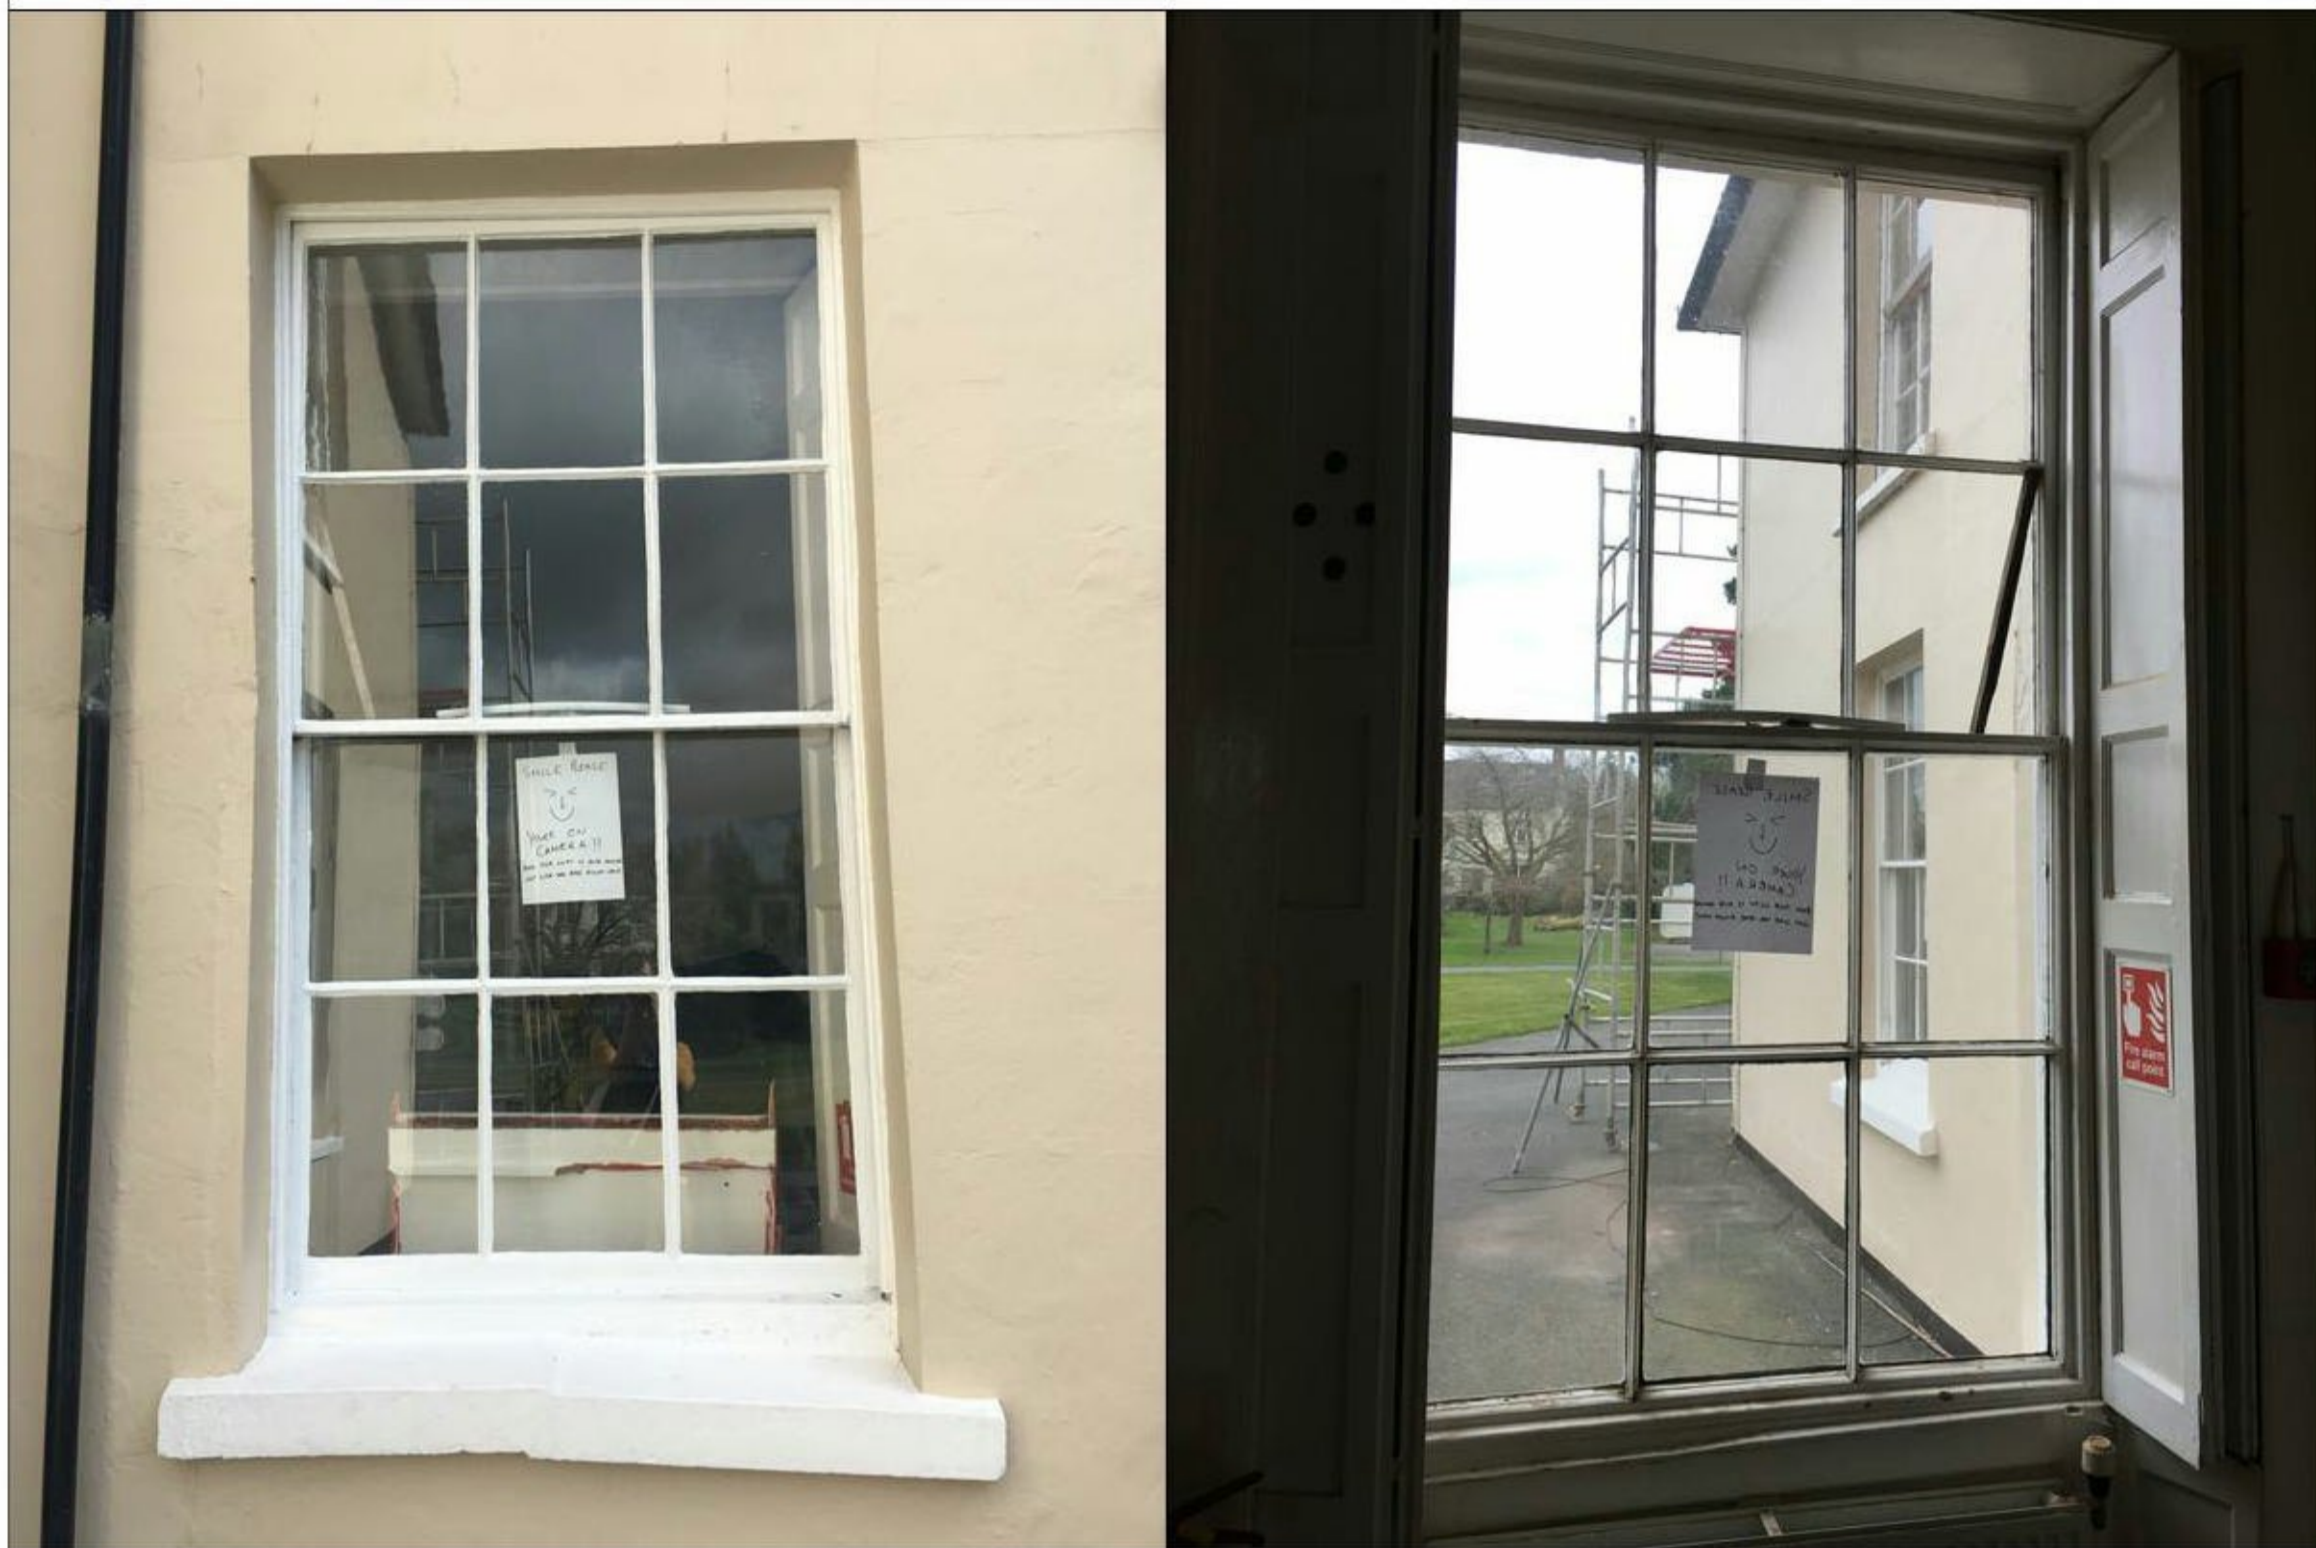
Photo Location - West_Window Number **W002** - See floor plans for location

Located with 1750's section of the building

Condition - Fair in need of refurbishment

Frame - Presumed Non Original

Glass - Presumed Non original

· Replacement window

it has been advised by a window restorer and fabricator that there is not enough good quality frame left to simply refurbish this window.

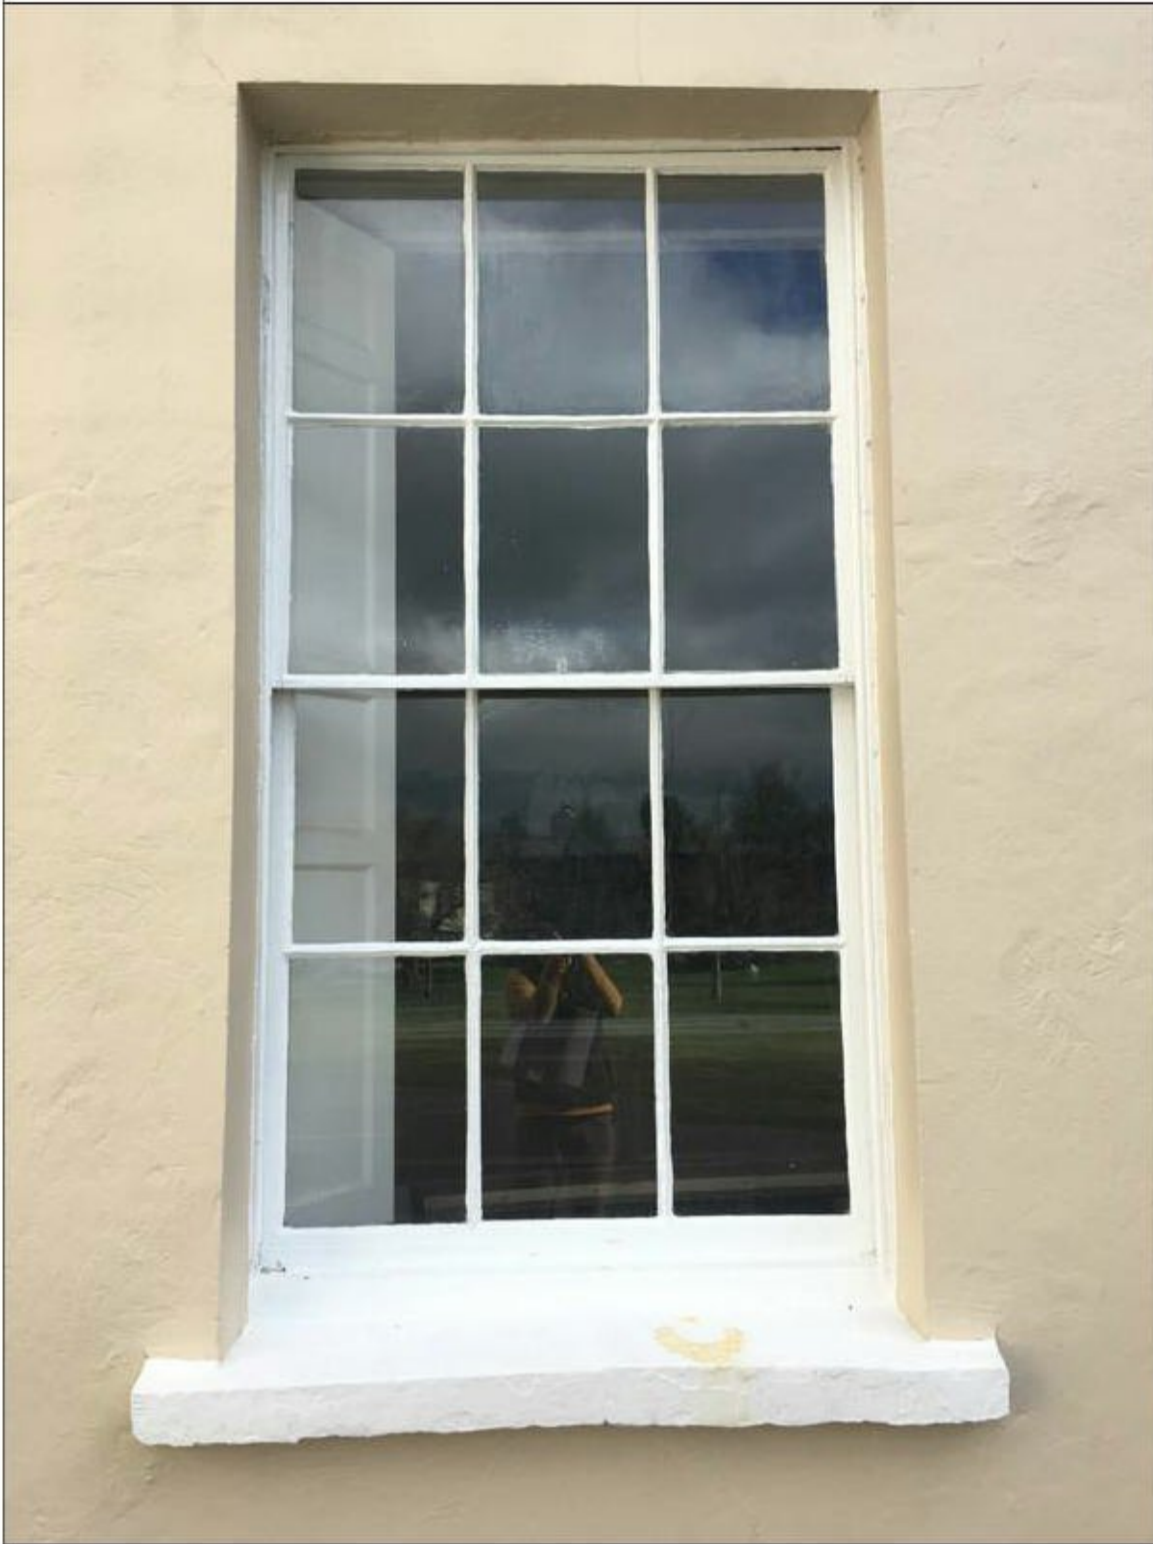
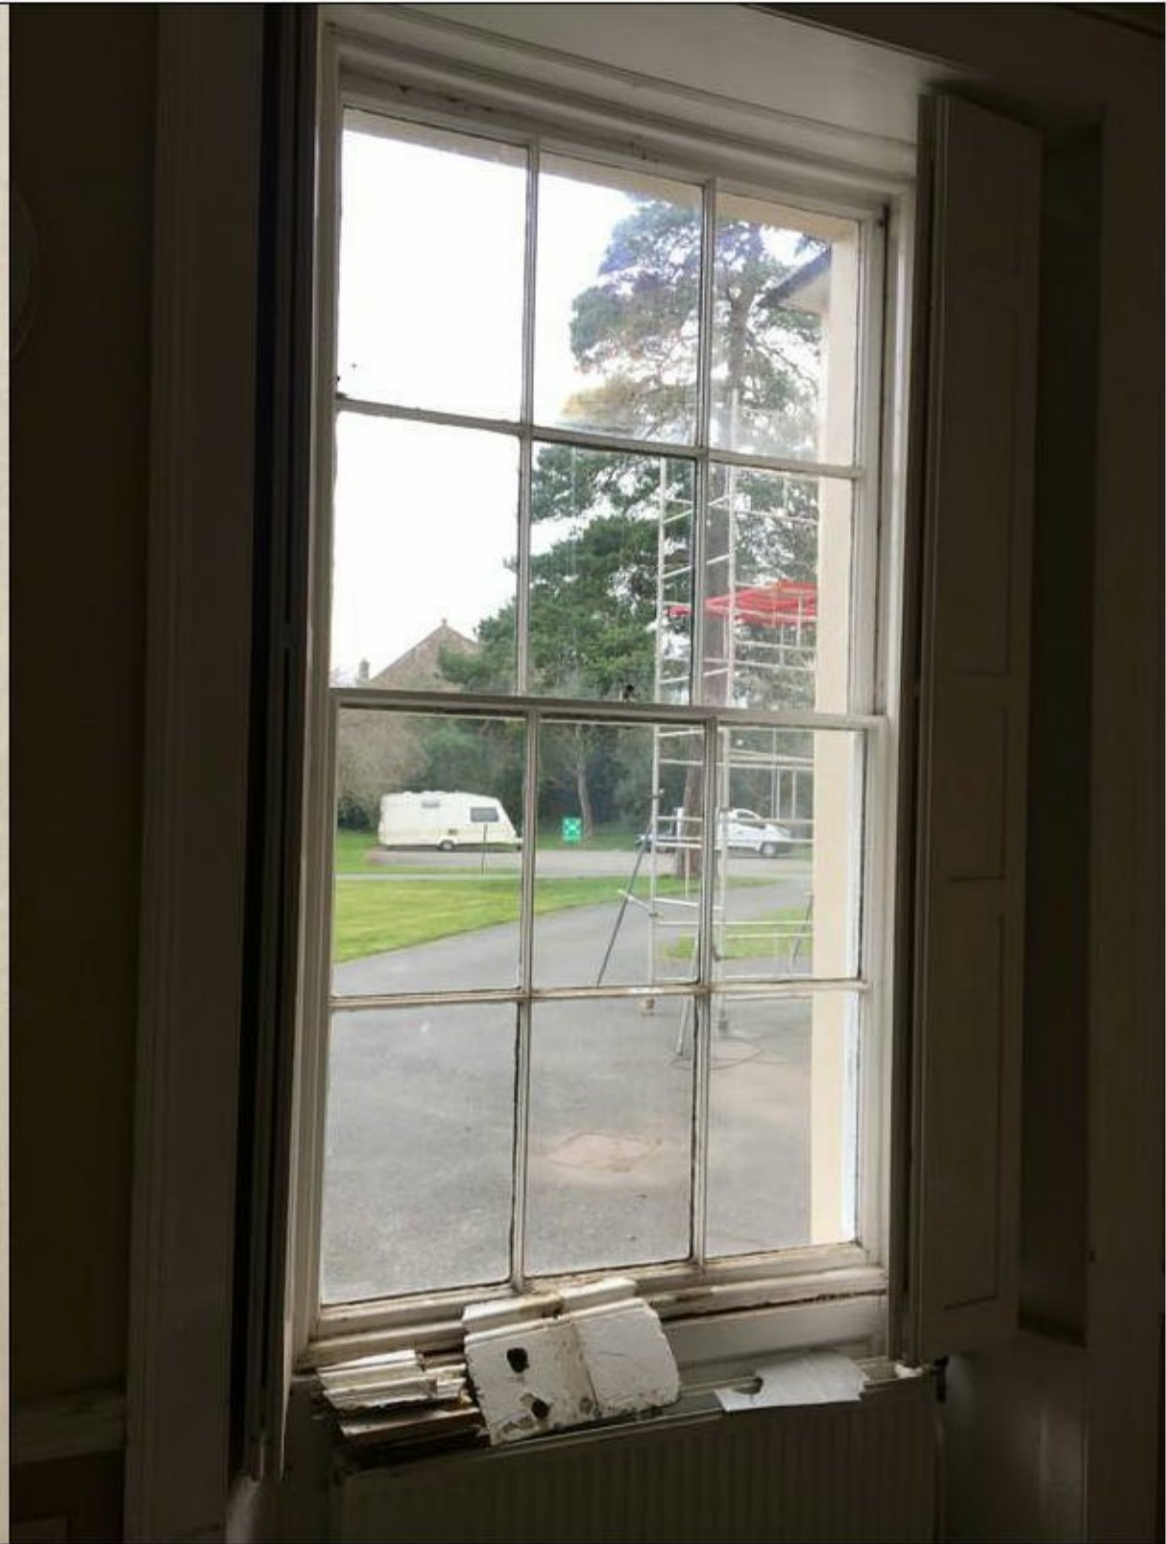
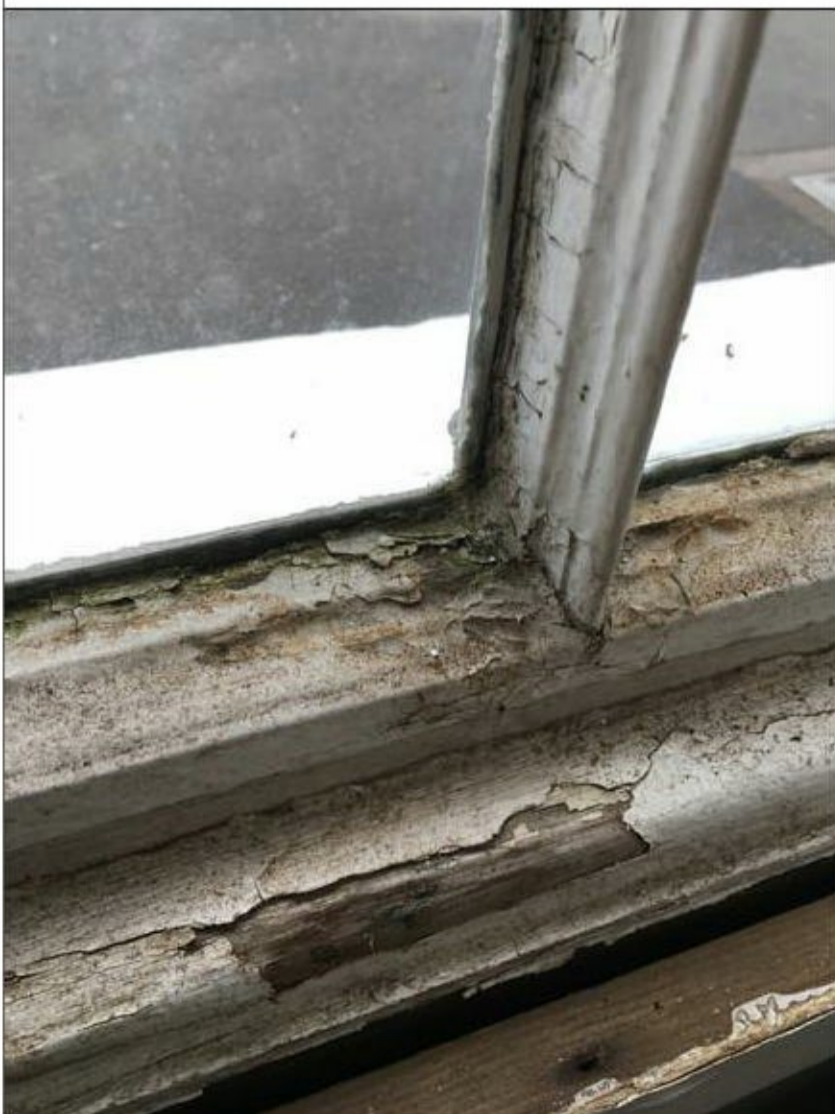
Photo Location - West_Window Number **W003** - See floor plans for location

Located with 1750's section of the building

Condition - Poor in need of refurbishment

Frame - Presumed Non Original

Glass - Presumed Non original

· Replacement window

it has been advised by a window restorer and fabricator that there is not enough good quality frame left to simply refurbish this window.

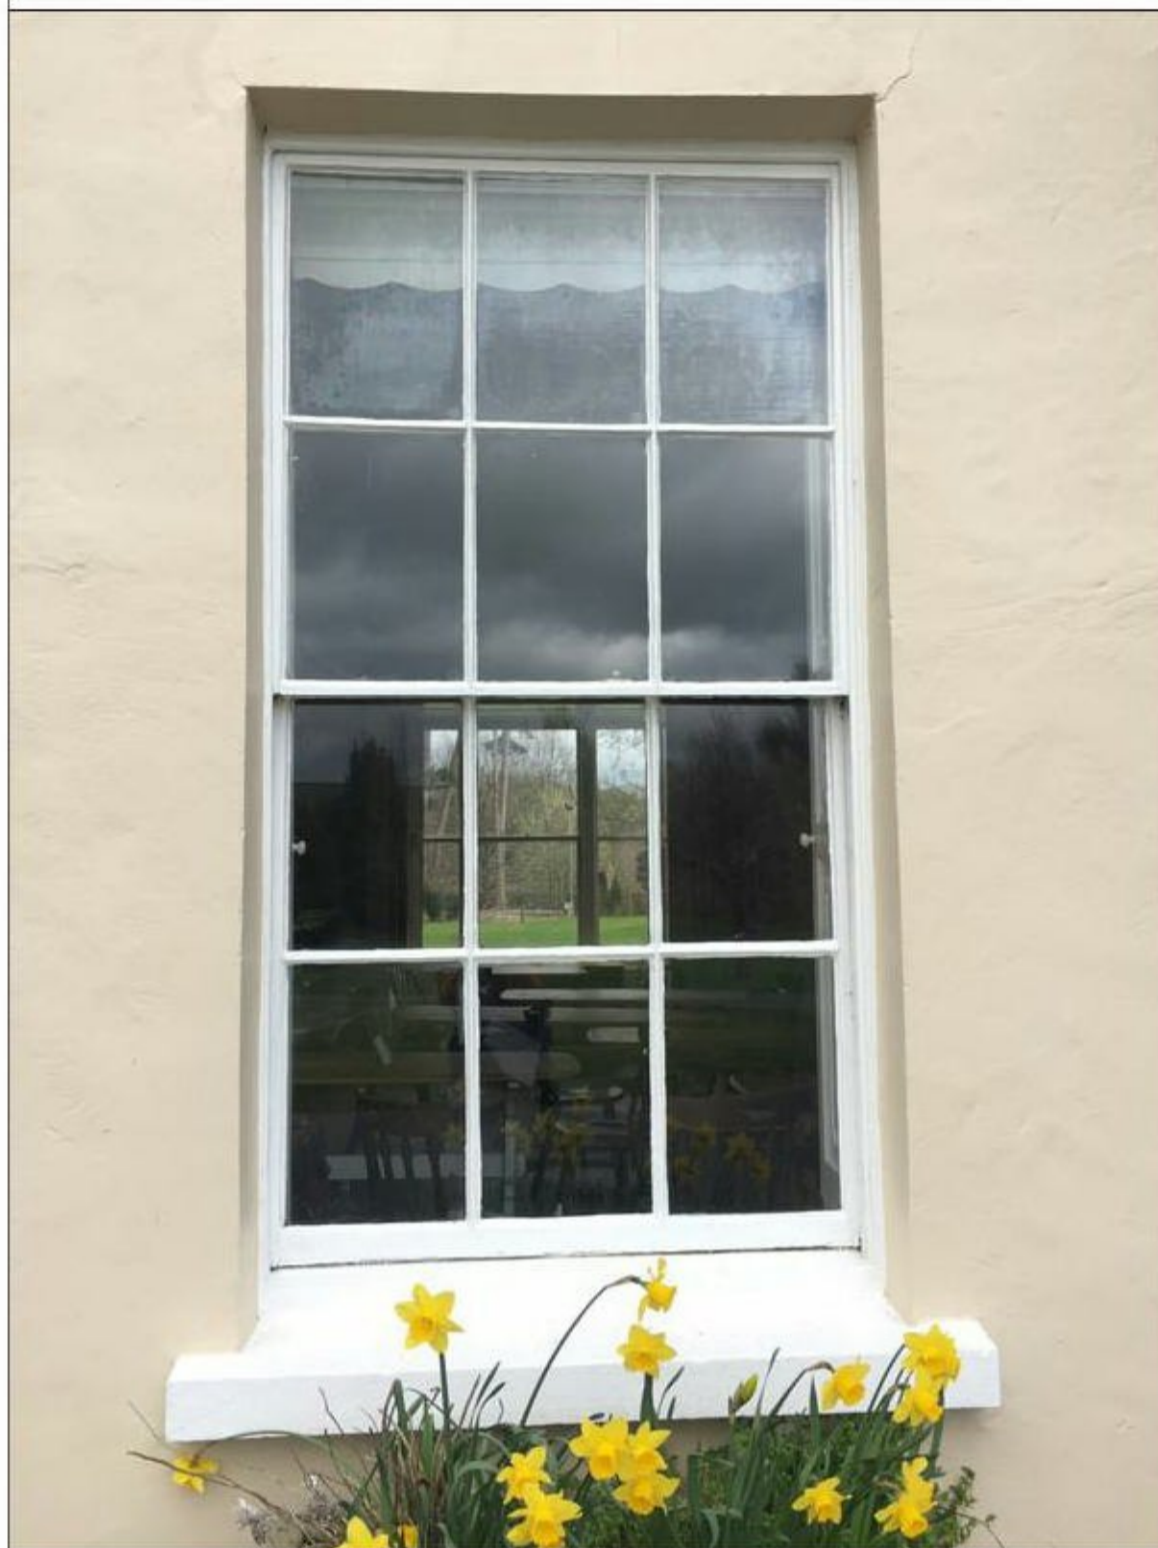
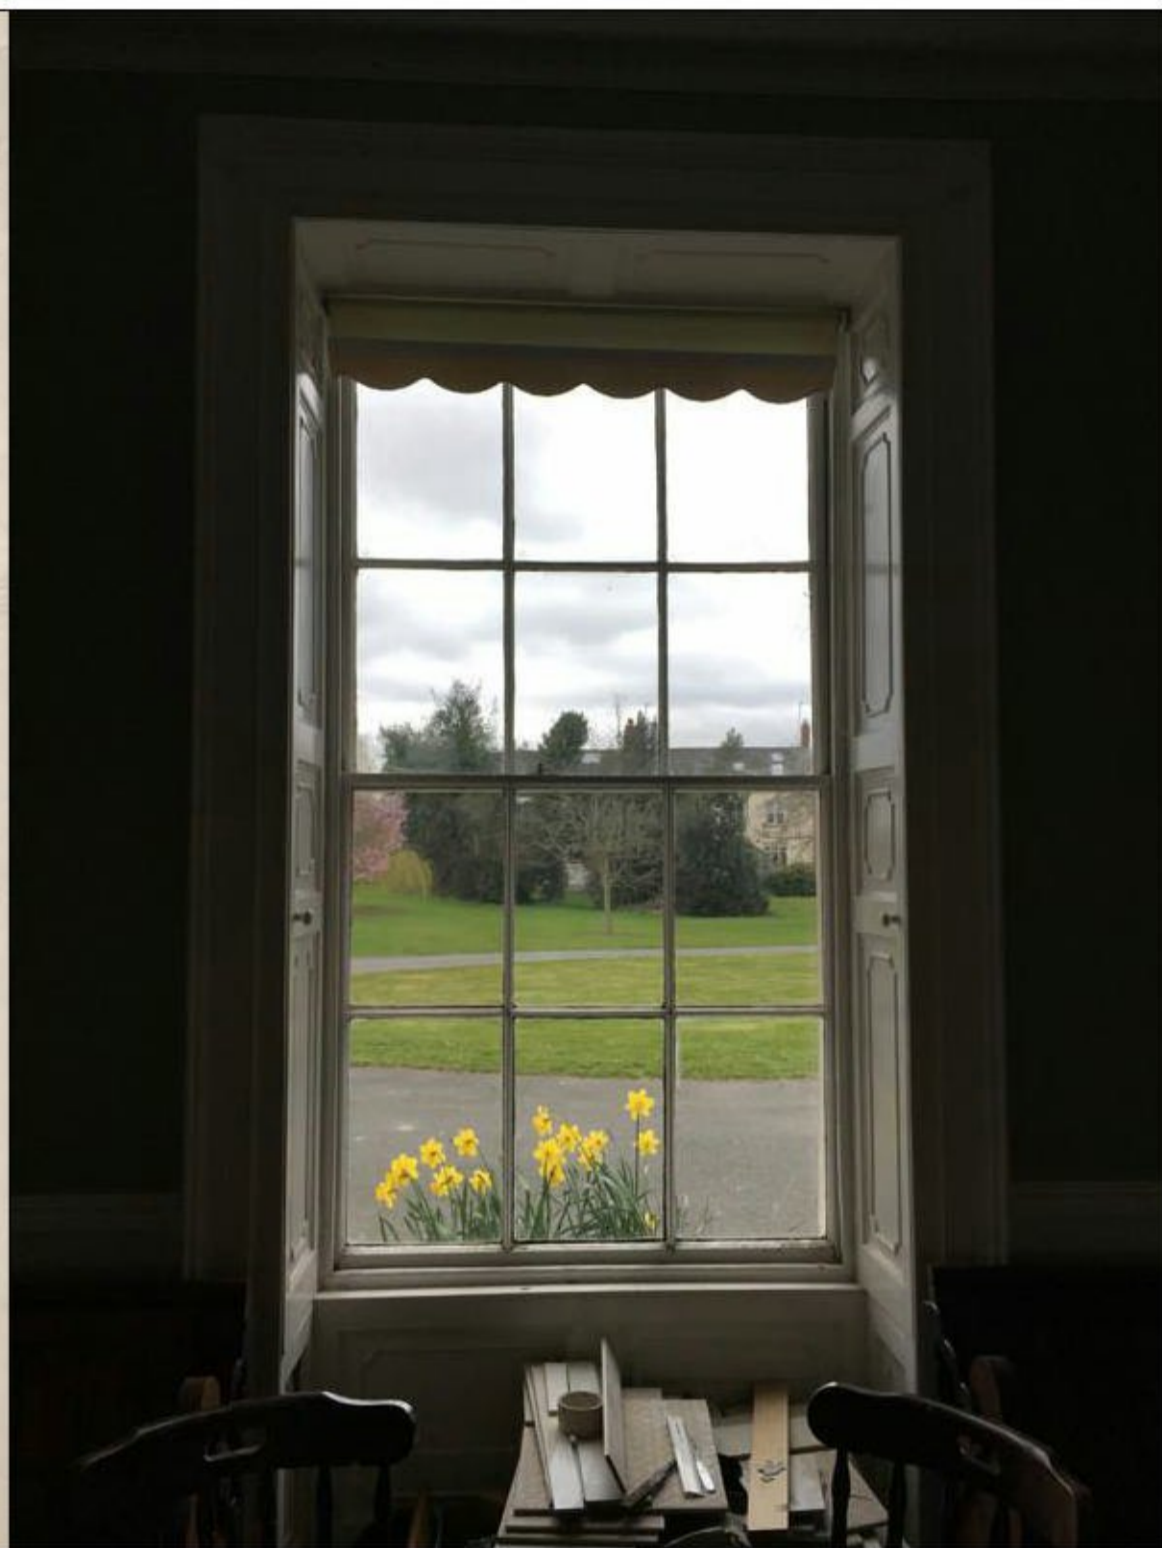
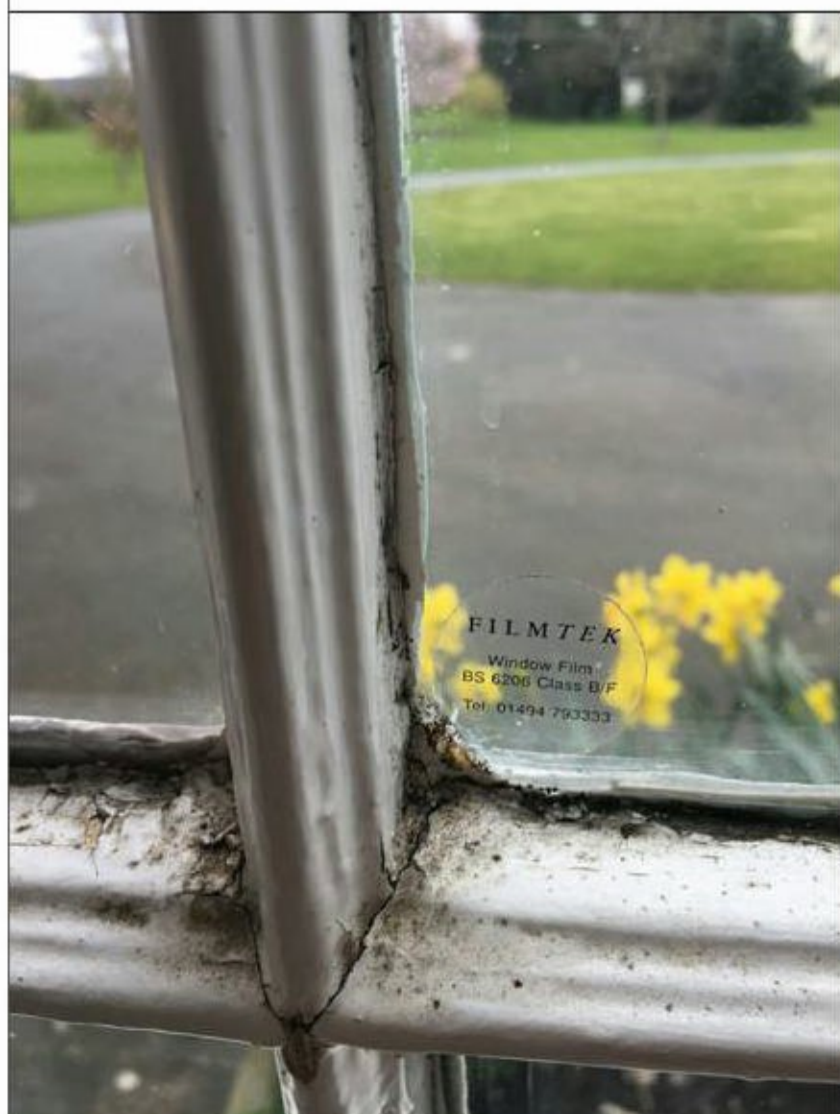
Photo Location - West_Window Number **W004** - See floor plans for location

Located with 1750's section of the building

Condition - fair in need of refurbishment

Frame - Presumed Non Original

Glass - Presumed Non Original

· Replacement window

it has been advised by a window restorer and fabricator that there is not enough good quality frame left to simply refurbish this window.
