Building Recording - Ground Floor

External and Internal Windows

showing existing photos, noted location, frame condition, glass condition and proposed refurbishment works.

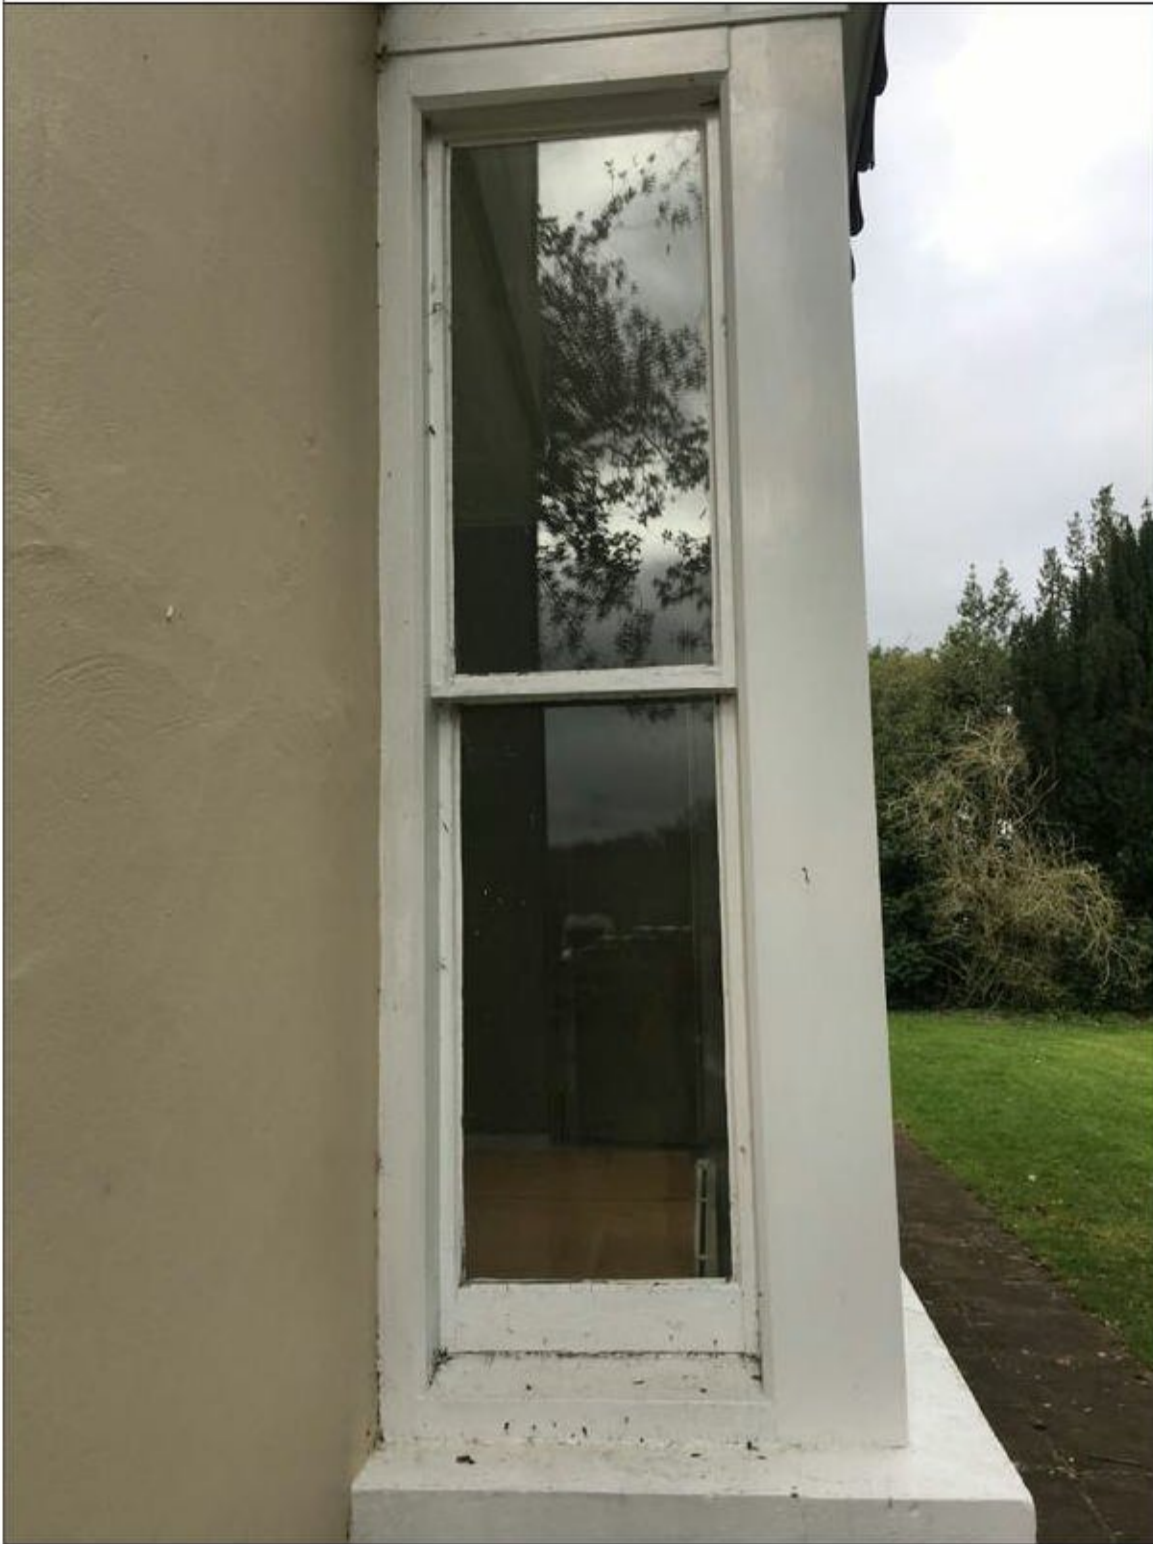
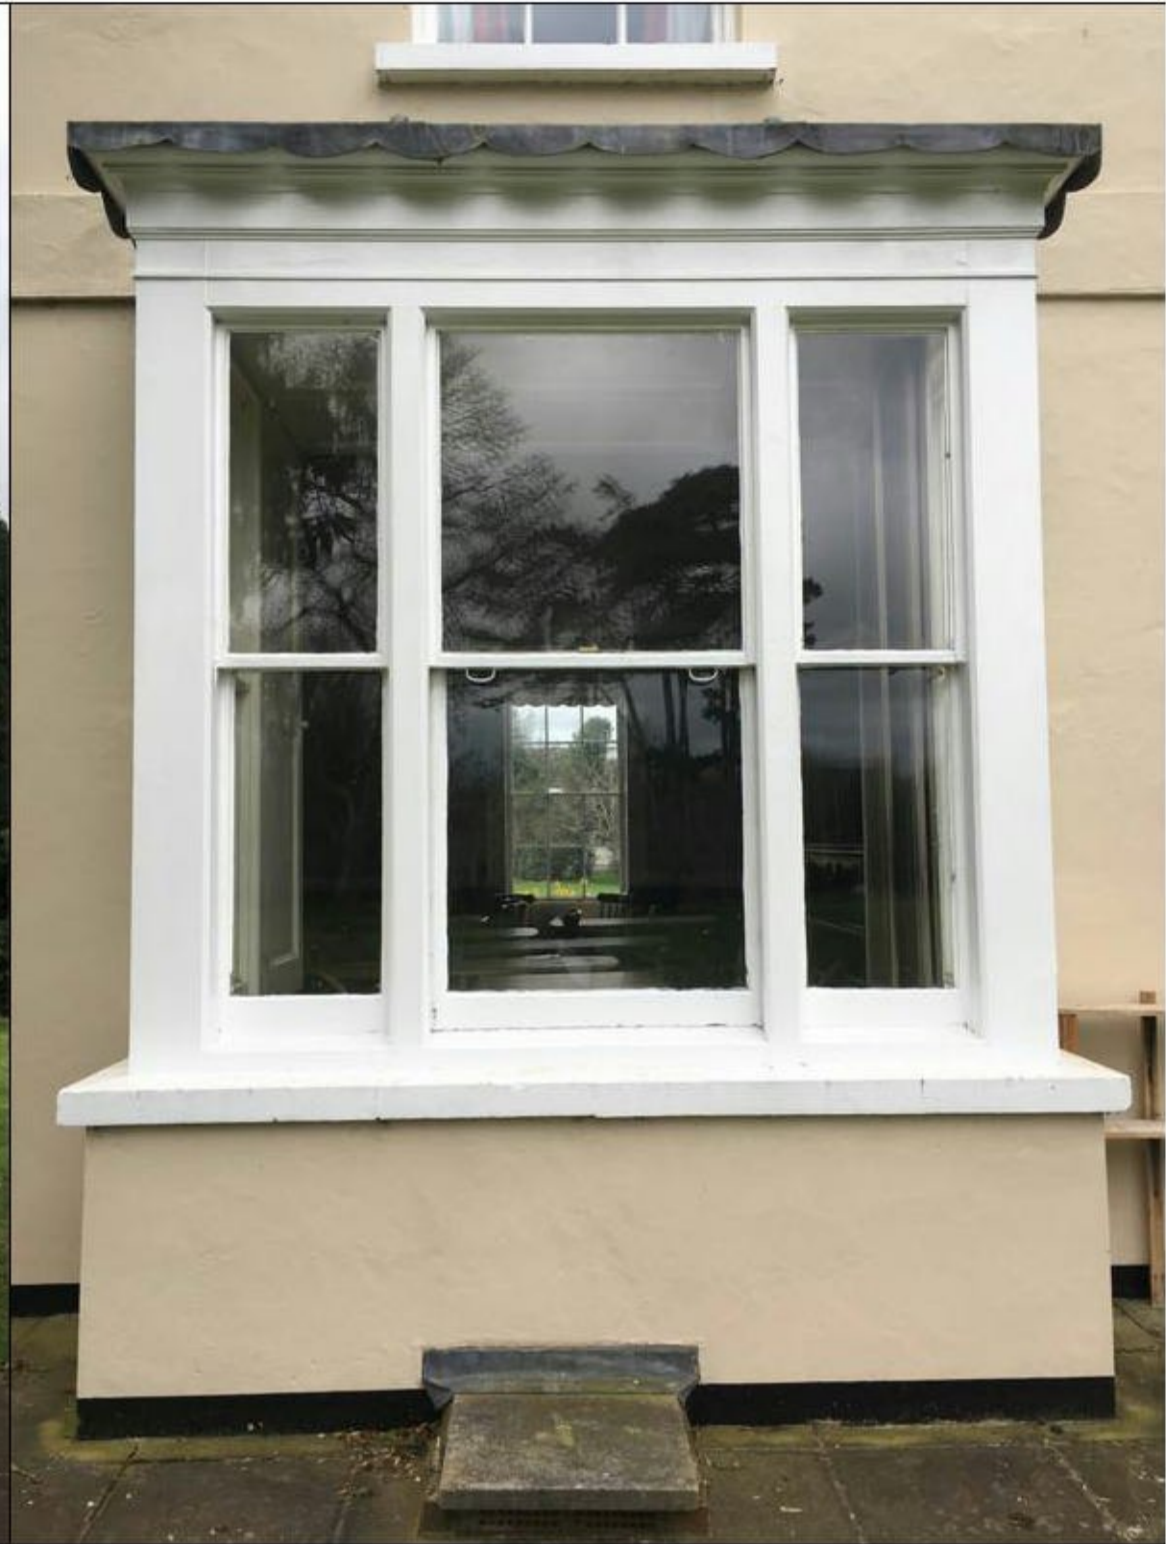
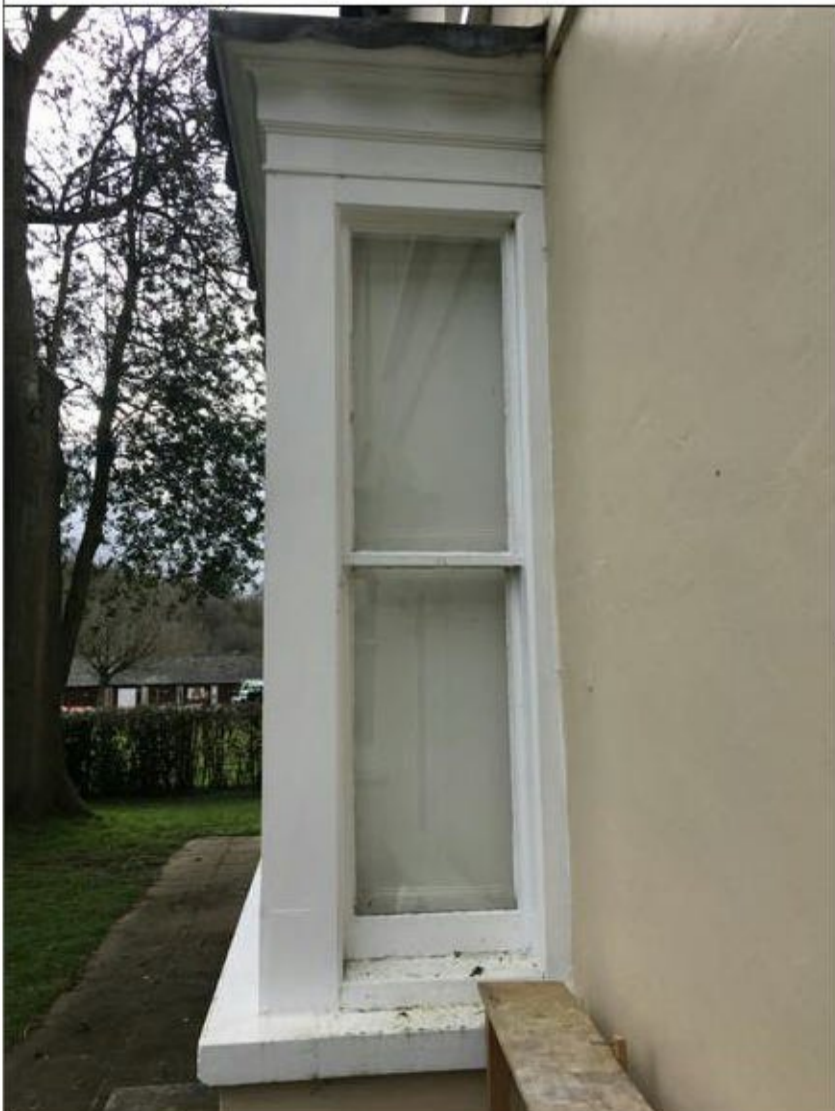
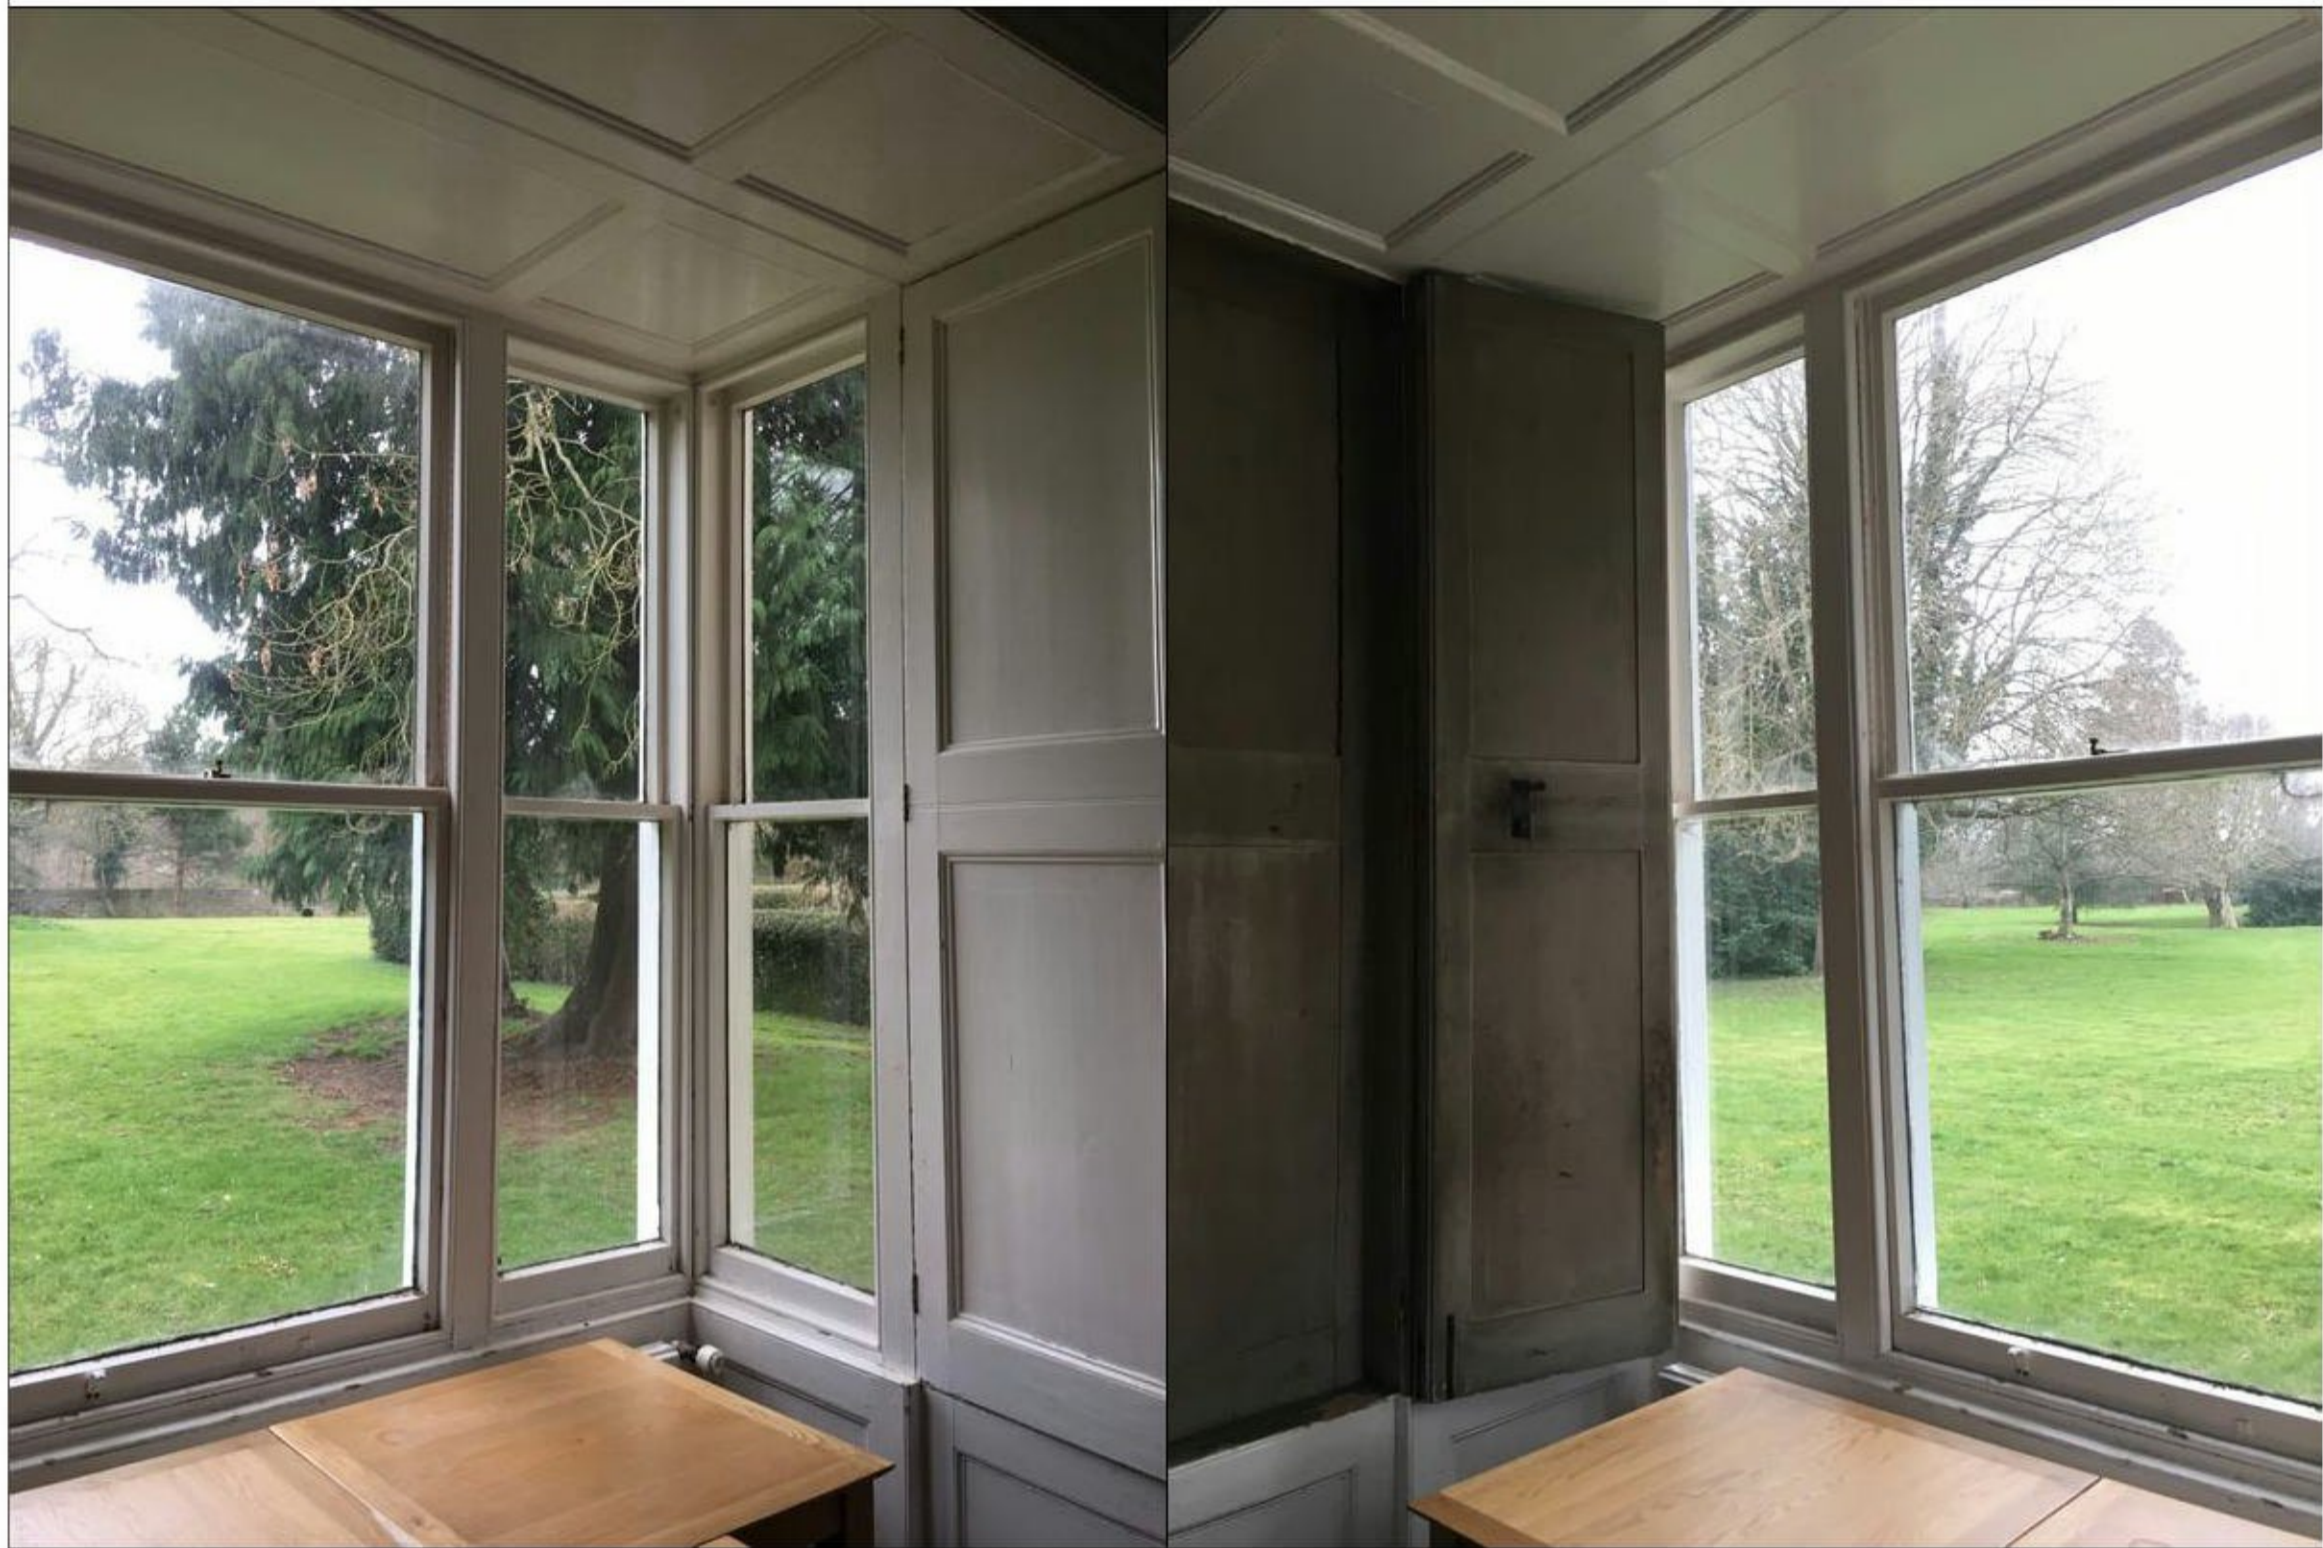
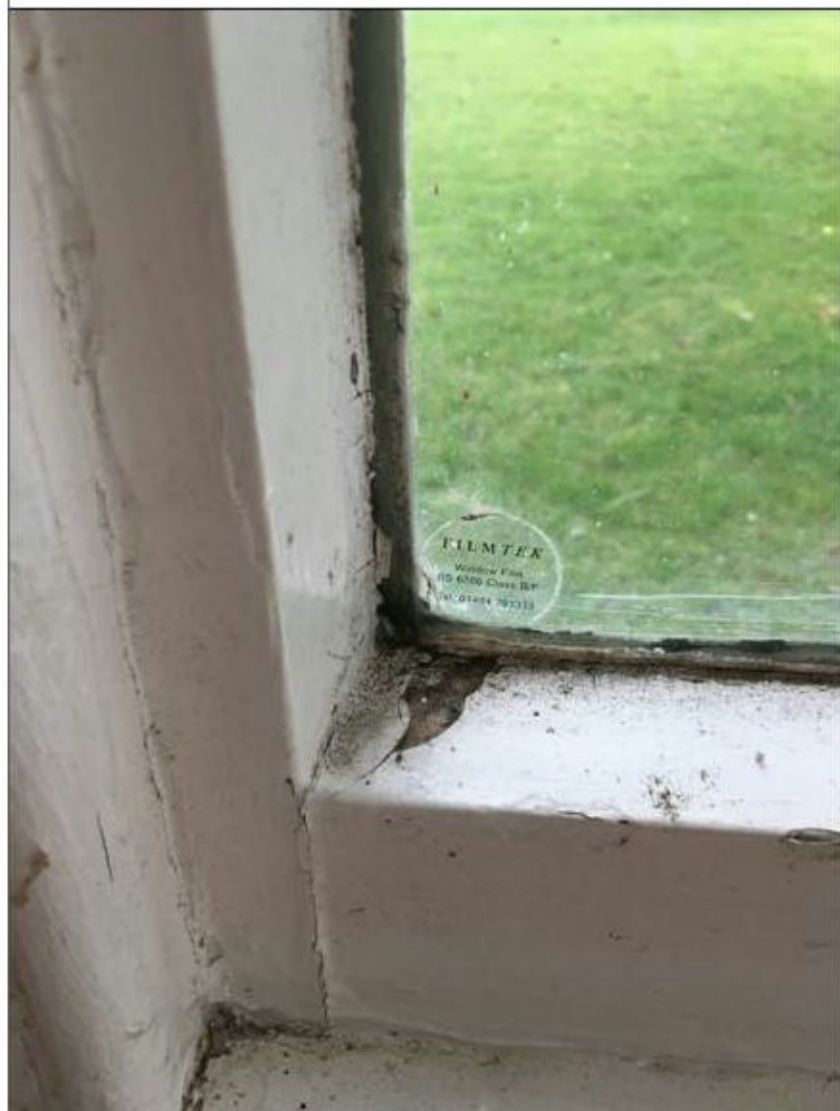
Photo Location - East_Window Number **W005** - See floor plans for location

Located with 1750's section of the building

Condition - fair in need of refurbishment

Frame - Presumed Non Original

Glass - Presumed Non Original

- Refurbish and re paint only if possible

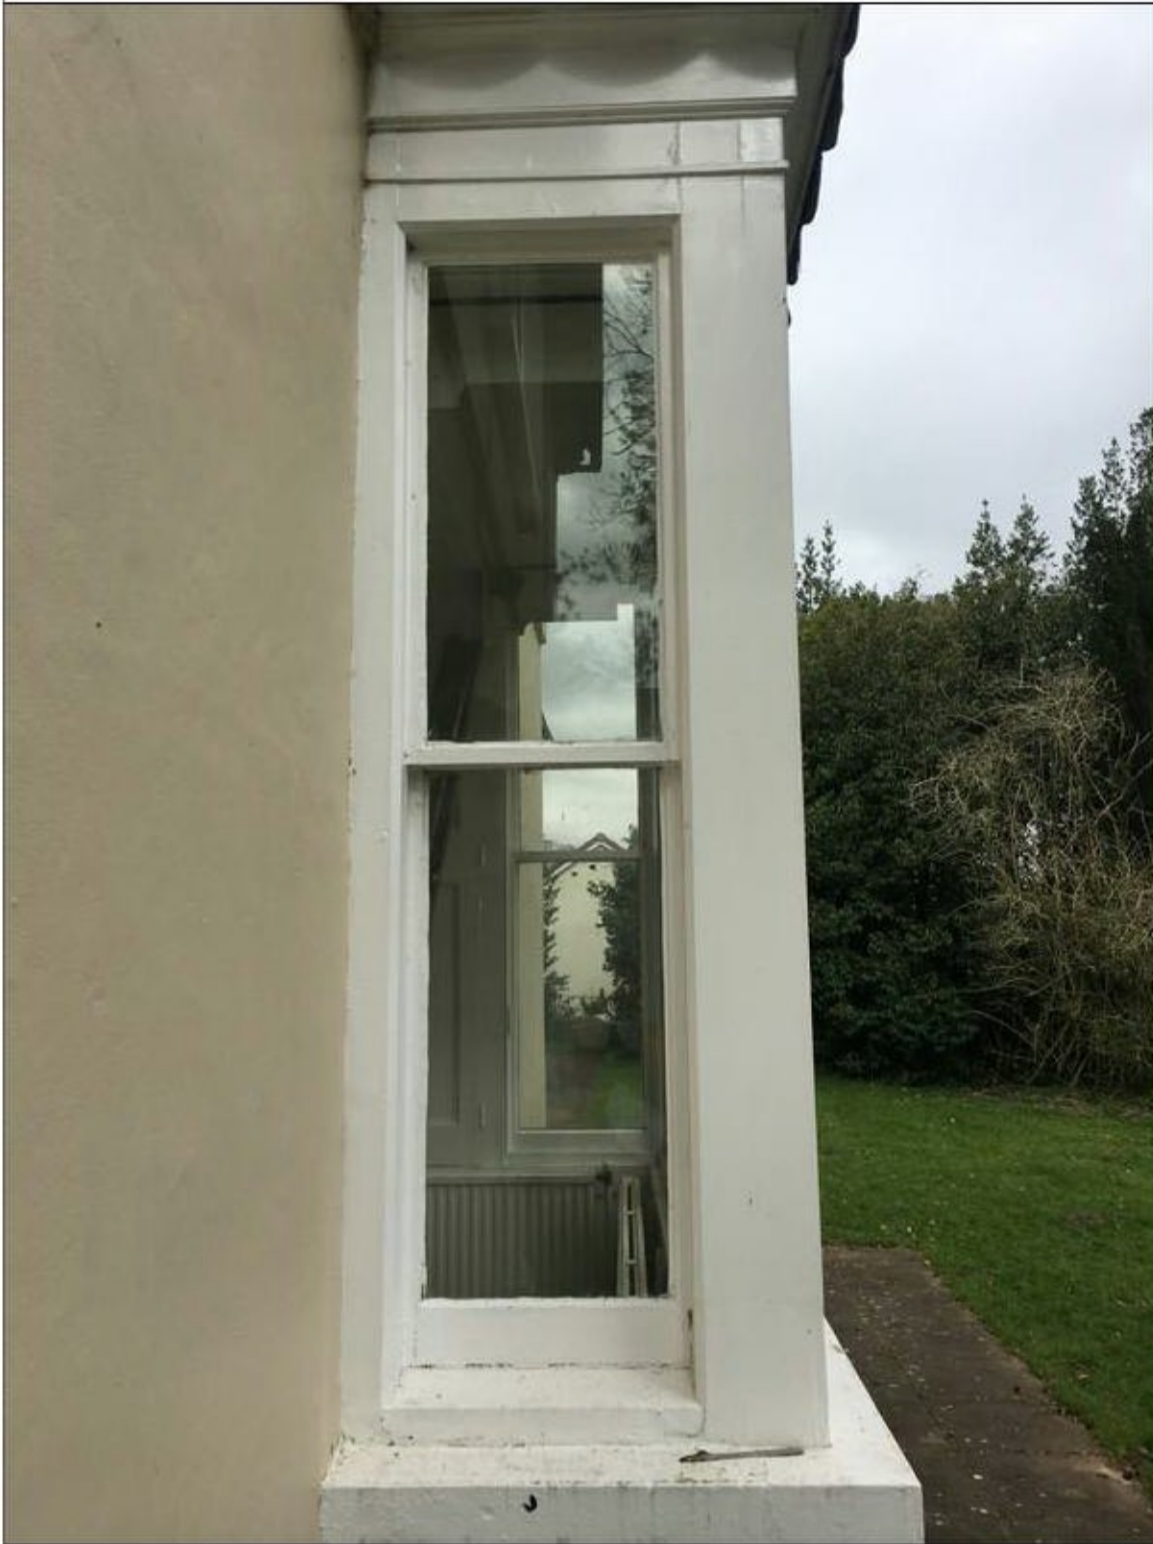
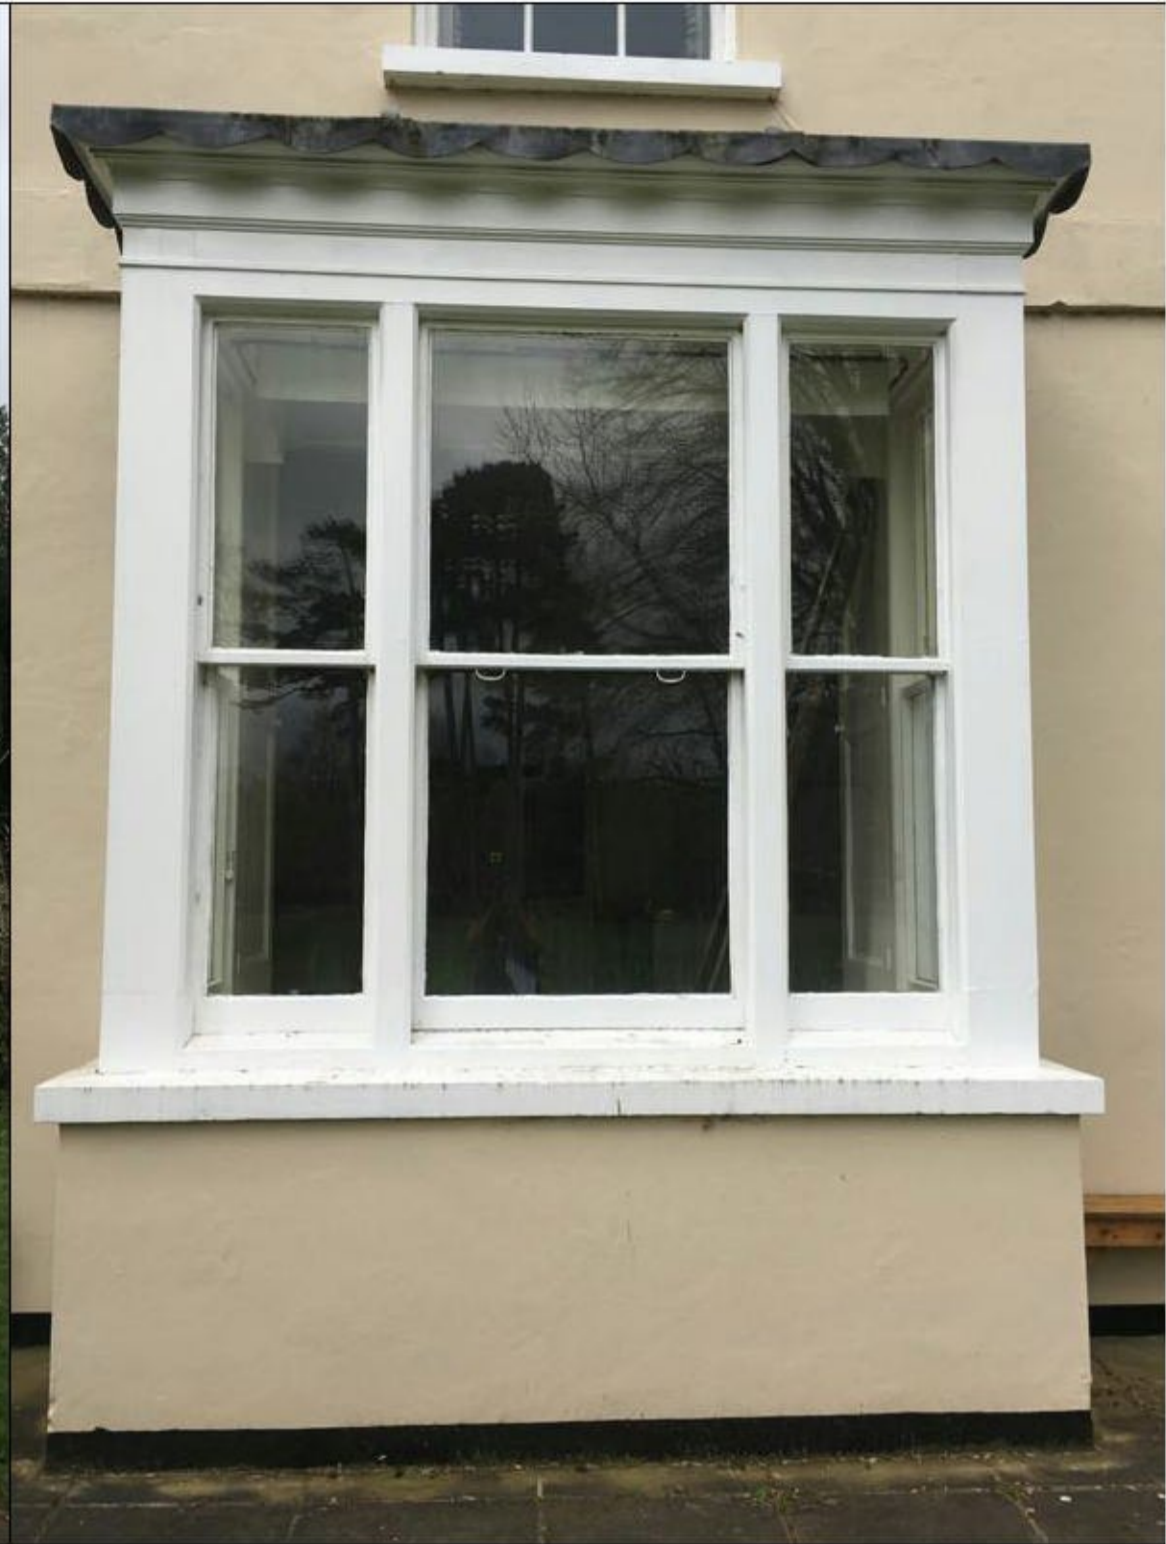
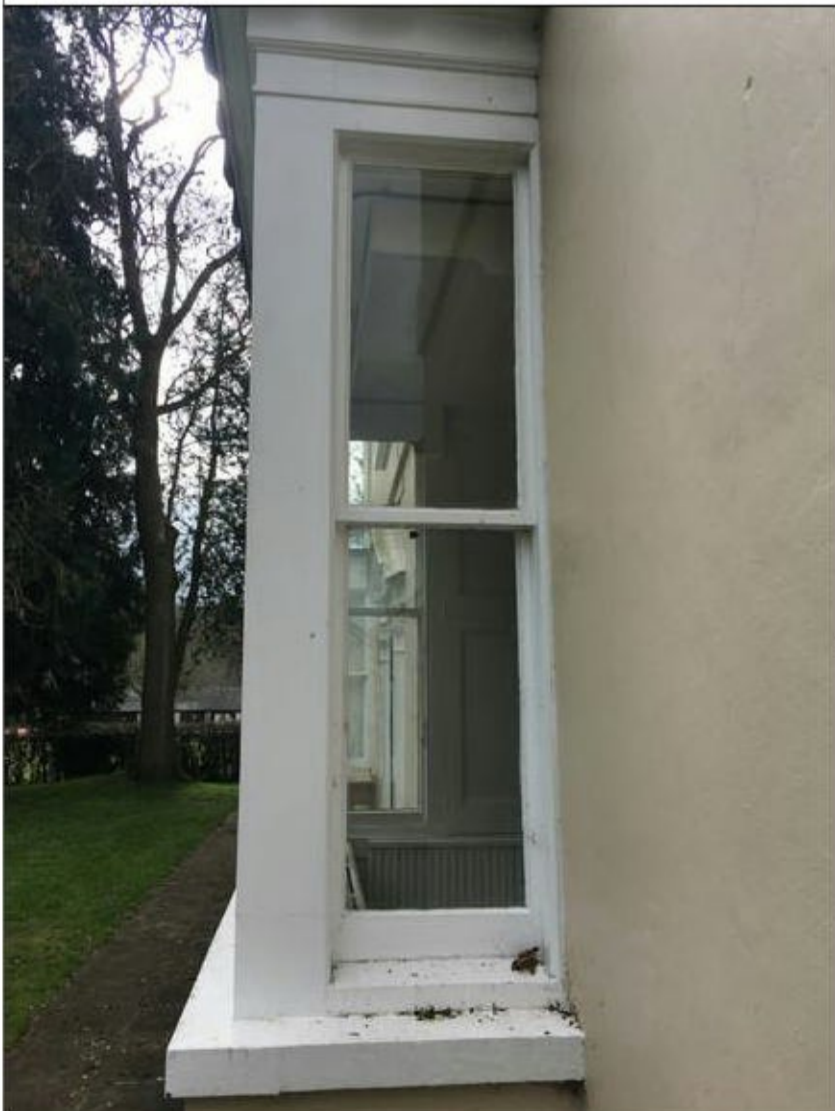
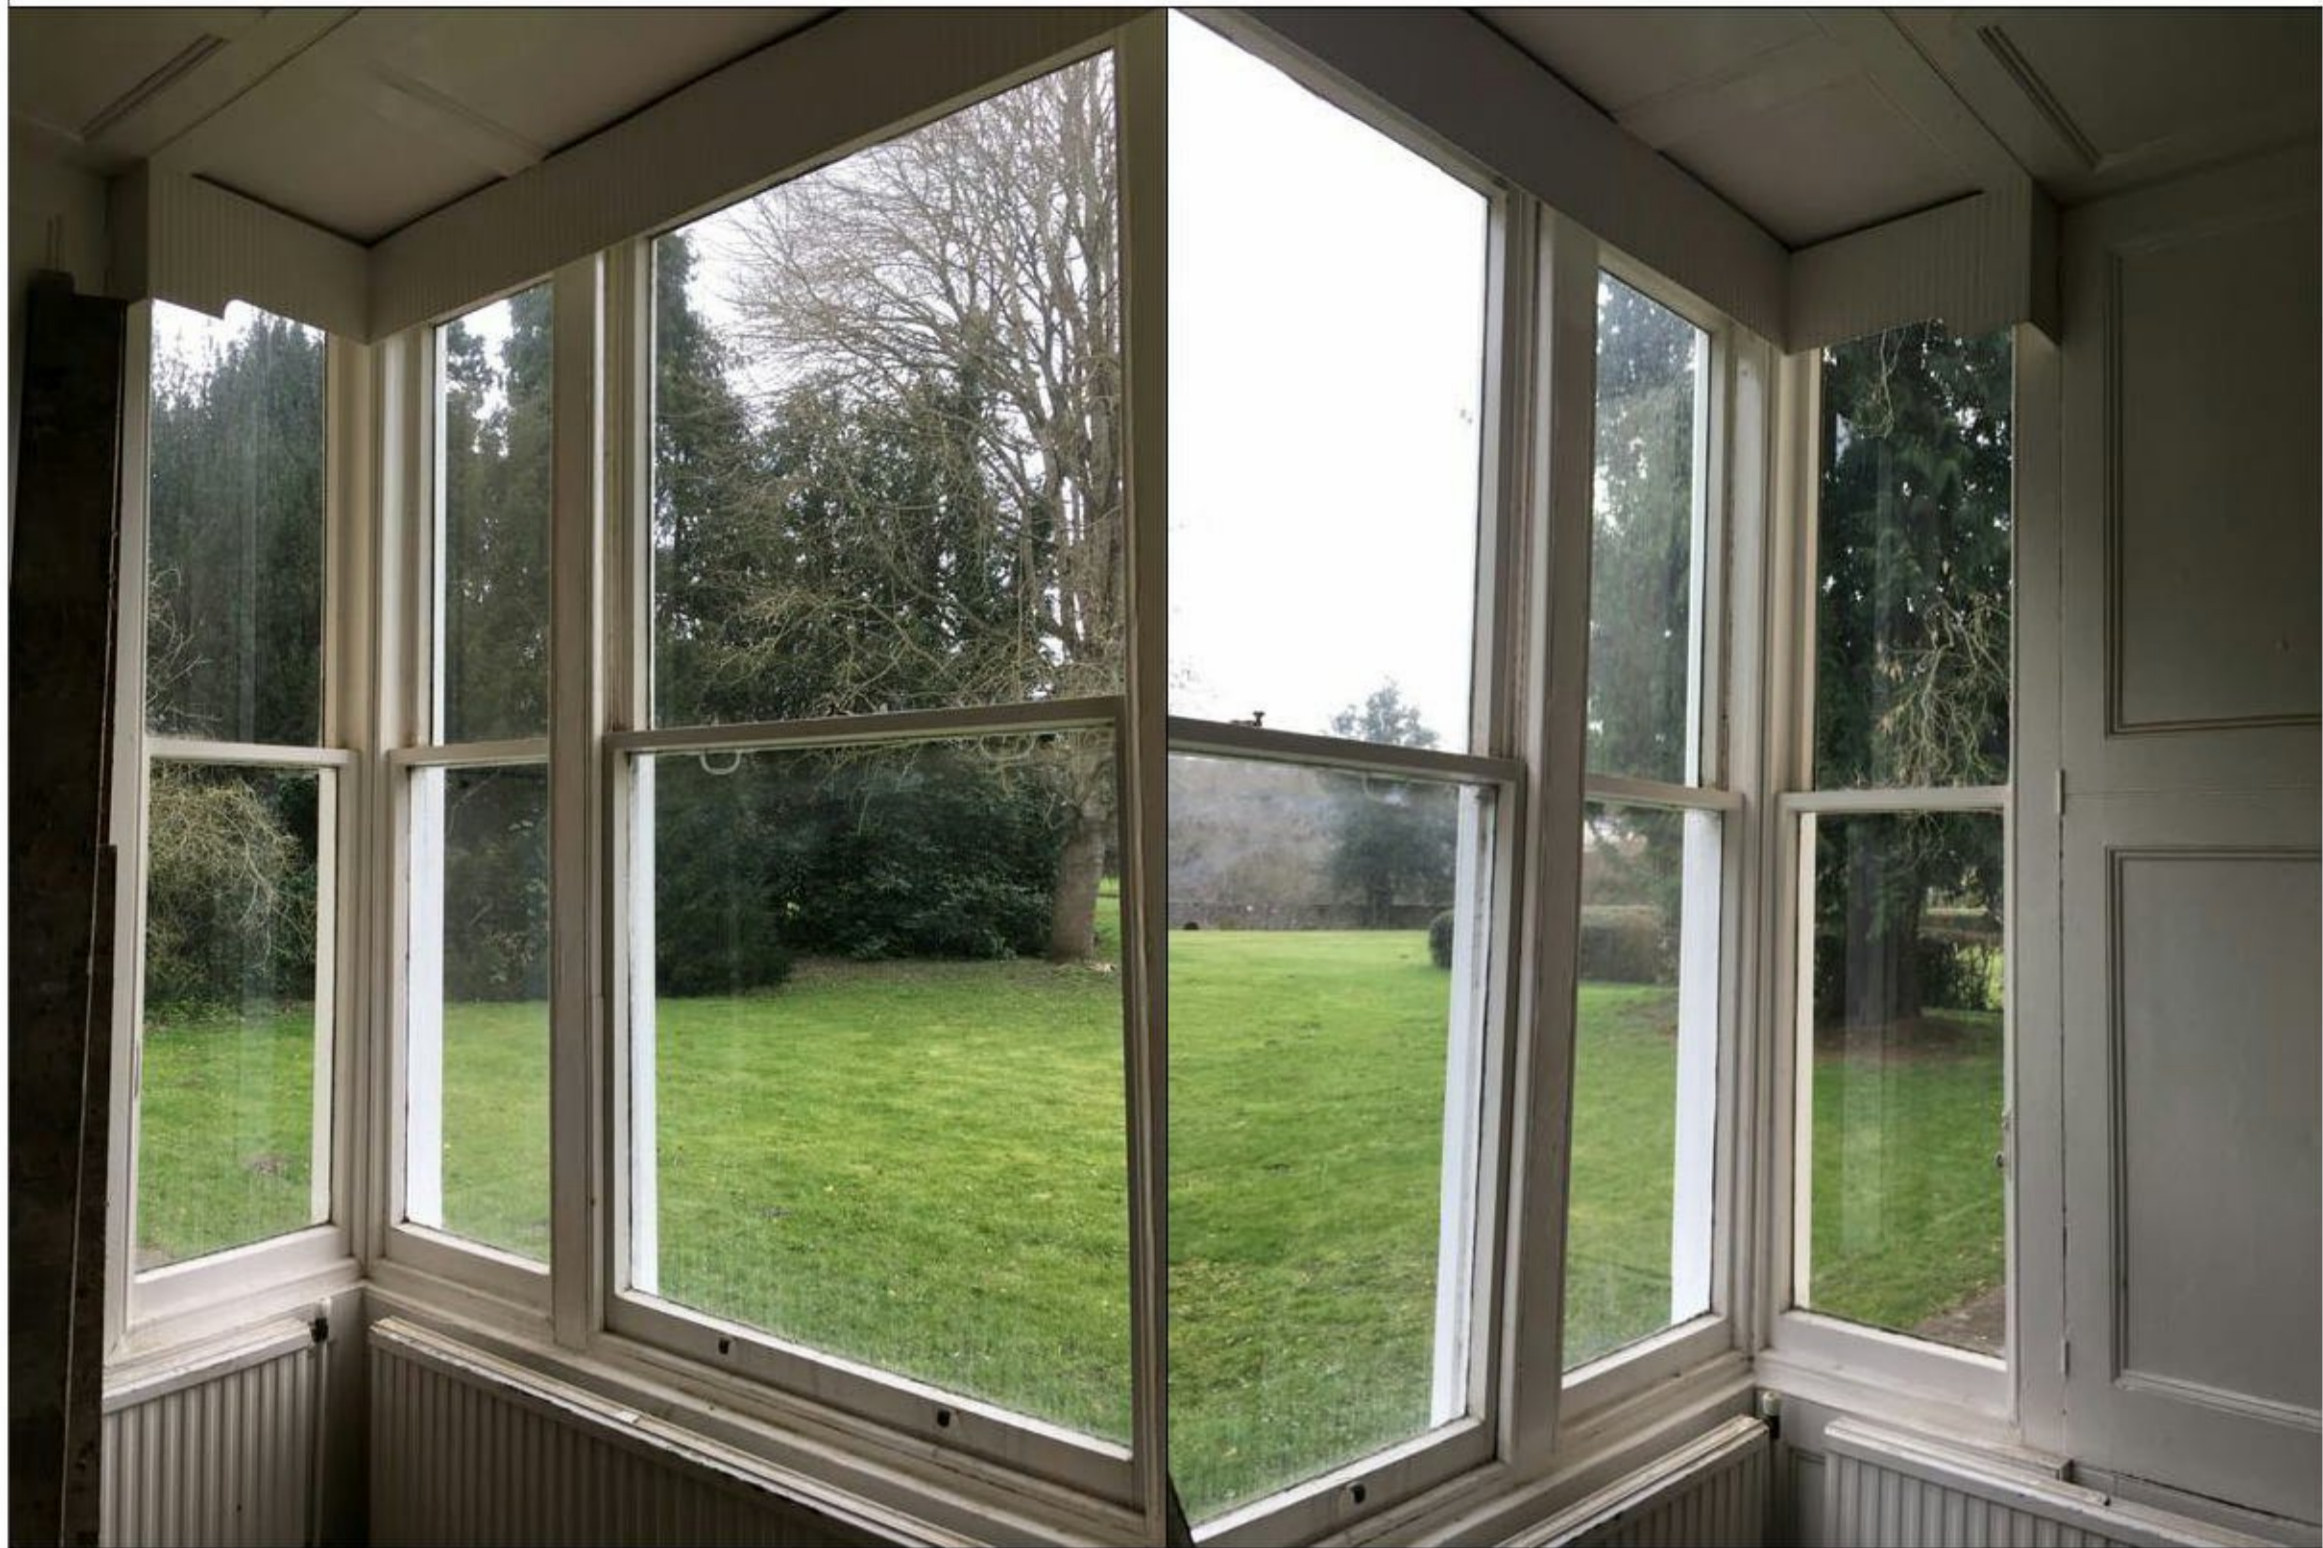
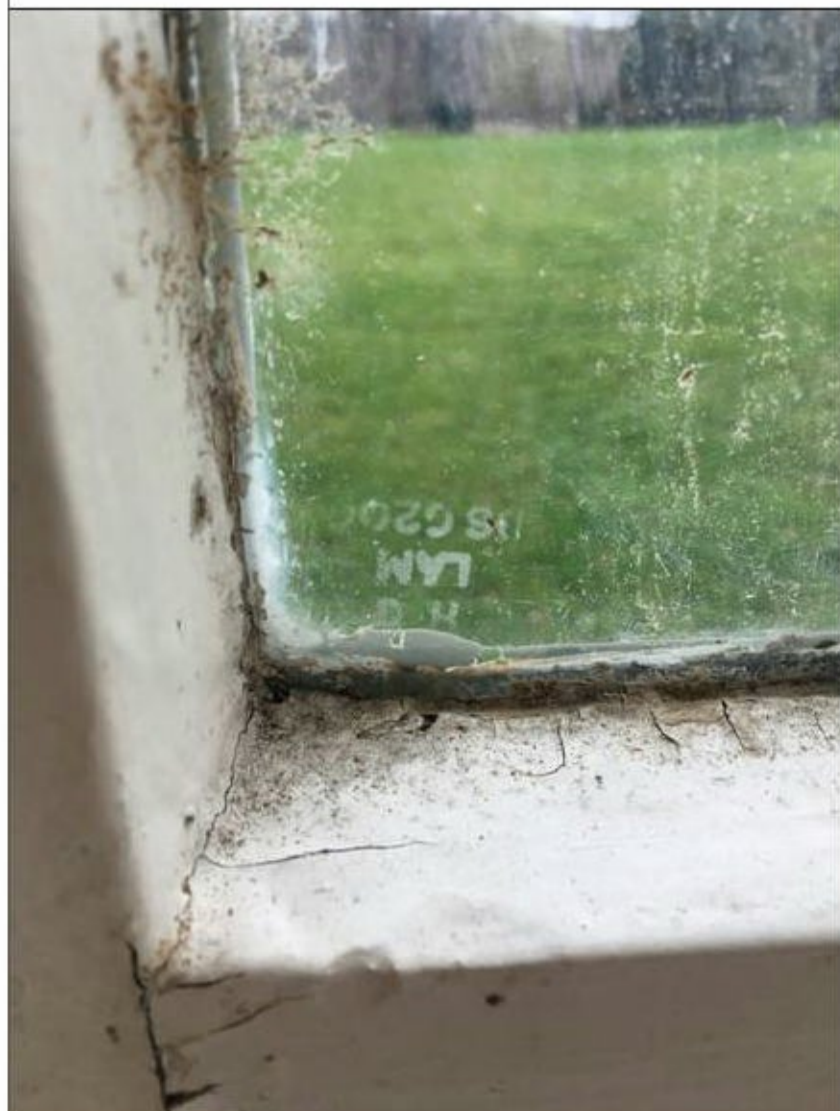
Photo Location - East_Window Number **W006** - See floor plans for location

Located with 1750's section of the building

Condition - fair in need of refurbishment

Frame - Presumed Non Original

Glass - Presumed Non Original

- Refurbish and re paint only if possible

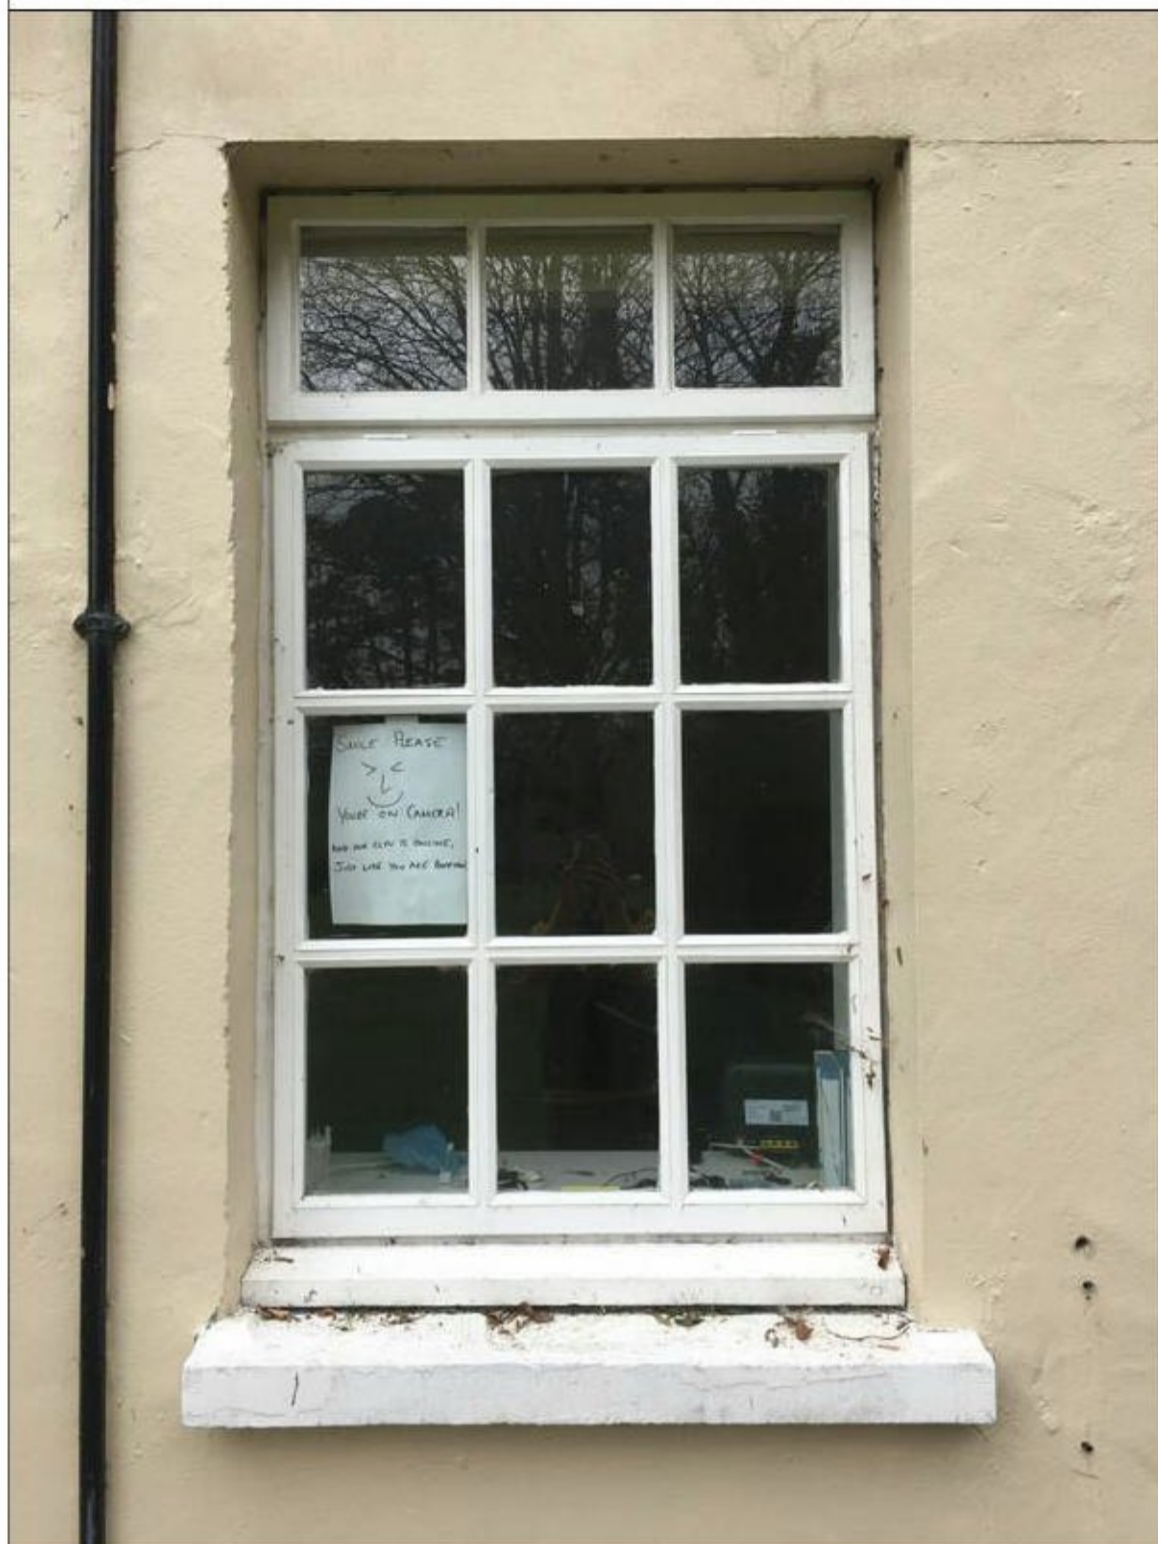
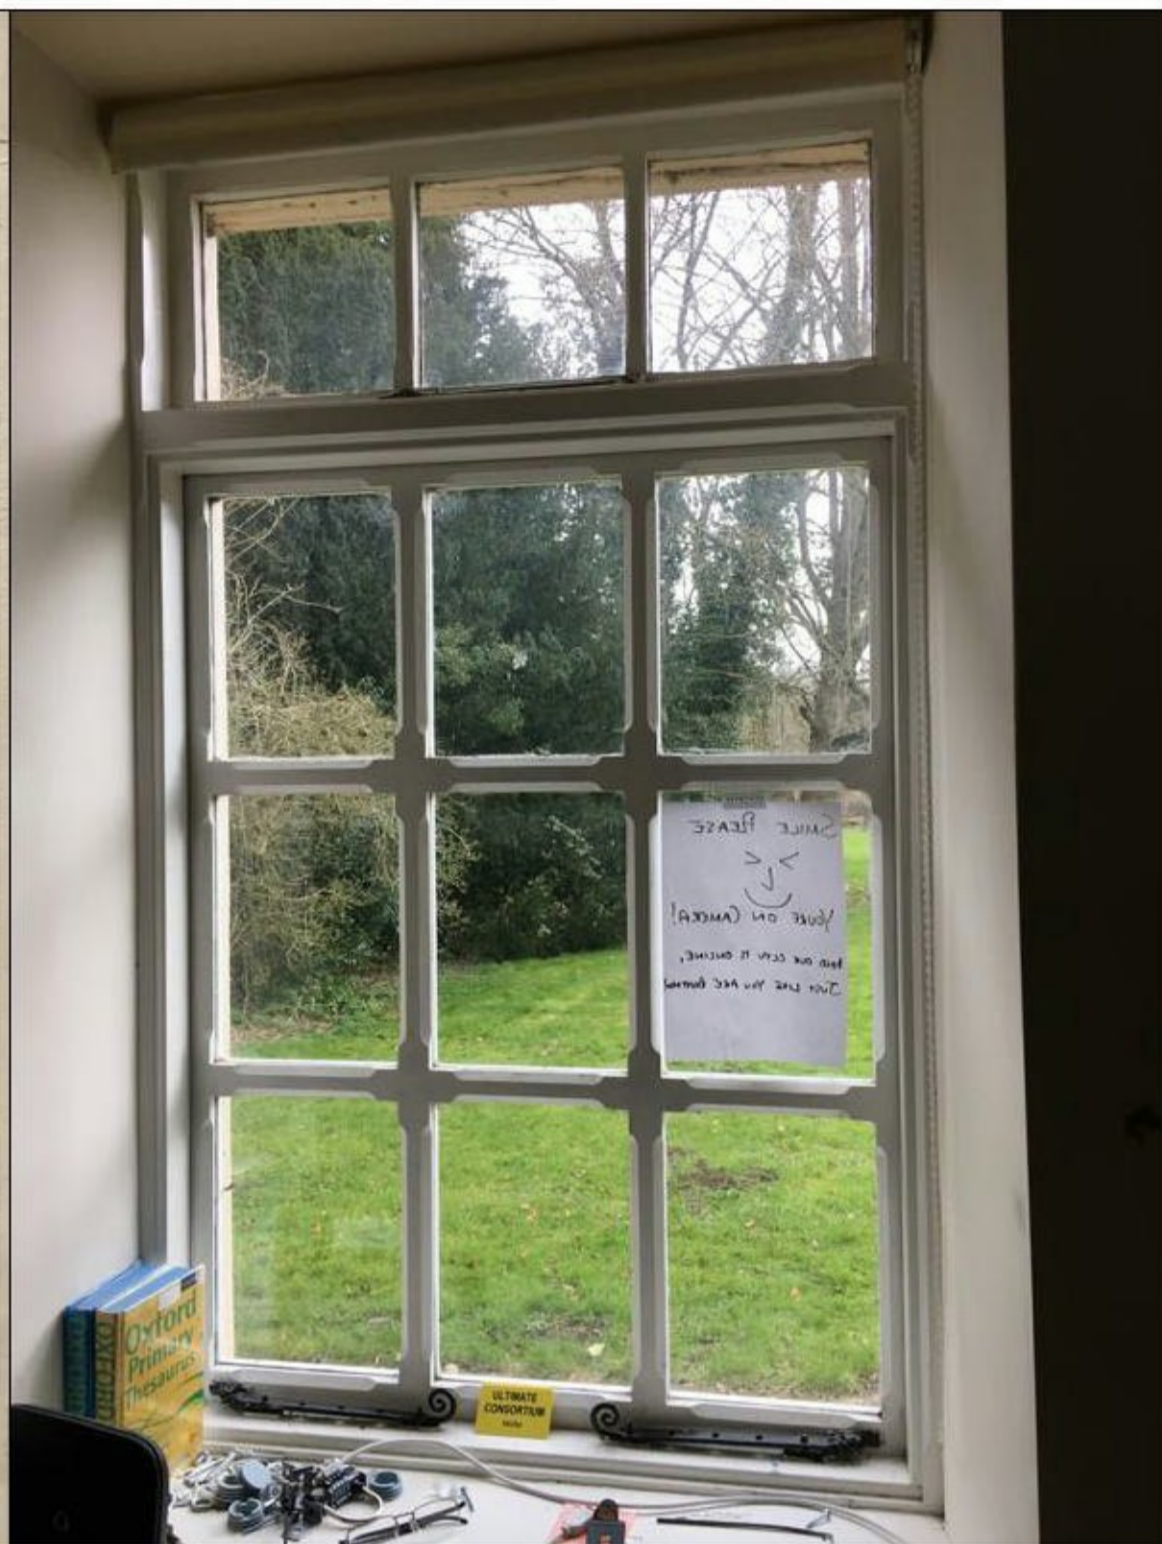
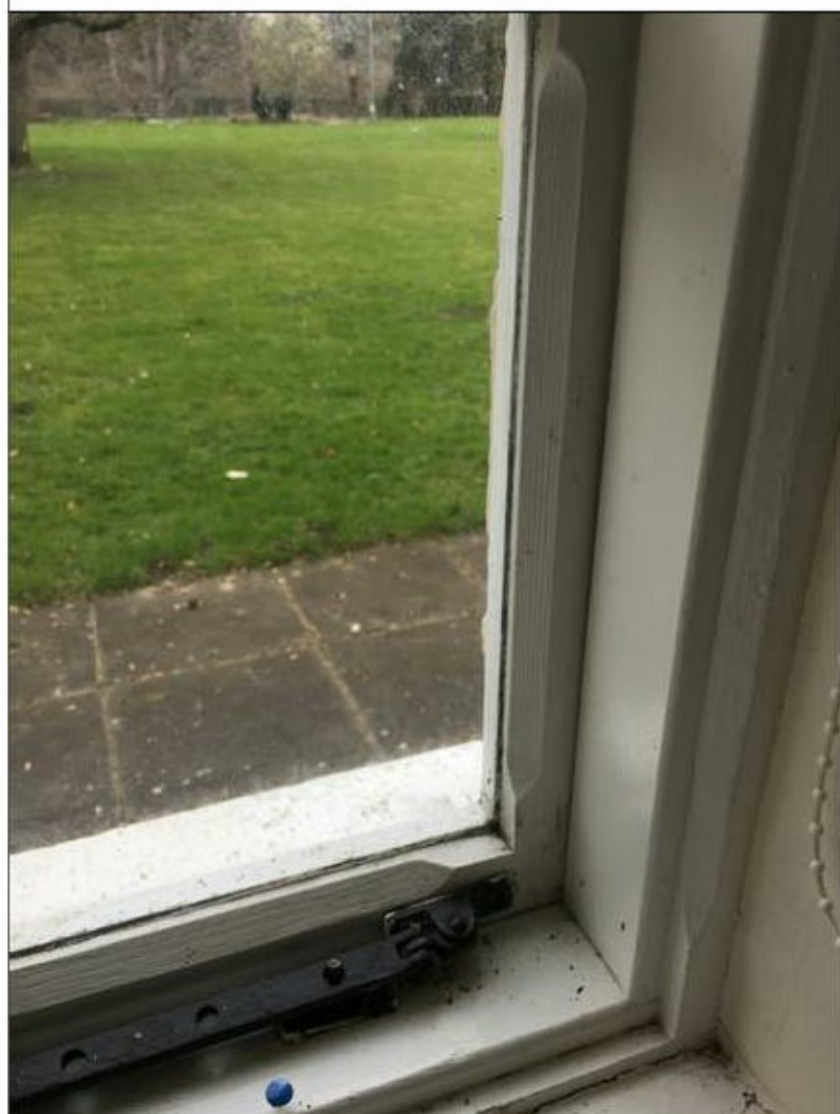
Photo Location - East_Window Number **W007** - See floor plans for location

Located with 1840's section of the building

Condition - Good

Frame - Presumed Non original

Glass - Presumed Non original

- Refurbish and re paint, but this may need replacing if during the refurbishment that the window condition is too poor to enable refurbishment.
