Building Recording - Ground Floor

External and Internal Windows

showing existing photos, noted location, frame condition, glass condition and proposed refurbishment works.

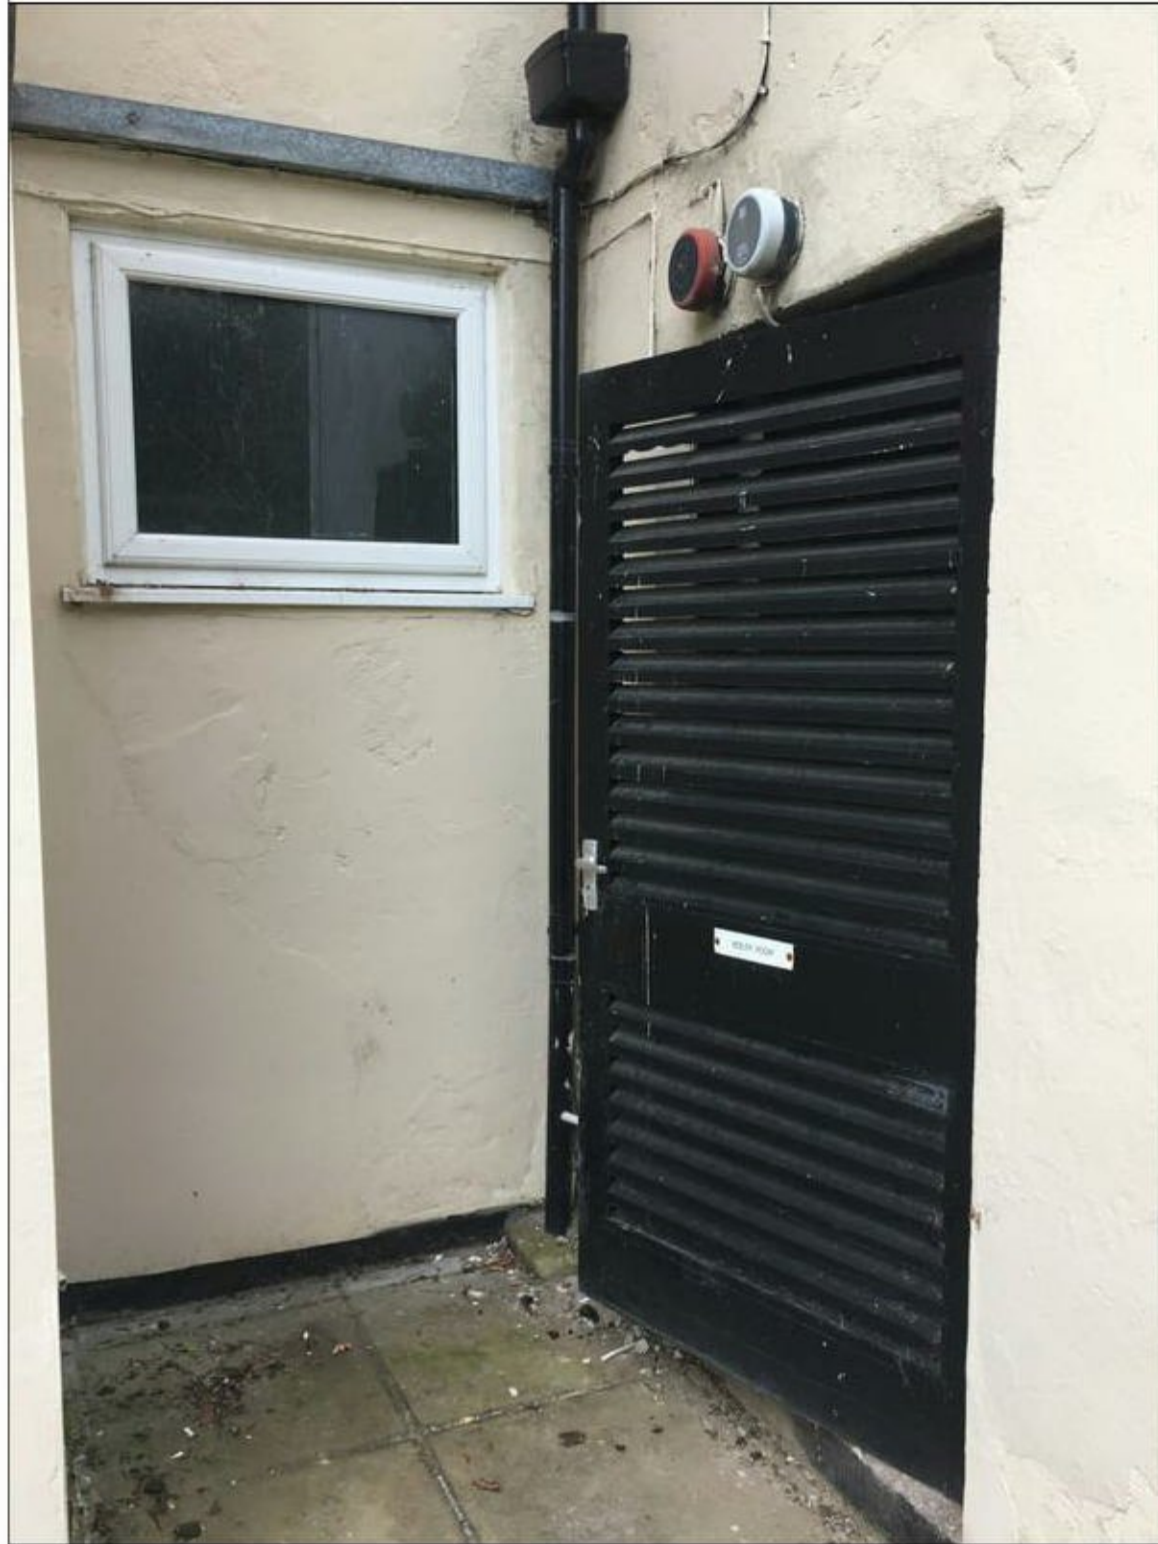
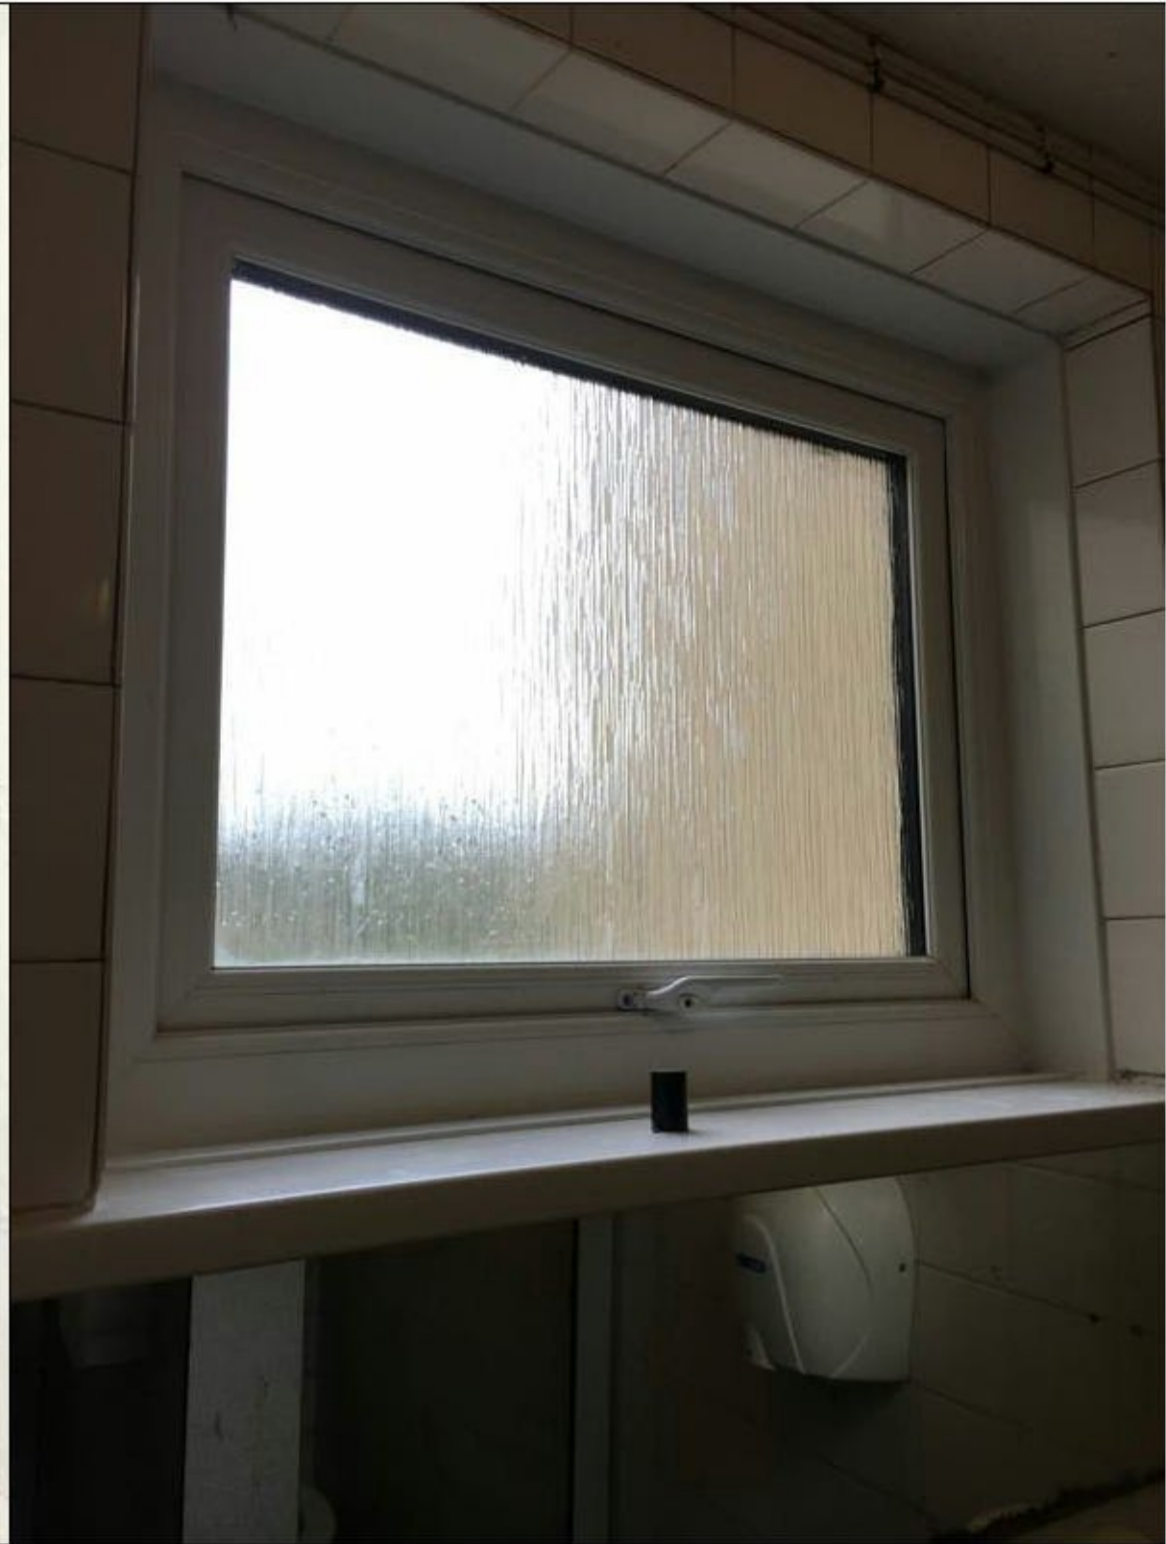
Photo Location - East_Window Number **W008** - See floor plans for location

Located with 1990's section of the building

Condition - Good

Frame - Original

Glass - Original

· Removed and replaced with a door way,
see proposed works pages.

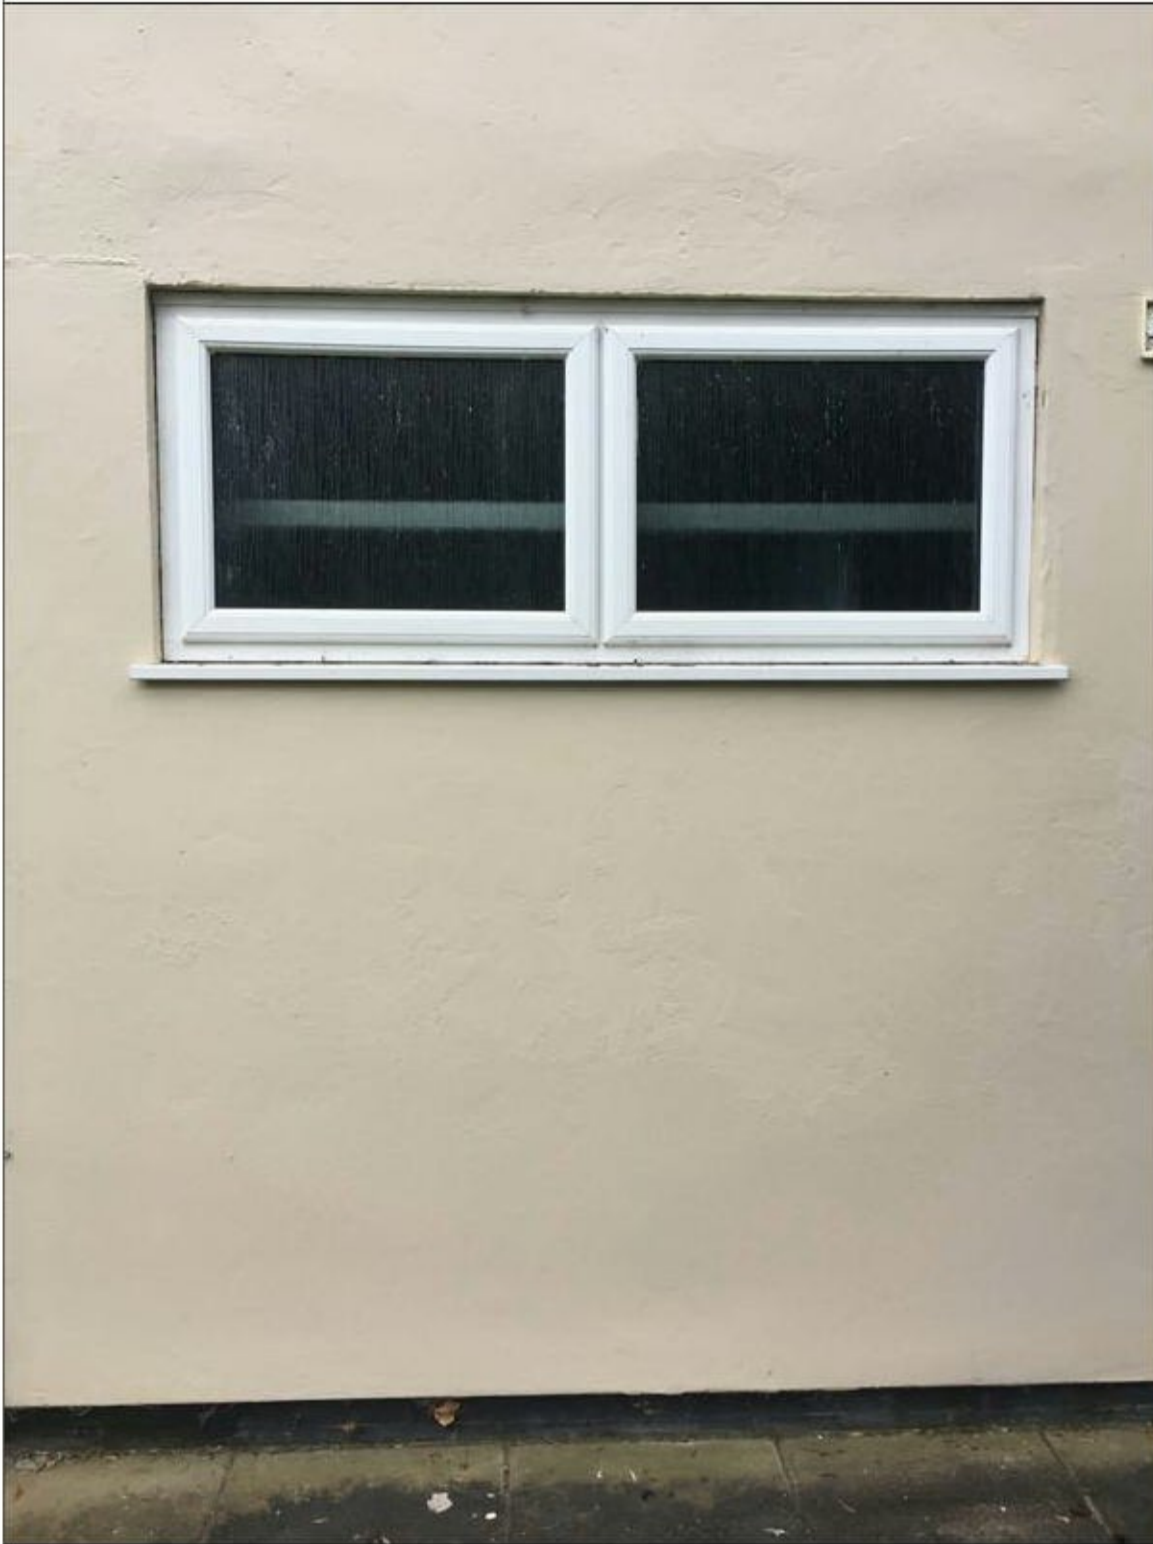
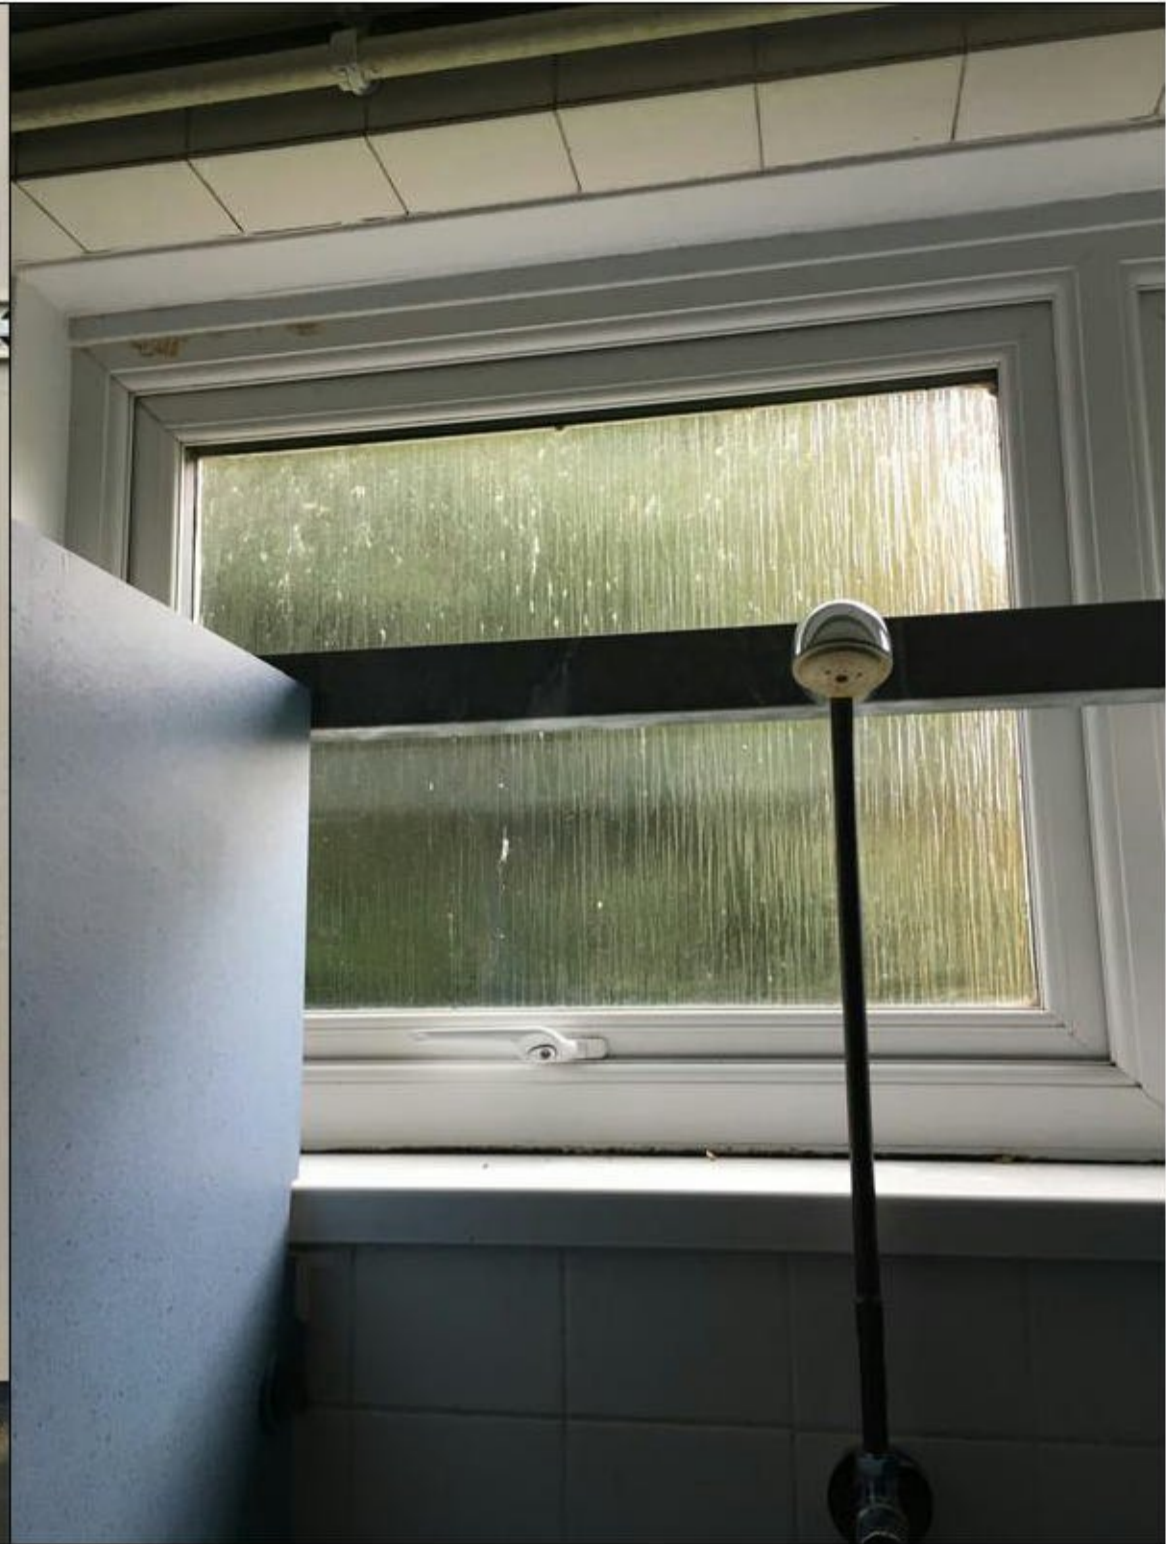
Photo Location - East_Window Number **W009** - See floor plans for location

Located with 1990's section of the building

Condition - Good

Frame - Original

Glass - Original

- To be replaced in the future with more in keeping windows

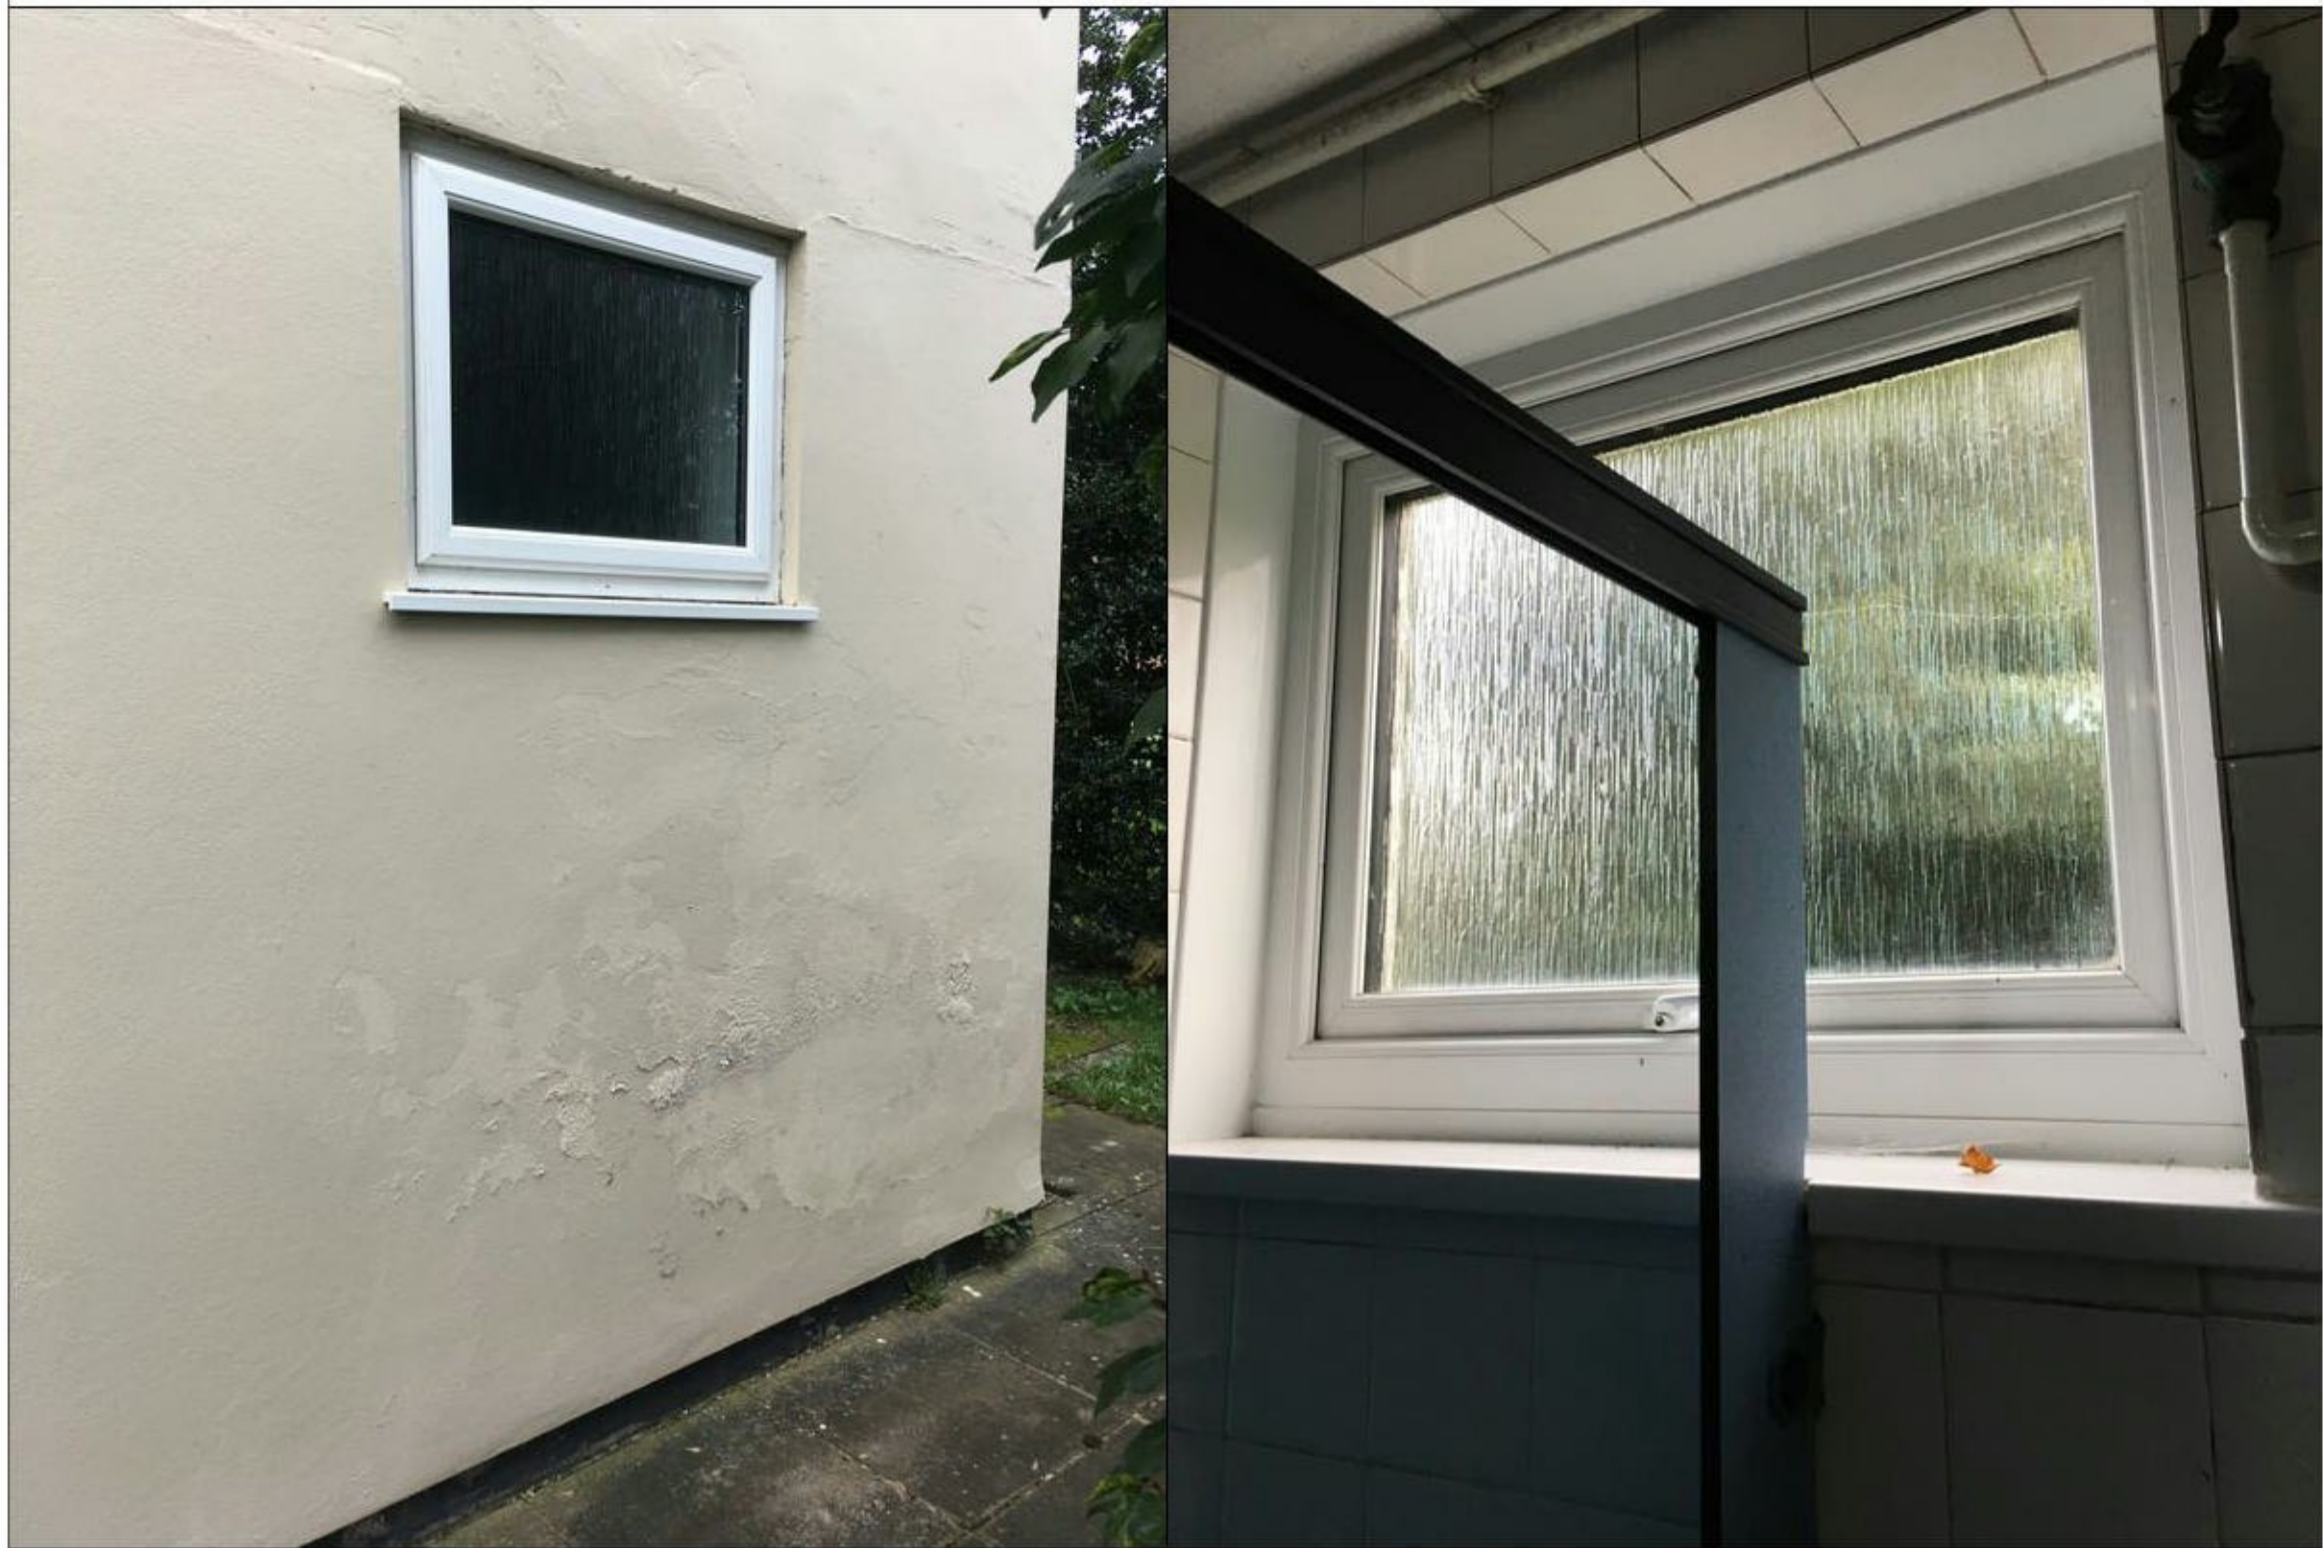
Photo Location - East_Window Number **W010** - See floor plans for location

Located with 1990's section of the building

Condition - Good

Frame - Original

Glass - Original

· Removed and replaced with a door way, see proposed works pages.

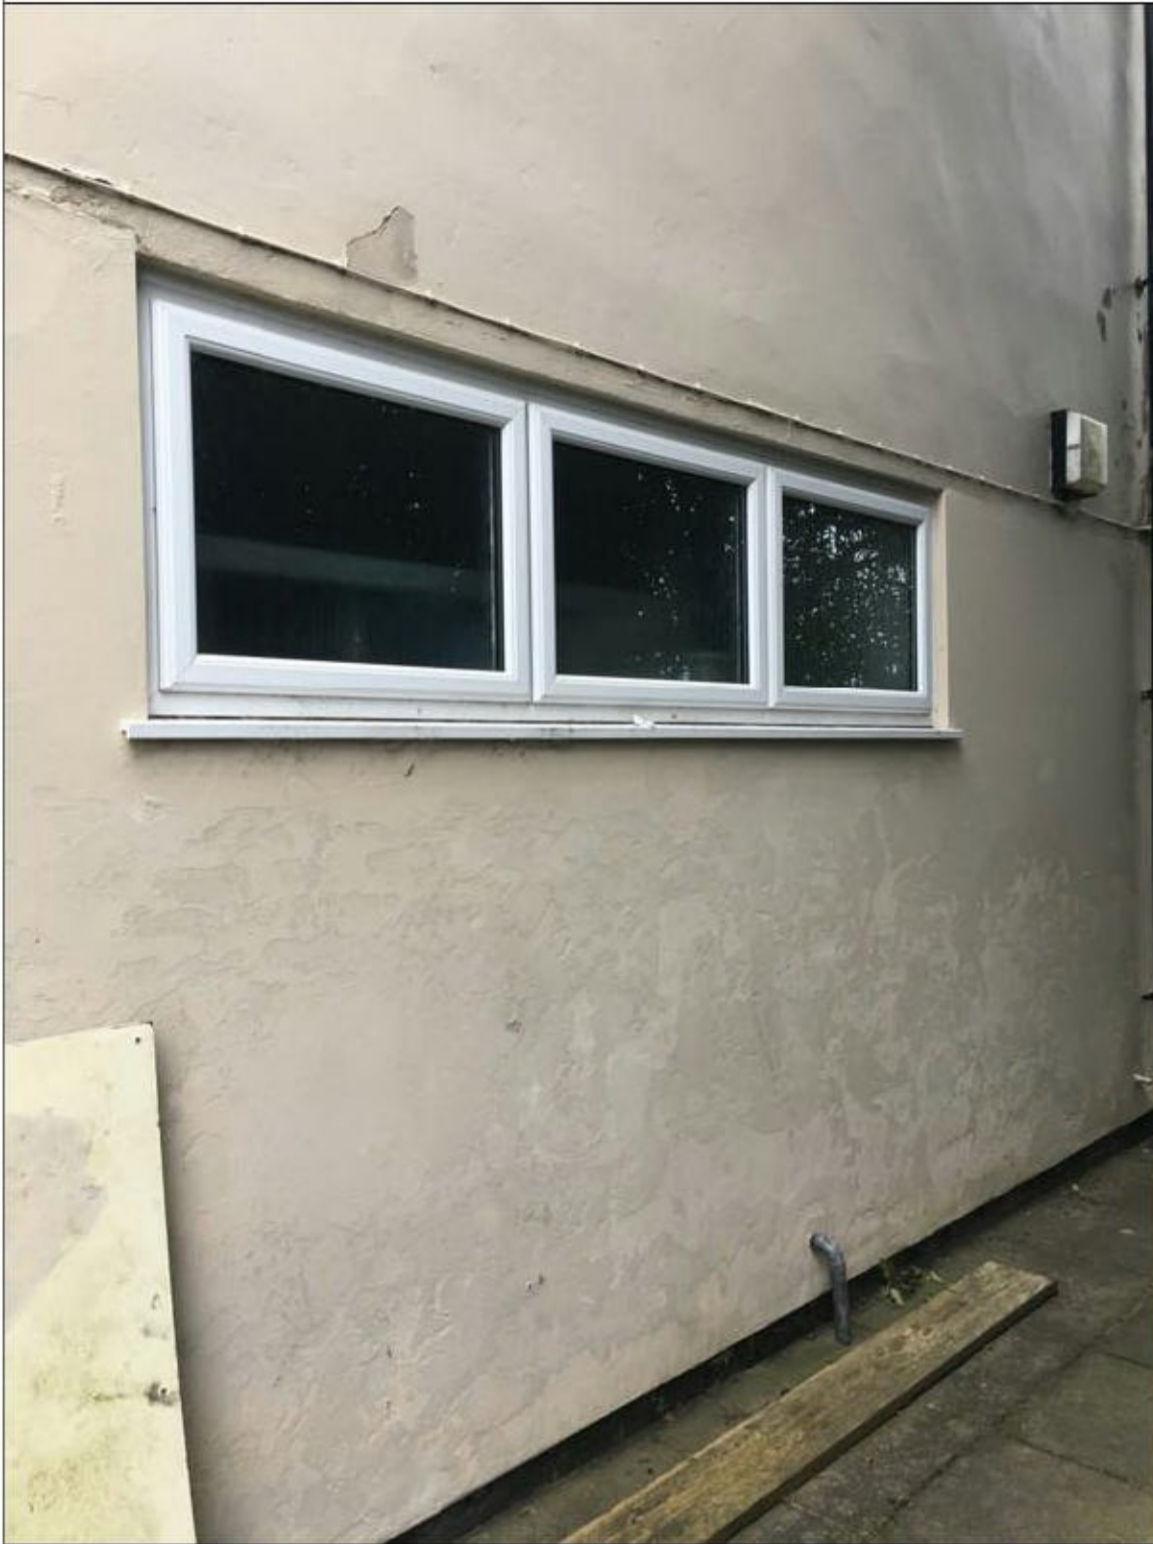
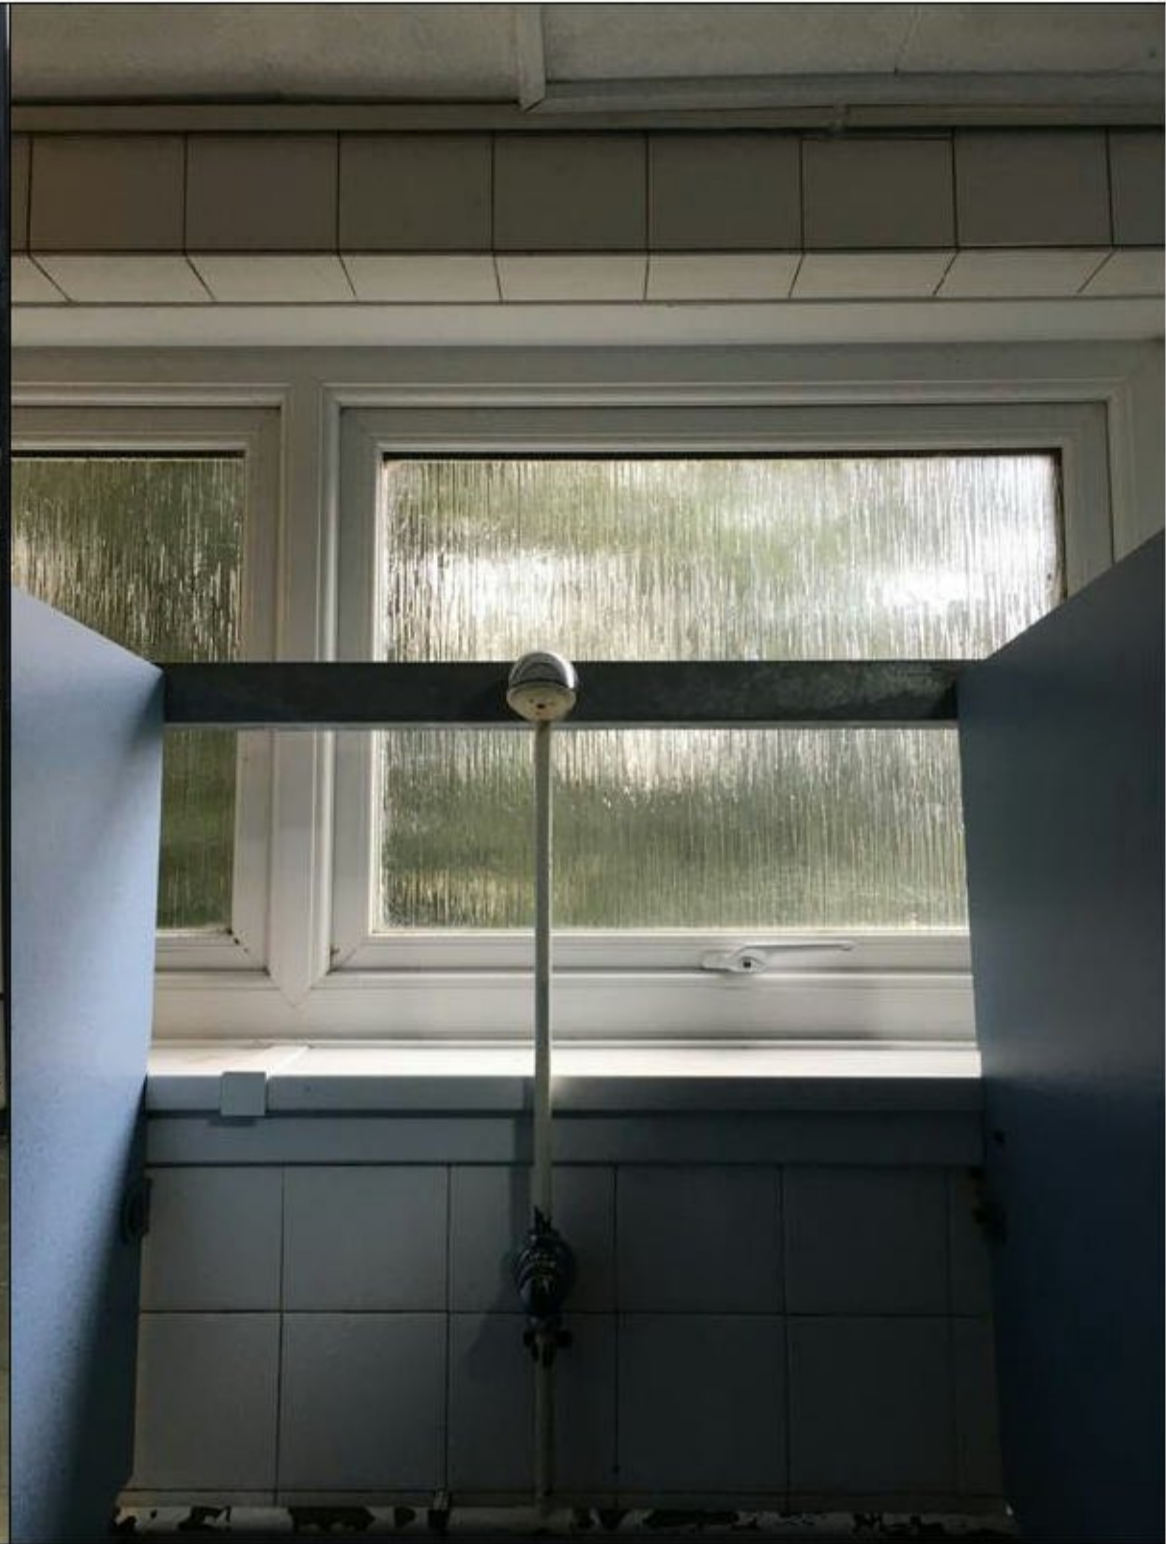
Photo Location - North_Window Number **W011** - See floor plans for location

Located with 1990's section of the building

Condition - Good

Frame - Original

Glass - Original

- To be replaced in the future with more in keeping windows

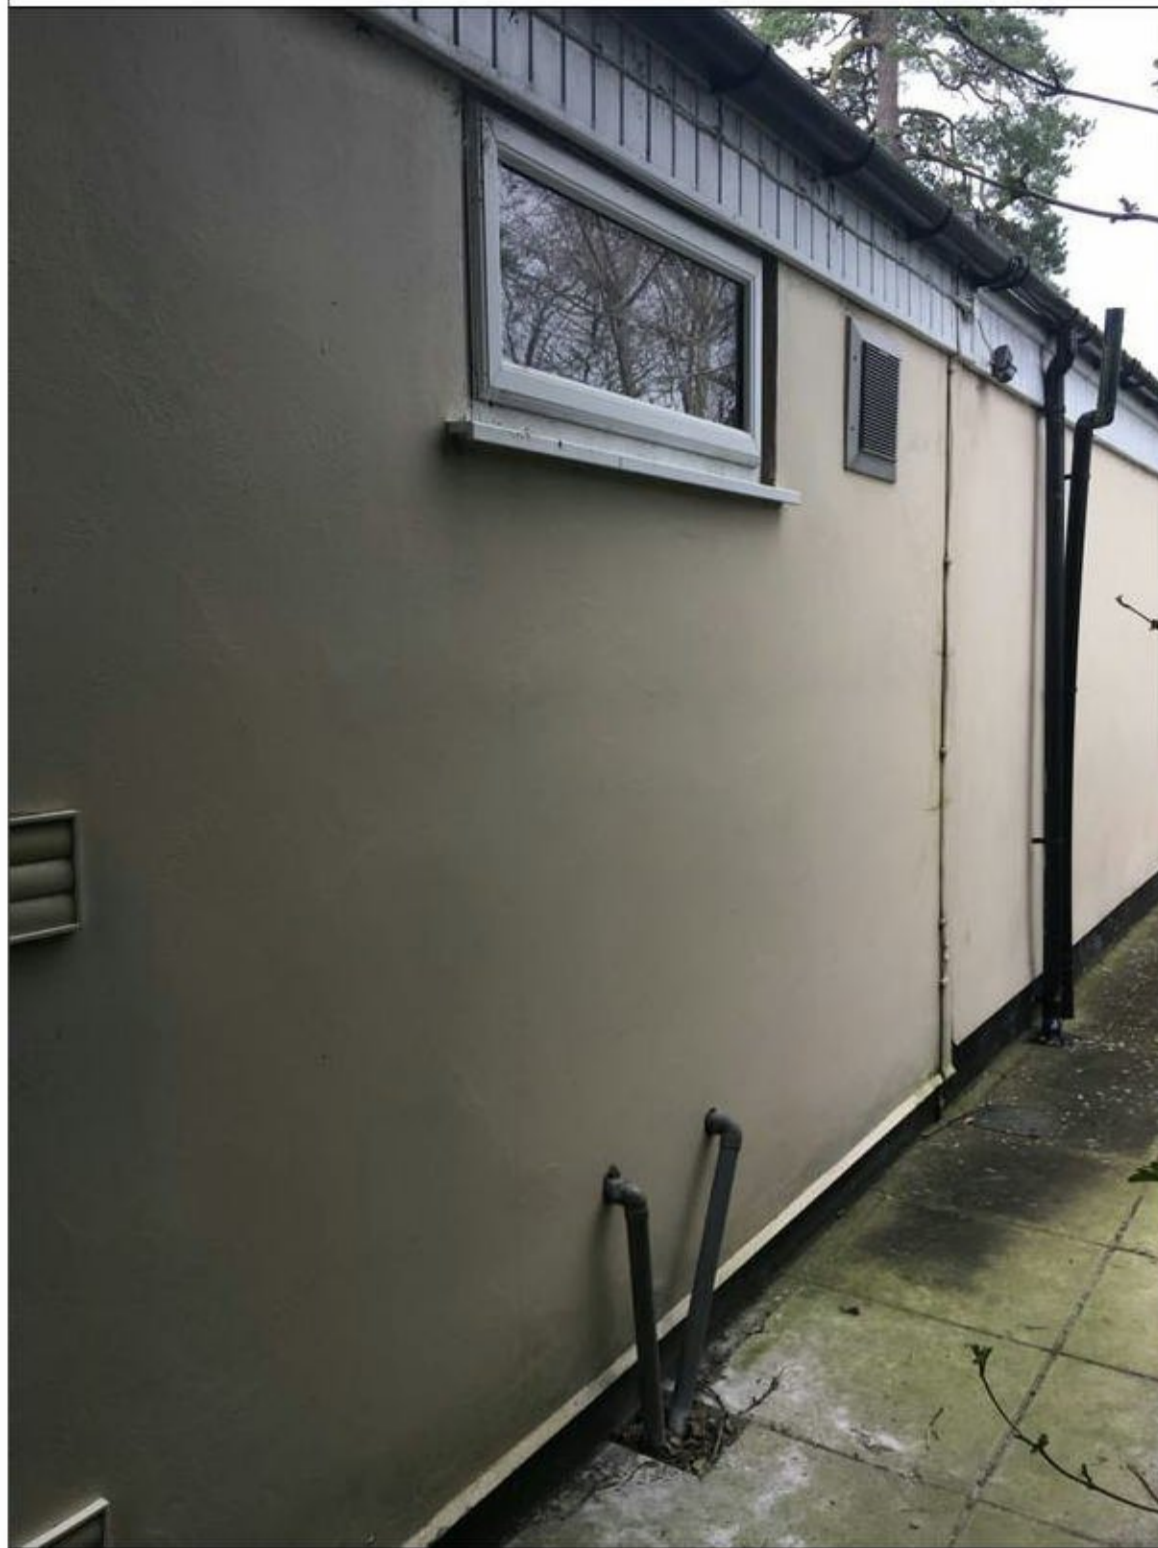
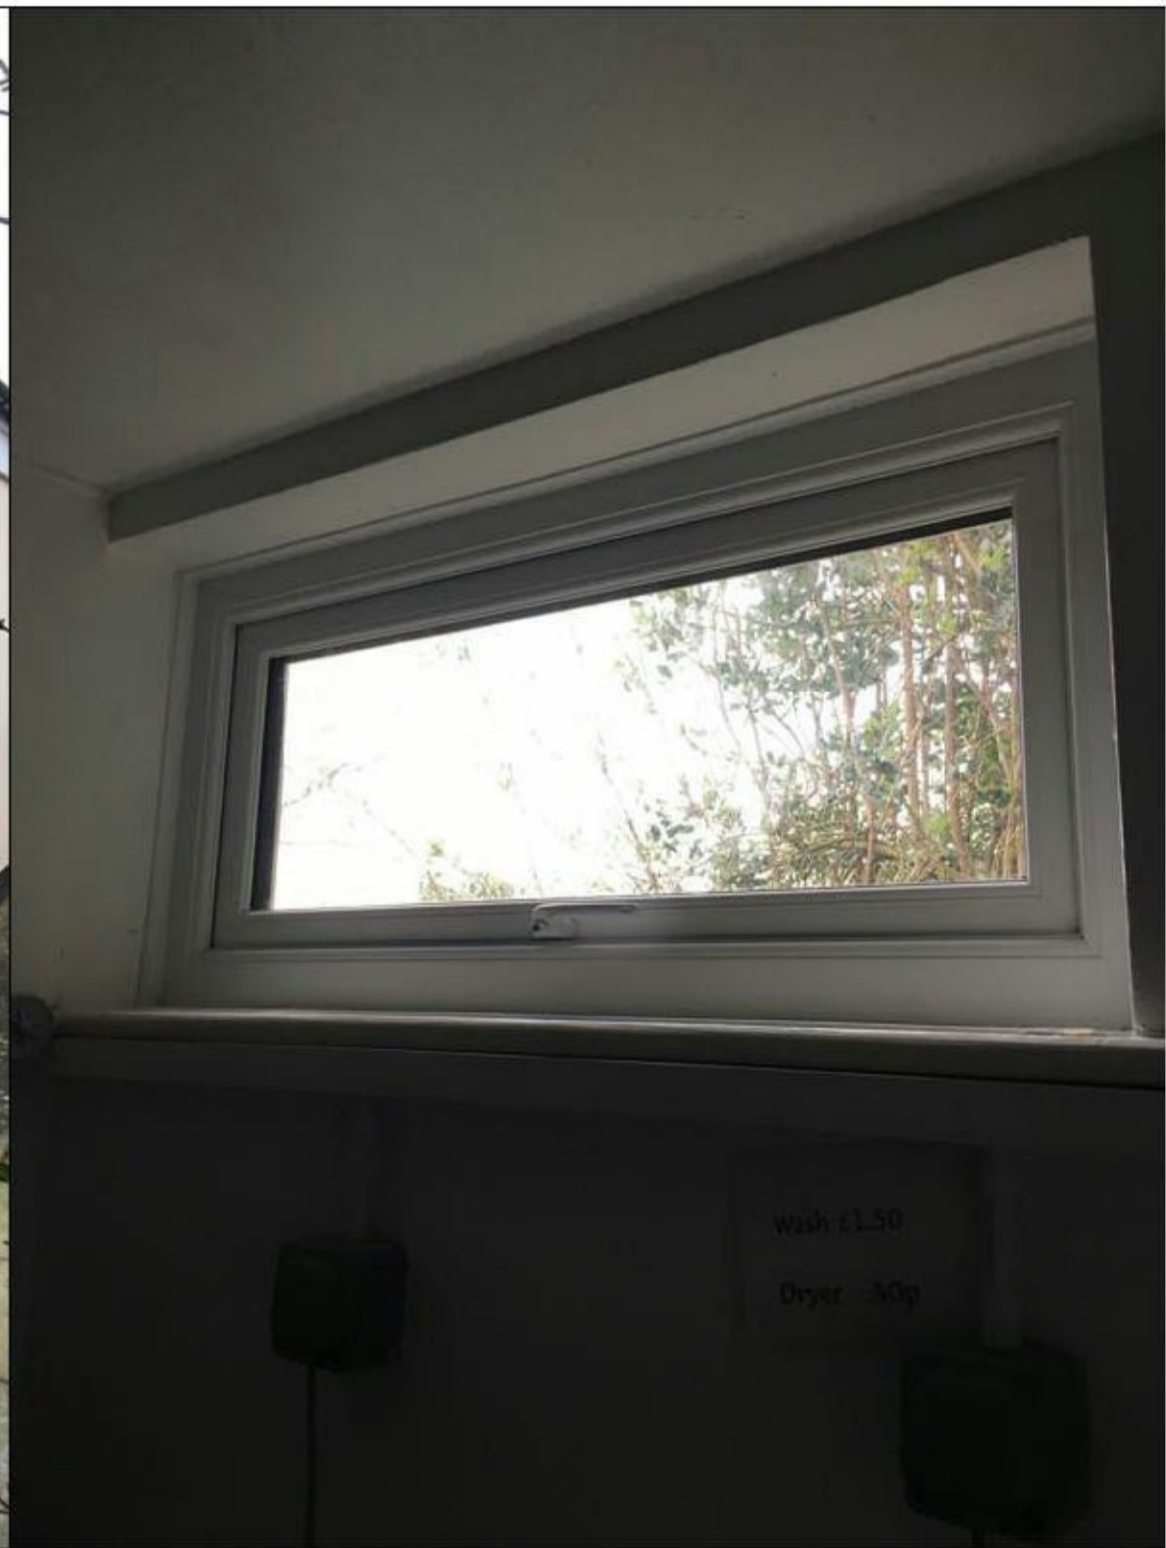
Photo Location - North_Window Number **W012** - See floor plans for location

Located with 1990's section of the building

Condition - Good

Frame - Original

Glass - Original

- To be replaced in the future with more in keeping windows

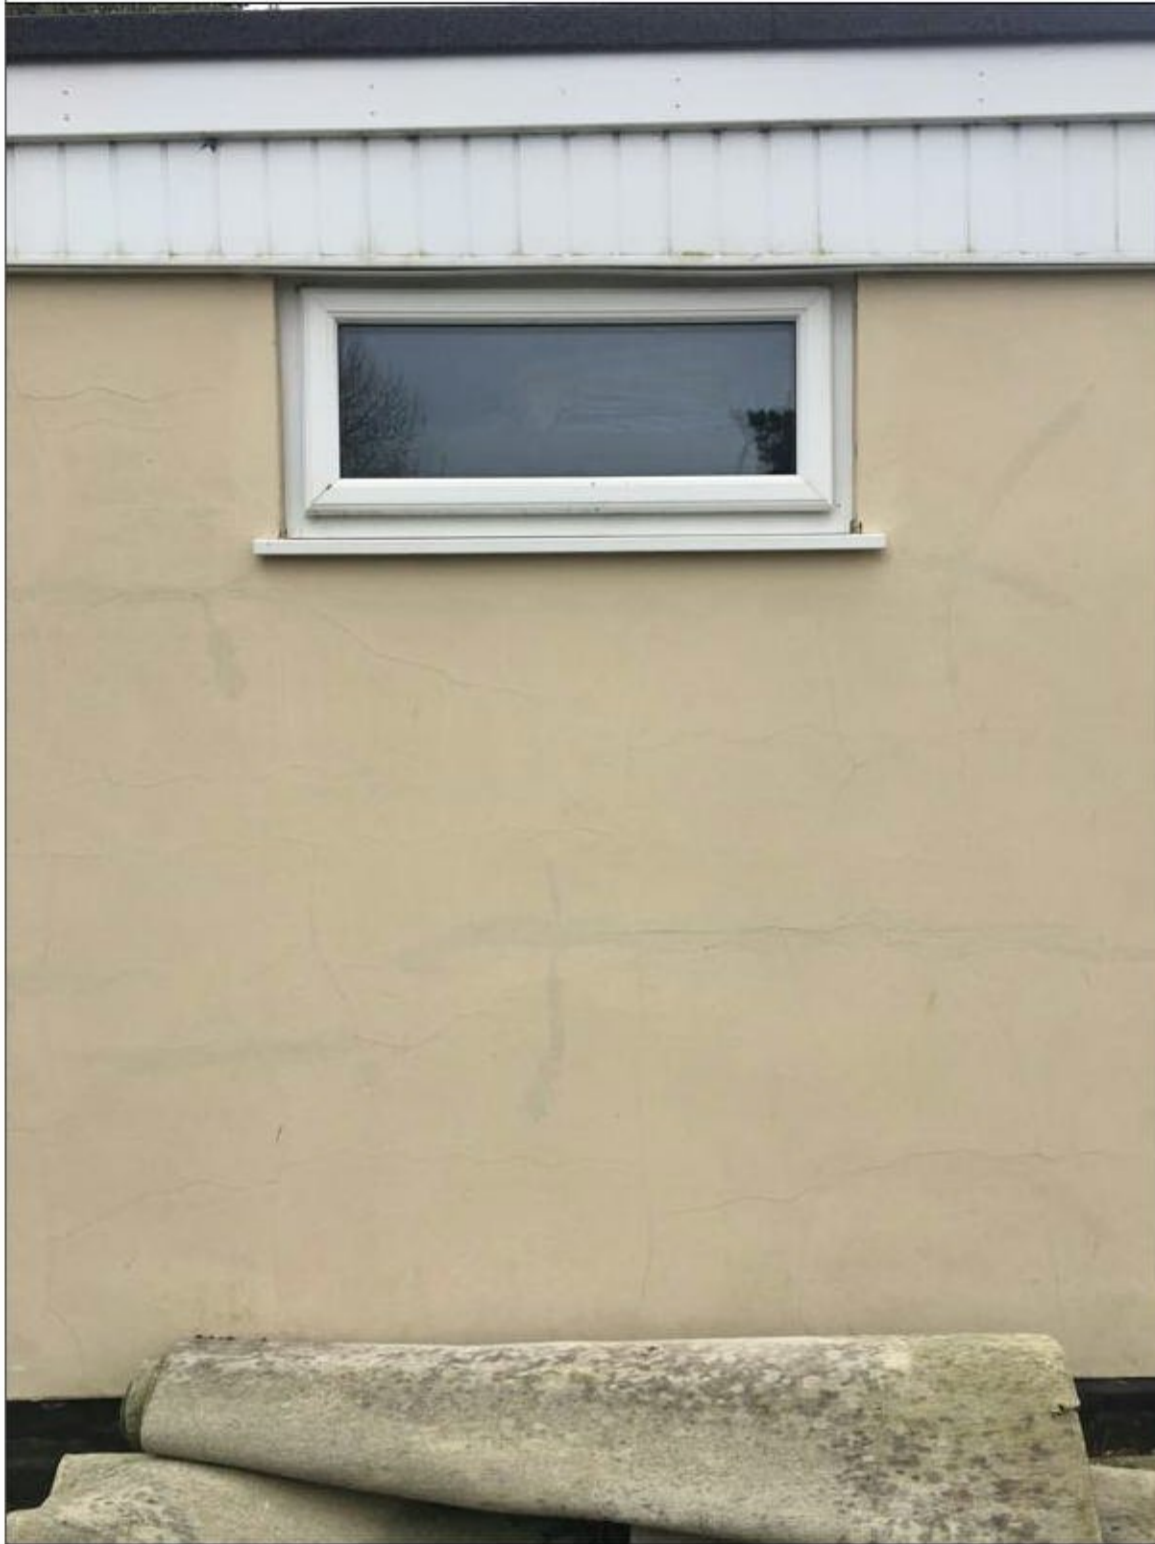
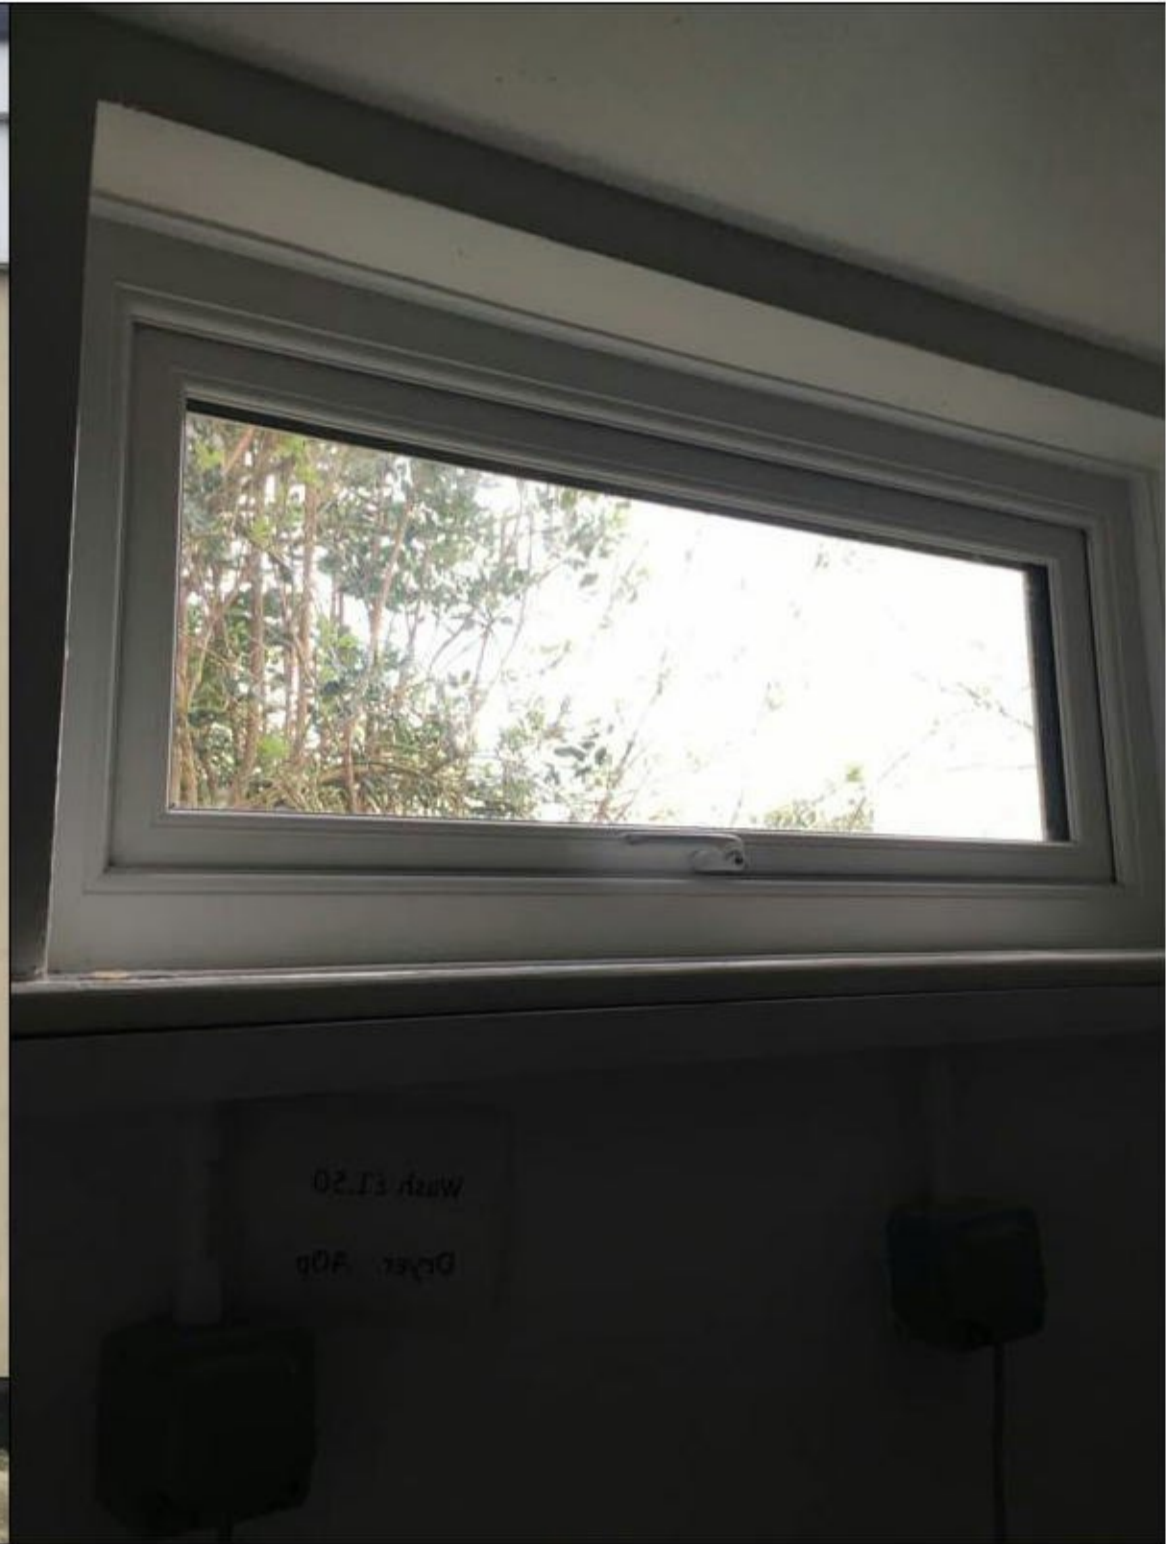
Photo Location - West_Window Number **W013** - See floor plans for location

Located with 1990's section of the building

Condition - Good

Frame - Original

Glass - Original

- To be replaced in the future with more in keeping windows
