Building Recording - Ground Floor

External and Internal Windows

showing existing photos, noted location, frame condition, glass condition and proposed refurbishment works.

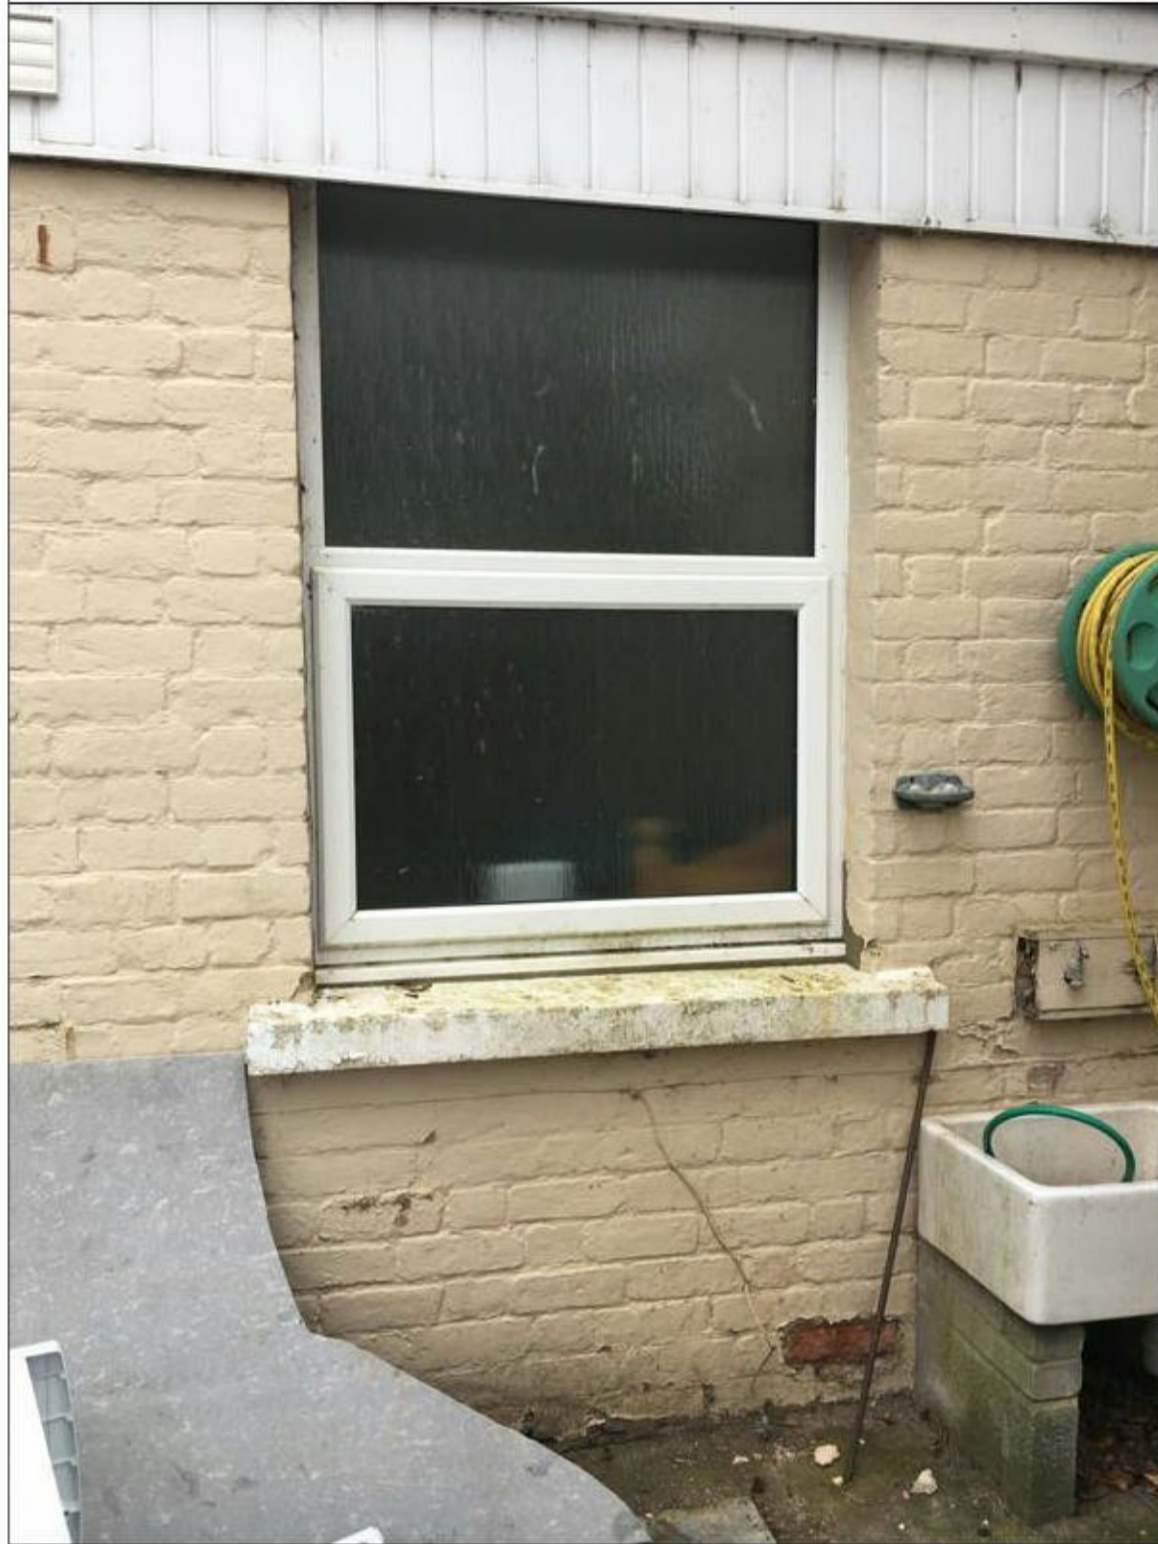
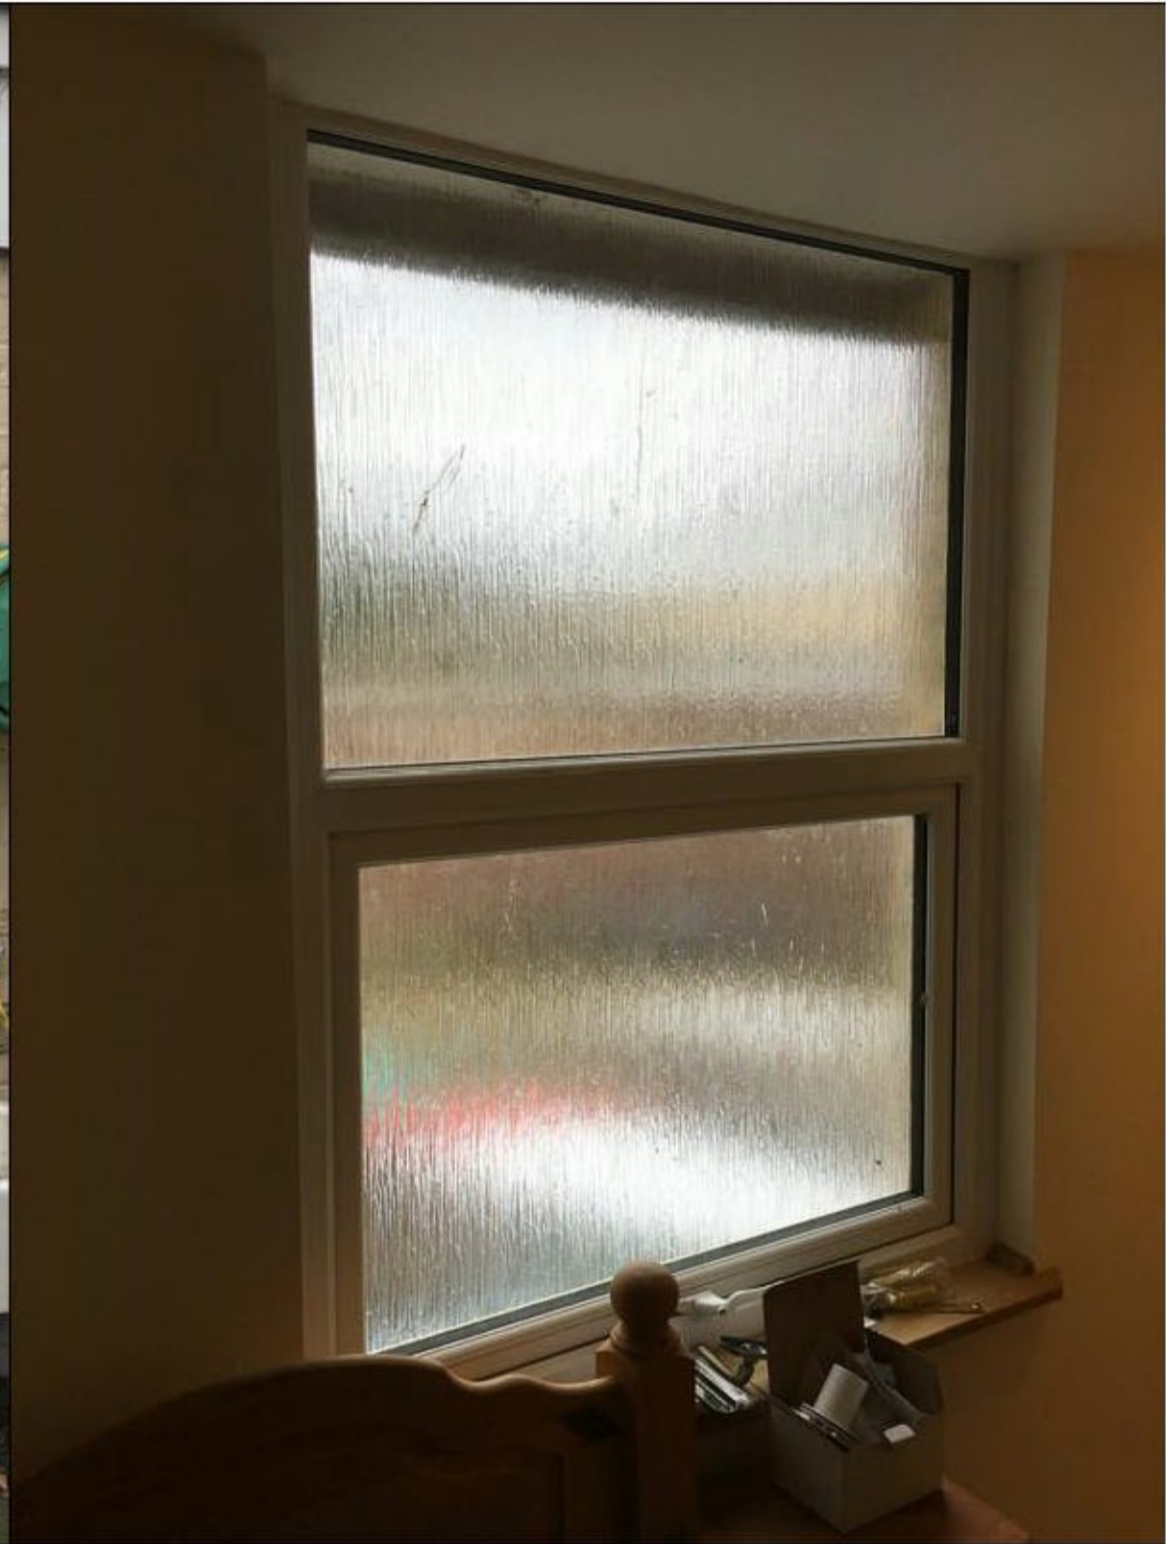
Photo Location - West_Window Number **W014** - See floor plans for location

Located with 1990's section of the building

Condition - Good

Frame - Original

Glass - Original

- To be replaced in the future with more in keeping windows

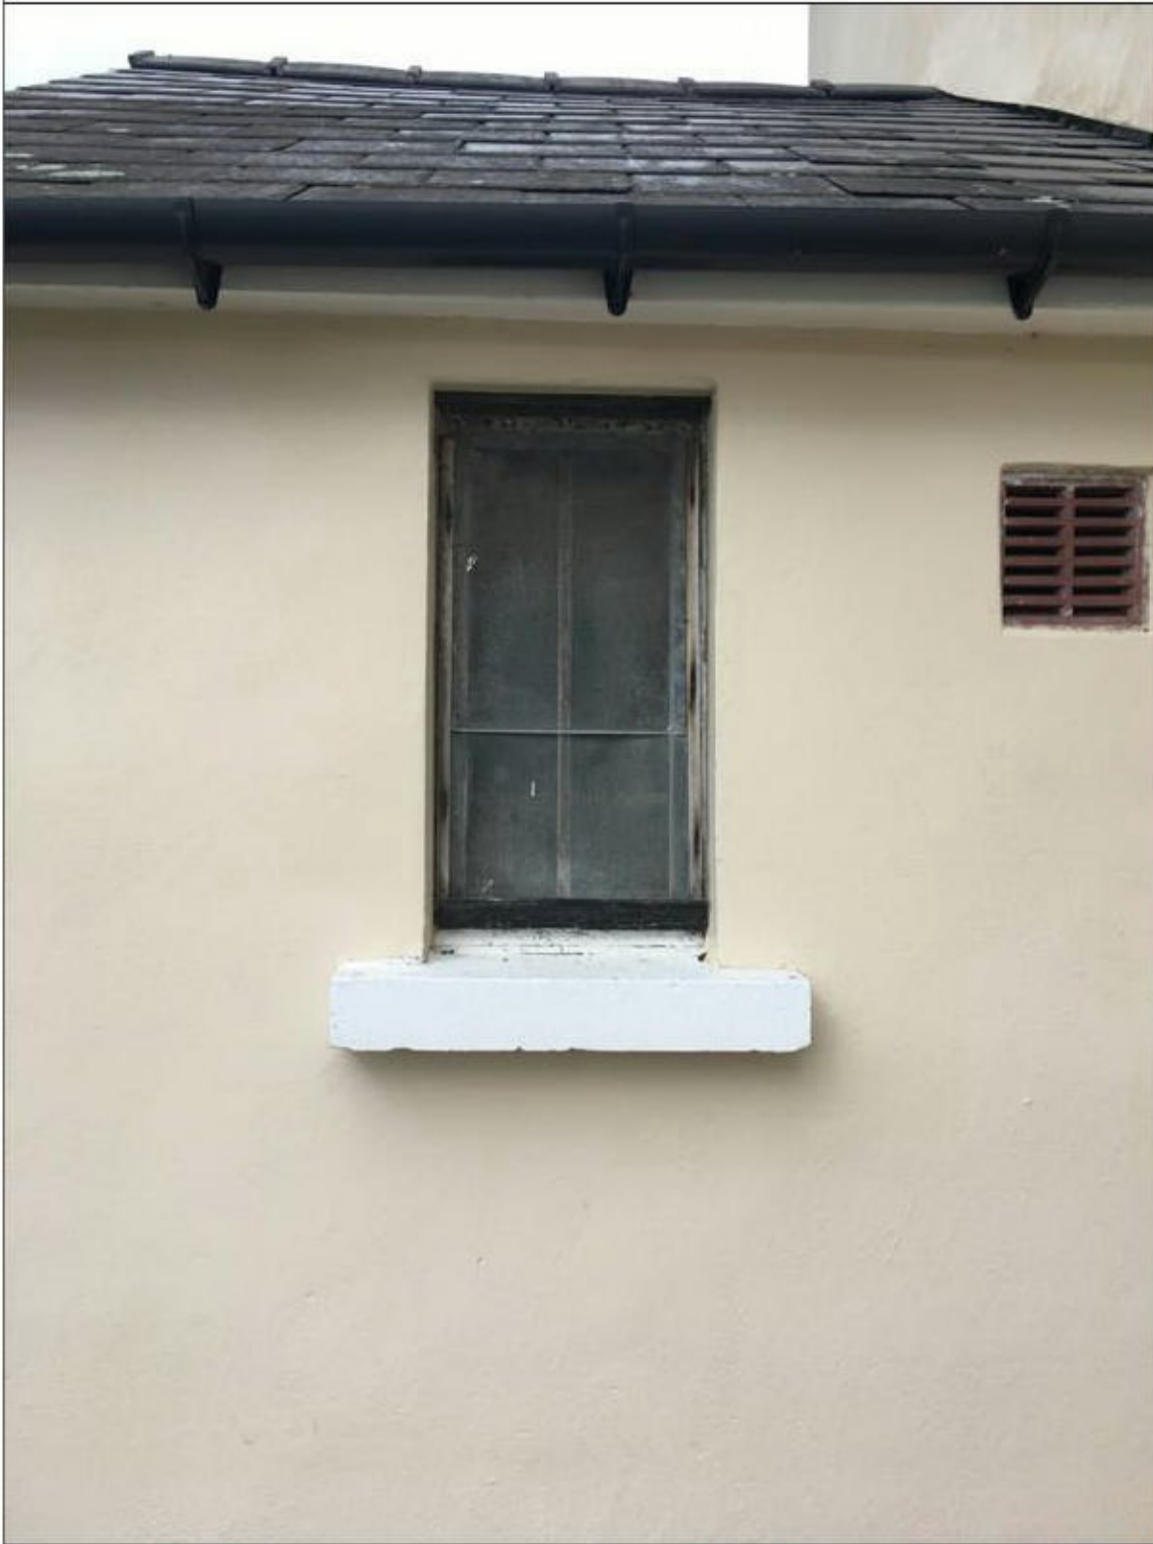
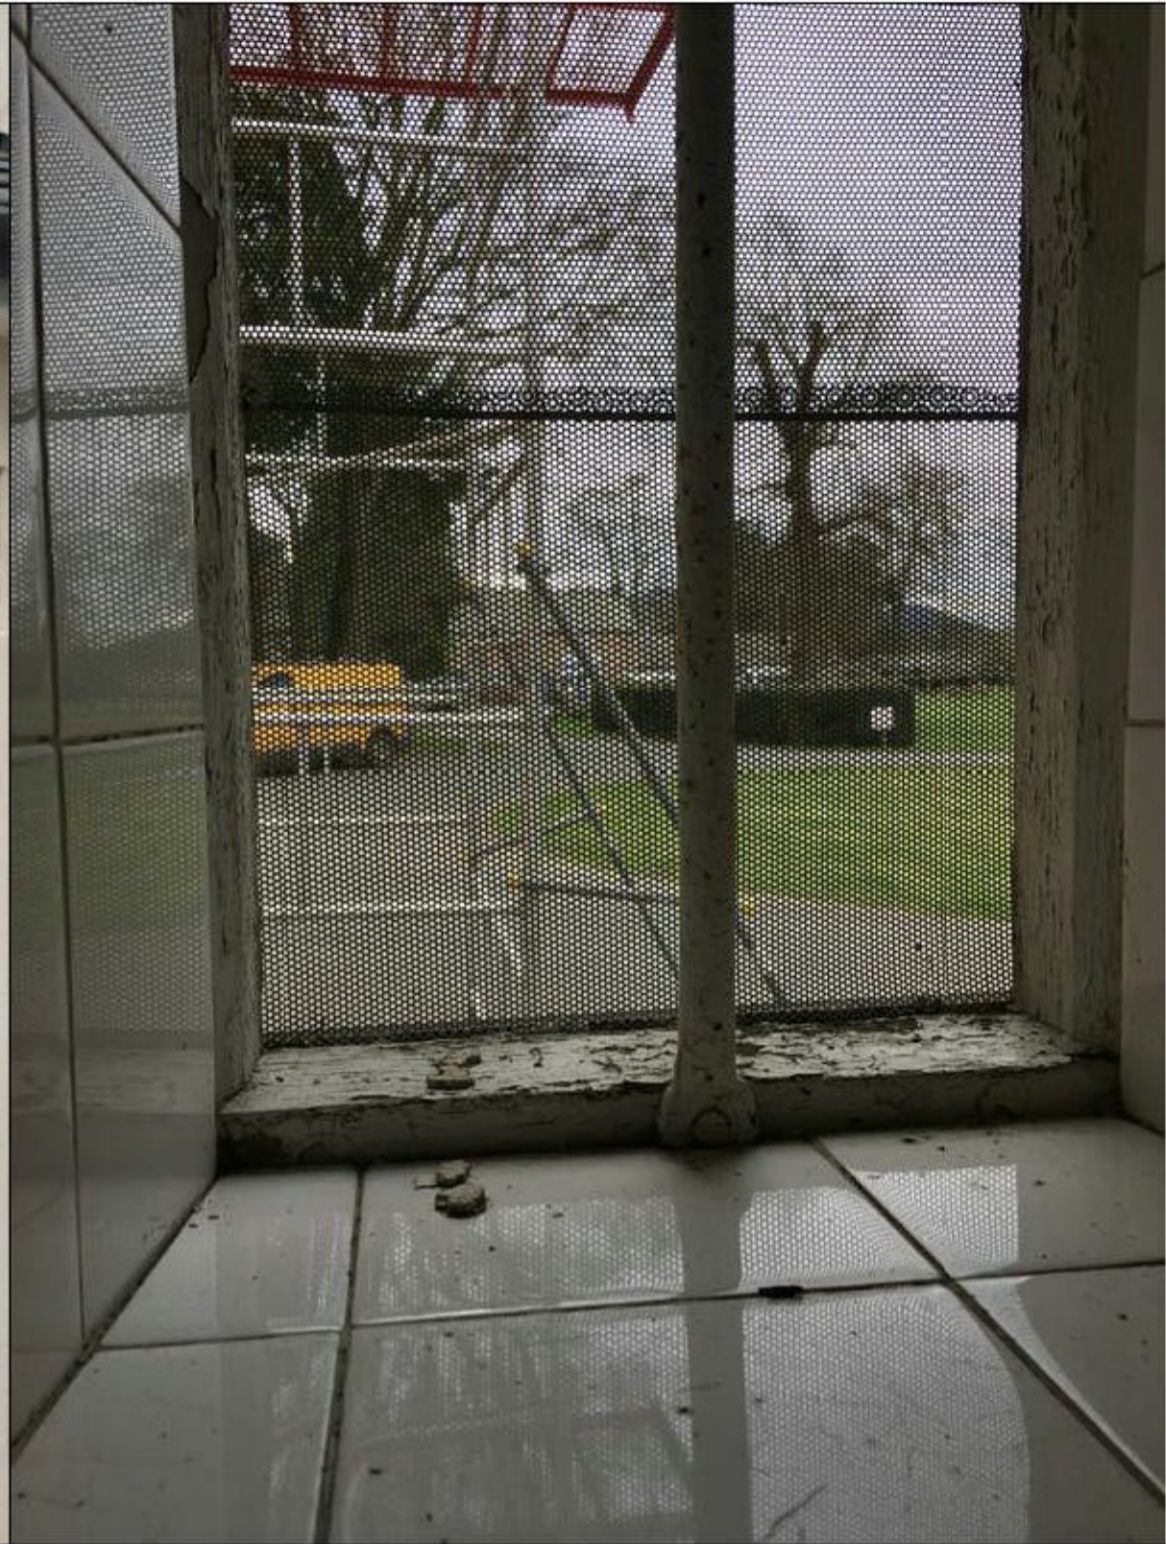
Photo Location - South_Window Number **W015** - See floor plans for location

Located with 1840's section of the building

Condition - Poor in need of refurbishment

Frame - Presumed Non Original

Glass - Insect mesh

- Refurbish and re paint only if possible
