Building Recording - First Floor

External and Internal Windows

showing existing photos, noted location, frame condition, glass condition and proposed refurbishment works.

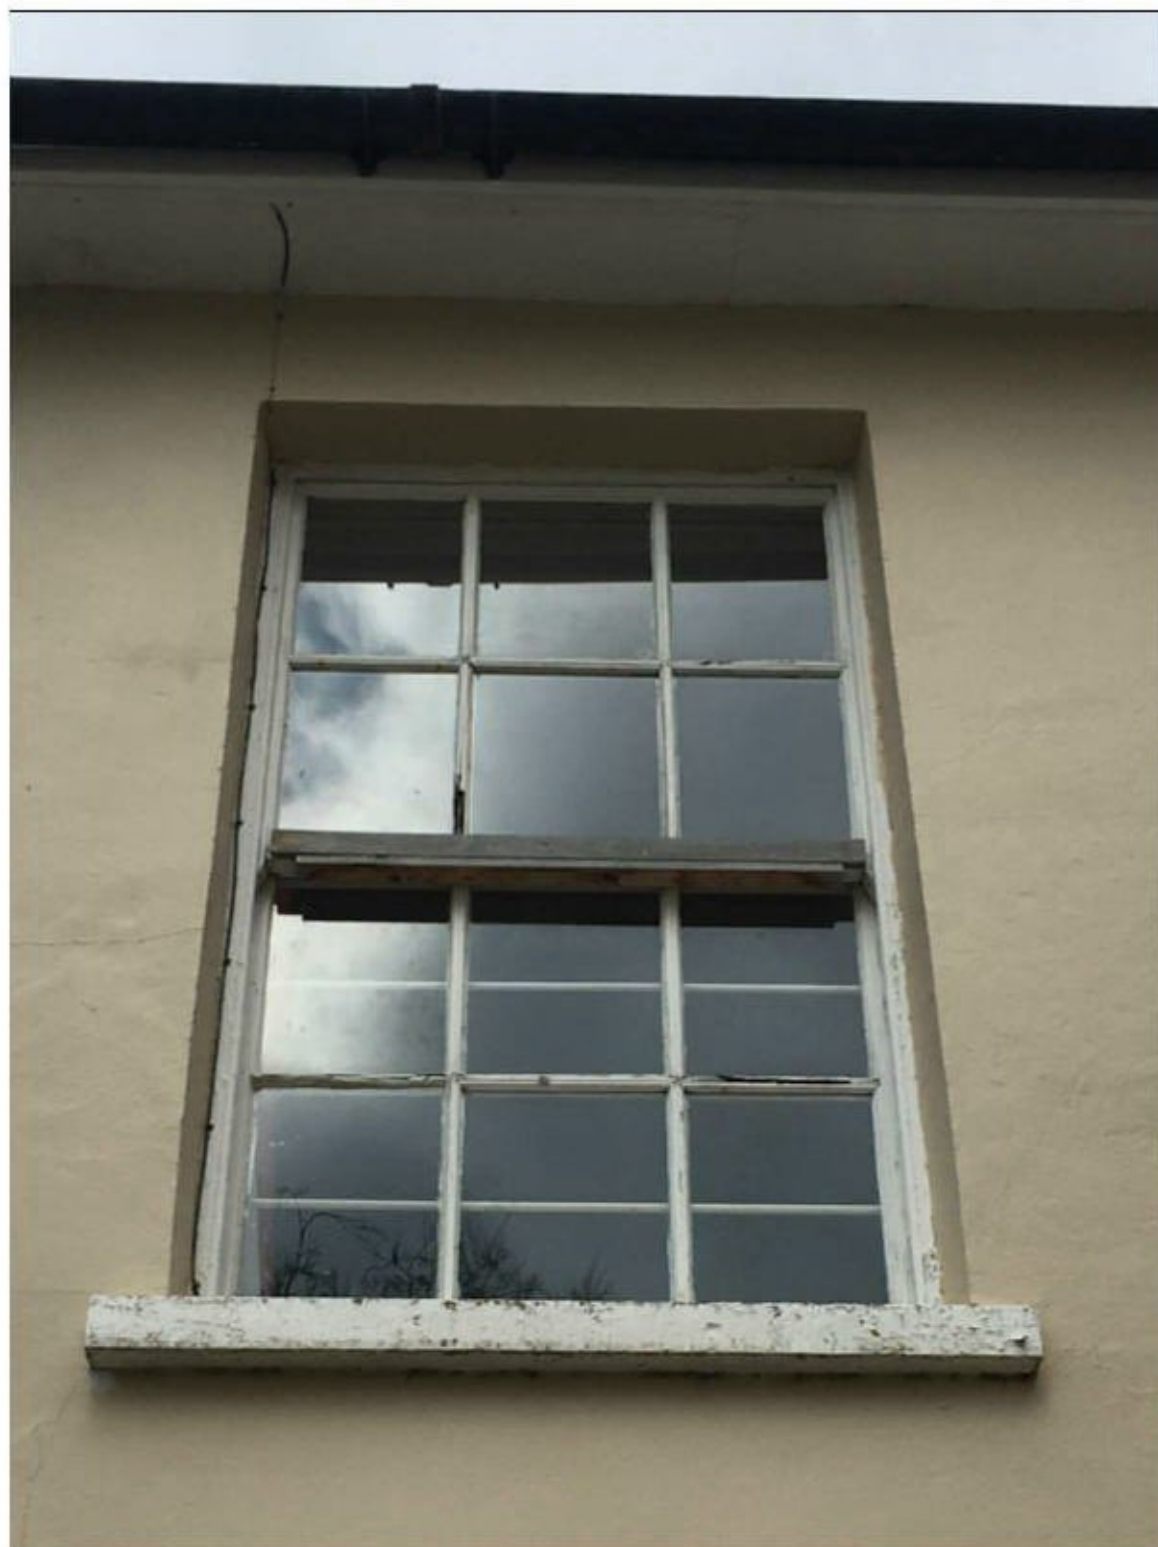
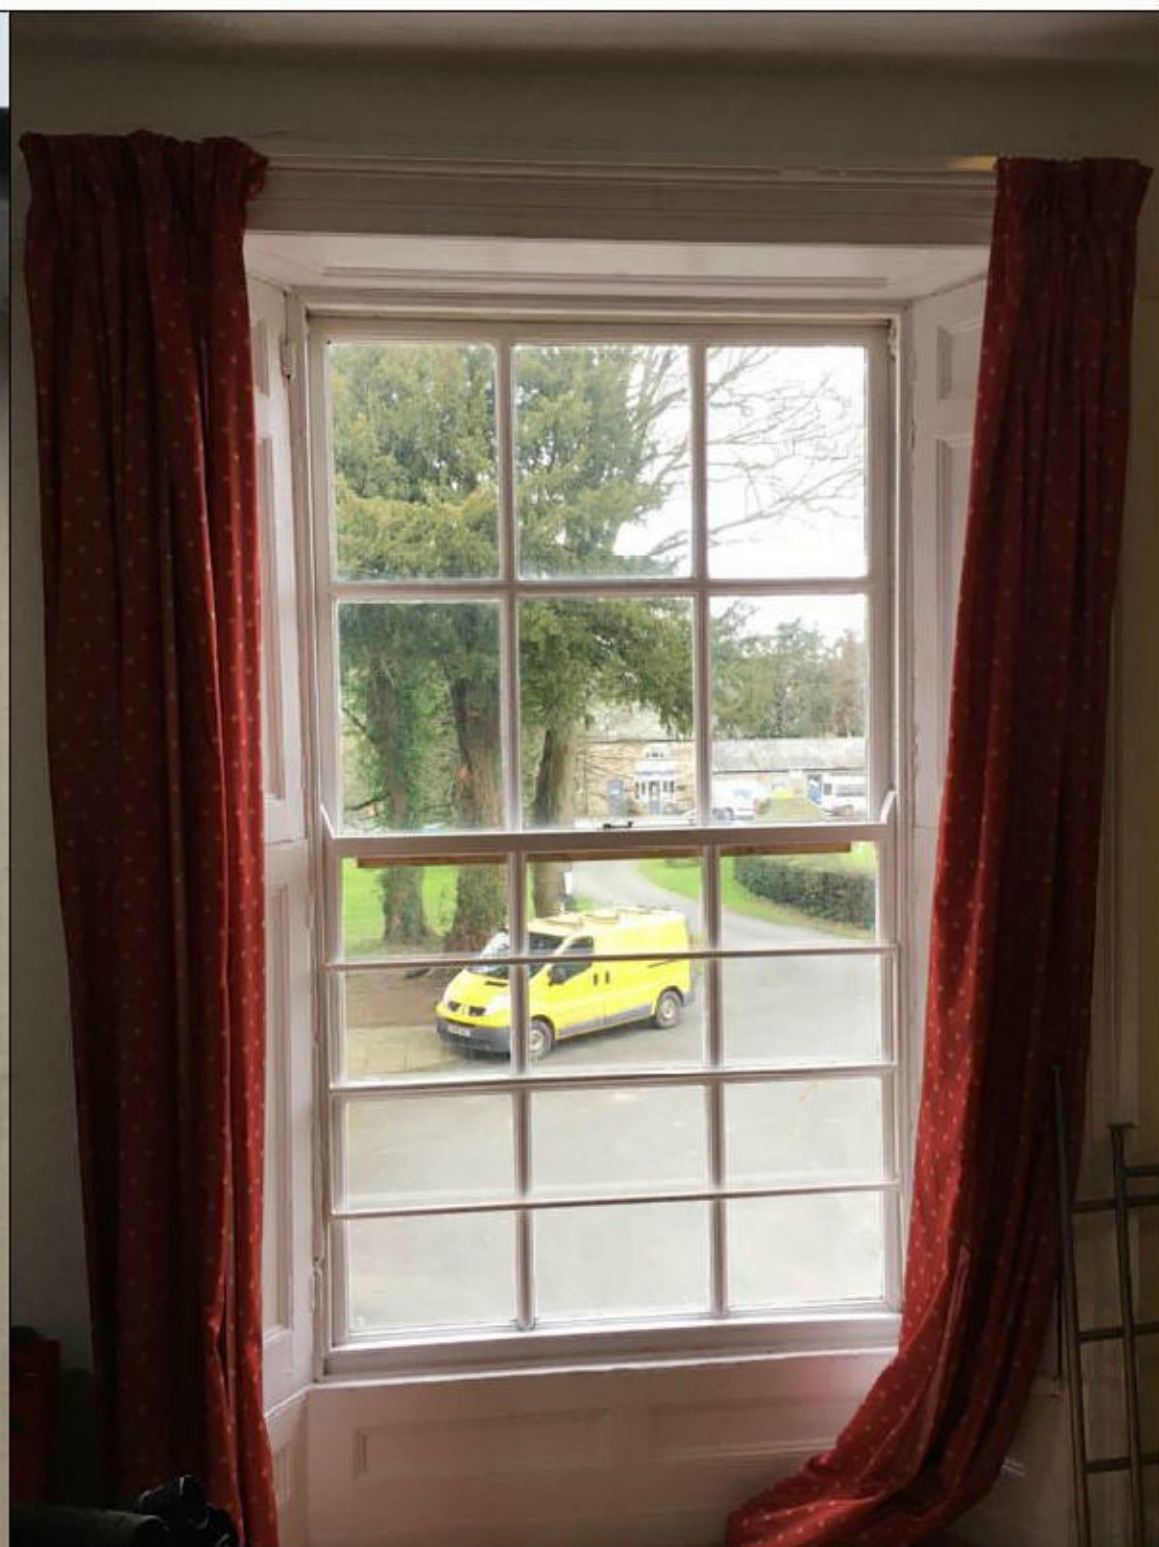
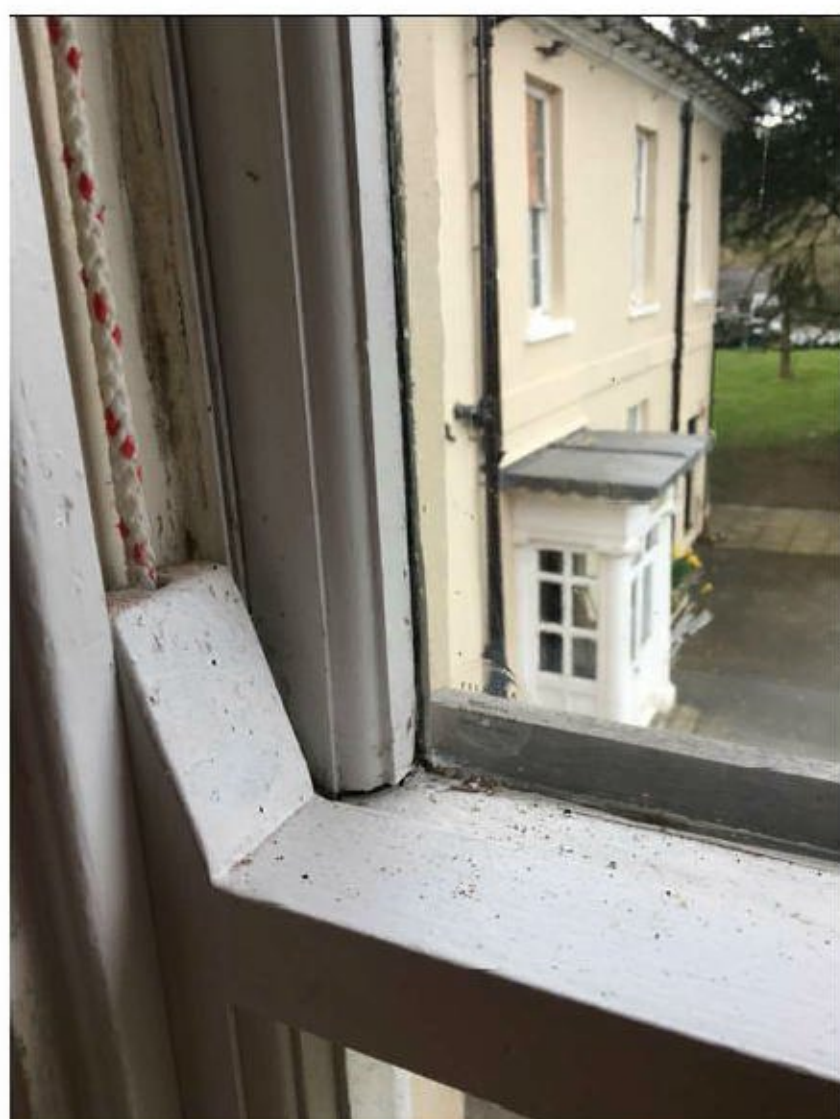
Photo Location - South_Window Number **W101** - See floor plans for location

Located with 1840's section of the building

Condition - Very poor in need of replacement

Frame - Presumed Non Original

Glass - Presumed Non Original

· Replacement window

it has been advised by a window restorer and fabricator that there is not enough good quality frame left to simply refurbish this window. The window is not considered original

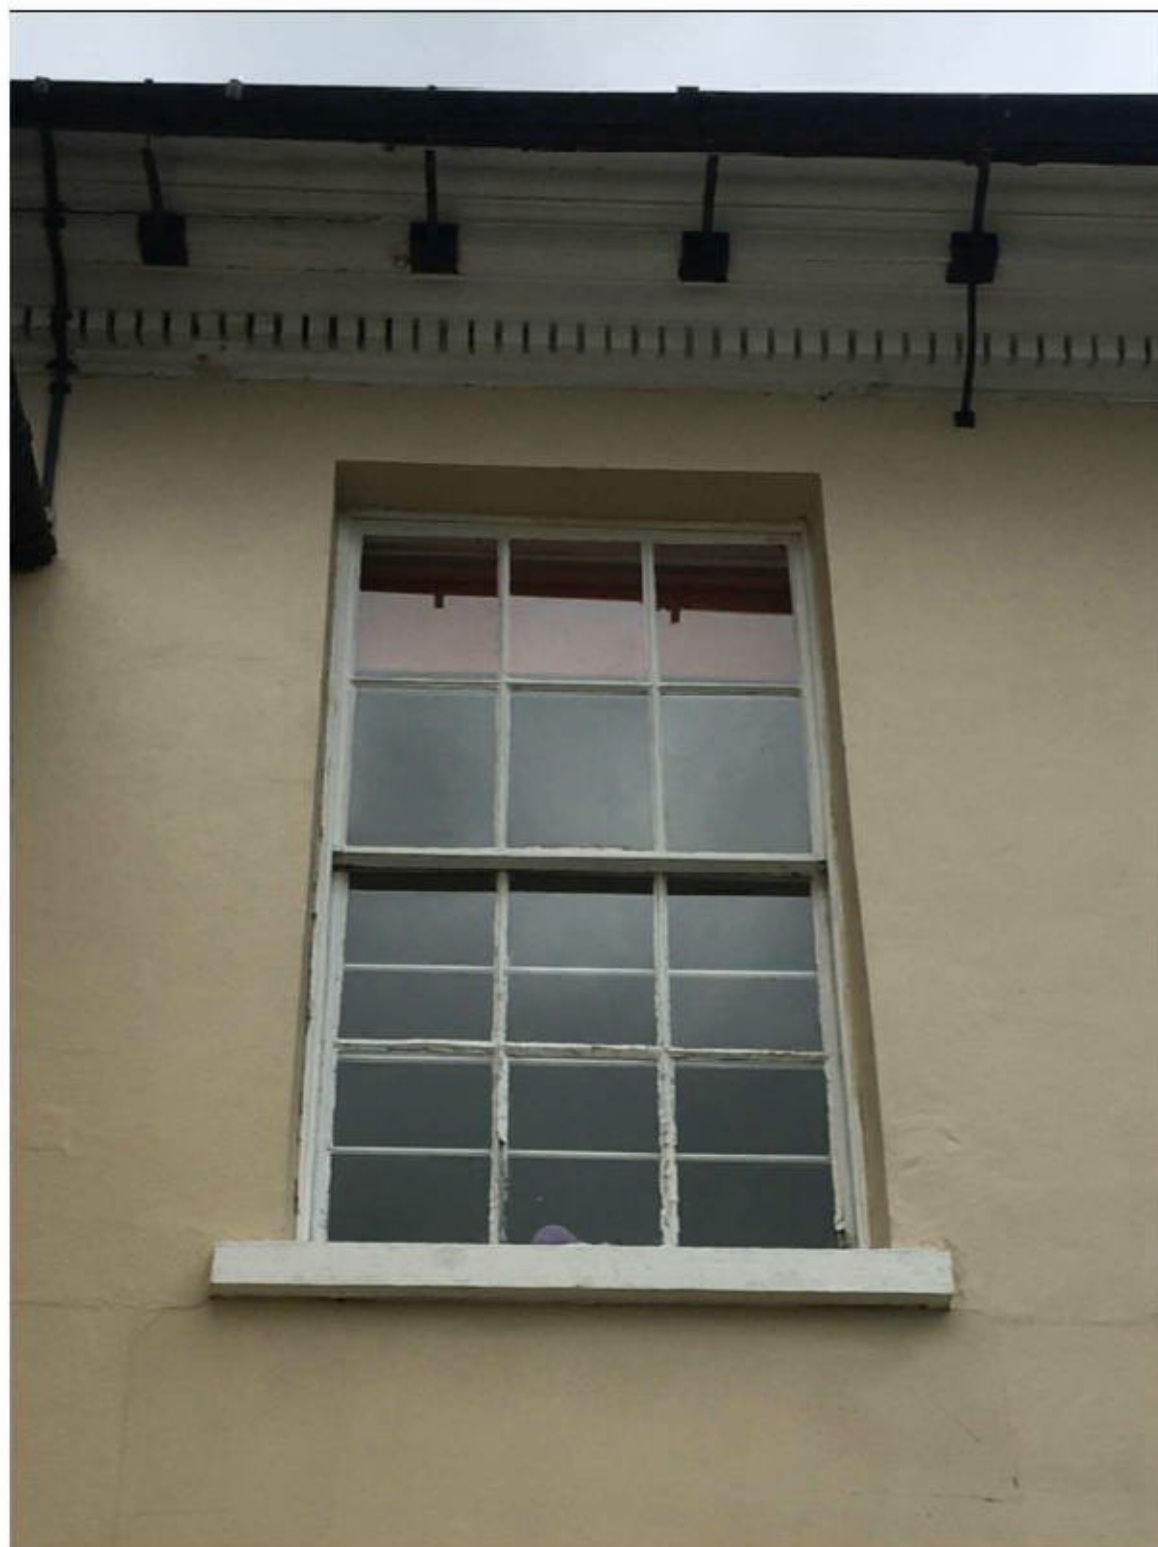
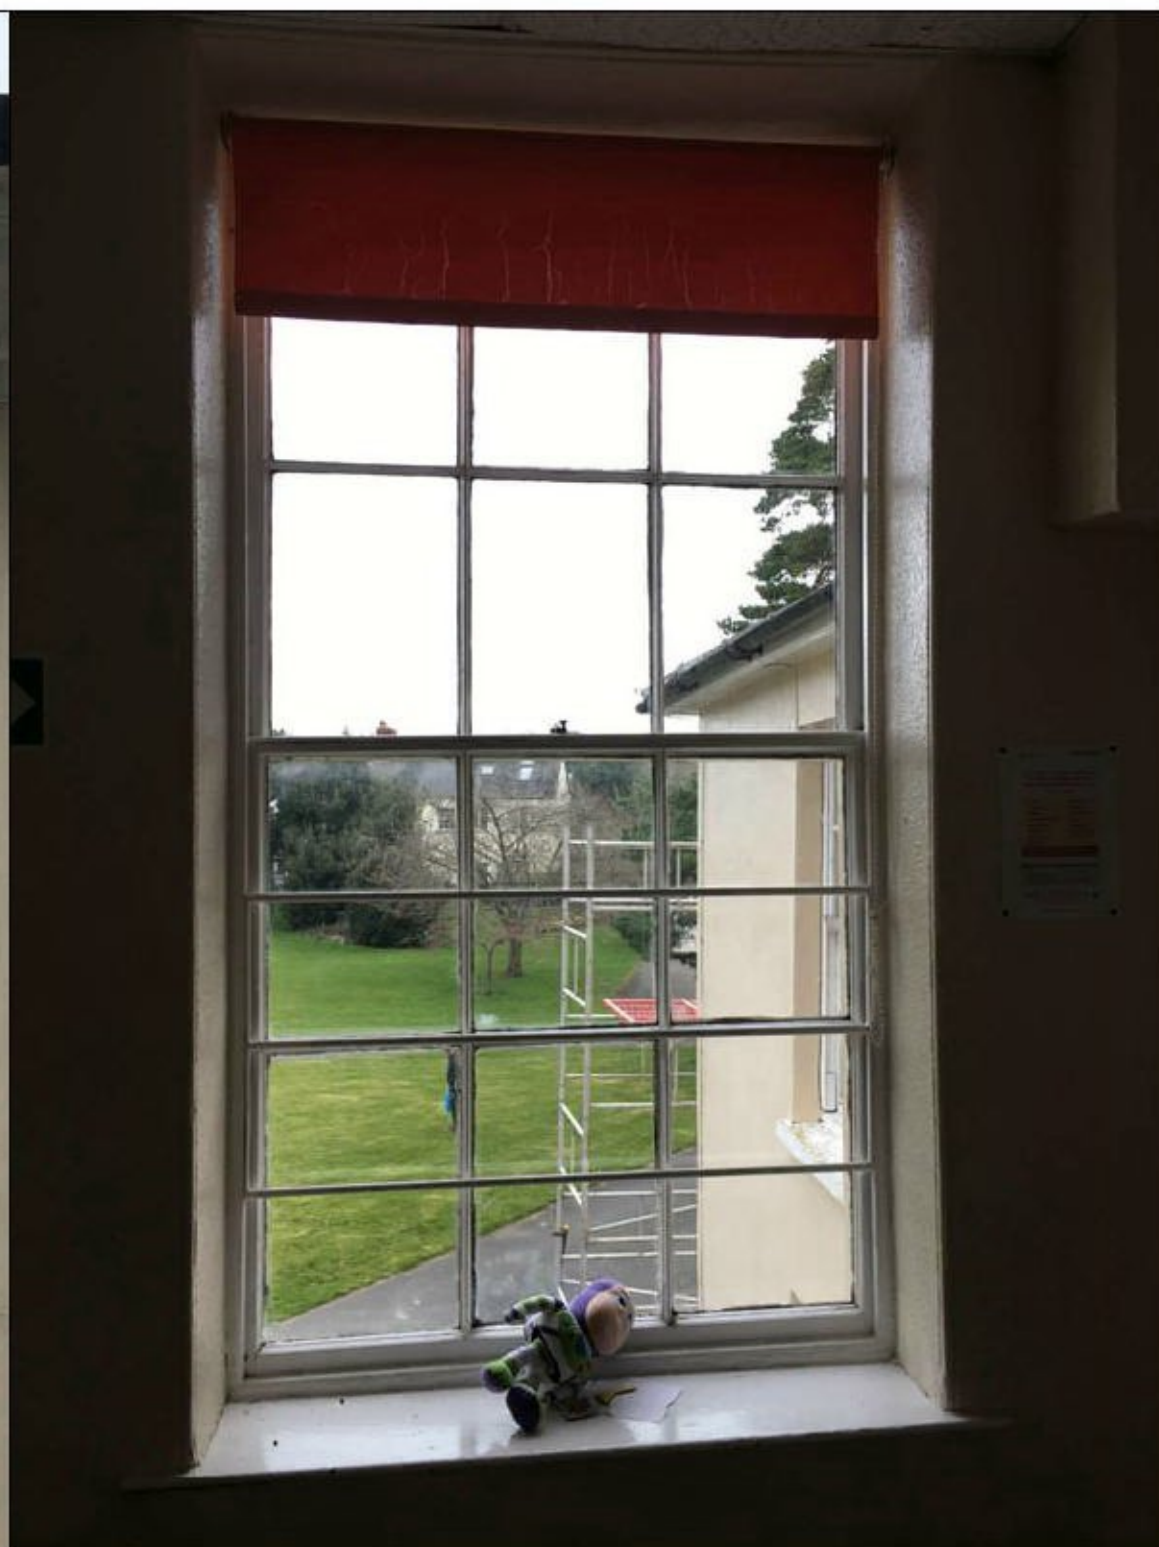
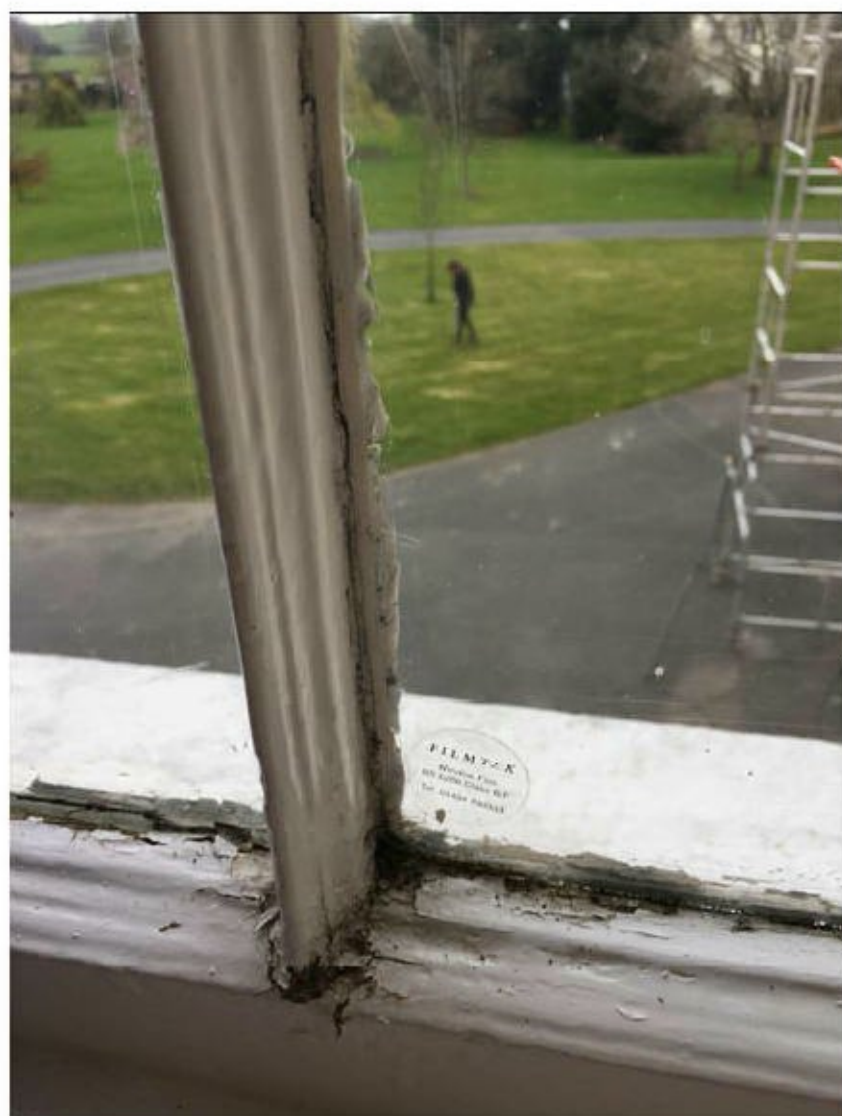
Photo Location - West_Window Number **W102** - See floor plans for location

Located with 1750's section of the building

Condition - Poor in need of replacement

Frame - Presumed Non Original

Glass - Presumed Non Original

· Replacement window

it has been advised by a window restorer and fabricator that there is not enough good quality frame left to simply refurbish this window.

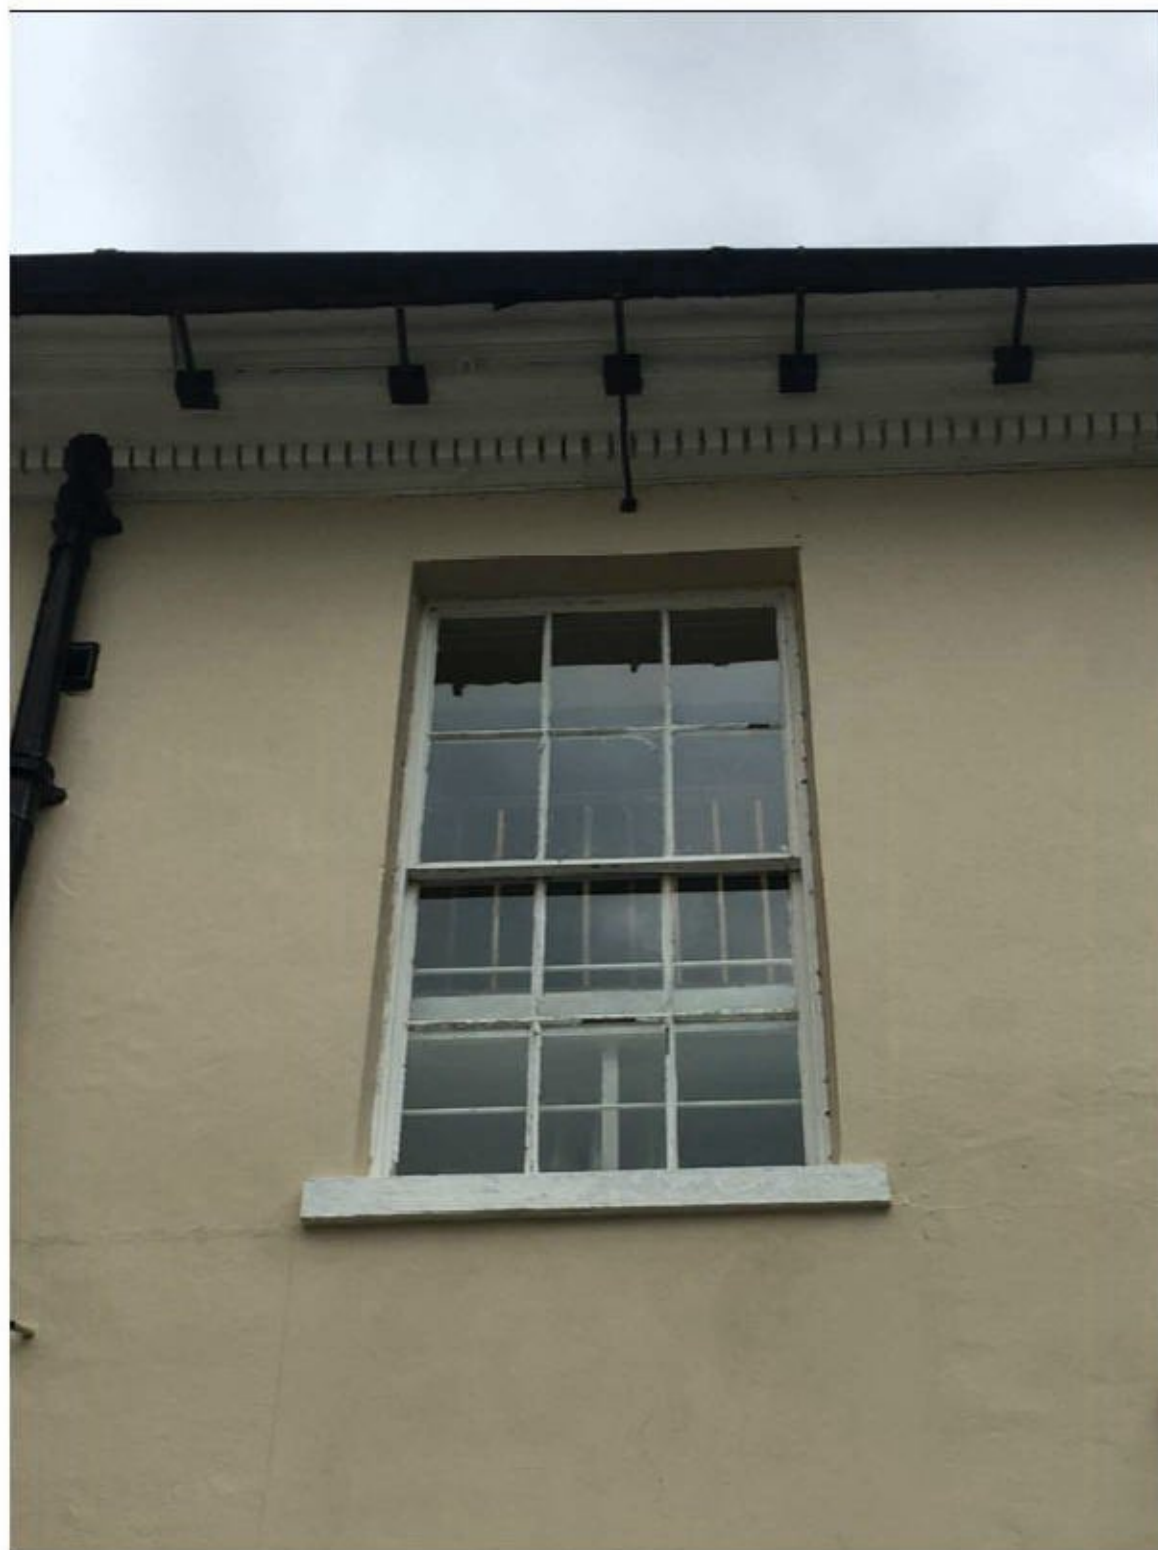
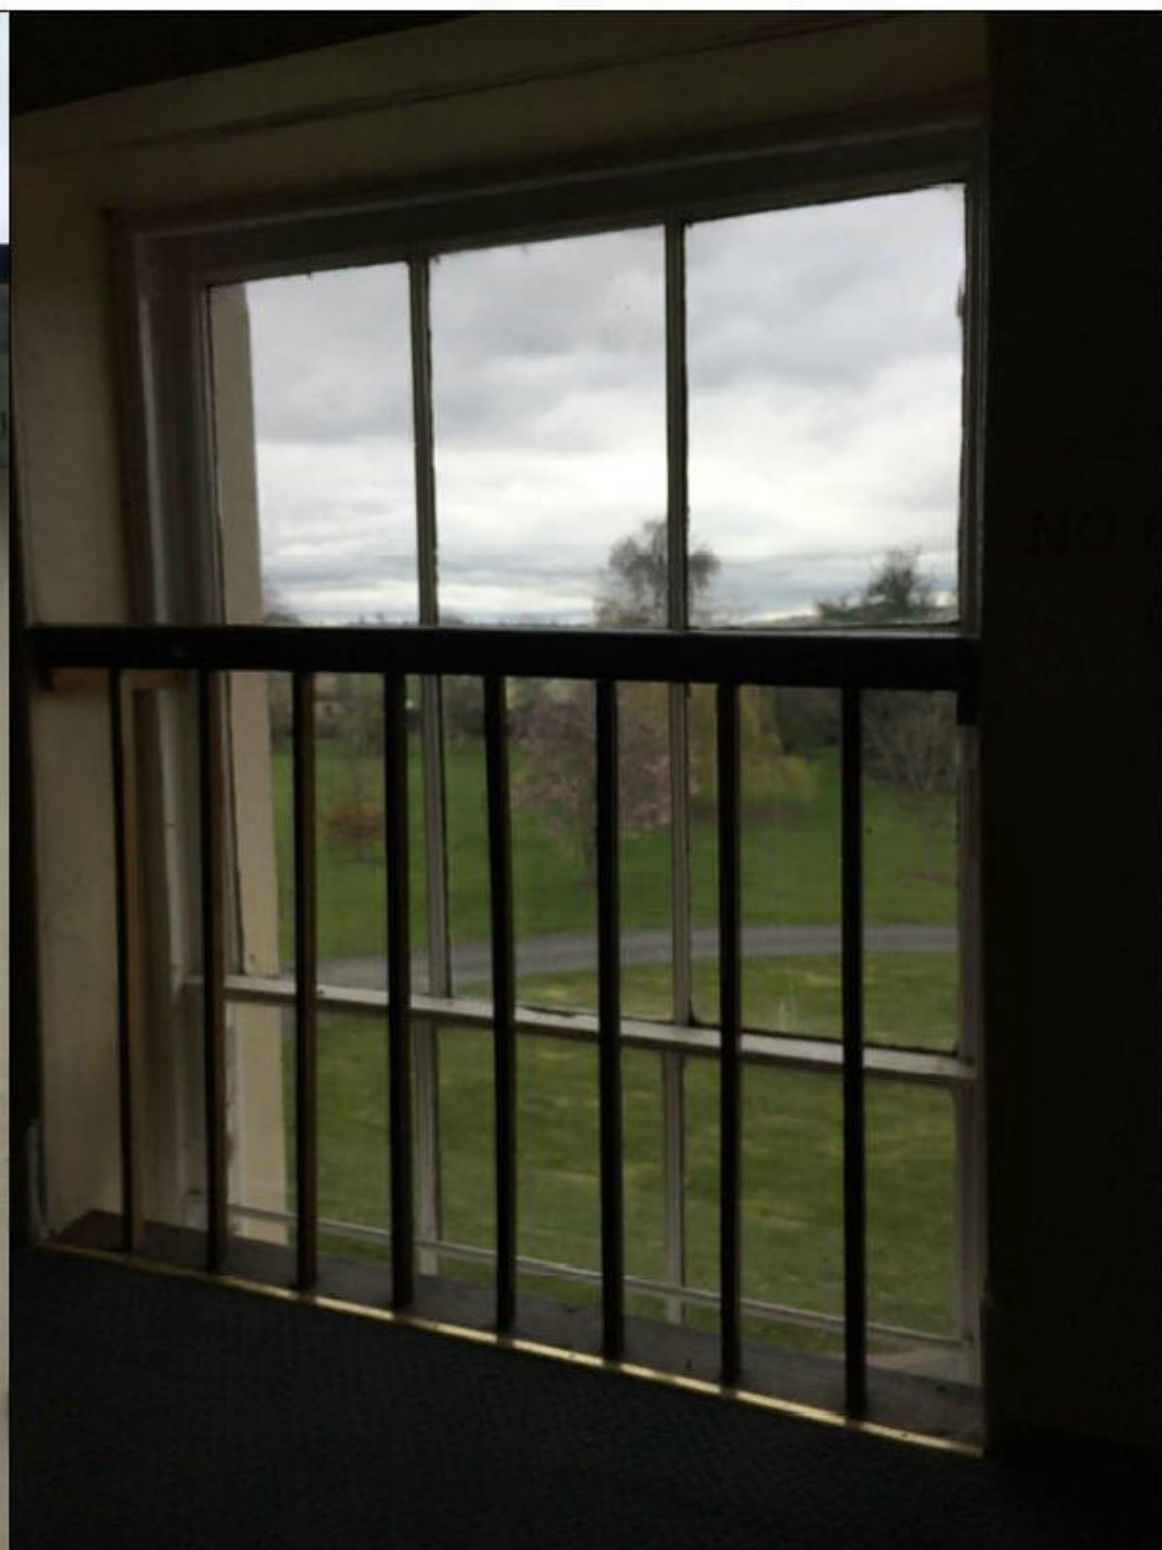
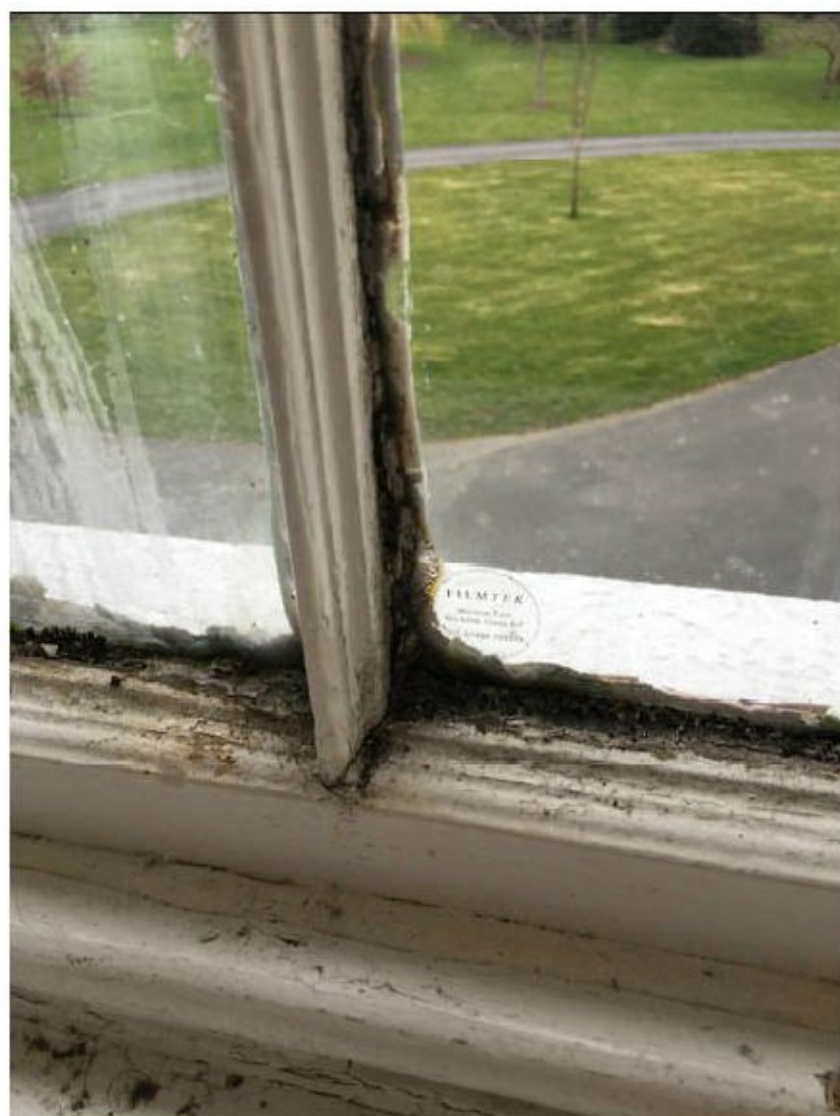
Photo Location - West_Window Number **W103** - See floor plans for location

Located with 1750's section of the building

Condition - Poor in need of replacement

Frame - Presumed Non Original

Glass - Presumed Non Original

· Replacement window

it has been advised by a window restorer and fabricator that there is not enough good quality frame left to simply refurbish this window.

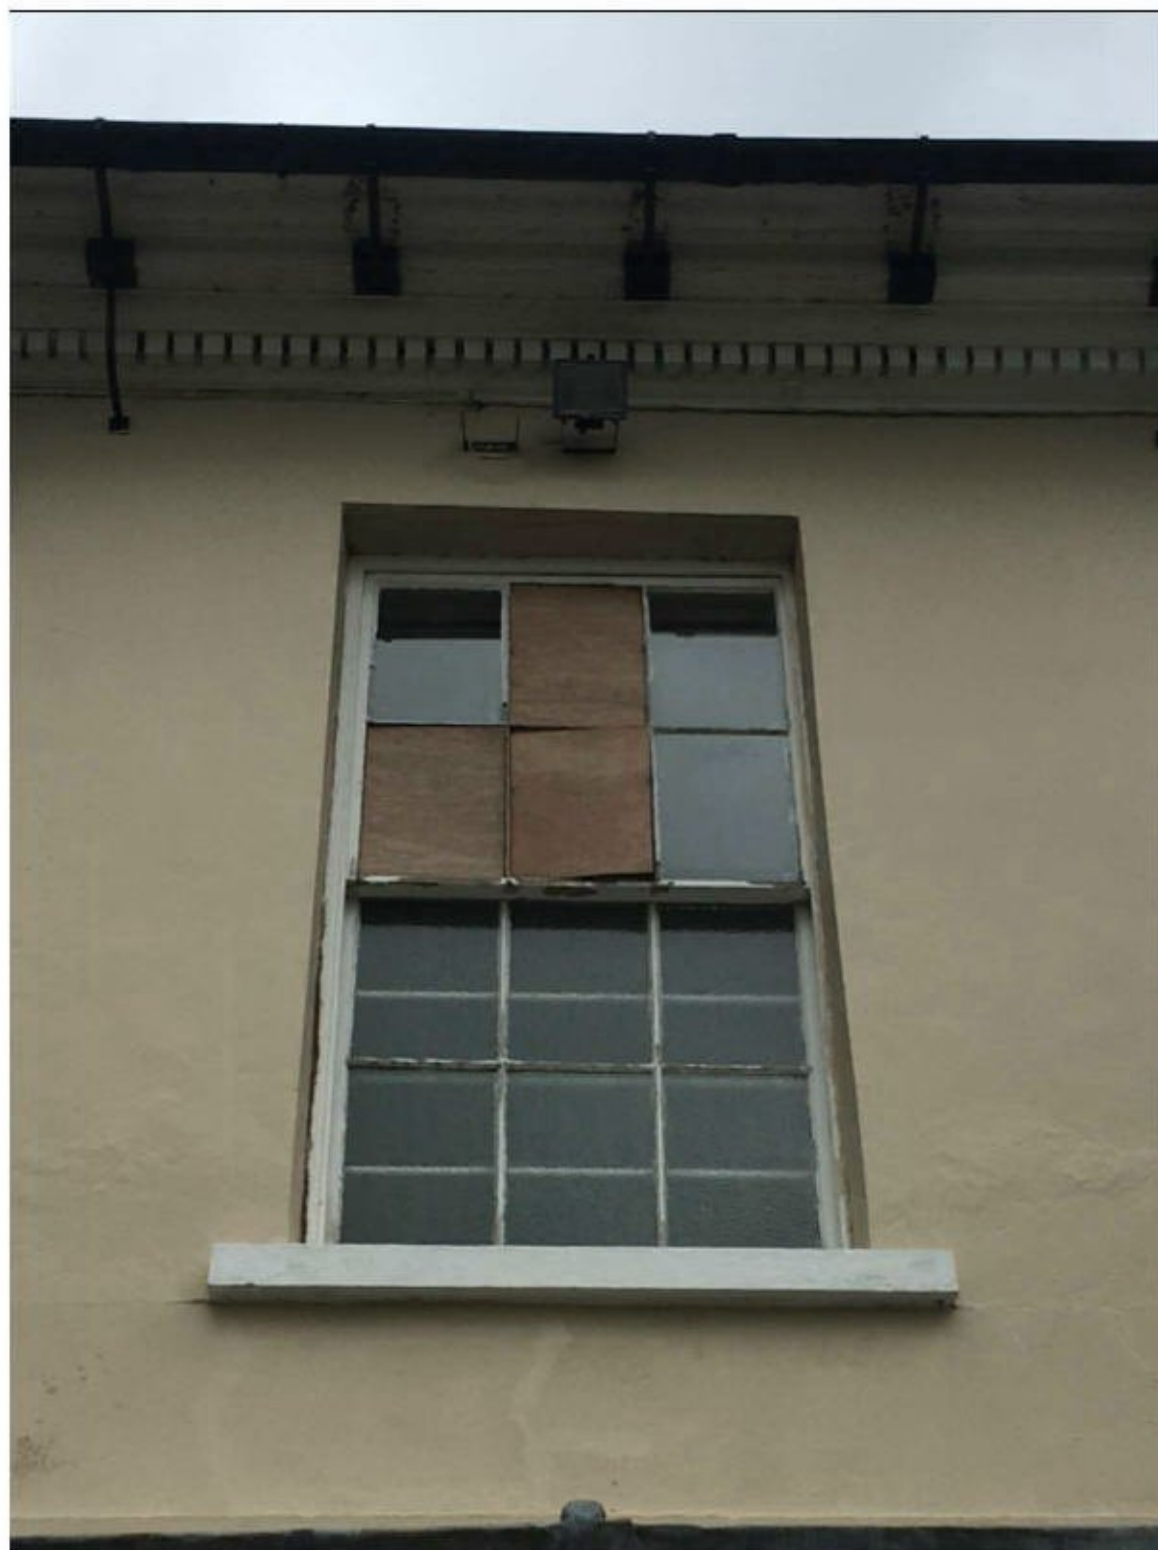
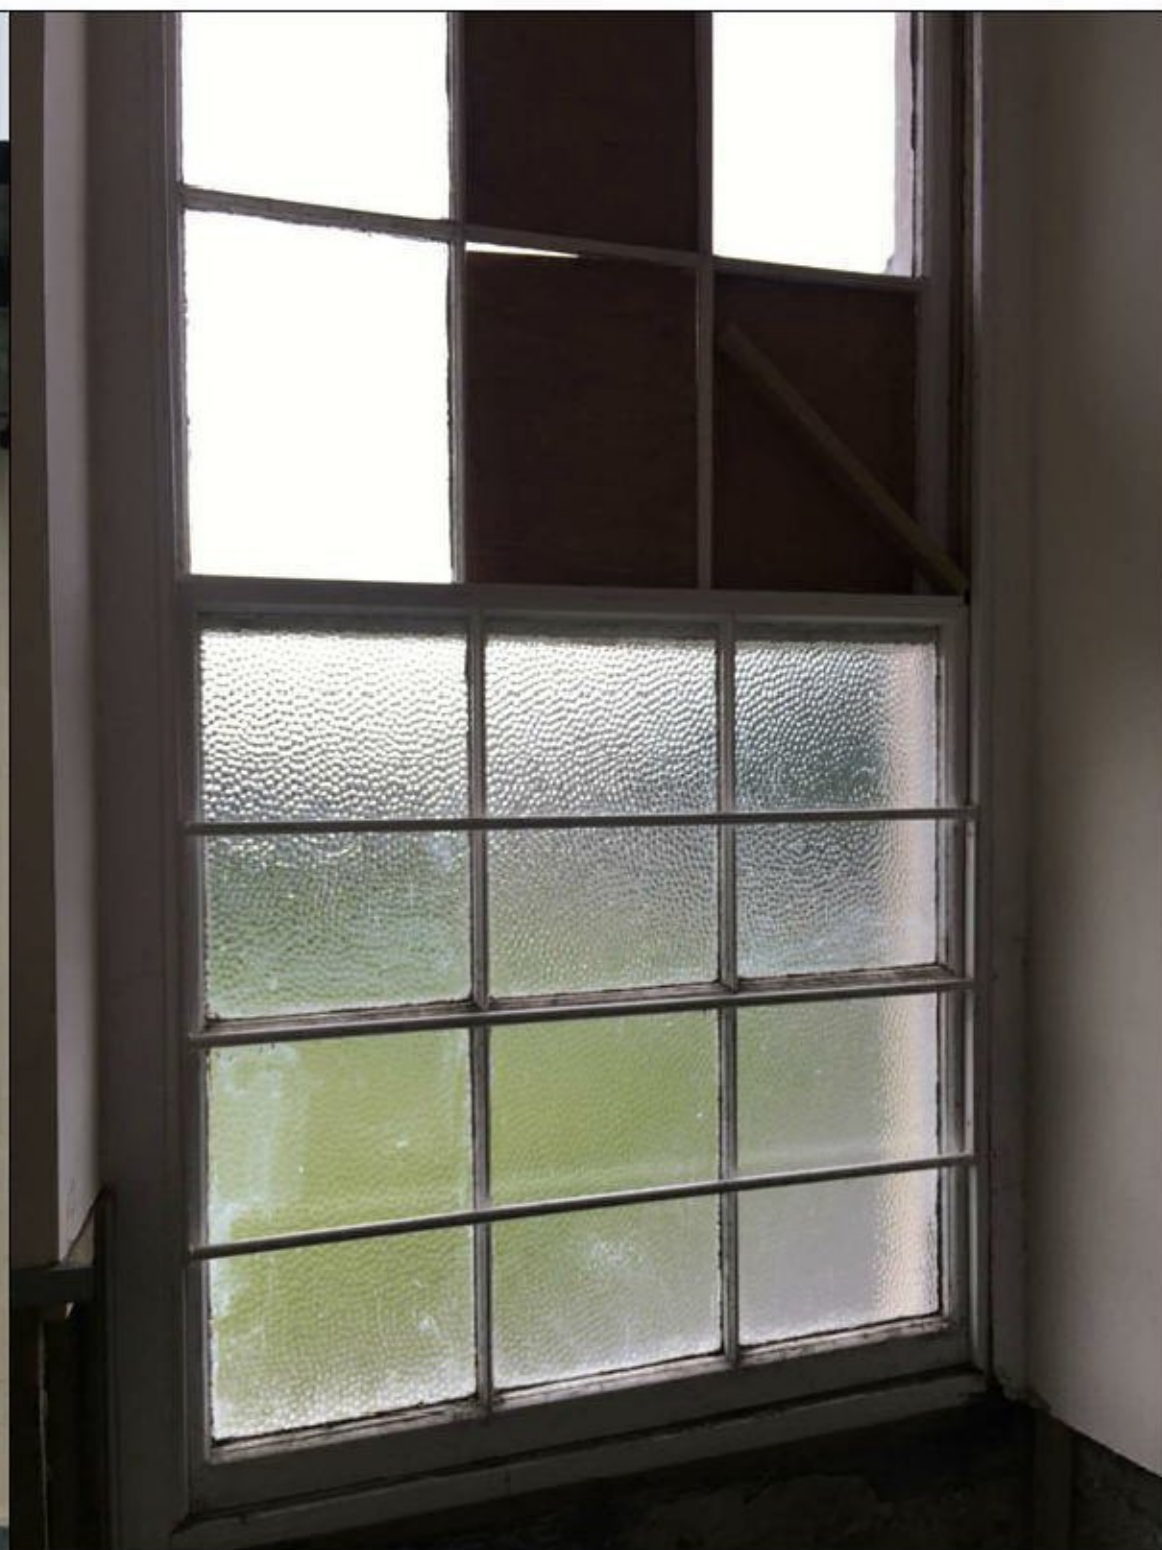
Photo Location - West_Window Number **W104** - See floor plans for location

Located with 1750's section of the building

Condition - Poor in need of replacement

Frame - Presumed Non Original

Glass - Presumed Non Original

· **Replacement window**

it has been advised by a window restorer and fabricator that there is not enough good quality frame left to simply refurbish this window.

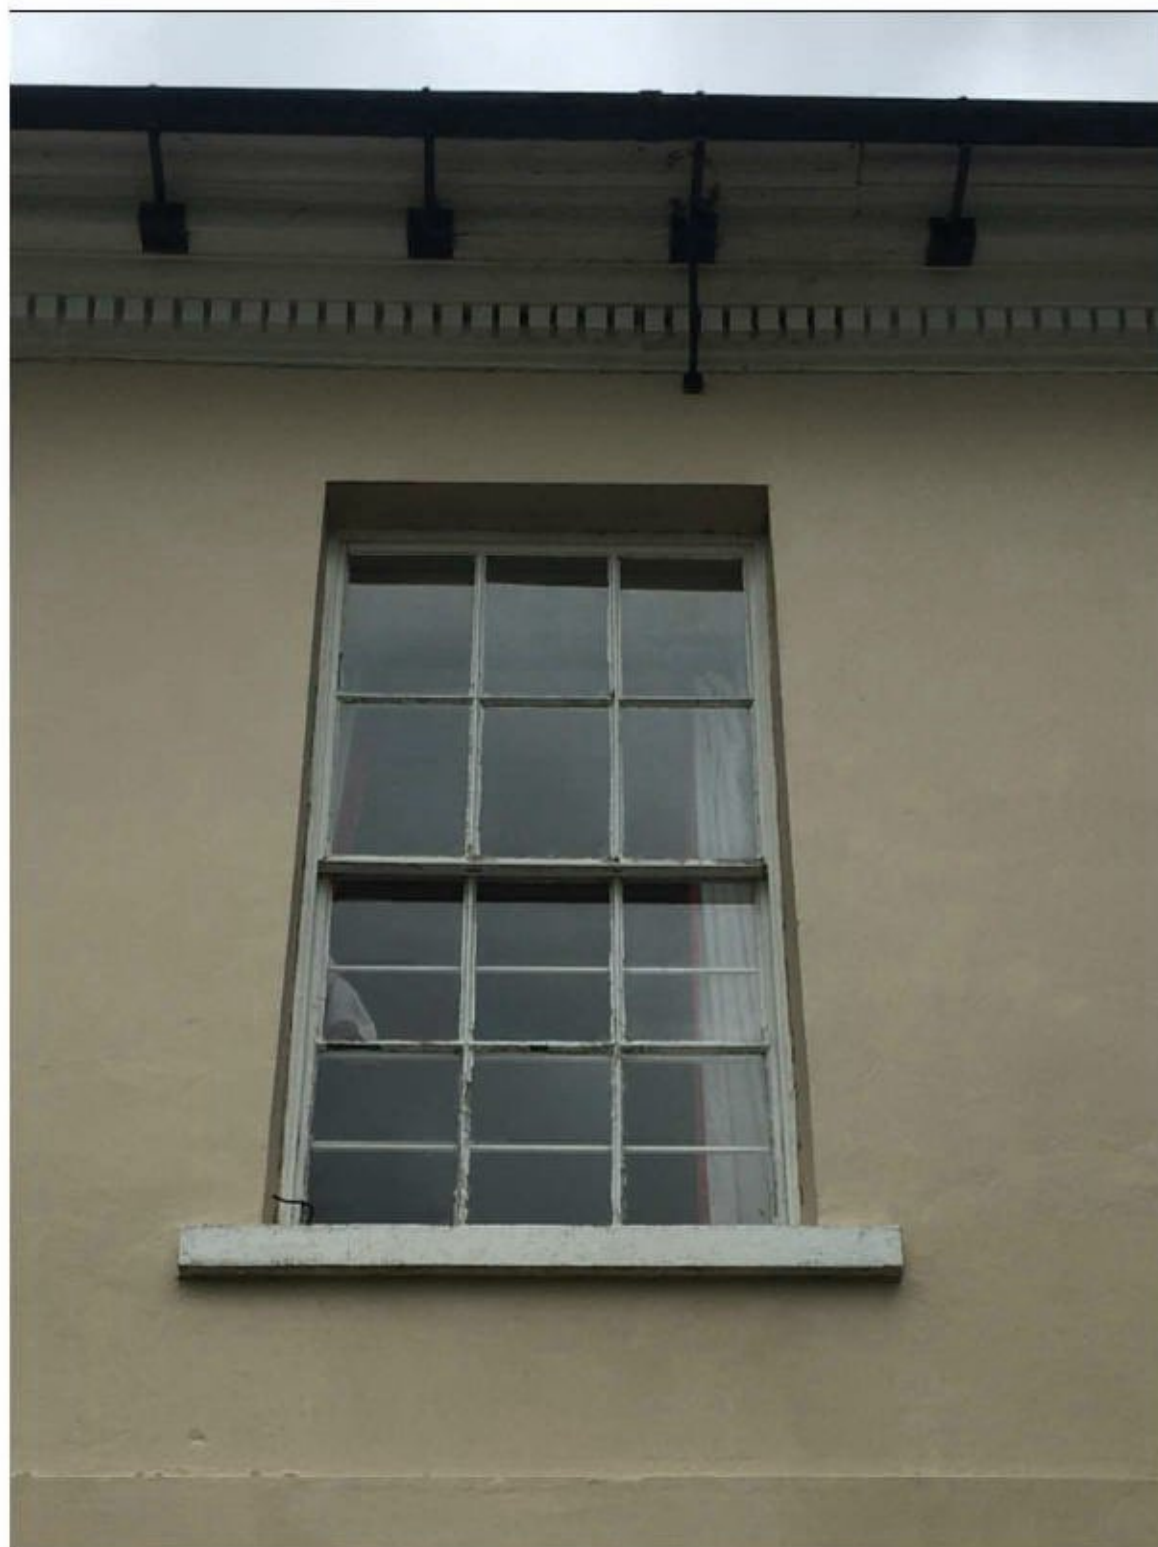
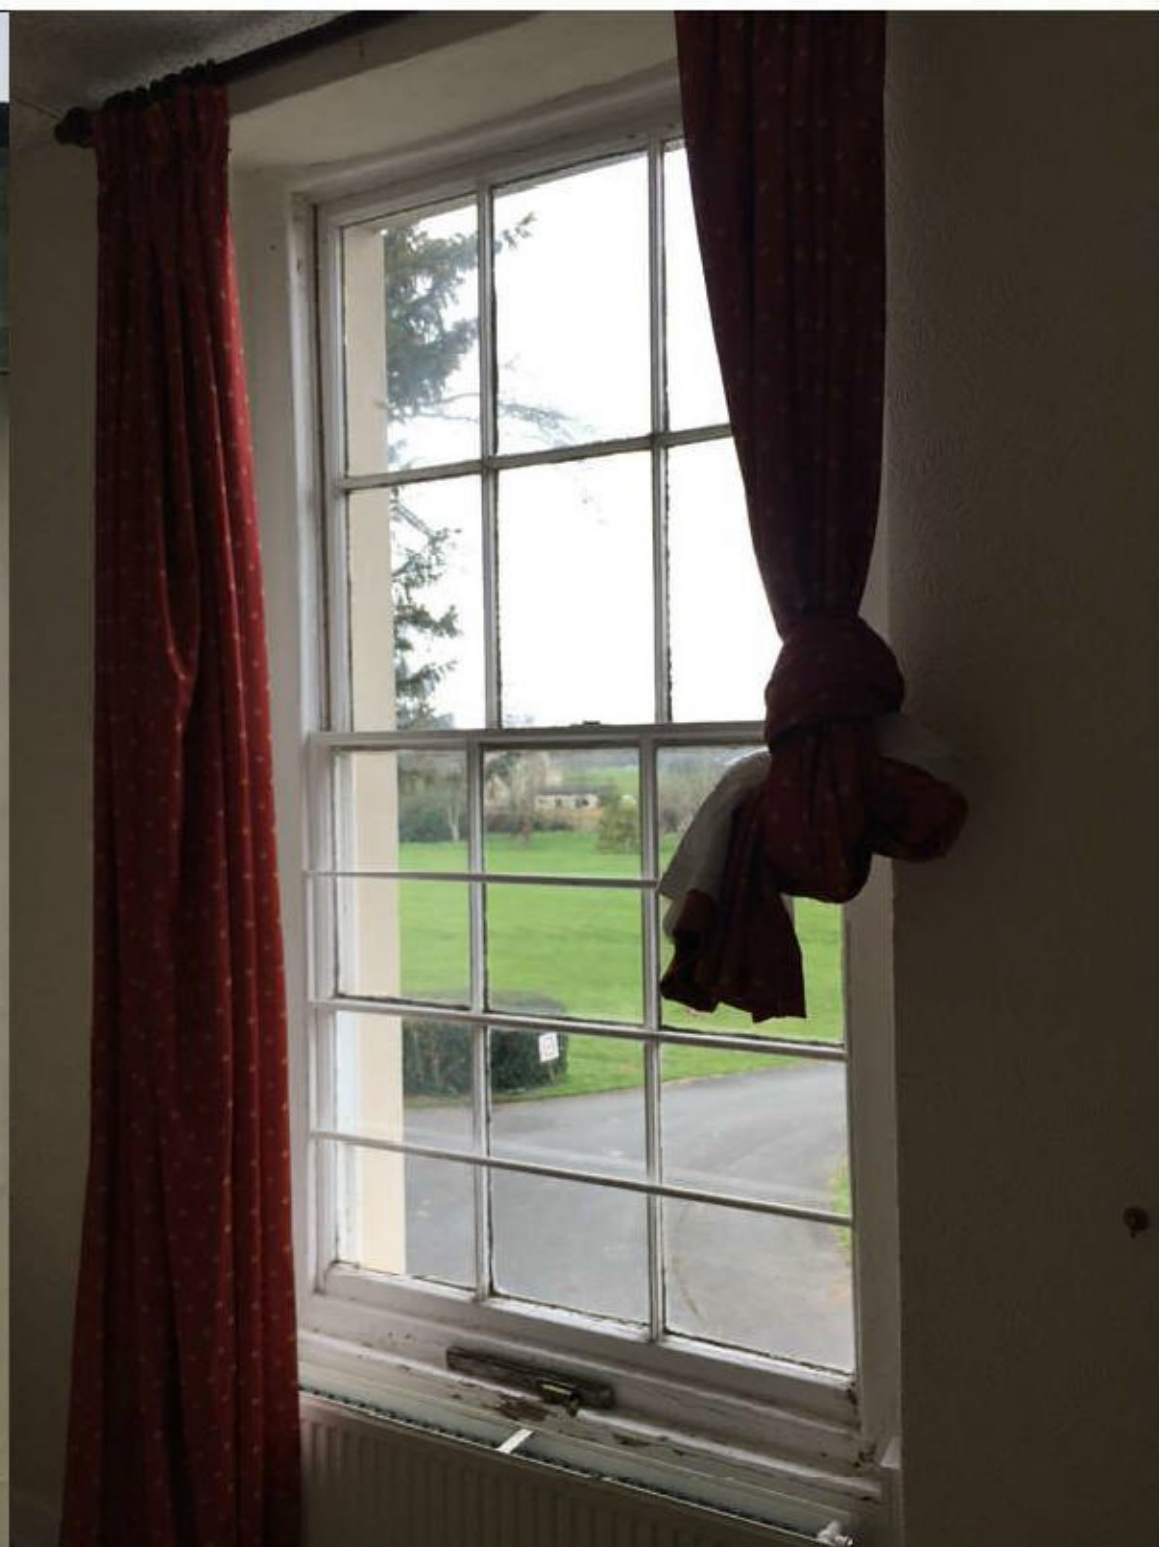
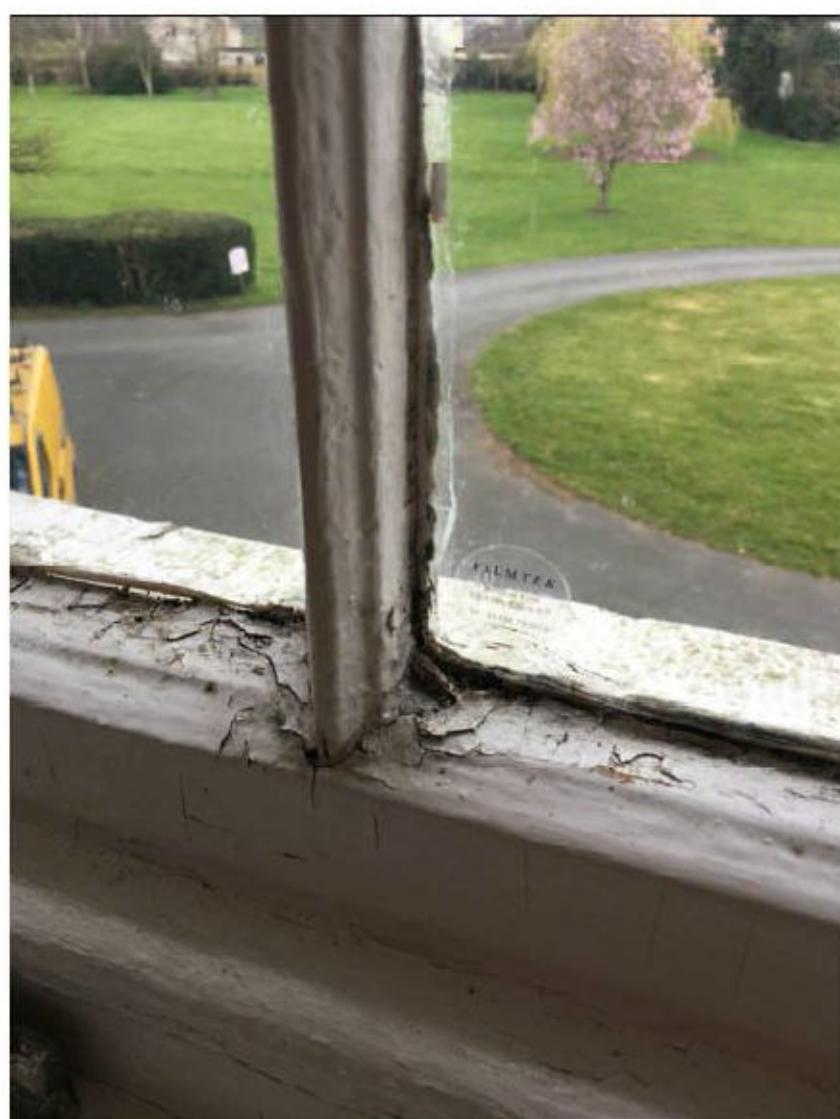
Photo Location - West_Window Number **W105** - See floor plans for location

Located with 1750's section of the building

Condition - Poor in need of replacement

Frame - Presumed Non Original

Glass - Presumed Non Original

· Replacement window

it has been advised by a window restorer and fabricator that there is not enough good quality frame left to simply refurbish this window.
