Building Recording - First Floor

External and Internal Windows

showing existing photos, noted location, frame condition, glass condition and proposed refurbishment works.

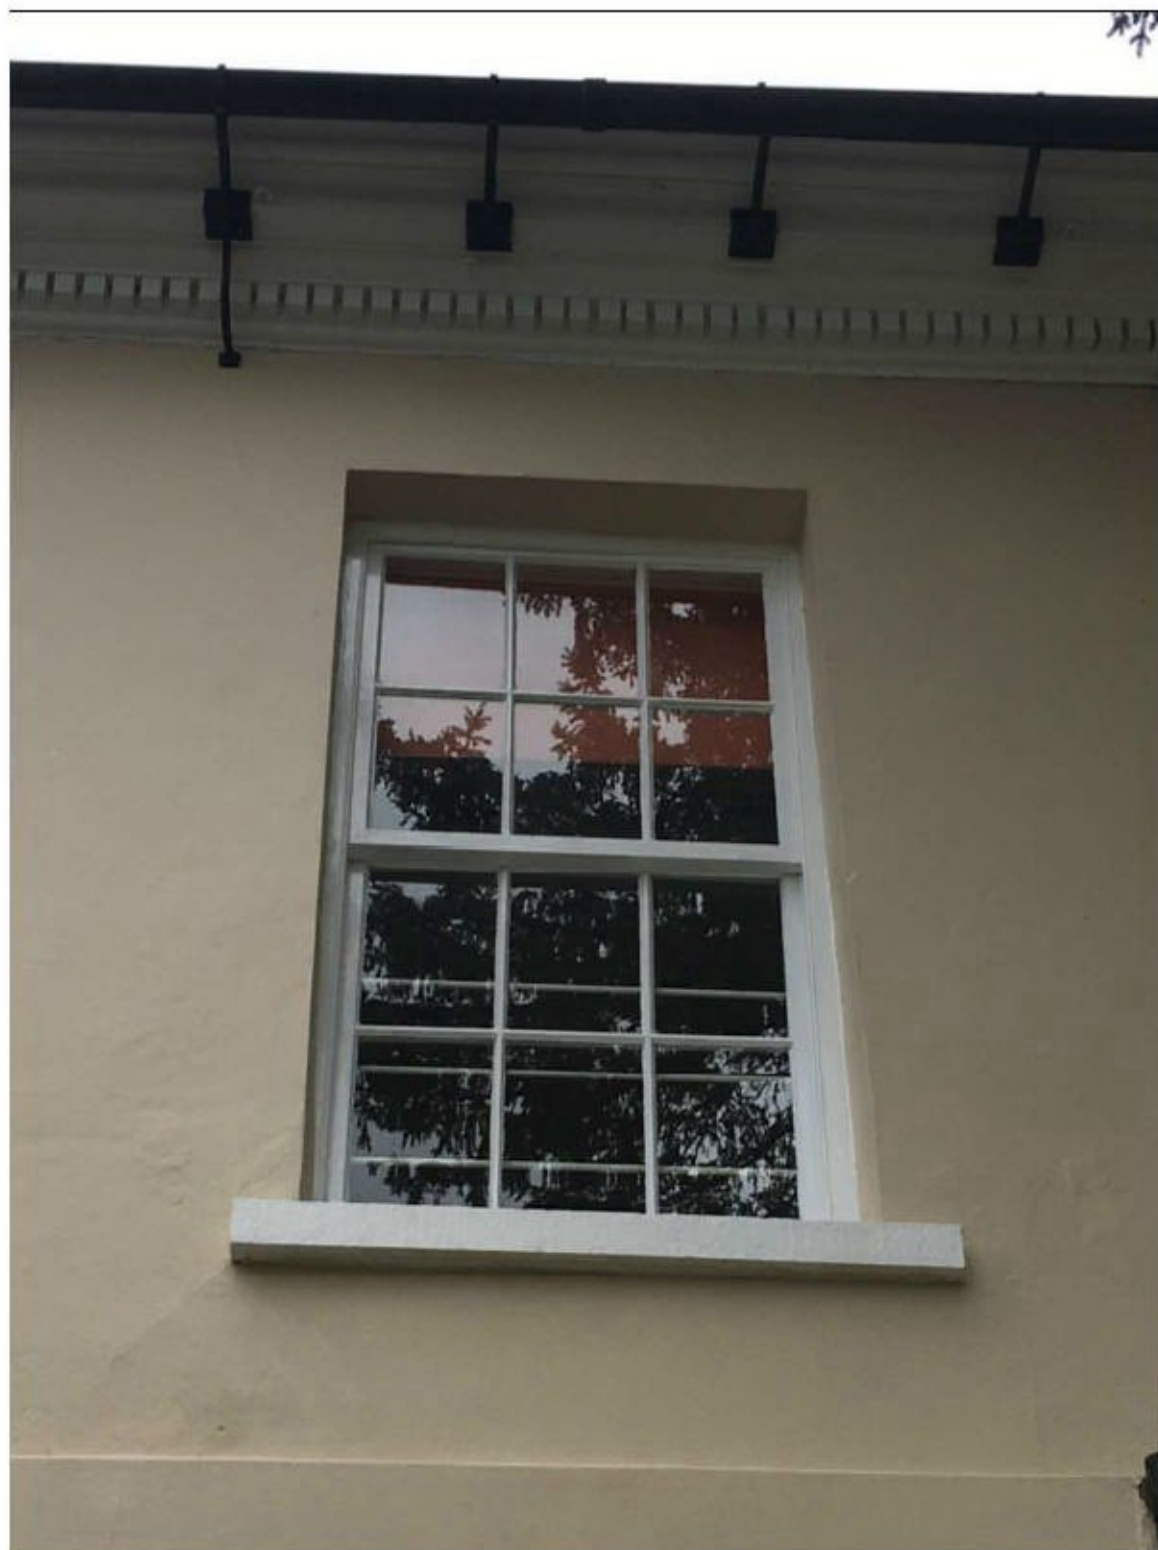
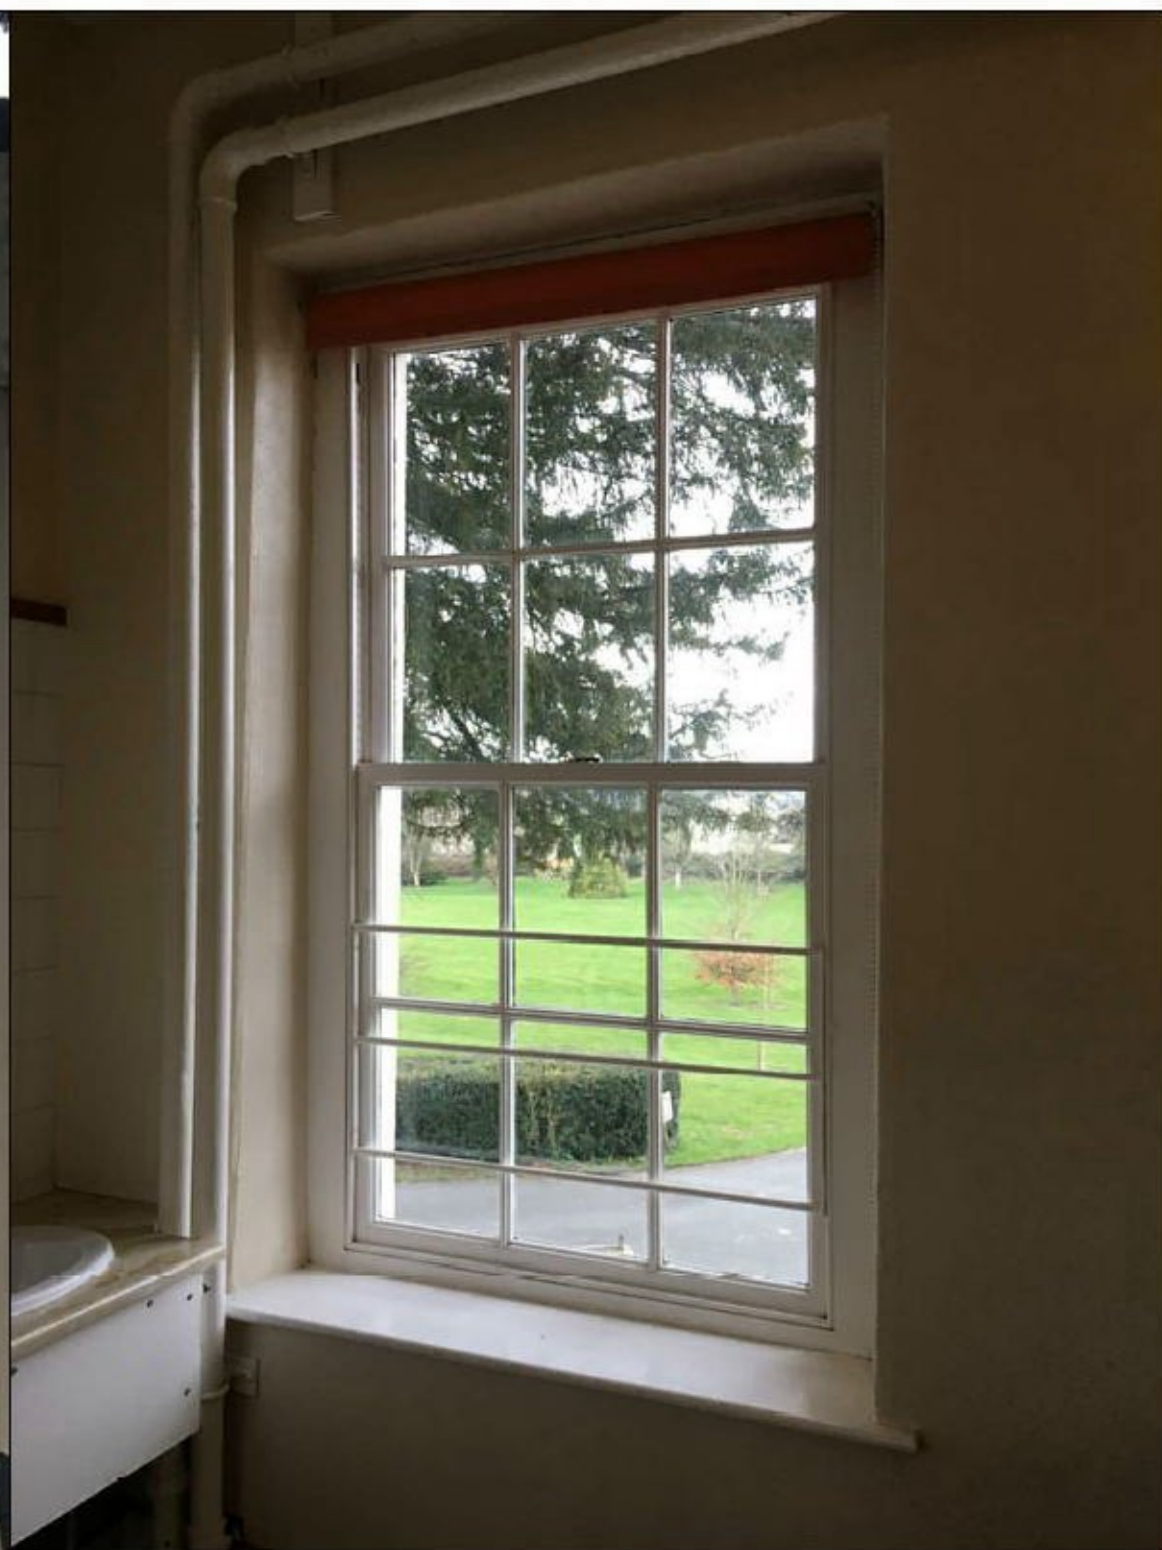
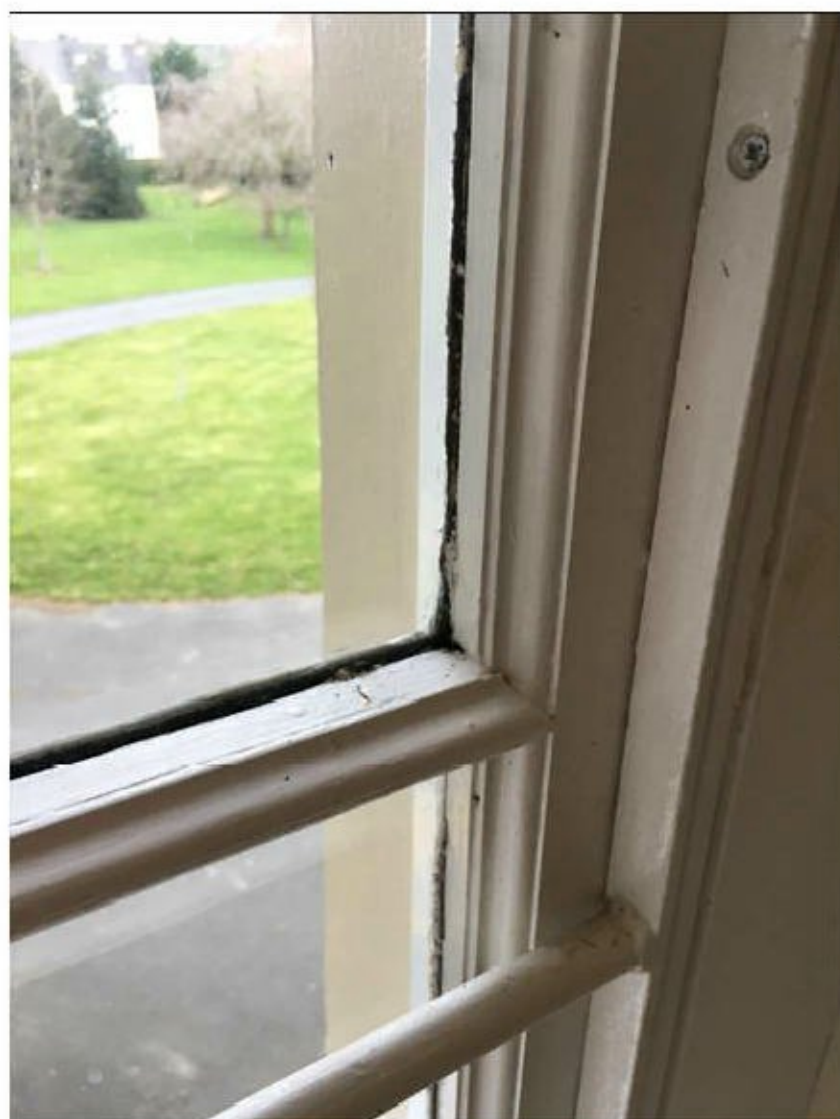
Photo Location - West_Window Number **W106** - See floor plans for location

Located with 1840's section of the building

Condition - Good

Frame - Presumed Non Original

Glass - Presumed Non Original

· Replacement window

it has been advised by a window restorer and fabricator that there is not enough good quality frame left to simply refurbish this window.

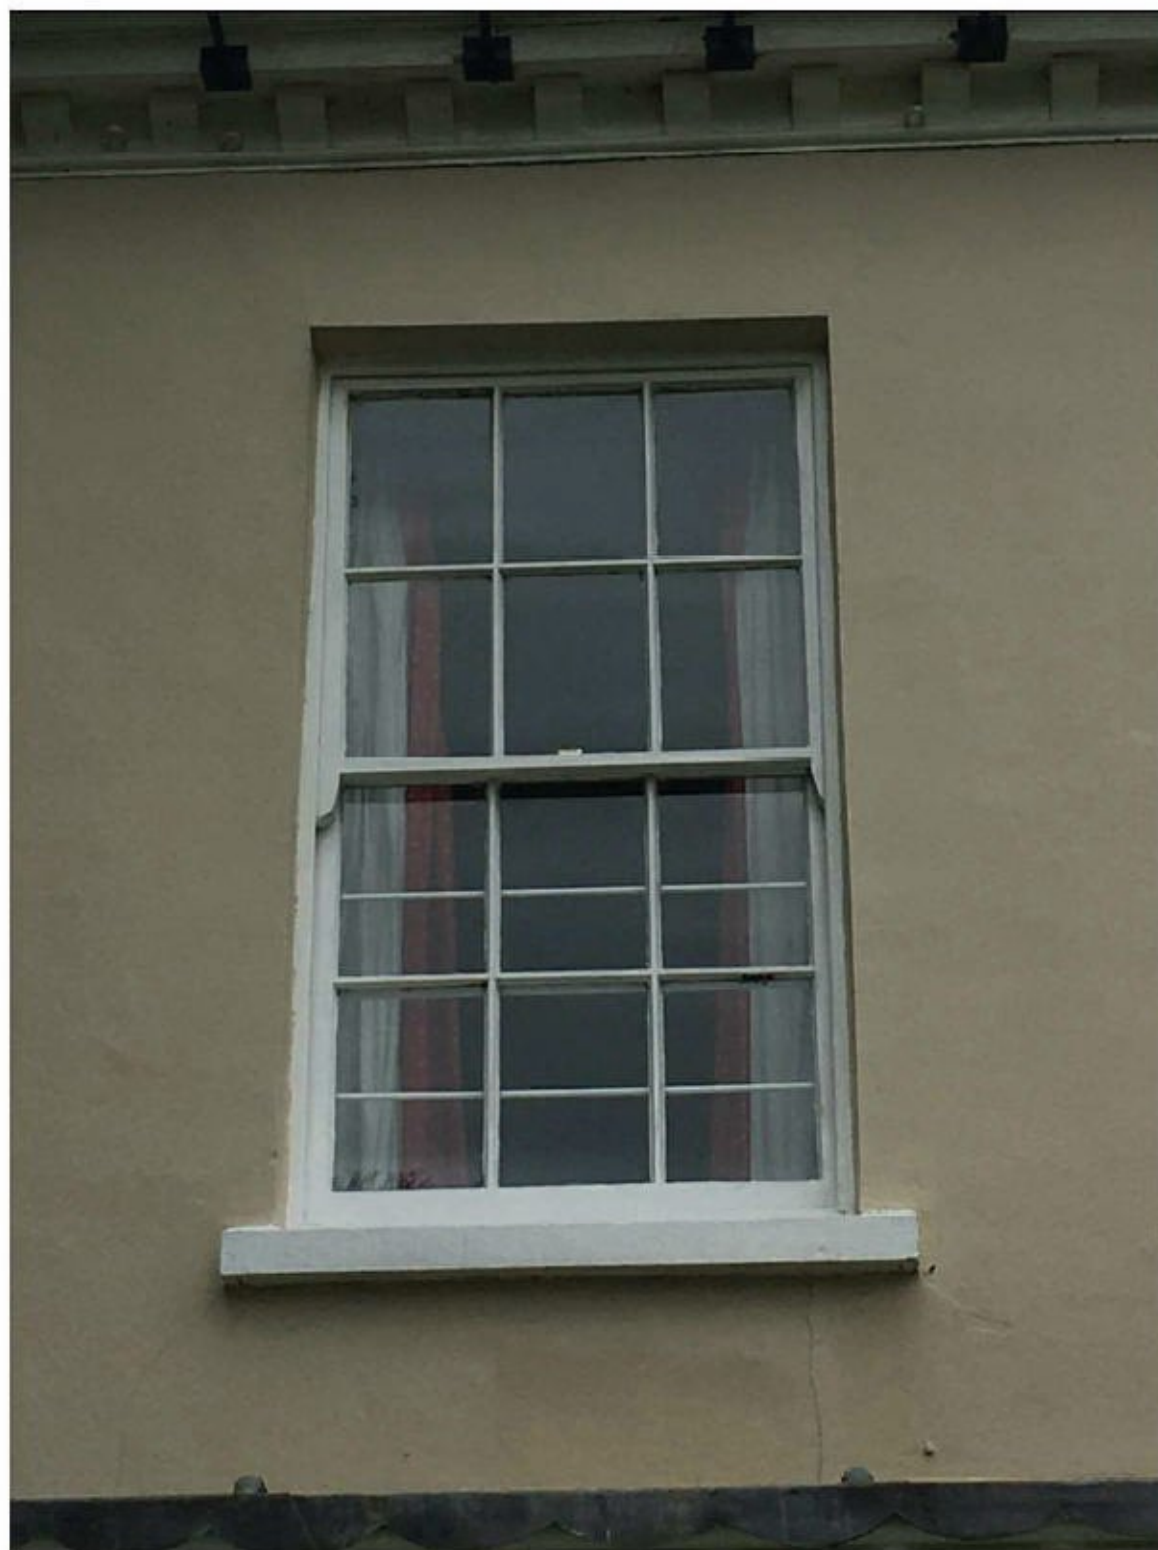
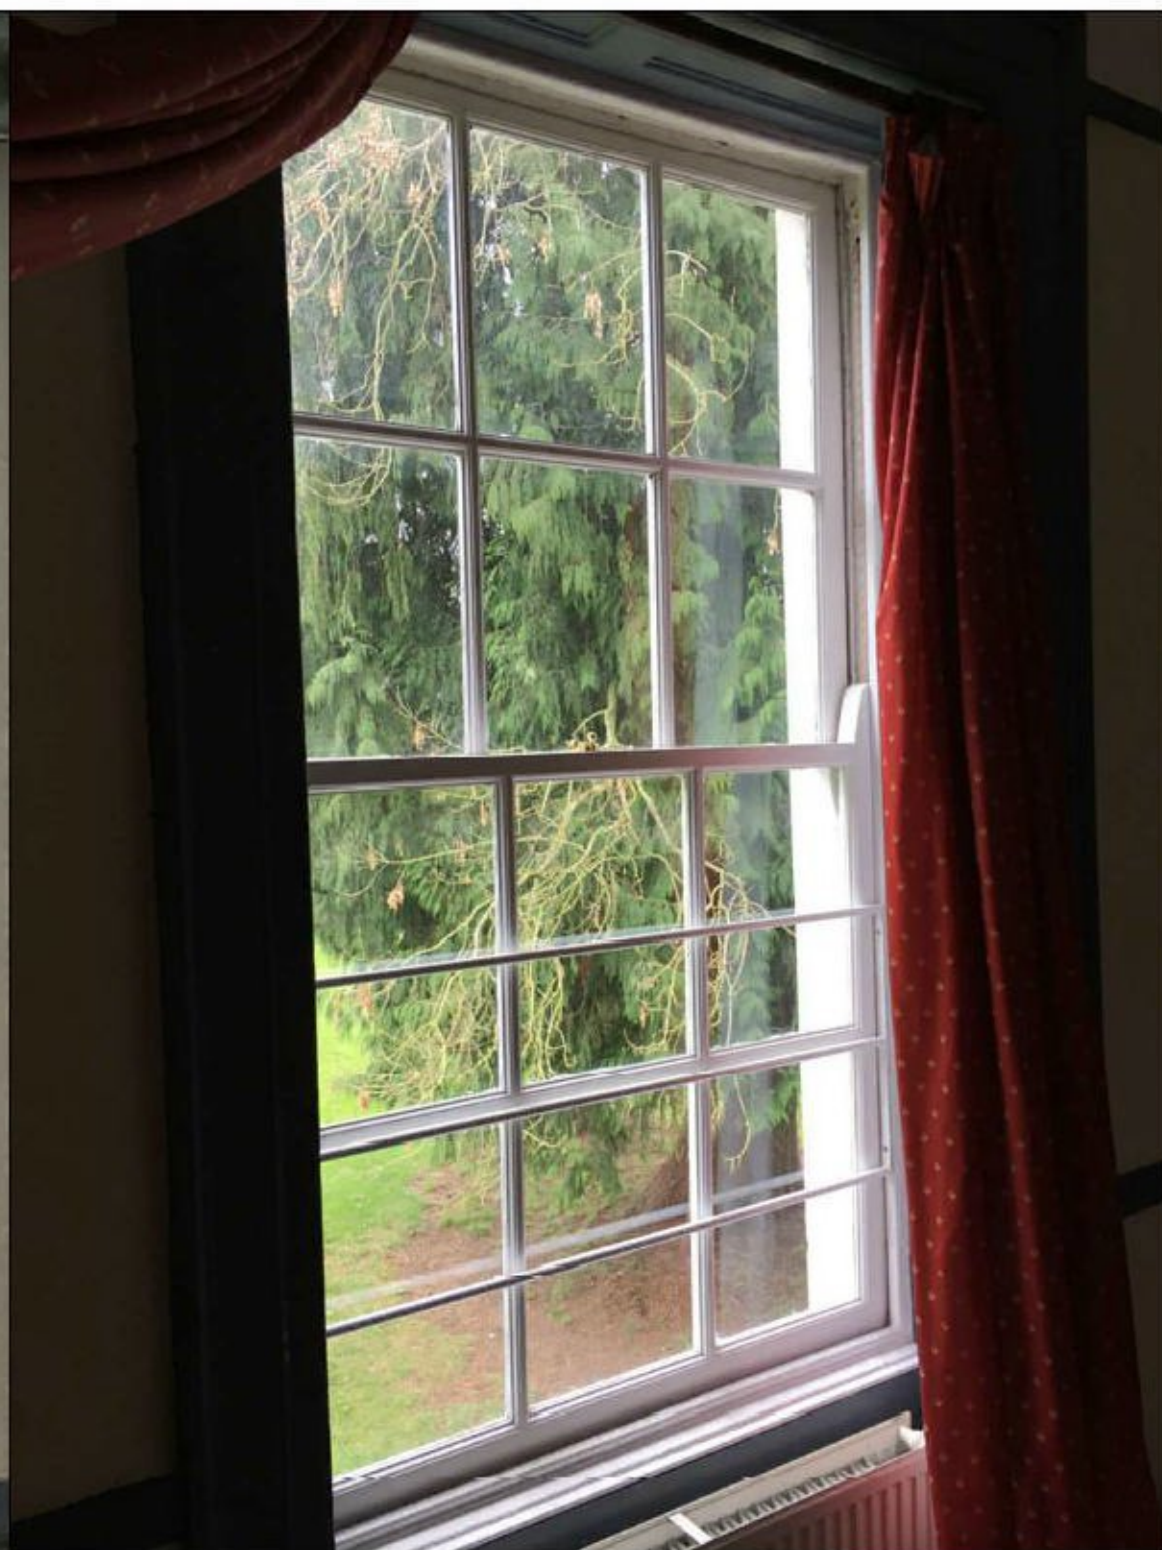
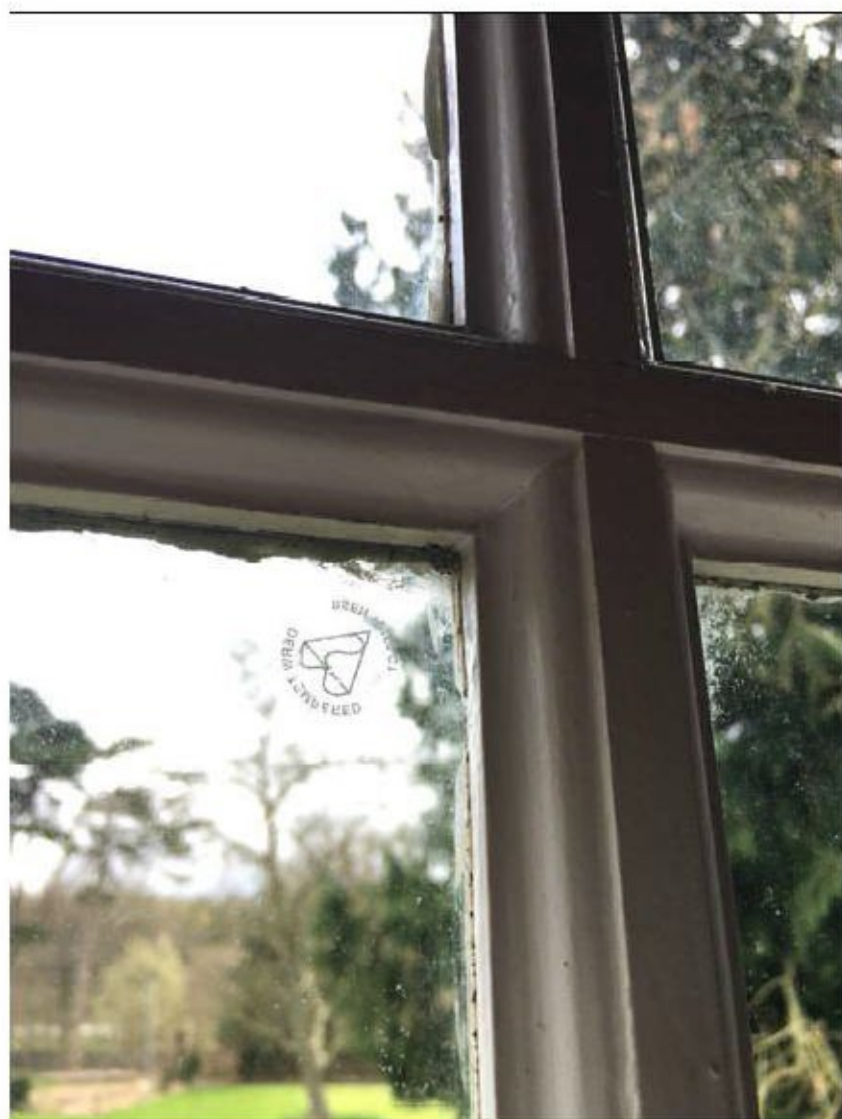
Photo Location - East_Window Number **W107** - See floor plans for location

Located with 1750's section of the building

Condition - Good

Frame - Presumed Non Original

Glass - Presumed Non Original

- Refurbished and re painted only if possible

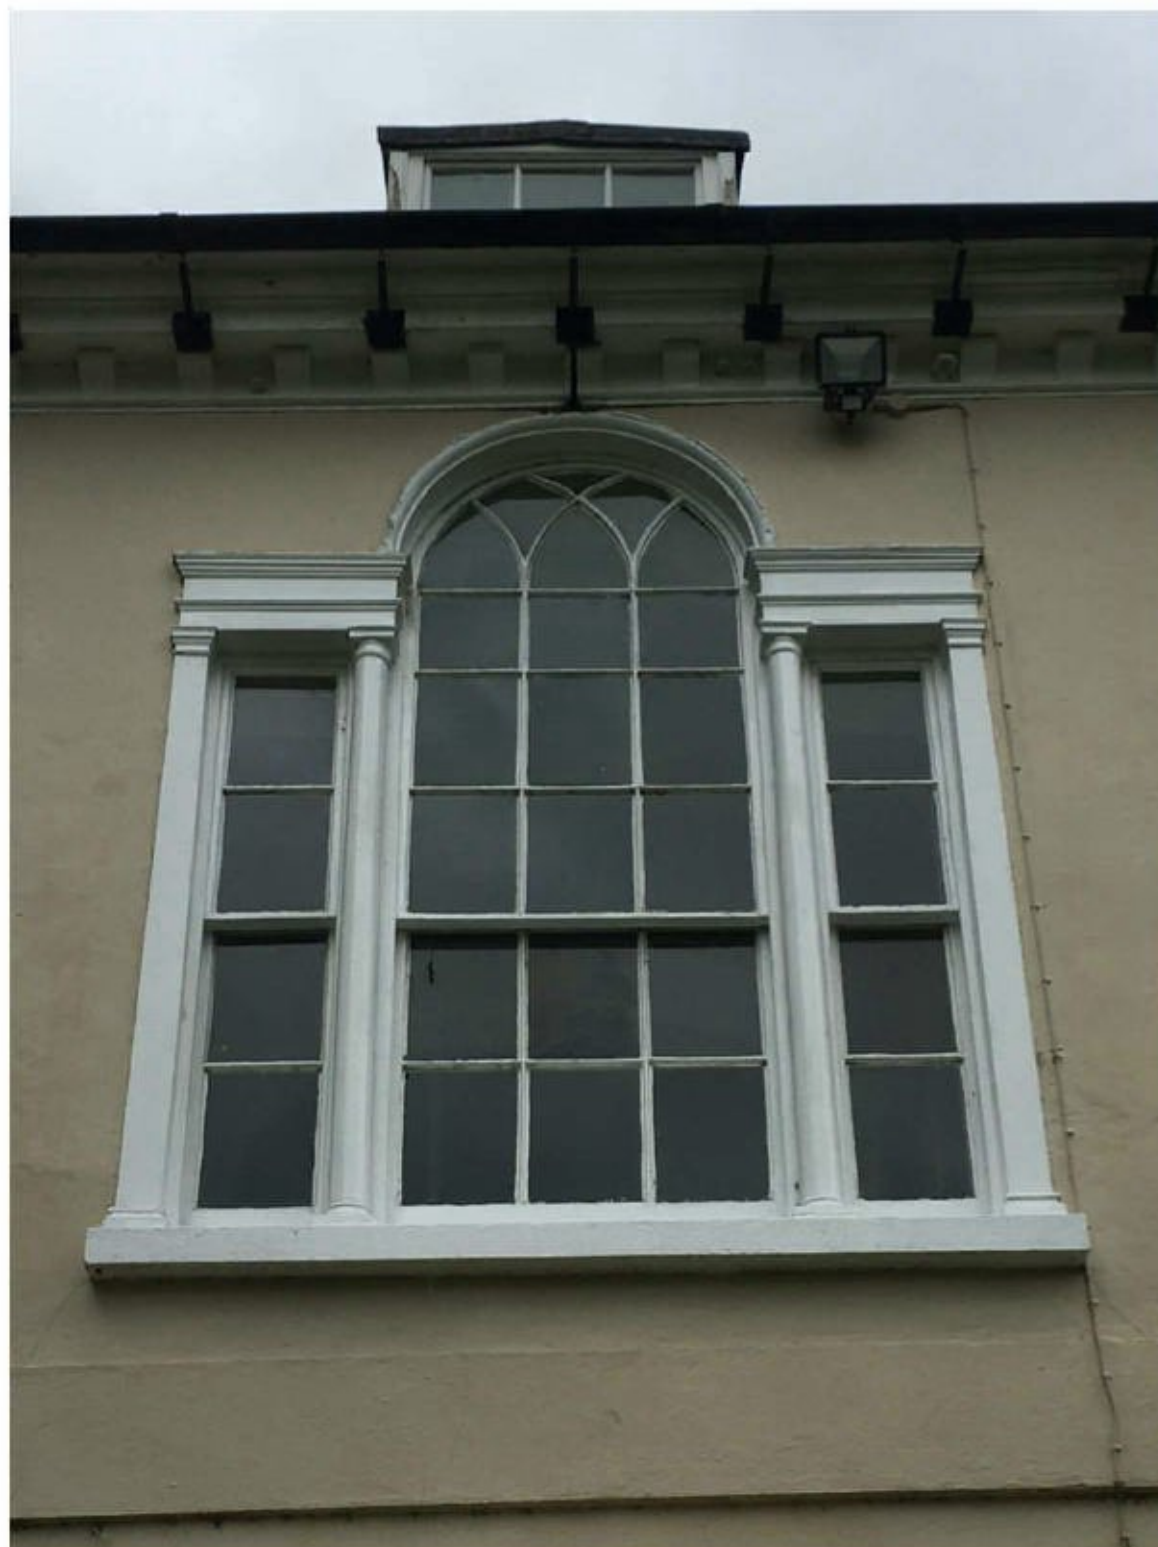
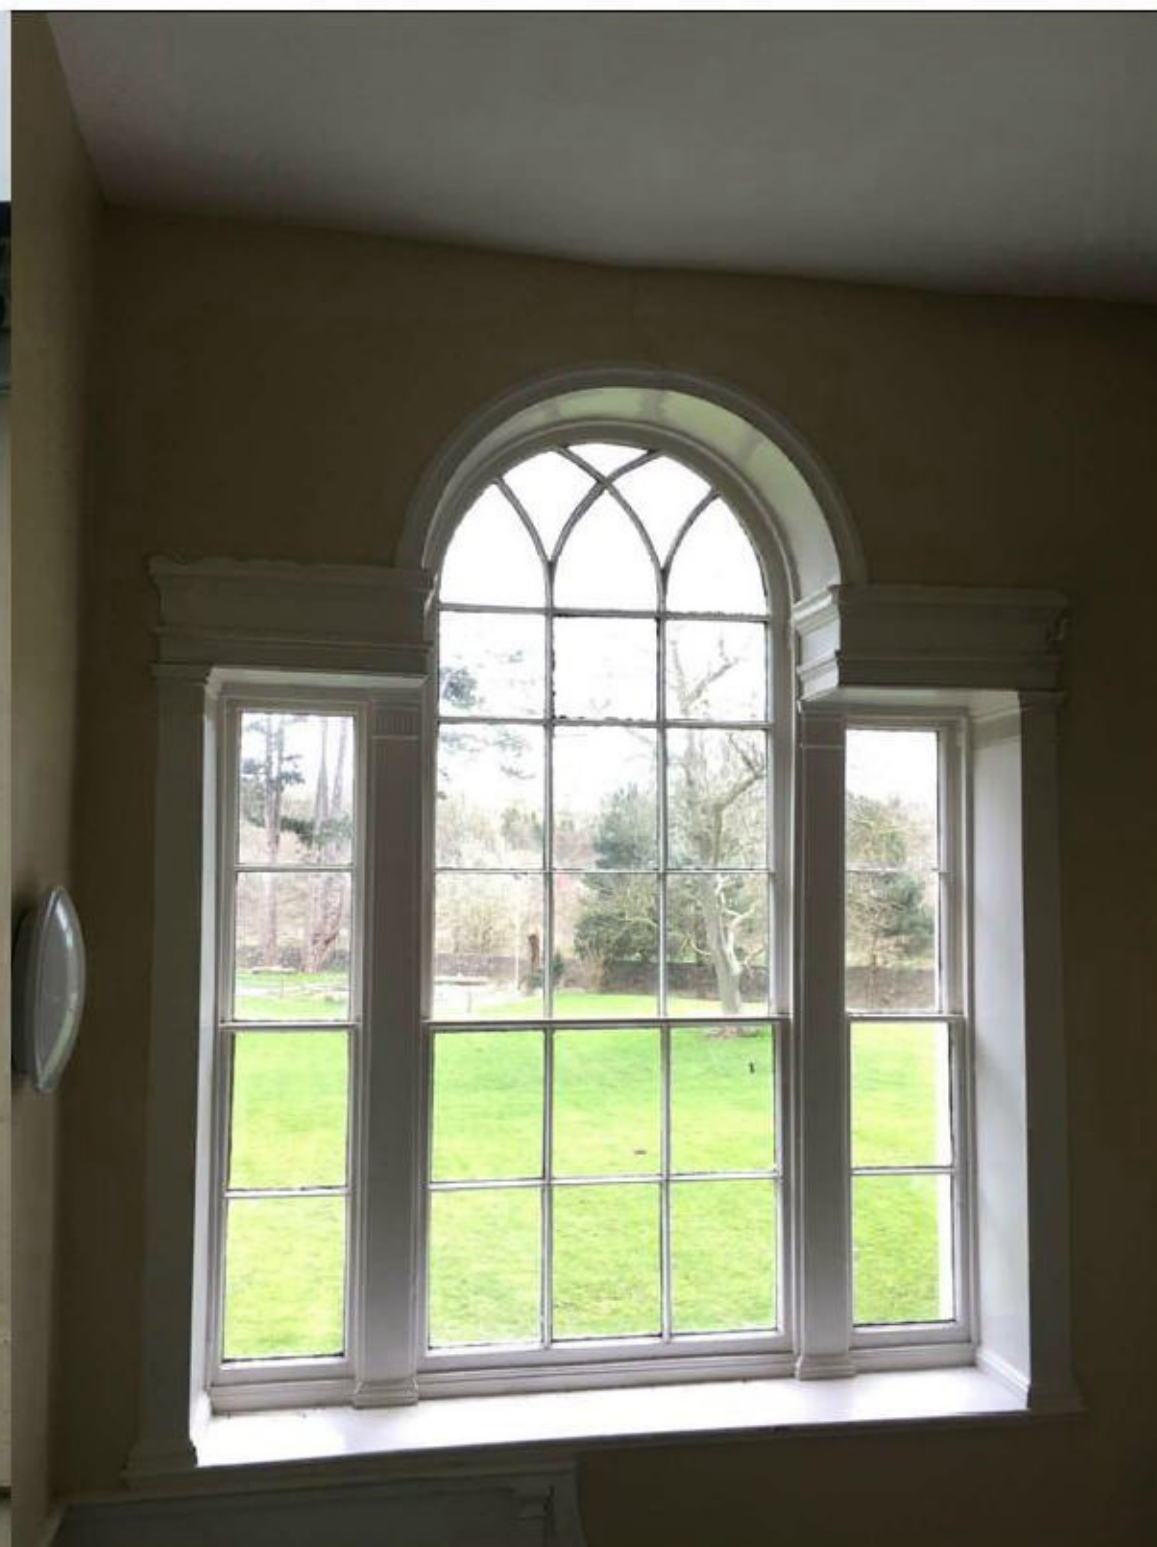
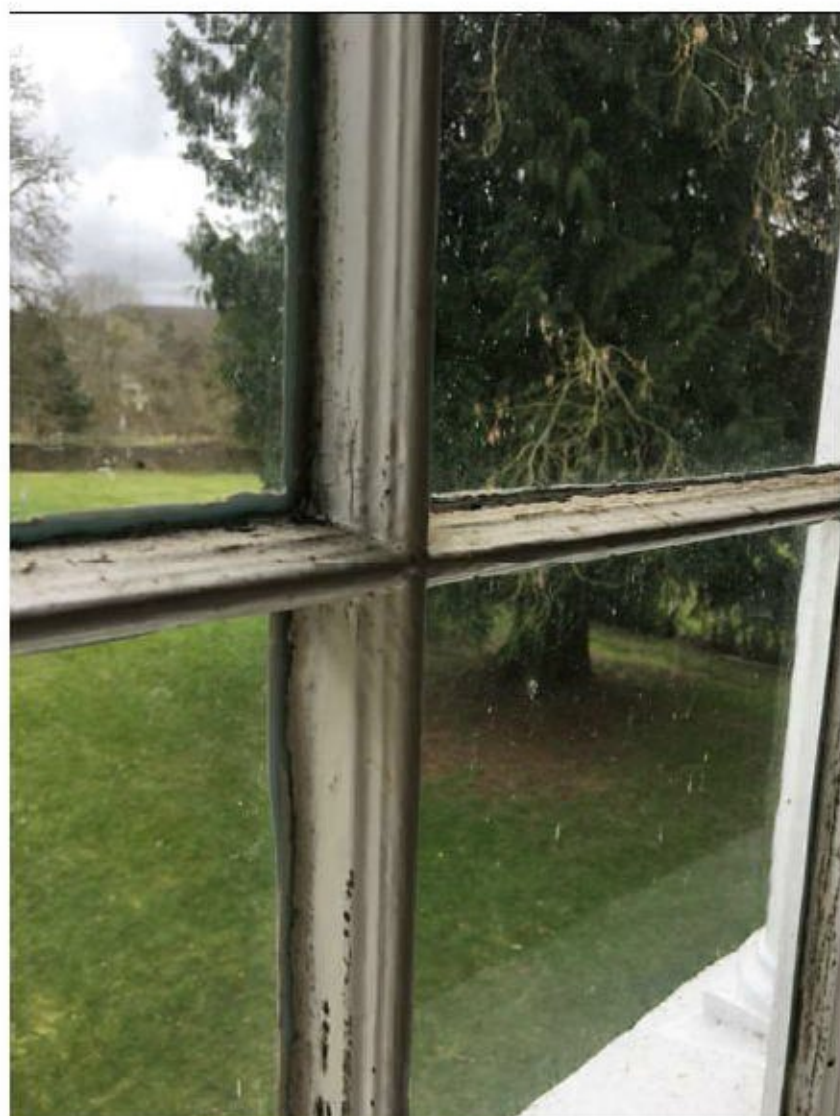
Photo Location - East_Window Number **W108** - See floor plans for location

Located with 1750's section of the building

Condition - Average in need of refurbishment

Frame - Presumed Non Original

Glass - Presumed Non Original

- Refurbished and re painted

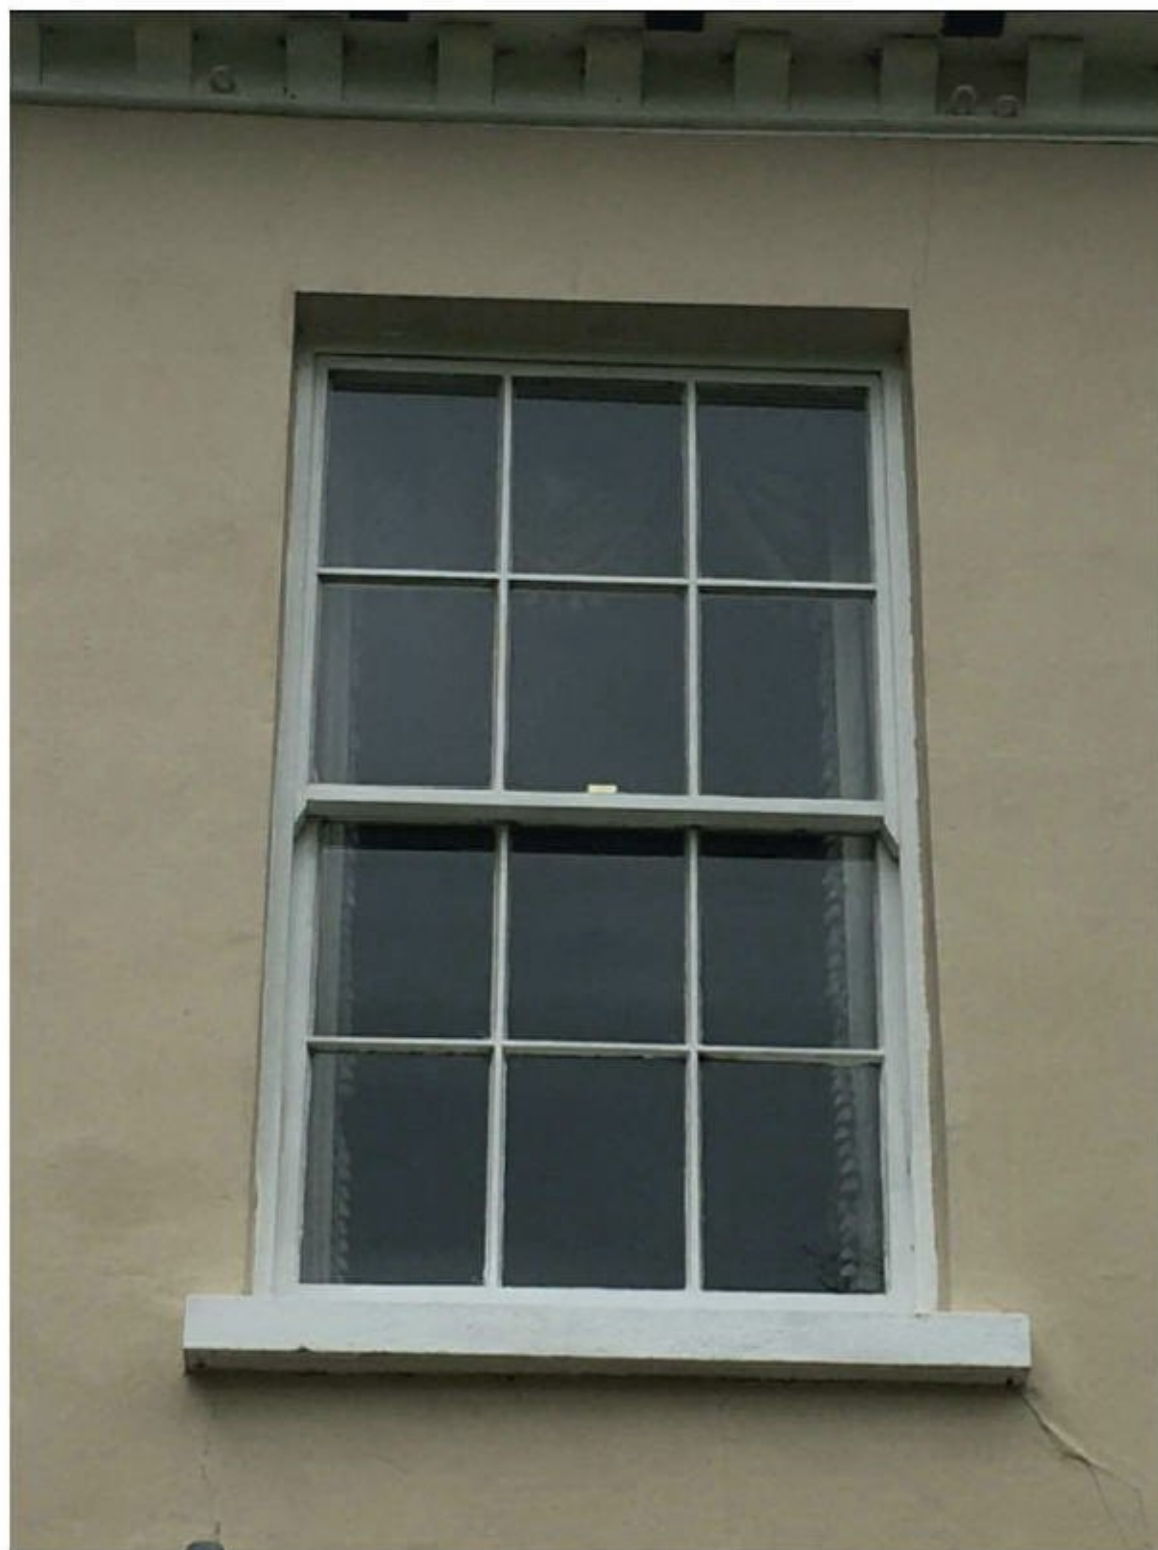
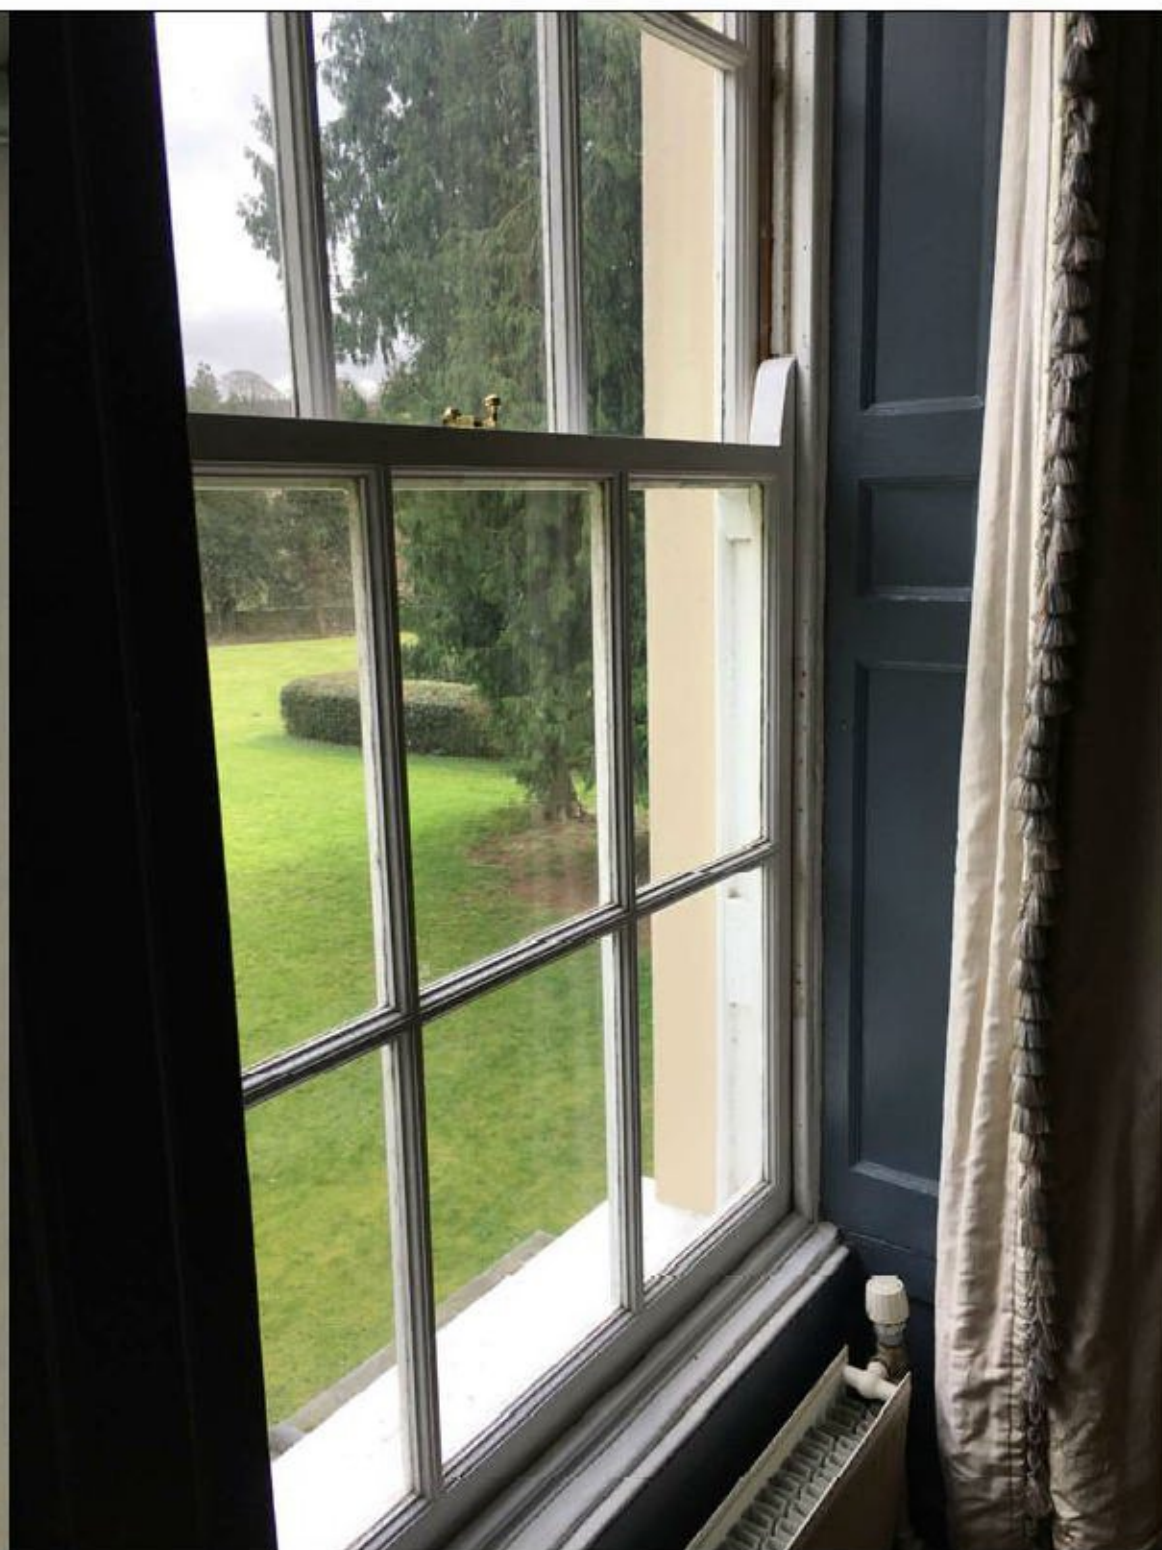
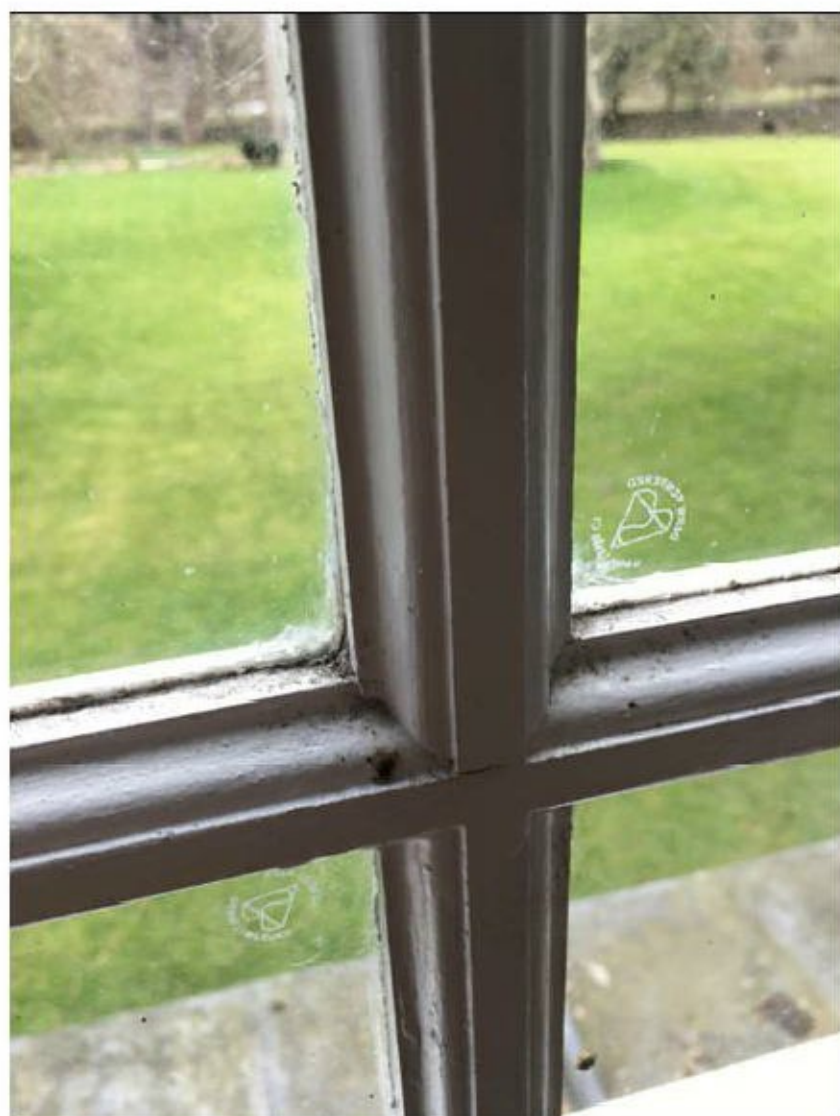
Photo Location - East_Window Number **W109** - See floor plans for location

Located with 1750's section of the building

Condition - Good

Frame - Presumed Non Original

Glass - Presumed Non Original

- Refurbished and re painted only if possible

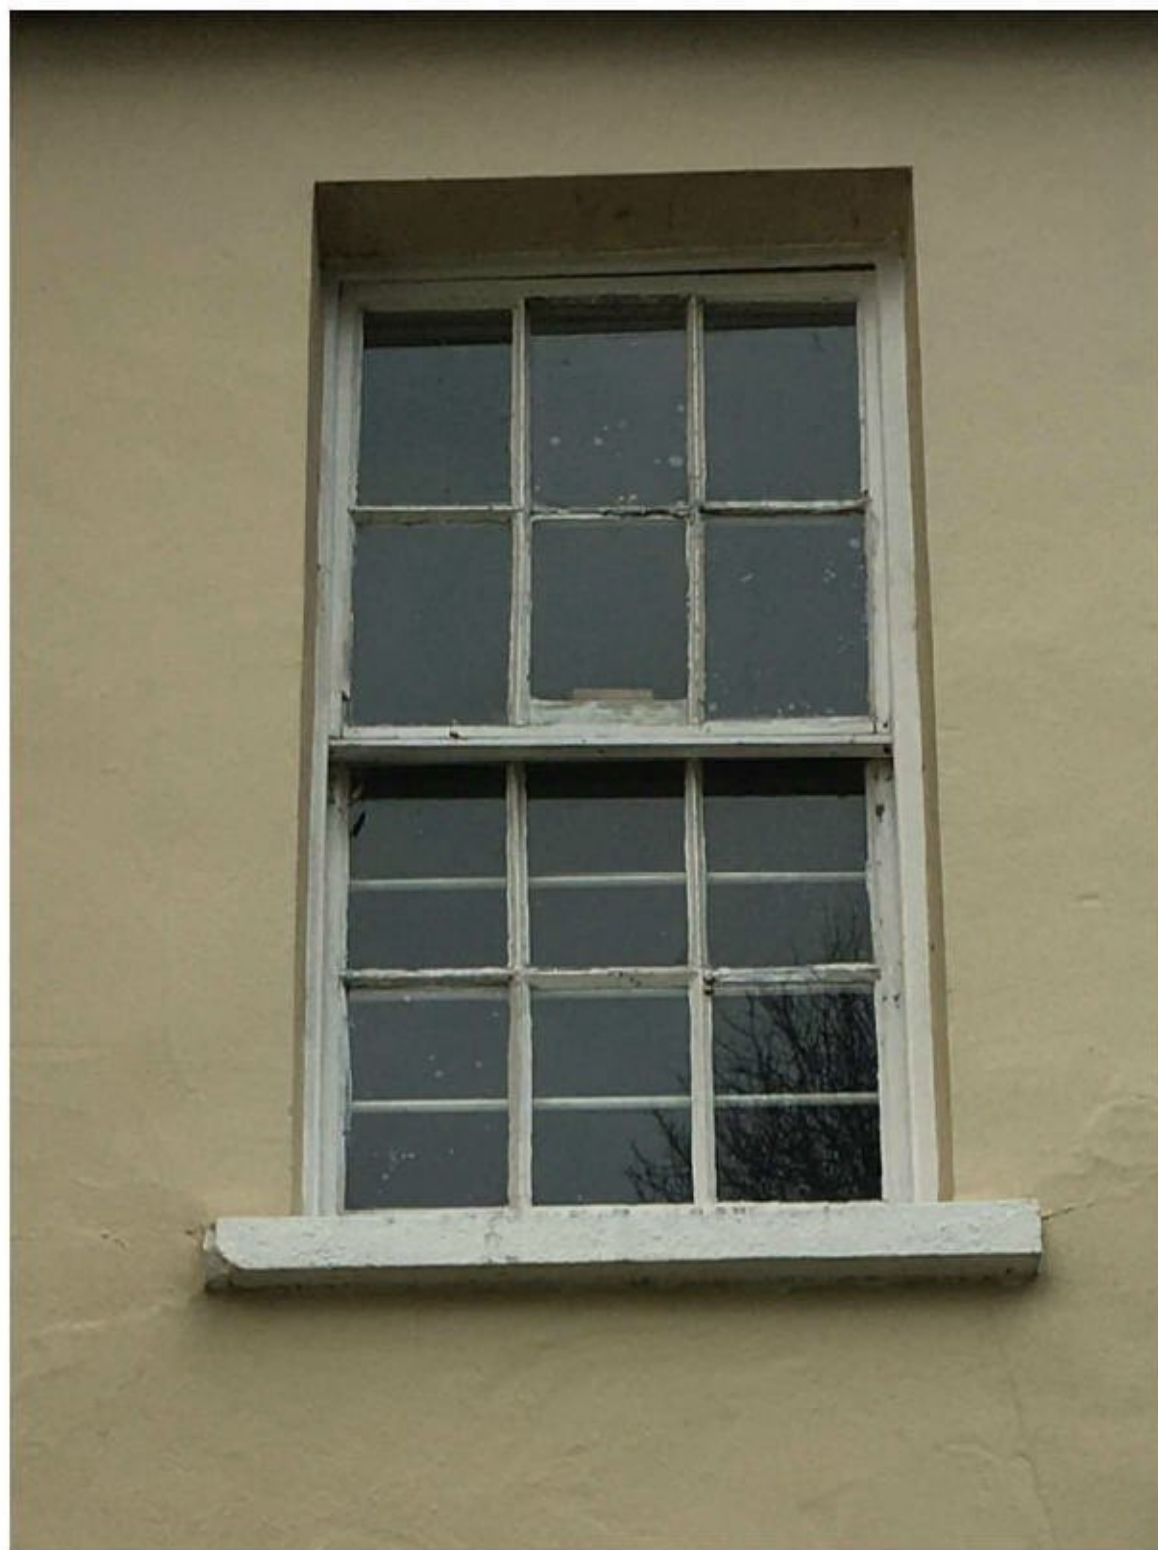
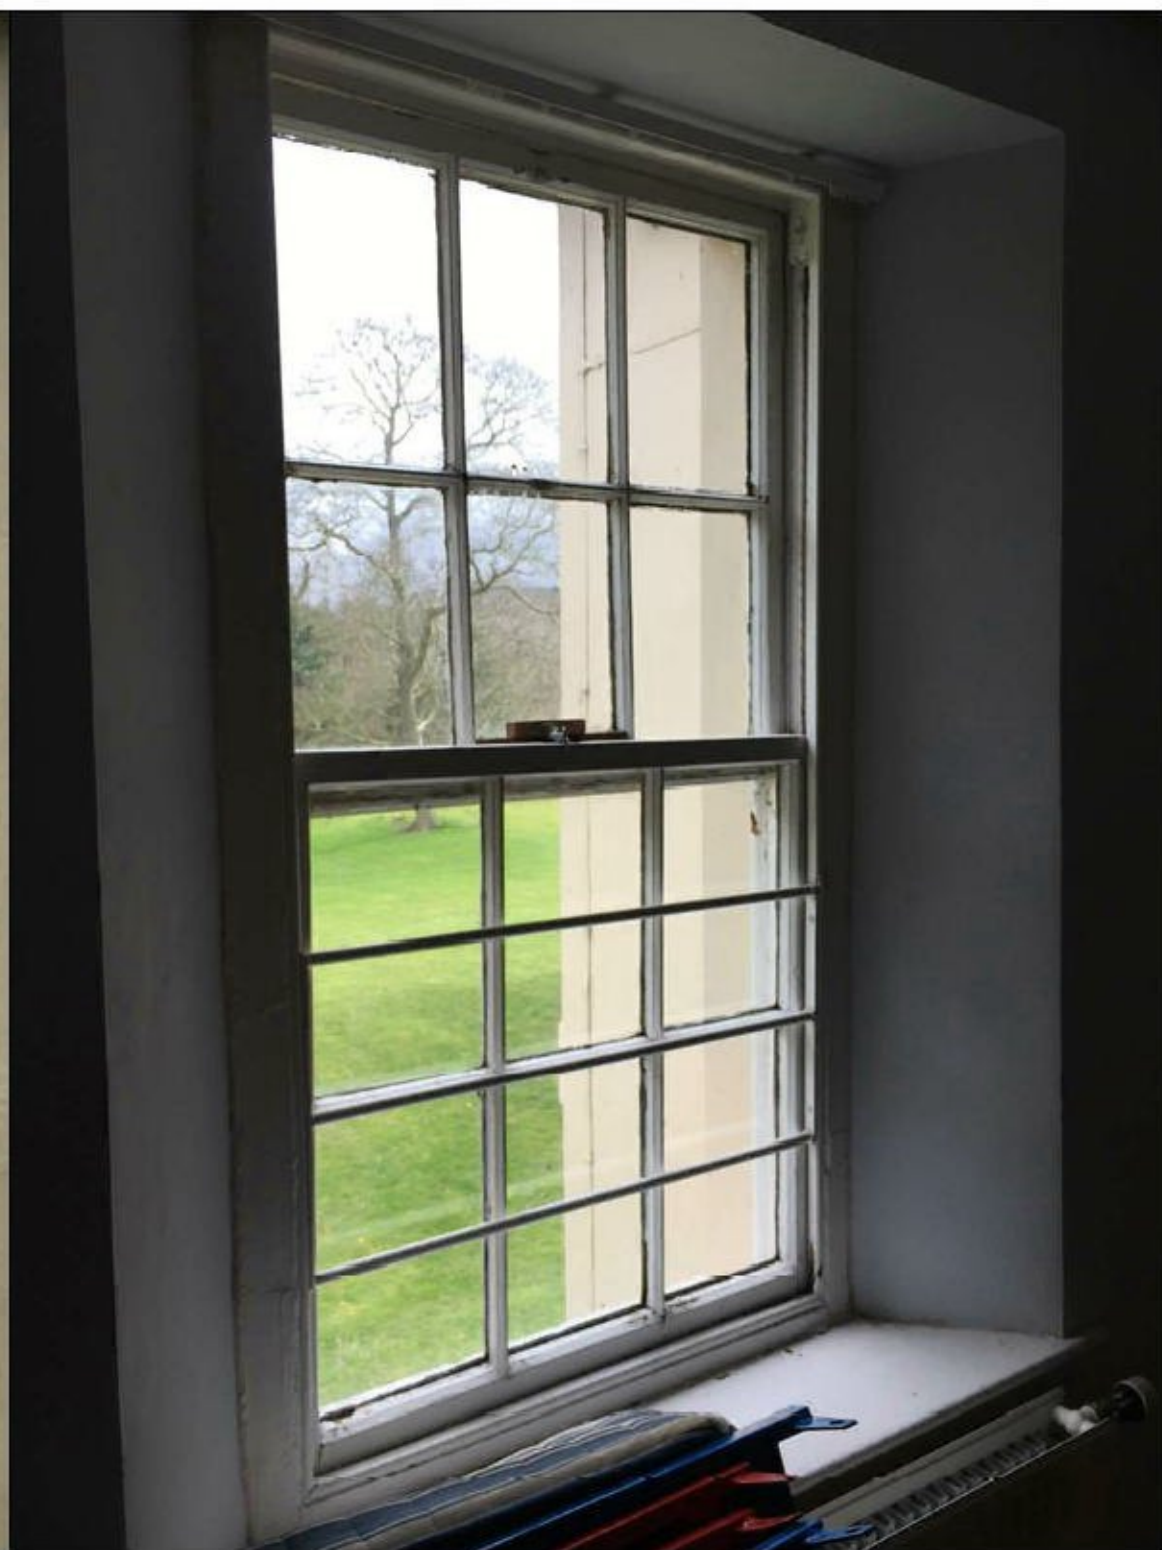
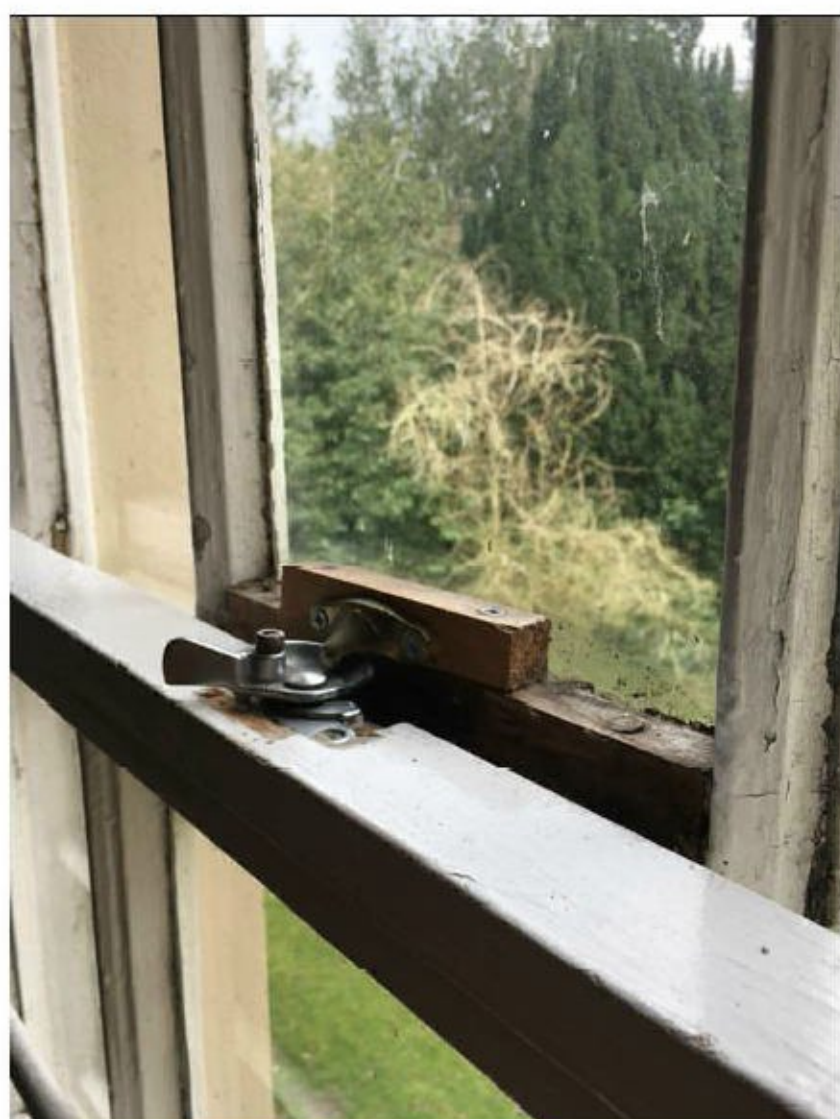
Photo Location - East_Window Number **W110** - See floor plans for location

Located with 1840's section of the building

Condition - Poor in need of replacement

Frame - Presumed Non Original

Glass - Presumed Non Original

· Replacement window

it has been advised by a window restorer and fabricator that there is not enough good quality frame left to simply refurbish this window.
