Building Recording - First Floor

External and Internal Windows

showing existing photos, noted location, frame condition, glass condition and proposed refurbishment works.

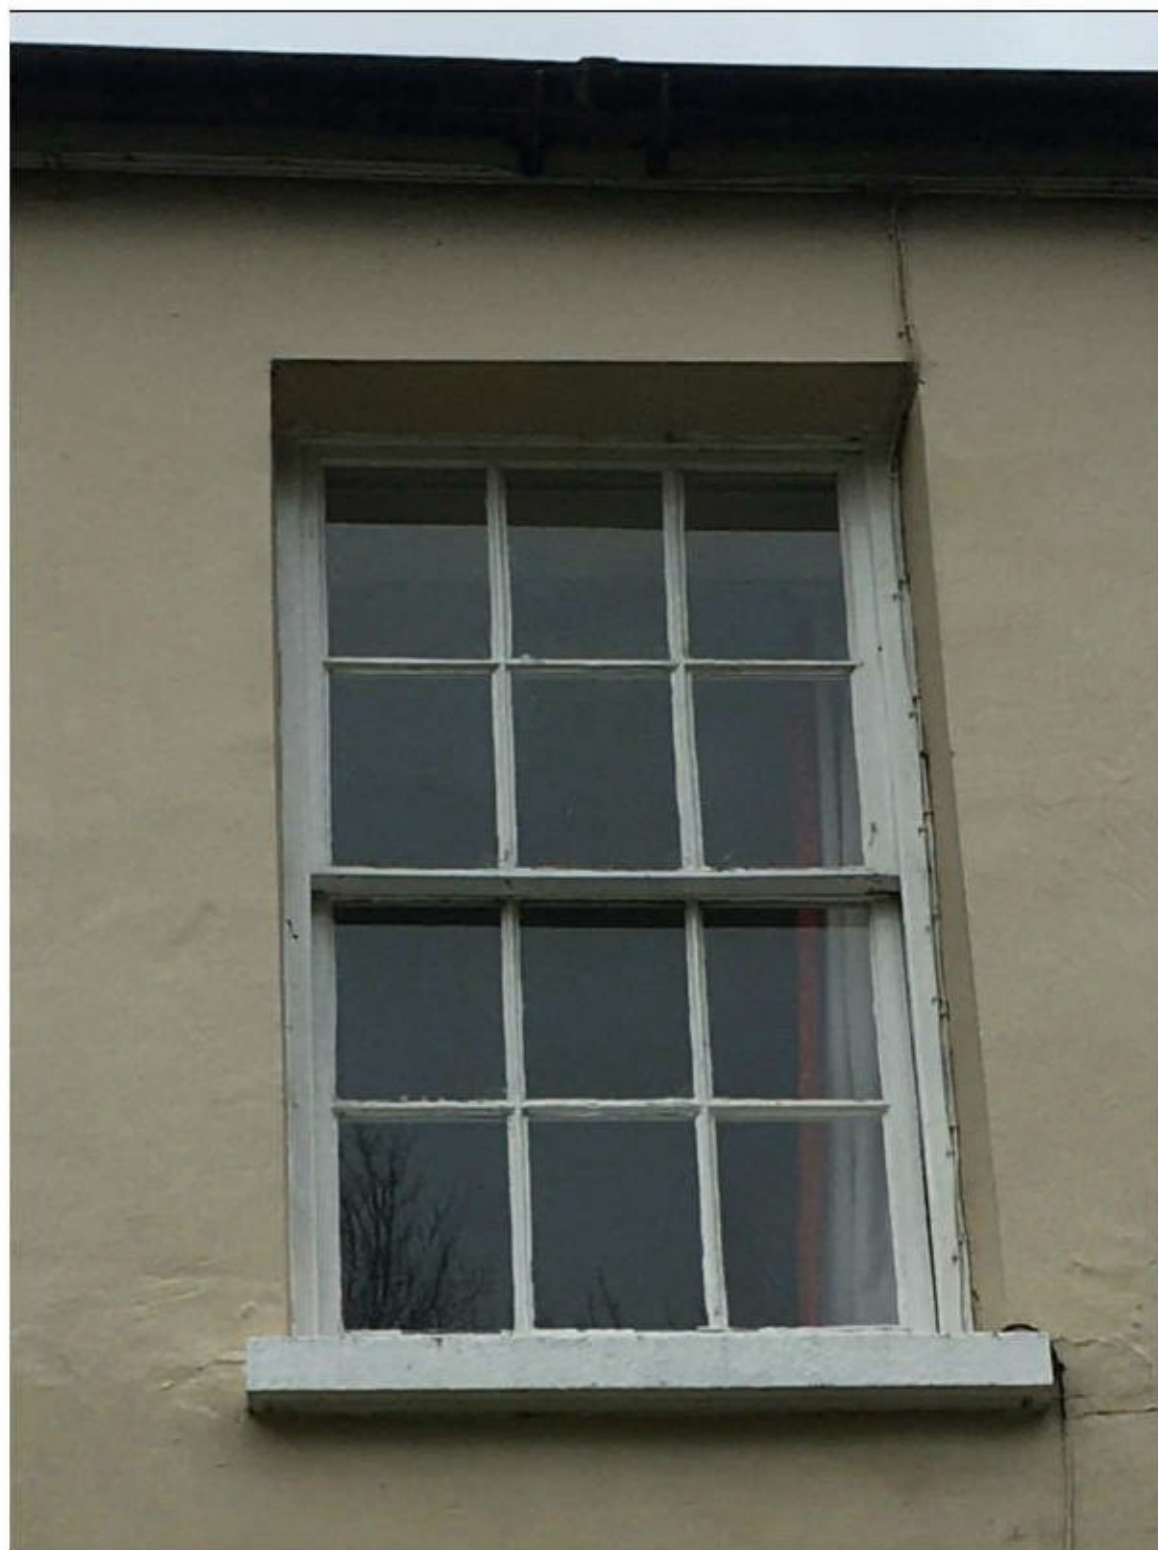
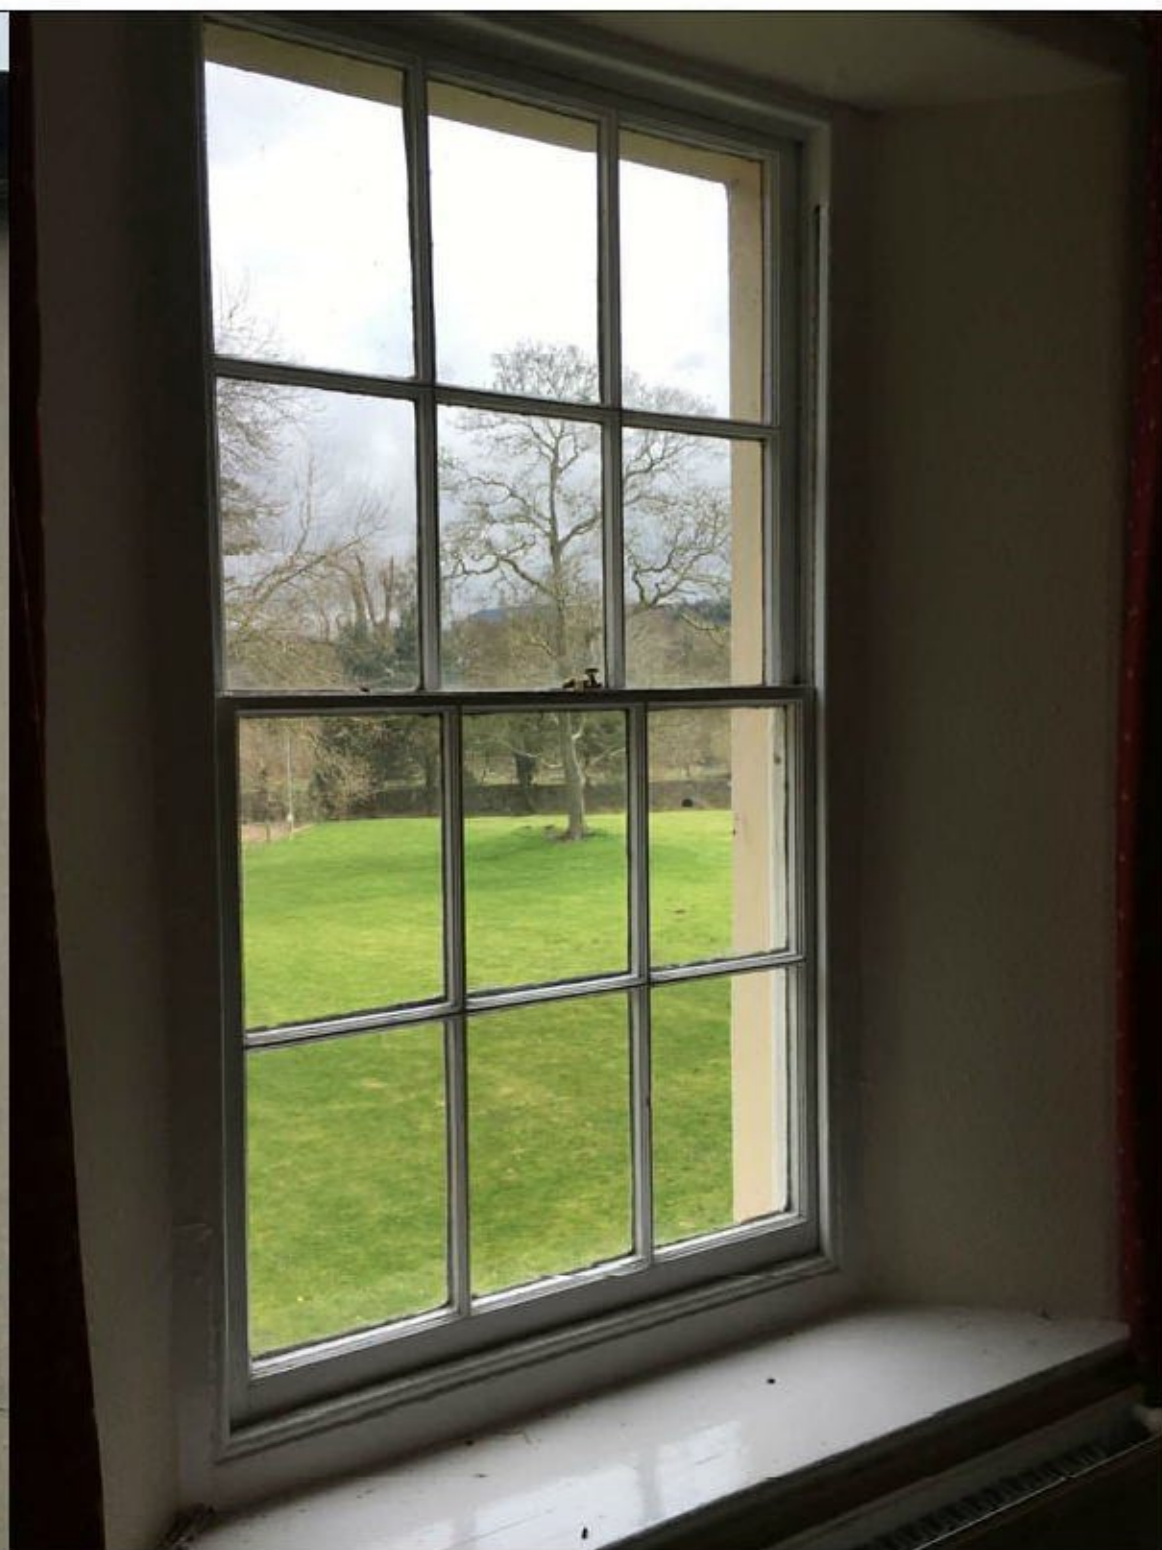
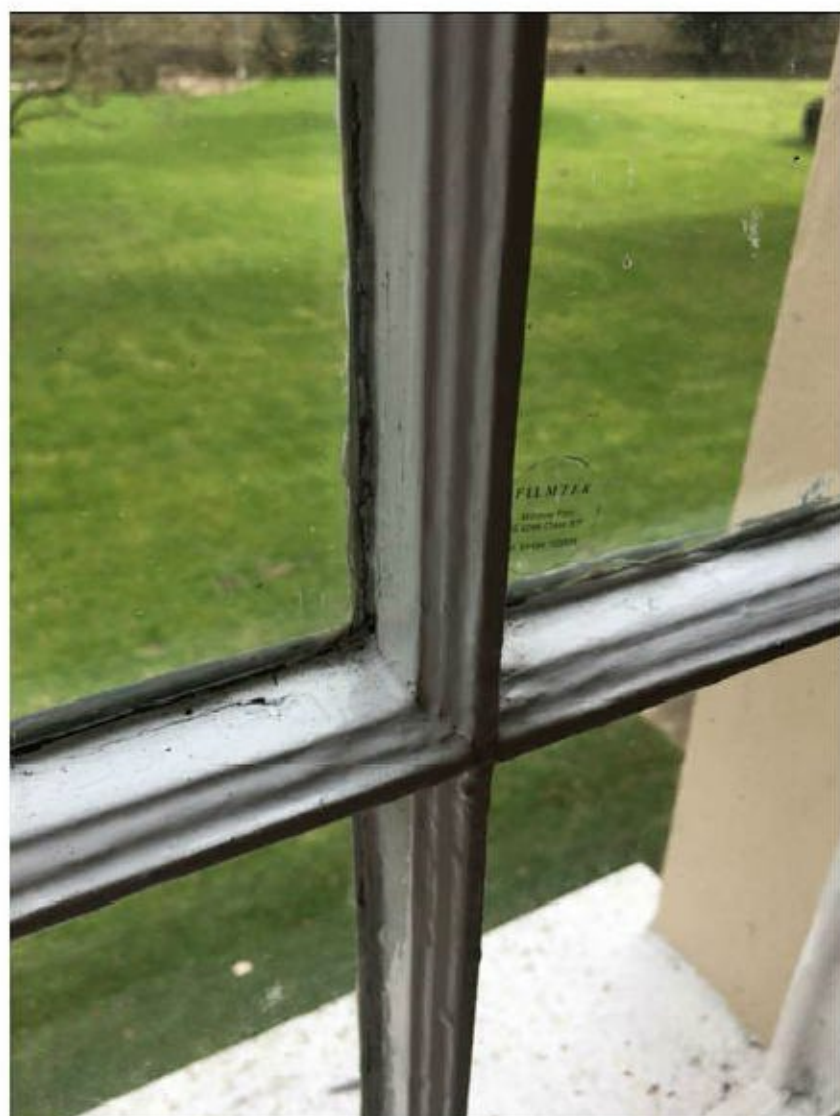
Photo Location - East_Window Number **W111** - See floor plans for location

Located with 1840's section of the building

Condition - Average in need of refurbishment

Frame - Presumed Non Original

Glass - Presumed Non Original

- Refurbished and re painted only if possible

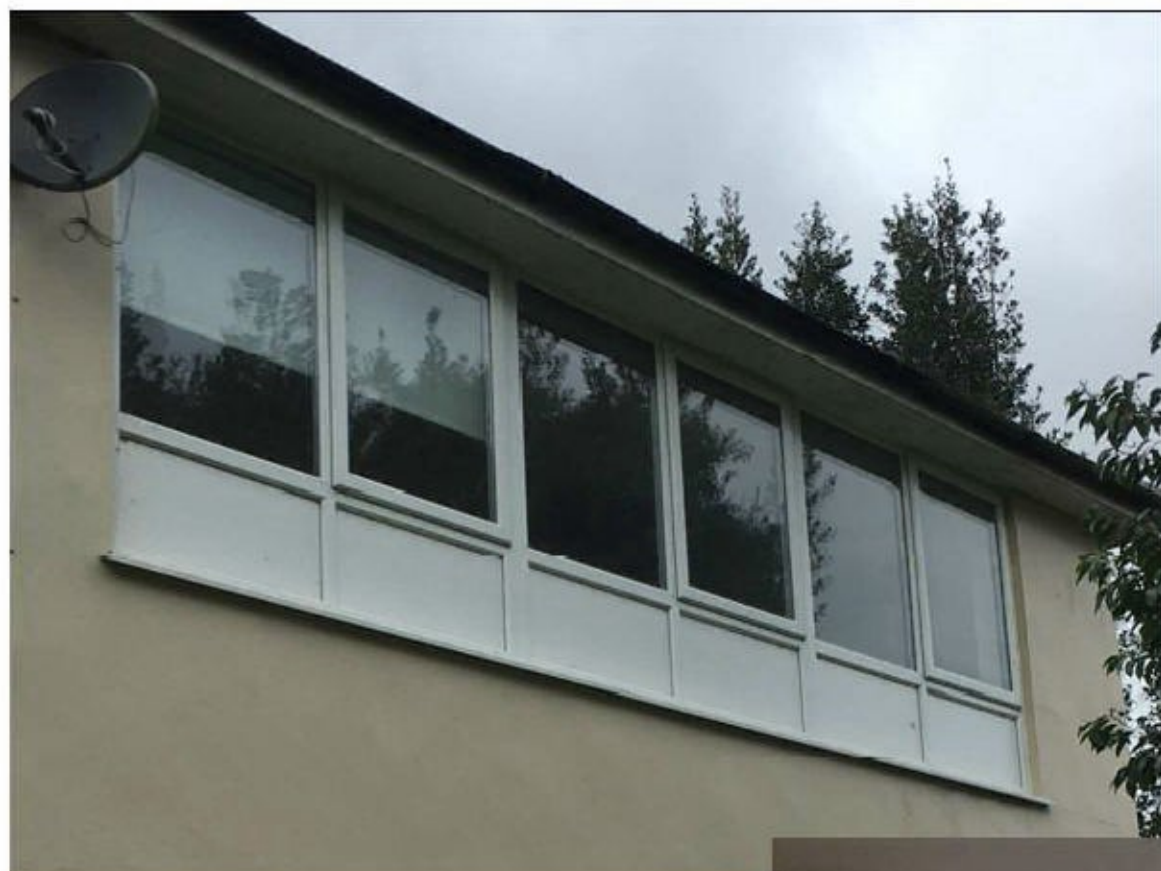
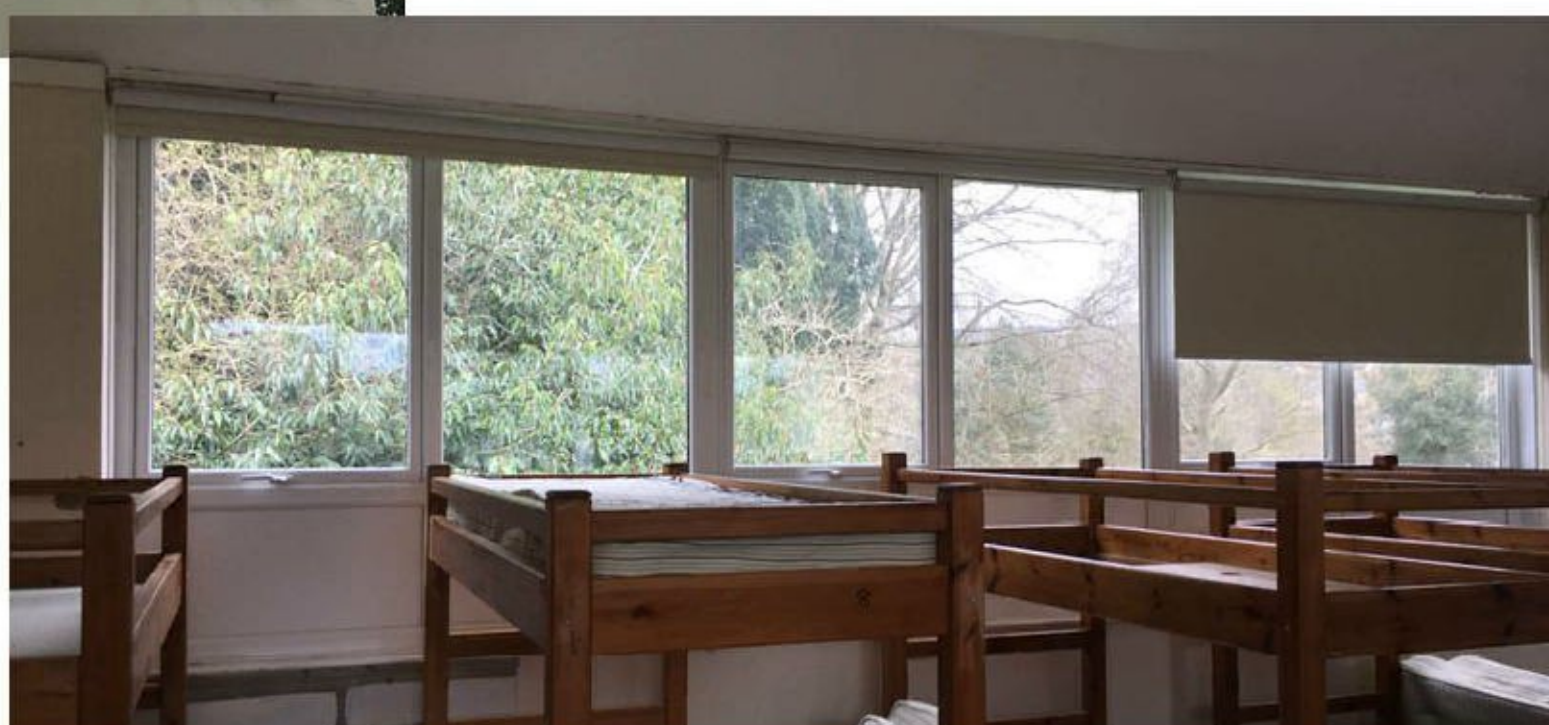
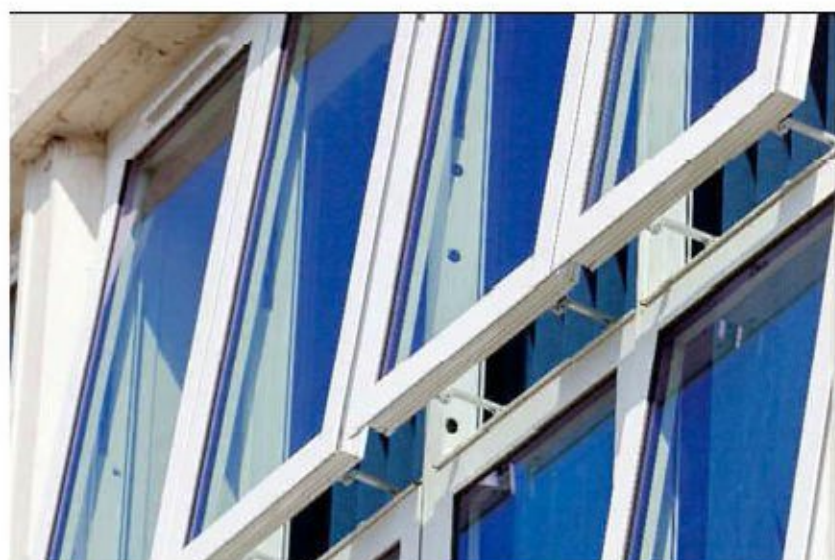
Photo Location - East_Window Number **W112** - See floor plans for location

Located with 1990's section of the building

Condition - Good

Frame - Presumed Original

Glass - Presumed Original

- To be replaced new metal frame opening window in a colour to match the existing listed house windows

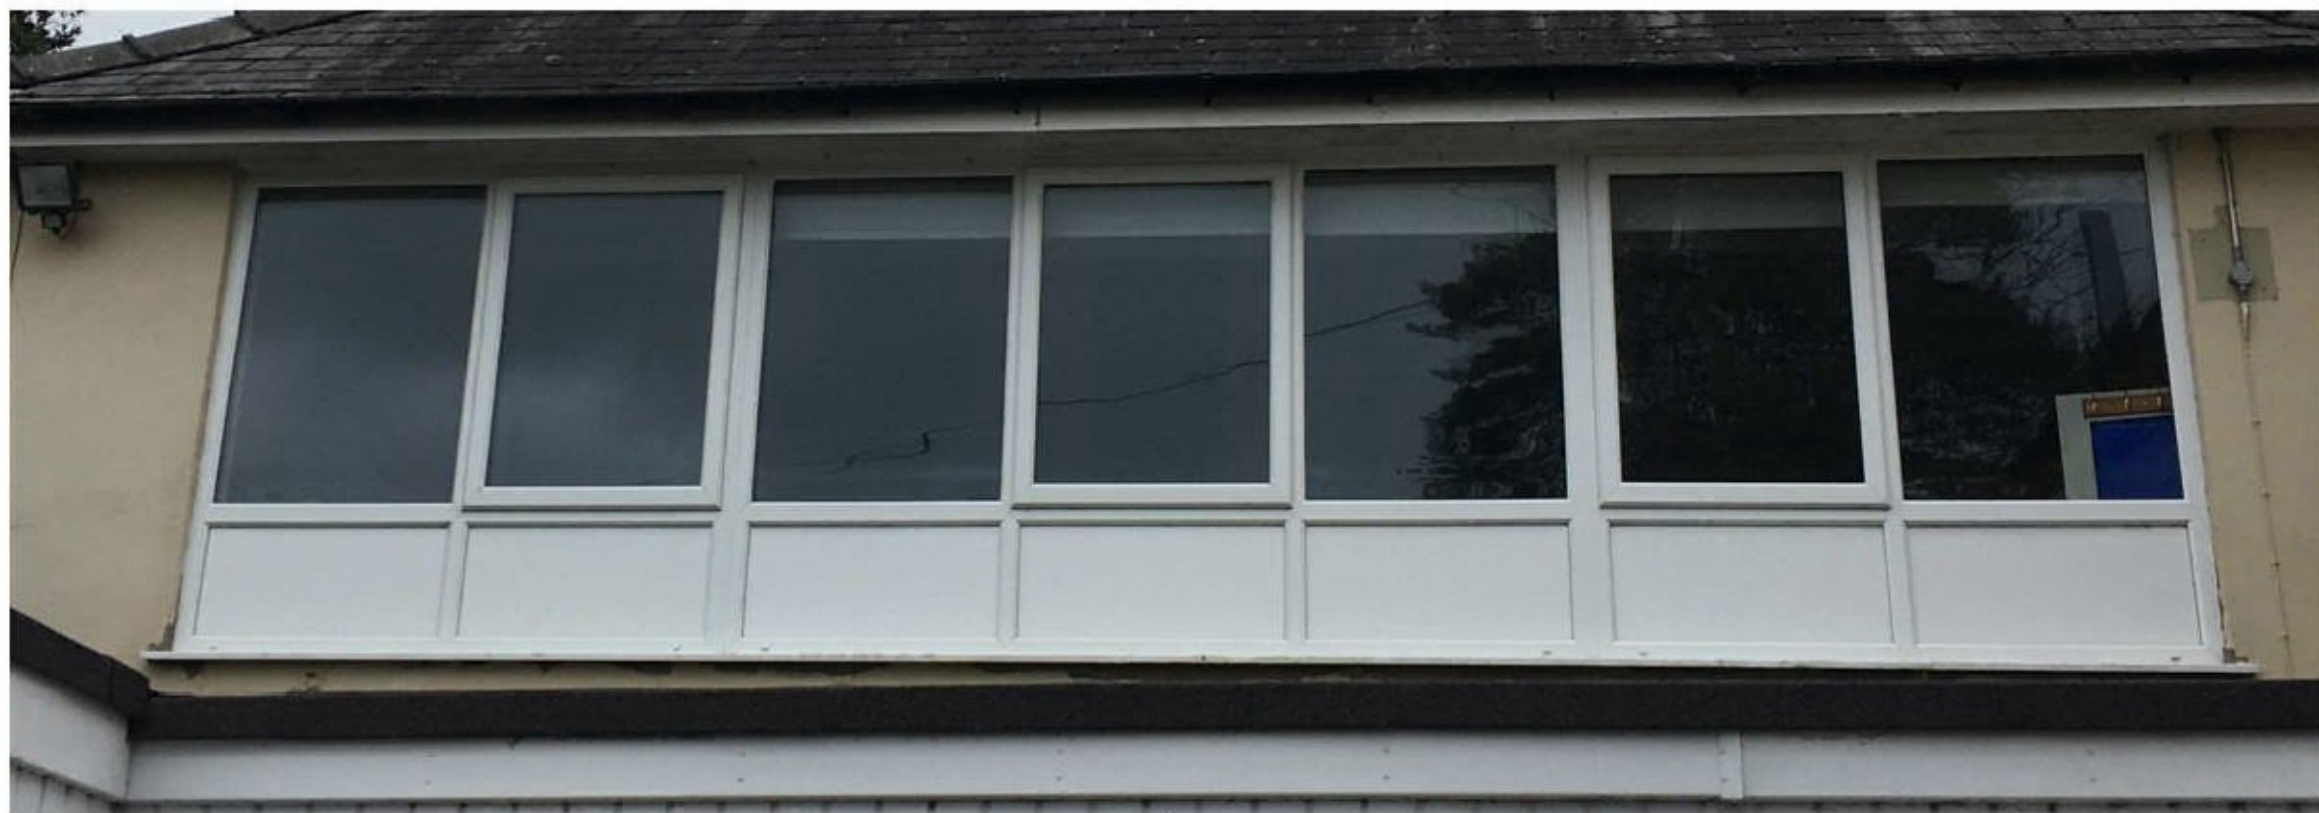
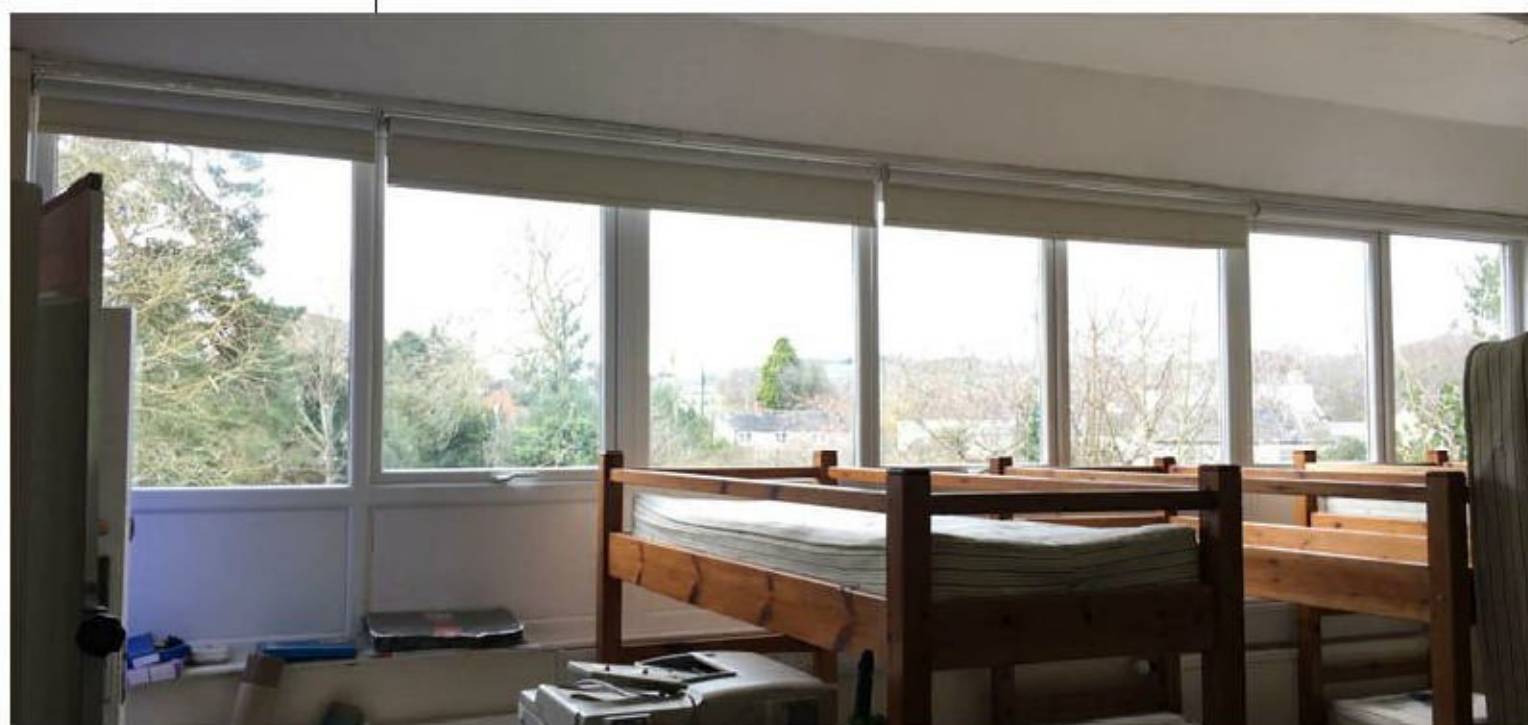
Photo Location - West_Window Number **W113** - See floor plans for location

Located with 1990's section of the building

Condition - Good

Frame - Presumed Original

Glass - Presumed Original

- To be replaced new metal frame bi folding doors in a colour to match the existing listed house

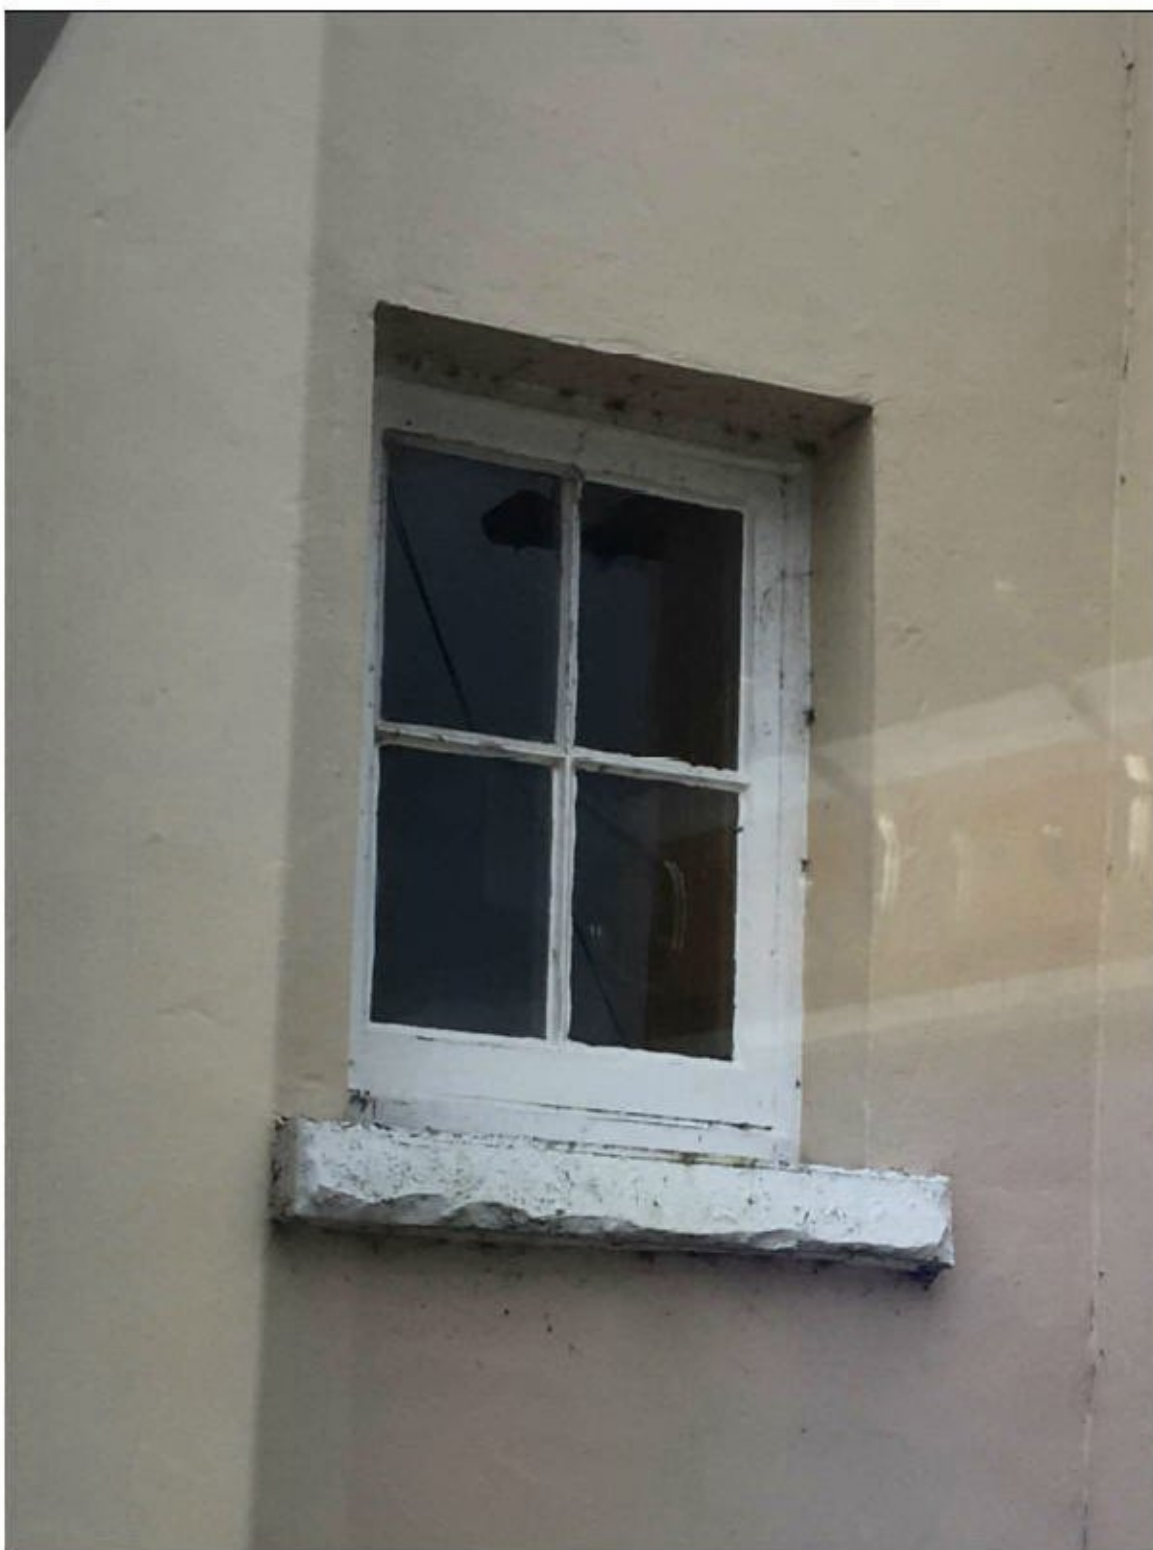
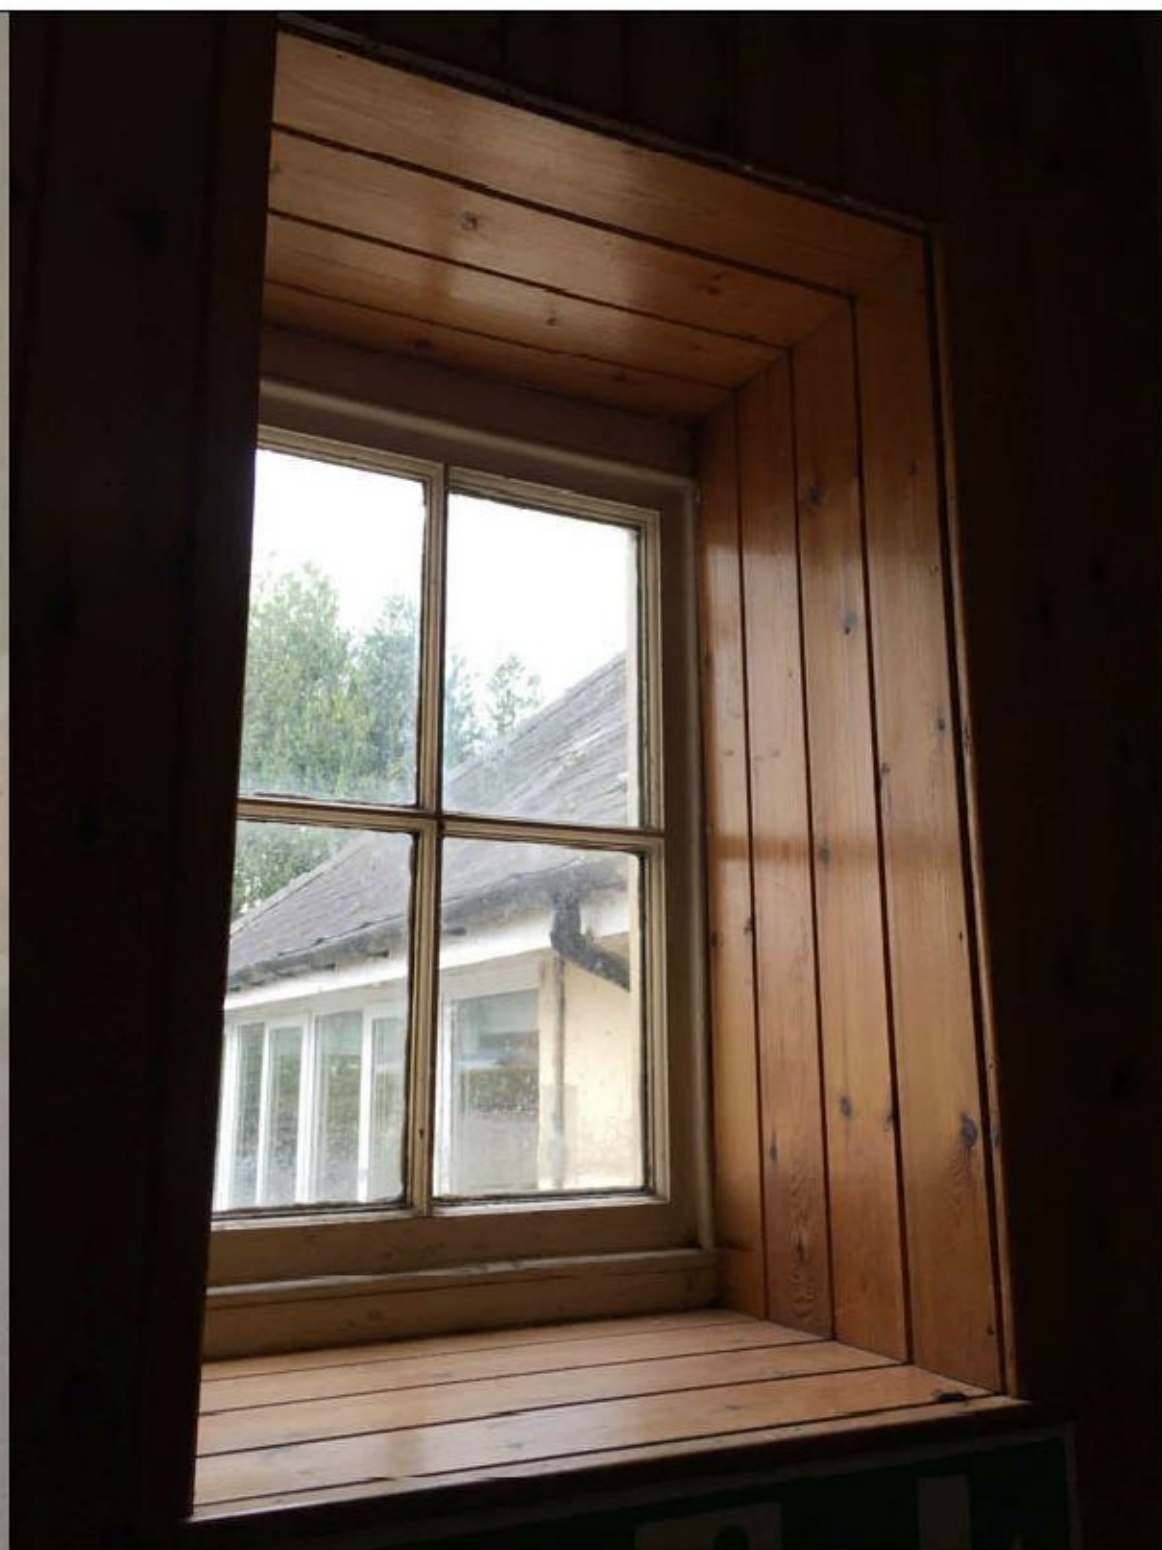
Photo Location - North_Window Number **W114** - See floor plans for location

Located with 1840's section of the building

Condition - Average in need of refurbishment

Frame - Presumed Non Original

Glass - Presumed Non Original

- Refurbished and re painted only if possible

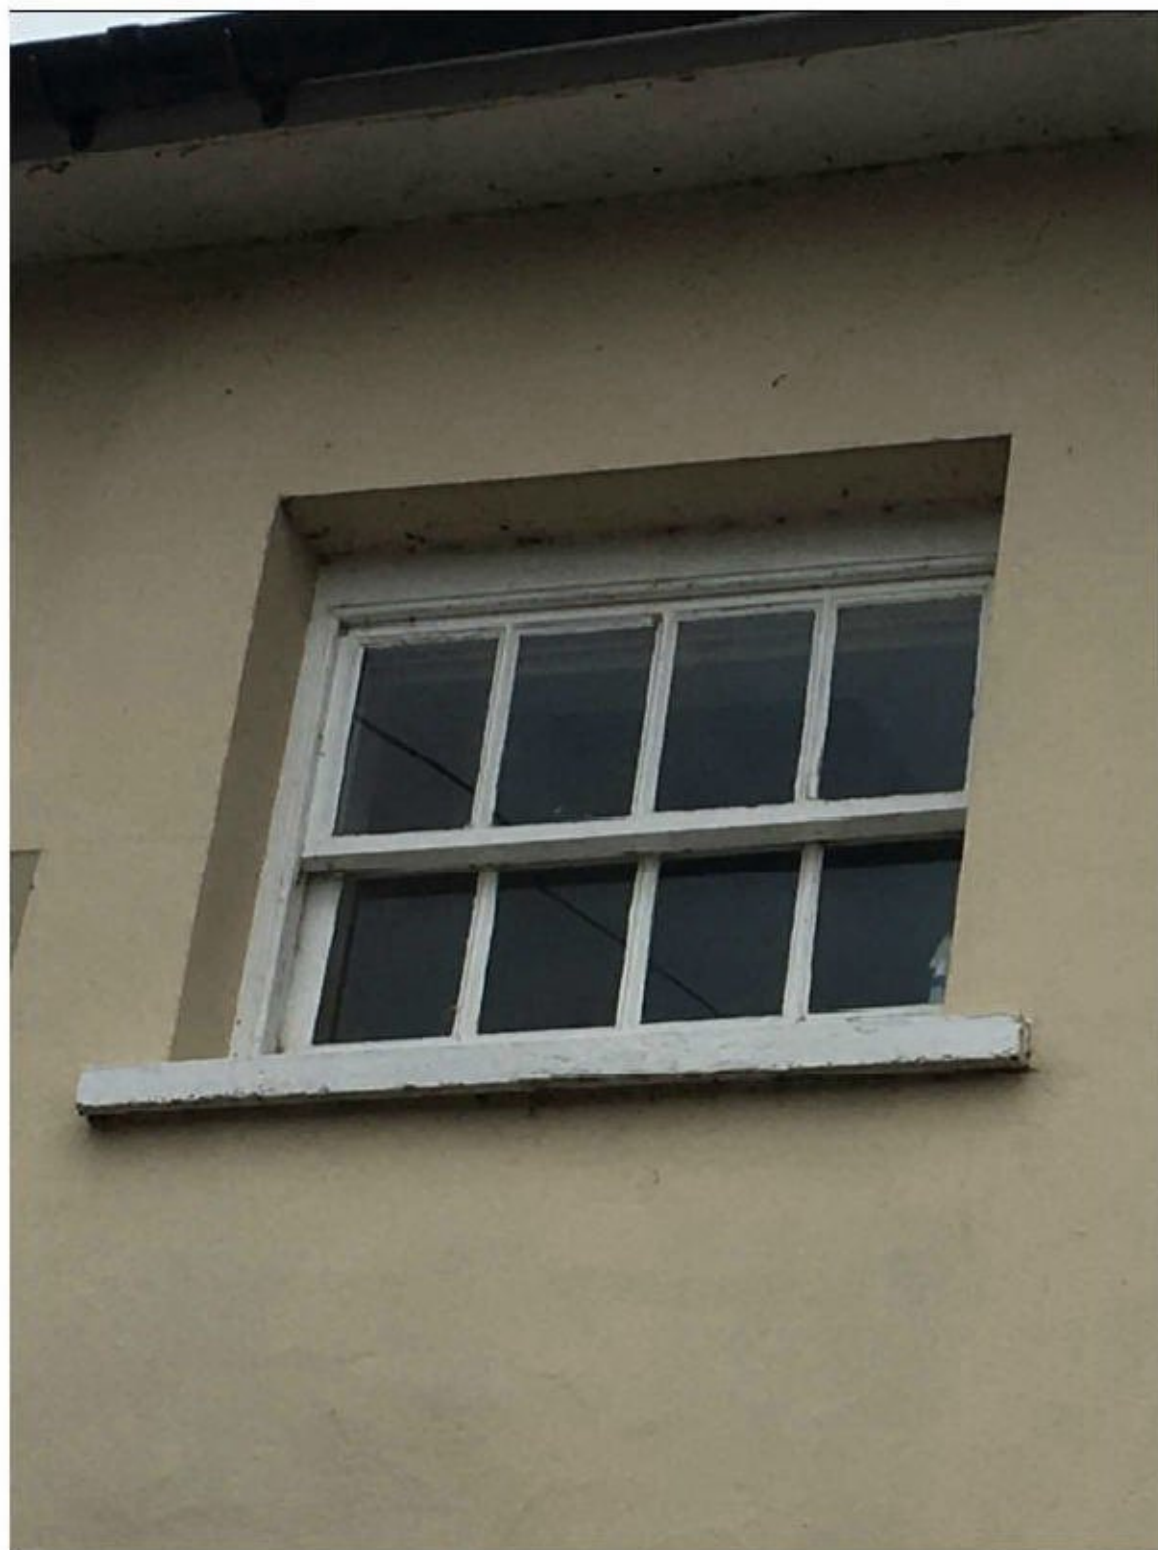
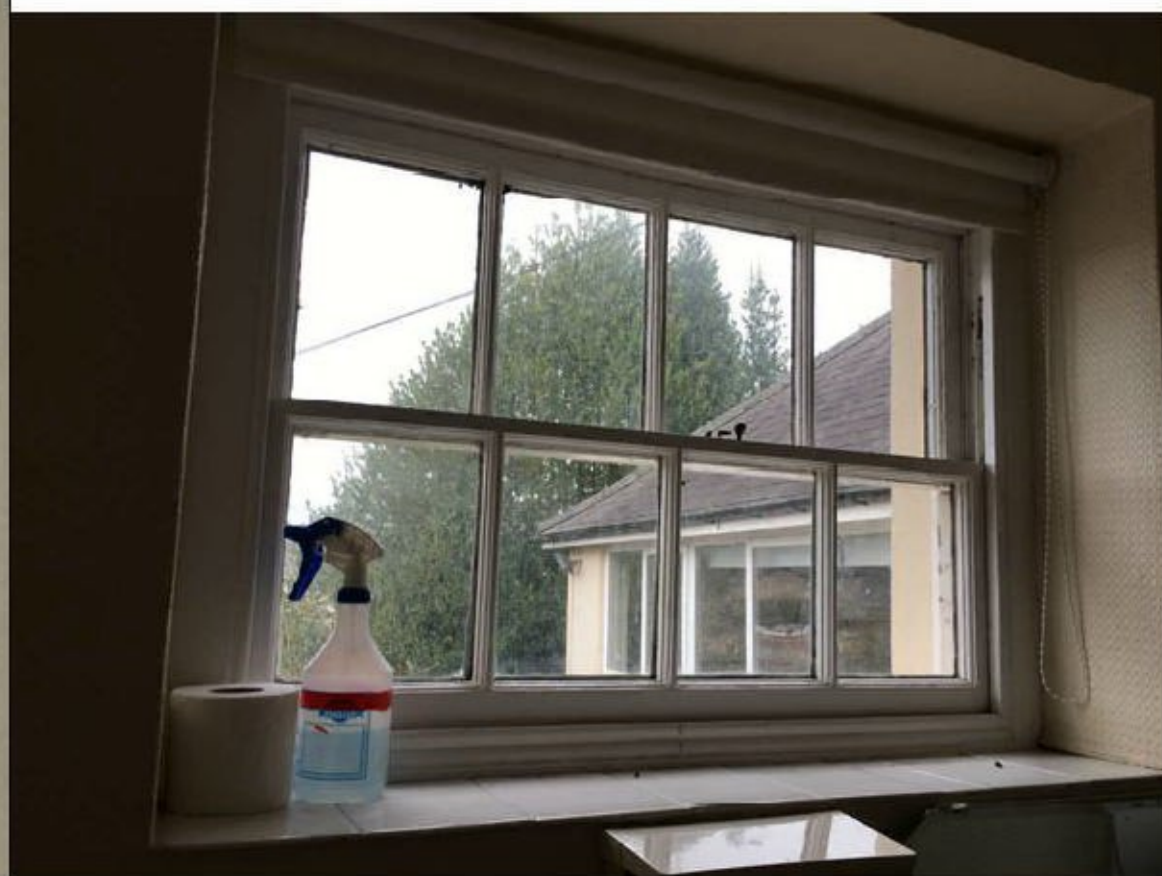
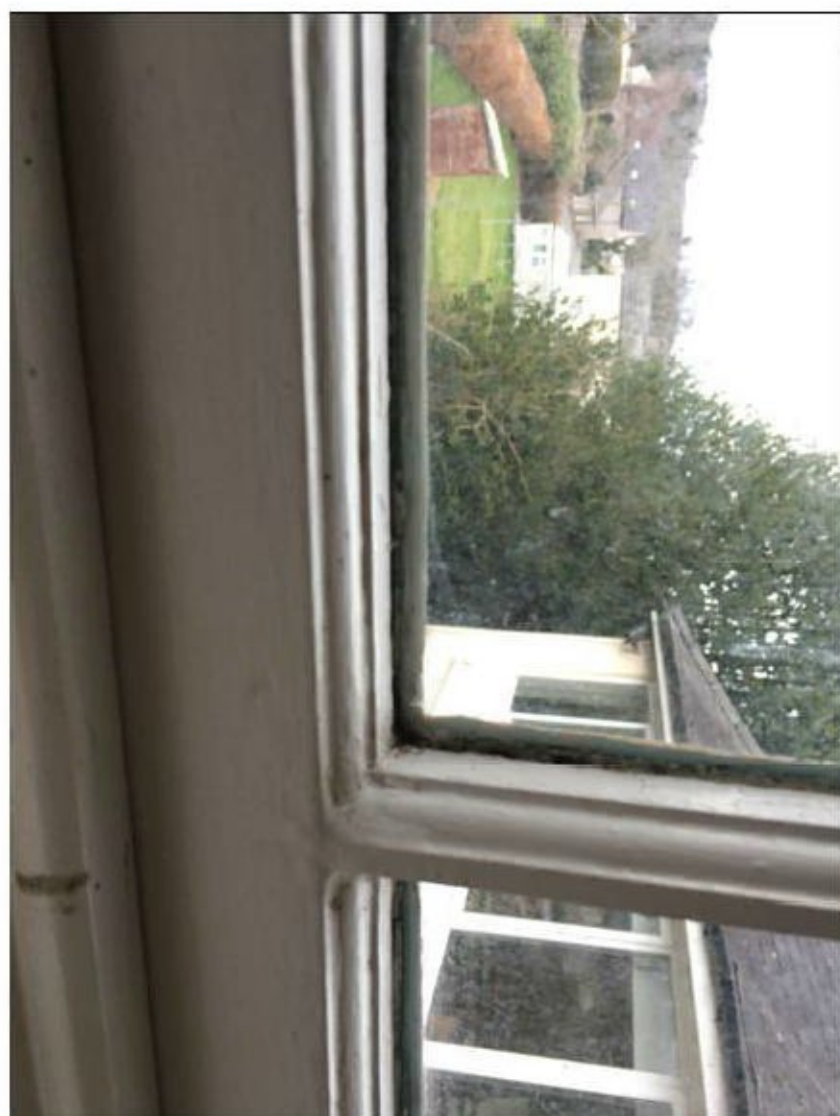
Photo Location - North_Window Number **W115** - See floor plans for location

Located with 1840's section of the building

Condition - Average in need of refurbishment

Frame - Presumed Non Original

Glass - Presumed Non Original

- Refurbished and re painted

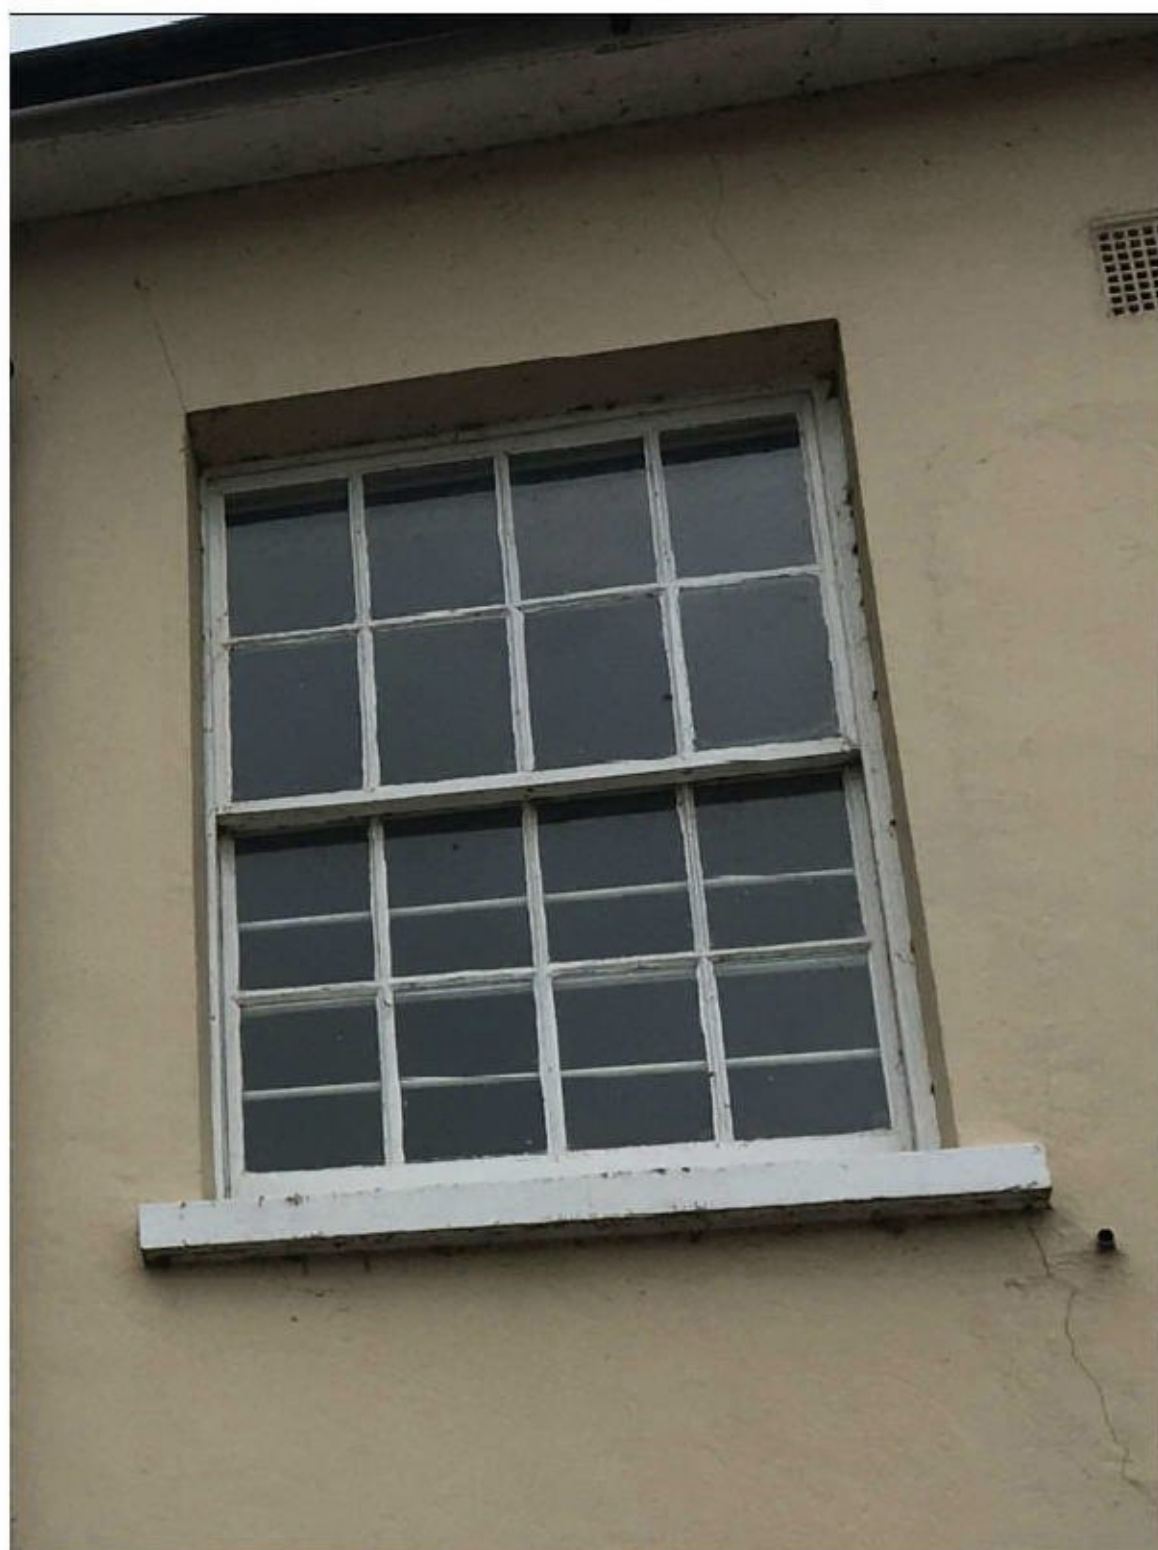
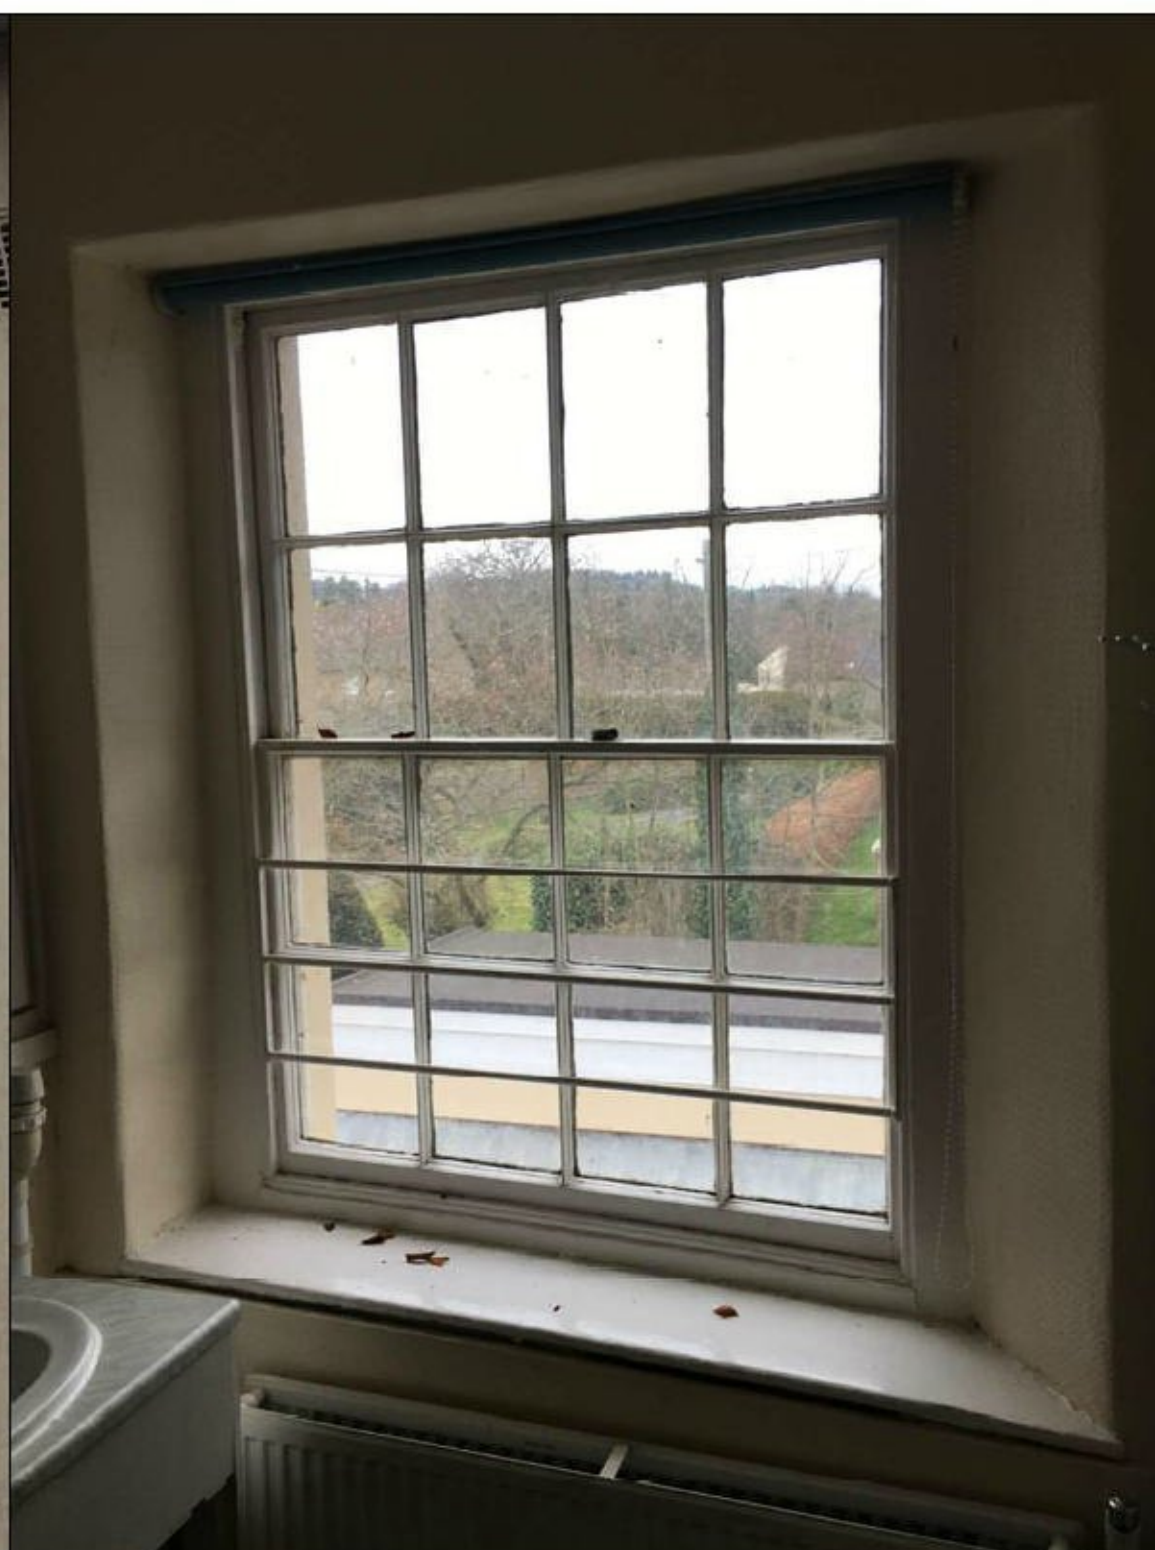
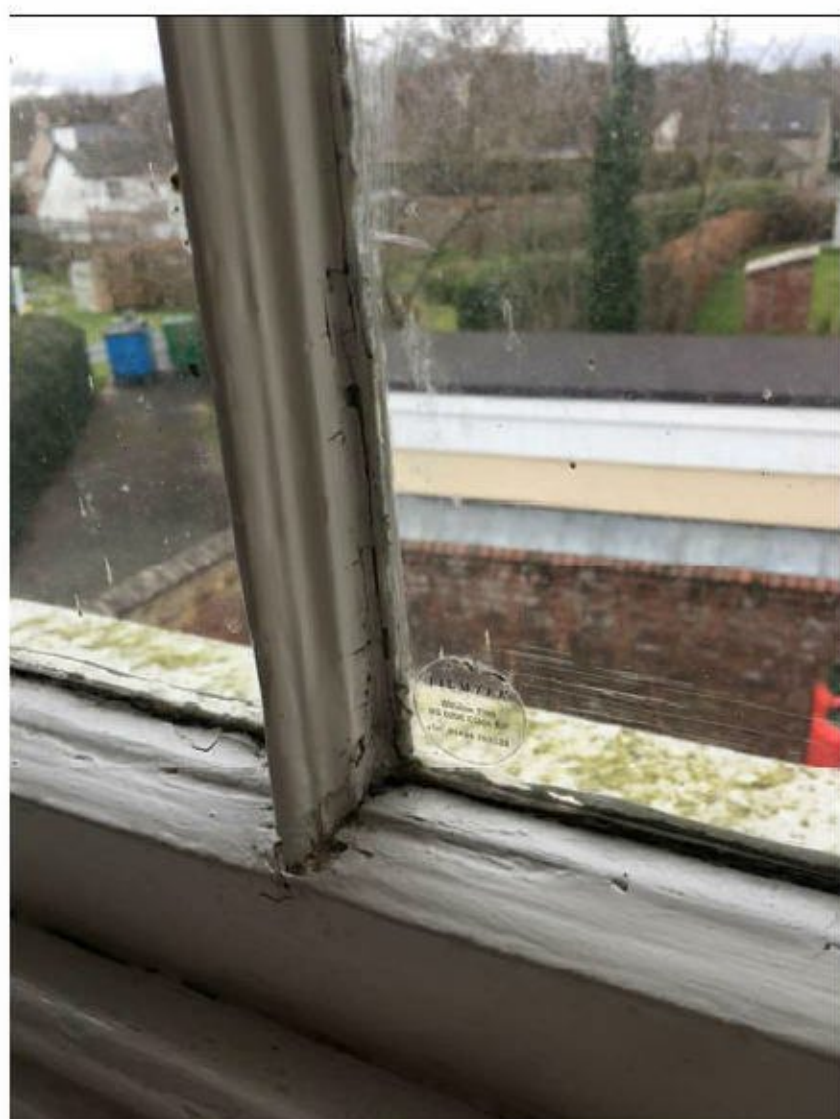
Photo Location - North_Window Number **W116** - See floor plans for location

Located with 1840's section of the building

Condition - Average in need of refurbishment

Frame - Presumed Non Original

Glass - Presumed Non Original

- Refurbished and re painted only if possible
