Building Recording - First Floor

External and Internal Windows

showing existing photos, noted location, frame condition, glass condition and proposed refurbishment works.

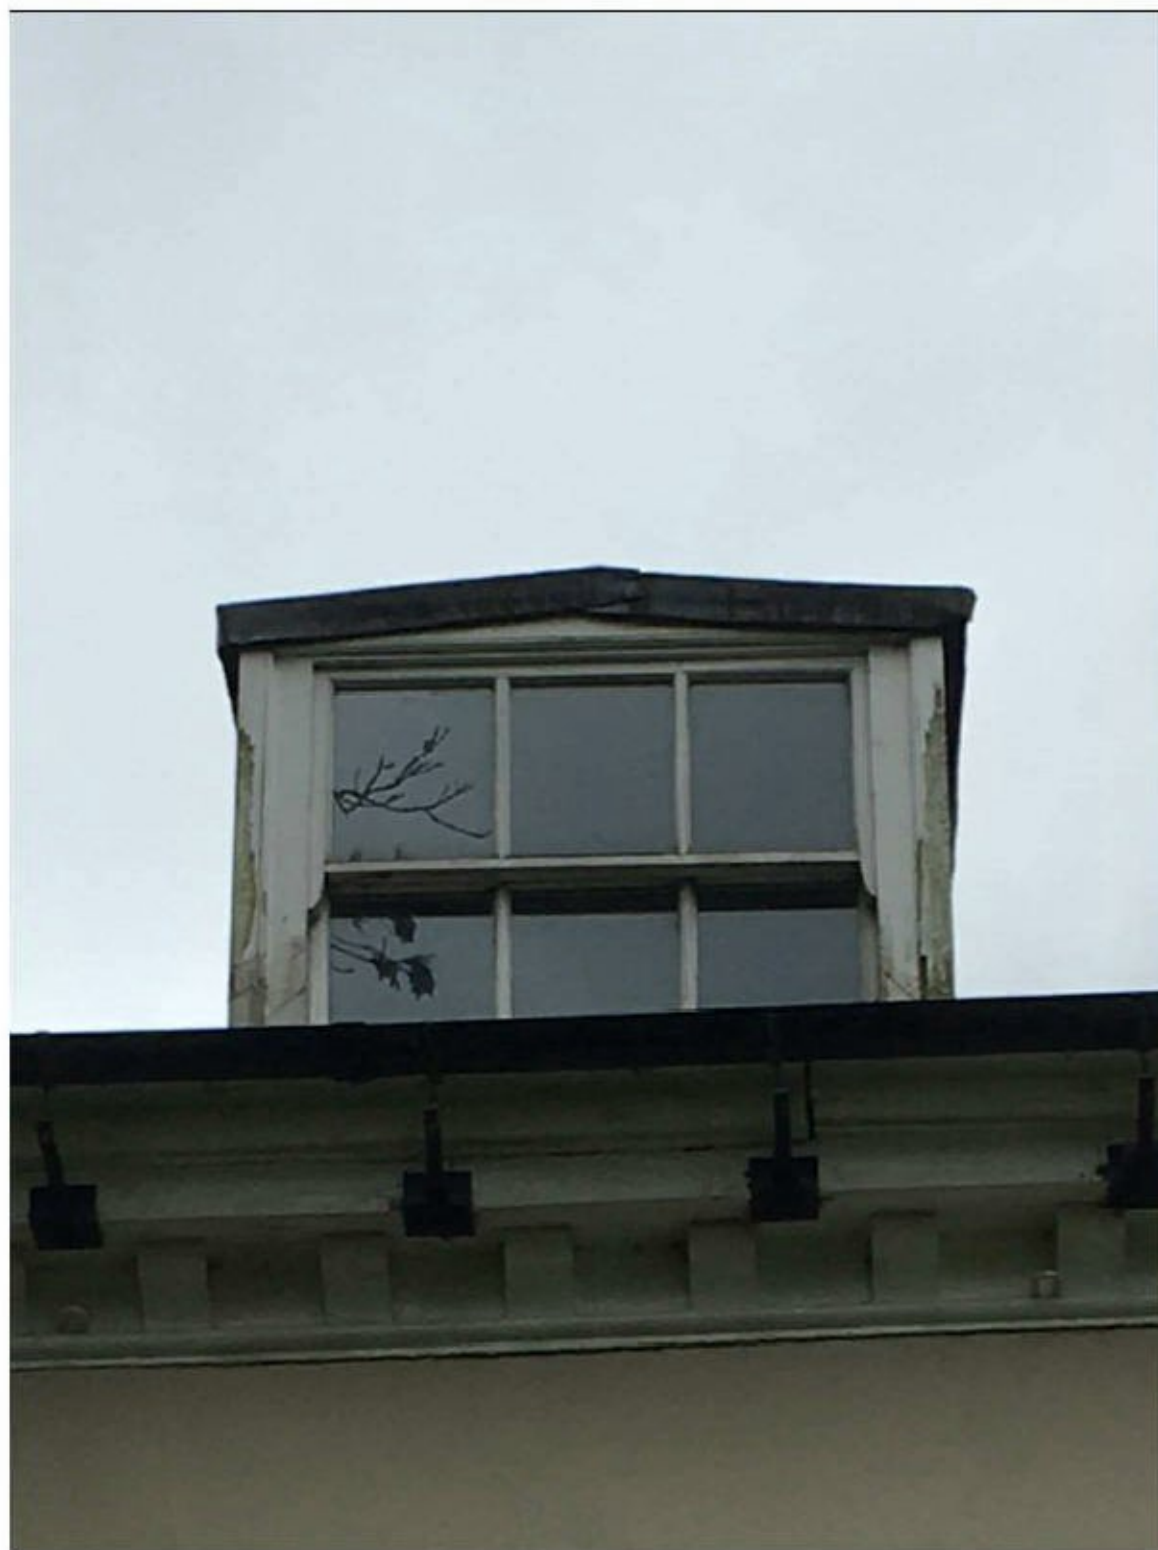
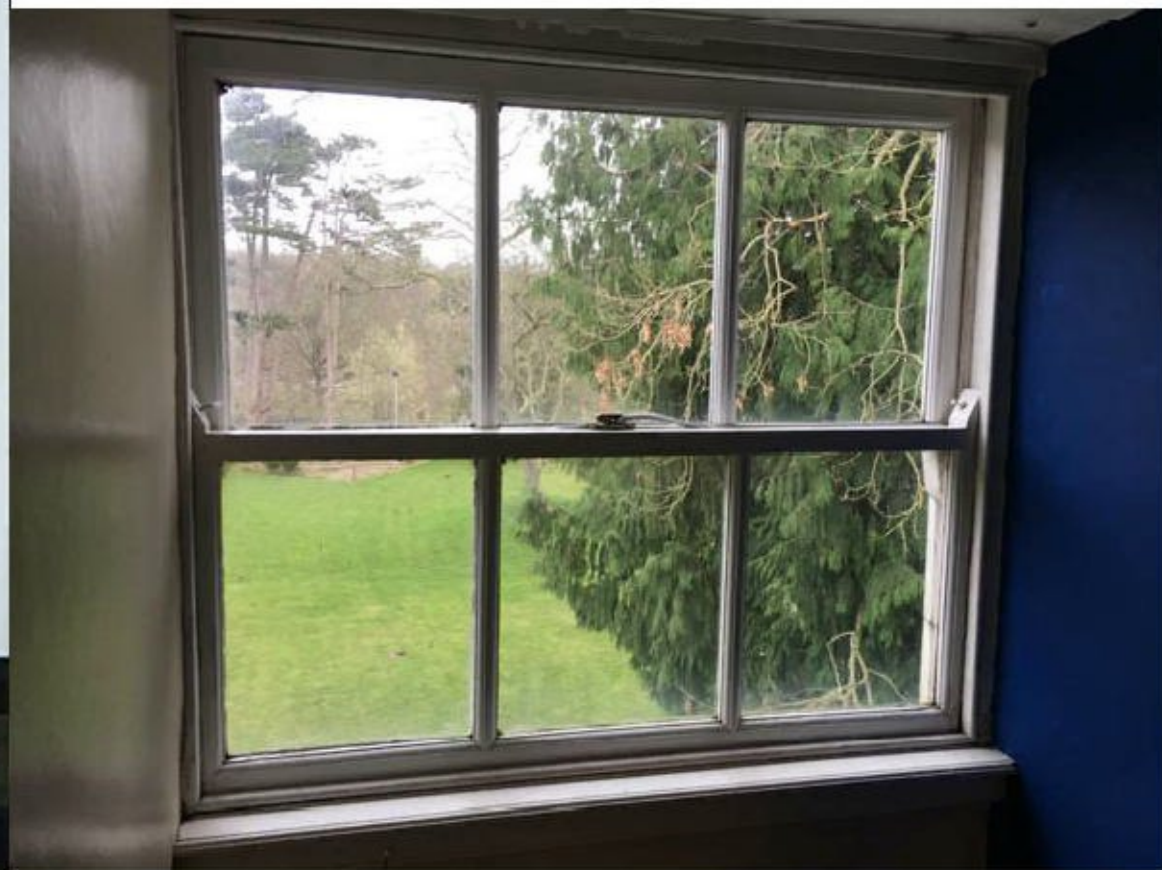
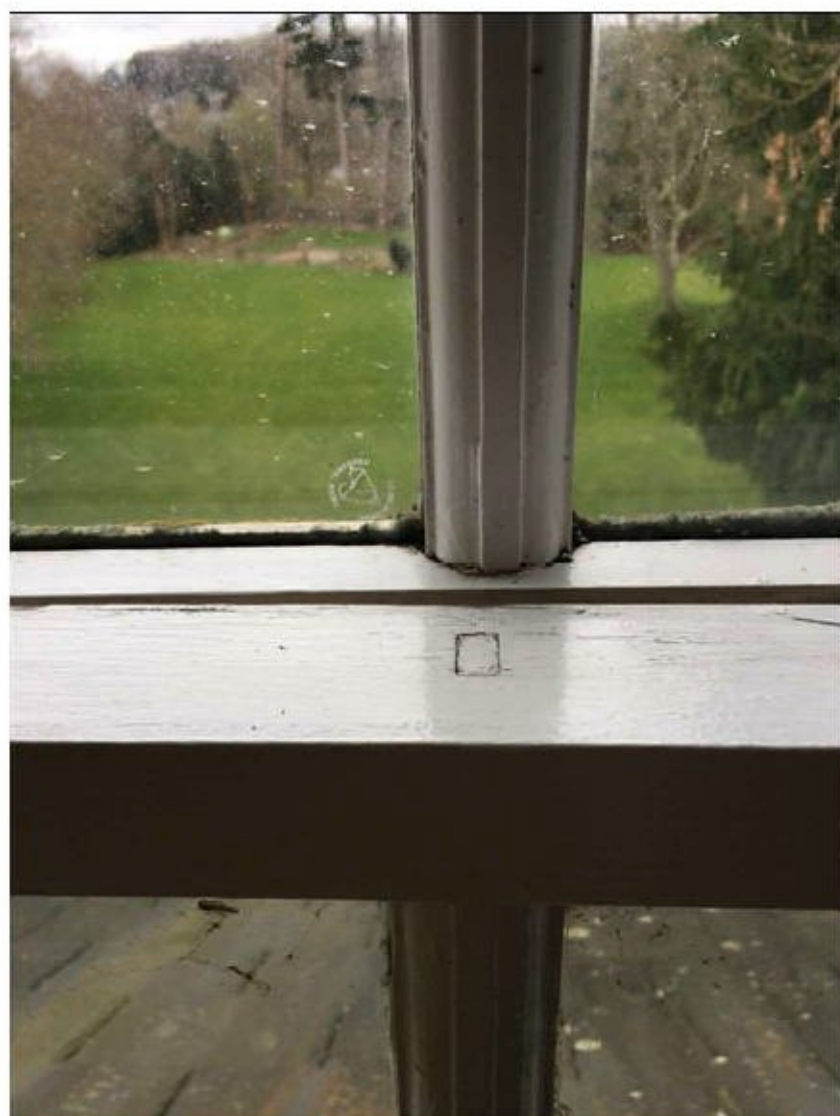
Photo Location - East_Window Number **W201** - See floor plans for location

Located with 1750's section of the building
Condition - Average in need of refurbishment
Frame - Presumed Non Original
Glass - Presumed Non Original

· **Replacement window**
it has been advised by a window restorer and fabricator that there is not enough good quality frame left to simply refurbish this window. The window is not considered original

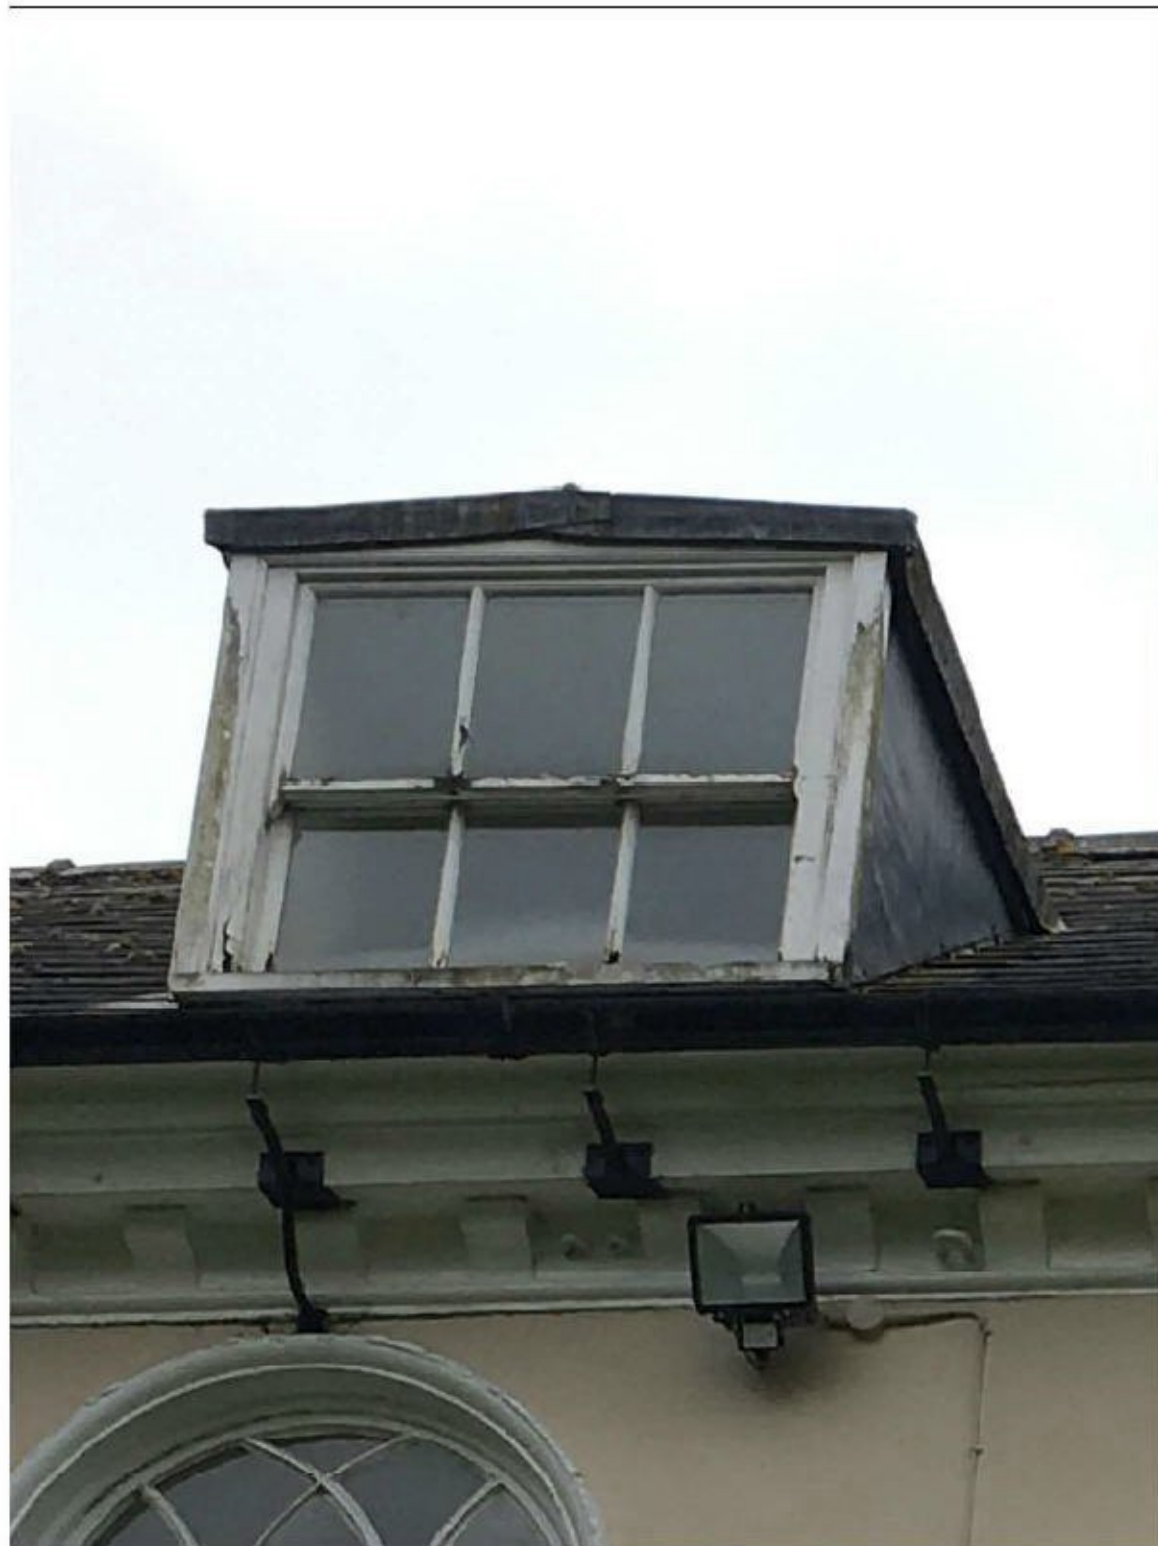
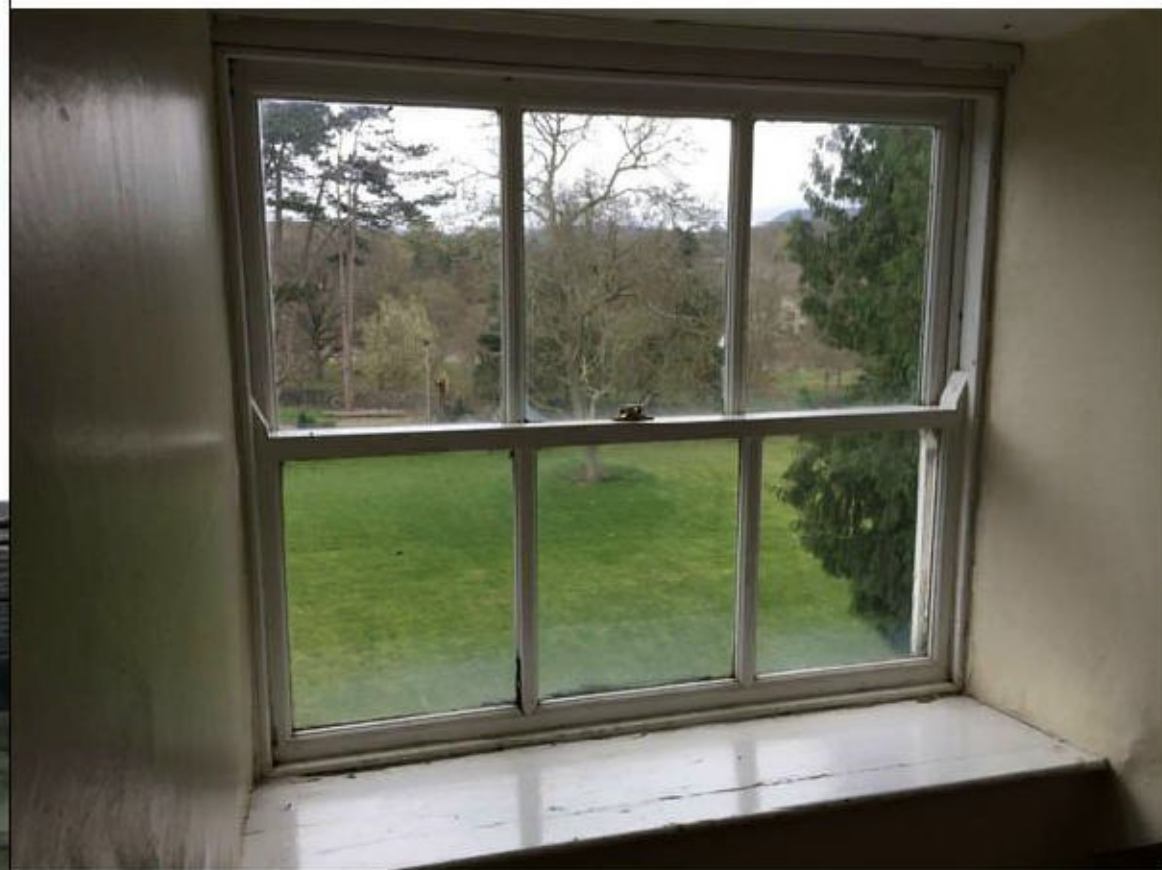
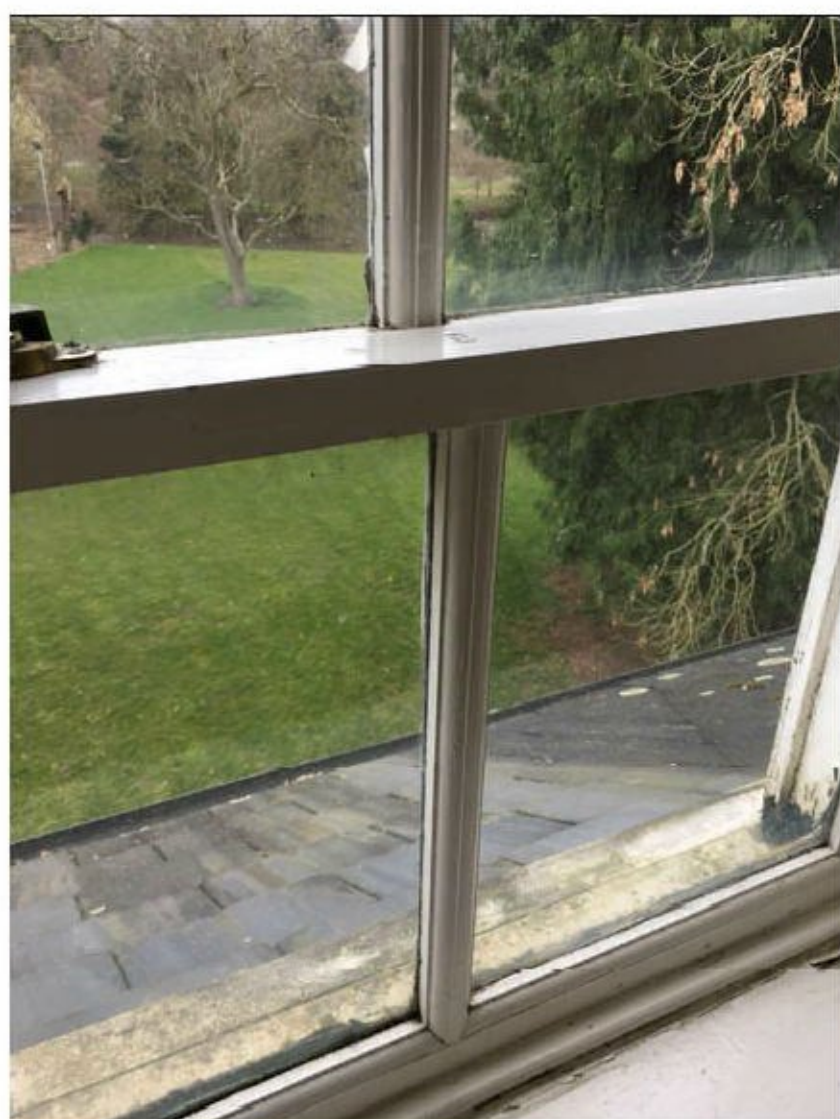
Photo Location - East_Window Number **W202** - See floor plans for location

Located with 1750's section of the building

Condition - Poor in need of refurbishment

Frame - Presumed Non Original

Glass - Presumed Non Original

· Replacement window

it has been advised by a window restorer and fabricator that there is not enough good quality frame left to simply refurbish this window. The window is not considered original

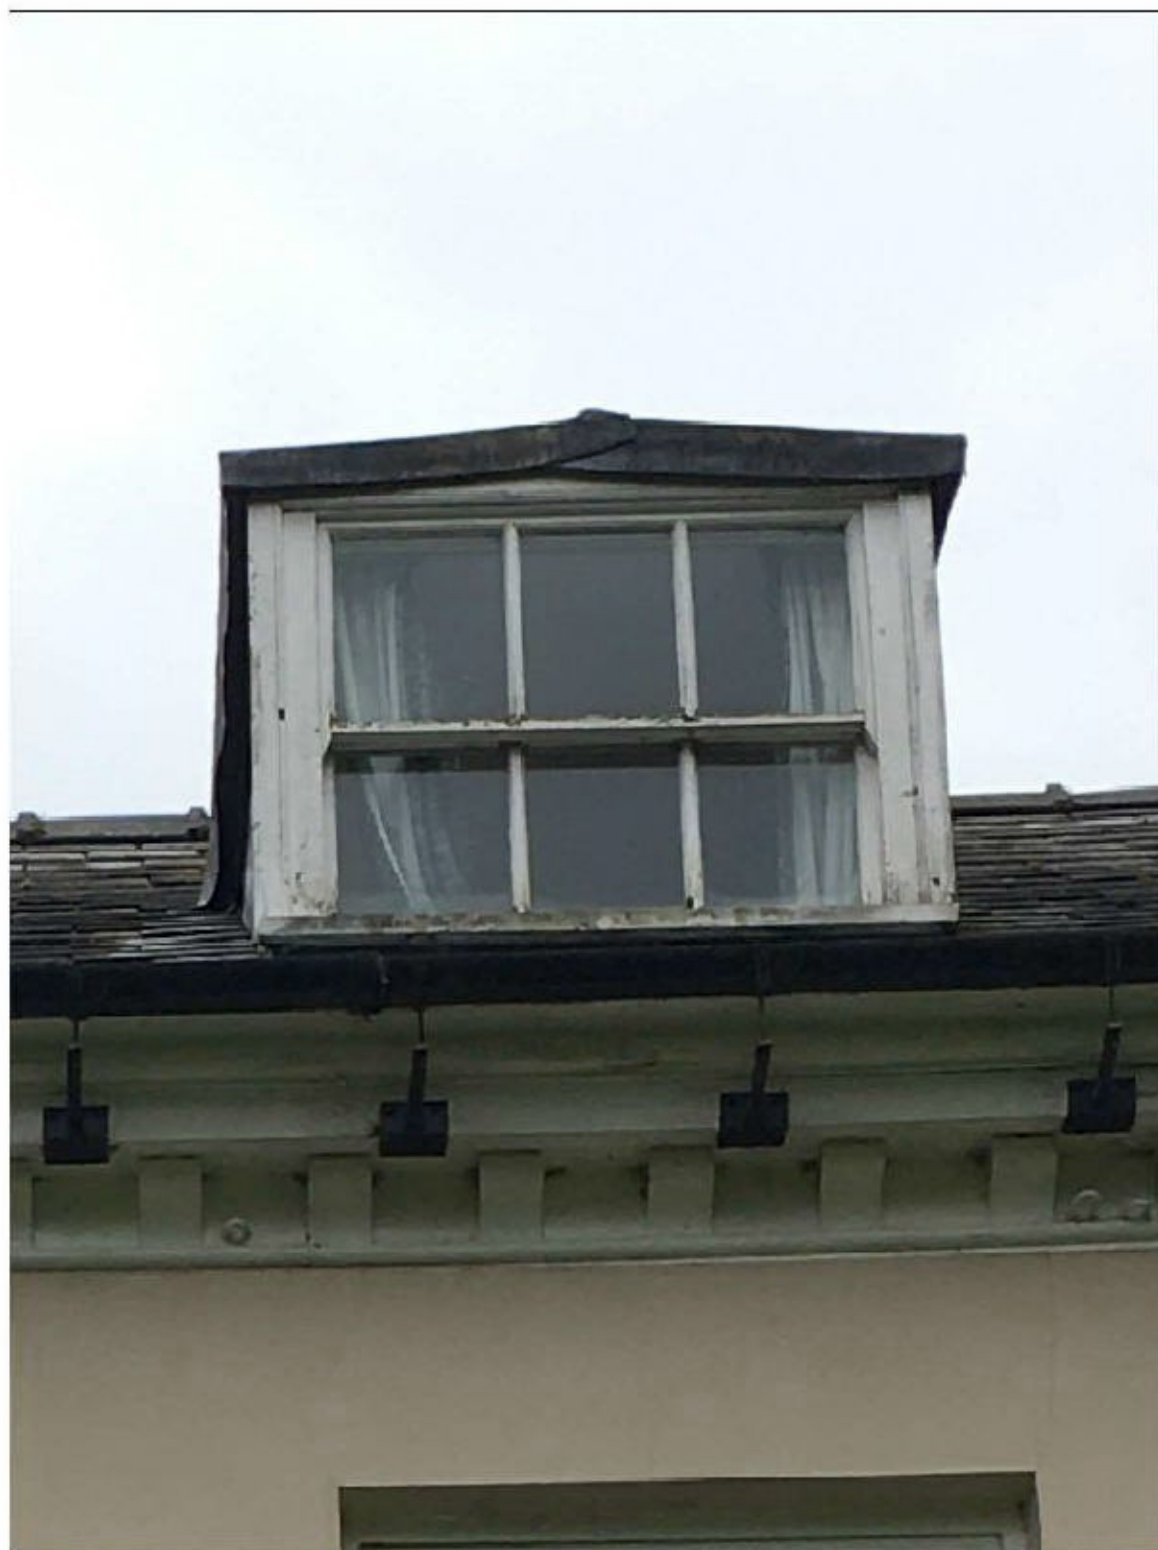
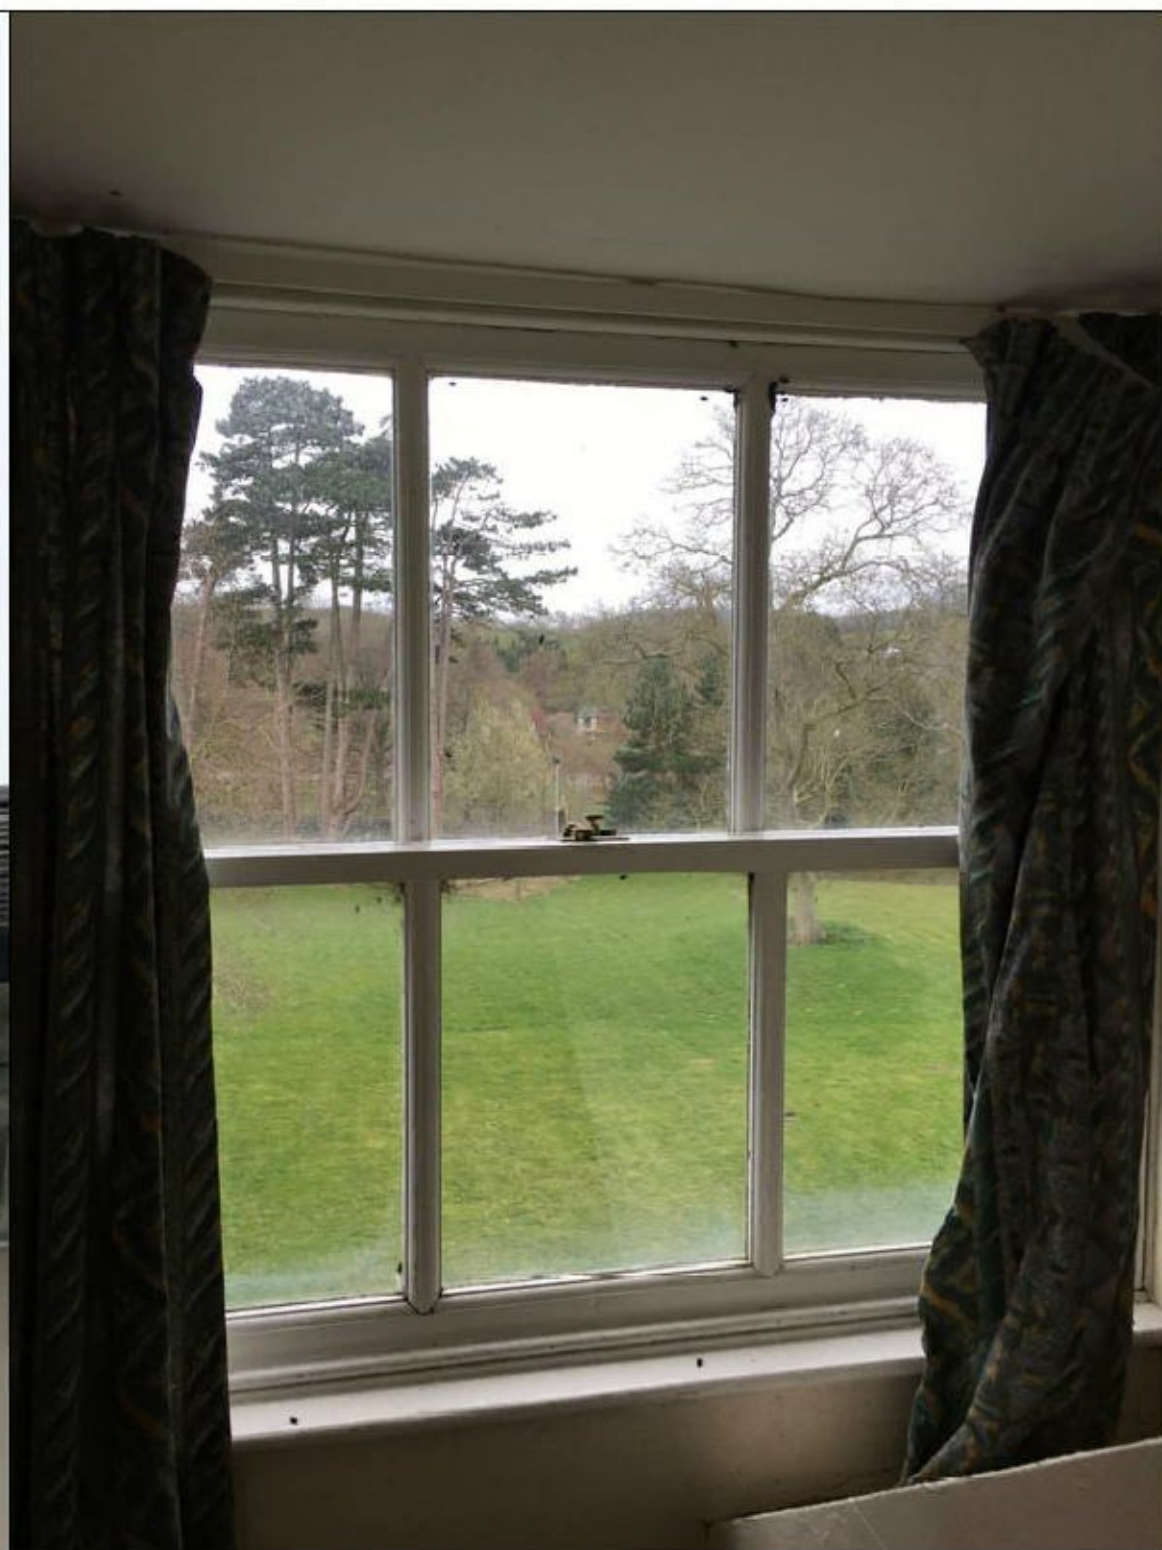
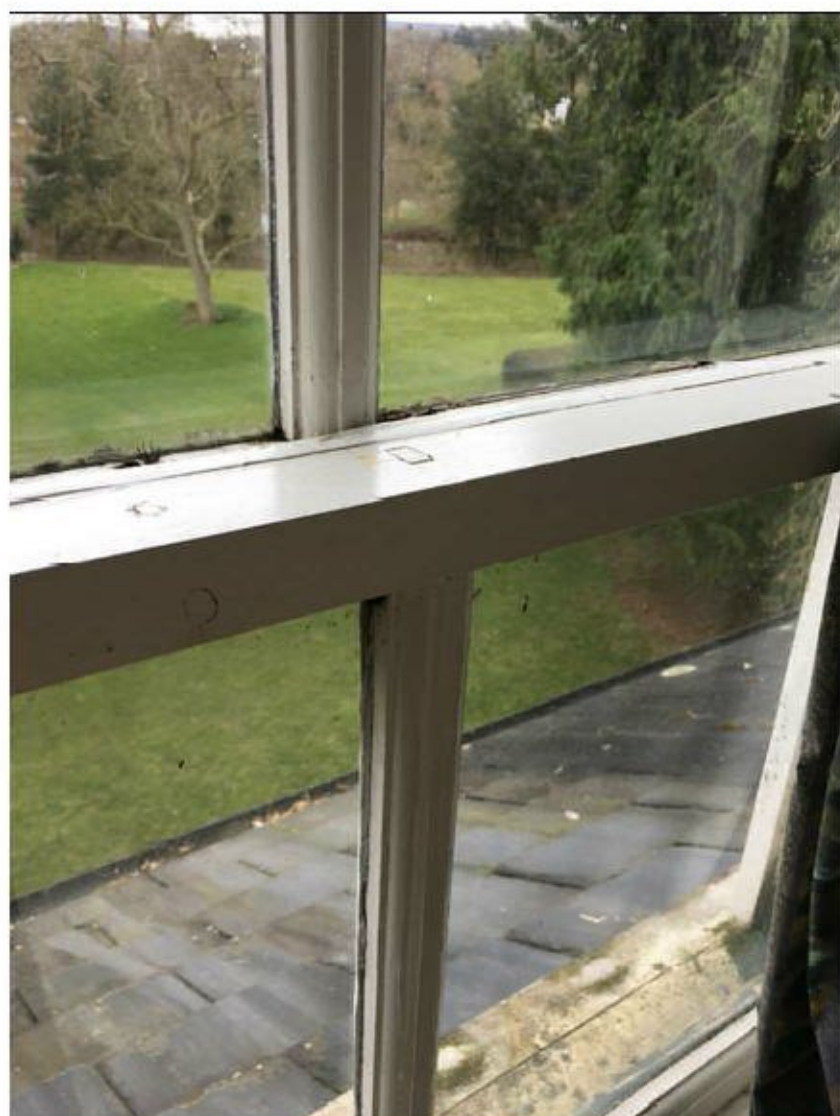
Photo Location - East_Window Number **W203** - See floor plans for location

Located with 1750's section of the building

Condition - Poor in need of refurbishment

Frame - Presumed Non Original

Glass - Presumed Non Original

· Replacement window

it has been advised by a window restorer and fabricator that there is not enough good quality frame left to simply refurbish this window. The window is not considered original
