# Building Recording - Ground Floor

## Internal Floors

Showing existing photos, noted location, frame condition, leaf condition and proposed refurbishment works

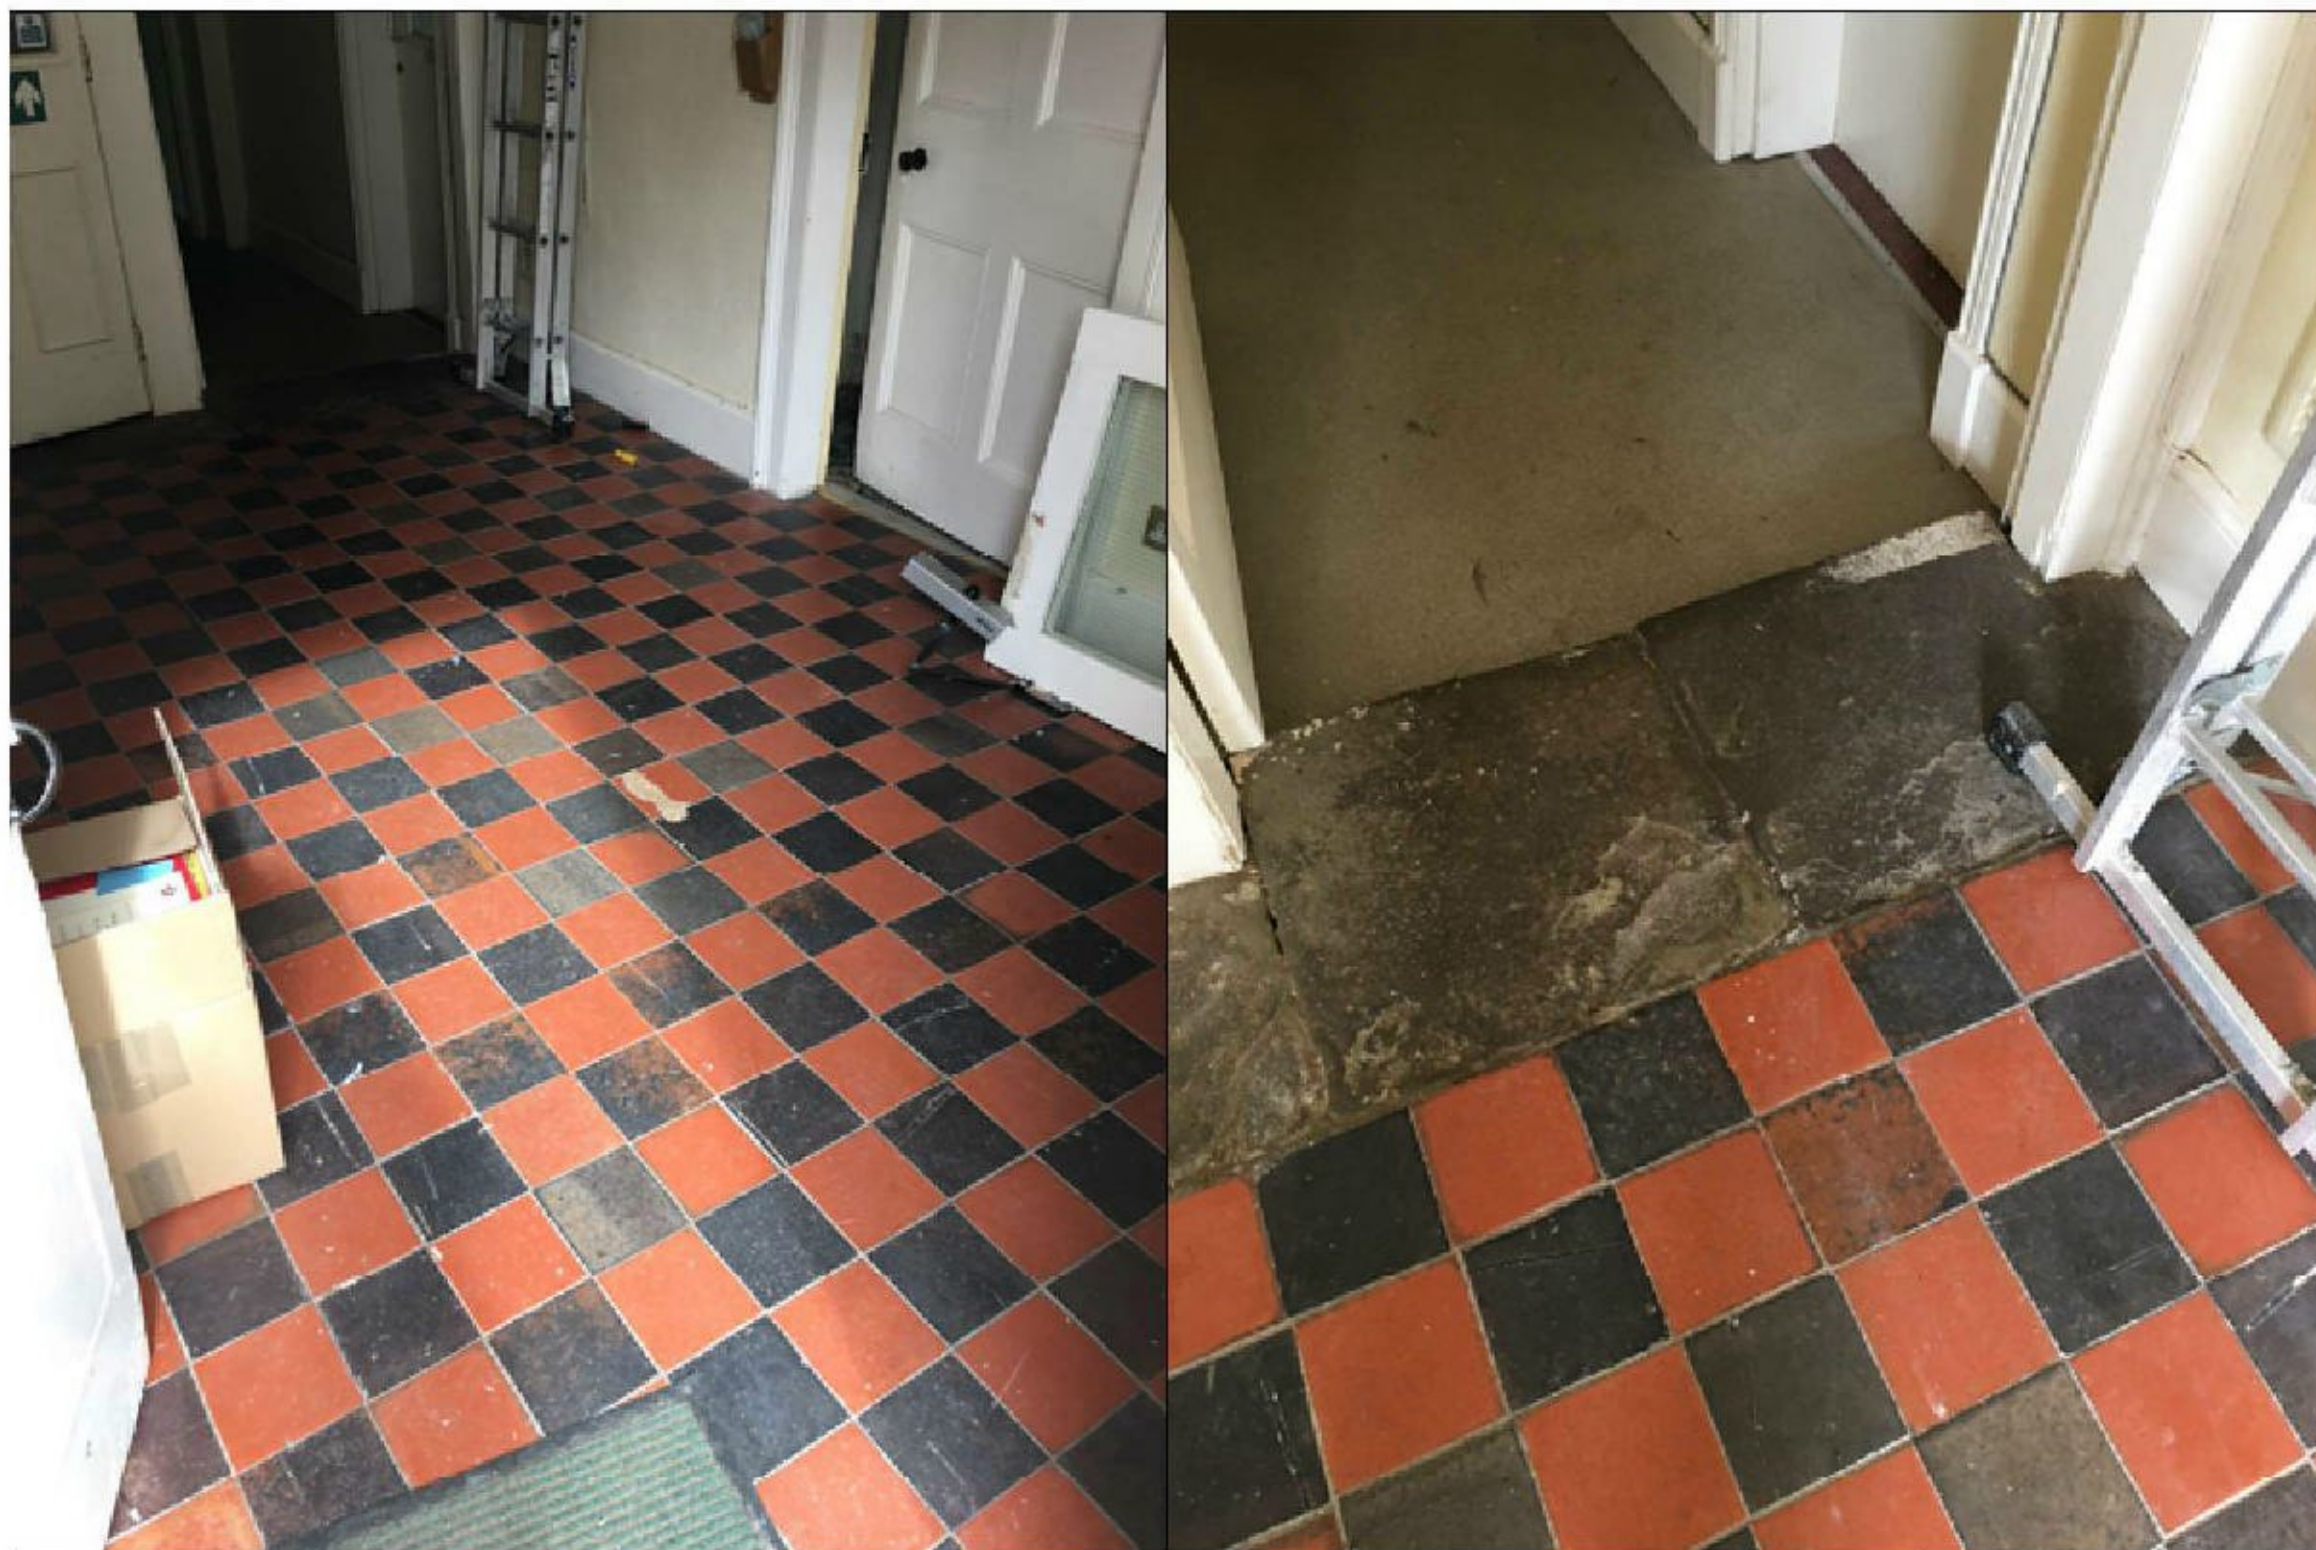
**Internal Photo F001a**

**Photo Location - Entrance Hall - Floor Number F001 - See floor plans for location**

**Located with 1840's section of the building**

**Floor - Flag Stone - Presumed original - Average condition**  
**- Black and Red Tiles - Presumed installed in the 1970's outside**  
**of the kitchen area - Average condition**

**· None**

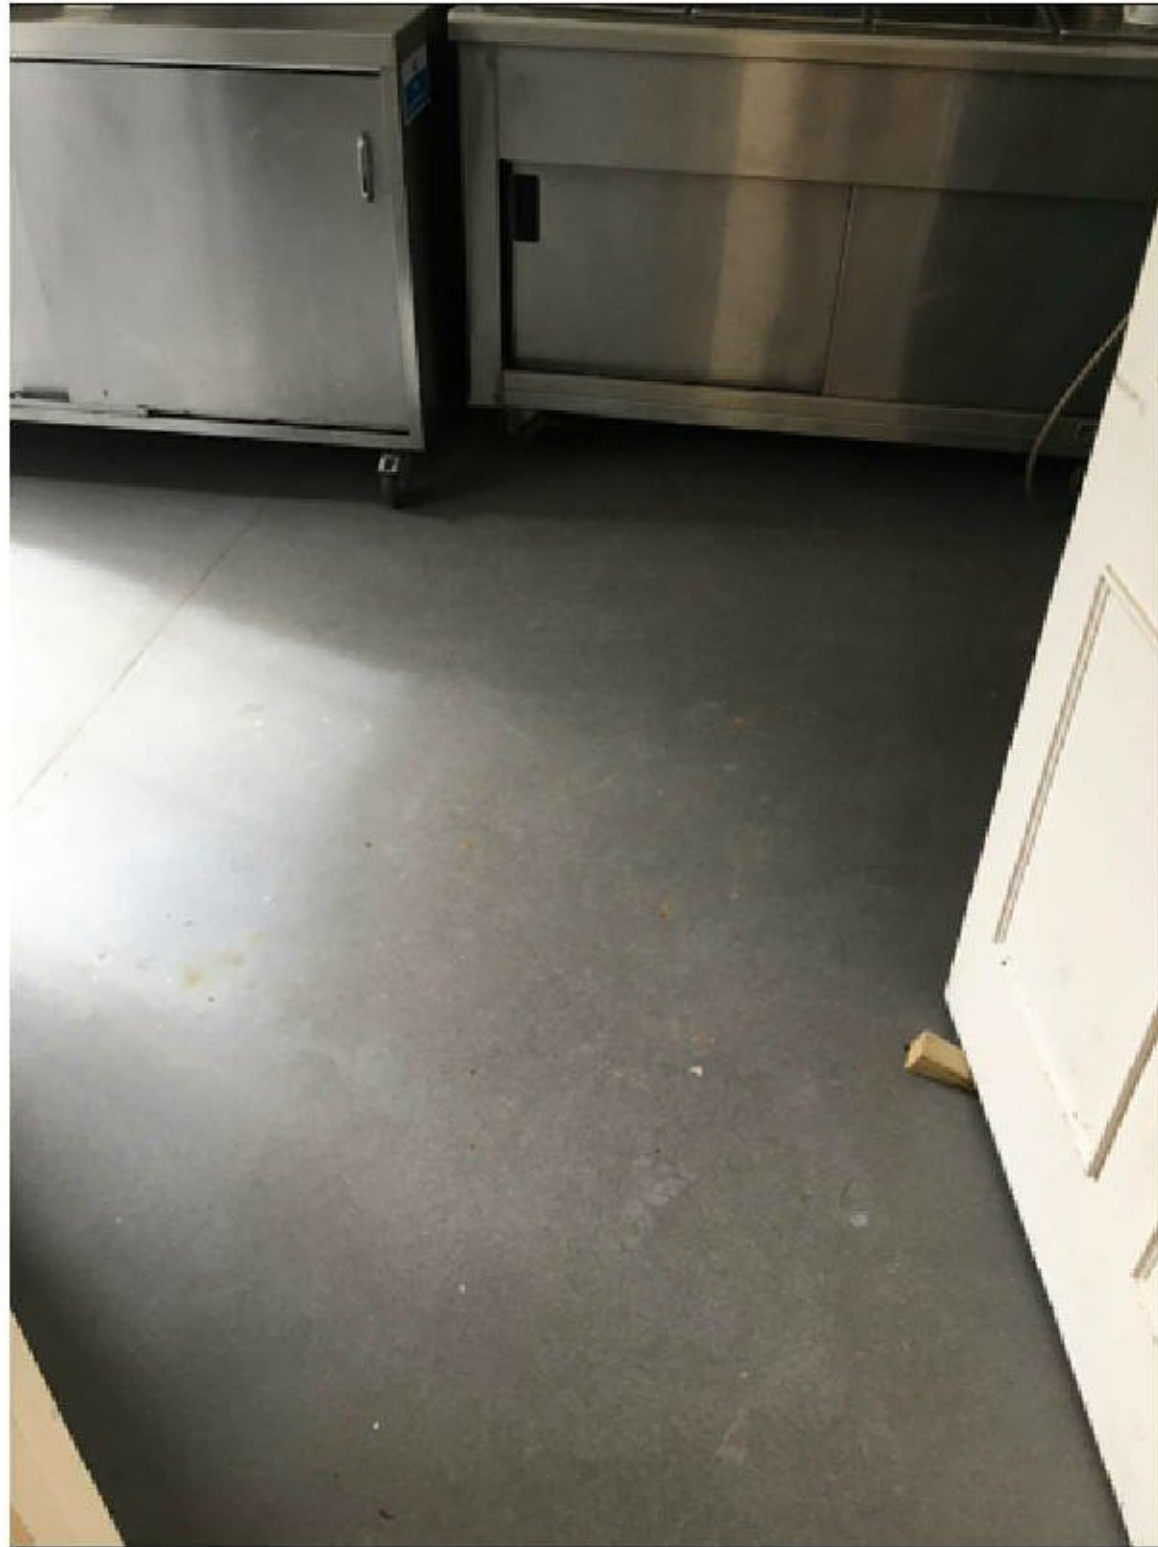
**Internal Photo F002**

**Photo Location - Kitchen - Floor Number F002 - See floor plans for location**

**Located with 1840's section of the building**

**Floor - Vinyl - Presumed non original - Average condition  
previous tile floor was removed in the late 1990's for increased slip resistance**

- Replaced in proposed works**
-

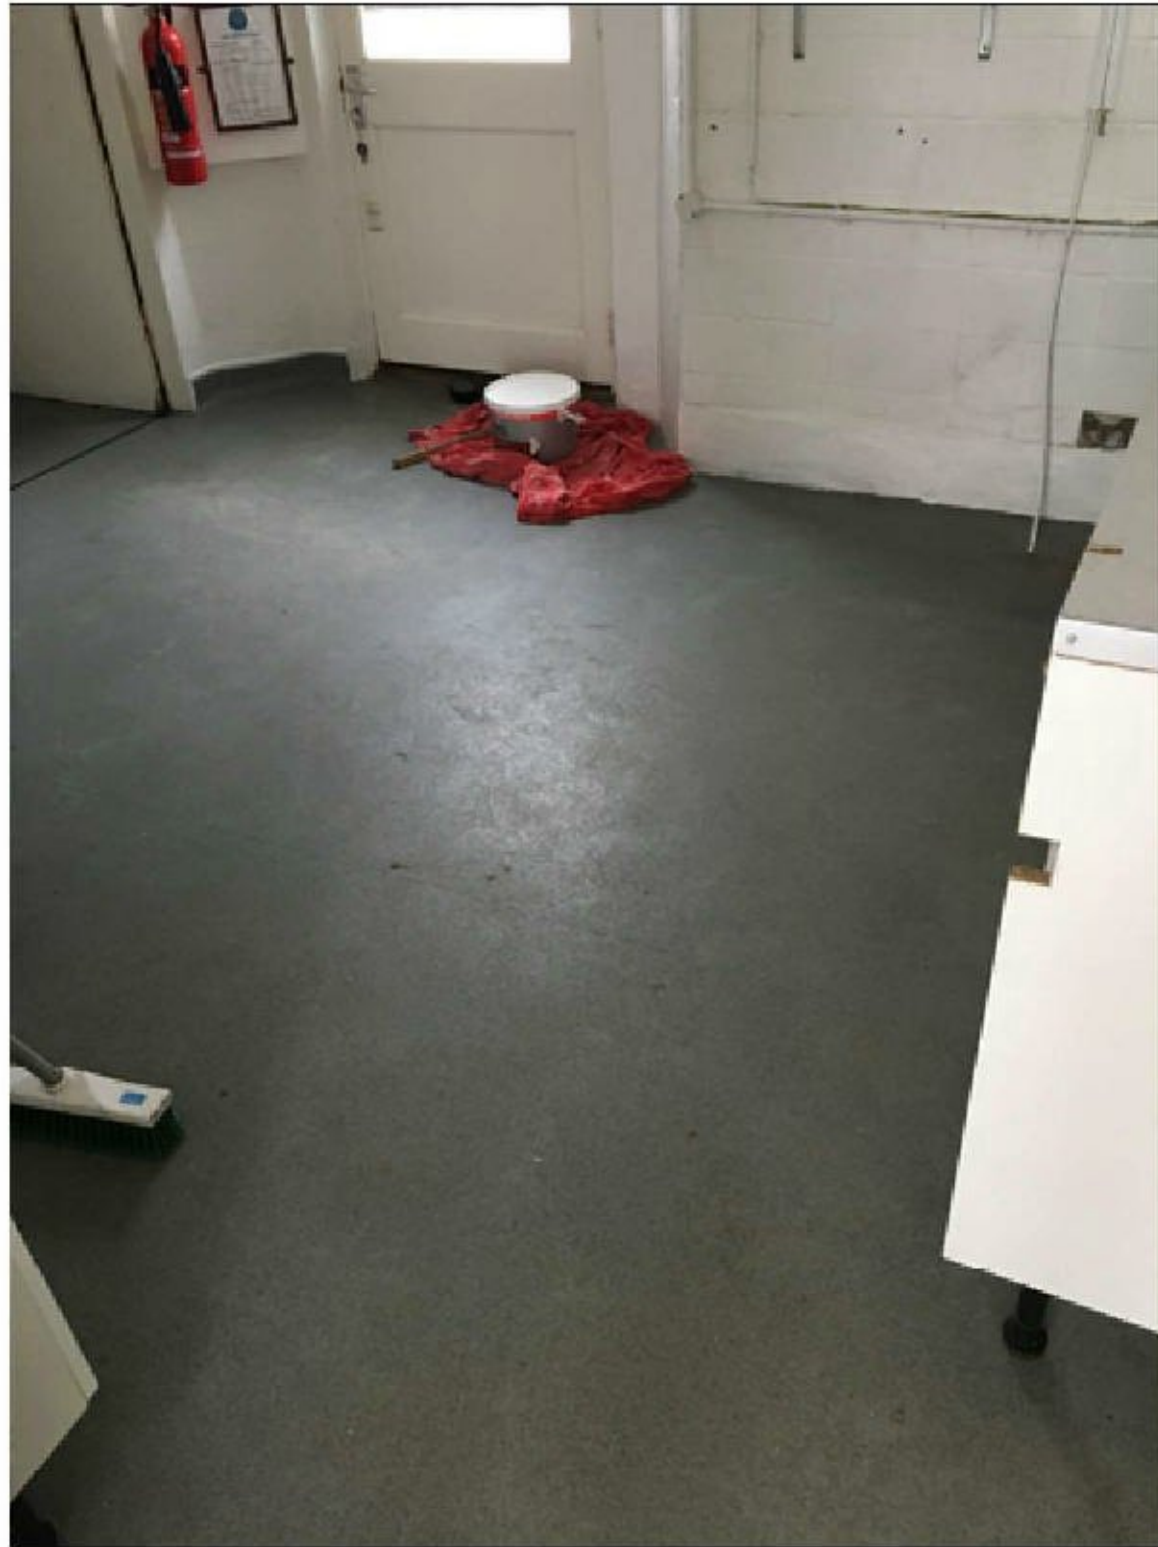
Internal Photo F003

Photo Location - Scullery - Floor Number **F003** - See floor plans for location

Located with 1840's section of the building

Floor - Vinyl - Presumed non original - Average condition  
previous tile floor was removed in the late 1990's for increased slip resistance

- Replaced in proposed works

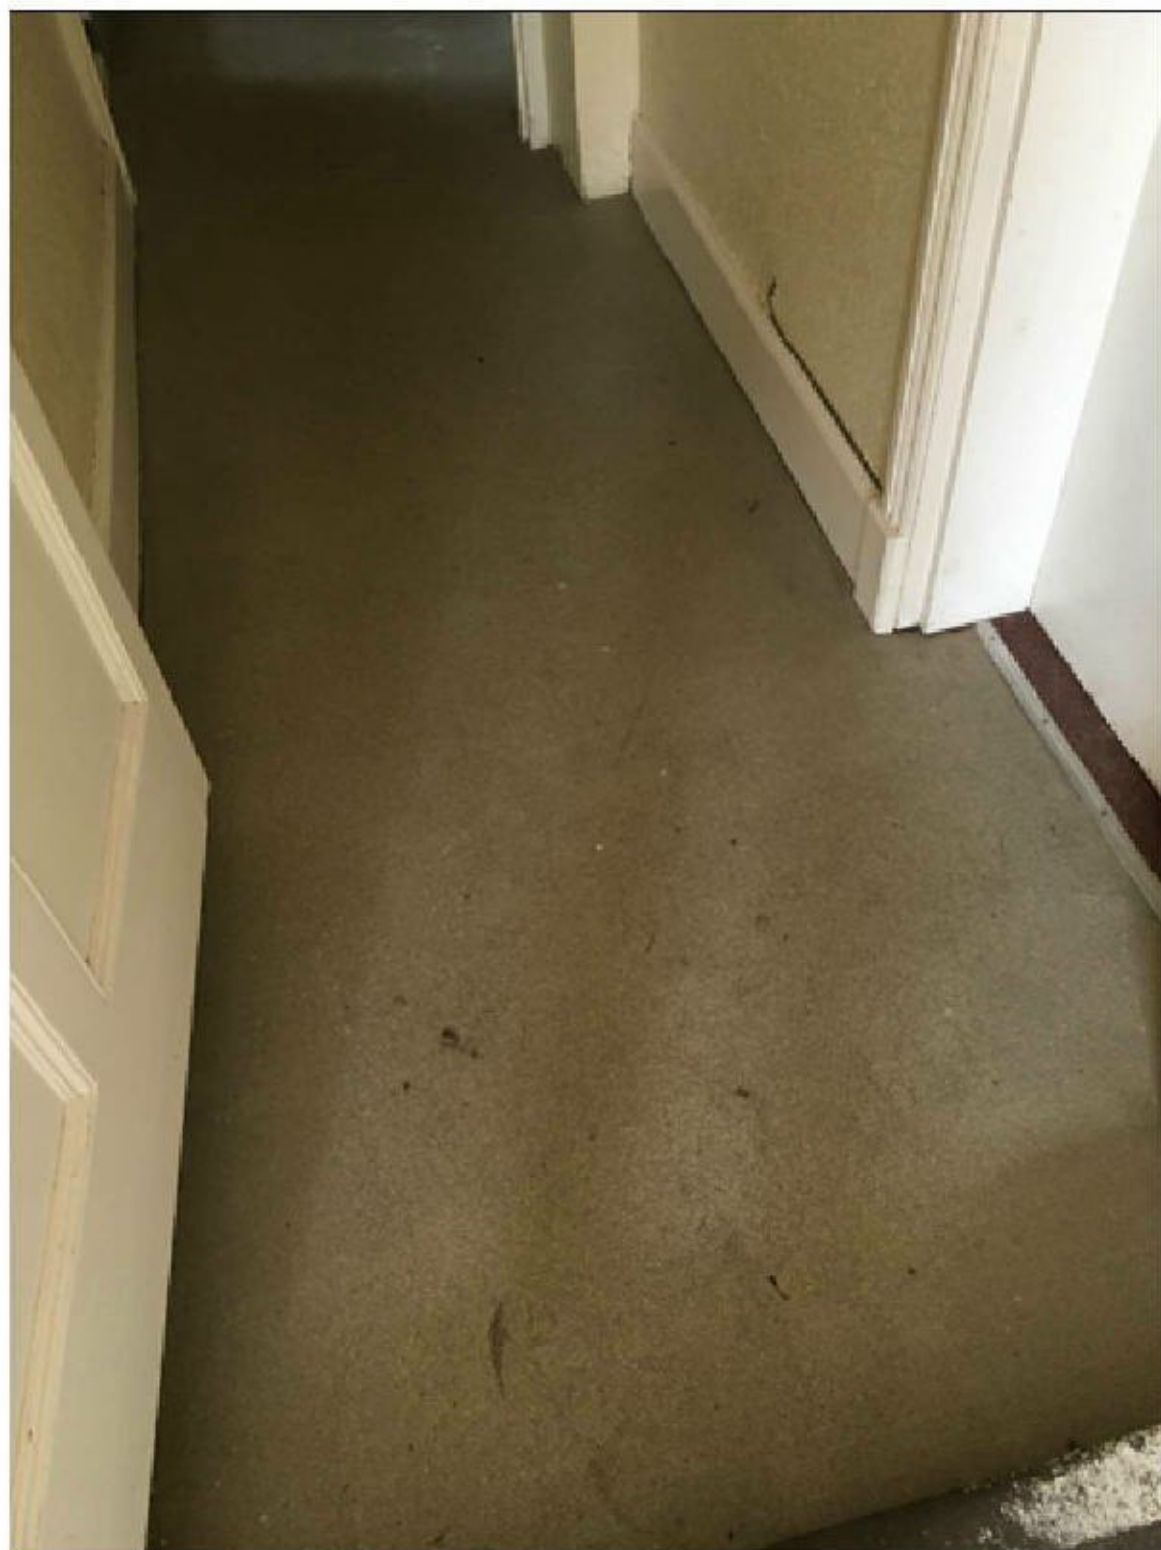
Internal Photo F004

Photo Location - Hall - Floor Number **F004** - See floor plans for location

Located with 1840's section of the building

Floor - Vinyl - Presumed non original - Poor condition

- Replaced in proposed works

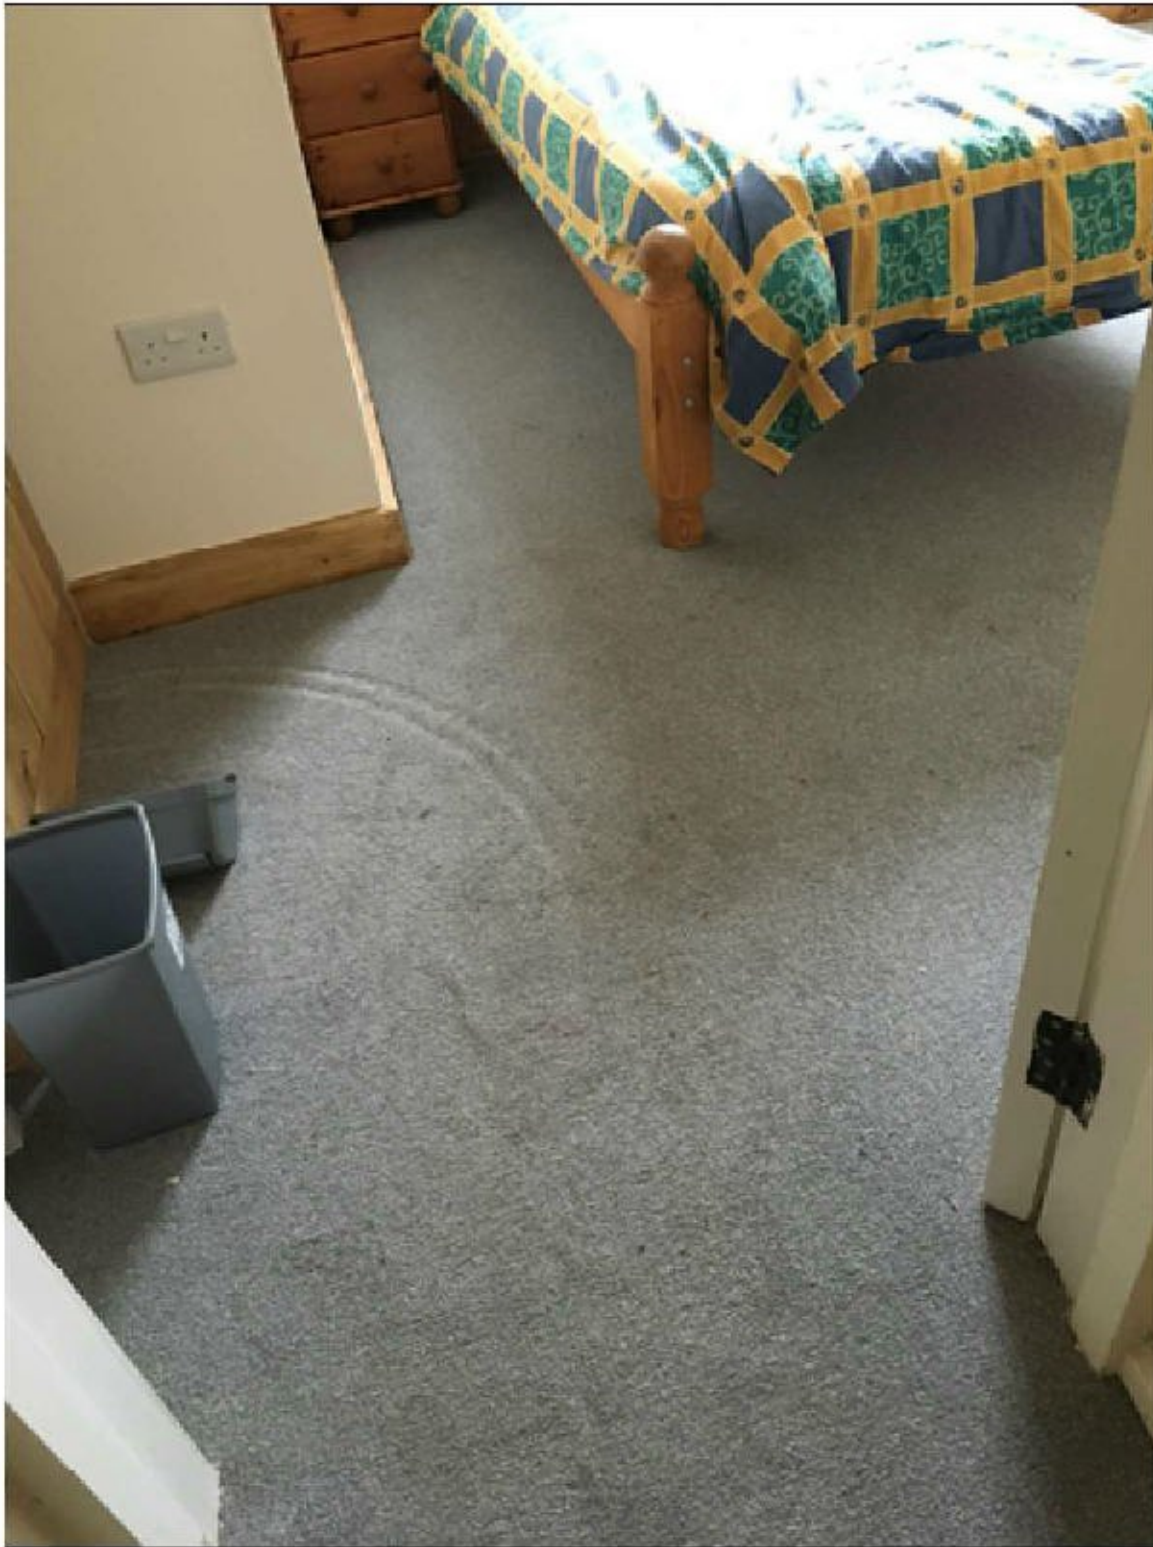
Internal Photo F005

Photo Location - Staff bedroom - Floor Number **F005** - See floor plans for location

Located with 1840's section of the building

Floor - Carpet - Presumed non original - Average condition

- Replaced in proposed works

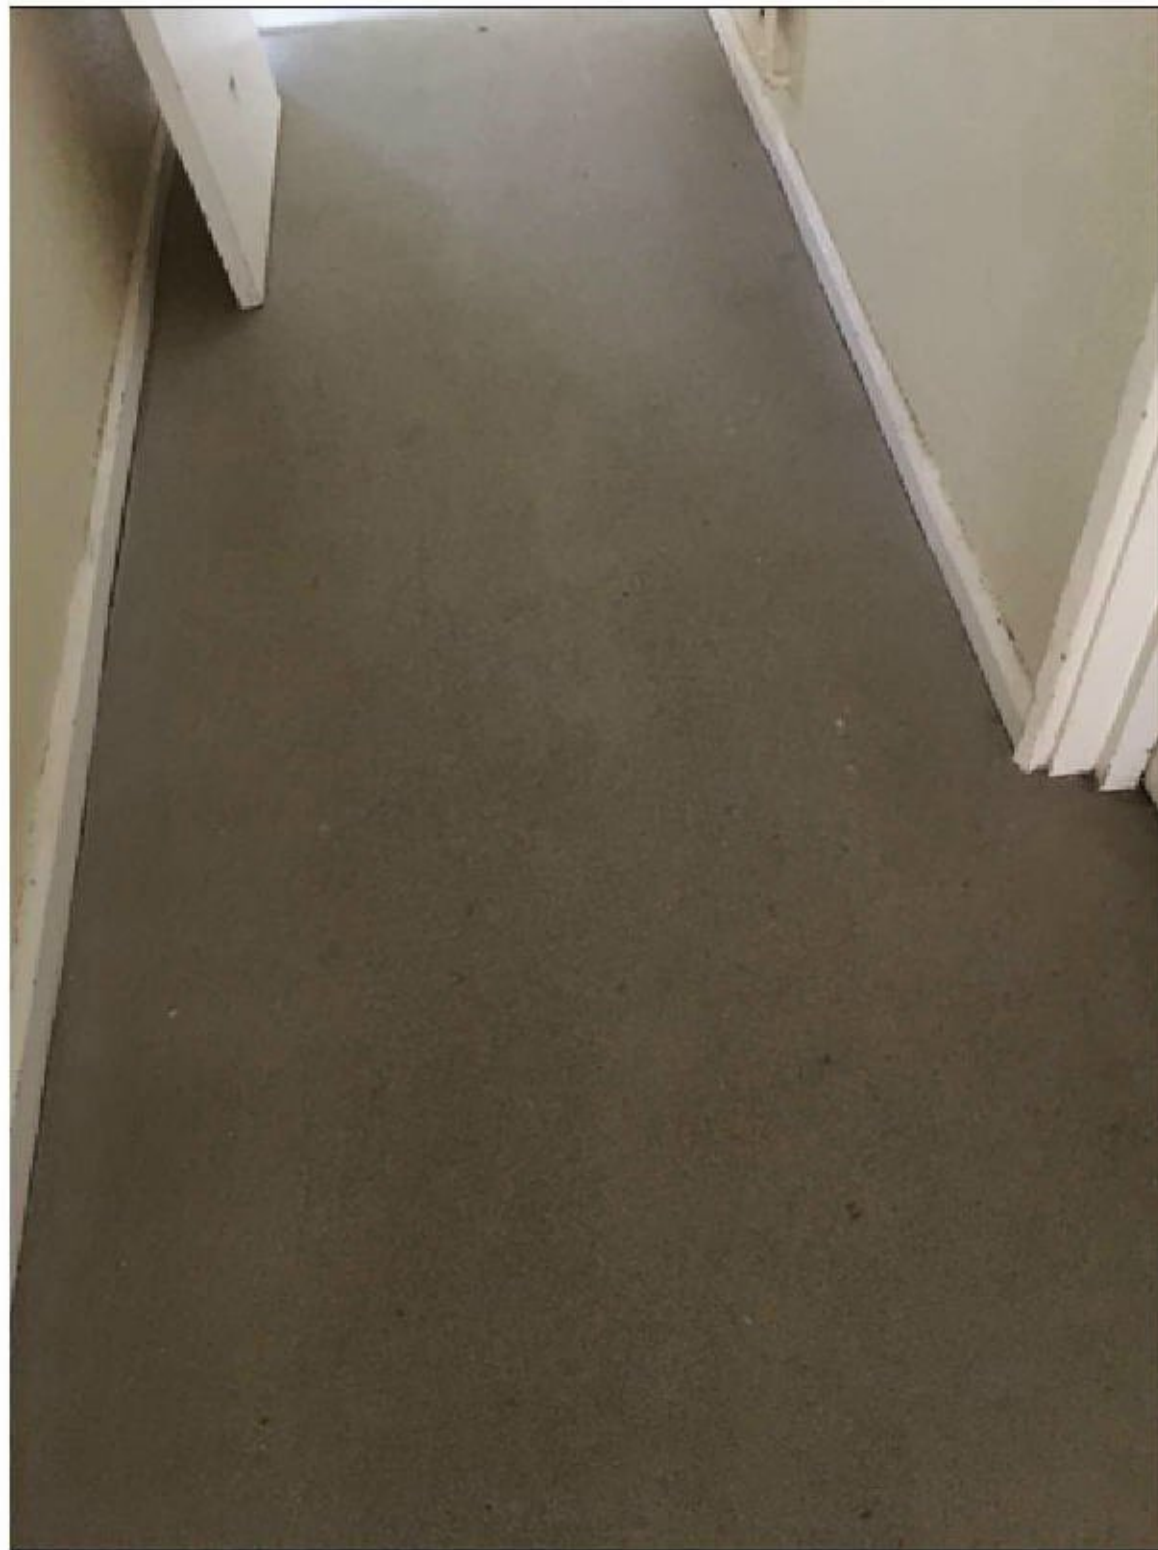
Internal Photo F006

Photo Location - Staff bedroom - Floor Number **F006** - See floor plans for location

Located with between 1840's and 1990's section of the building

Floor - Vinyl - Presumed non original - Average condition

- Replaced in proposed works

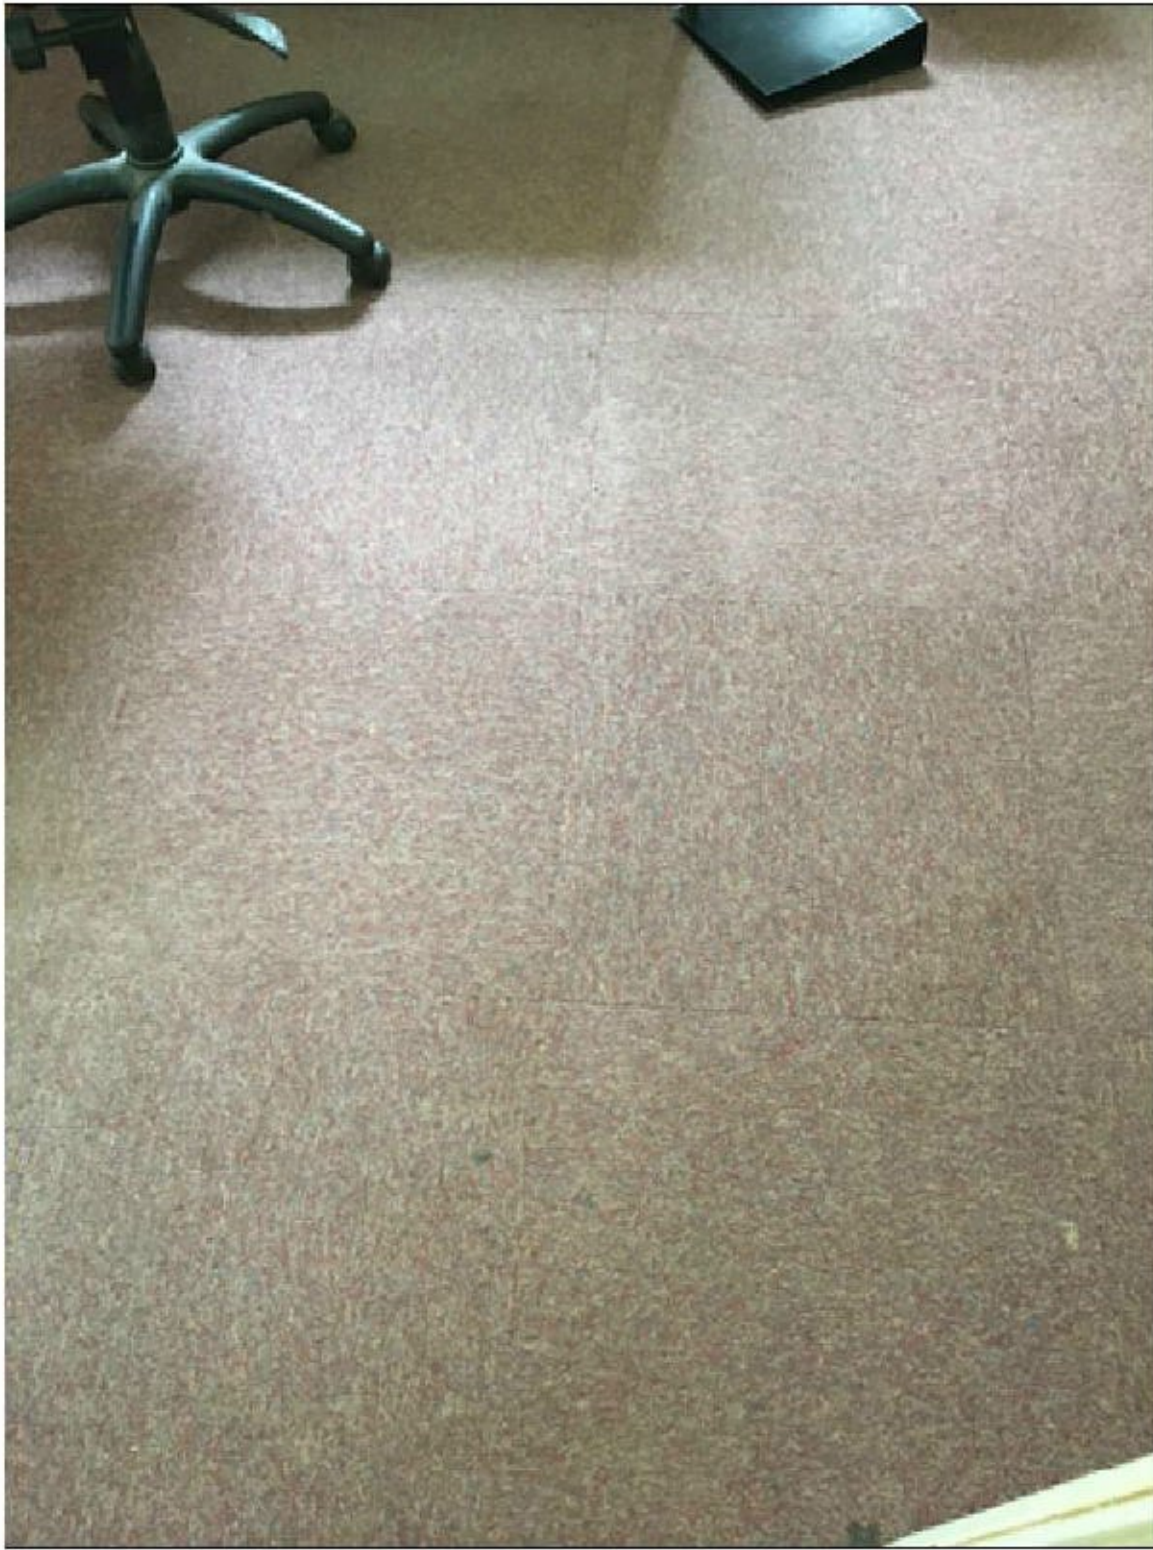
Internal Photo F007

Photo Location - Staff Room - Floor Number **F007** - See floor plans for location

Located with 1840's section of the building

Floor - Carpet - Presumed non original - Average condition

The existing finish under the floor is of concrete.

- Replaced in proposed works with a black and white floor tiles

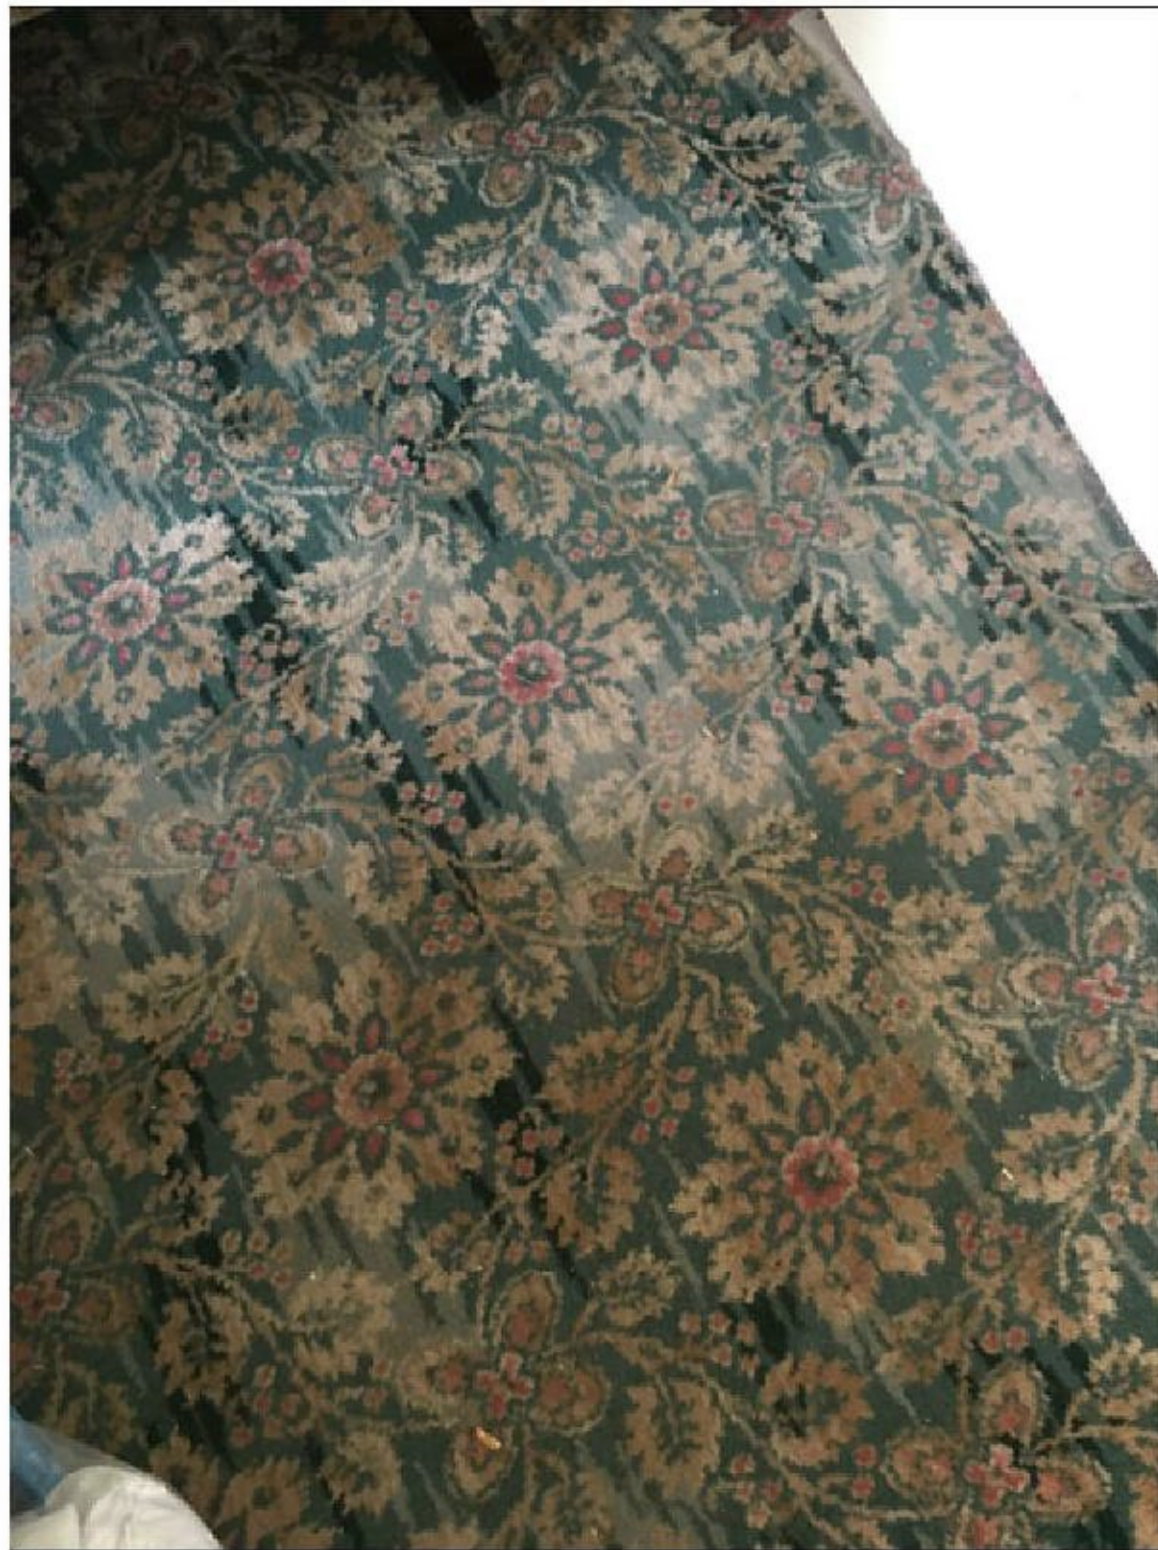
Internal Photo F008

Photo Location - Staff Room - Floor Number **F008** - See floor plans for location

Located with 1840's section of the building

Floor - Carpet - Presumed non original - Average condition

The existing finish under the floor is of concrete.

- Replaced in proposed works with a black and white floor tiles

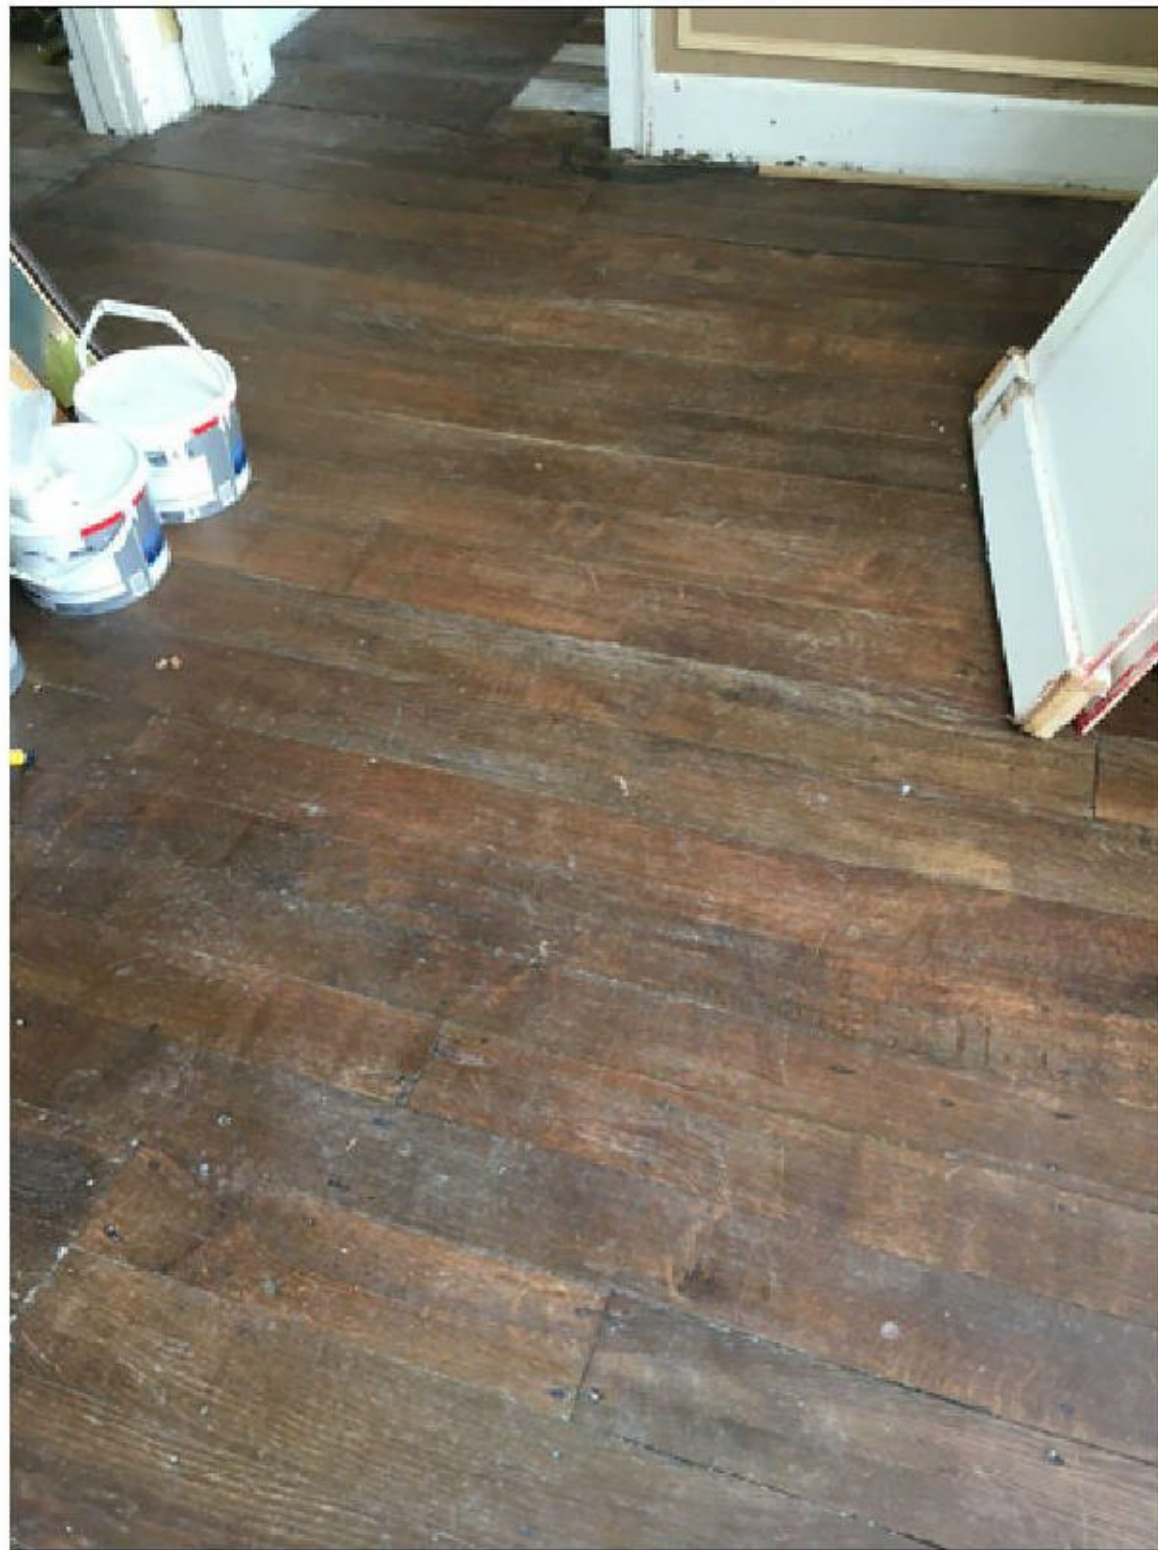
**Internal Photo F009**

**Photo Location - Hall - Floor Number F009 - See floor plans for location**

**Located with 1750's section of the building**

**Floor - Timber plank - Presumed original - Good condition**

- Cleaned and sympathetically restored repaired where required, retaining the patina.**

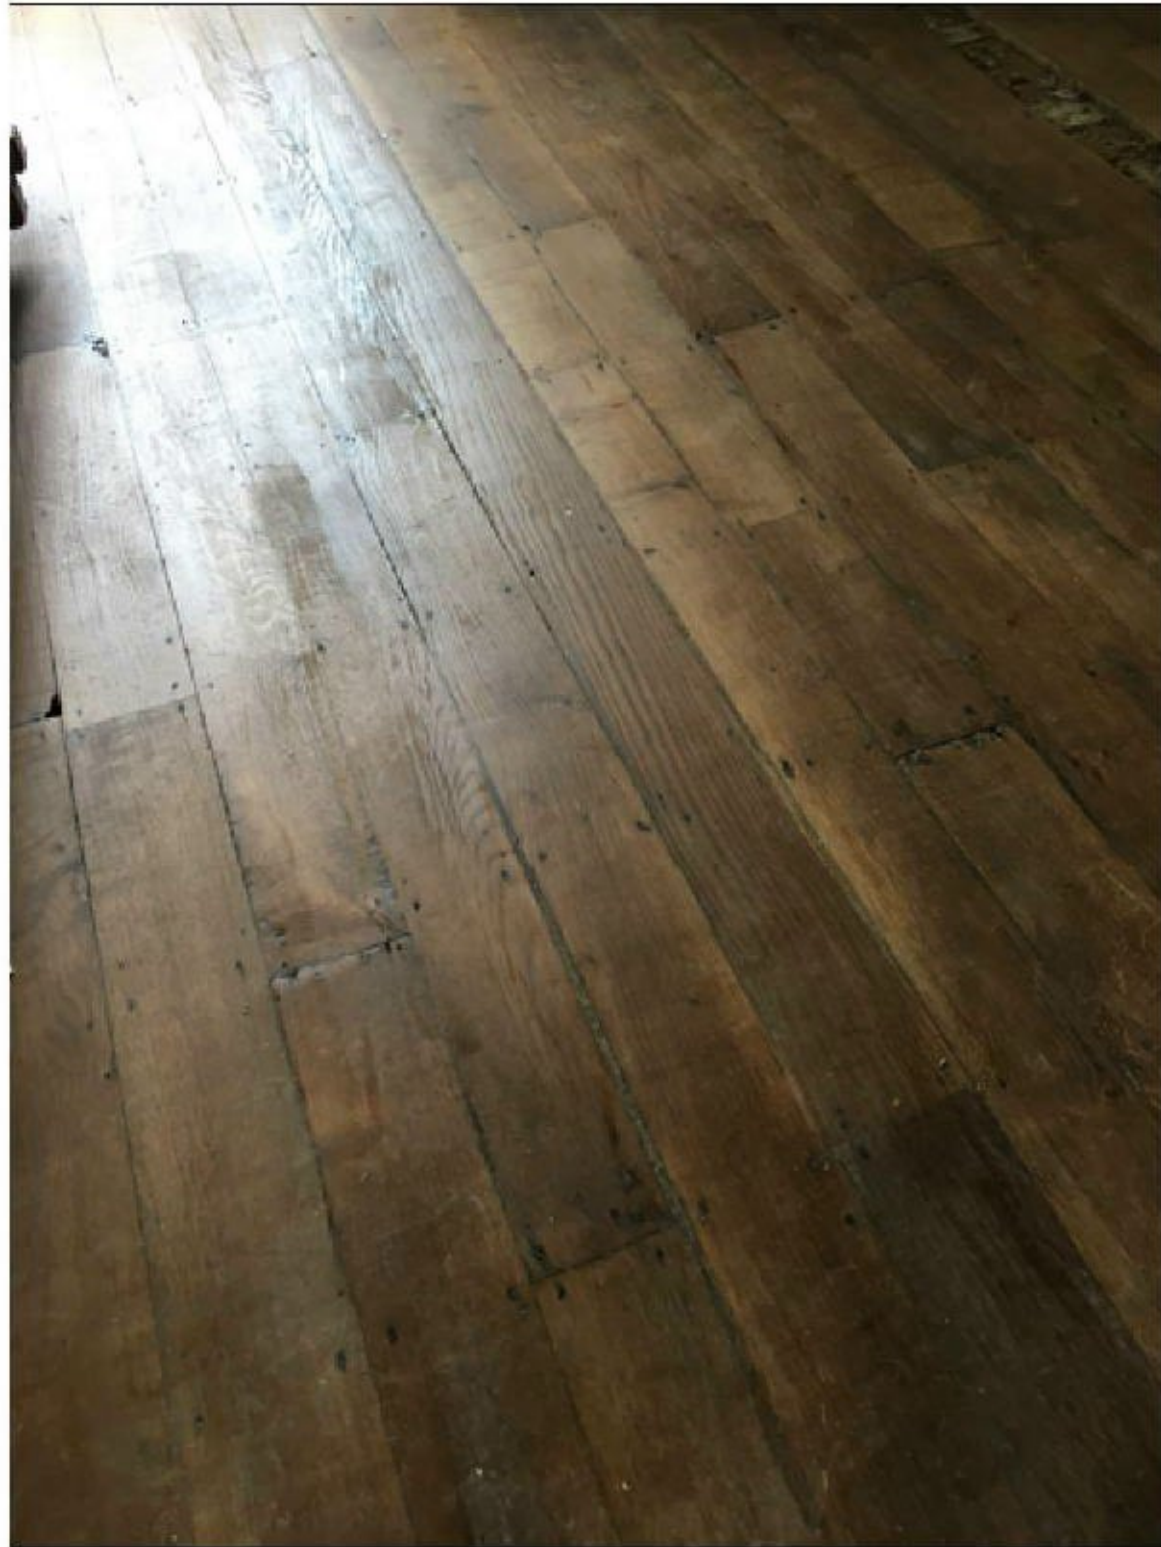
**Internal Photo F010**

**Photo Location - Lounge - Floor Number F010 - See floor plans for location**

**Located with 1750's section of the building**

**Floor - Timber plank - Presumed original - Good condition**

**· Cleaned and sympathetically restored repaired where required, retaining the patina.**

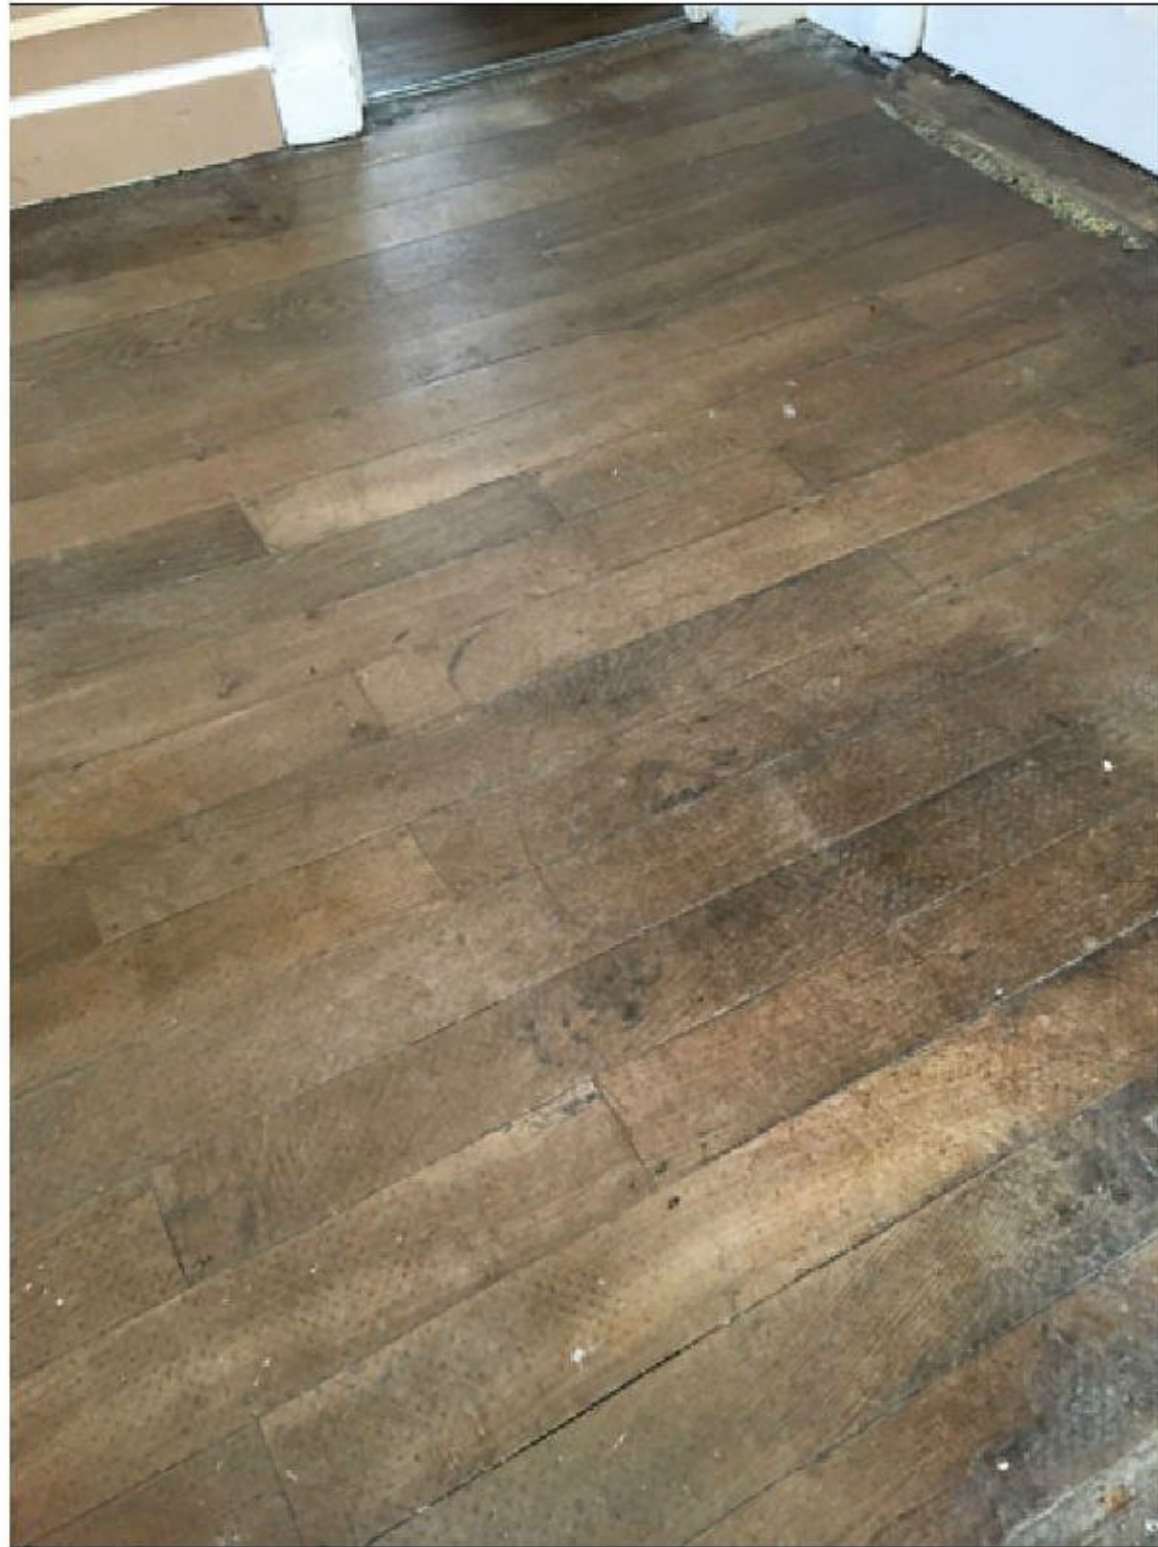
**Internal Photo F011**

**Photo Location - Entrance Hall - Floor Number F011 - See floor plans for location**

**Located with 1750's section of the building**

**Floor - Timber plank - Presumed original - Good condition**

**· Cleaned and sympathetically restored repaired where required, retaining the patina.**
