# Building Recording - Ground Floor

## Internal Floors

Showing existing photos, noted location, frame condition, leaf condition and proposed refurbishment works

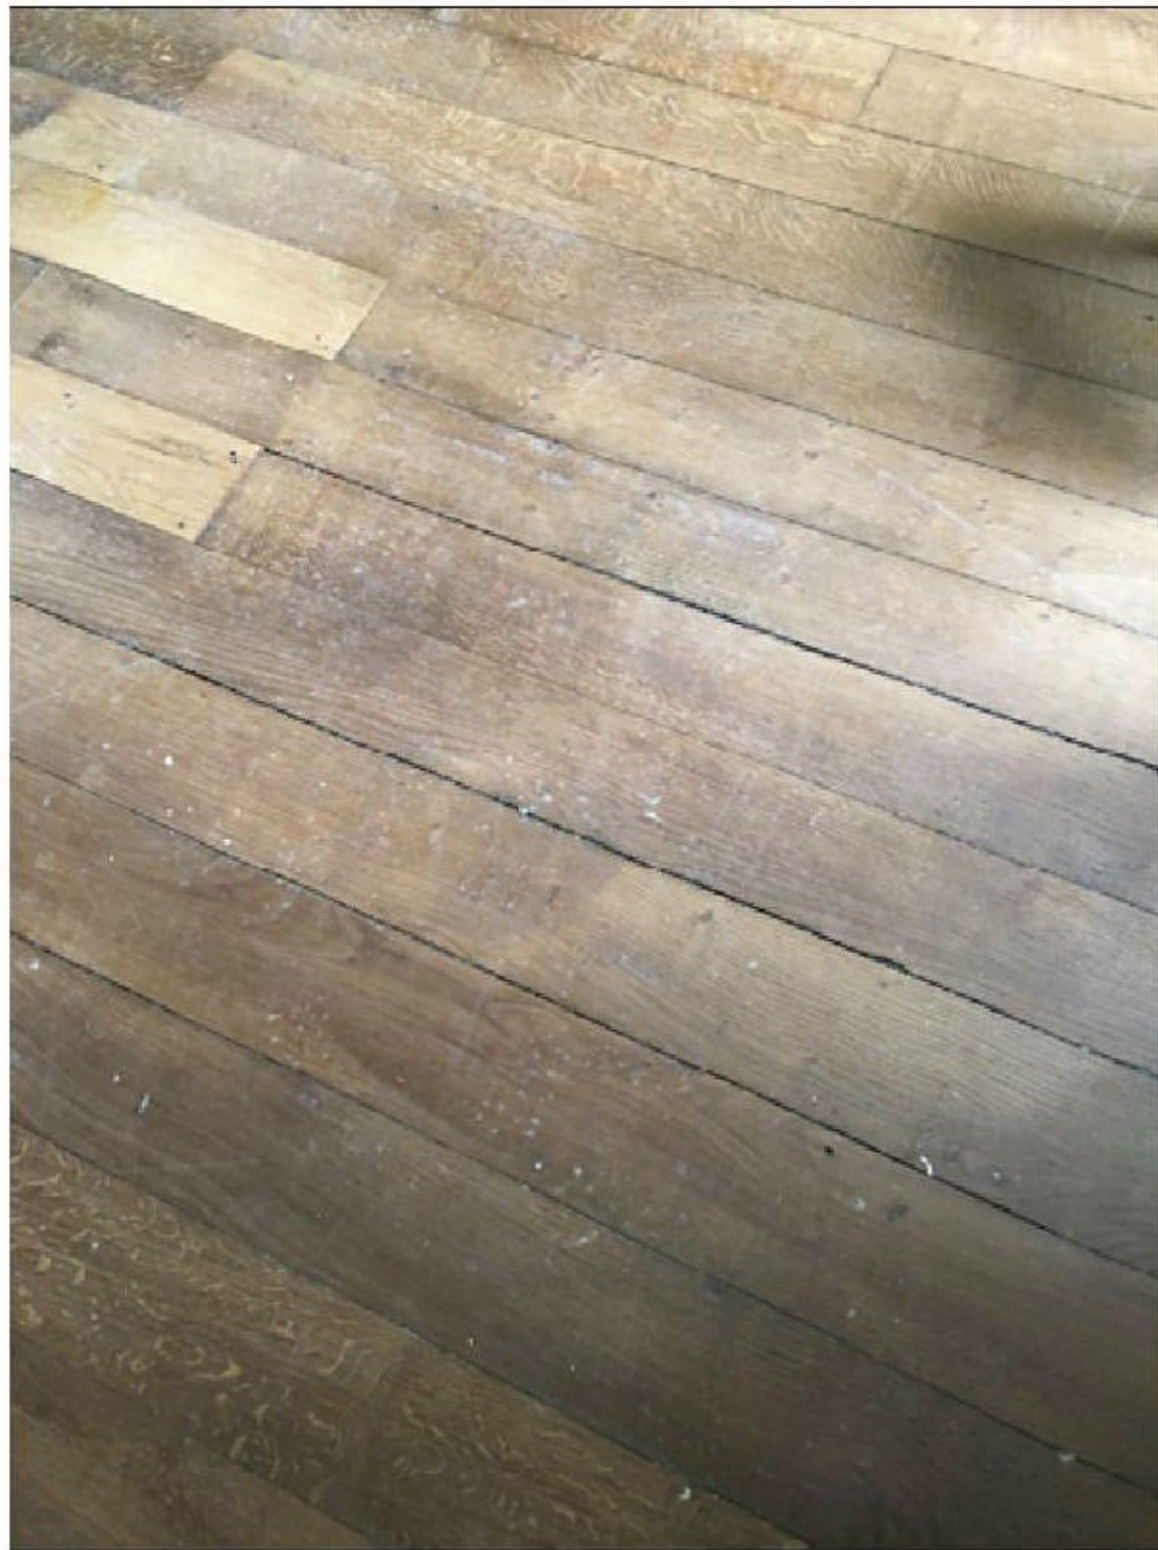
**Internal Photo F012**

**Photo Location - Dining Room - Floor Number F012 - See floor plans for location**

**Located with 1750's section of the building**

**Floor - Timber plank - Presumed original - Good condition**

- Cleaned and sympathetically restored repaired where required, retaining the patina.**
-

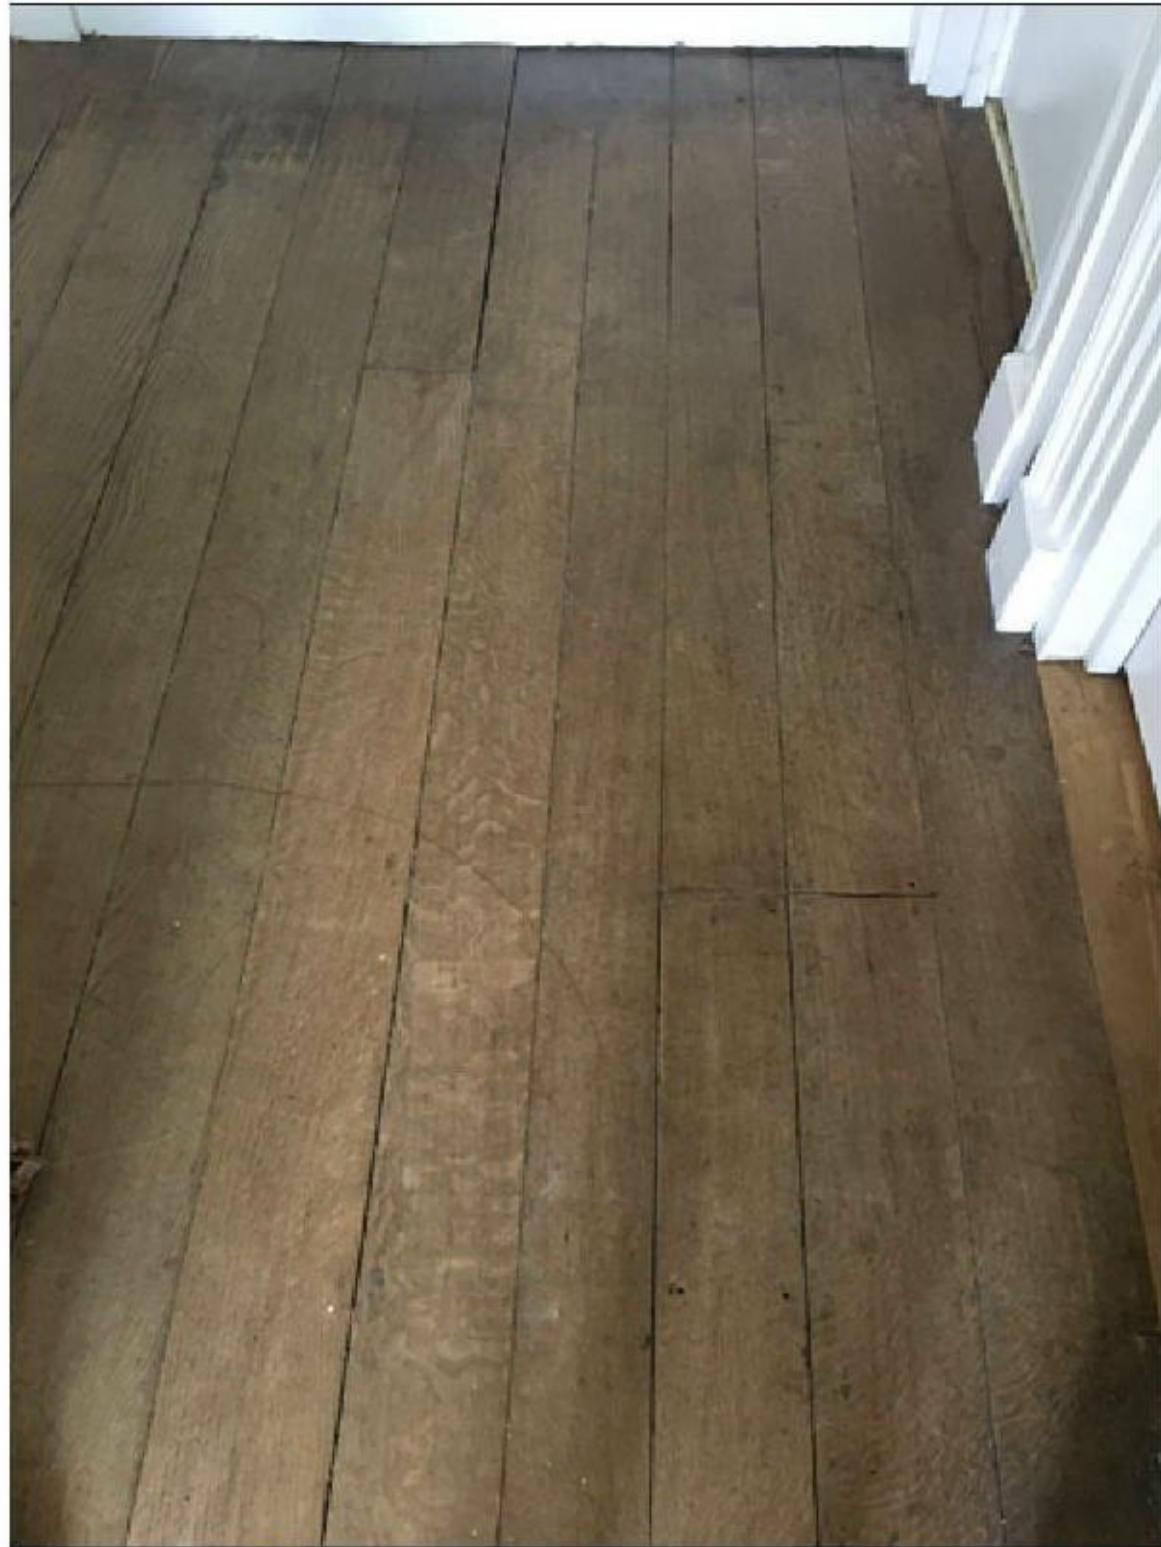
**Internal Photo F013**

**Photo Location - Landing - Floor Number F013 - See floor plans for location**

**Located with 1750's section of the building**

**Floor - Timber plank - Presumed original - Good condition**

- Cleaned and sympathetically restored repaired where required, retaining the patina.**
-

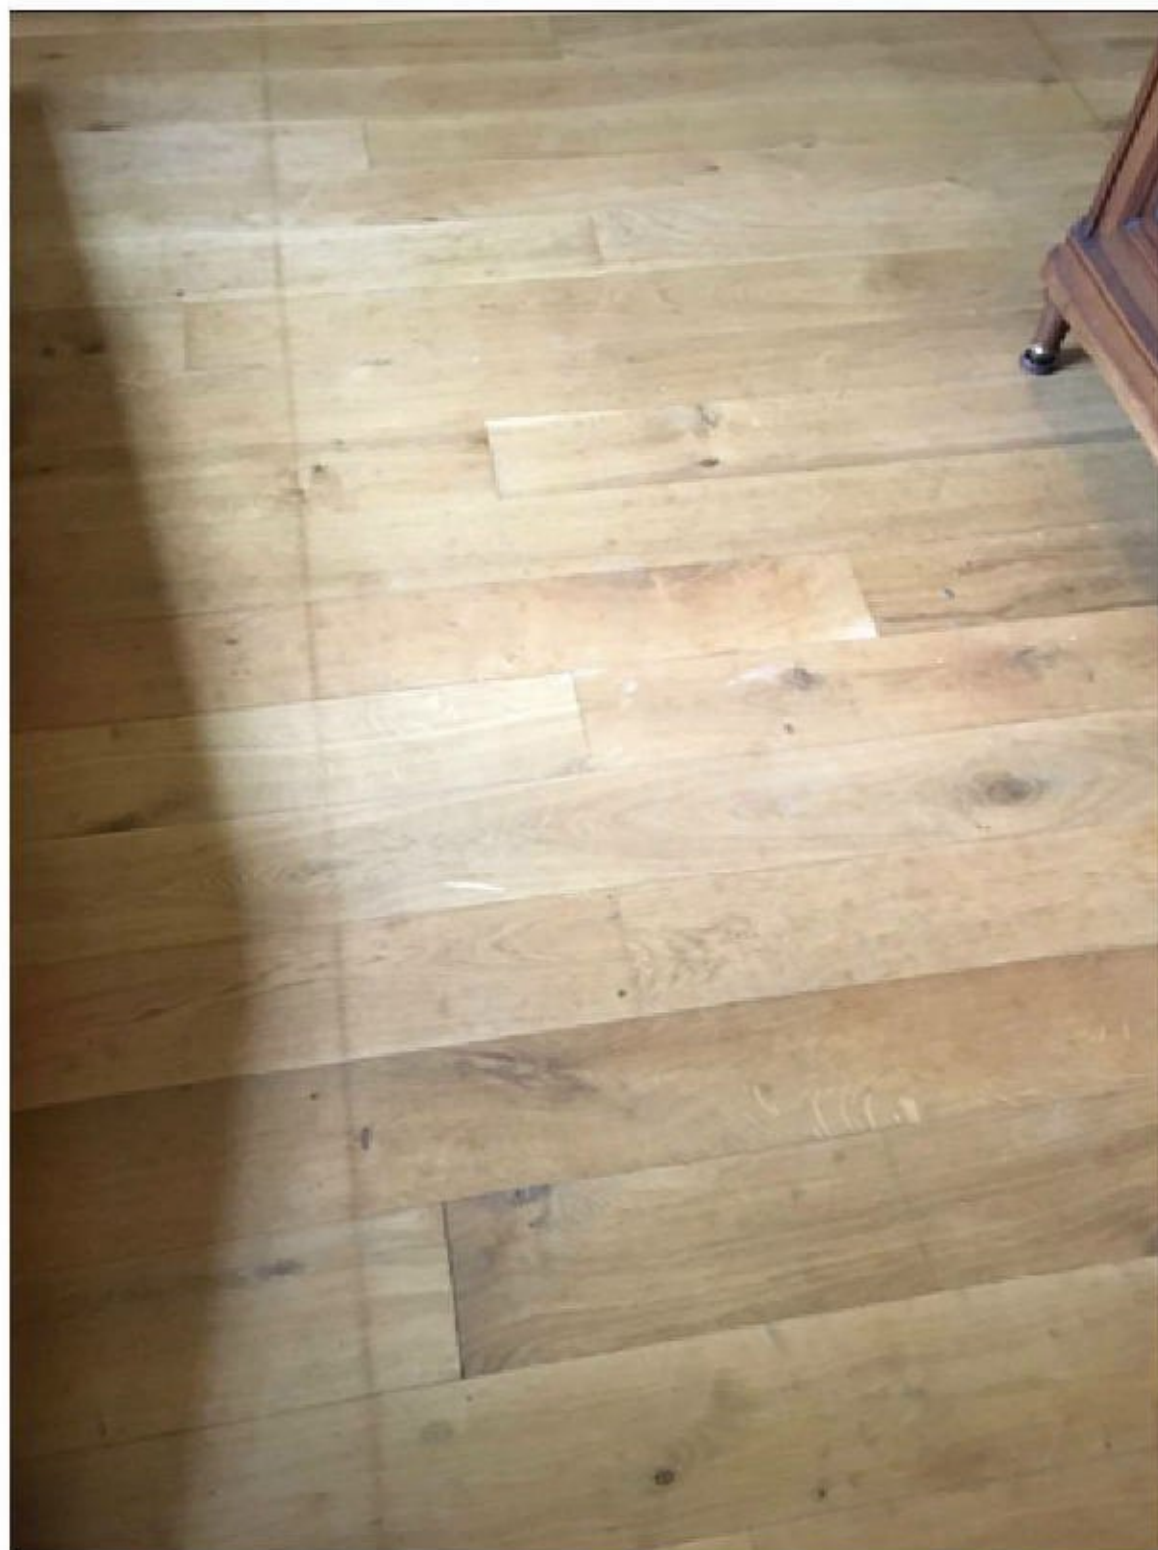
Internal Photo F014

Photo Location - Pembroke Dorm - Floor Number **F014** - See floor plans for location

Located with 1750's section of the building

Floor - Timber plank - Presumed non original - Good condition

- Cleaned
-

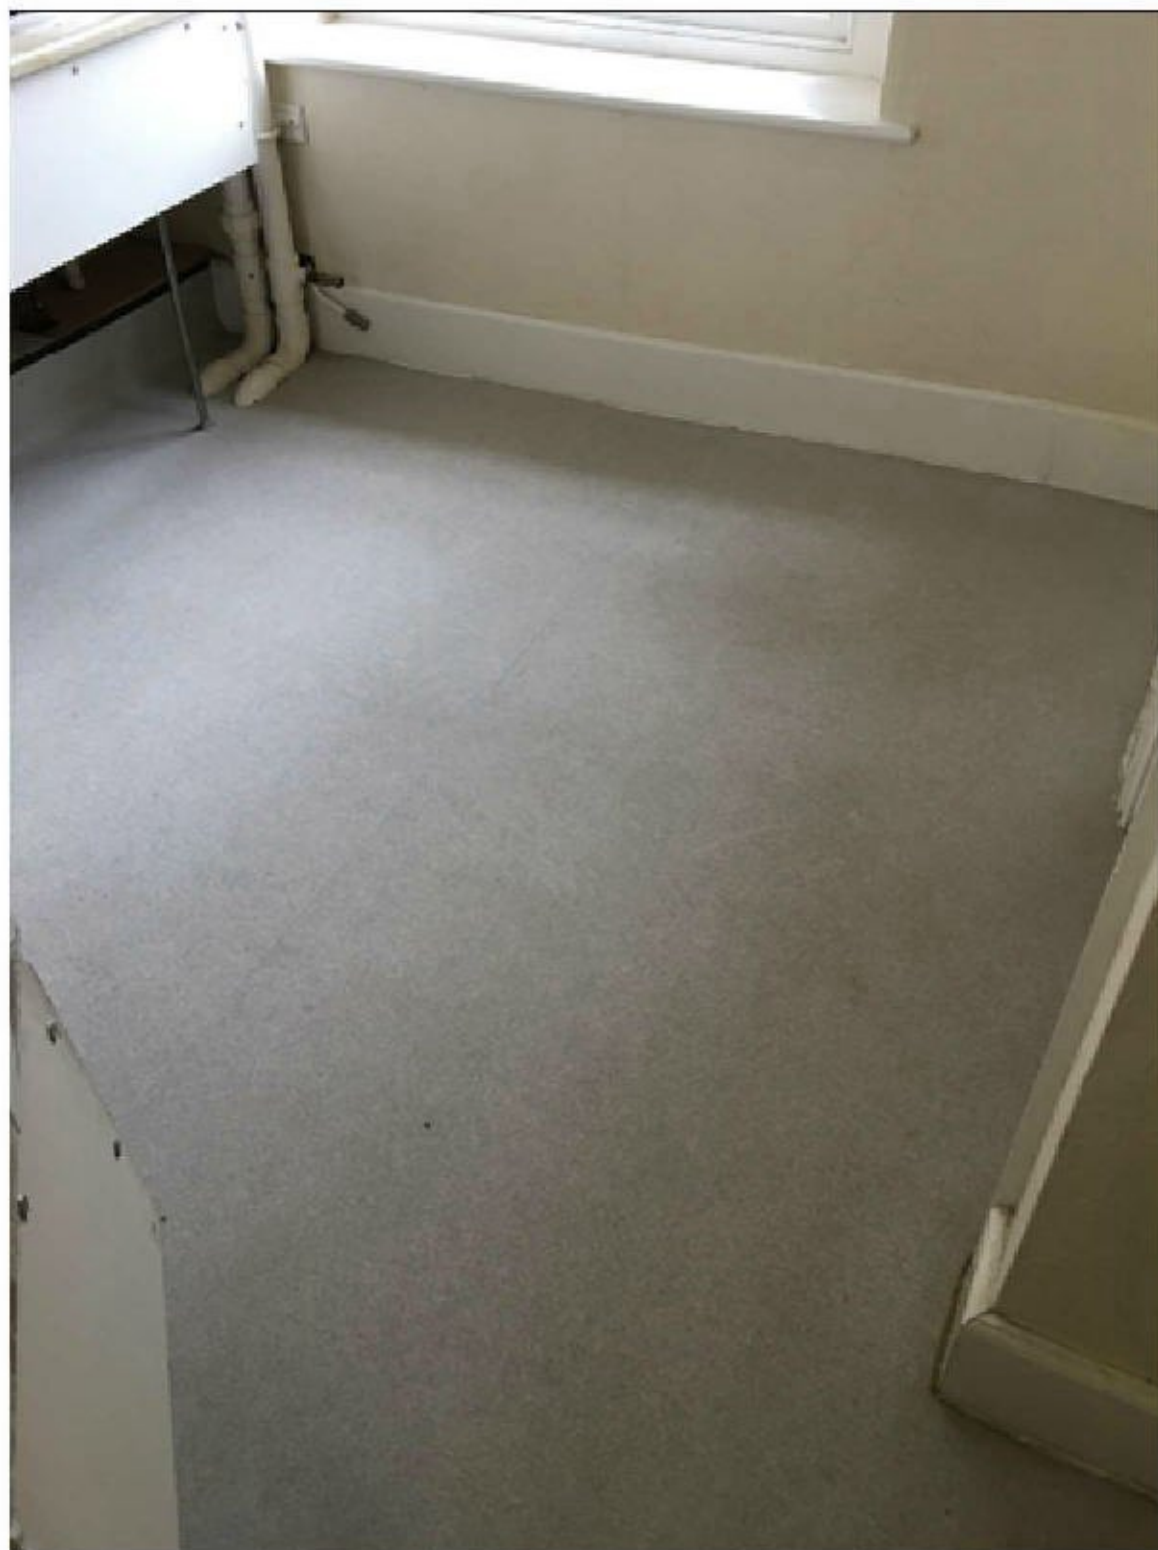
Internal Photo F015

Photo Location - Wc - Floor Number **F015** - See floor plans for location

Located with 1750's section of the building

Floor - Vinyl- Presumed non original - Average condition

- Replaced in proposed works

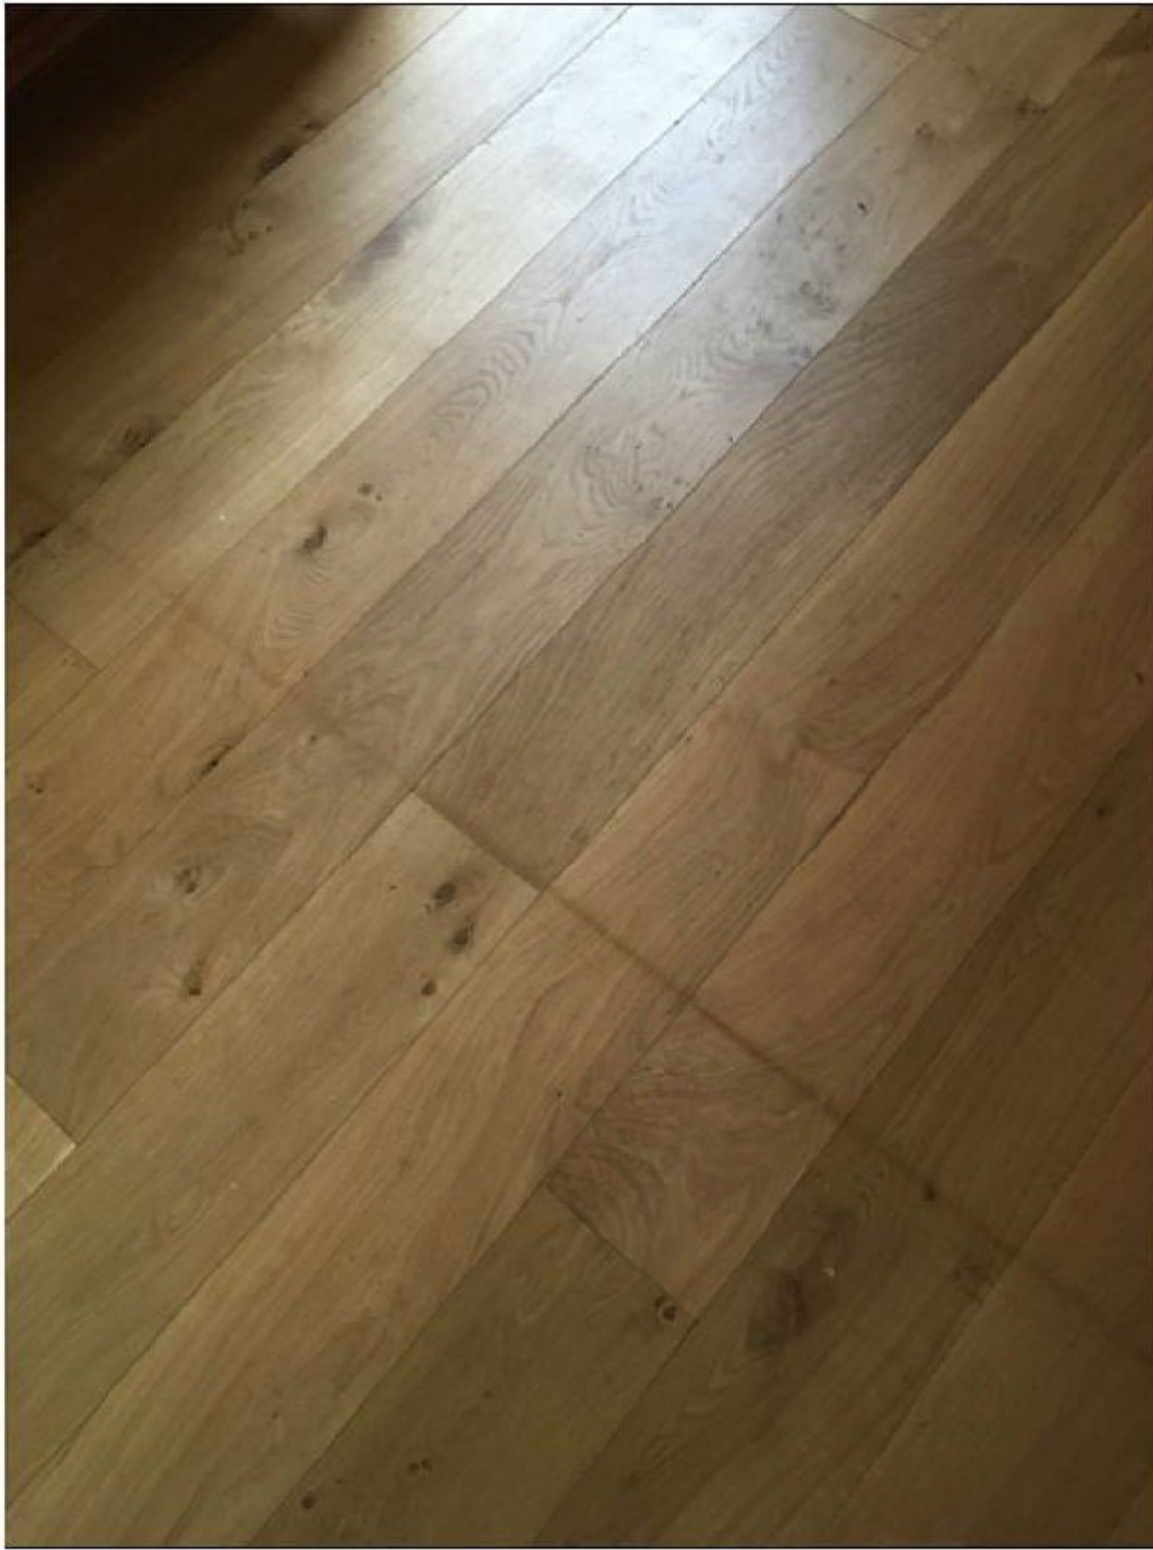
Internal Photo F016

Photo Location - Bedroom - Floor Number **F016** - See floor plans for location

Located with 1750's section of the building

Floor - Timber plank - Presumed non original - Good condition

- Cleaned
-

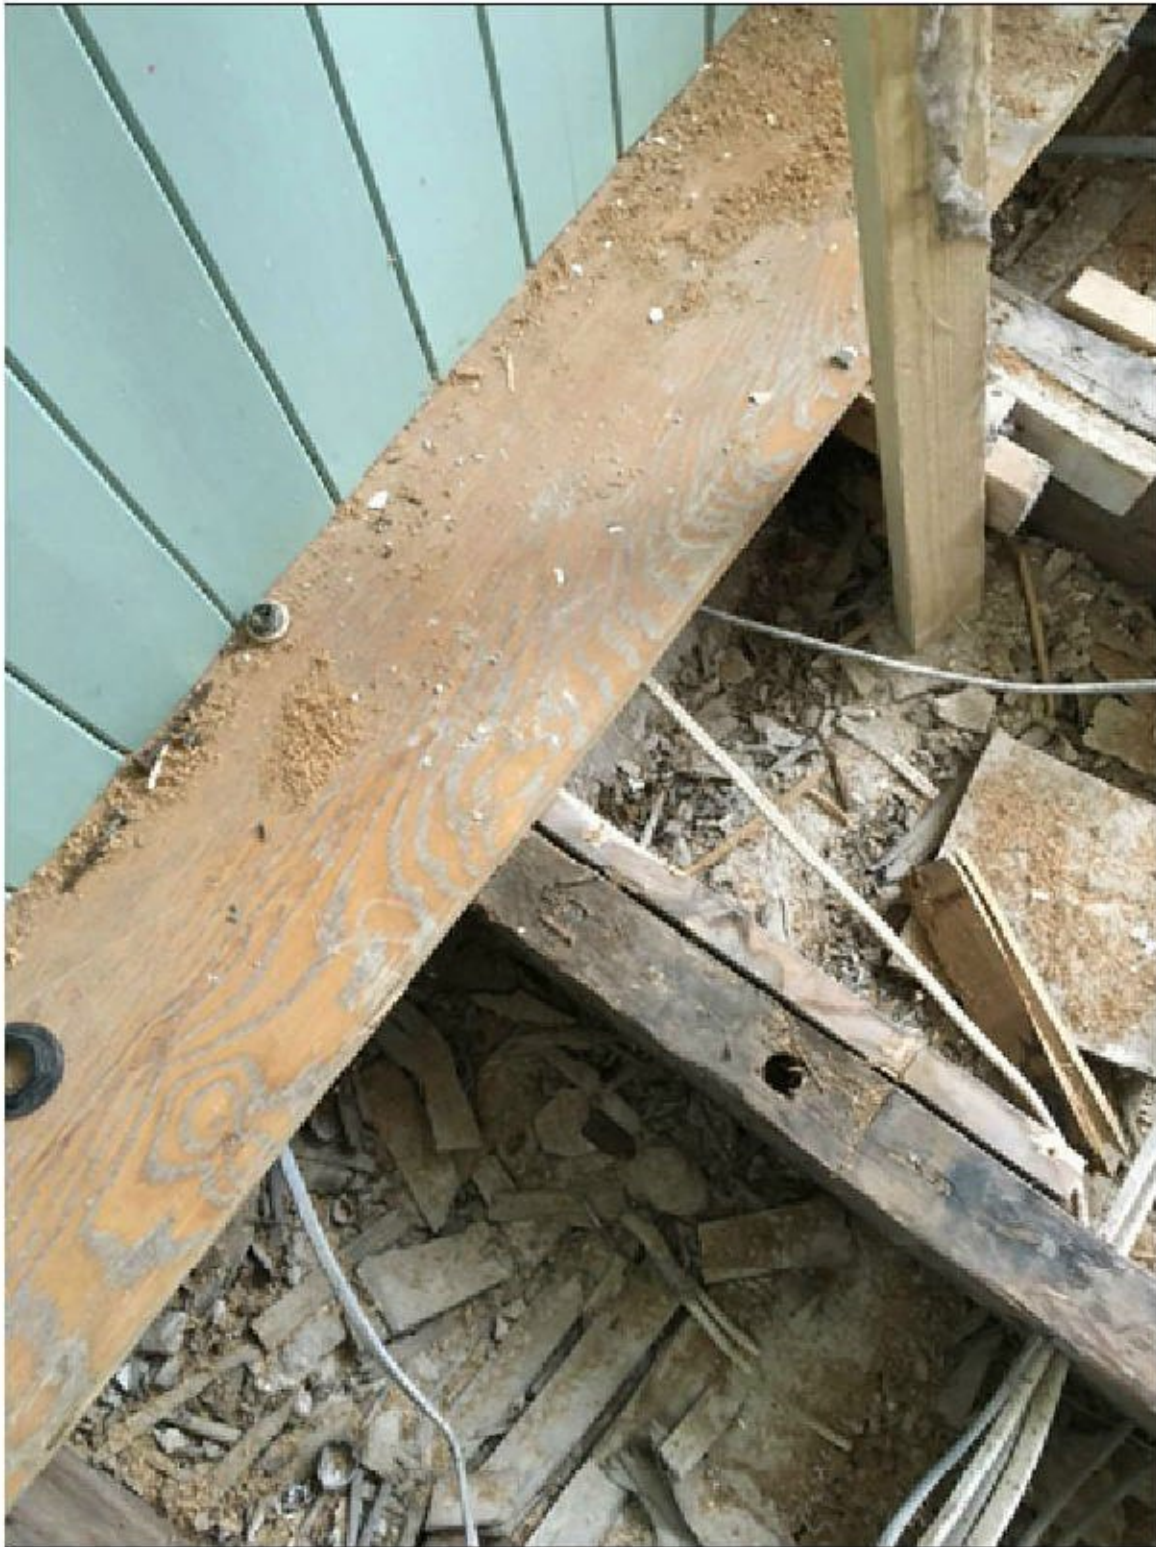
**Internal Photo F017**

**Photo Location - Bathroom - Floor Number F017 - See floor plans for location**

**Located with 1750's section of the building**

**Floor - Timber plank - Presumed non original - currently lifted for repair works**

- replaced and over laid in proposed works

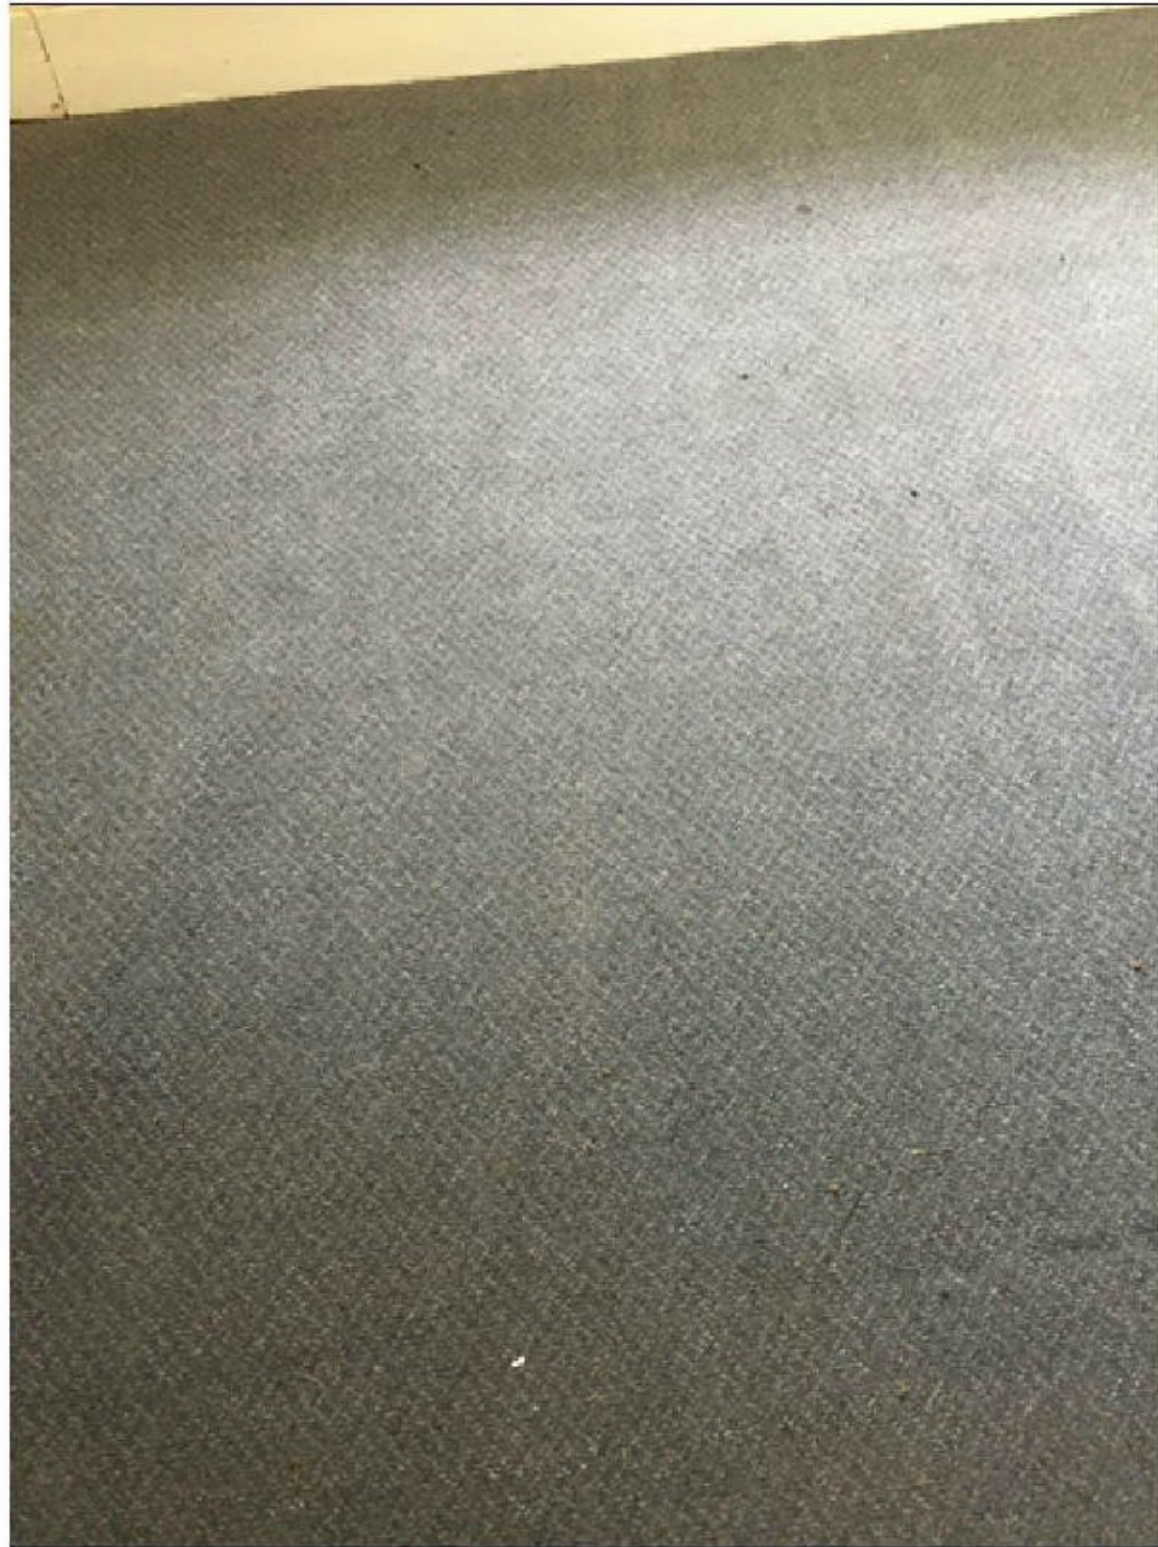
Internal Photo F018

Photo Location - Staircase - Floor Number **F018** - See floor plans for location

Located with 1750's section of the building

Floor - Carpet - Presumed non original - Average condition

- Replaced in proposed works
-

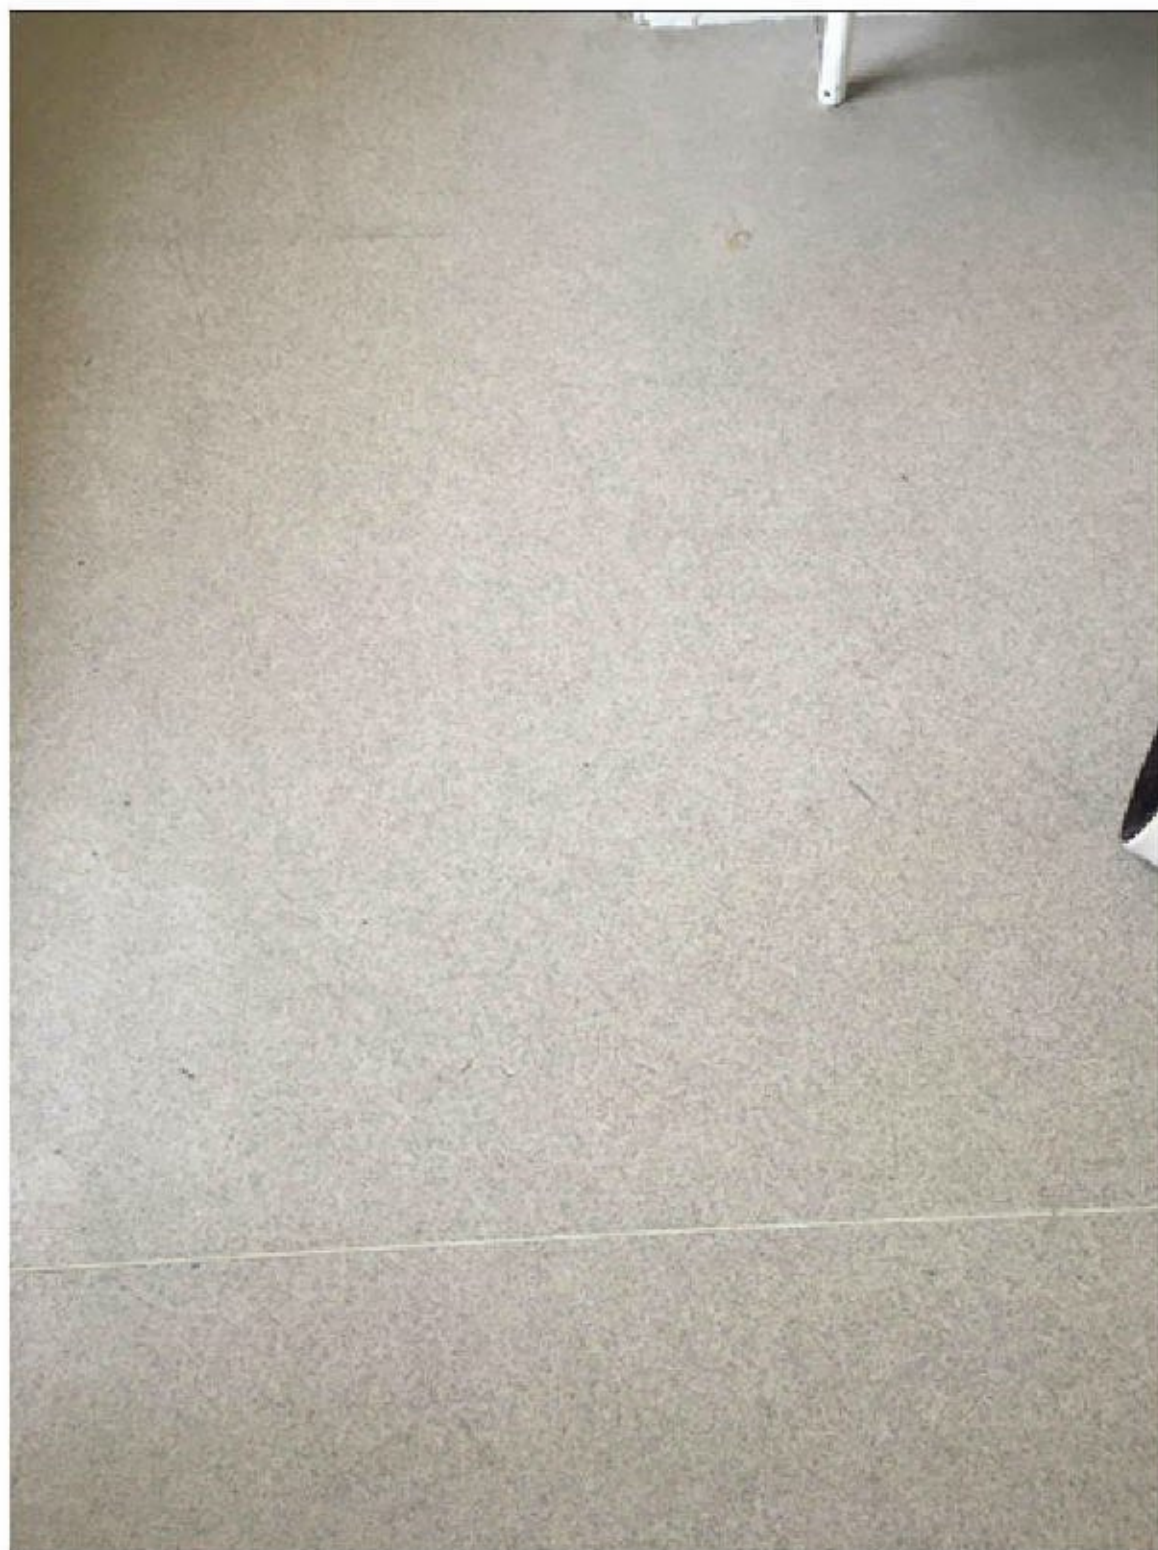
Internal Photo F019

Photo Location - Wc - Floor Number **F019** - See floor plans for location

Located with 1750's section of the building

Floor - Vinyl - Presumed non original - Average condition

- Replaced in proposed works
-

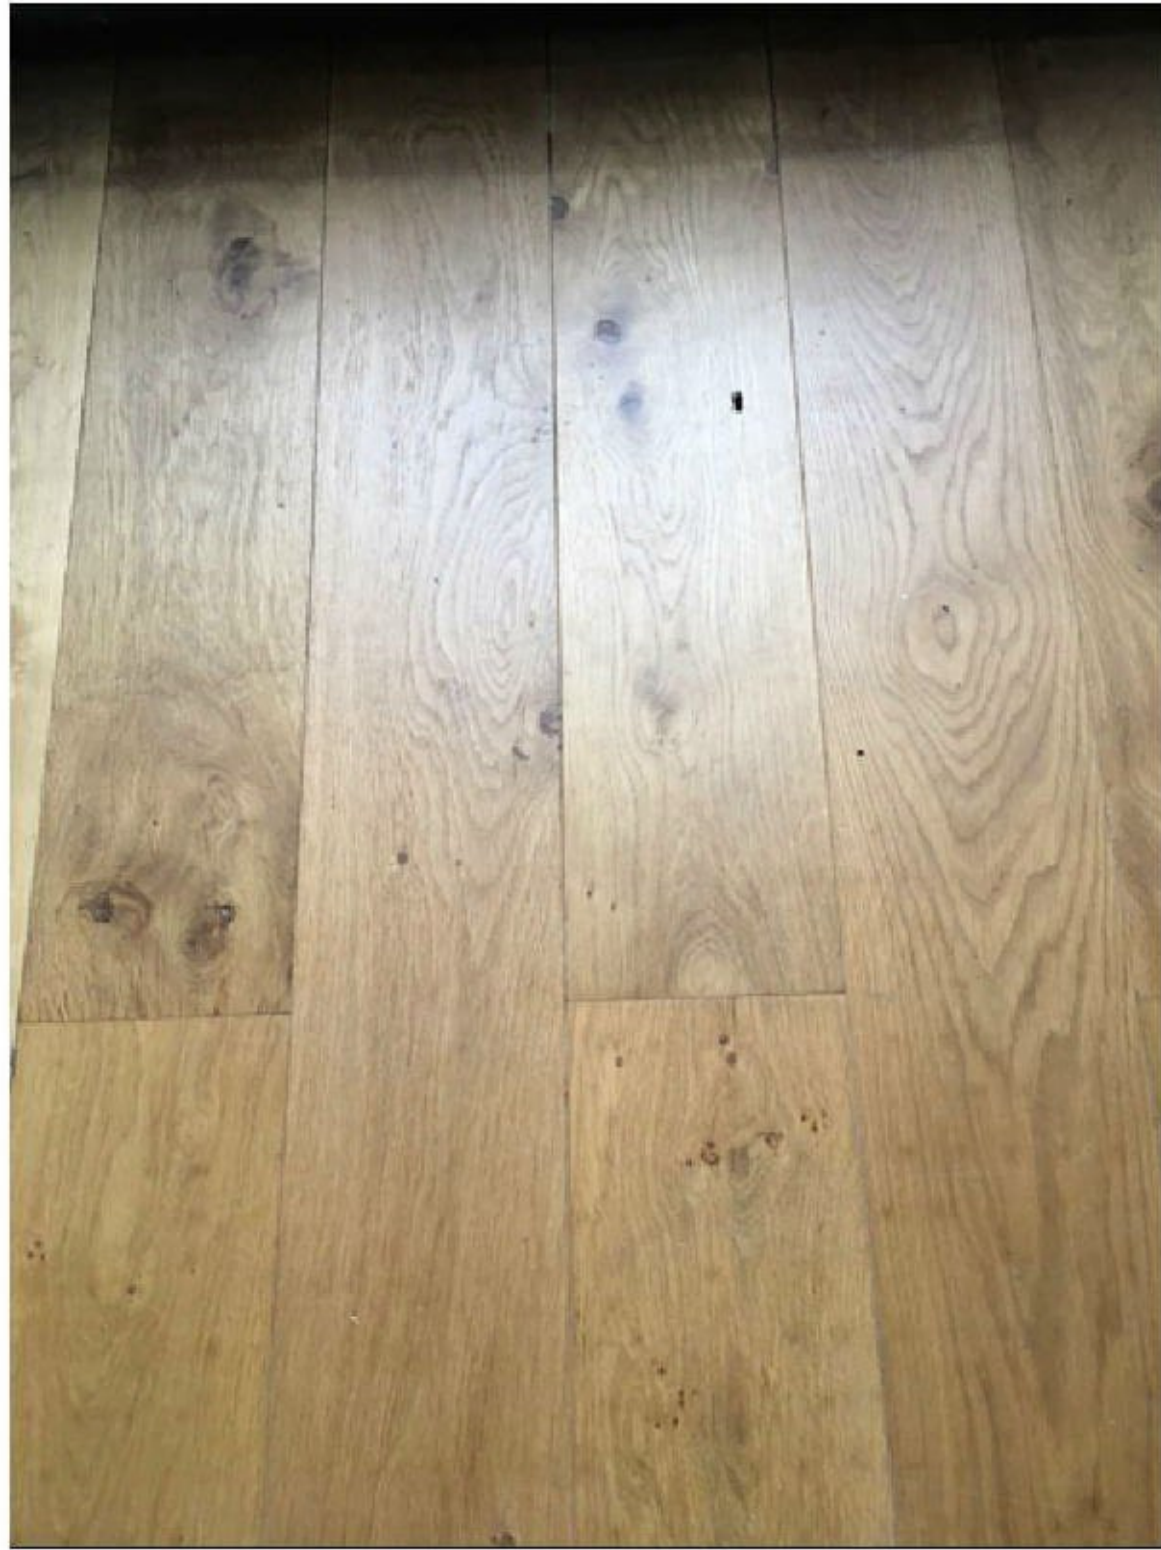
Internal Photo F020

Photo Location - Montgomery - Floor Number **F020**- See floor plans for location

Located with 1750's section of the building

Floor - Timber plank - Presumed non original - Good condition

· None

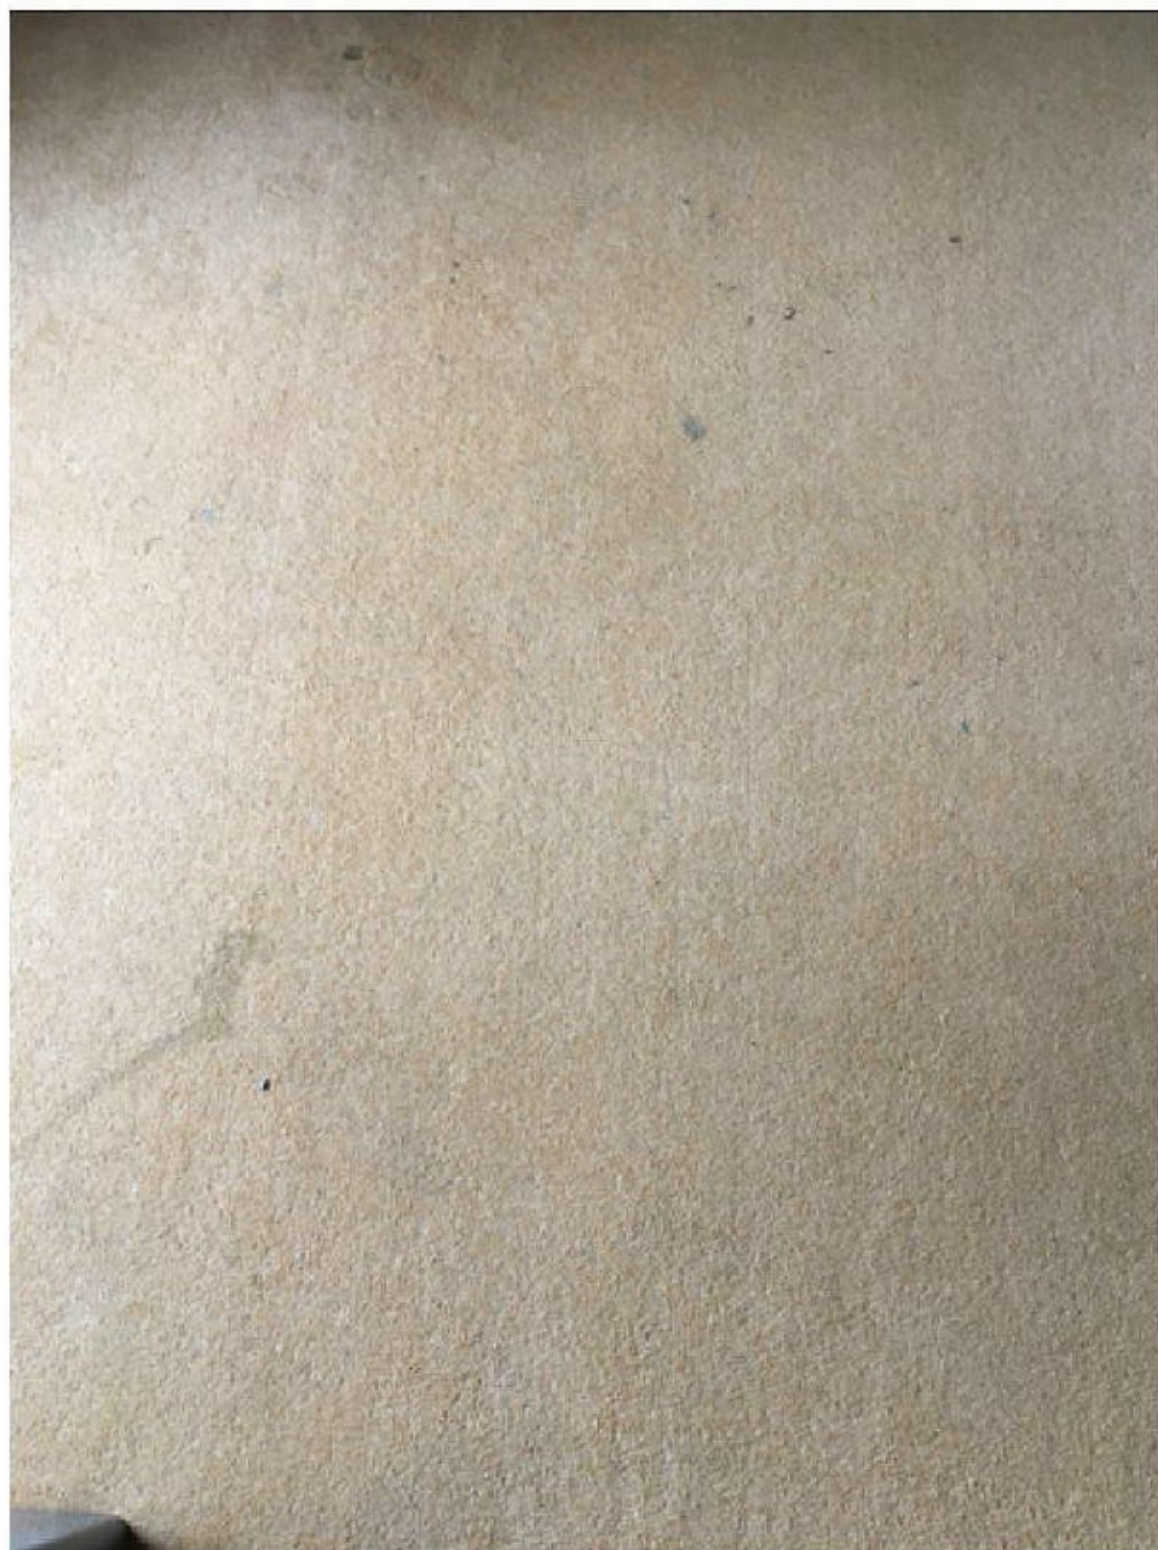
**Internal Photo F021**

**Photo Location - Brecon Dorm - Floor Number F021 - See floor plans for location**

**Located with 1840's section of the building**

**Floor - Carpet - Presumed non original - Good condition**

- Replaced in proposed works
-

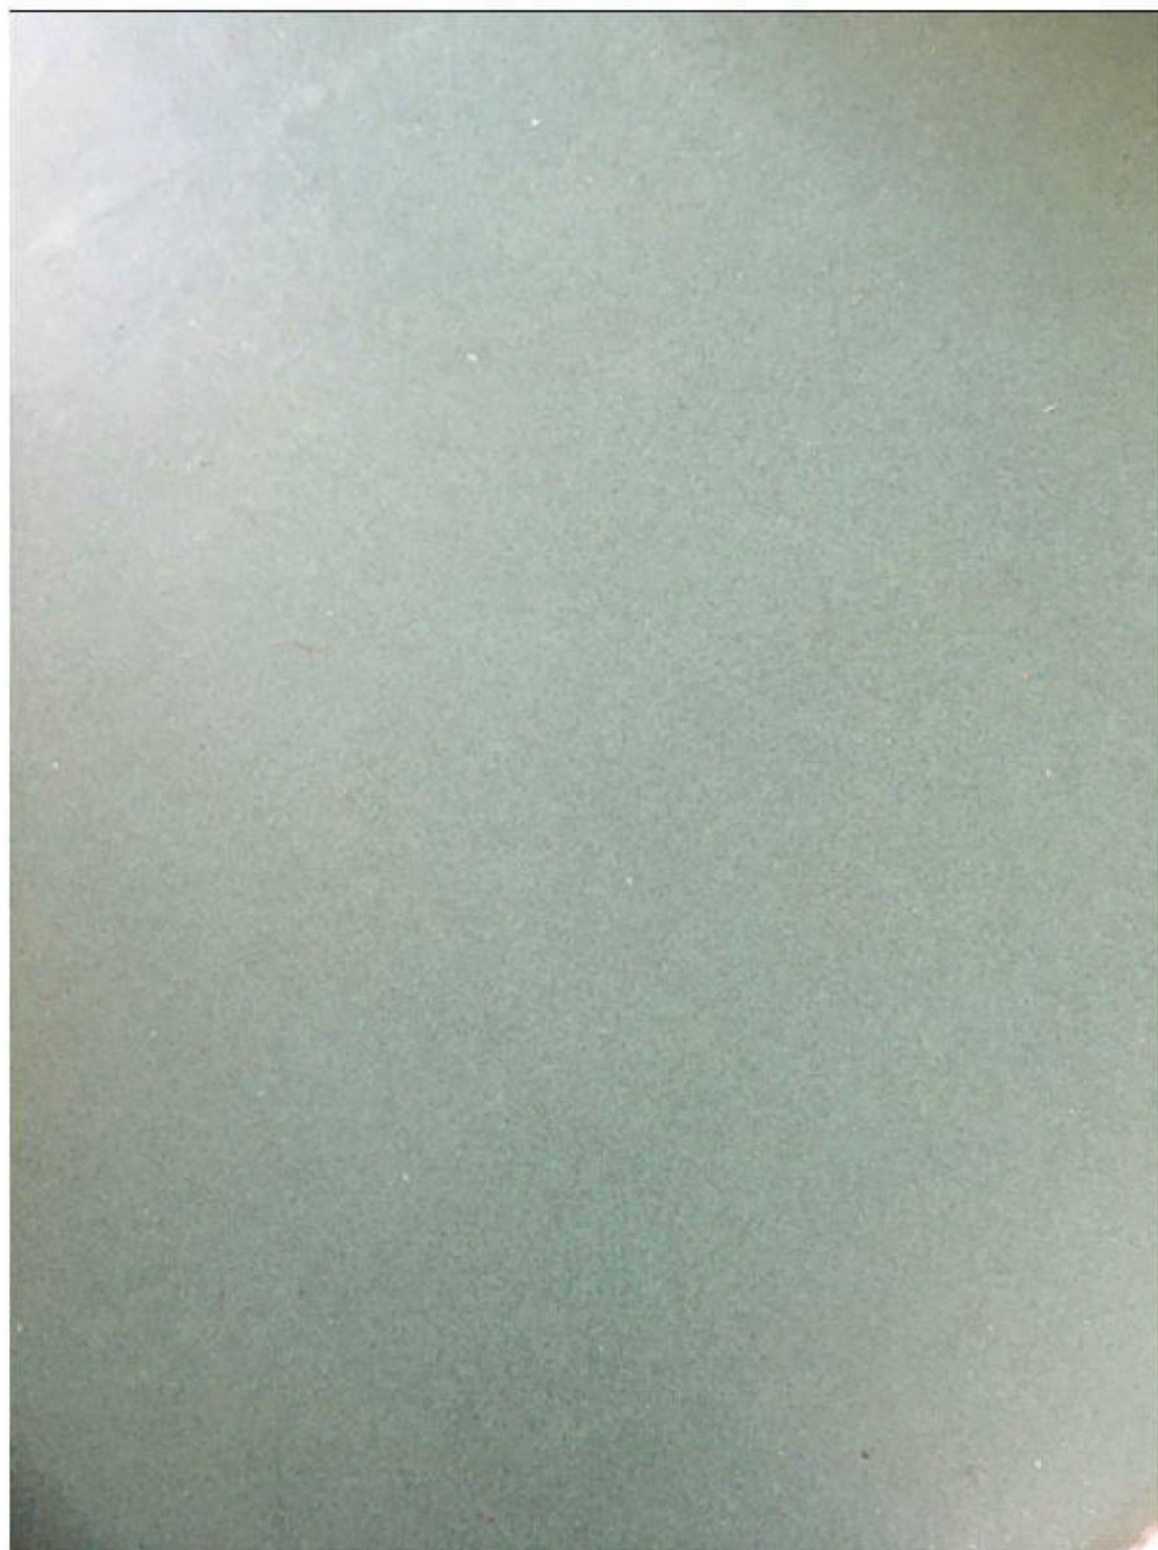
Internal Photo F022

Photo Location - Wc - Floor Number **F022**- See floor plans for location

Located with 1840's section of the building

Floor - Vinyl - Presumed non original - Good condition

- Replaced in proposed works

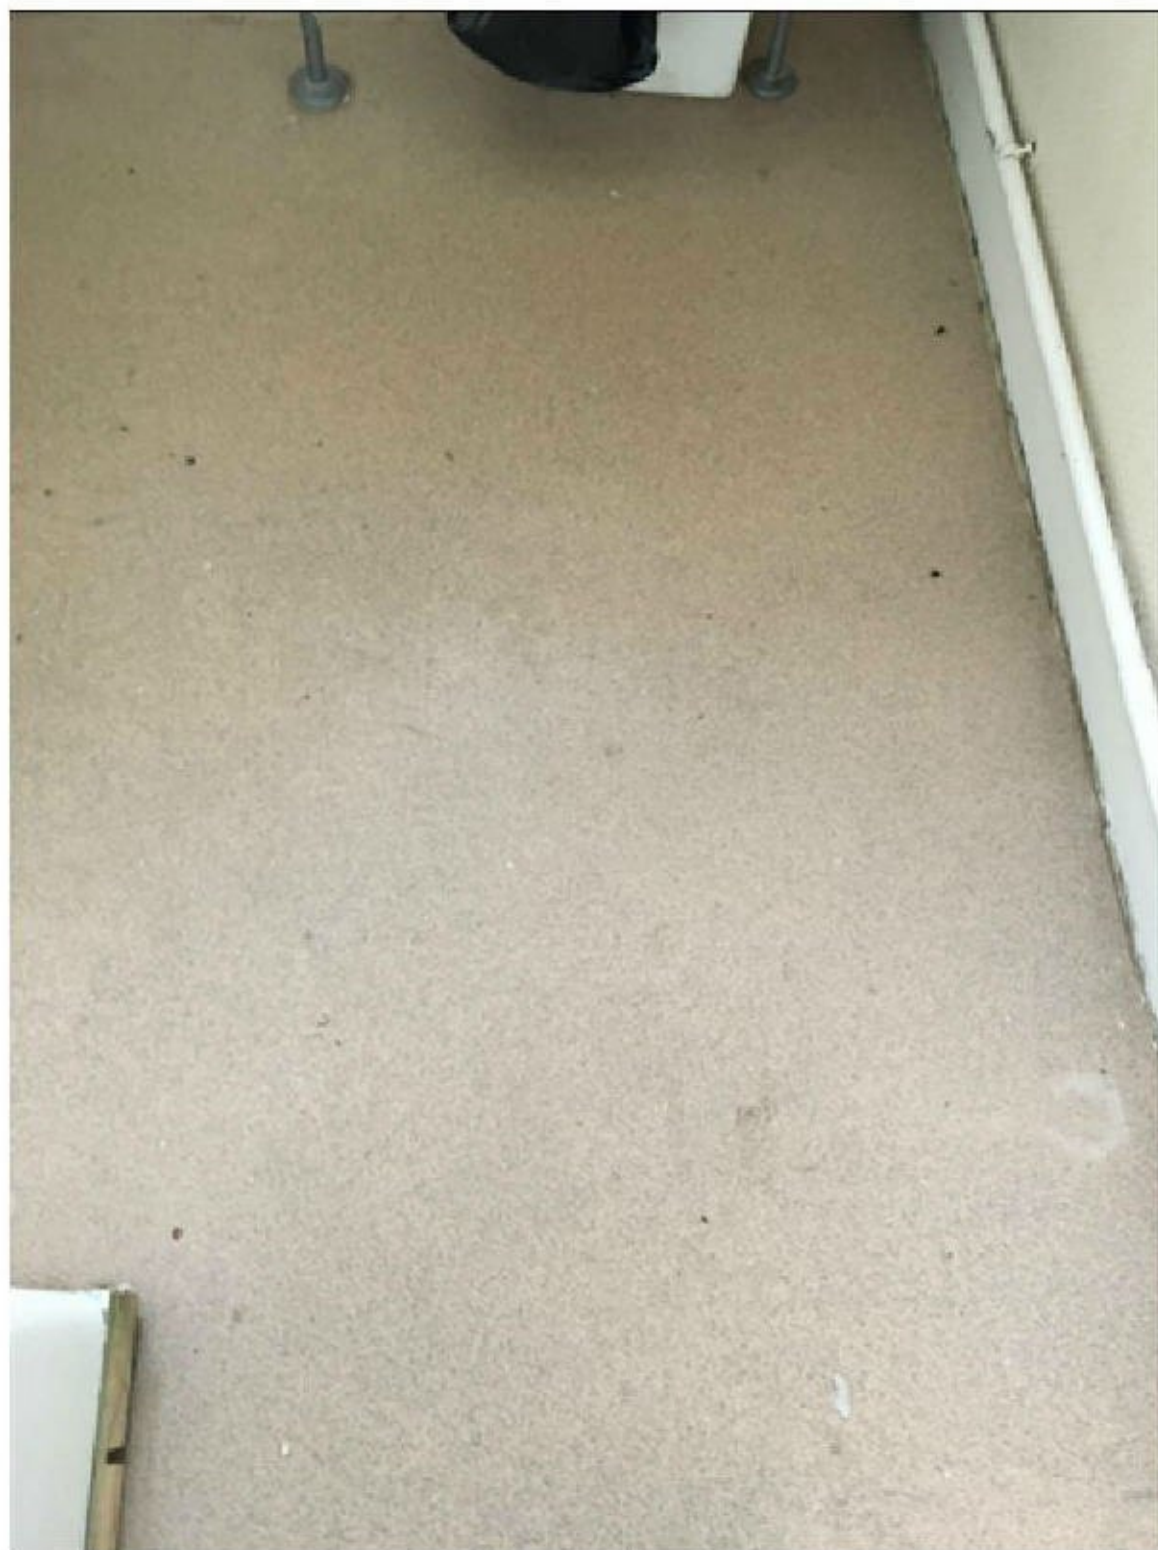
Internal Photo F023

Photo Location - Wc - Floor Number **F023** - See floor plans for location

Located with 1840's section of the building

Floor - Vinyl - Presumed non original - Average condition

- Replaced in proposed works
