# Building Recording - Ground Floor

## Internal Floors

Showing existing photos, noted location, frame condition, leaf condition and proposed refurbishment works

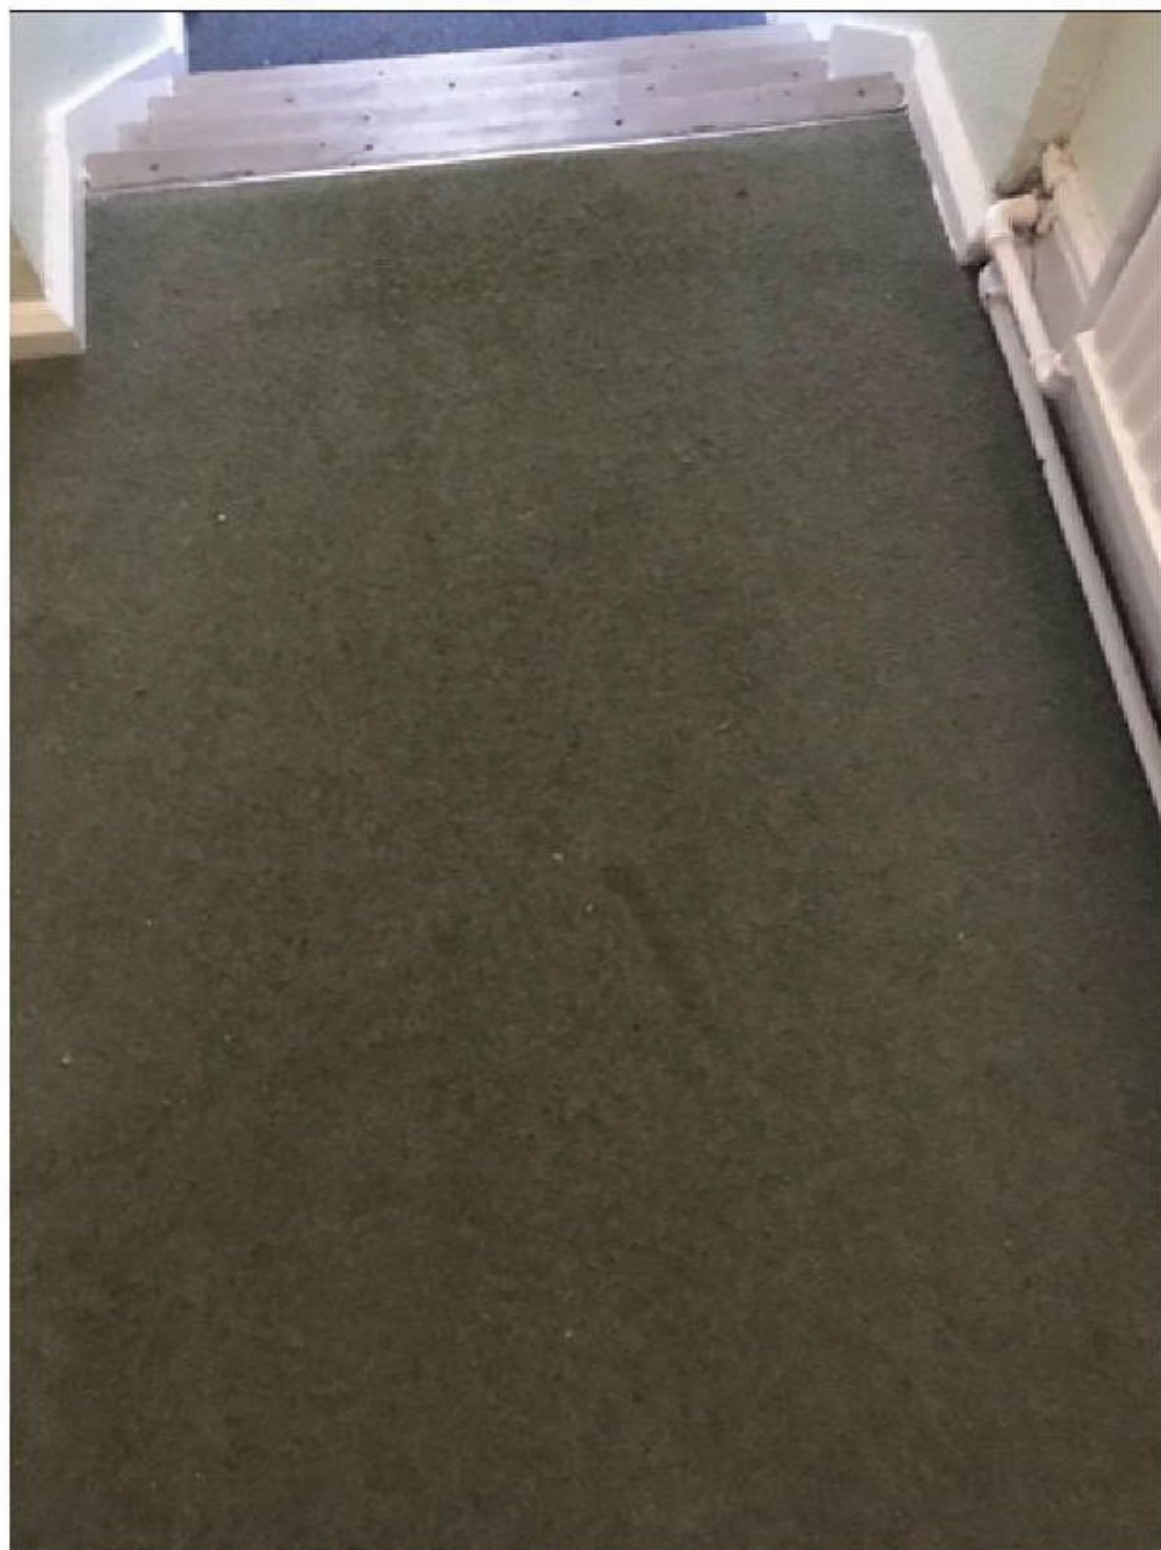
Internal Photo F024

Photo Location - Landing - Floor Number **F024** - See floor plans for location

Located with 1840's section of the building

Floor - Vinyl - Presumed non original - Average condition

- Replaced in proposed works

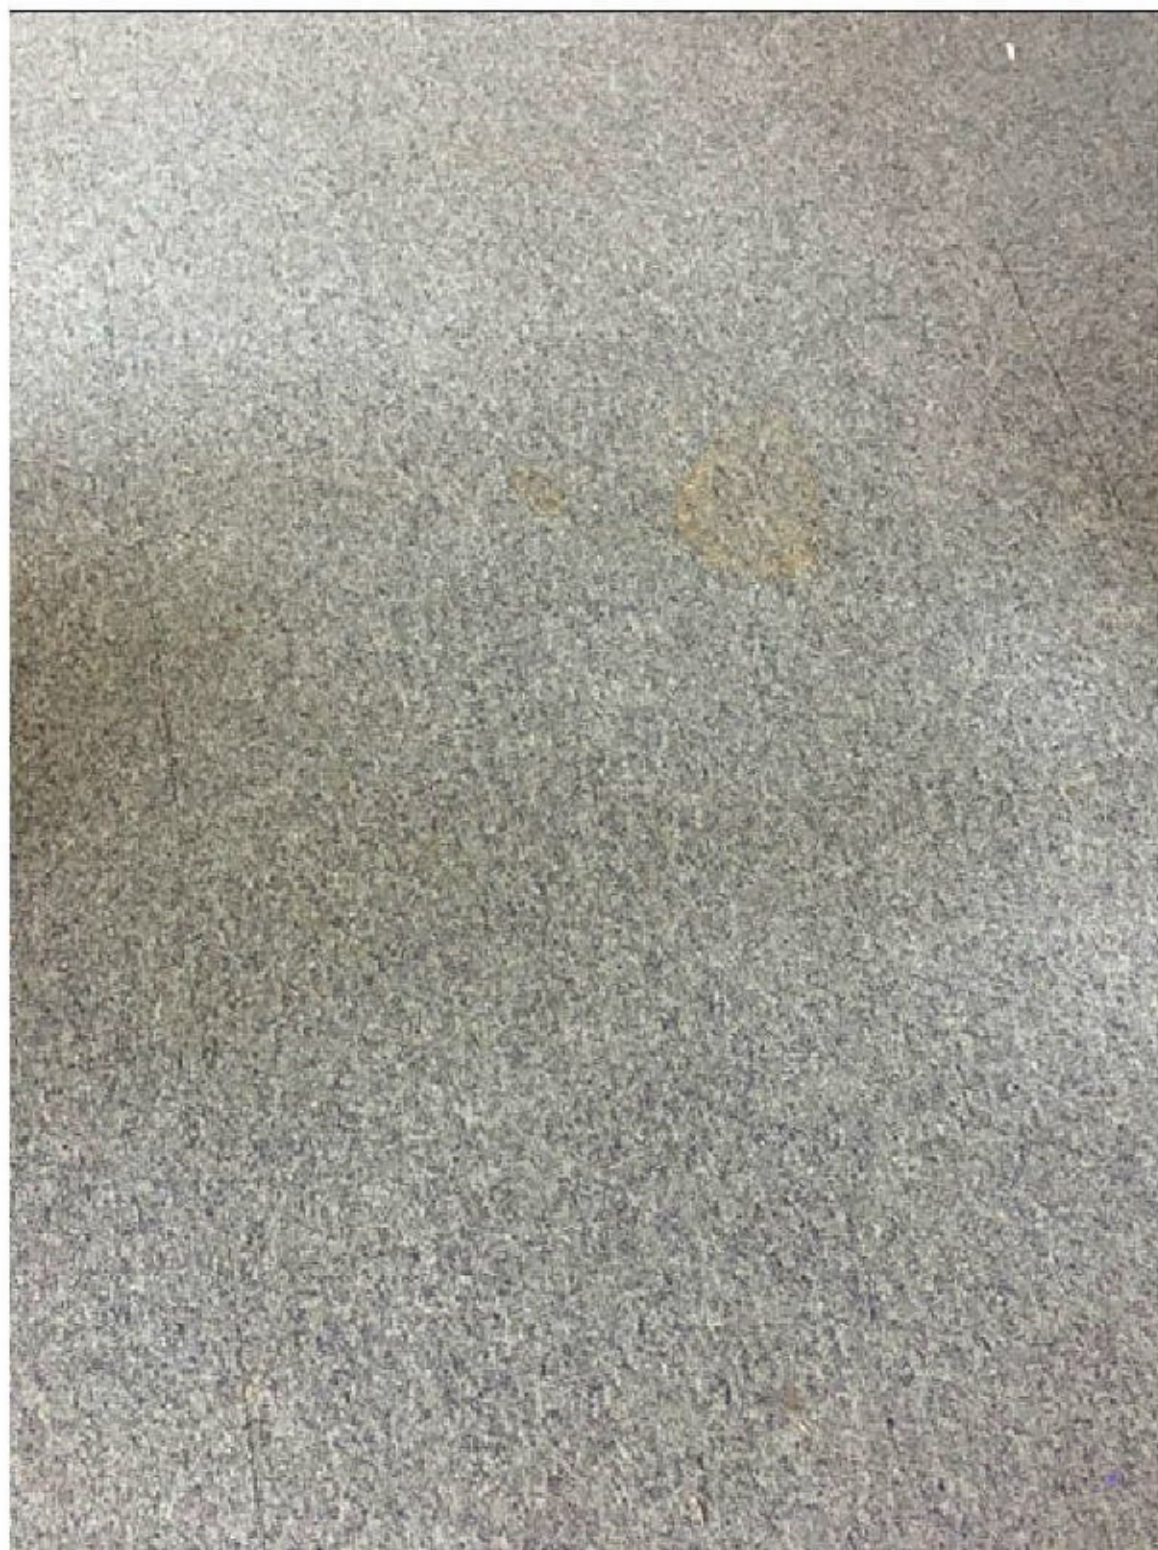
**Internal Photo F025**

**Photo Location - Lecture Room - Floor Number **F025** - See floor plans for location**

**Located with 1990's section of the building**

**Floor - Carpet - Presumed non original - Average condition**

- **Replaced in proposed works**

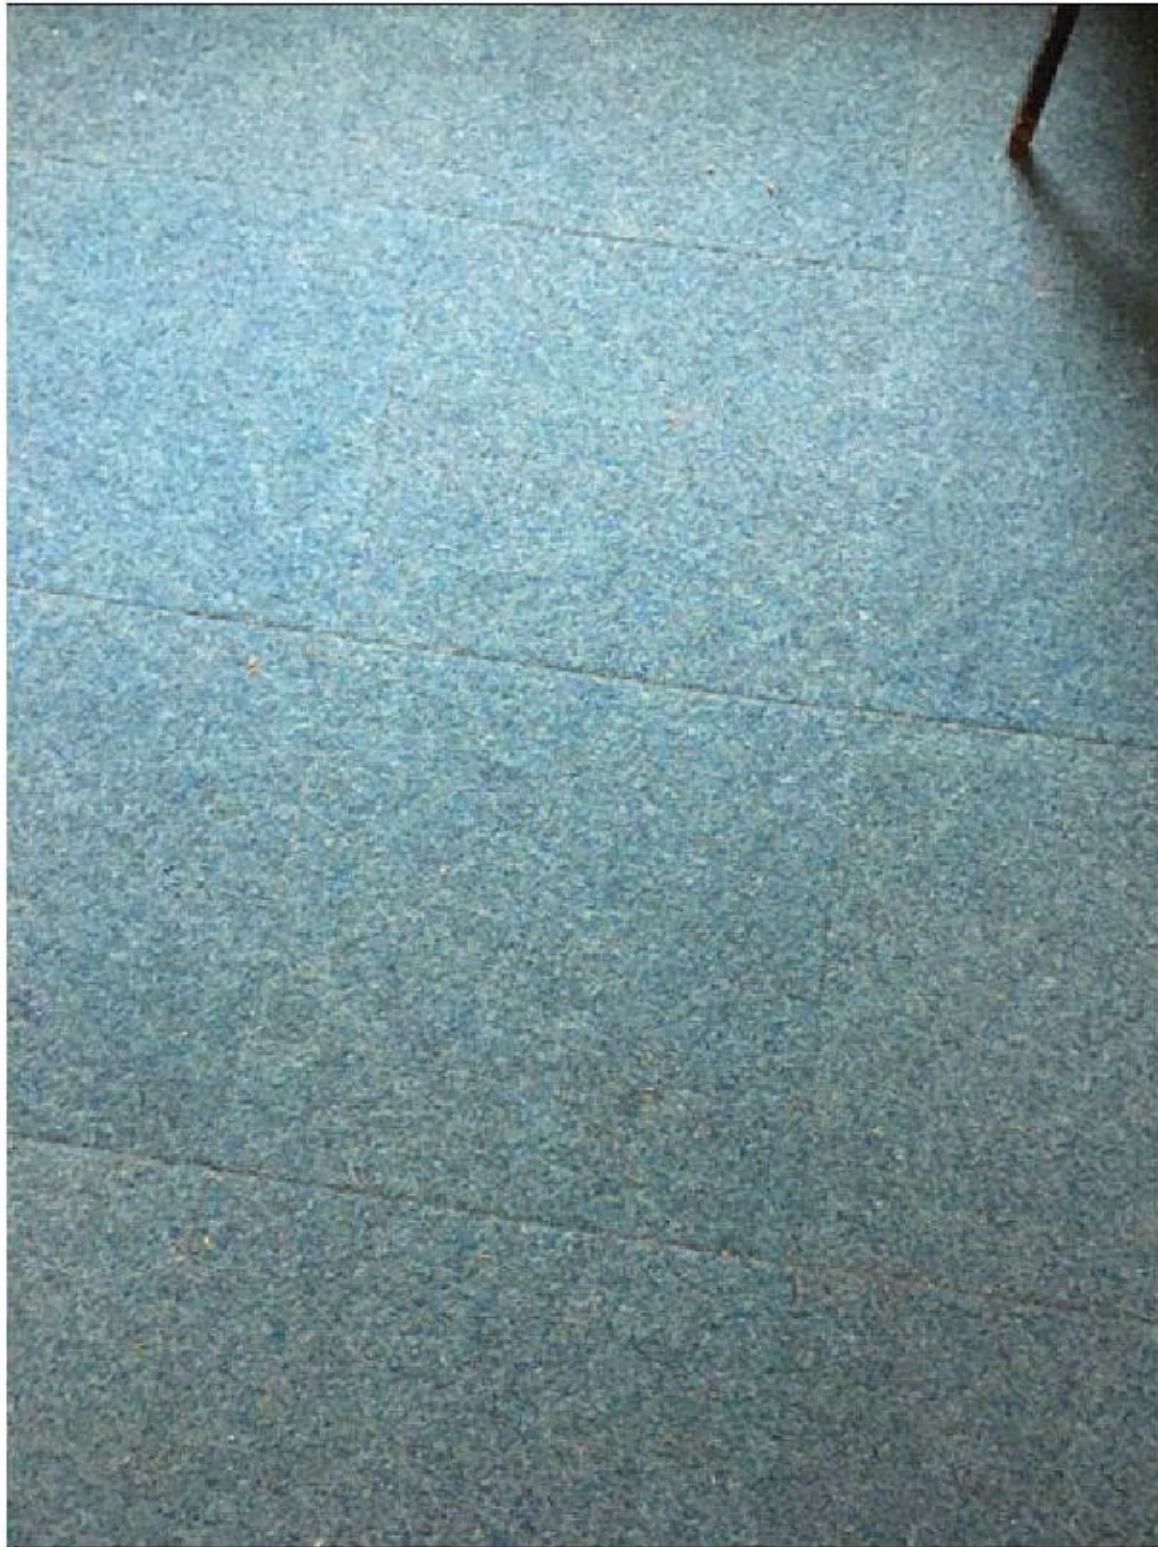
Internal Photo F026

Photo Location - Bedroom - Floor Number **F026** - See floor plans for location

Located with 1840's section of the building

Floor - Carpet - Presumed non original - Average condition

- Replaced in proposed works
-

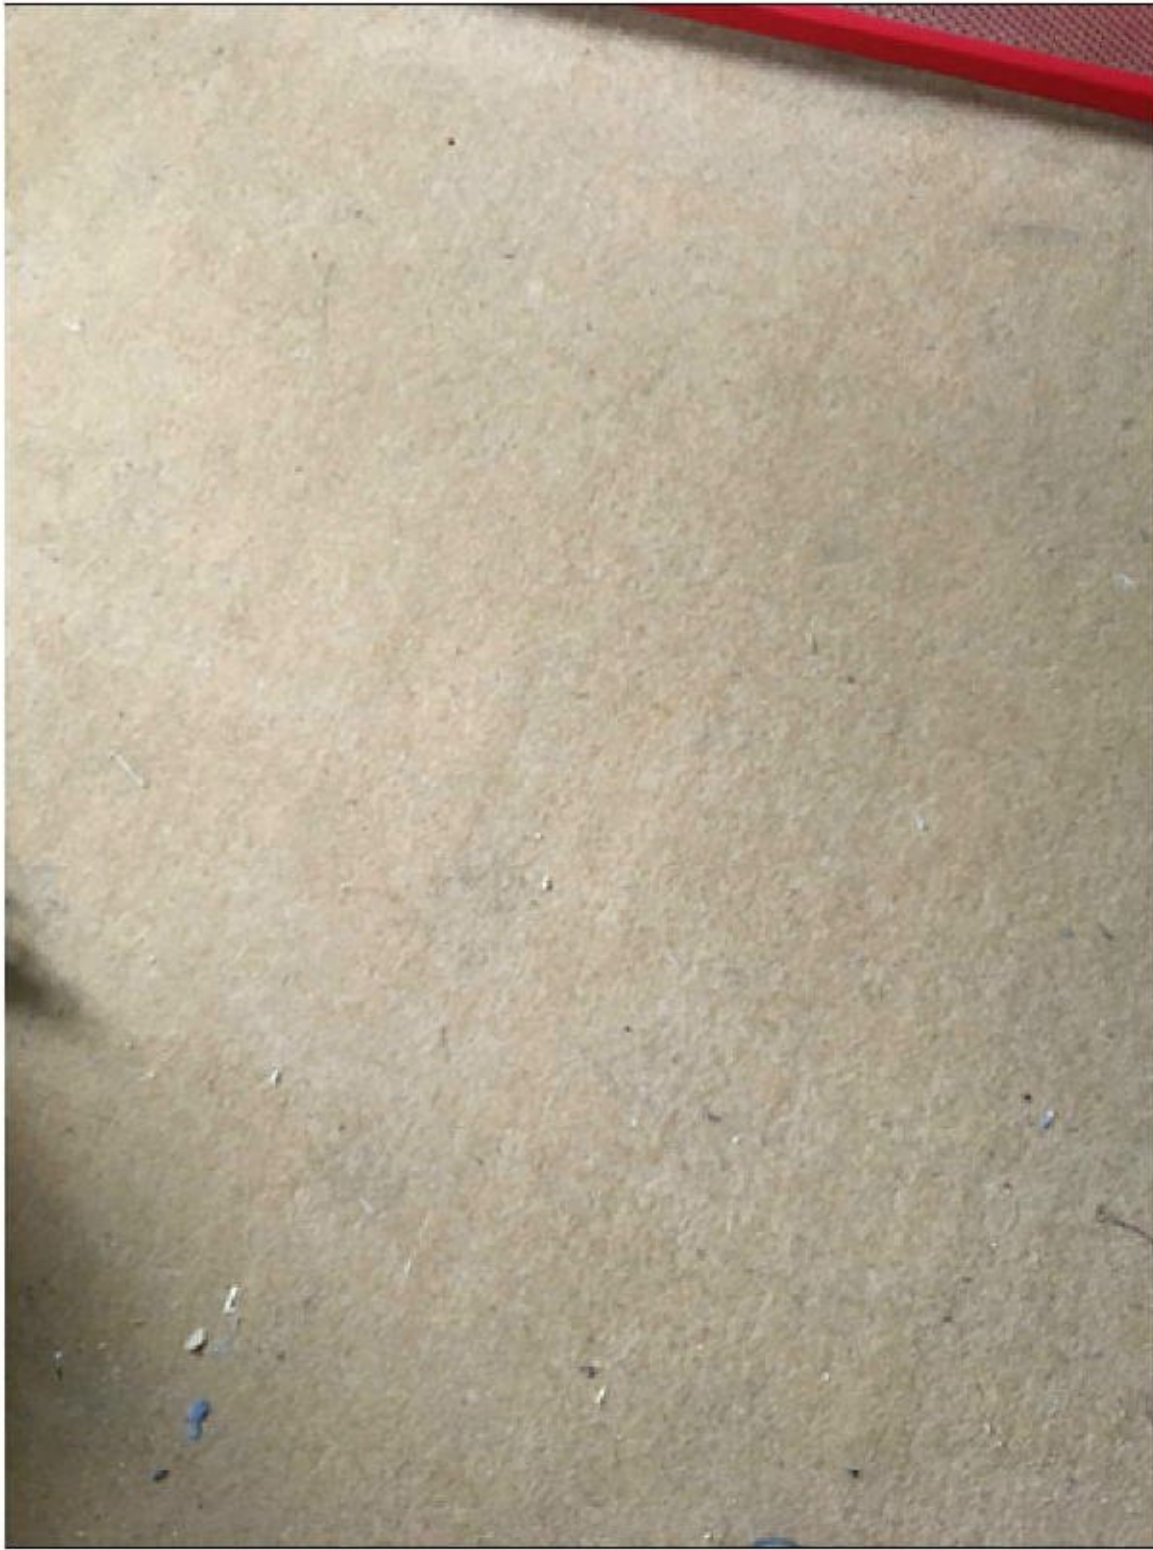
Internal Photo F027

Photo Location - Nador Dorm - Floor Number **F027** - See floor plans for location

Located with 1840's section of the building

Floor - Carpet - Presumed non original - Poor condition

- Replaced in proposed works
-
