Former General Post Office
36-40 Abingdon Street, Blackpool. FY1 1DA

Structural Appraisal

Project number: 2200335

Date: Jan 2021

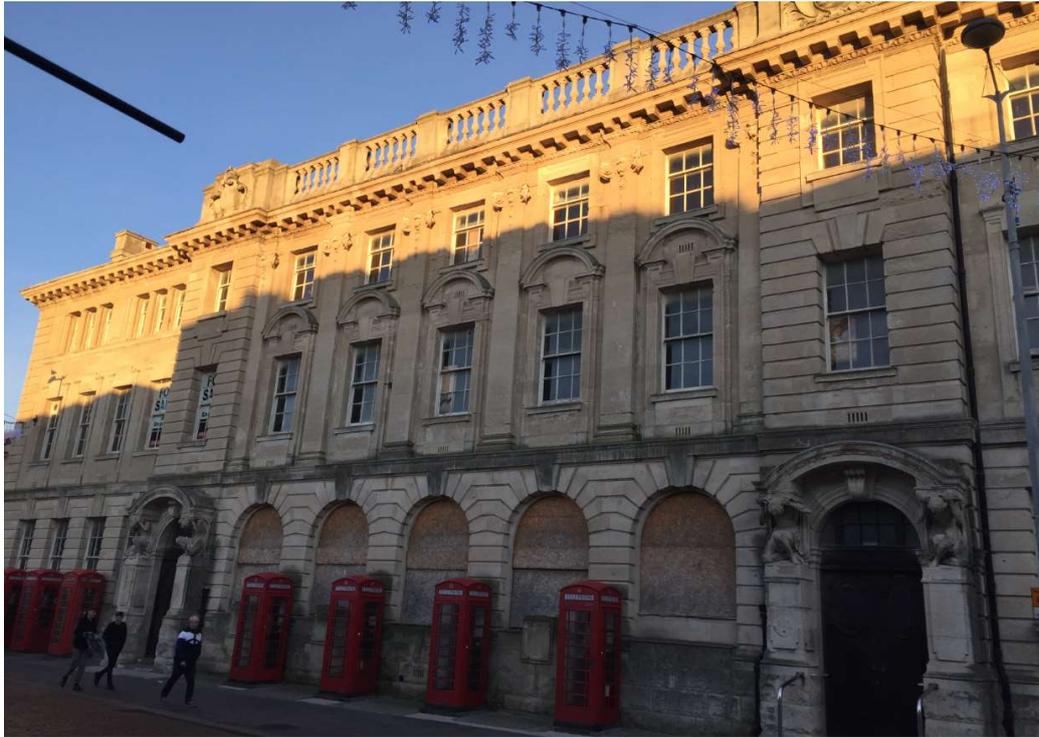
Photo A- 1- Grade II listed western facade

6.1.3.1 The Grade II listed façade's stone cladding appears to be in a reasonable condition with no visible structural concerns considering its age and only minor spalling in localised areas which will need repair. All local repairs should be carried out by an appropriate specialist contractor and discussed and approved with the conservation officer.

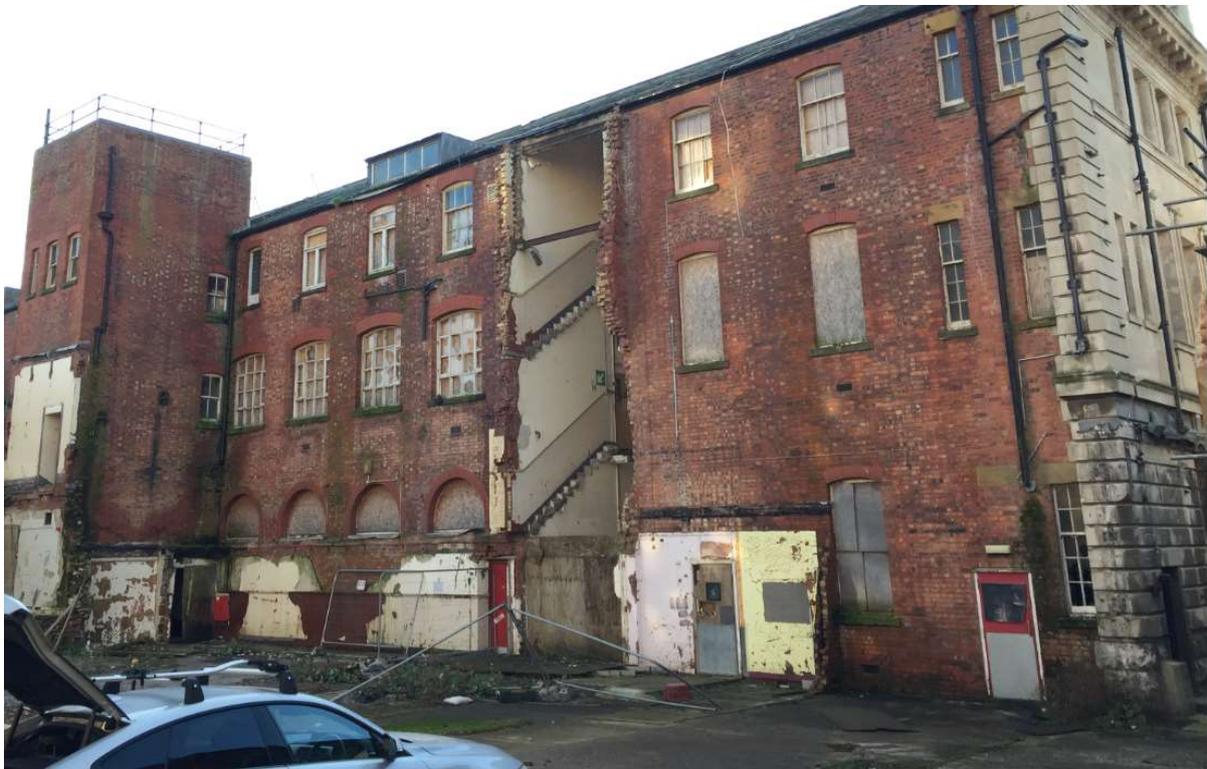
5.1.6.2 The rear (eastern) façade showed areas in a state of disrepair with some areas noticeably wet/damp likely caused by the damaged guttering. There were no visible signs of notable structural cracking and there was a large hole in the façade where the stairs had been previously demolished.

Photo A- 2 Eastern facade at rear of building

6.1.3.2 The rear façade masonry wall needs repairing where the stair well has demolished. The wall should be made good by closing of the ends of the walls with all bricks toothed in to match the existing construction. Dependant on the future design of this the façade will need to be closed with new exterior cladding.

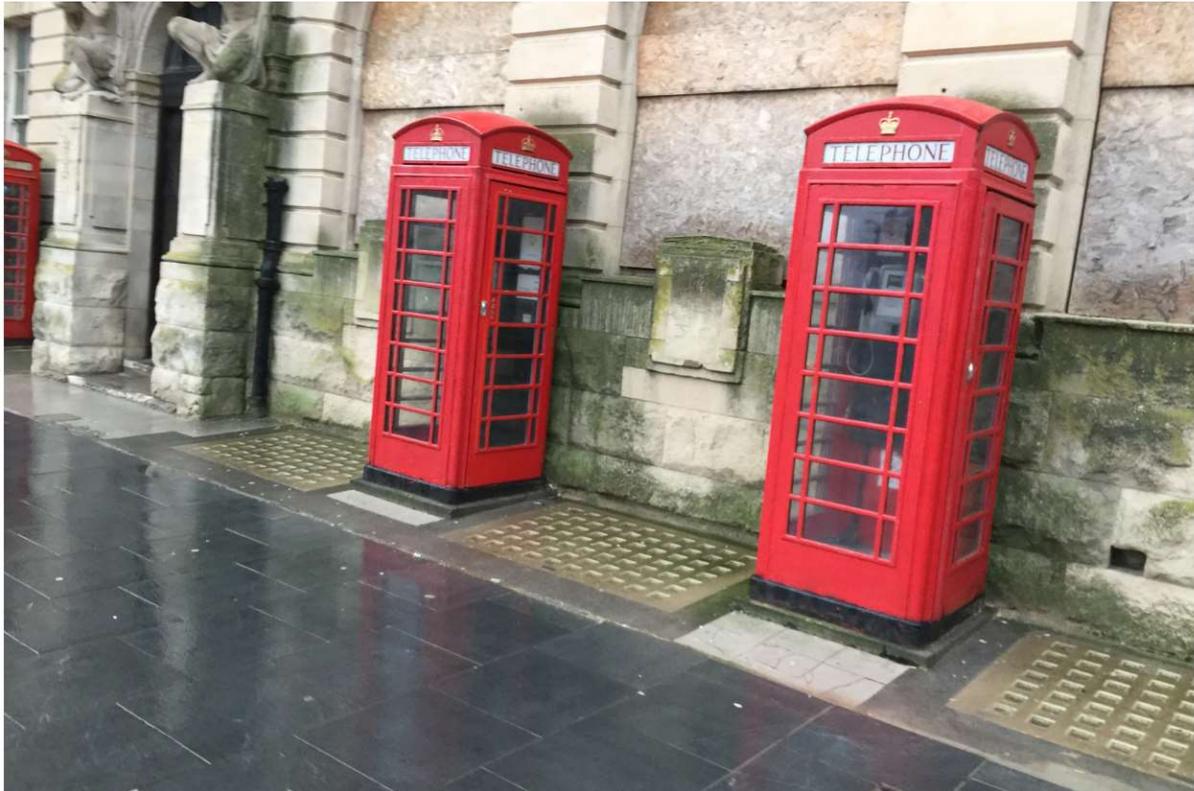
5.1.4.4 The existing lightwells along Abingdon Street appear to have been covered up when referencing against some archive images. The steel beams supporting the slab/finishes have surface corrosion and it appears that some have been replaced with new galvanised sections.

Photo A- 3 - Post box's and slabs over previous lightwell for the basement

- 6.1.1.7 All beams within the dis-used lightwell along Abingdon Street that are supporting the external build up/finishes need sufficient corrosion protection. Whilst some repairs have previously been carried out there is still a number of steel beams with surface corrosion. It is recommended that these steel beams are replaced with galvanised steel beams.

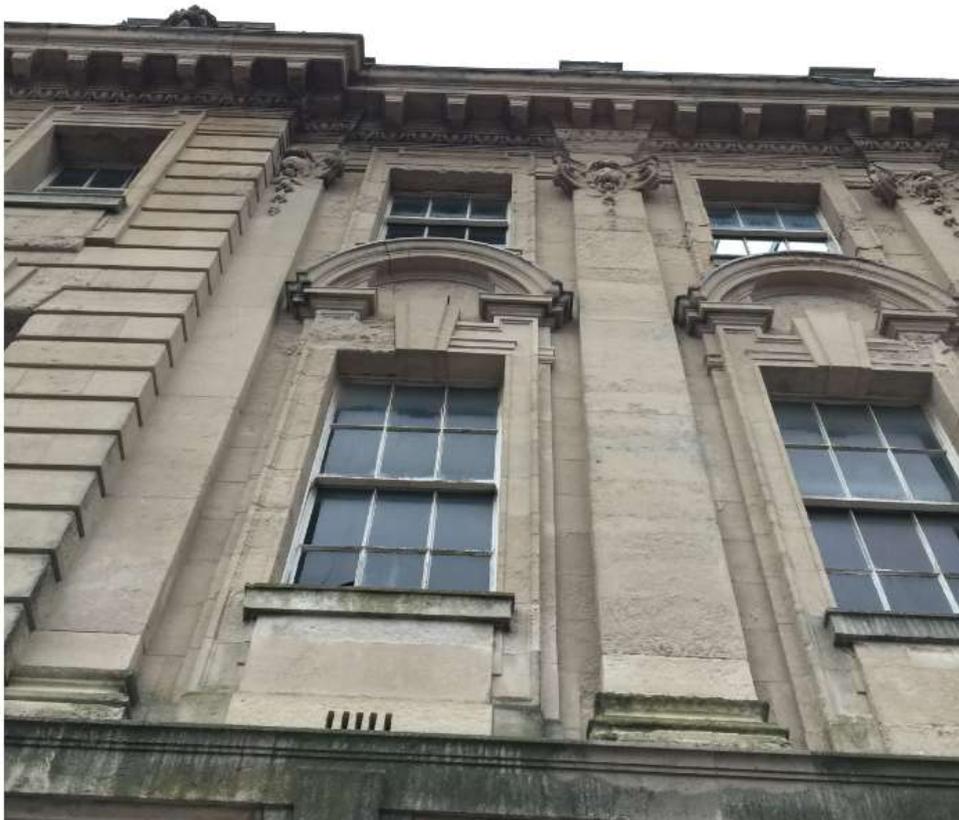
5.1.6.1 The Grade II listed western and northern façade appeared to be in a reasonable condition with only some local signs of weathering to areas of the stonework. This was typically around every floor level. There were no visible signs of any notable cracking.

Photo A- 4 - Localised weathering to areas of the stone façade typically at window level

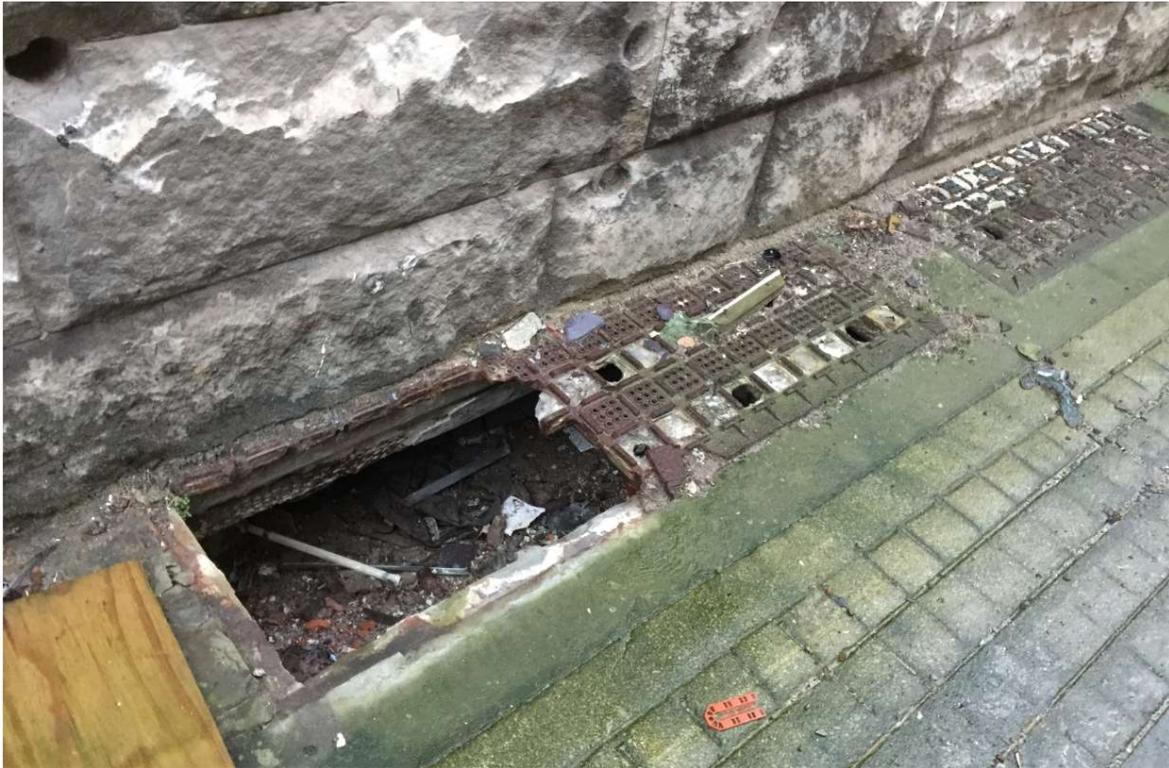
Photo A- 5 - Ventilation voids into the basement along the northern facade

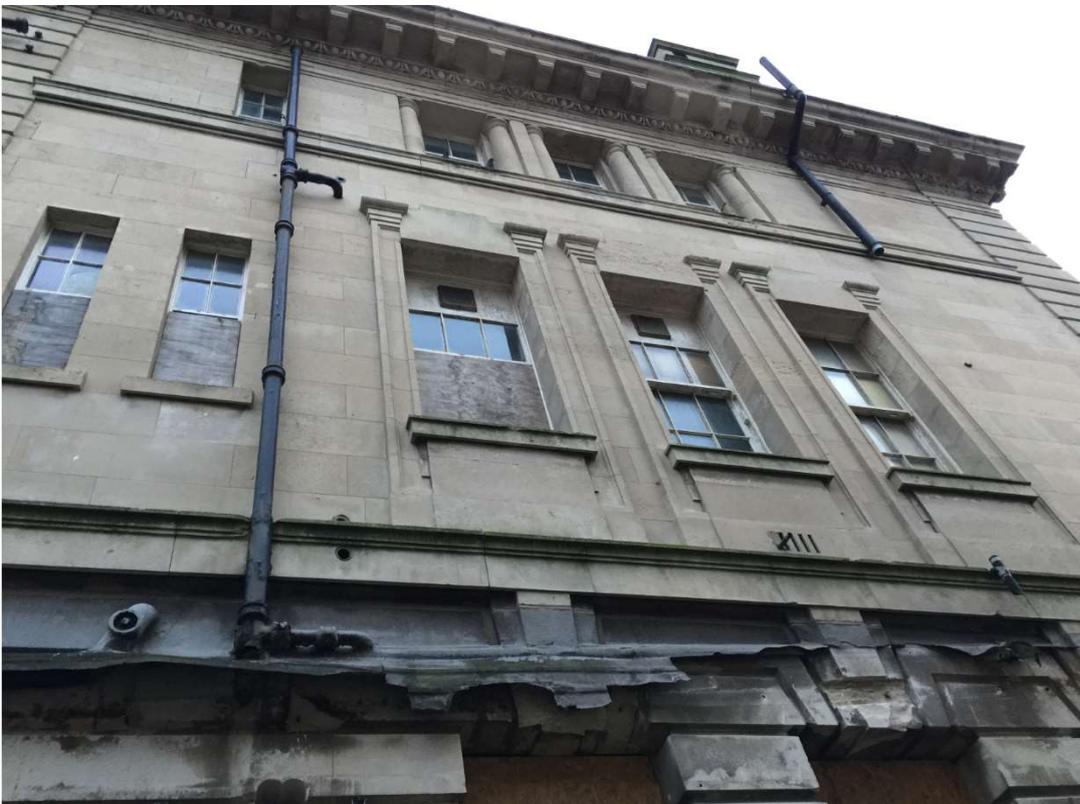
Photo A- 6 -Northern facade with remnants of flashing to demolished covered area

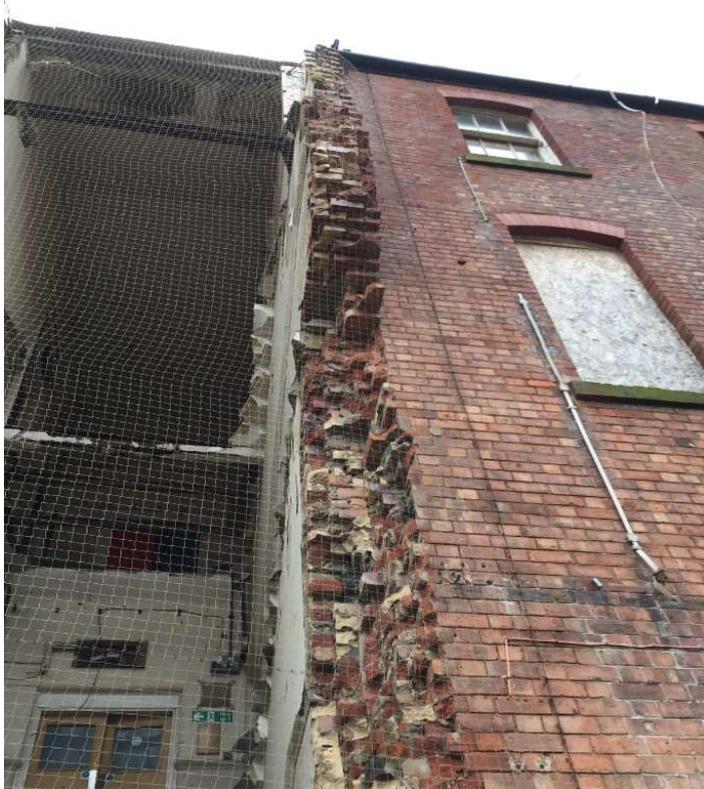
Photo A- 7- Damaged brickwork following demolition of stairwell

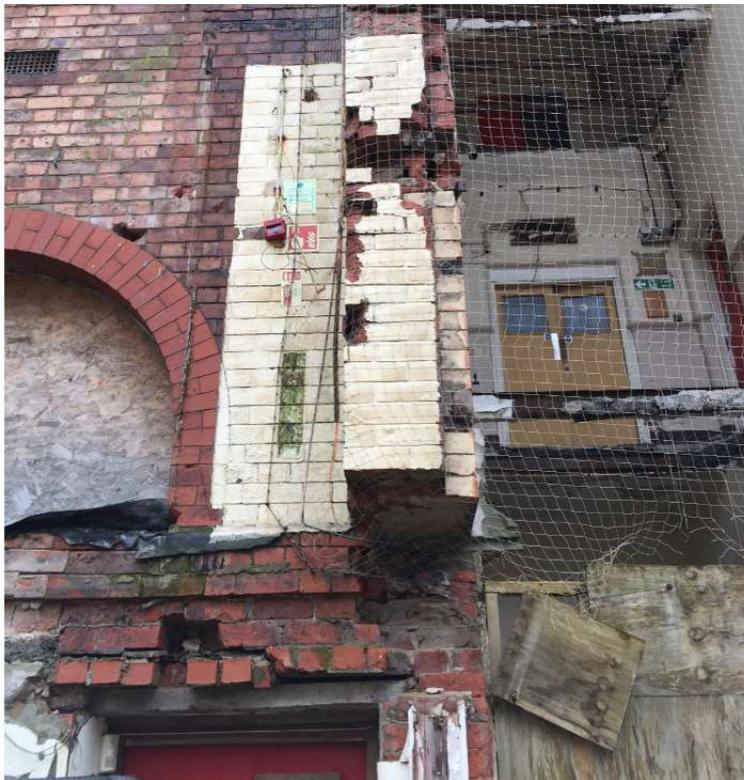
Photo A- 8 - Brickwork left hanging following demolition of stairwell

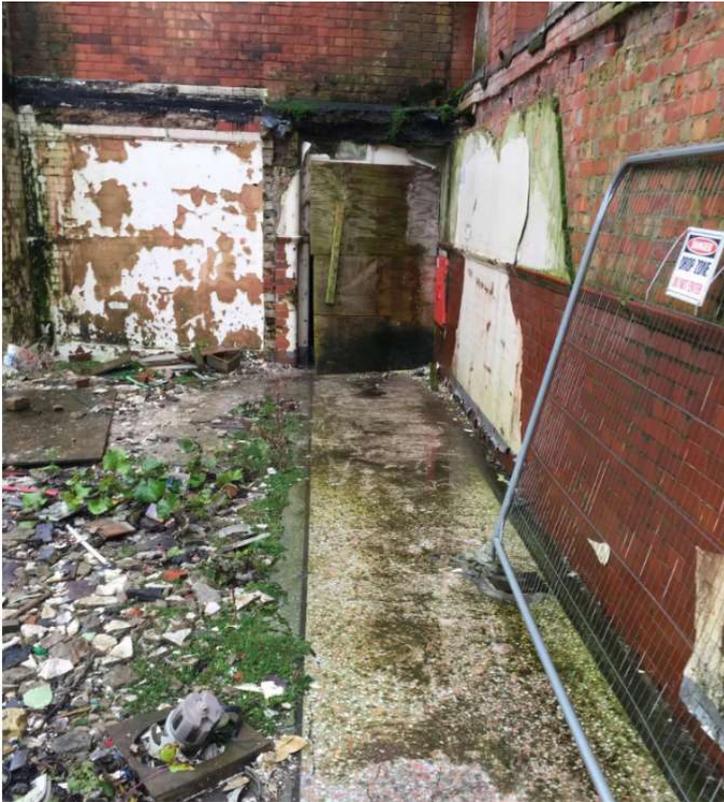
Photo A- 9 - Exposed slab over basement below with the doorway in the background which water was entering the building through

- 6.1.1.8 The exposed ground floor over the assumed old lightwell on the eastern side of the basement may need replacing. The continual exposure to moisture (refer to 6.1.1.2) may have heavily corroded the steel joist and further investigation should be completed to confirm the exact extent of damage. Steel beams forming openings within the basement outer wall are heavily corroded and should either be replaced or removed with the holes suitably infilled.

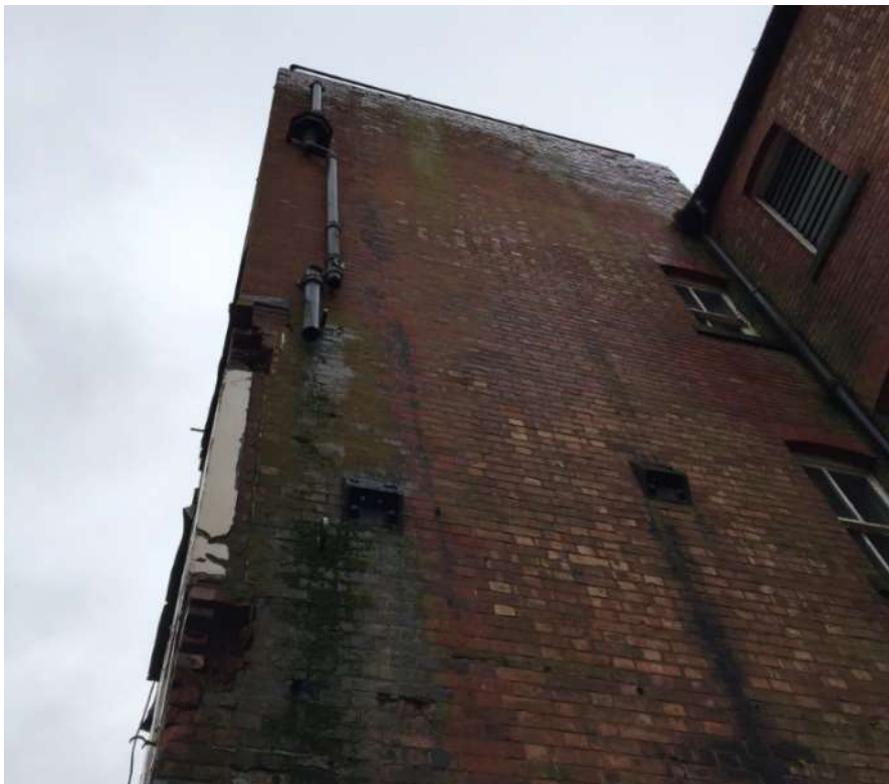
Photo A- 10 - Damaged guttering allowing rainwater to run down the external face of the walls

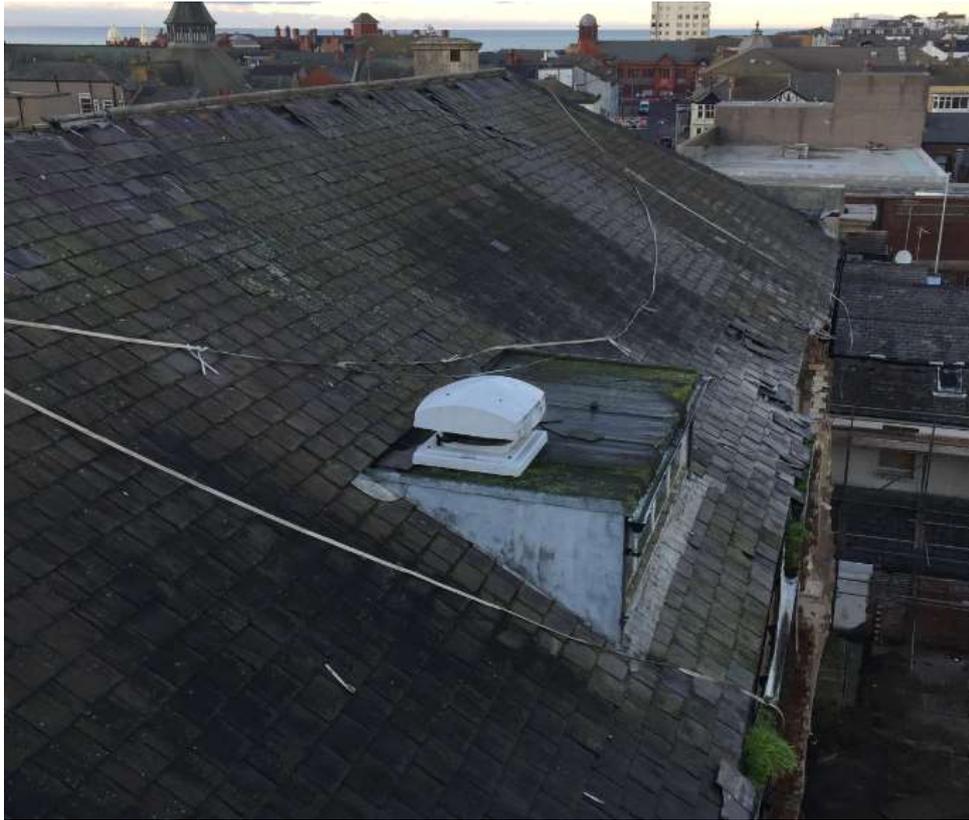
Externally the roof appeared in poor condition with tiles missing and visible gaps along the ridge.

Photo A- 11 - Roof looking north showing the condition of the roof

6.1.2.1 The roof is in poor condition with substantial amounts of damage or missing tiles across the whole roof, it would be beneficial to consider temporary short-term weatherproofing to minimise damage caused to the rest of the structure from prolonged water ingress.

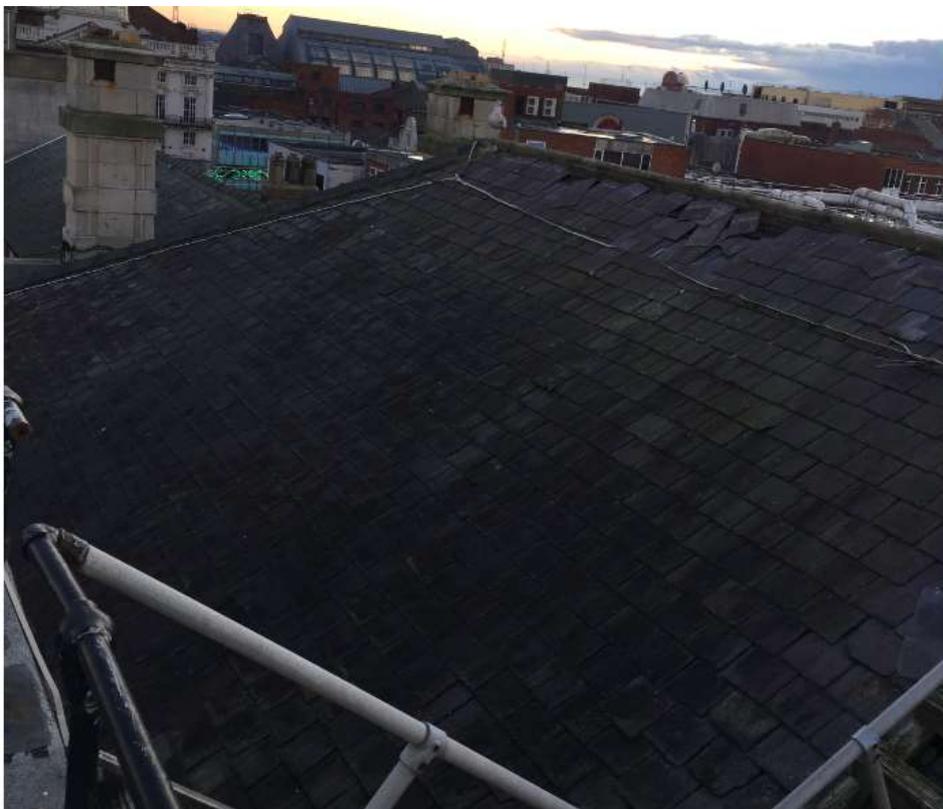
Photo A- 12 - Roof looking south showing the condition of the roof

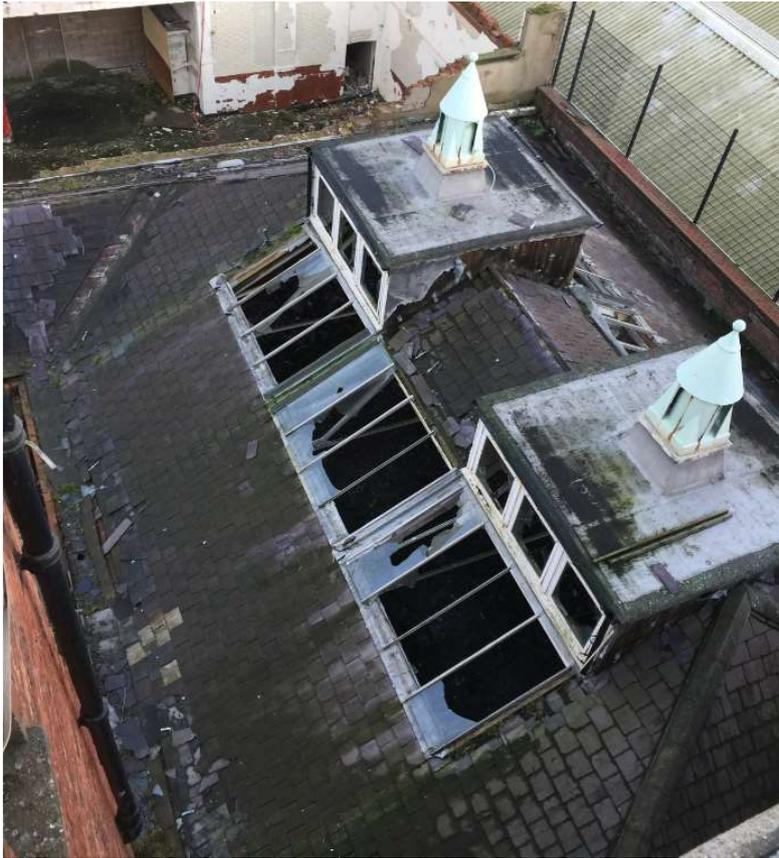
5.1.4.2 The remnants of the single storey building to the rear appear to have been compromised by the previous demolition with internal beams now left exposed to the elements. The roof is formed from purlins sat onto steel trusses that are supported by load bearing masonry walls and steel columns. The steel trusses appear to be in reasonable condition although the roof itself is in disrepair allowing water into this area of the building.

Photo A- 13 - Roof of rear single storey building

- 6.1.1.9 The single storey building at ground floor to the rear of the main building is in a state of disrepair although there are no immediate structural concerns. The existing assumed steel roof trusses only appear to have mild surface corrosion with a low risk of inherent structural defects. The surfaces should be sufficiently cleaned and painted with a surface protection to prolong their long-term durability. The remnants of the roof structure supported by the trusses should be removed and replaced following the same principles (i.e. purlins spanning between trusses). There is a lack of on plan bracing within the roof structure and the building appeared to rely on the adjacent buildings for stability which has been compromised due to the demolition. If the building structure is to remain the stability will need to be analysed with an allowance at this stage for vertical bracing/masonry shear walls to be added/replaced.

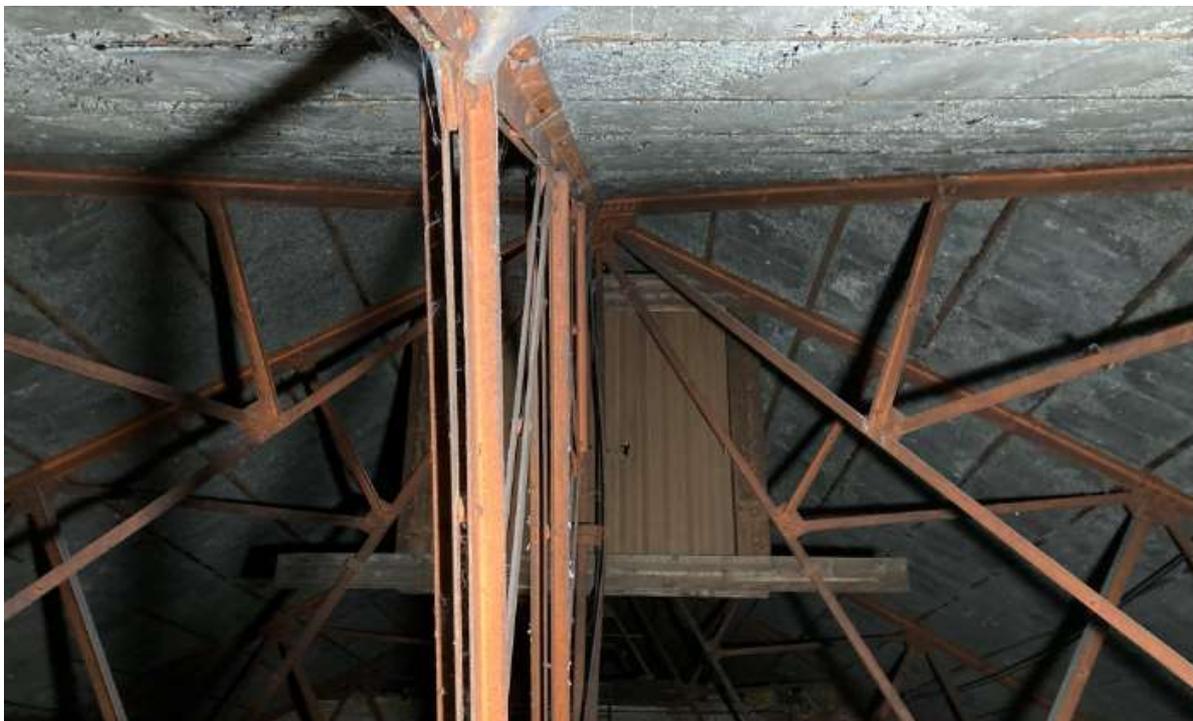
5.1.1.2 The existing hipped roof comprises steel trusses with concrete filler joist panels spanning in-between. The underside of the steel joists was visible from underneath with no concrete cover to the bottom flange. There was evidence of corrosion to the steel joists with reduction to section sizes in places and staining to underside of the concrete. Sections were also visibly wet.

Photo A- 14 - Hipped end of roof structures showing concrete filler joist roof structure supported on the roof trusses

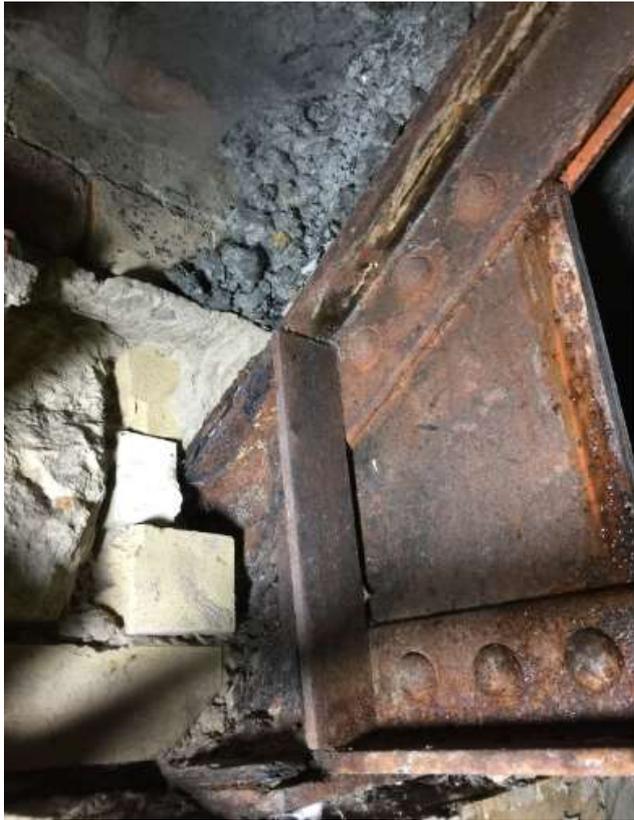
5.1.1.4 A few of the main steel trusses were viewed through holes in the ceiling. The trusses appeared to be in a good condition with nominal corrosion.

Photo A- 15 - Roof truss showing water ingress supported on external masonry wall

6.1.2.3 The existing assumed steel roof trusses only appeared to have mild surface corrosion with a low risk of any inherent structural defects. The surfaces should be sufficiently cleaned and painted with a surface protection to prolong their long-term durability.

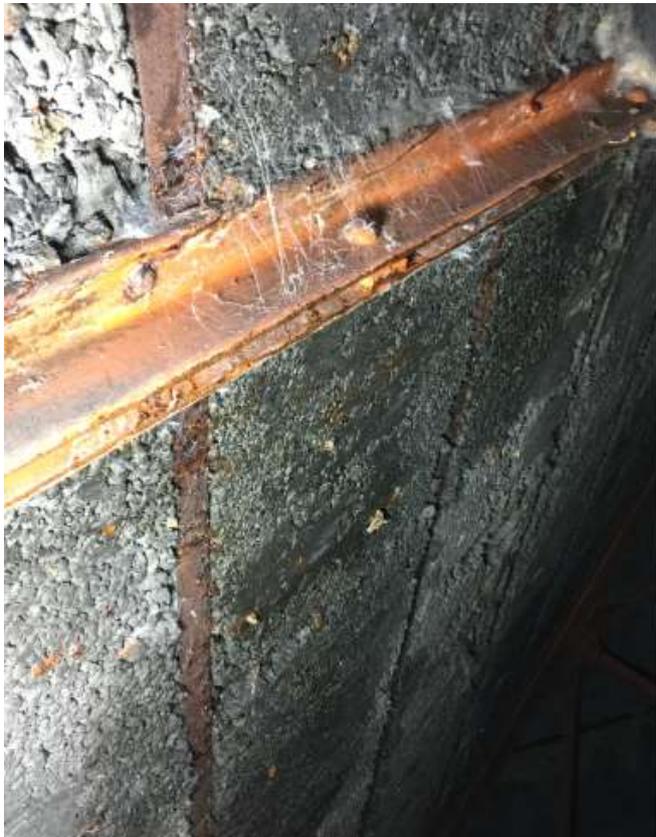
6.1.2.2 The water ingress due to the condition of the roof appears to have caused corrosion to the majority of the filler joist roof with visible staining in all areas viewed during the survey. It is likely that a substantial (if not all) of the filler joist roofing may need replacing/strengthening. It is recommended that opening up works are completed with the concrete removed locally to expose the steel joist in the worst areas. The client may wish to consider retaining the main trusses but replacing the sections in between with say timber purlins and rafters.

Photo A- 16 - Corrosion to roof filler joists

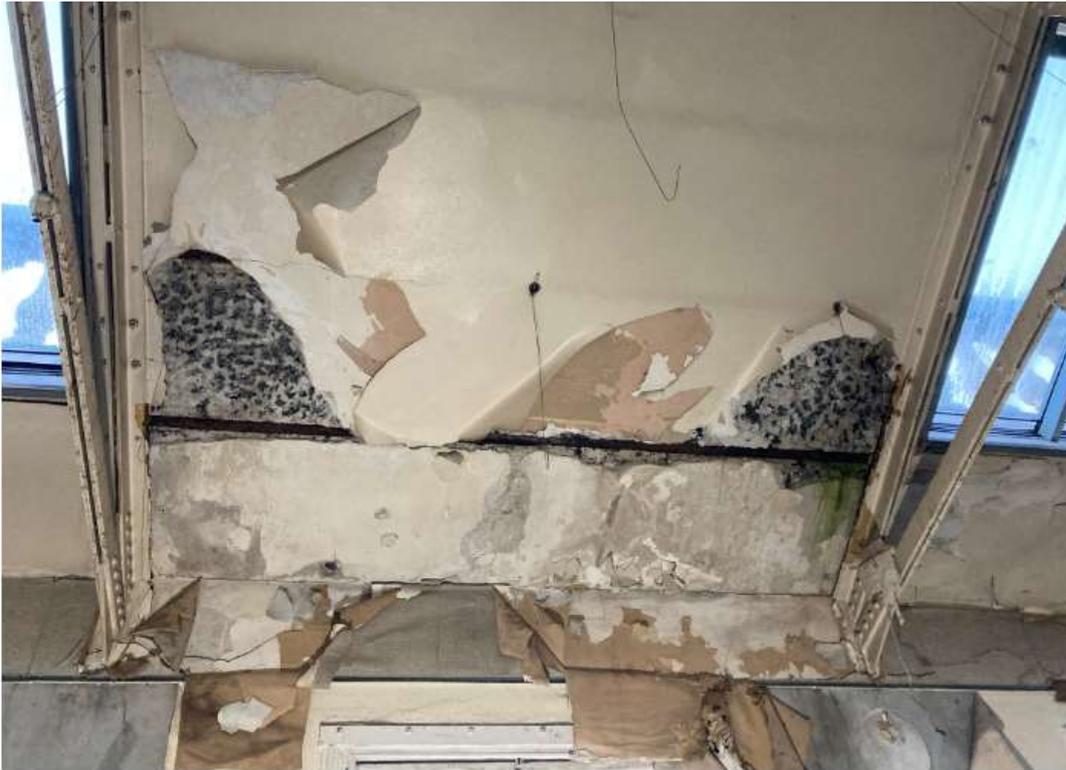
5.1.1.3 There were a few areas where water ingress has caused the ceiling finishes to collapse with further water staining down the walls to the floor below

Photo A- 17 – Ceiling finishes come away exposing filler joist roofing due to water ingress between the existing roof lights

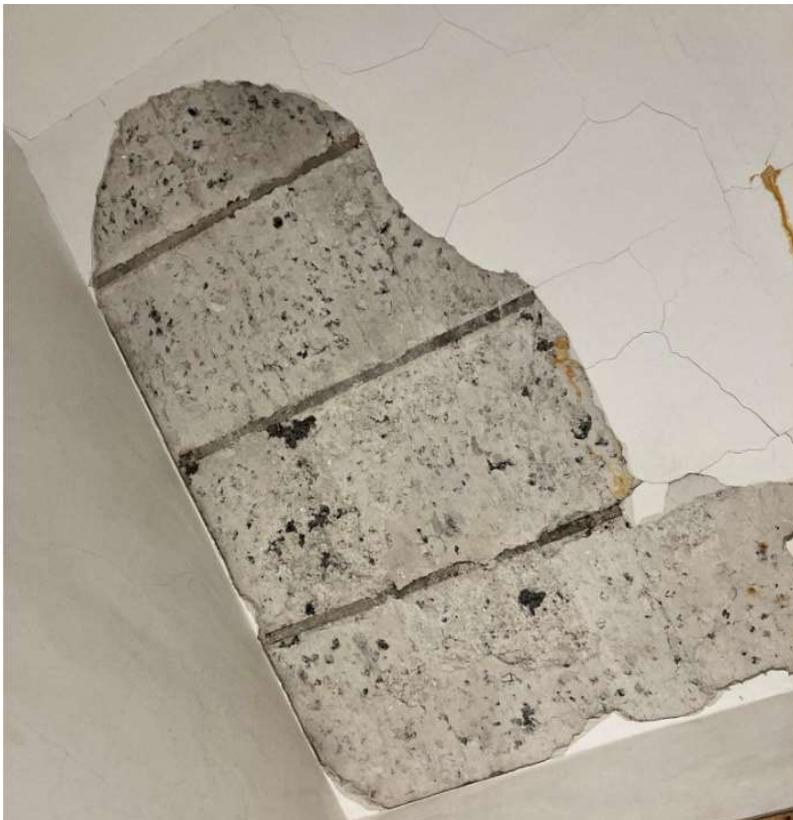
Photo A- 18- Further example of roof ceiling finishes coming away assumed due to water ingress

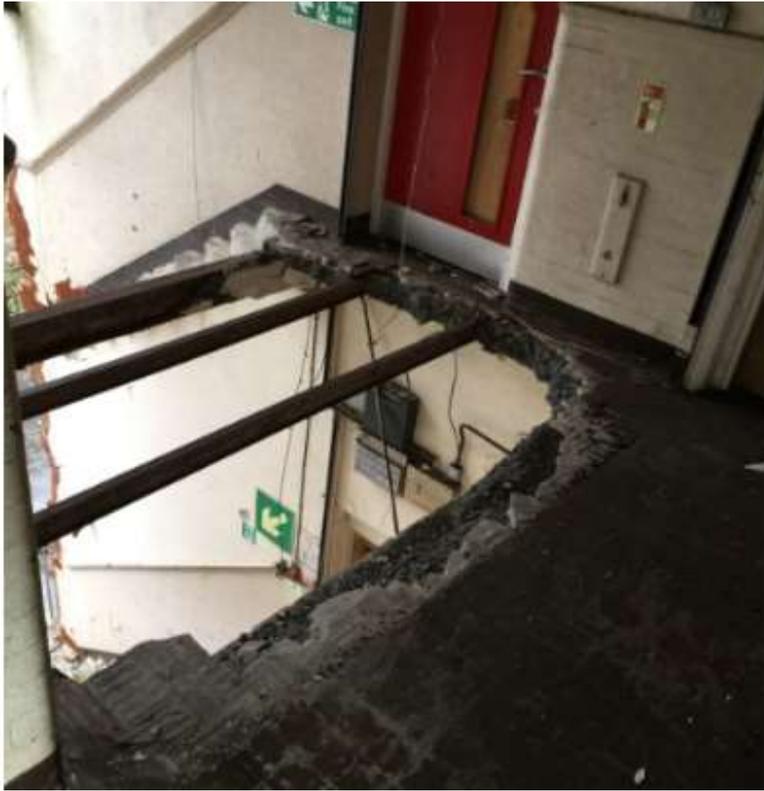
- 5.1.2.6 The removal of the stairwell has damaged/removed sections of the floor with exposed steel joists remaining
- 5.1.2.7 Cracking to the concrete beam encasement was observed on one of the primary steel beams with the encasement removed locally to inspect the steel beam. The beam appeared in reasonable condition with no obvious signs of defects.

Photo A- 19 - Remains of second floor around demolished stairwell

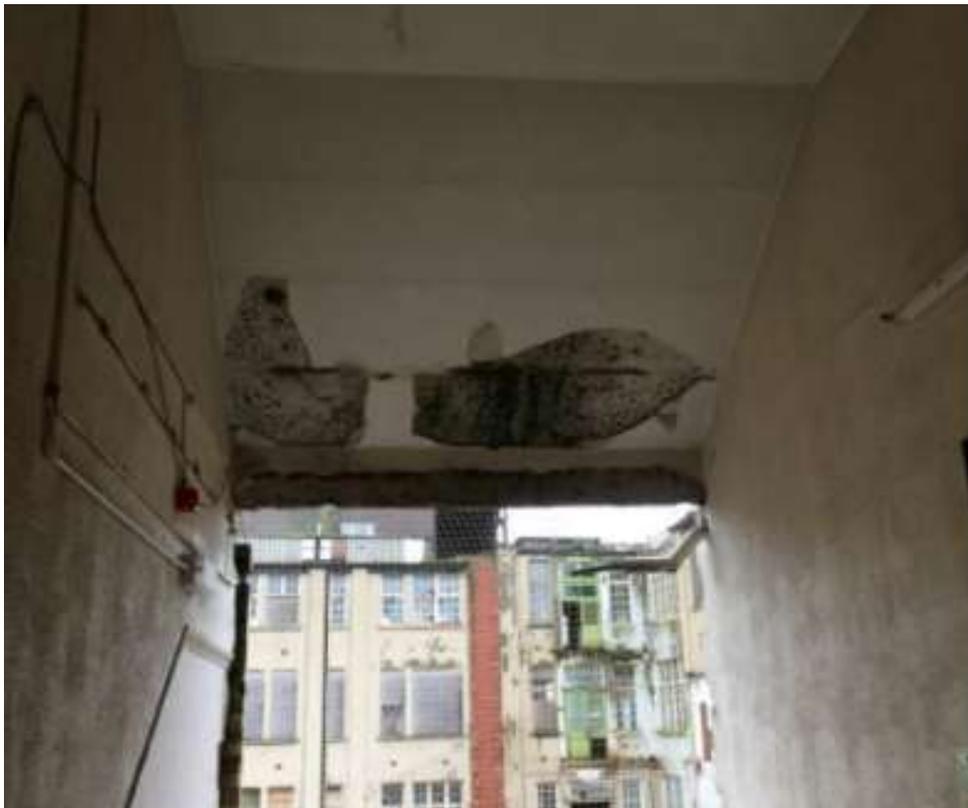
Photo A- 20 - Example of water ingress assumed due to condition of roof

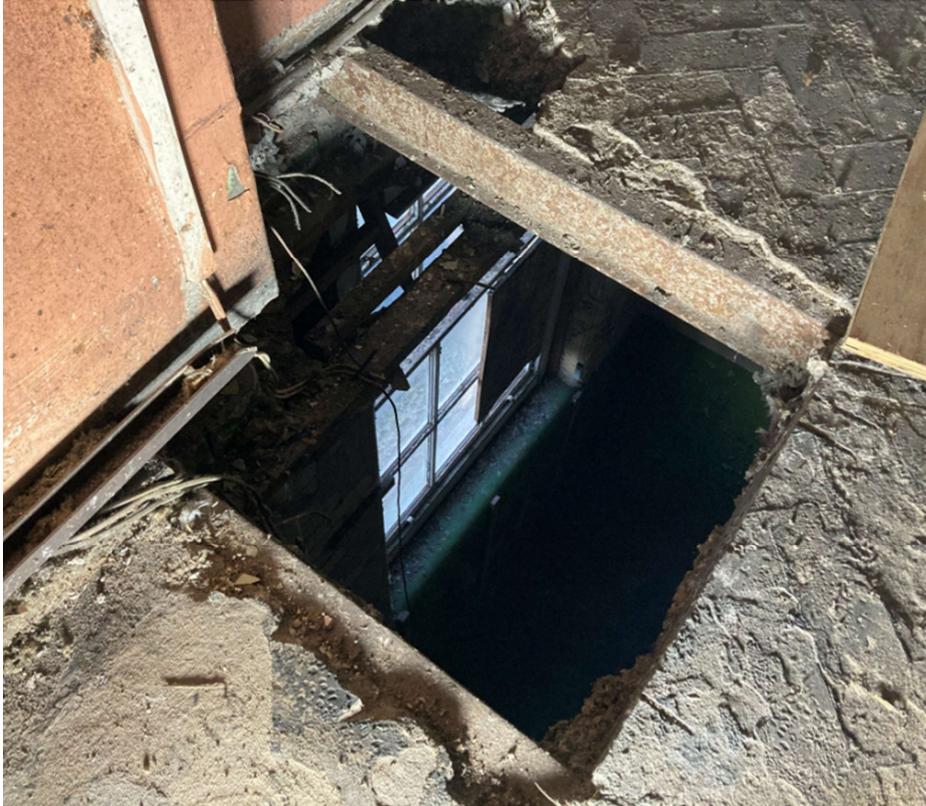
- 5.1.2.2 Previous opening up works had already been carried out to break away a section of the concrete floor along the western façade, exposing the steel joists. These appeared to be in a reasonable condition.

Photo A- 21 - Previous opening up works identifying steel joists of concrete filler joist floor

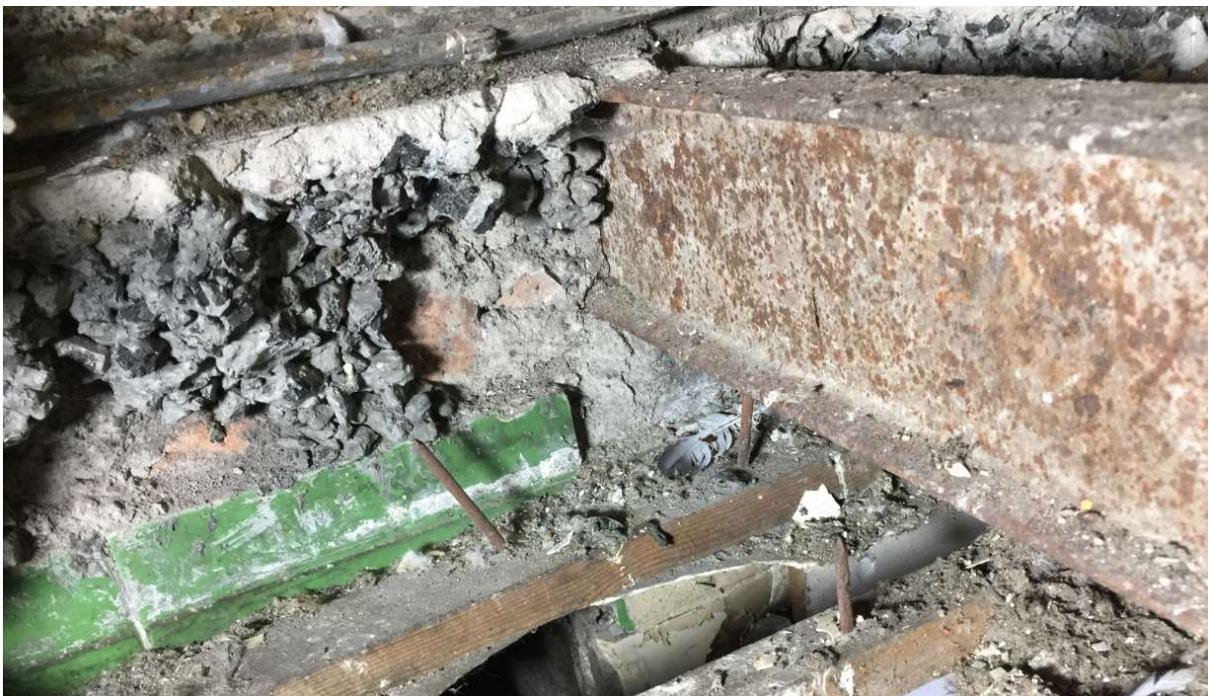
Photo A- 22 - Bearing of 2nd floor joist into masonry wall

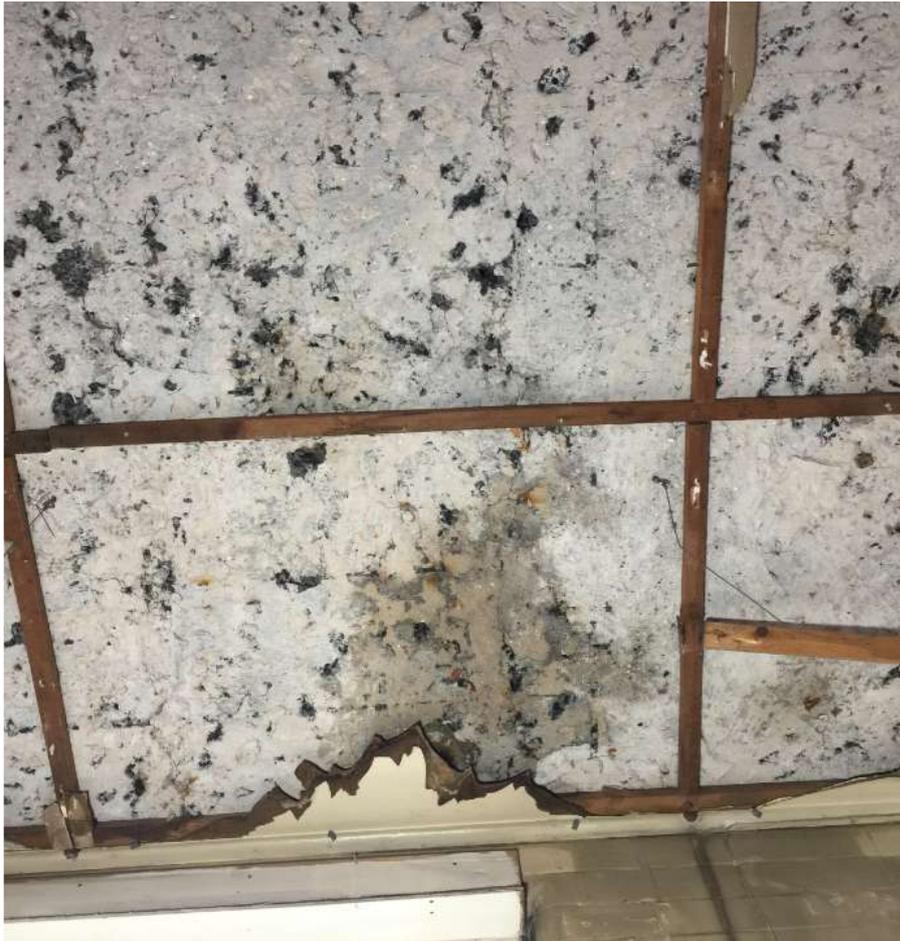
- 5.1.2.4 The concrete appeared to be 'clinker' which is significantly different to concrete that is used in current construction.
- 5.1.2.5 There were some signs of corrosion with staining to the underside of the floor in areas where the water had been entering through from the roof

Photo A- 23 - Soffit to 2nd floor showing signs of prolonged water ingress

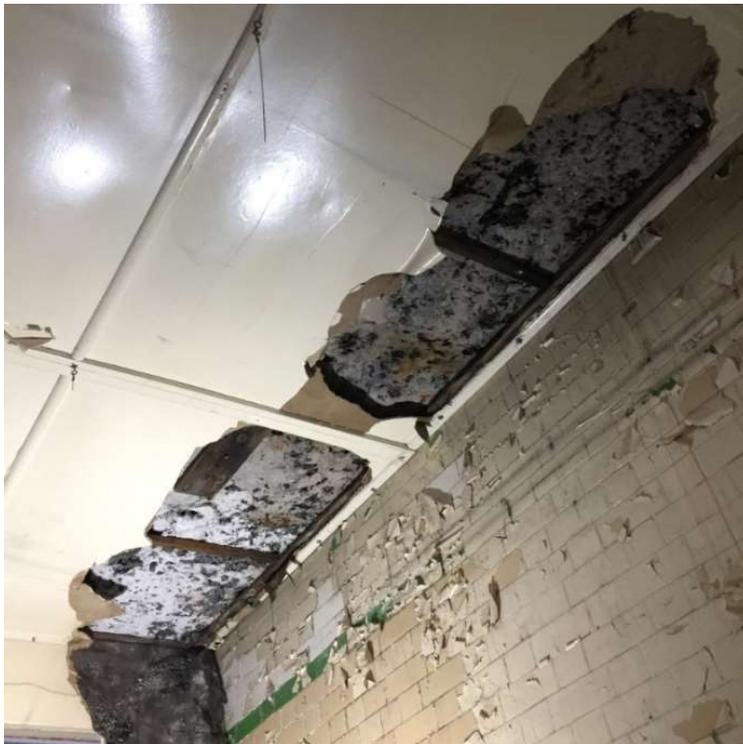
Photo A- 24 - Further water ingress along the southern elevation (2nd floor soffit of slab)

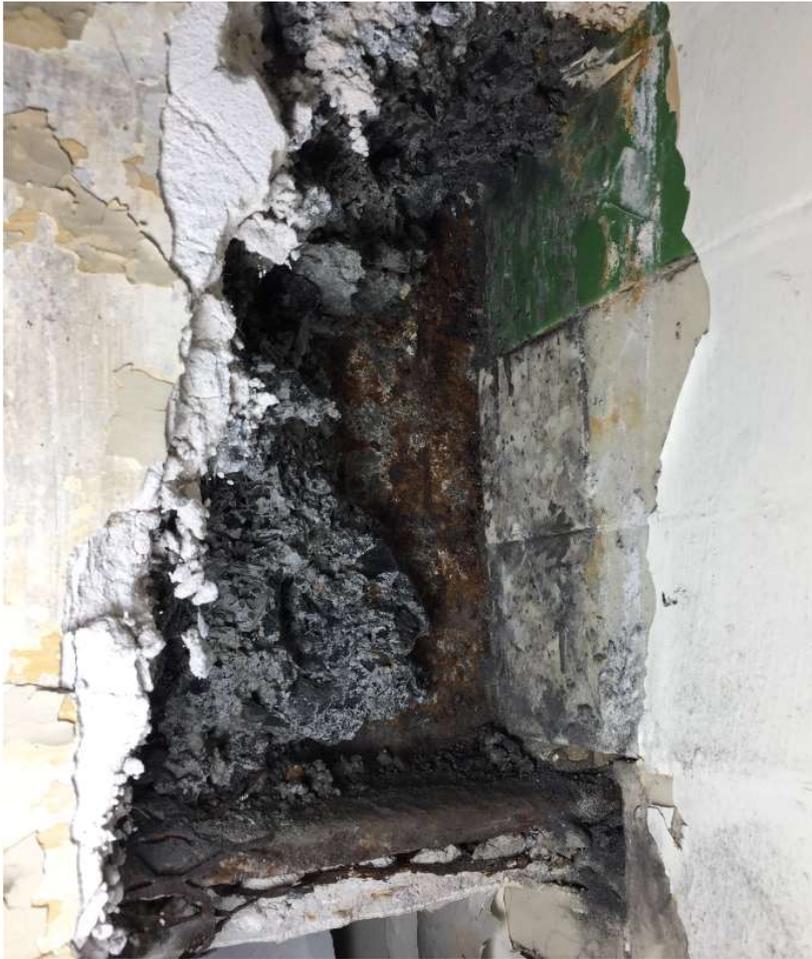
Photo A- 25 - Concrete encasement removed to review condition of second floor beam supported by the rear elevation

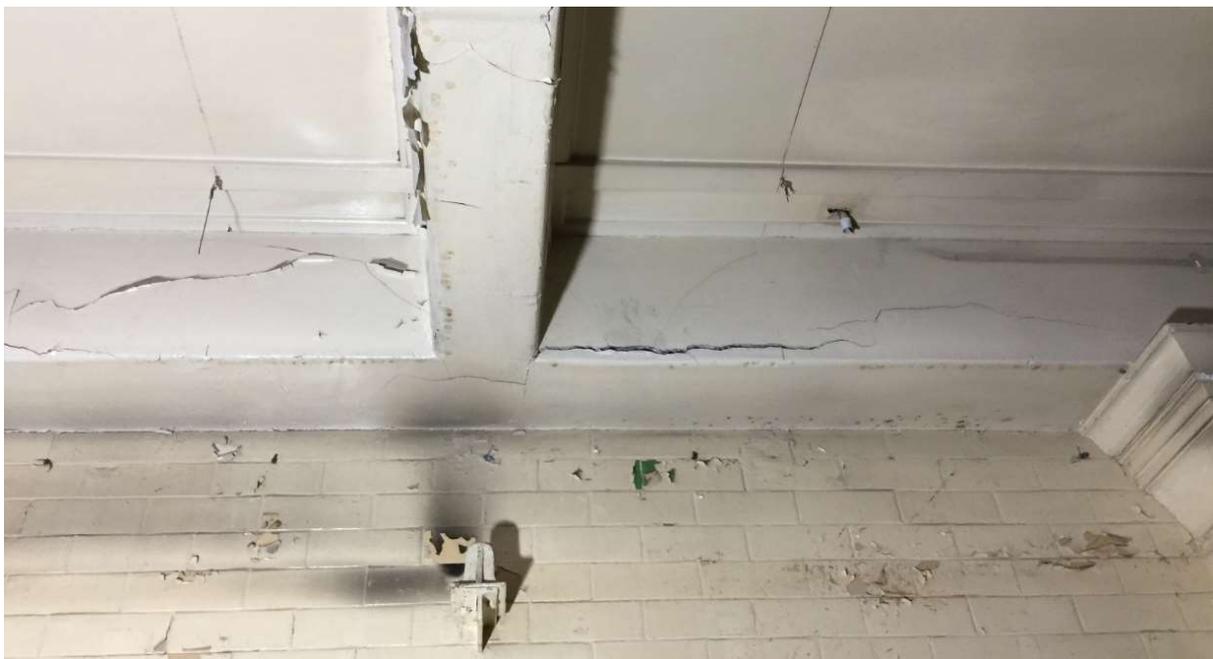
Photo A- 26 - Minor serviceability cracks to the concrete encasement around the second floor steel beams

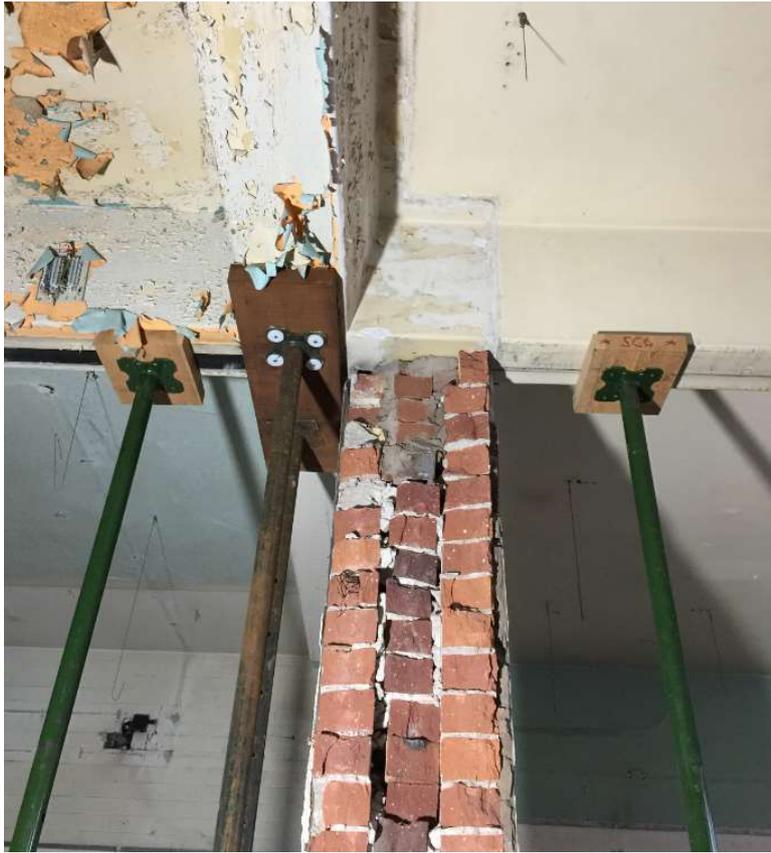
Photo A- 27 - Existing masonry pier with temporary props - appeared to be non-loadbearing TBC

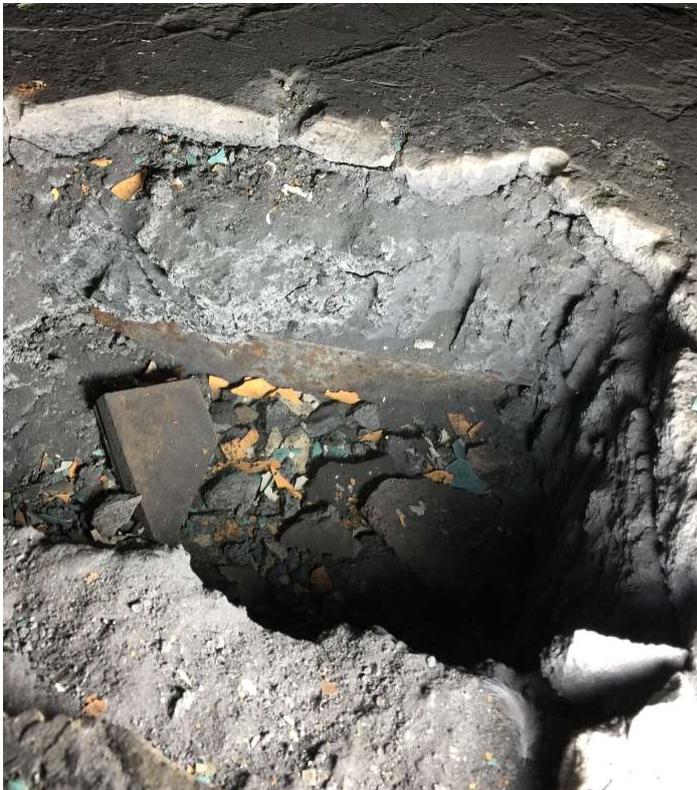
Photo A- 28 - Previous opening up works, distinct different colour and texture to the concrete within the first-floor filler joists
