Former General Post Office
36-40 Abingdon Street, Blackpool. FY1 1DA

Structural Appraisal

Project number: 2200335

Date: Jan 2021

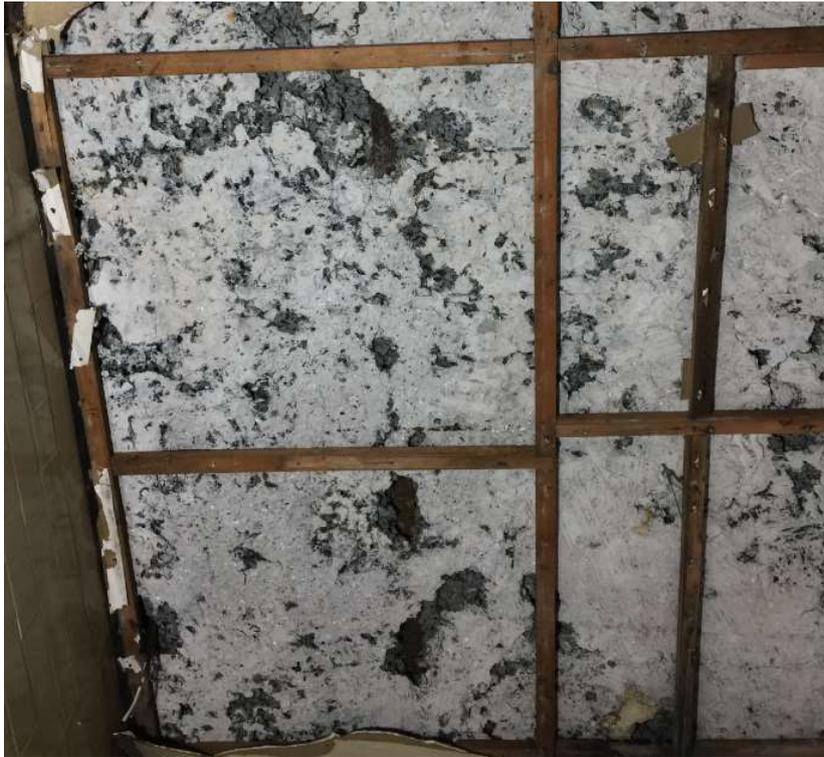
- 5.1.2.4 The concrete appeared to be 'clinker' which is significantly different to concrete that is used in current construction.
- 5.1.2.5 There were some signs of corrosion with staining to the underside of the floor in areas where the water had been entering through from the roof

6.1.1.3 The second floor (and roof) appear to be constructed with 'clinker' concrete which is a relatively weak material that expands and softens in contact with moisture. This 'softening' process causes a lack of integrity. Whilst EWP did not encounter any areas that could easily be picked away with a screwdriver whilst on site, exposed steel joists and general honeycombing to the underside of the slab suggest that either pieces have come away previously, or it was poorly constructed. Further visual inspections should be undertaken once all finishes have been removed to confirm the long-term durability of the floor as well as its resistance to fire compared with today's requirements.

Photo A- 29 - Bottom flange of steel joists exposed due to local 'pockets' to underside of second floor. Concrete appeared to be clinker

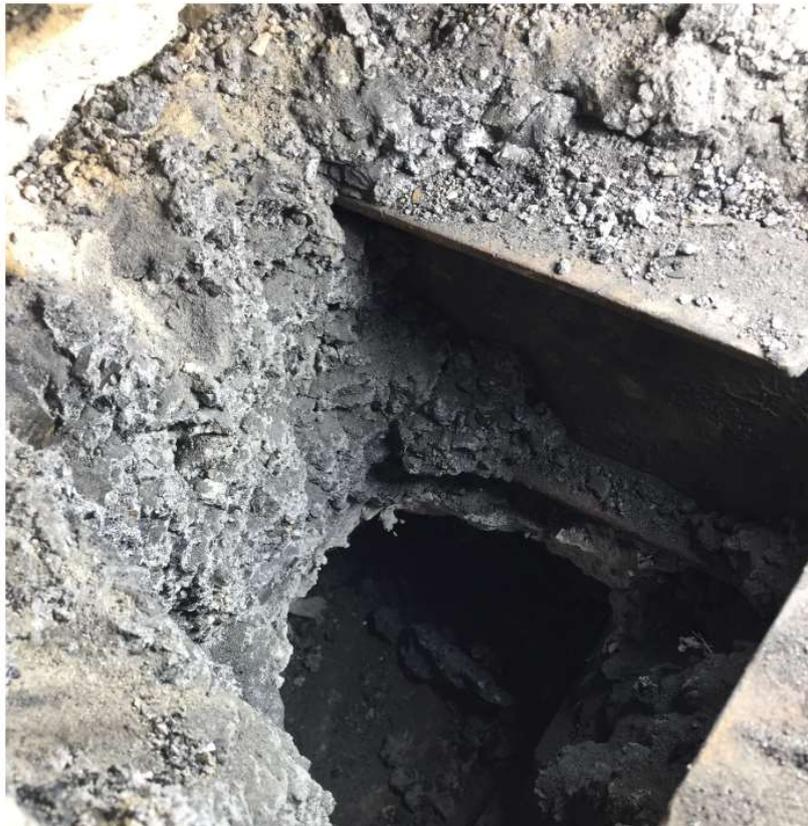
Photo A- 30 - Hole in 1st floor slab exposing the steel joist

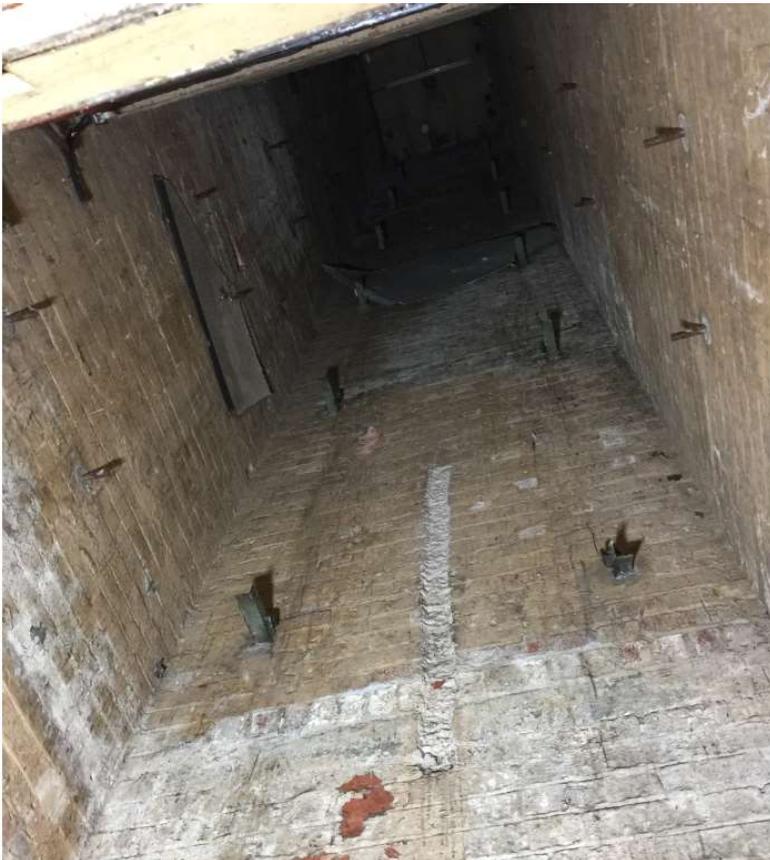
5.1.5.2 The existing lift pit (approx. 1100mm deep) was fully submerged in water. The masonry lift shaft appeared in reasonable condition.

Photo A- 32 - Lift shaft looking from up from within the basement

6.1.1.14 The existing lift shaft appears in a reasonable condition although its stability may need to be reviewed subject to re-use with new modern lifts. It is expected that the lift pit will drain once the source of the water is controlled (see 6.1.1.11).

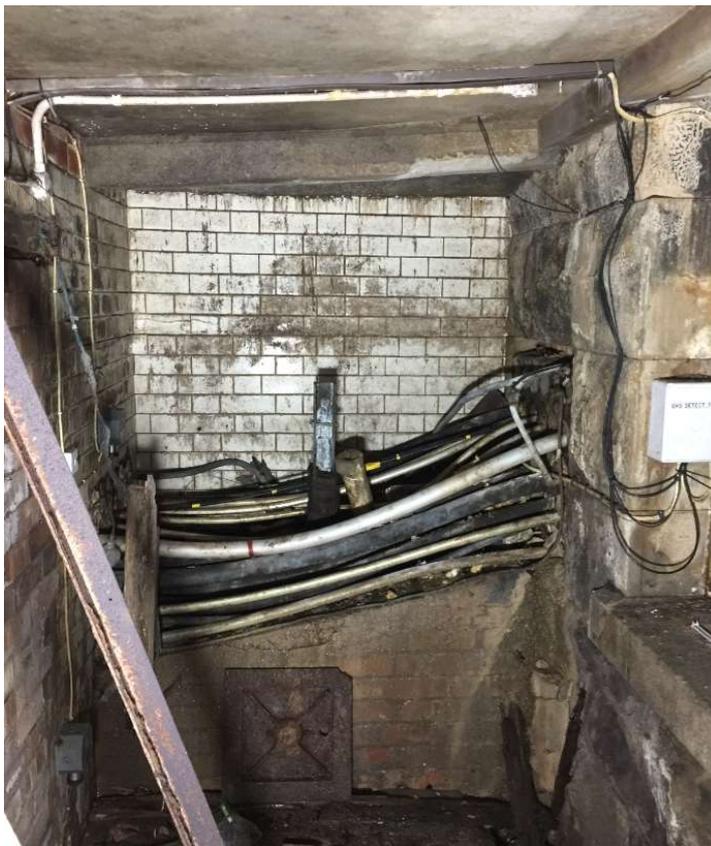
5.1.4.4 The existing lightwells along Abingdon Street appear to have been covered up when referencing against some archive images. The steel beams supporting the slab/finishes have surface corrosion and it appears that some have been replaced with new galvanised sections.

Photo A- 34 - Previous lightwell area along Abbingdon Street

- 6.1.1.7 All beams within the dis-used lightwell along Abingdon Street that are supporting the external build up/finishes need sufficient corrosion protection. Whilst some repairs have previously been carried out there is still a number of steel beams with surface corrosion. It is recommended that these steel beams are replaced with galvanised steel beams.
