THE ROYAL OAK, MONK SOHAM  
RECORD OF CLAY LUMP RANGE

June 2021  
ET/jm/6350

The record has been prepared to record the clay lump range that is to be demolished and re-built at the Royal Oak, in relation to condition 9 of Listed Building Consent (DC/21/01925) and Planning Permission (DC/21/01924).

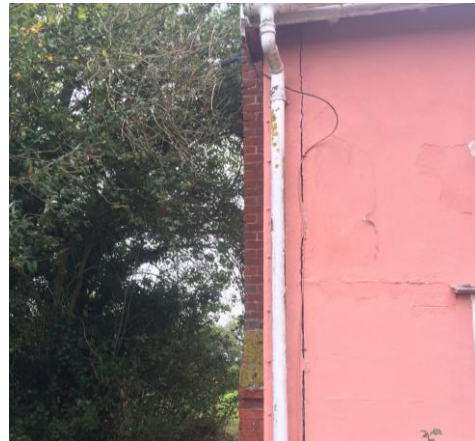
Severe linear crack / movement to corner of south elevation and west elevation. Running from ground to eaves.

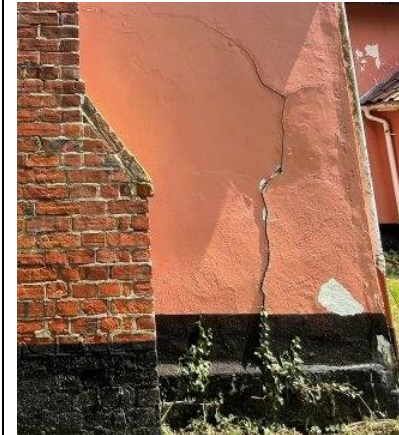
Severe crazing to west elevation south and north of chimney breast

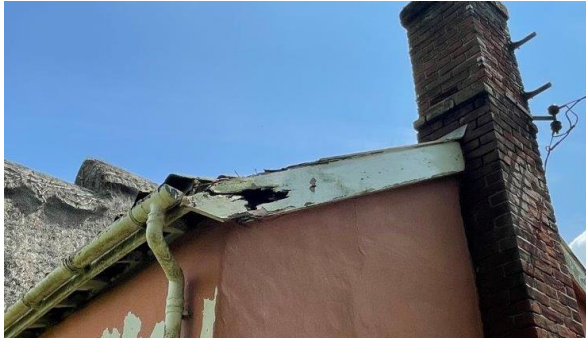
Timber has deteriorated throughout

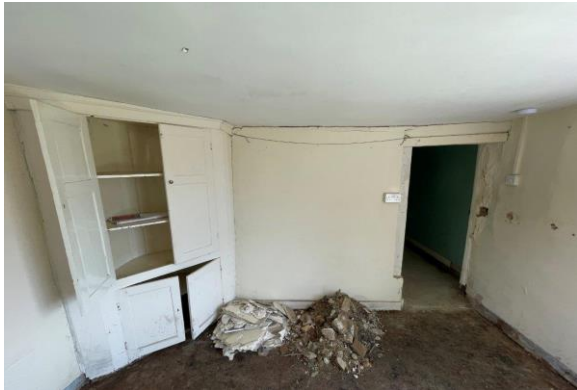
Interior ground floor facing east, cupboard to corner, formed off damp floor timber deteriorated

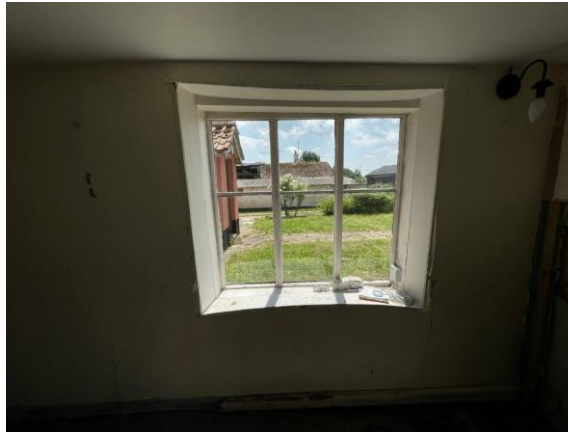
Ground floor window to south, saturated plinth shows swelling and movement evident by warping to cill and head of window

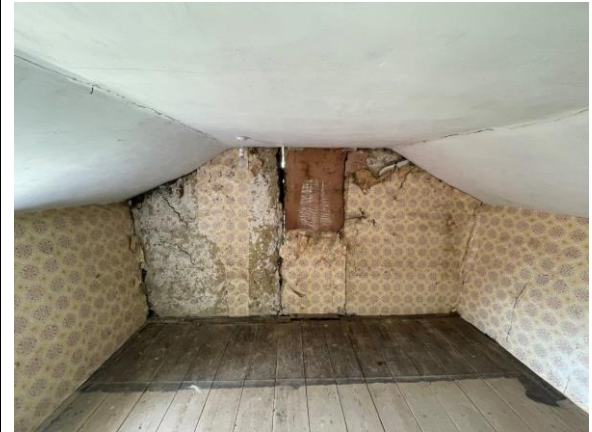
First floor facing west, movement between clay lump and masonry chimney evident, daylight clearly visible.

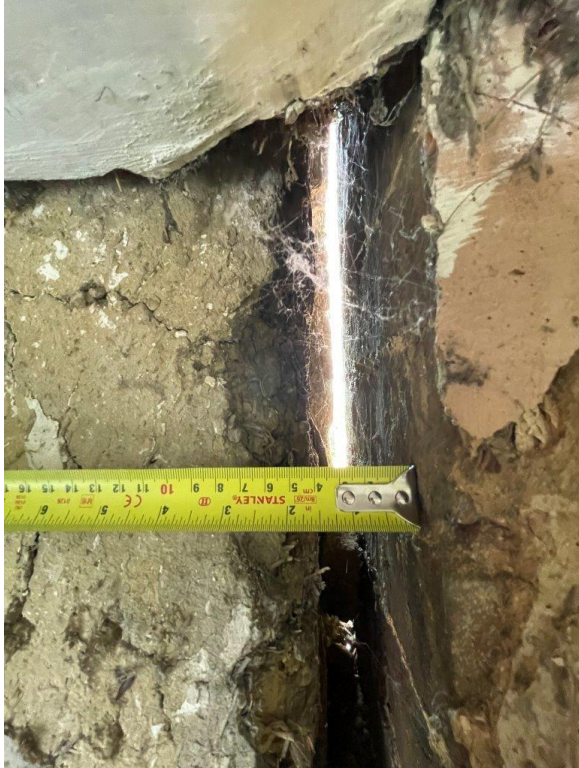
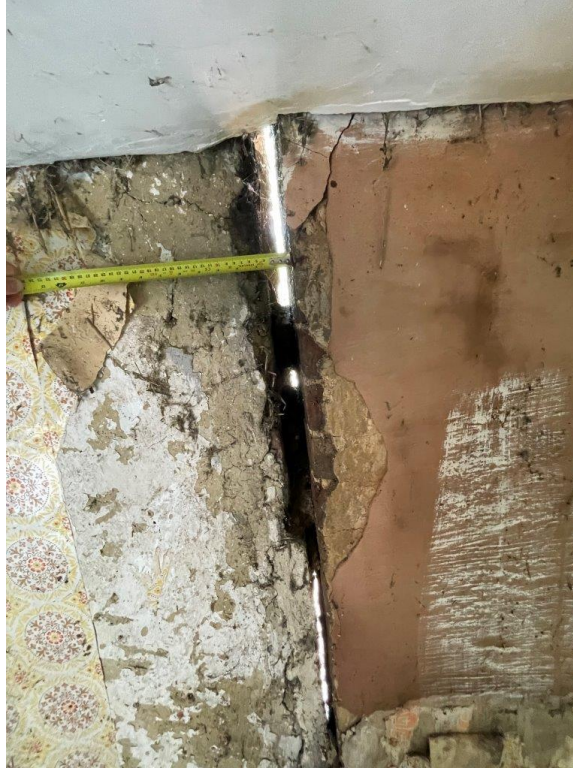
Crack between masonry chimney and clay lump

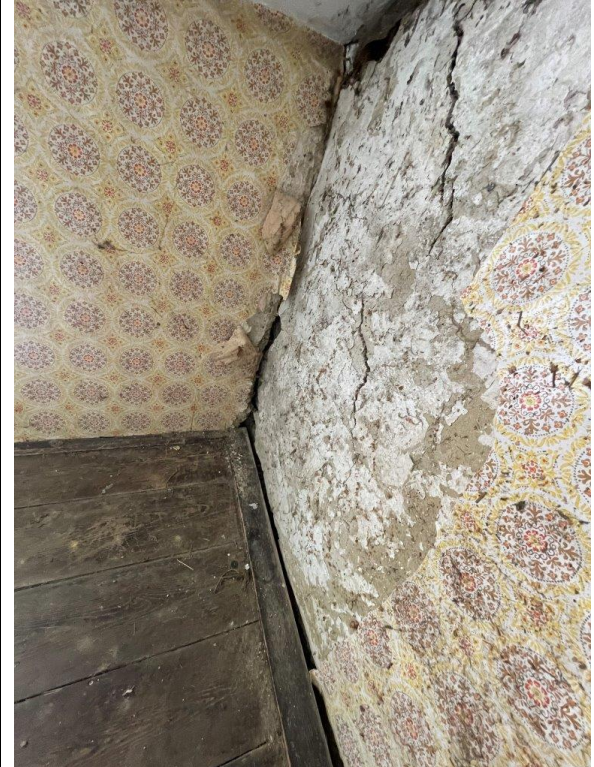
Cracking between west and south walls, evidence of walls splaying out by latter infill timber strips to perimeter of room. Bearing of floor joists in walls and condition questionable.

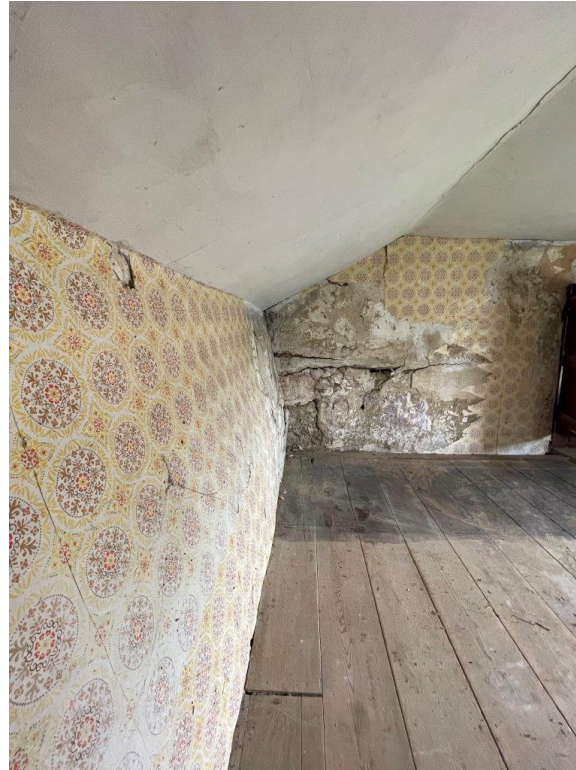
Photo of north wall showing extent of lean/splaying of roof structure to first floor walls

The roof is presumably rafters supported by purlins, these are splaying and in turn causing the walls to splay outwards.

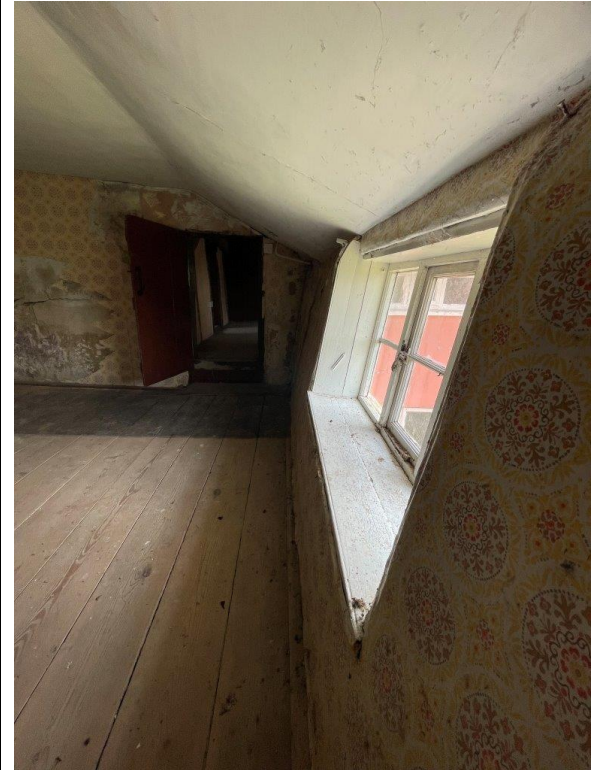
Photo of south wall showing extent of lean/splaying of roof structure to first floor walls

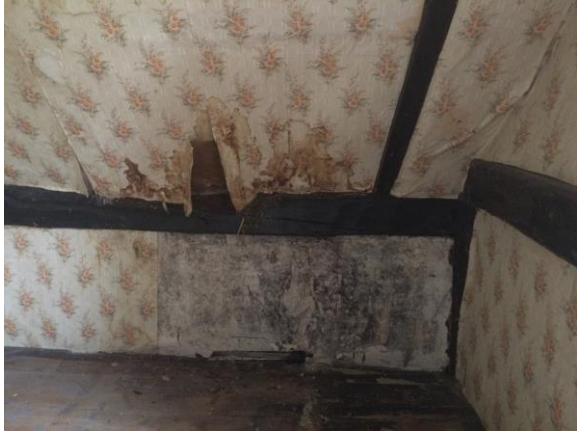
Photo facing west inside northern bedroom to main house, indicating the leak from the poor flashing detail between the pan tiled, clay lump extension and the thatch of the existing house.
