# Geotechnical Survey Report

Issue Date:	October 2020
Risk Address:	15 Sladburys Lane Clacton-on-sea Essex CO15 6NU
Claim Ref:	107232

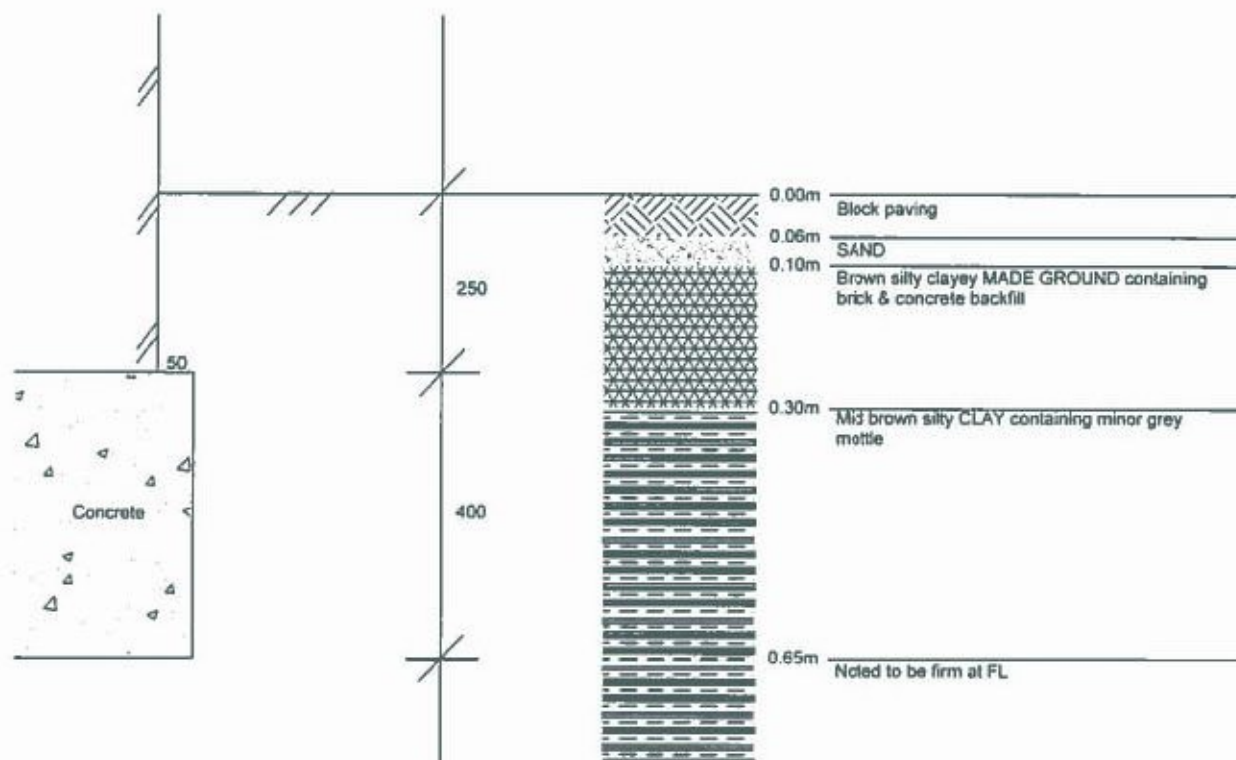
## TRIAL PIT 1

D1 @ F.L. (0.65m)

V = 72-74kPa

Founding strata:

Firm Mid brown silty CLAY containing minor grey mottle

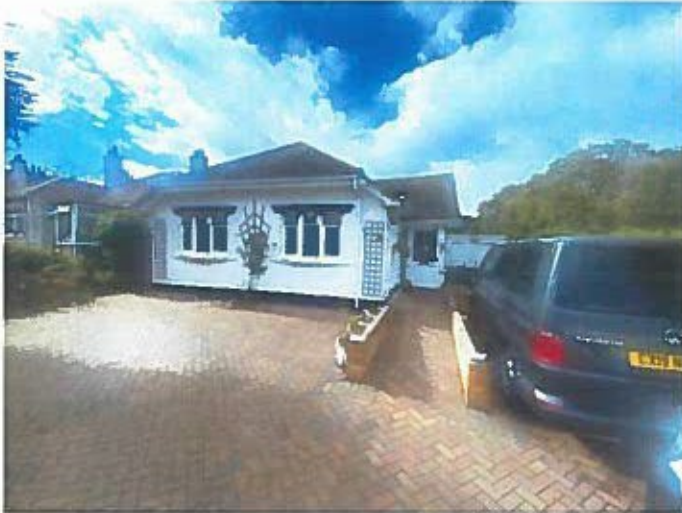
**Photo 1 (Showing the front of the property)**

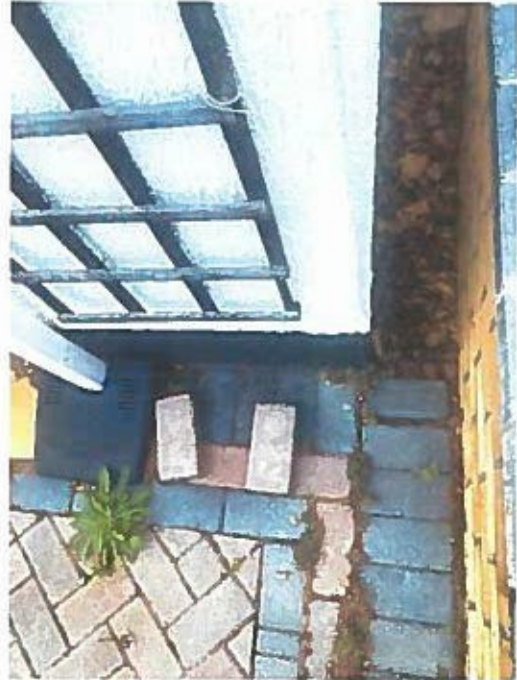
**Photo 2 (Showing TP1 before excavation)**

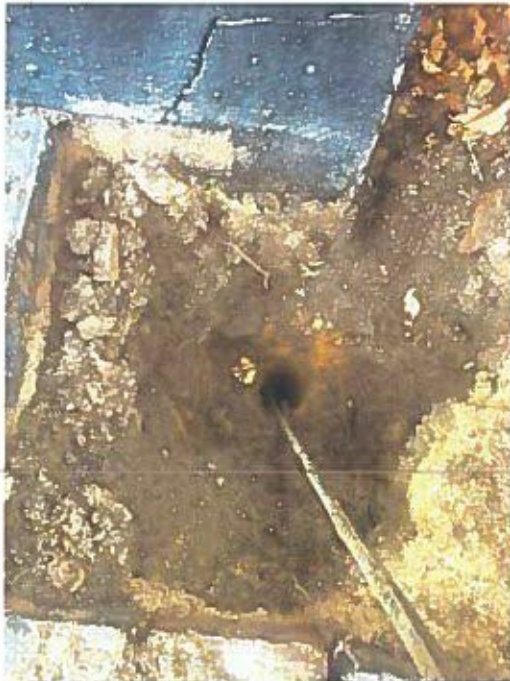
**Photo 3 (Showing TP1 during excavation)**

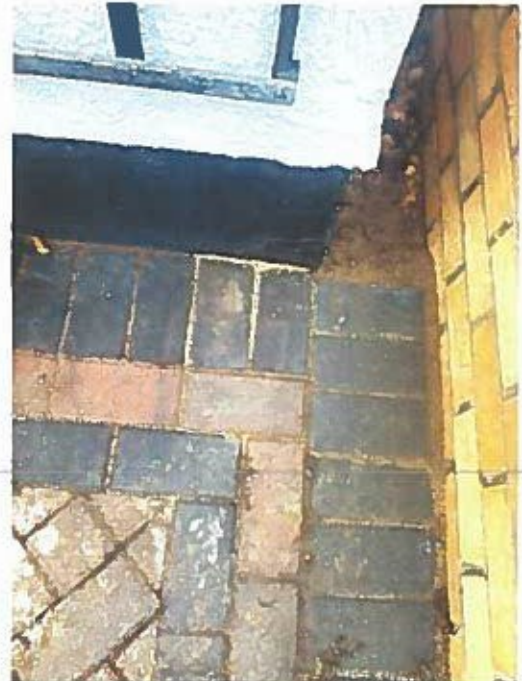
**Photo 4 (Showing TP1/ BH1 on completion)**

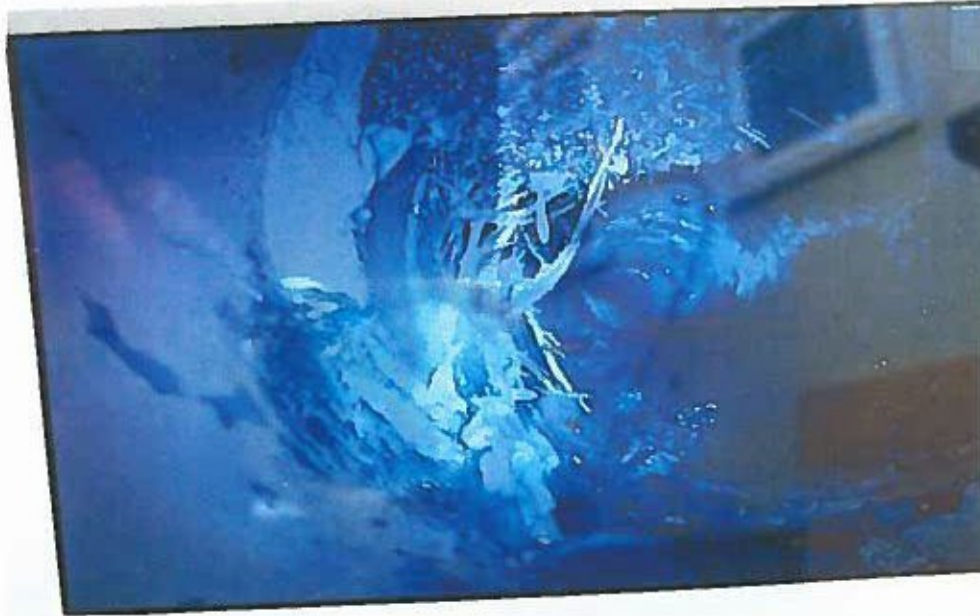
Photo 5 (Showing damage in run 1 at 1.50m)

Run	Grade	Recommended action
1	B	Line run from MH1 to MH2
2	A	None required
3	A	None required
4	B	Replace gully & 4m of pipe
5		
6

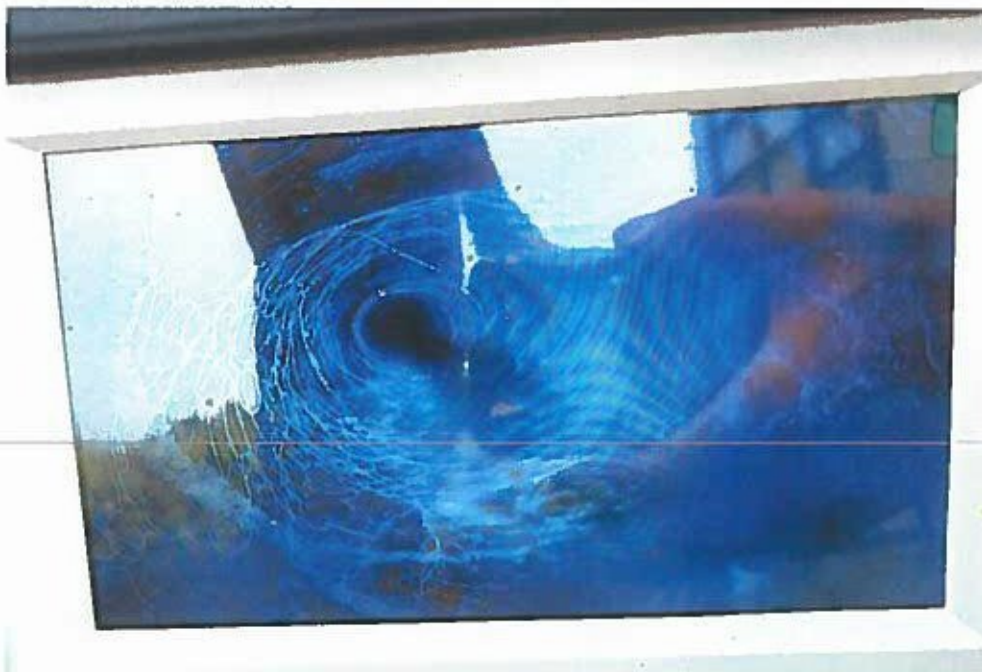
Photo 6 (Showing damage in run 4 at 0.50m)

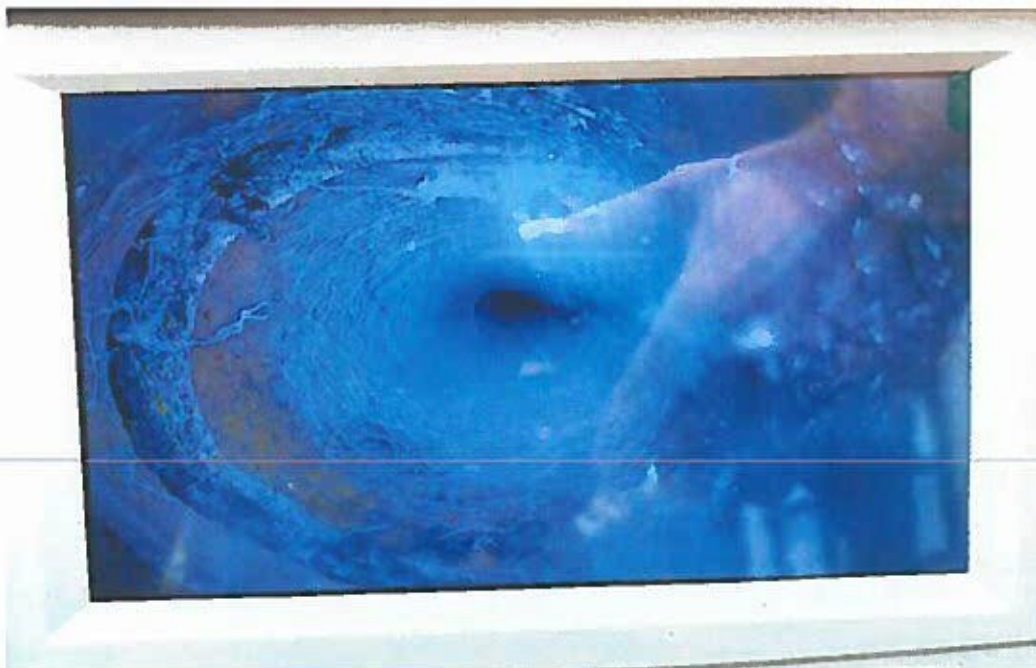
Photo 8 (Showing damage in run 4 at 2.00m)

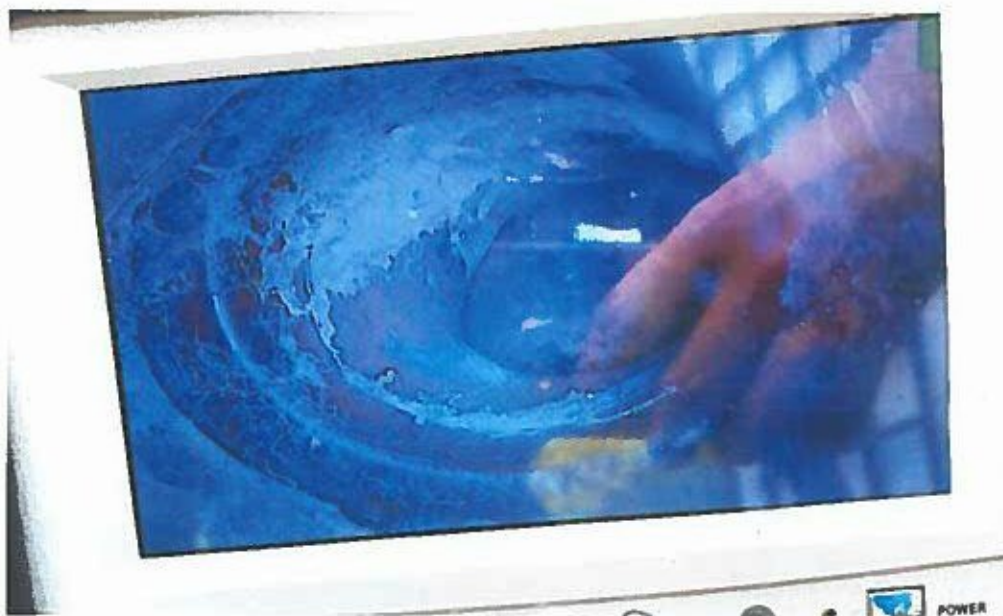
Photo 9 (Showing damage in run 4 at 3.5m)
