Addendum Subsidence Report

15 Sladburys Lane

Date: 1st May 2021

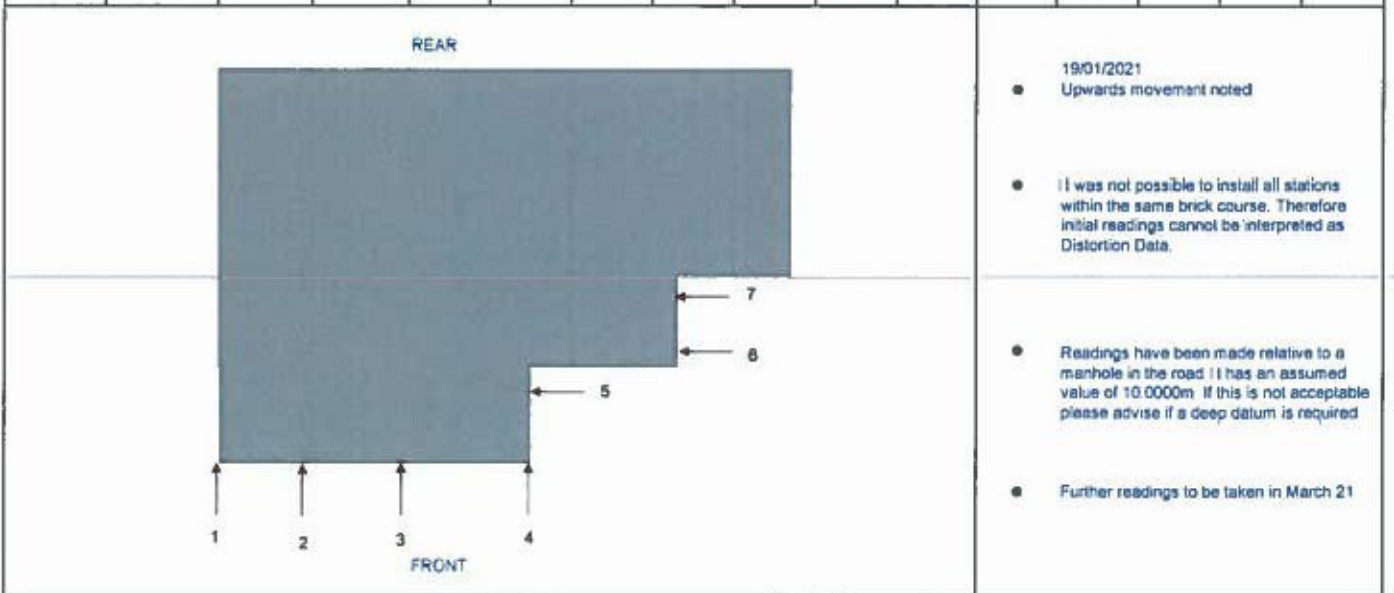
- 19/01/2021
 - Upwards movement noted
- It was not possible to install all stations within the same brick course. Therefore initial readings cannot be interpreted as Distortion Data
- Readings have been made relative to a manhole in the road. It has an assumed value of 10 0000m. If this is not acceptable please advise if a deep datum is required
- Further readings to be taken in March 21
