# **BS5837:2012 -Trees in relation to design, demolition and construction. Arboricultural matters in relation to Maystone House, Harringworth.**

**Prepared by: East Midlands Tree Surveys.**

**Date: 05/07/2021**

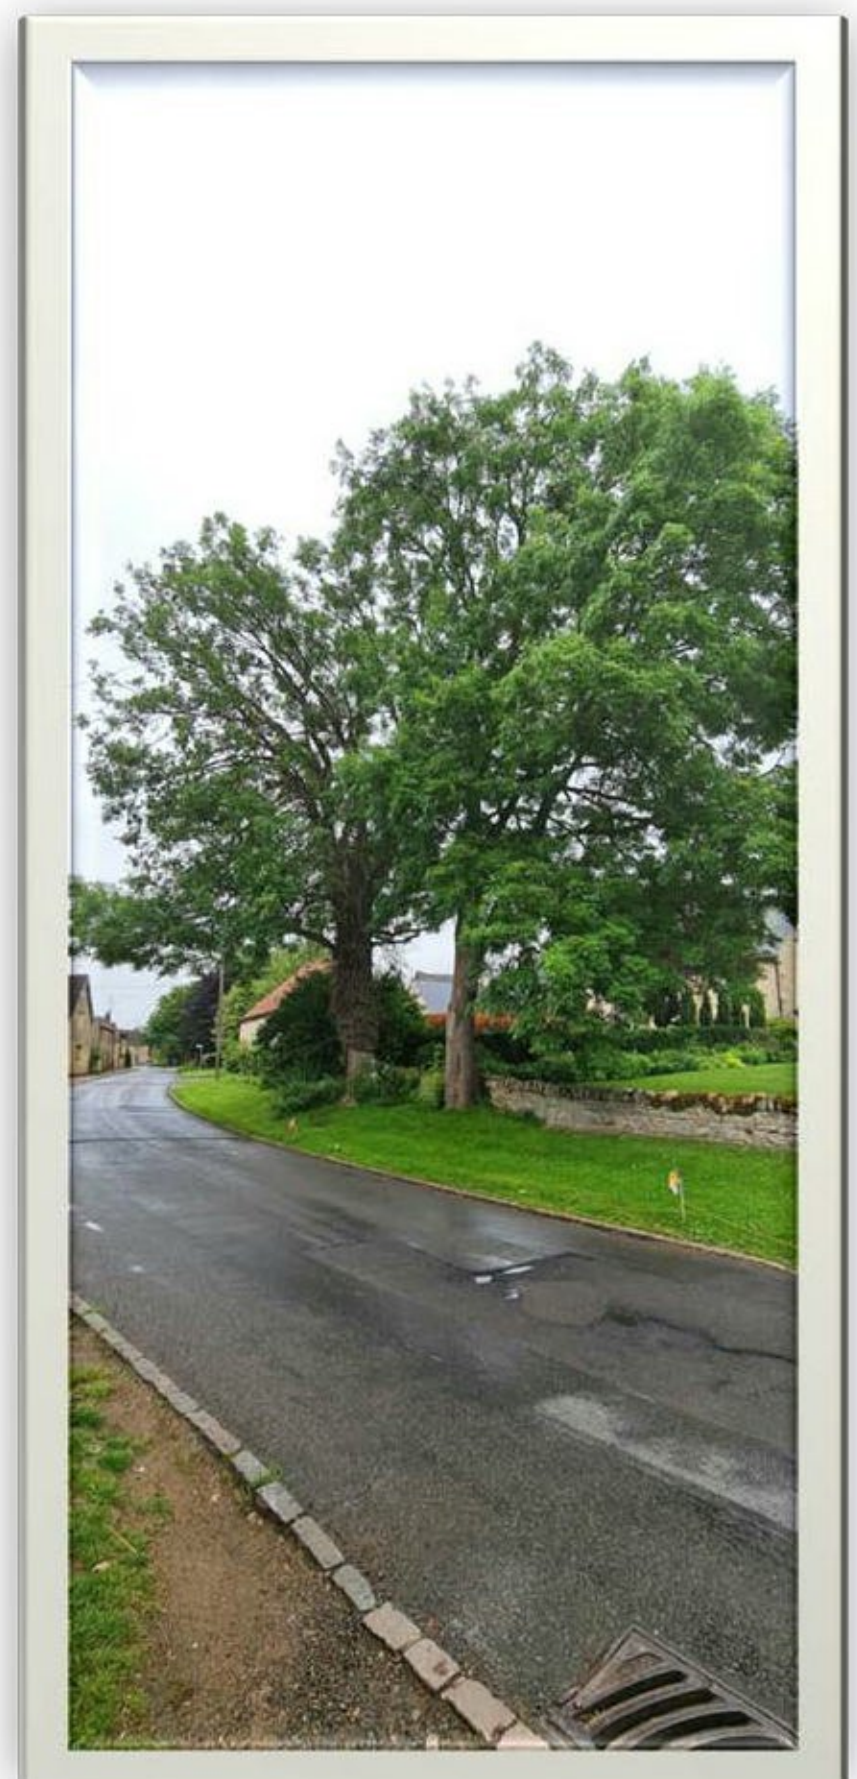
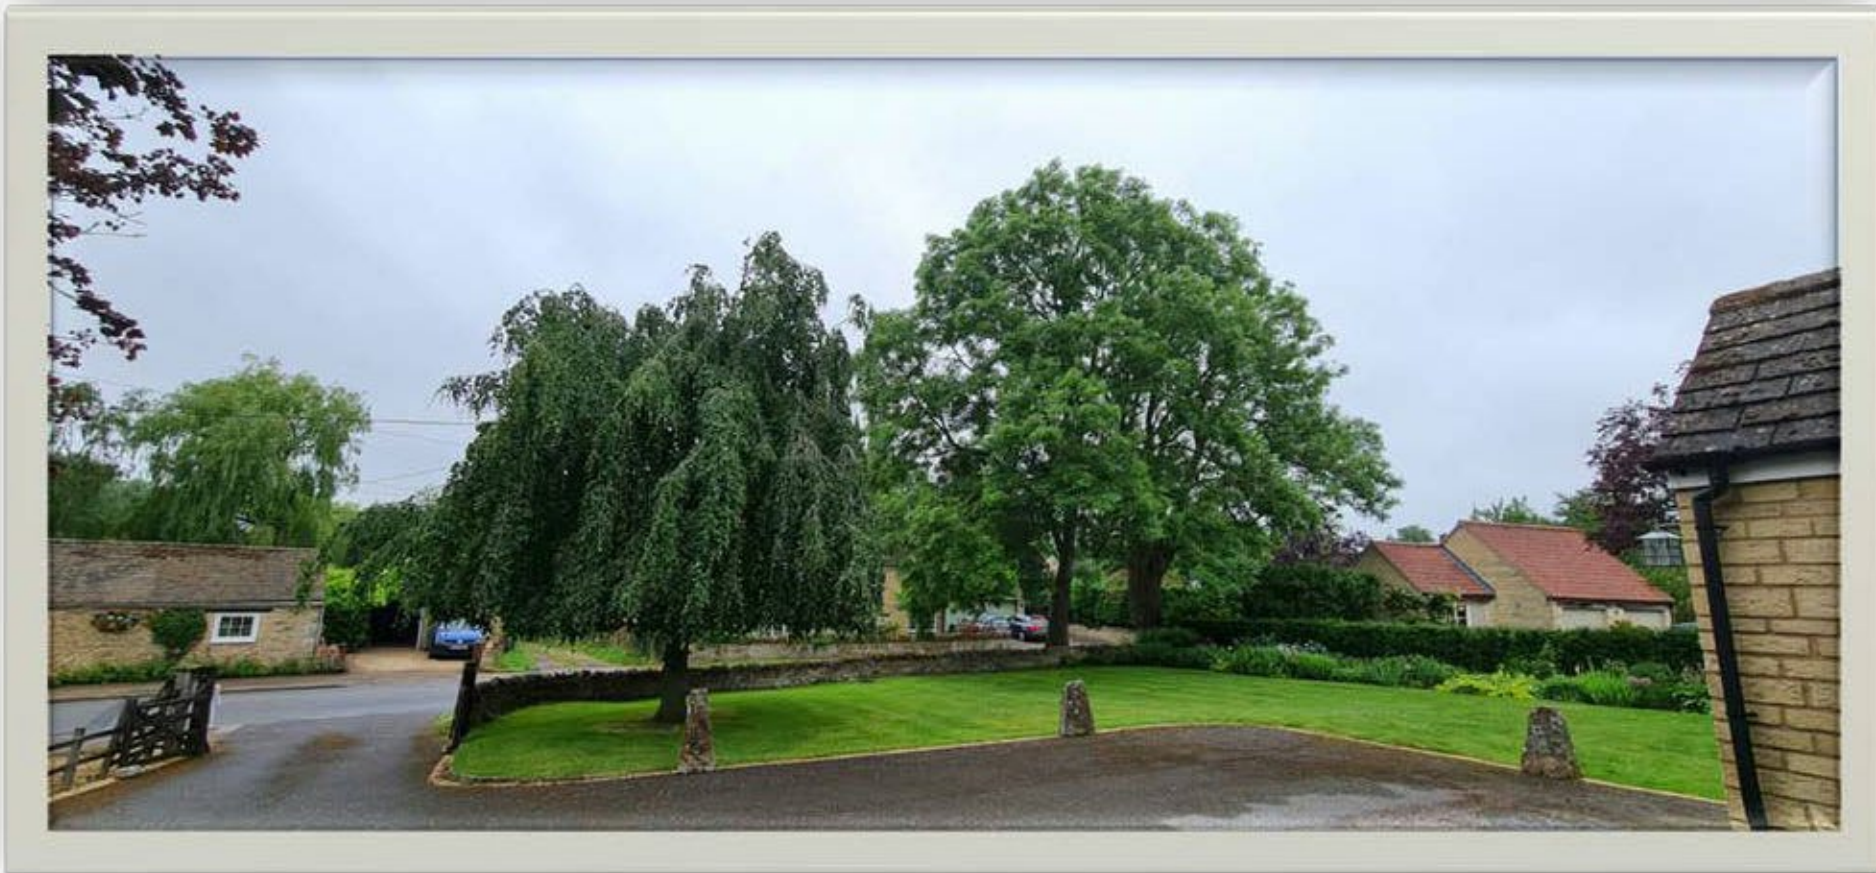
NT2 is also a mature off-site Ash with heart rot from 20cm up to approx. 2.2m NE. Whilst there is evidence of reaction growth around the defect resulting in strengthening material, the decay channel is of significance. The tree has also damaged the boundary wall as it has encroached into the client's land which has resulted in the wall being rebuilt, circumnavigating the trunk of the tree.

It is advised that discussions are entered into with the owner of the 2 Ash trees to ensure that they have been inspected by a competently trained individual to meet the landowner's Duty of Care under common law. Equally, the encroachment by Ash NT2 needs to be resolved as the main trunk has crossed garden boundary and damaged the wall. This damage is considered to be a civil matter. I would advise however that due to the defect identified, this Ash is felled before further damage or failure occurs.

The wall will need to be rebuilt around NT2.

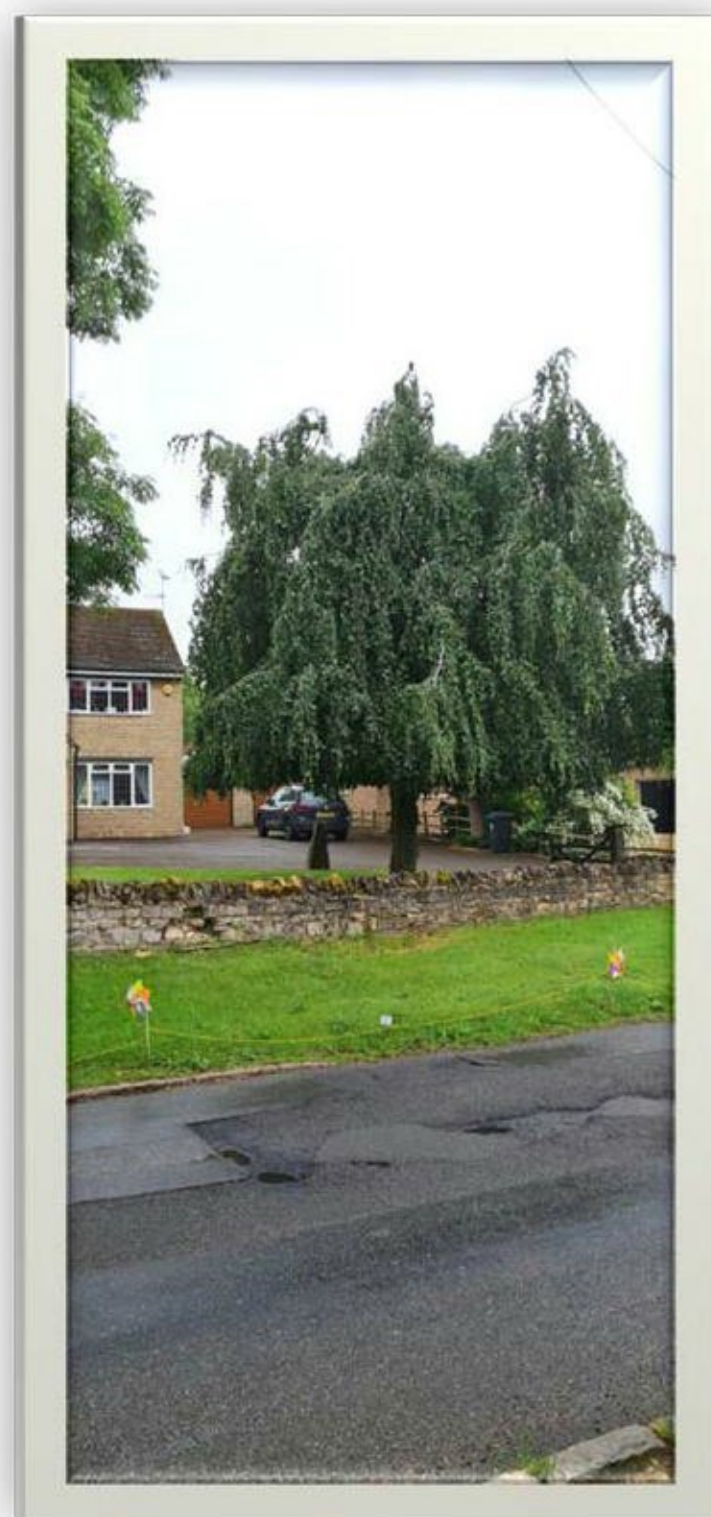
NT3 is a Weeping Beech in good condition with no significant defects.

In terms of NT3, the gate piles have been located as far north as possible and are 500x500mm and the new road incursion at the widest point into the RPA is 14cm. Whilst not ideal and also acknowledging that Beech do not take kindly to root disturbance, with the closest gate post at 3.1m it is unlikely that there will be any significant diameter roots – the root loss is more likely to be fibrous.

In terms of NT3, the fence is to be set back 0.5m from the edge of the proposed grass mat to allow for installation space, thereafter, anti-compaction measures such as scaffold boards or hired-in steel sheets such as EveTrakway to be installed as per the Tree Protection Plan – between the proposed installation area and the fencing. Either solution will be laid on top of 4 inches of compressible material – the woodchip from the removed trees would be ideal.

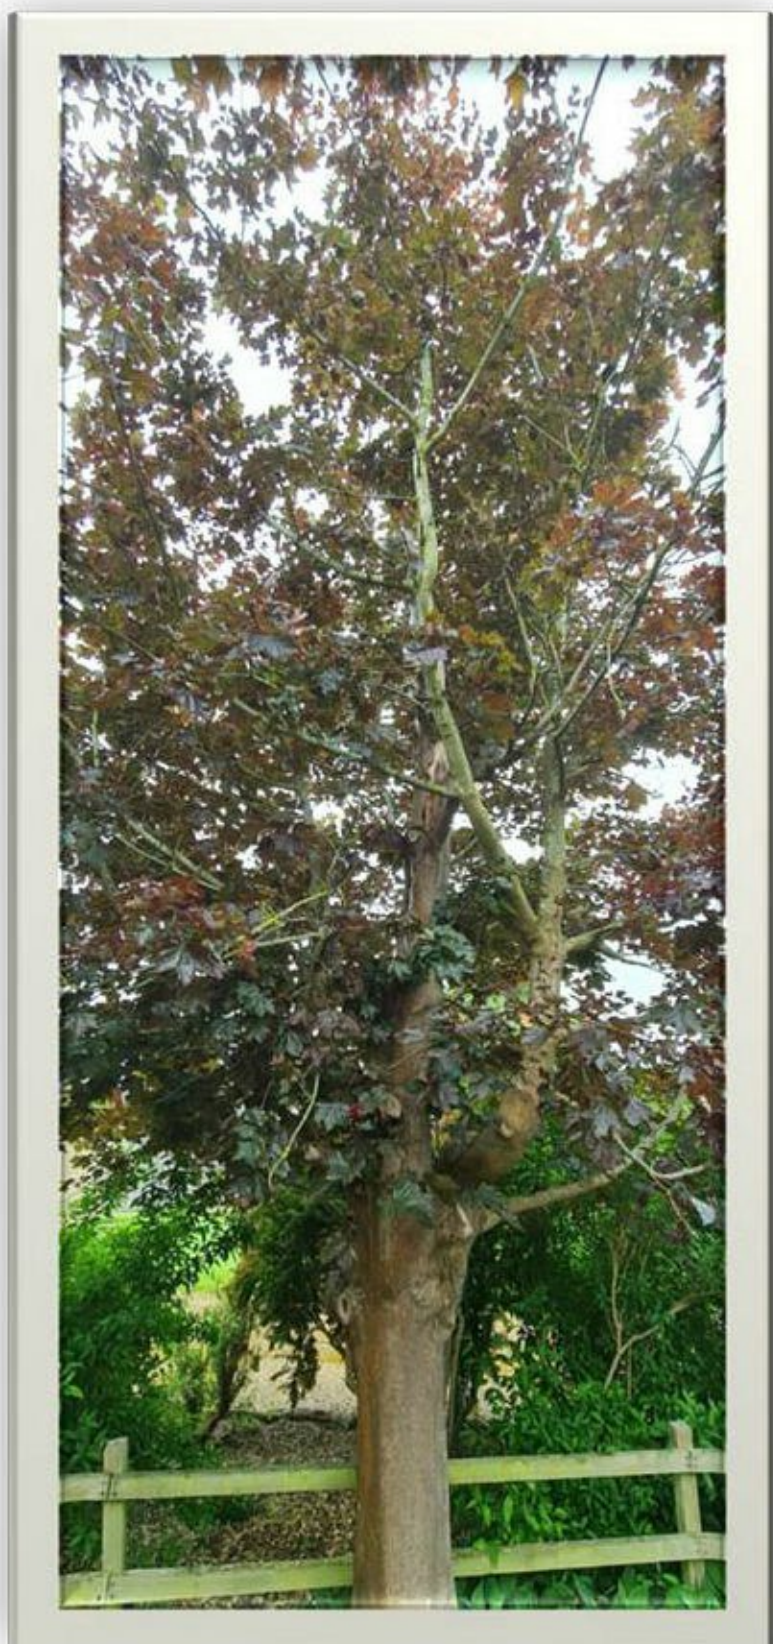
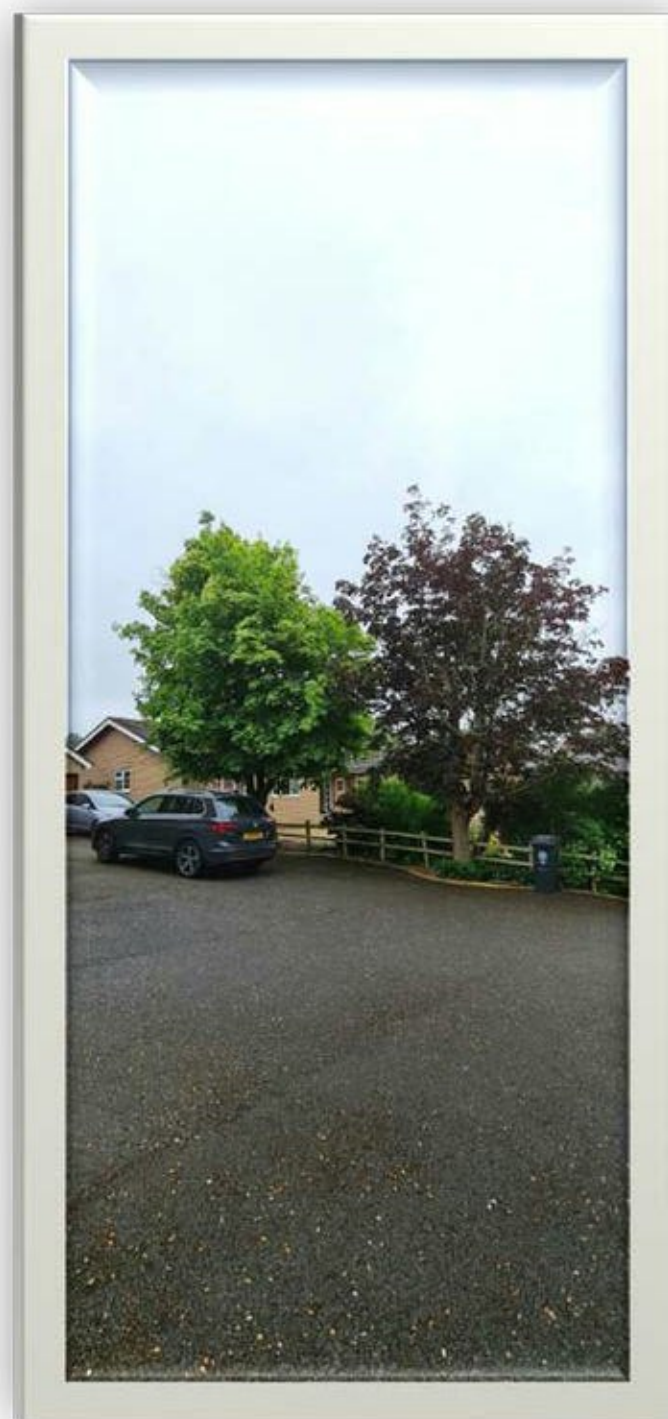
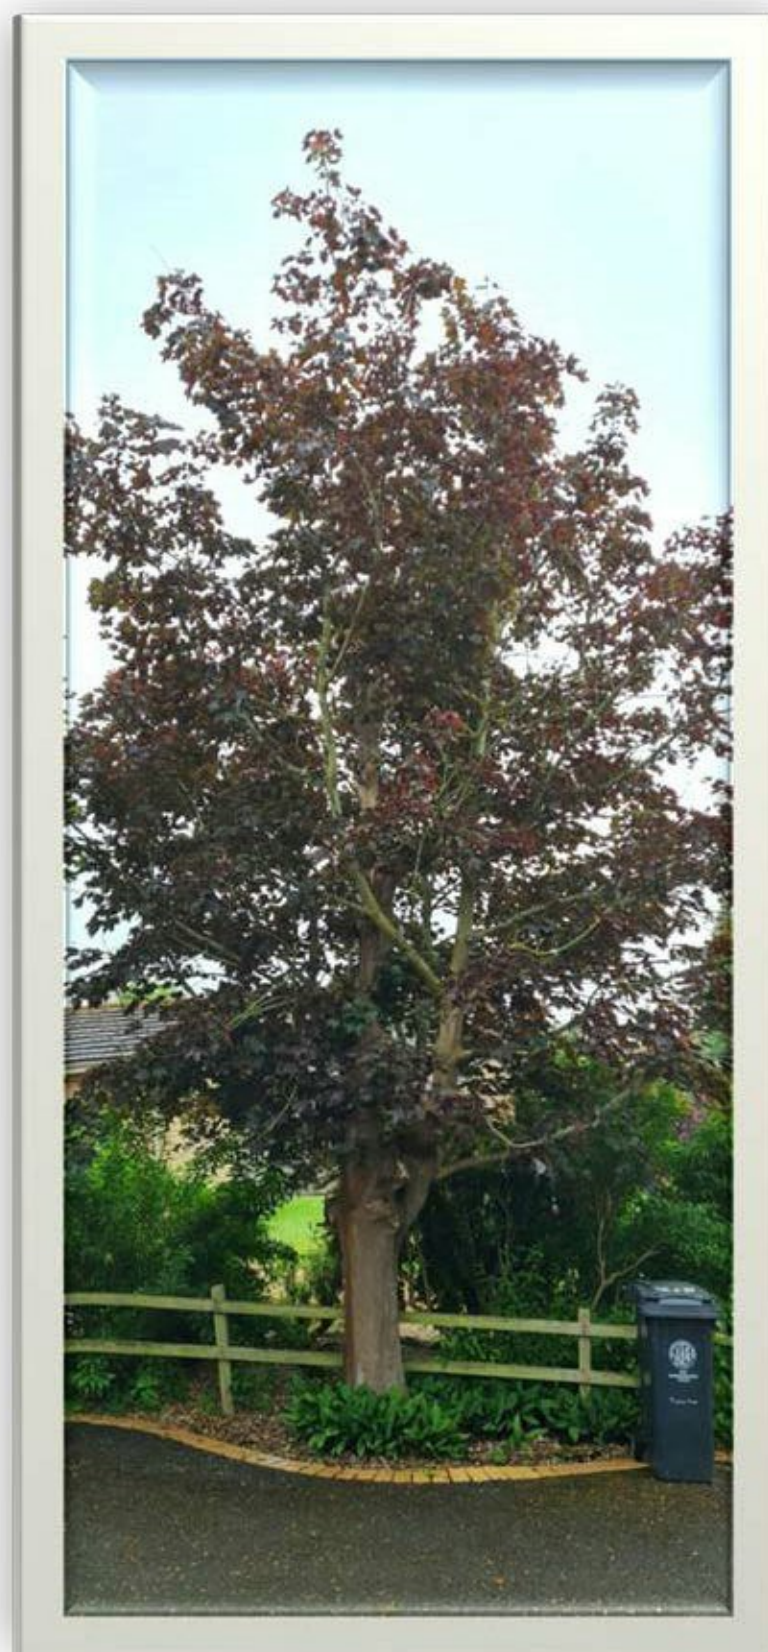
NT4 is a semi-mature Crimson King Norway Maple showing typical die back, the main central trunk is dead.

NT5 is a semi-mature Norway Maple in reasonably good condition, other some historic pruning wounds, there are no significant defects.

The Crimson King Maple is a poor specimen that is in decline and should not be seen as constraint to development.

Although no sound Arboricultural justification can be put forward for the loss of NT5, I would suggest that it could be removed to facilitate the build with a replacement tree planted along the frontage.

Fell NT4 & NT5.
