Arboricultural matters relating to trees on land at and adjacent to Pond Yard, Collyweston.

Prepared by: John Wilcockson

Arboricultural Consultant.

Date: 11/11/16

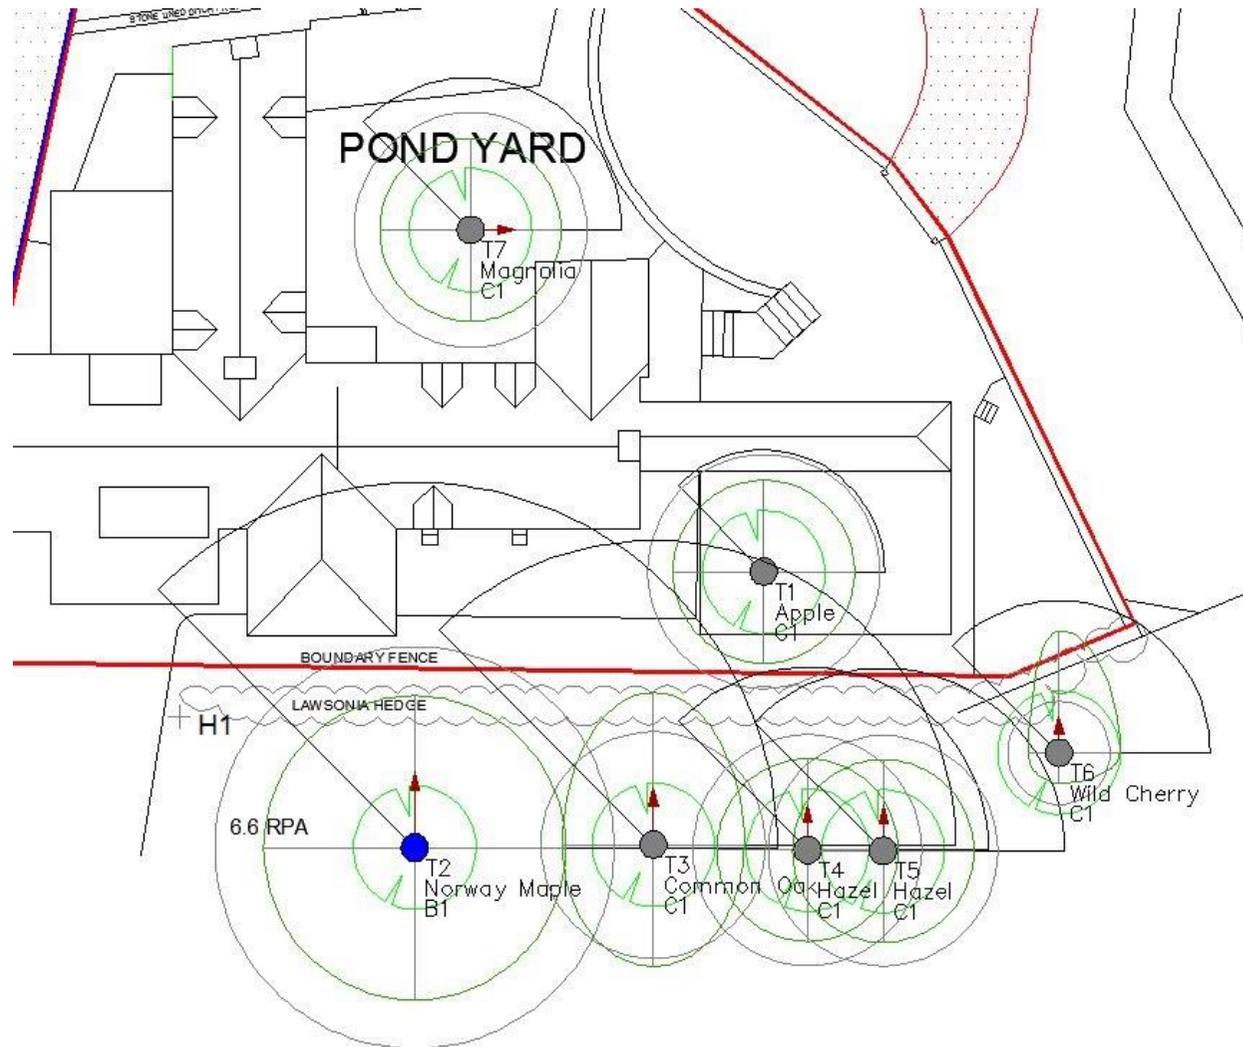
Appendix 2 – Constraints/implications Plan (Not to scale)

The root protection areas have been plotted on the site plan at Appendix 2.

Only T1 Apple and T2 Norway Maple form constraints in terms of their RPAs.

T1 will need to be removed to facilitate the build of the garage, the RPAs of T3, T4 & T5 are not implicated.

The RPA of T2 is not directly implicated by the extension however there is a 10% incursion of the RPA in terms of alterations to the shrub edge.
