# **BS5837 Tree Survey & Arboricultural Impact Assessment**

**Site: Ascot House, Hever Road, TN8 7NP**

**Ref: TCL-MA-AH AIA**

**Issued: 22.06.2021**

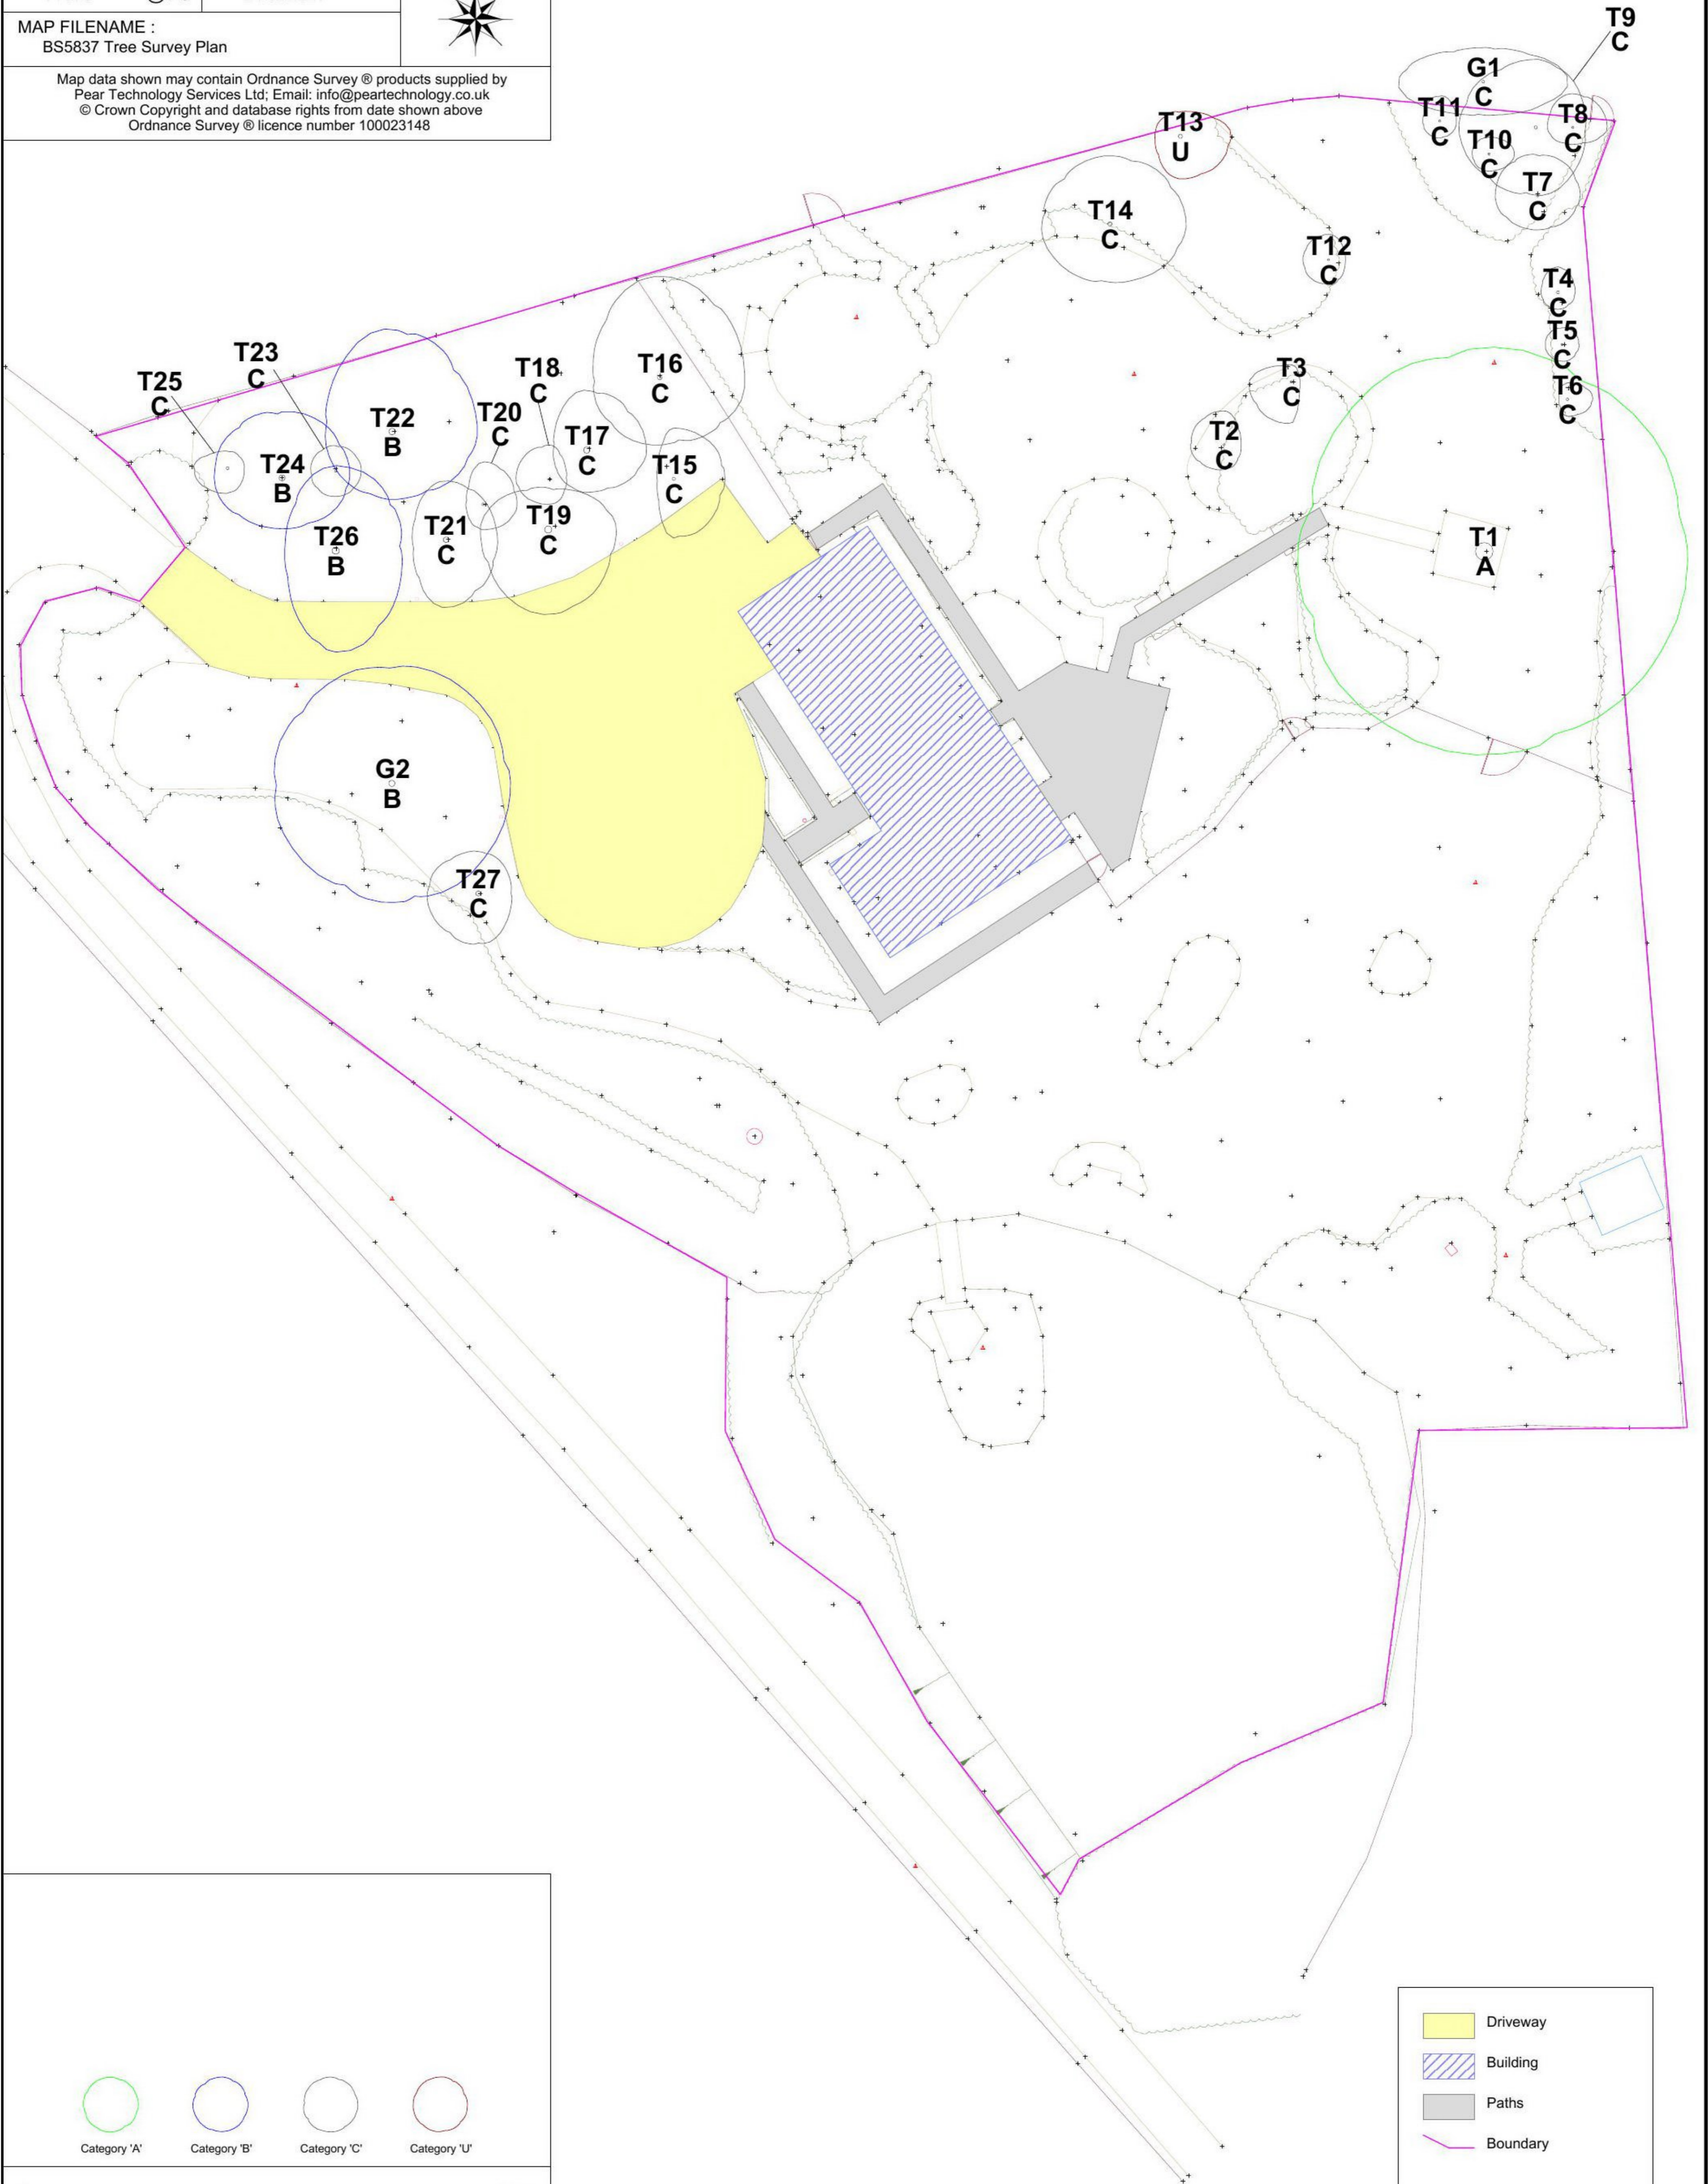
MAP FILENAME :  
BS5837 Tree Survey Plan

**4.1 Tree survey plan:** The tree survey plan (**Appendix B**) is based on tree survey data recorded and plotted onto a topographical plan of the current site layout, and shows the existing trees, numbered and categorised in accordance with BS 5837:2012. Details of each tree surveyed are included in the tree schedule, part of Appendix B.

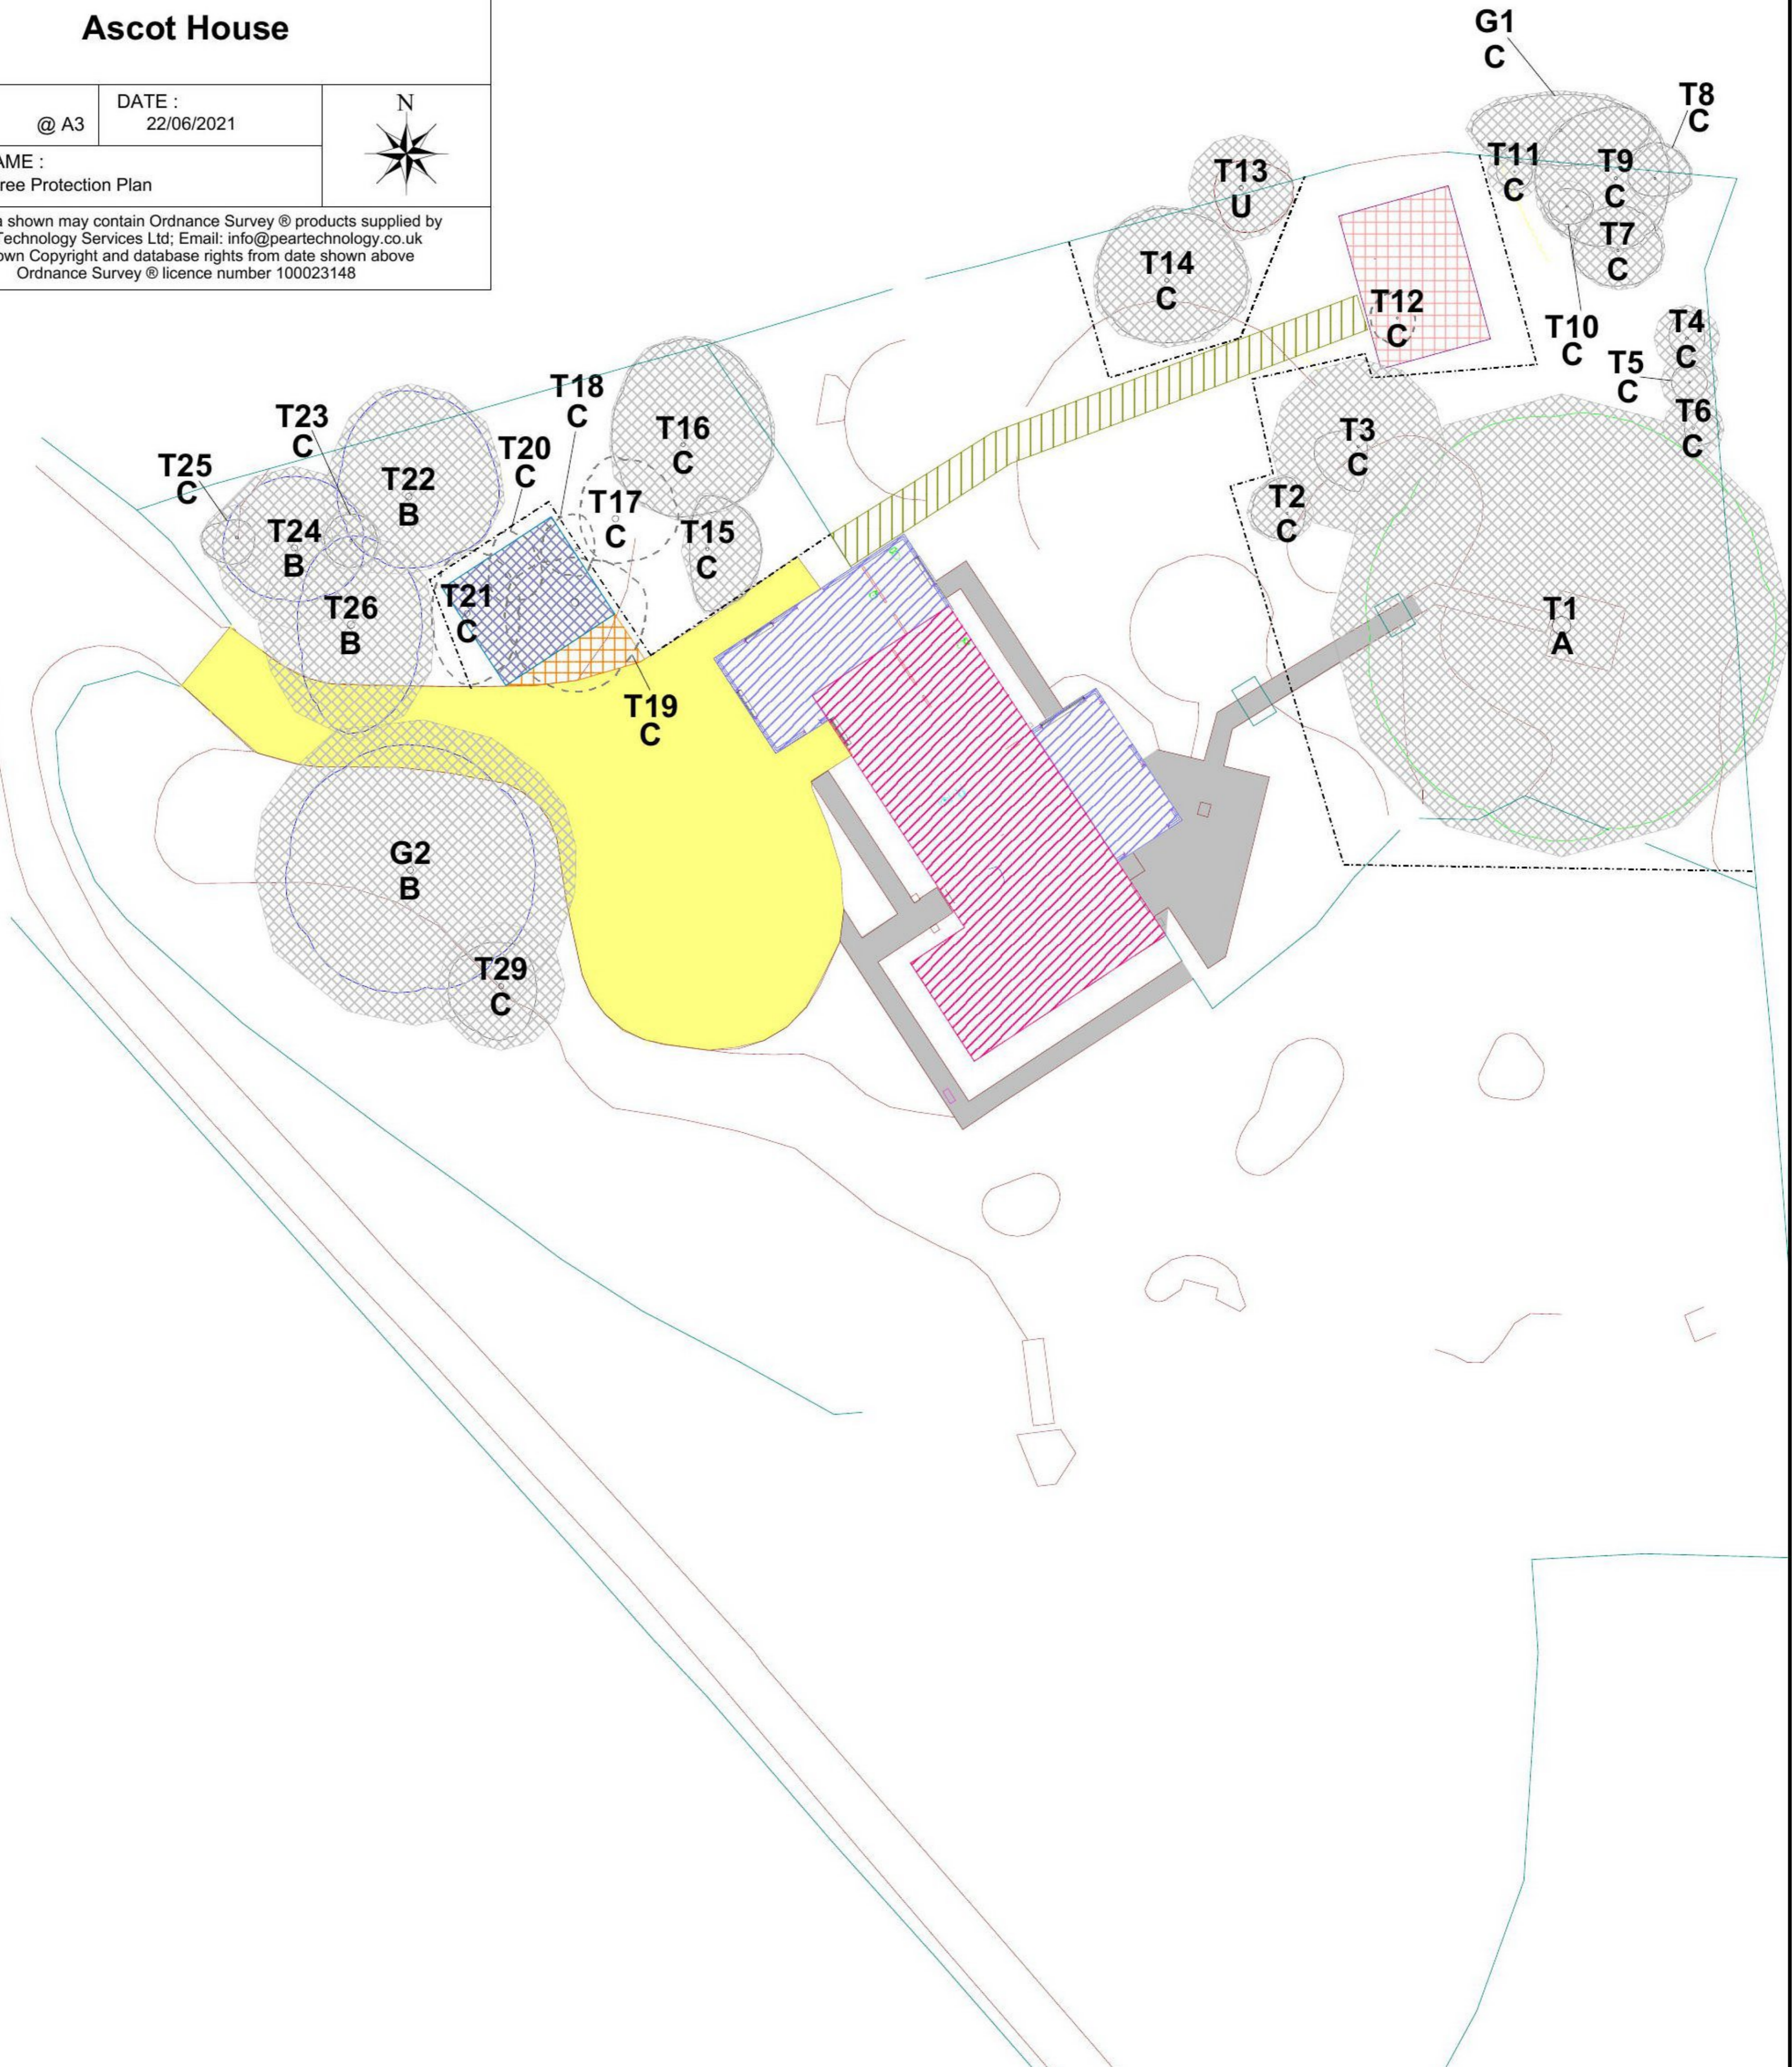
MAP FILENAME : BS5837 Tree Protection Plan

4.1.1 The Tree Protection Plan (**Appendix C**) is based on the tree survey data overlaid onto the proposed layout plan and shows the extent of the RPAs of the surveyed trees. Below ground constraints are represented by the RPA. The above ground constraints arise from the current and ultimate height and spread of the trees. An assessment of the Tree Protection Plan has determined the likely impact of the development proposals on the trees and vice-versa.

**4.3 Incursions within the RPAs of retained trees:** the proposed development works will result in an incursion into the RPA of one retained tree, as detailed below:

Works	Trees/Hedges Affected
Construction of new studio building	T3 (Category C)

The above incursion represents an area of approximately 1.1m<sup>2</sup>, on the outer, northern edge of the 71.97m<sup>2</sup> RPA – approximately 1.57% of the total RPA. This can therefore be considered an extremely minor incursion, particularly as it is 3 metres outside the canopy line of the tree which, as a semi-mature specimen of a species with moderate tolerance to minor ground disturbance, is not at high risk of physiological damage. As the minor incursion is at the very outer edge of the RPA, it is also unlikely that major roots will be discovered or disturbed in the course of the work. Any minor roots which must be removed will be carefully pruned using sharp bypass secateurs or a pruning saw; due to the small size and the location of the incursion area, such minor root pruning is not expected to have any detrimental effect on the tree. Provided, therefore, that protection measures outlined in this report are followed (particularly with regard to use of hand tools only within the RPA, and avoiding soil contamination), the work will cause very little disturbance to the tree. This incursion should therefore have no negative impact on the condition and/or longevity of T3.

**4.8 Protective fencing:** Protective fencing shall be erected in the locations shown on the Tree Protection Plan (**Appendix C**) to provide construction exclusion zones within the RPAs of the retained trees on site. The fencing shall be 'fit for purpose' and preferably as prescribed in section 6.2 (Figure 2) of British Standard 5837: 2012 (e.g. metal welded mesh panels secured with scaffold poles), as illustrated on the copy extract (**Appendix D**).

4.8.1 The RPAs should be regarded as sacrosanct and the fencing should be installed prior to construction works, and plant and machinery arriving on site. The fencing should remain intact throughout the duration of the development and only be removed upon completion.
