Re: The Rise, George Lane, Plympton PL7 1LJ

We visited the above site on Friday 25th June 2021 and undertook a ground based visual survey of all the trees growing at the property ("the site"). The purpose of the survey was to assess the health and safety of the trees and to give recommendations for any risk management of the trees that may be required. The site was walked over and the trees assessed from ground level unless otherwise noted. Where we have noted defects associated with an individual tree that could lead to a risk of harm being caused to persons or property, we have undertaken a detailed inspection of that tree. We have then given recommendations for managing the tree so as to reduce any risk of harm to an acceptable level. Details of those trees subject to a detailed inspection are given at Appendix A of this report. Trees within the survey remit but not individually recorded are considered a low enough risk to not require an individual assessment. A site map, showing the approximate location of the inspected trees, is attached at Appendix B. Photographs of selected trees are attached at Appendix C.

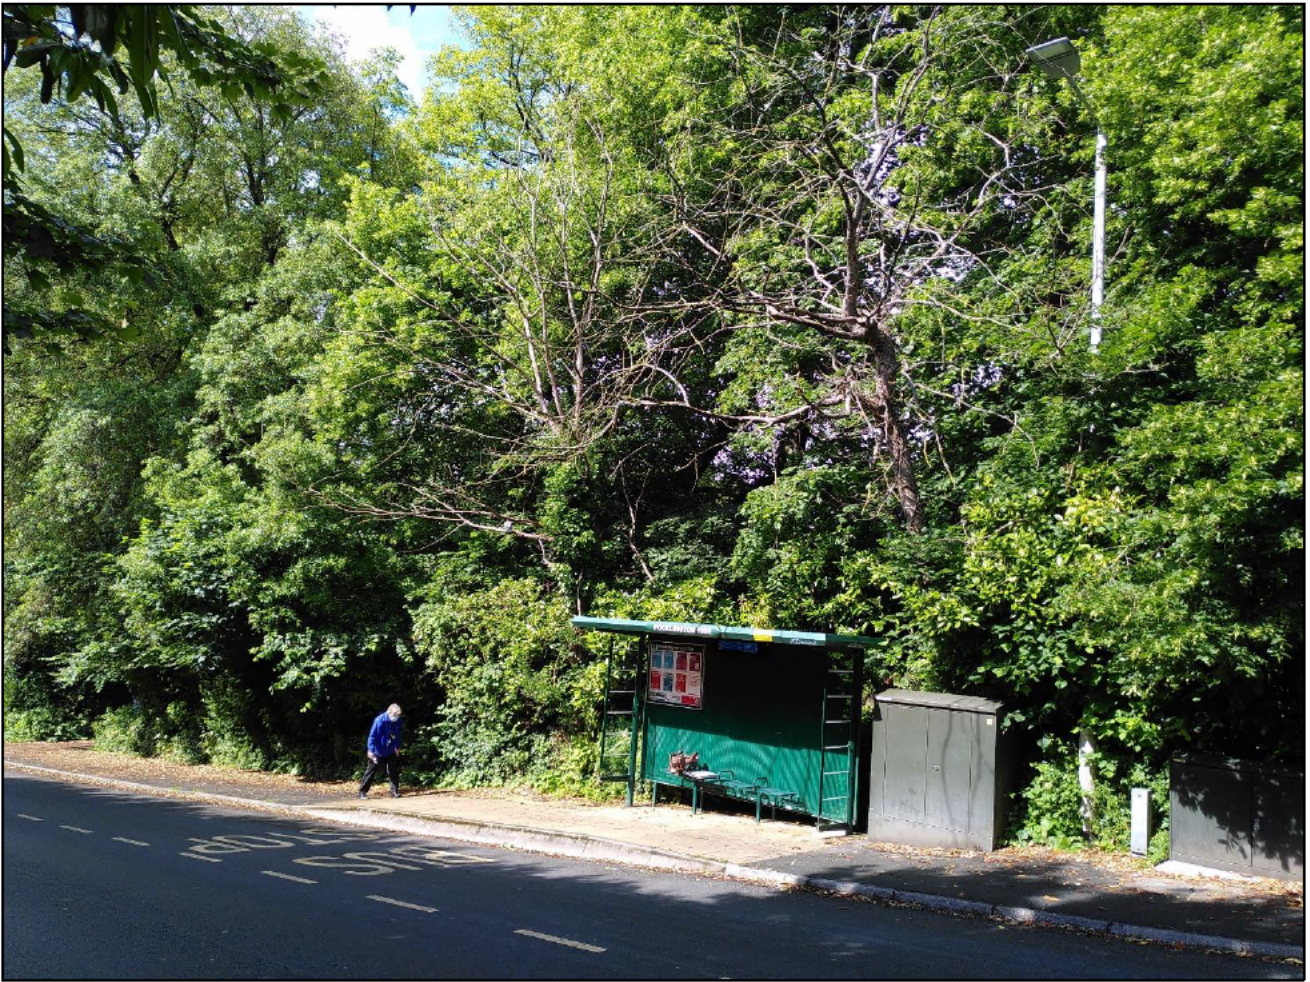
Four other trees growing near George Lane require more significant works. Elms T1986 and T1987 (photograph 1, Appendix C) are both dead and both are sited immediately above the bus stop on George Lane. These trees are likely to have died as a result of infection with Dutch Elm Disease. The two trees have already been identified as hazardous and permission has been given from Plymouth City Council to remove them as a matter of urgency. I advise, when removing these trees, that the appointed contractors also cut back the hedgerow alongside George Lane where obstructing the footpath. These hedge cutting works should not require the prior permission of Plymouth City Council. I have not tagged this hedgerow or marked it on the site map, but the works concerned are self-evident on site. Part of the hedgerow affected is visible in photograph 1.

Photograph 1 – Elms T1986 and T1987

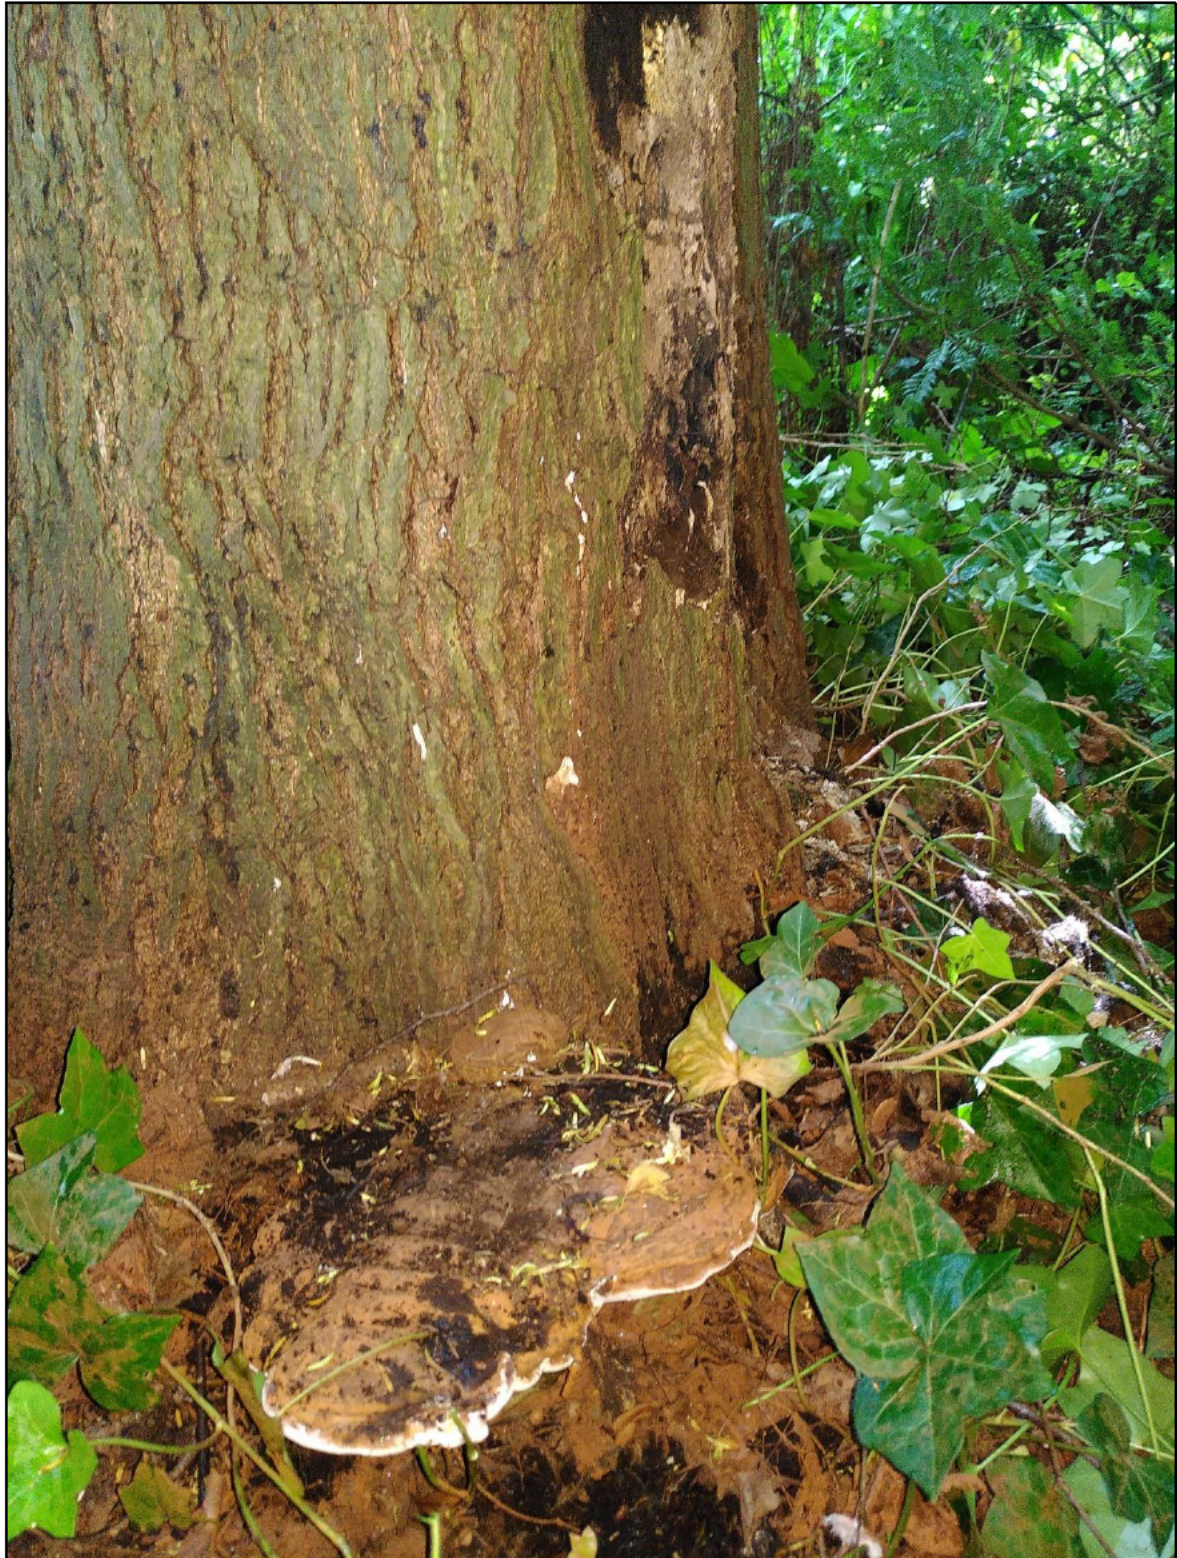
Tree No	Species	Age Class	Ht (m)	L/E	AE	Struct Cond	Phys Cond	Comments	Haz Rate
T1988	Red Oak	M	M	L	M	P	P	<ul style="list-style-type: none"> Tree growing in wooded area and leaning over driveway Strip of decay and dysfunction on lower stem base, western aspect. Visible decay extends for 50cm around basal circumference and rises to a point at around 1.5m above ground level Probing with rod reveals decay extends to at least 50cm into trunk, diameter of trunk at this point 60cm. Sounding with hammer suggests decay throughout base of tree Fungal fruiting bodies at base of tree Tarry exudation from trunk of tree up to around 2m above ground level, particularly prominent on northern trunk aspect Trunk leans over highway to east and crown heavily weighted in this direction Dieback in crown 	H
T1989	Elm	MA	L	L	M	P	G	<ul style="list-style-type: none"> Tree infested with ivy Heavy lean over highway 	L

Photograph 2 – Base of Red Oak T1988

A further, currently healthy Elm T1989, is growing just to the north of T1987, near the entrance to The Rise. This Elm has been suppressed by the adjacent trees to the west and hence leans heavily over the roadside (photograph 4). Nearby is a larger Red Oak, T1988. This tree exhibits dieback within its crown and, upon examination of the tree's trunk, it became clear that this tree presents significant decay within its base. A strip of decayed wood is visible on the western trunk aspect, extending from ground level up to around 1.5m above ground level. Probing with a metal rod revealed that the decay extends at least 50cm into the base of the tree (photograph 3). Sounding with a hammer also suggests that decay is present throughout the trunk. Fungal fruiting bodies of the decay fungus *Ganoderma applanatum* are visible on the base of the tree near the site of decay (photograph 2). The tree leans significantly and is weighted over the driveway and roadside; I therefore consider that this tree requires removal as soon as reasonably possible. The tree is covered by the site TPO and hence any works will require the prior permission of Plymouth City Council. Given that the removal of T1988 will expose the heavily leaning T1989 to new wind stresses and that this Elm tree is also very likely to succumb to the effects of Dutch Elm Disease in the near future, I recommend that Elm T1989 also be removed at the same time as Red Oak T1988.

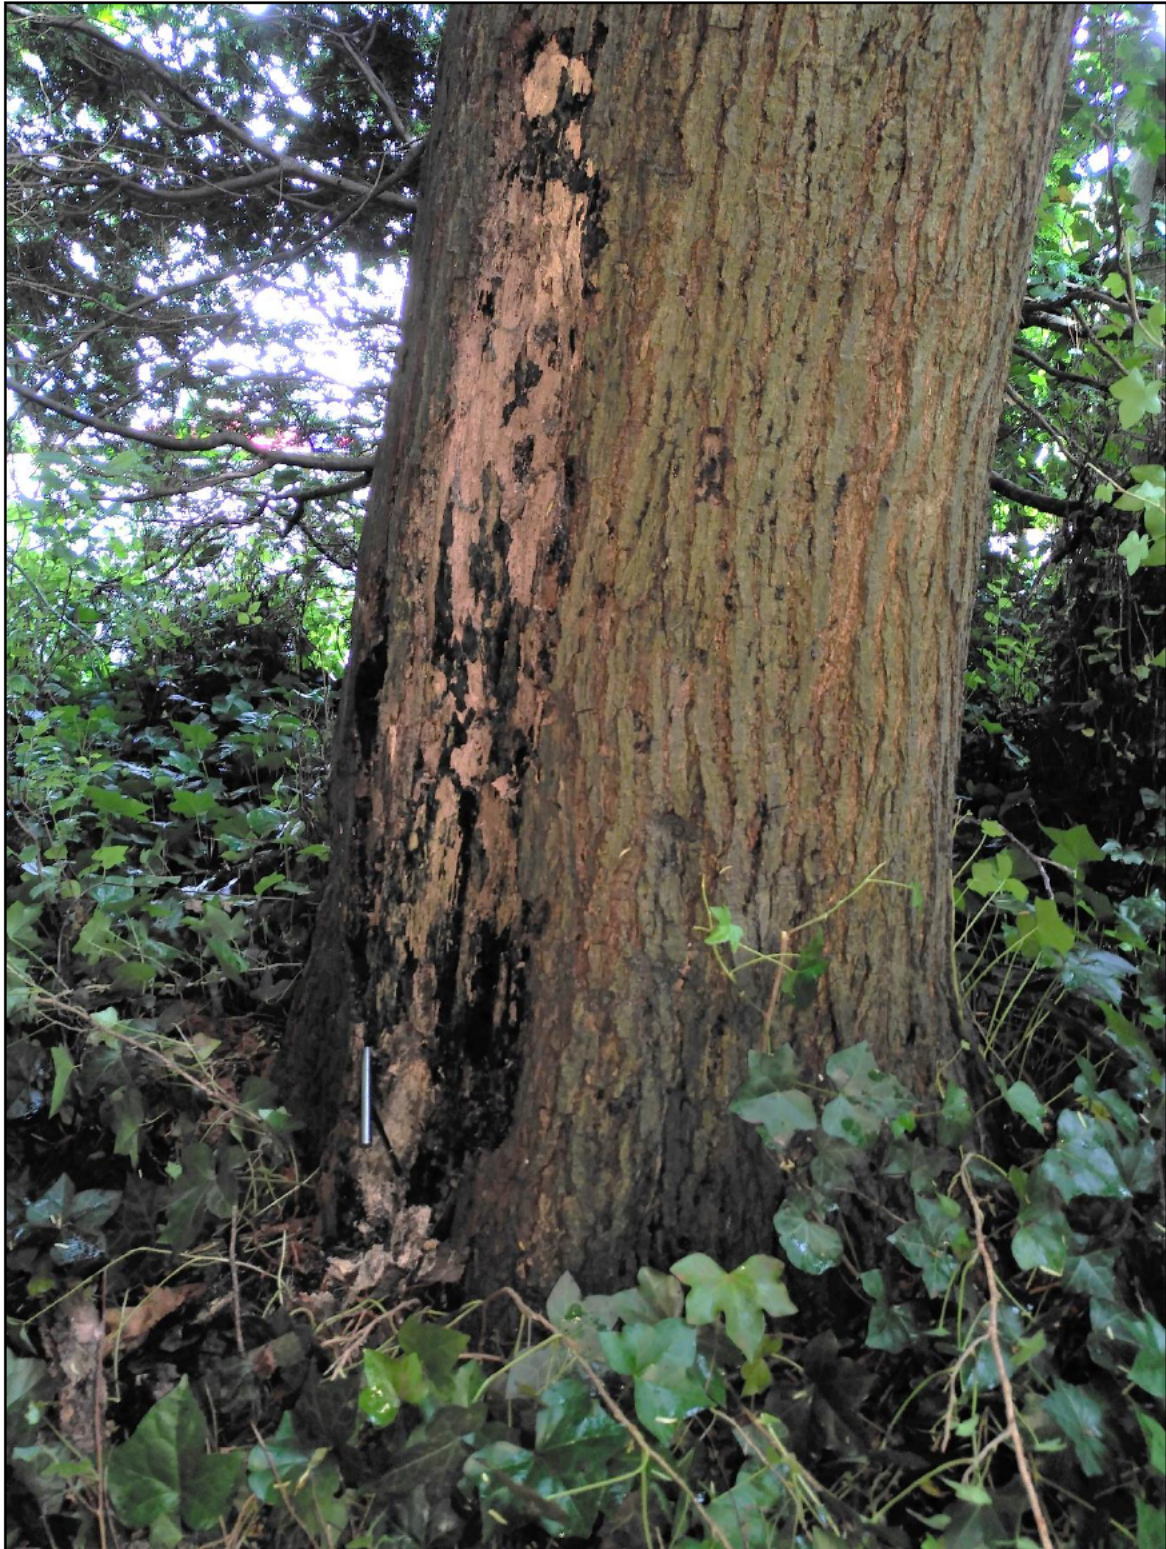
Photograph 3 – Base of T1988 showing rod extended 50cm into base of tree

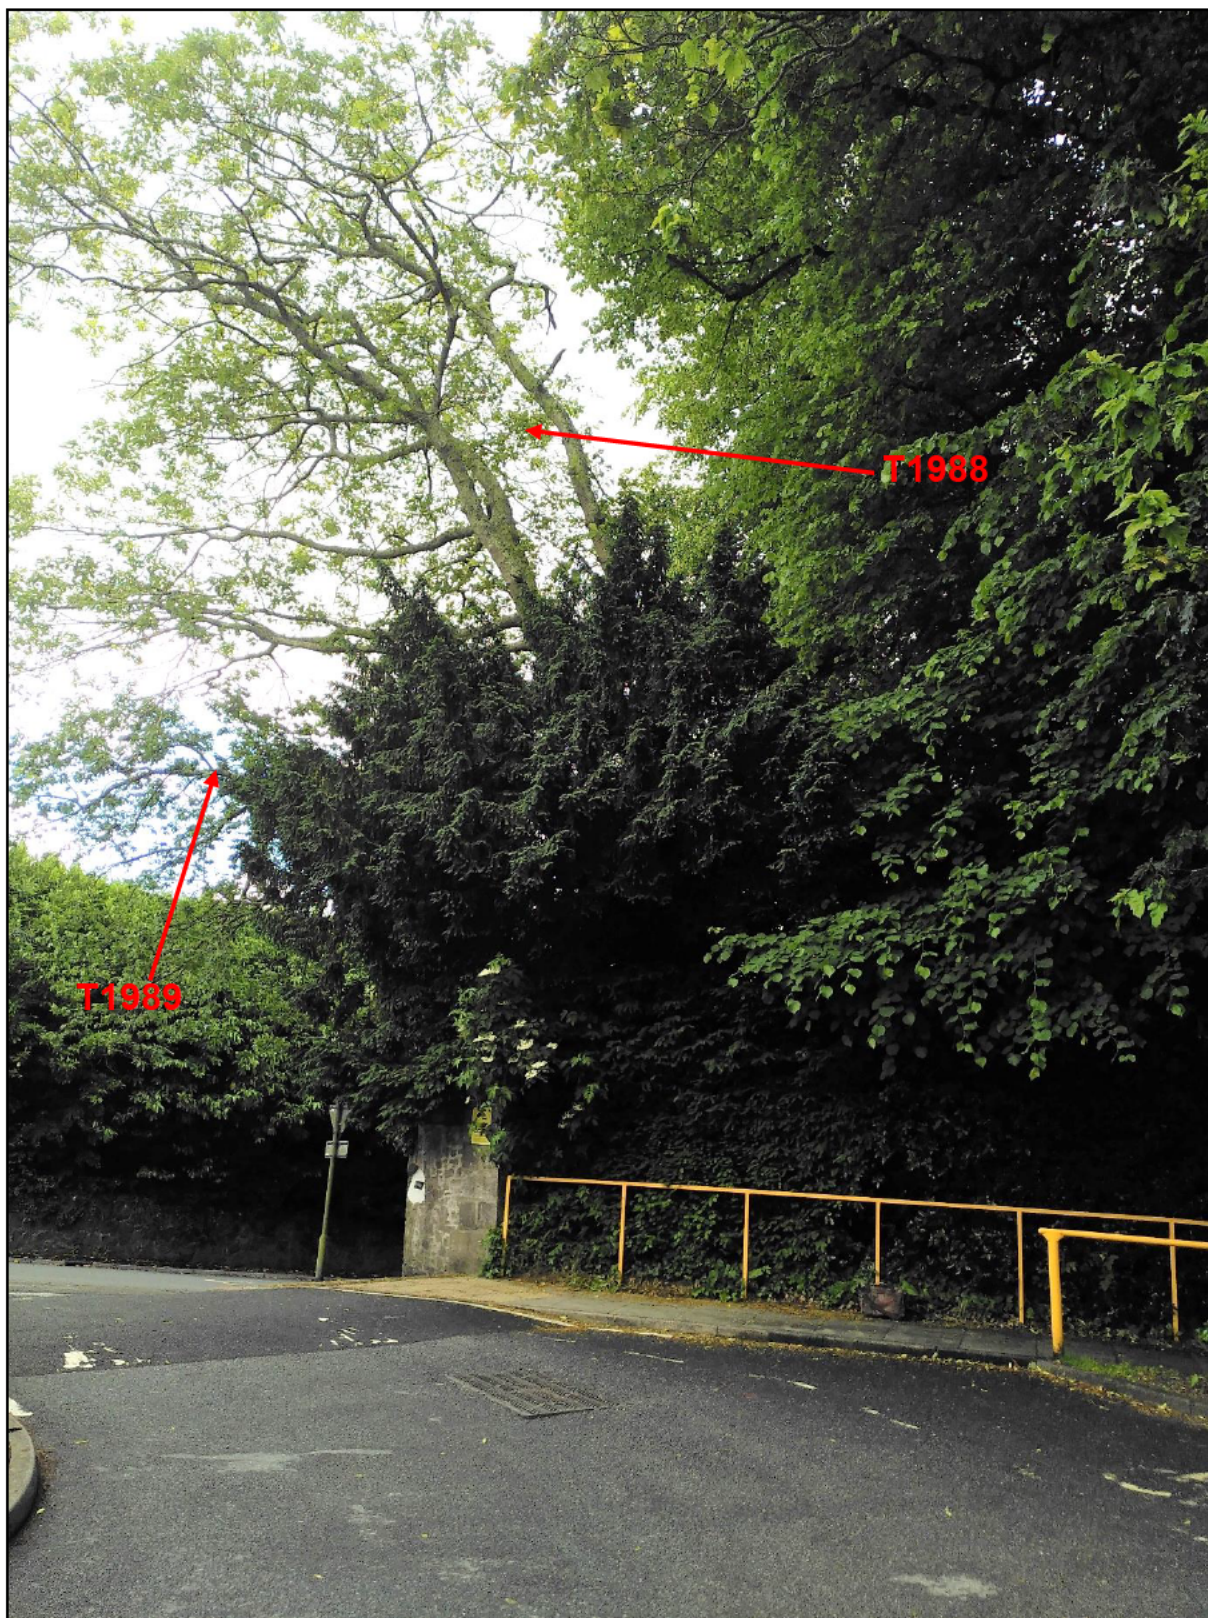
Photograph 4 – T1988 and T1989

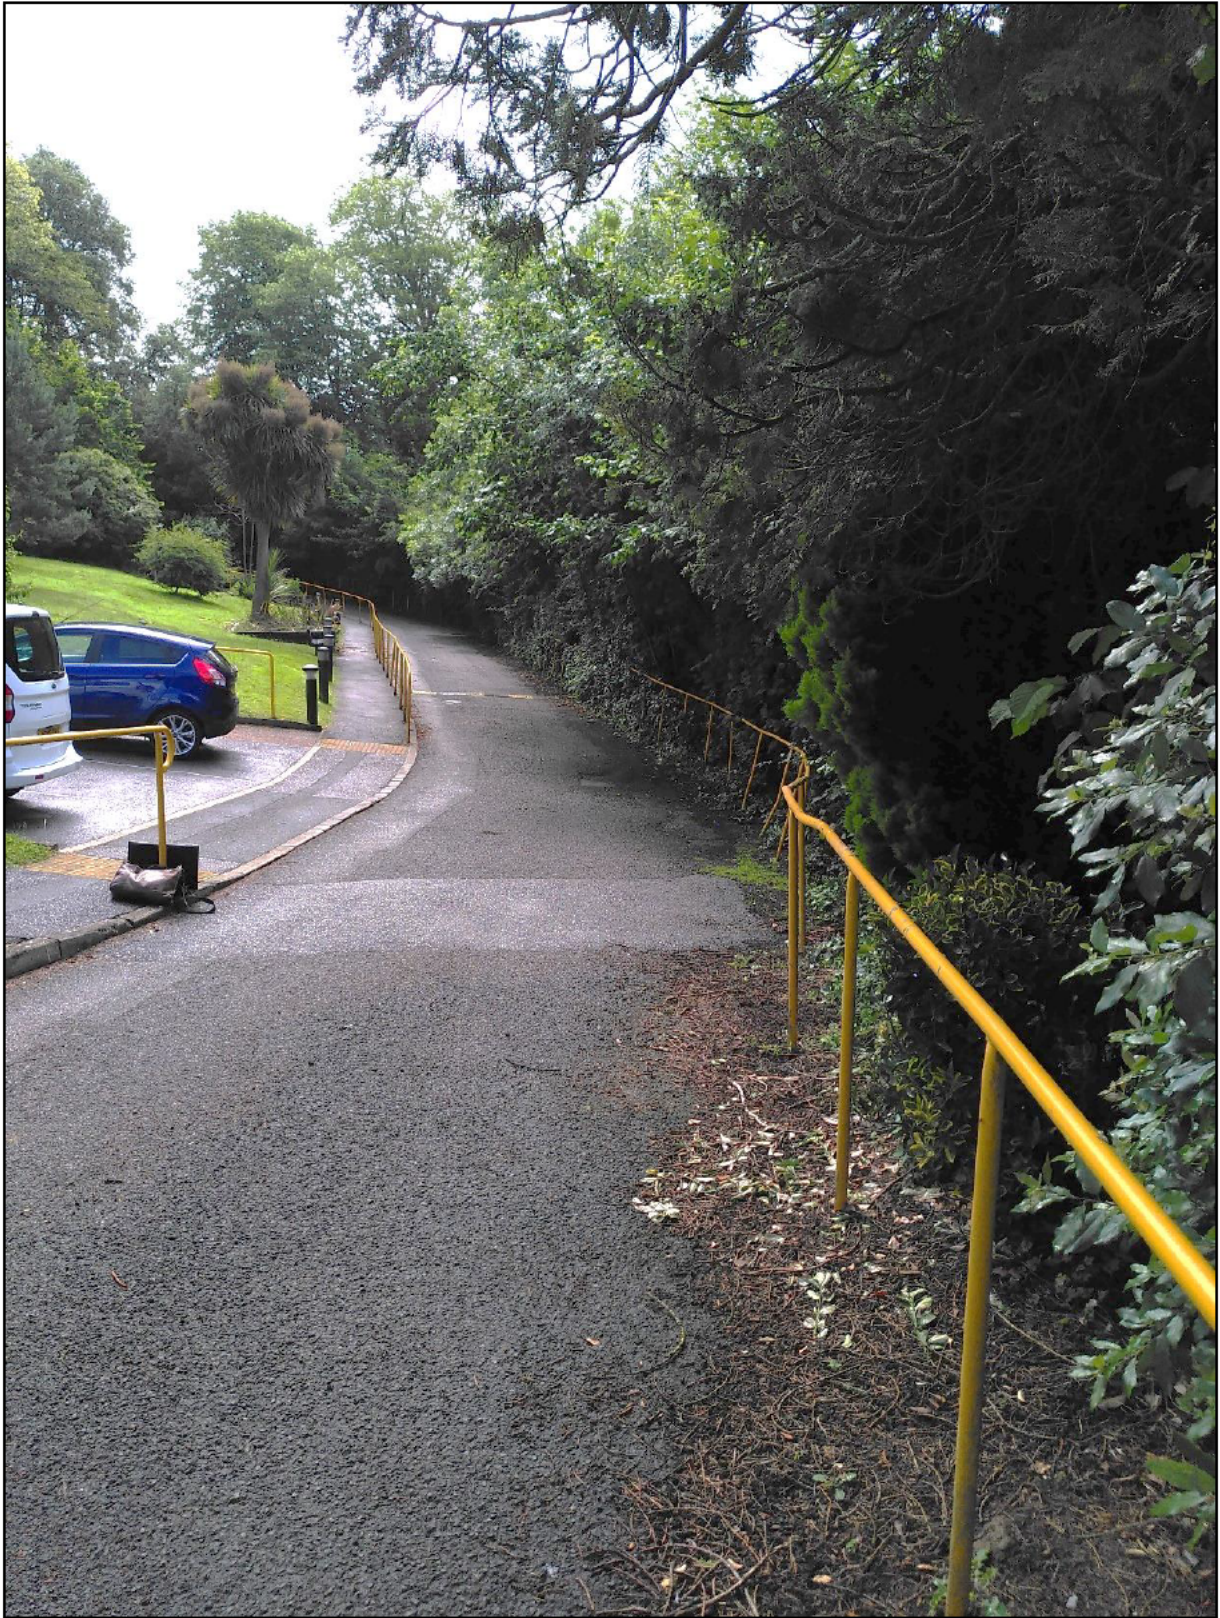
Finally, I note that the hedgerow bordering the rear access lane requires cutting back off this lane. I understand that this hedgerow falls within the ownership of Plymouth City Council. I consider it unlikely that Plymouth City Council are liable for the cutting back of this hedgerow, but that I do advise that you are entitled to cut back the hedgerow to your boundary as required. I advise that this hedgerow be cut back to the boundary as required to clear the driveway. These hedge trimming works should be exempt from requiring a TPO application and therefore do not require the prior permission of Plymouth City Council's planning department. I have not tagged this hedgerow or shown it on the site map at Appendix B but photograph 5 at Appendix C shows a view of the length of hedgerow concerned.

Photograph 5 – Neighbouring hedgerow overhanging driveway
