Tree Risk Management Report

The Loudwater Estate
Chorleywood Road
WD3

Ref: 101 514
Date: August 2020

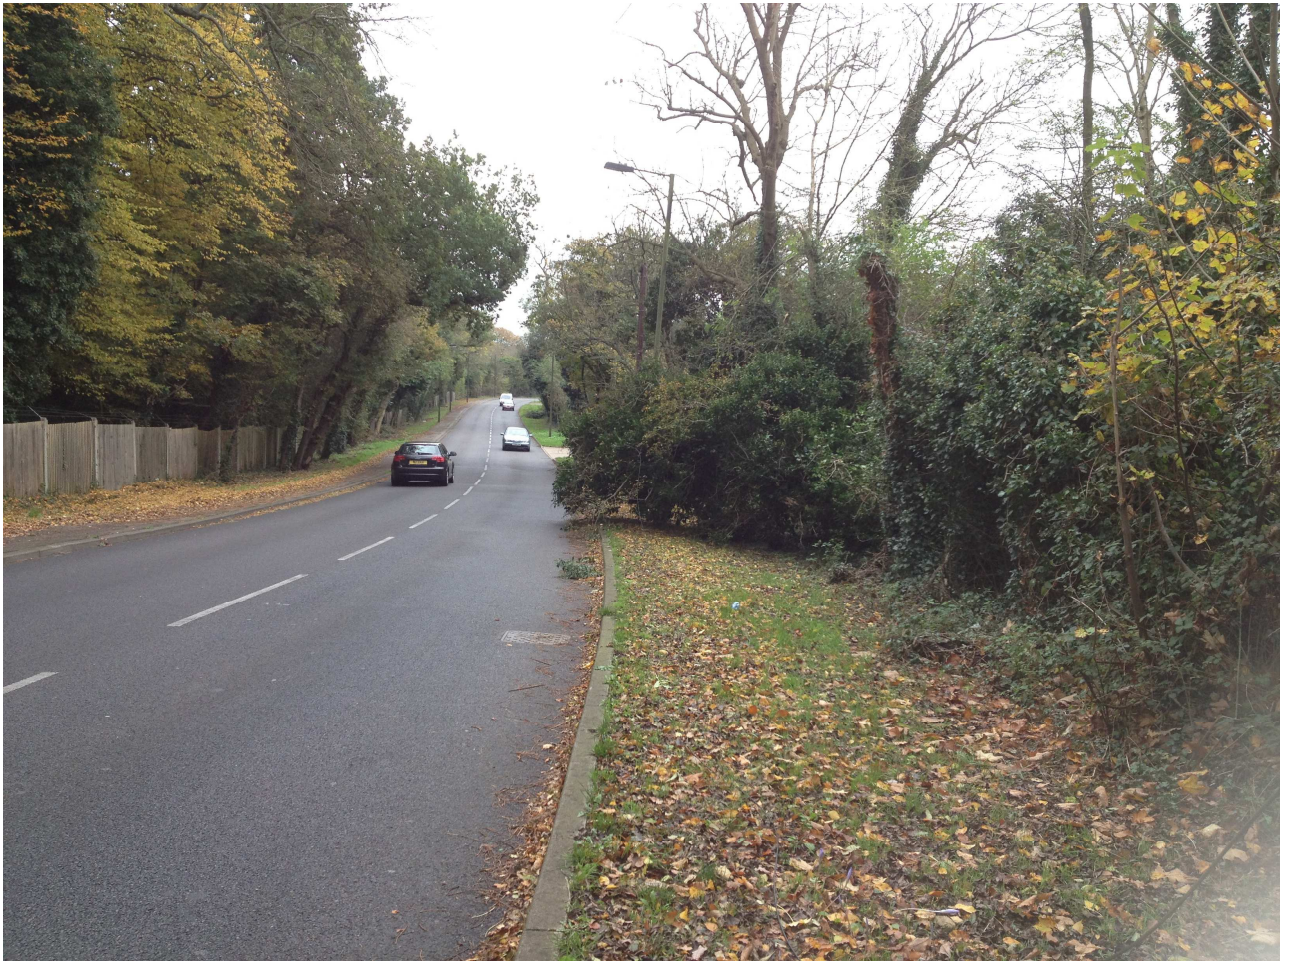
Whilst ivy can be a valuable wildlife habitat, for trees it can obscure structural defects (& any associated decay fungi) in trunks and branches. Ivy can also increase the wind-sail area and weight of crowns. For these reasons, ivy on trees adjacent to roads, paths, buildings and other targets should be managed (see photo below).

Failure of a live ivy-clad hawthorn tree across a road (the extra weight of ivy caused this tree failure)
