**Manor Barn  
Great Trill Farm  
Musbury, Axminster, Devon, EX13 8TU**

Proposed Conversion and adaptation of existing manor barn to form 1No. 4 bedroom dwelling.

**Structural Analysis of Manor Barn in connection with the proposed residential conversion to the eastern half of the barn.**

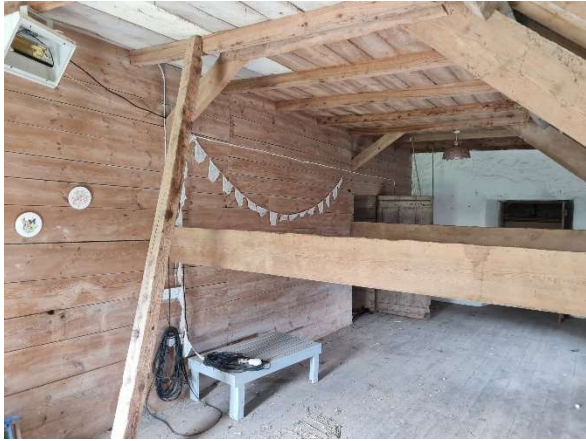
As part of these approvals, it was proposed that the whole of the existing roof structure be raised by approximately 900mm, and the external walls built up to suit this new roof height. The alteration has been proposed in order to facilitate sufficient headroom between the existing first floor level and the underside of the bottom of the roof trusses. It is recognised that this is a significant and unsympathetic intervention, severely affecting the character and setting of the listed building and its fabric.

*Existing first floor showing low level of truss.*

Accordingly, a more sympathetic approach will be employed whereby the collars of the relatively modern roof trusses will be raised to the area over the first-floor habitable accommodation. The trusses over the remaining barn element of the building will remain as existing.

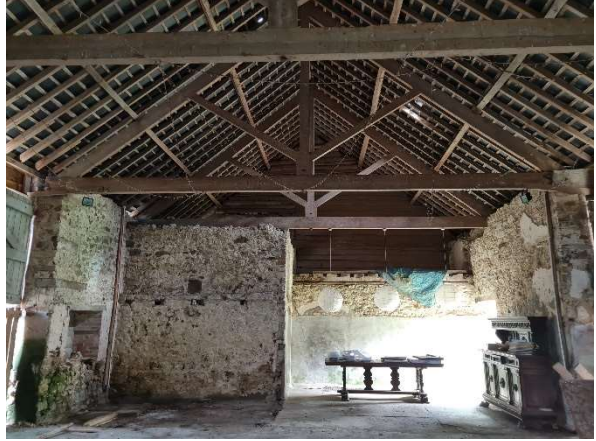
The roof of the barn is slated below which are rafters supported off purlins, which in turn are supported off king post trusses at regular intervals along the length of the barn. Overall, the condition of the roof would appear to be good. All components appear to date from the late 19<sup>th</sup> century tying in with the major 19<sup>th</sup> century intervention, necessitating the need for a new roof structure to the entire barn. The structure is cut in situ with a series of king post trusses employing principal rafters and collars with king post and struts. Common rafters span between 2 purlins on each slope with additional lateral support from short collars near the ridge. No significantly historic roof timbers remain.

*Roof structure over barn*

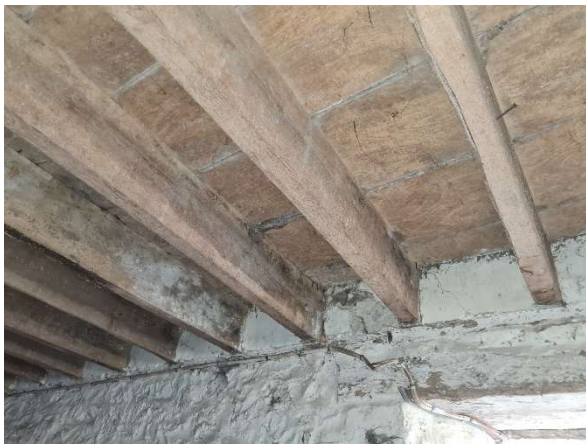
To the east end of the barn, the section which will be converted to a dwelling, is a first-floor structure. This first-floor structure is a combination of primary timber beams and secondary floor joists, housed into the primary beams. A number of areas of joists would appear to be 18<sup>th</sup> C. however there is evidence of a new section of floor over the area where the kitchen and internal staircase are proposed, and these would seem 19<sup>th</sup> C. contemporary with the 19<sup>th</sup> C. roof structure. Floorboards are butt jointed softwood boards.

*Existing first floor structure*

Internally, the first-floor structure, in places, requires repair, where the joist/ beam ends have rotted and it is suggested in the case of joists, new joists are placed alongside the existing, of similar section size and timber species. Where beam ends have rotted, new sections of timber can be provided again of a similar section size and timber species as existing, and these would be spliced to the existing timber beam using bolted steel plates.

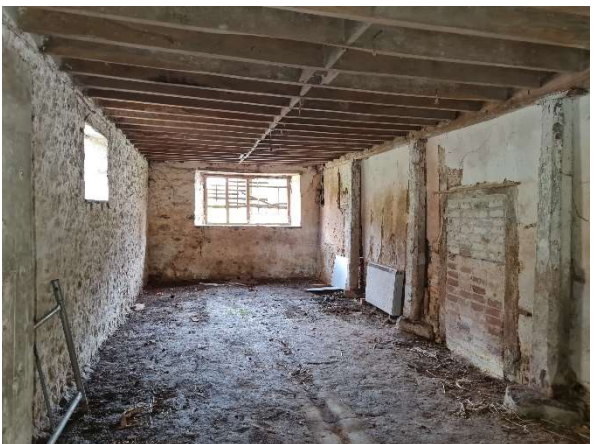
Throughout the barn, at ground floor level, the floor would appear to be an amalgam of packed earth, concrete and areas of flagstones.

*Existing ground floor interior*

At ground floor level a new floor construction is proposed in lieu of the current packed earth and concrete.

This will comprise a limecrete slab laid over a foamed crushed glass insulation layer. This form of construction is a recognised way of introducing an insulated ground floor slab into a building such as this barn, allowing the requisite levels of insulation whilst allowing the building to breathe.

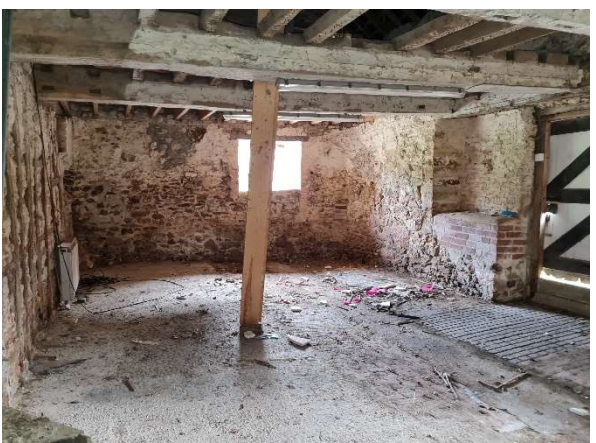
*Existing ground floor interior*
