**Report No.:** J177345 V2  
**Nature of Work:** Demolition Survey  
**Issue Date:** 12/01/2021  
**Client Name:** Regenda Homes  
Commutation Plaza, 1 Commutation Row, Islington, Liverpool,  
L3 8QF  
**Site Address:** Prospect Court (1-6), Rossall Road, Thornton-Cleveleys, FY5  
1HQ

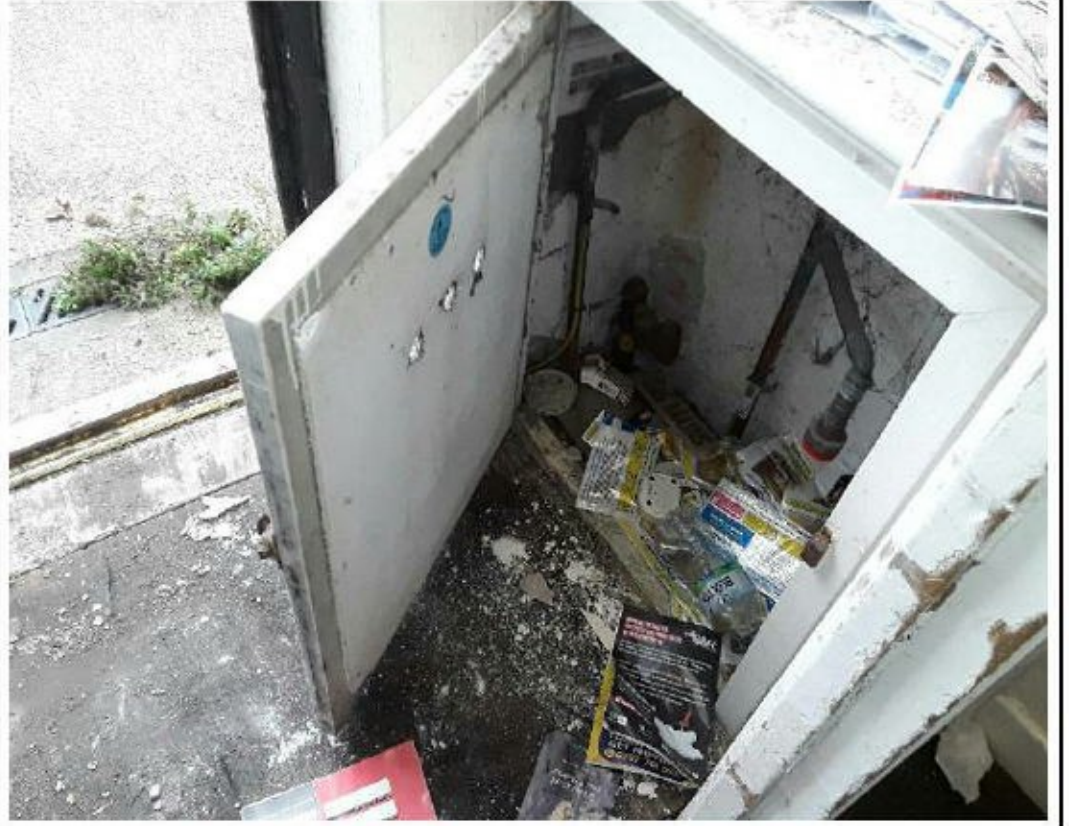
<b>Item:</b>	Insulating board panels to door			
<b>Asbestos Content:</b>		<b>Result Based on:</b>		
No Asbestos Detected		Analysis of sample using PLM		
<b>Sample Analysed By:</b>	C Hay	<b>Extent:</b>	1 m <sup>2</sup>	
<b>Comments:</b> The insulating board panels are also present to the cupboard walls and ceiling. A composite sample was taken, however the insulating board panels appear to be modern and have been sampled to prove no asbestos is present.

<b>Material Assessment Total Score: 0</b>		<b>Likelihood of Disturbance Assessment Total Score: 0</b>		<b>Management Assessment</b>  <b>Recommendations:</b> Not Applicable  <b>Reinspection Interval:</b> Not Applicable  <b>Overall Risk Category:</b> E0
<b>Product Type:</b>	0 Not Applicable	<b>Location:</b>	0 Not Applicable	
<b>Condition:</b>	0 Not Applicable	<b>Accessibility:</b>	0 Not Applicable	
<b>Surface Treatment:</b>	0 Not Applicable			
<b>Asbestos Type:</b>	0 Not Applicable	<b>Extent Score:</b>	0 Not Applicable

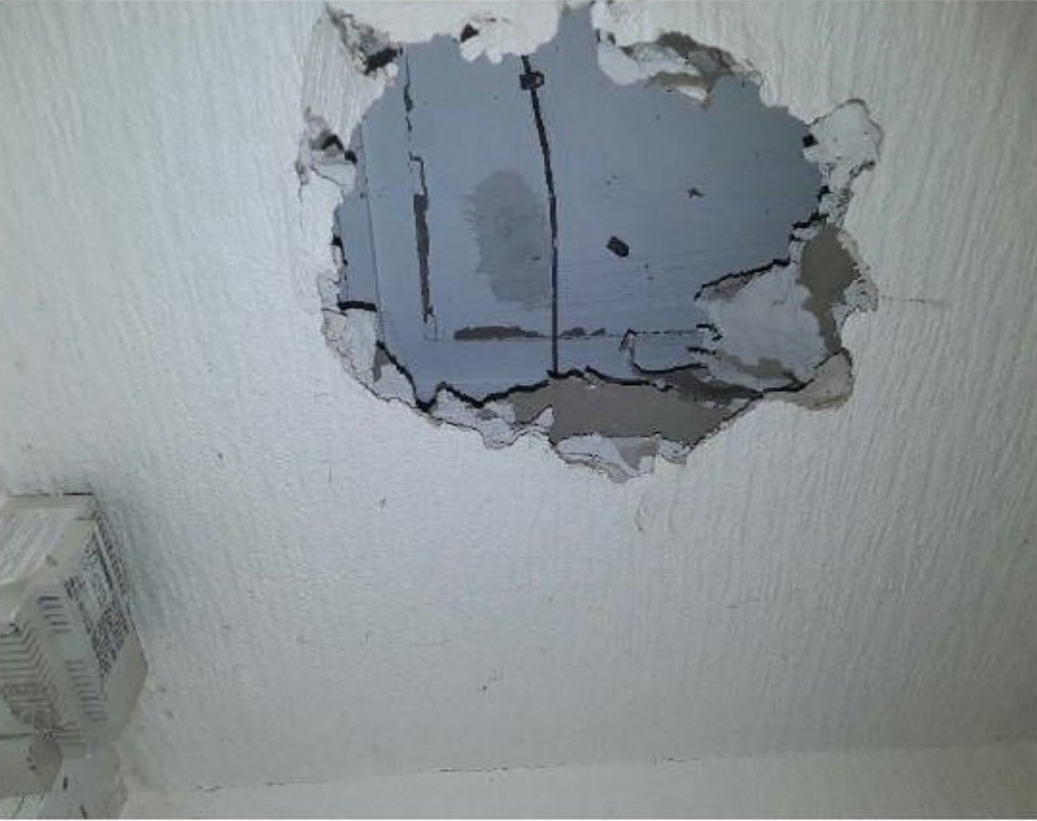
<b>Item:</b>	Textured coating to plasterboard ceiling			
<b>Asbestos Content:</b>		<b>Result Based on:</b>		
No Asbestos Detected		Analysis of sample using PLM		
<b>Sample Analysed By:</b>	C Hay	<b>Extent:</b>	2 m <sup>2</sup>	
<b>Comments:</b> Visible beyond the plasterboard ceiling

<b>Material Assessment Total Score: 0</b>		<b>Likelihood of Disturbance Assessment Total Score: 0</b>		<b>Management Assessment</b>  <b>Recommendations:</b> Not Applicable  <b>Reinspection Interval:</b> Not Applicable  <b>Overall Risk Category:</b> E0
<b>Product Type:</b>	0 Not Applicable	<b>Location:</b>	0 Not Applicable	
<b>Condition:</b>	0 Not Applicable	<b>Accessibility:</b>	0 Not Applicable	
<b>Surface Treatment:</b>	0 Not Applicable			
<b>Asbestos Type:</b>	0 Not Applicable	<b>Extent Score:</b>	0 Not Applicable

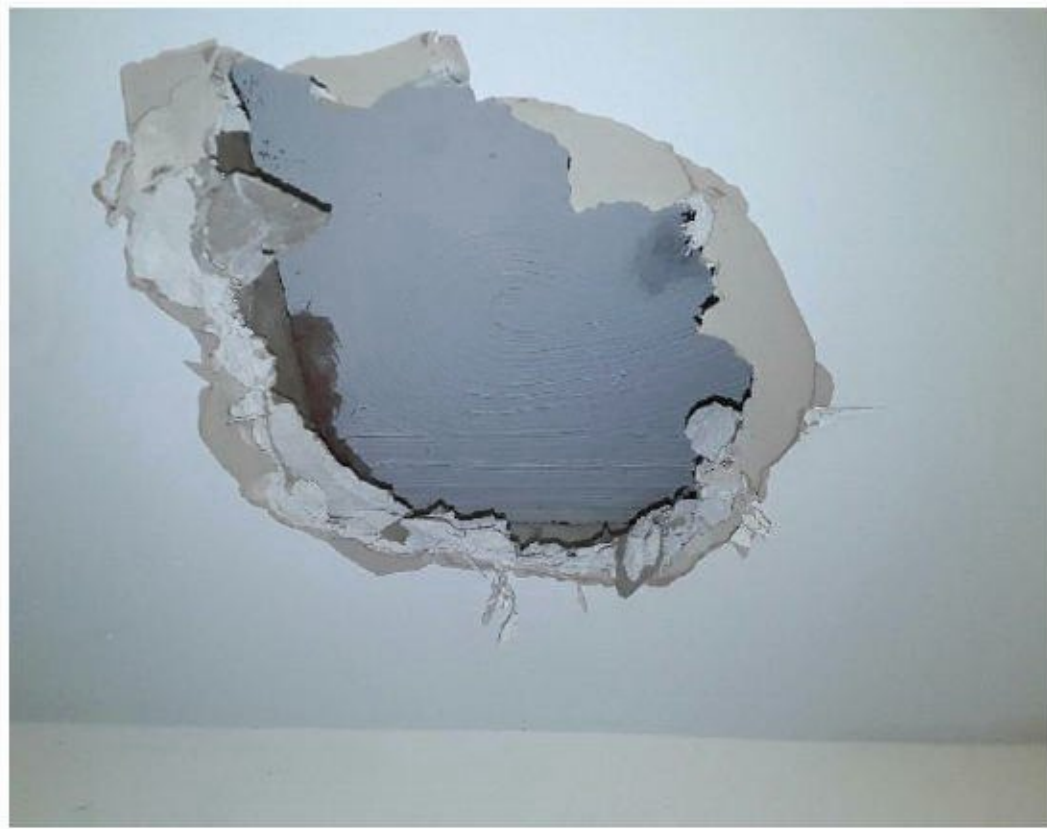
<b>Item:</b>	Textured coating to plasterboard ceiling			
<b>Asbestos Content:</b>		<b>Result Based on:</b>		
No Asbestos Detected		Analysis of sample using PLM		
<b>Sample Analysed By:</b>	C Hay	<b>Extent:</b>	4 m <sup>2</sup>	
<b>Comments:</b> Visible beyond the plasterboard ceiling

<b>Material Assessment Total Score: 0</b>		<b>Likelihood of Disturbance Assessment Total Score: 0</b>		<b>Management Assessment</b>  <b>Recommendations:</b> Not Applicable  <b>Reinspection Interval:</b> Not Applicable  <b>Overall Risk Category:</b> E0
<b>Product Type:</b>	0 Not Applicable	<b>Location:</b>	0 Not Applicable	
<b>Condition:</b>	0 Not Applicable	<b>Accessibility:</b>	0 Not Applicable	
<b>Surface Treatment:</b>	0 Not Applicable			
<b>Asbestos Type:</b>	0 Not Applicable	<b>Extent Score:</b>	0 Not Applicable

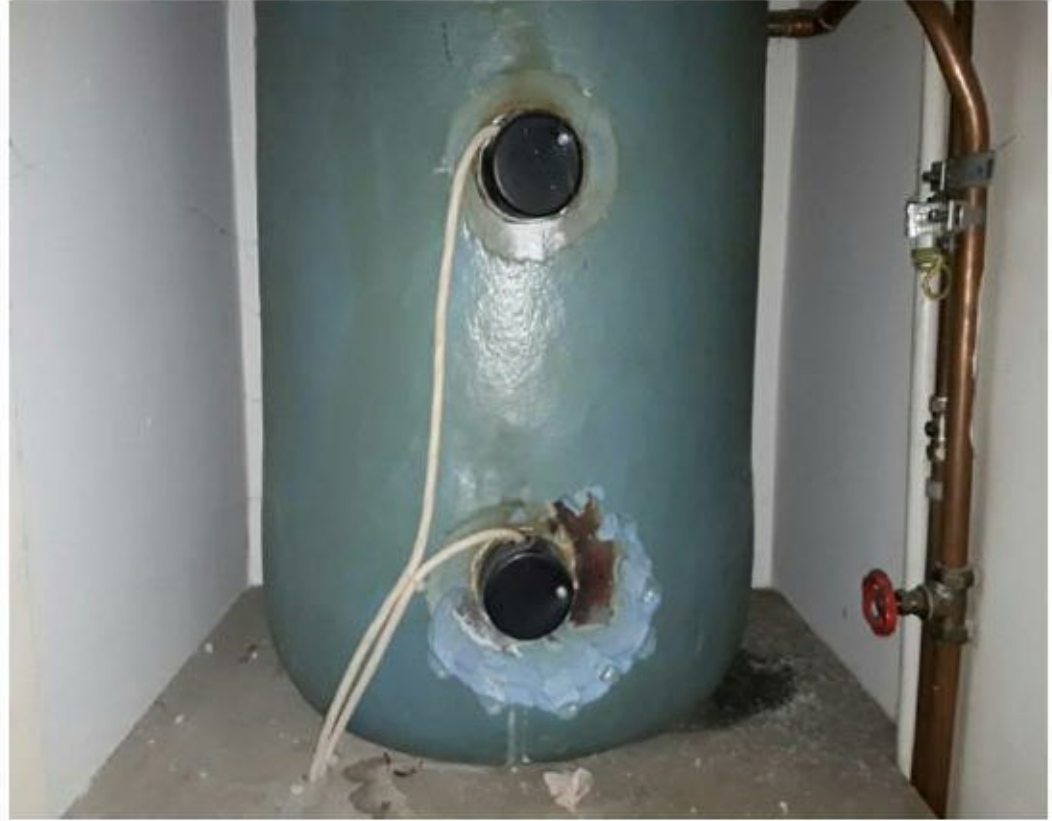
<b>Item:</b>	Gaskets to copper cylinder				
<b>Asbestos Content:</b>		<b>Result Based on:</b>			
No Asbestos Detected		Analysis of sample using PLM			
<b>Sample Analysed By:</b>	S Deasey-Jones	<b>Extent:</b>	2 units		
<b>Comments:</b>

<b>Material Assessment Total Score: 0</b>		<b>Likelihood of Disturbance Assessment Total Score: 0</b>		<b>Management Assessment</b>  <b>Recommendations:</b> Not Applicable  <b>Reinspection Interval:</b> Not Applicable  <b>Overall Risk Category:</b> E0
<b>Product Type:</b>	0 Not Applicable	<b>Location:</b>	0 Not Applicable	
<b>Condition:</b>	0 Not Applicable	<b>Accessibility:</b>	0 Not Applicable	
<b>Surface Treatment:</b>	0 Not Applicable			
<b>Asbestos Type:</b>	0 Not Applicable	<b>Extent Score:</b>	0 Not Applicable

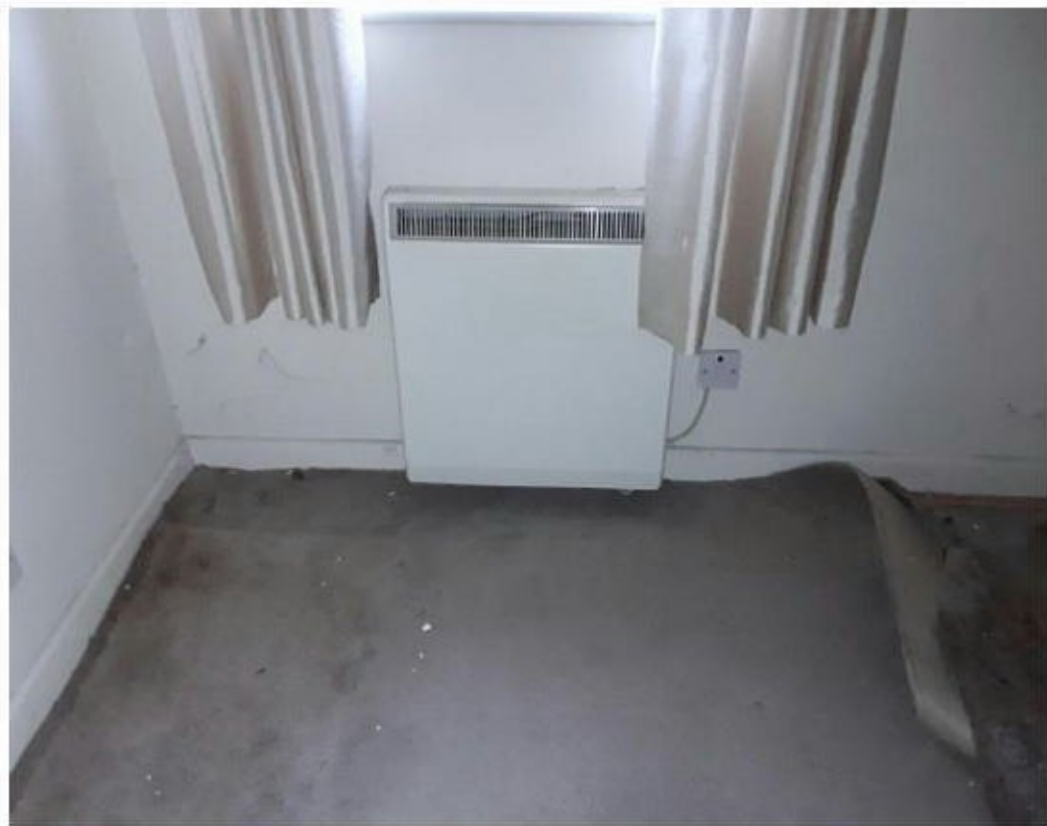
<b>Item:</b>	Asbestos Textile within electric heater				
<b>Asbestos Content:</b>	<b>Result Based on:</b>				
Chrysotile	Presumed				
<b>Sample Analysed By:</b>	Not applicable	<b>Extent:</b>	1 unit		
<b>Comments:</b> Presumed due to no safe access, live and connected

<b>Material Assessment Total Score: 6</b>		<b>Likelihood of Disturbance Assessment Total Score: 3</b>		<p><b>Management Assessment</b></p> <p><b>Recommendations:</b> Program removal</p> <p><b>Reinspection Interval:</b> Not Applicable</p> <p><b>Overall Risk Category:</b> C9</p>
<b>Product Type:</b>	2 (Asbestos textile)	<b>Location:</b>	2 (Rooms up to 100 sq m)	
<b>Condition:</b>	1 (Minor scratches)	<b>Accessibility:</b>	0 (Usually inaccessible or unlikely to be disturbed)	
<b>Surface Treatment:</b>	2 (Unencapsulated textile/paper)			
<b>Asbestos Type:</b>	1 (Chrysotile)	<b>Extent Score:</b>	1 (<10 sq m or 10m pipe run)

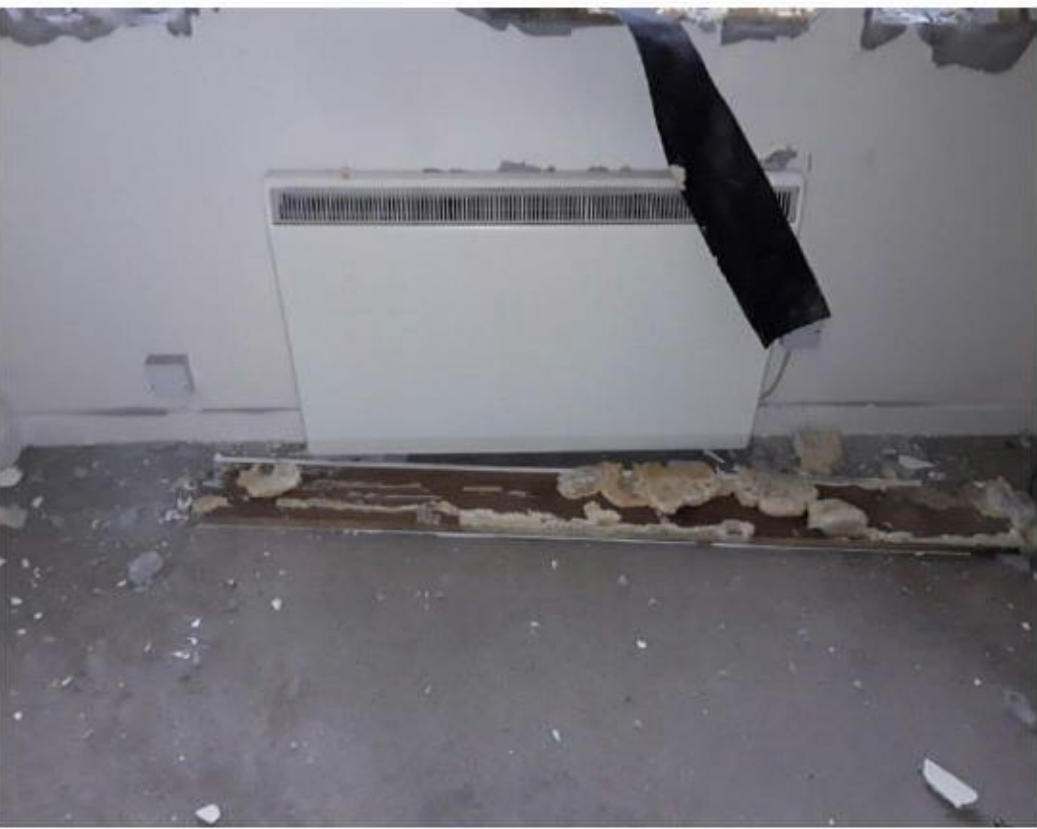
<b>Item:</b>	Asbestos Textile within electric heater				
<b>Asbestos Content:</b>	<b>Result Based on:</b>				
Chrysotile	Presumed				
<b>Sample Analysed By:</b>	Not applicable	<b>Extent:</b>	1 unit		
<b>Comments:</b> Presumed due to no safe access, live and connected

<b>Material Assessment Total Score: 6</b>		<b>Likelihood of Disturbance Assessment Total Score: 3</b>		<p><b>Management Assessment</b></p> <p><b>Recommendations:</b> Program removal</p> <p><b>Reinspection Interval:</b> Not Applicable</p> <p><b>Overall Risk Category:</b> C9</p>
<b>Product Type:</b>	2 (Asbestos textile)	<b>Location:</b>	2 (Rooms up to 100 sq m)	
<b>Condition:</b>	1 (Minor scratches)	<b>Accessibility:</b>	0 (Usually inaccessible or unlikely to be disturbed)	
<b>Surface Treatment:</b>	2 (Unencapsulated textile/paper)			
<b>Asbestos Type:</b>	1 (Chrysotile)	<b>Extent Score:</b>	1 (<10 sq m or 10m pipe run)

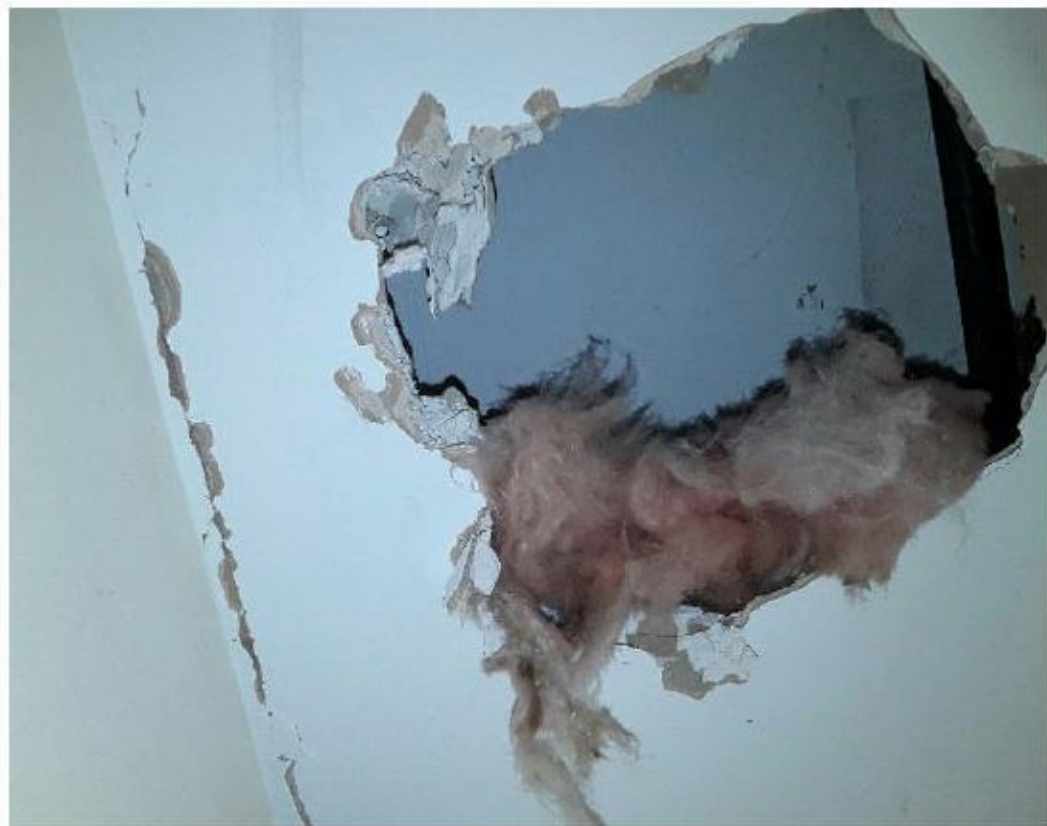
<b>Item:</b>	Textured coating to plasterboard ceiling			
<b>Asbestos Content:</b>		<b>Result Based on:</b>		
No Asbestos Detected		Analysis of sample using PLM		
<b>Sample Analysed By:</b>	C Hay	<b>Extent:</b>	6 m <sup>2</sup>	
<b>Comments:</b> Visible beyond the plasterboard ceiling

<b>Material Assessment Total Score: 0</b>		<b>Likelihood of Disturbance Assessment Total Score: 0</b>		<b>Management Assessment</b>  <b>Recommendations:</b> Not Applicable  <b>Reinspection Interval:</b> Not Applicable  <b>Overall Risk Category:</b> E0
<b>Product Type:</b>	0 Not Applicable	<b>Location:</b>	0 Not Applicable	
<b>Condition:</b>	0 Not Applicable	<b>Accessibility:</b>	0 Not Applicable	
<b>Surface Treatment:</b>	0 Not Applicable			
<b>Asbestos Type:</b>	0 Not Applicable	<b>Extent Score:</b>	0 Not Applicable

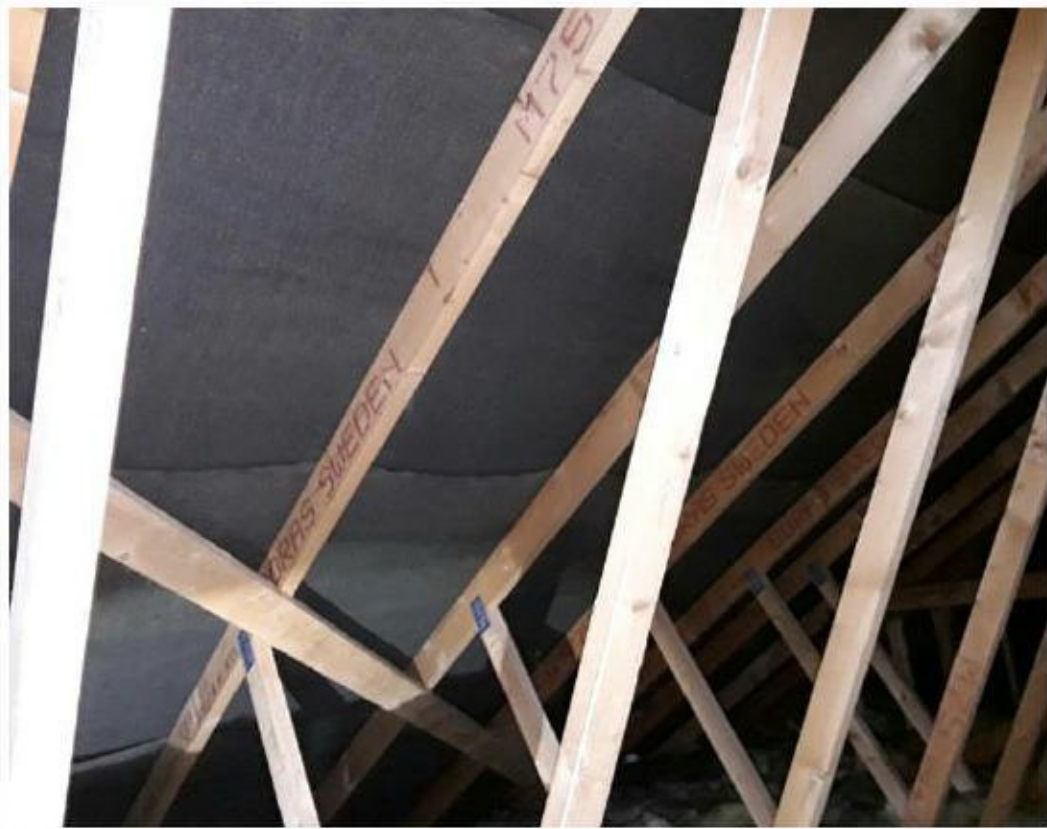
<b>Item:</b>	Bitumen roof sarking			
<b>Asbestos Content:</b>		<b>Result Based on:</b>		
No Asbestos Detected		Analysis of sample using PLM		
<b>Sample Analysed By:</b>	S Deasey-Jones	<b>Extent:</b>	70 m <sup>2</sup>	
<b>Comments:</b> Present to the underside of a pitched roof

<b>Material Assessment Total Score: 0</b>		<b>Likelihood of Disturbance Assessment Total Score: 0</b>		<b>Management Assessment</b>  <b>Recommendations:</b> Not Applicable  <b>Reinspection Interval:</b> Not Applicable  <b>Overall Risk Category:</b> E0
<b>Product Type:</b>	0 Not Applicable	<b>Location:</b>	0 Not Applicable	
<b>Condition:</b>	0 Not Applicable	<b>Accessibility:</b>	0 Not Applicable	
<b>Surface Treatment:</b>	0 Not Applicable			
<b>Asbestos Type:</b>	0 Not Applicable	<b>Extent Score:</b>	0 Not Applicable

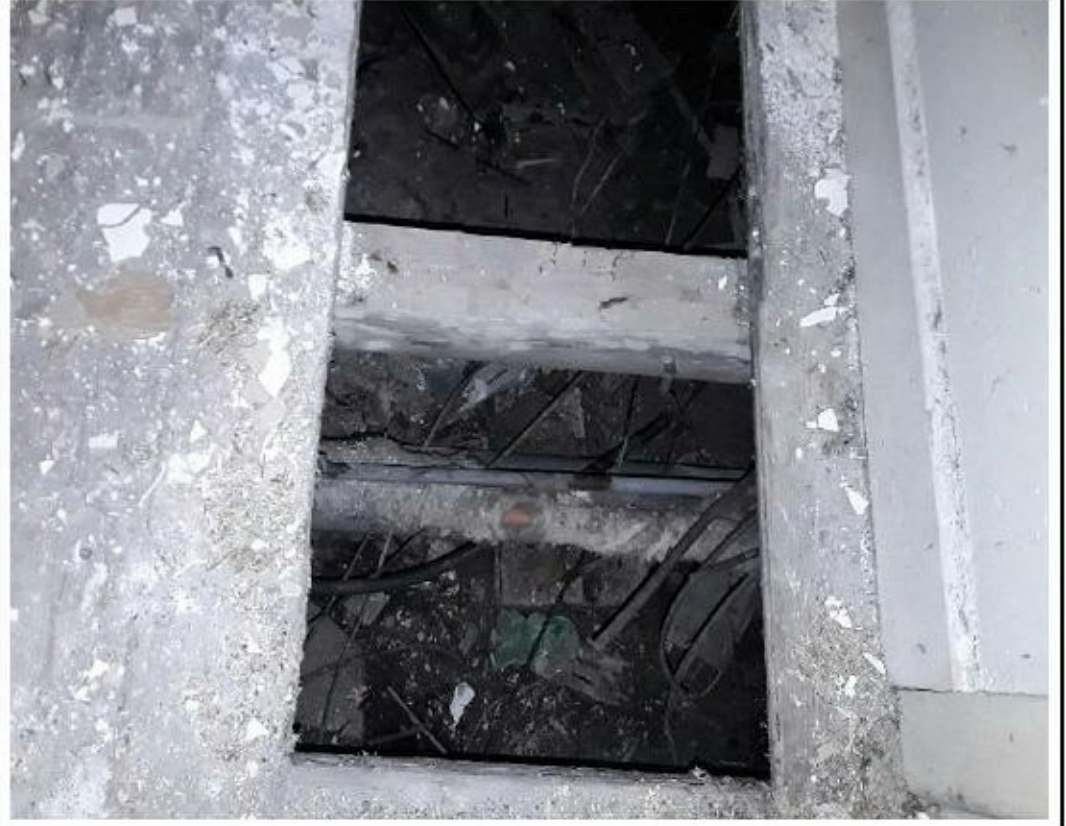
<b>Item:</b>	Hessian wrapped copper pipework			
<b>Asbestos Content:</b>	<b>Result Based on:</b>			
No Asbestos Detected	Analysis of sample using PLM			
<b>Sample Analysed By:</b>	C Hay	<b>Extent:</b>	10 linear metres	
<b>Comments:</b> The Hessian wrap is located beyond the timber floorboards and present to numerous pipework. It appears to be modern and has been sampled to prove no asbestos is present.

<b>Material Assessment Total Score: 0</b>		<b>Likelihood of Disturbance Assessment Total Score: 0</b>		<b>Management Assessment</b>  <b>Recommendations:</b> Not Applicable  <b>Reinspection Interval:</b> Not Applicable  <b>Overall Risk Category:</b> E0
<b>Product Type:</b>	0 Not Applicable	<b>Location:</b>	0 Not Applicable	
<b>Condition:</b>	0 Not Applicable	<b>Accessibility:</b>	0 Not Applicable	
<b>Surface Treatment:</b>	0 Not Applicable			
<b>Asbestos Type:</b>	0 Not Applicable	<b>Extent Score:</b>	0 Not Applicable

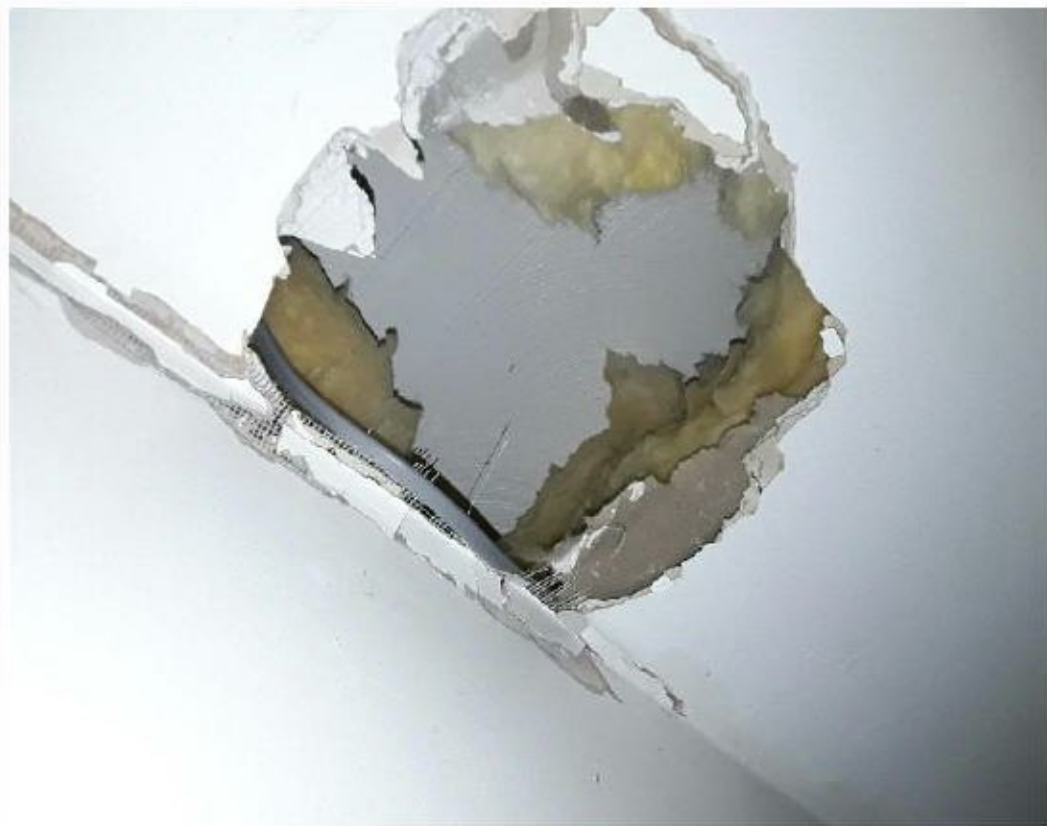
<b>Item:</b>	Textured coating to plasterboard ceiling				
<b>Asbestos Content:</b>		<b>Result Based on:</b>			
No Asbestos Detected		Analysis of sample using PLM			
<b>Sample Analysed By:</b>	C Hay	<b>Extent:</b>	7 m <sup>2</sup>		
<b>Comments:</b> Visible beyond plaster to plasterboard ceiling

<b>Material Assessment Total Score: 0</b>		<b>Likelihood of Disturbance Assessment Total Score: 0</b>		<p><b>Management Assessment</b></p> <p><b>Recommendations:</b> Not Applicable</p> <p><b>Reinspection Interval:</b> Not Applicable</p> <p><b>Overall Risk Category:</b> E0</p>
<b>Product Type:</b>	0 Not Applicable	<b>Location:</b>	0 Not Applicable	
<b>Condition:</b>	0 Not Applicable	<b>Accessibility:</b>	0 Not Applicable	
<b>Surface Treatment:</b>	0 Not Applicable			
<b>Asbestos Type:</b>	0 Not Applicable	<b>Extent Score:</b>	0 Not Applicable

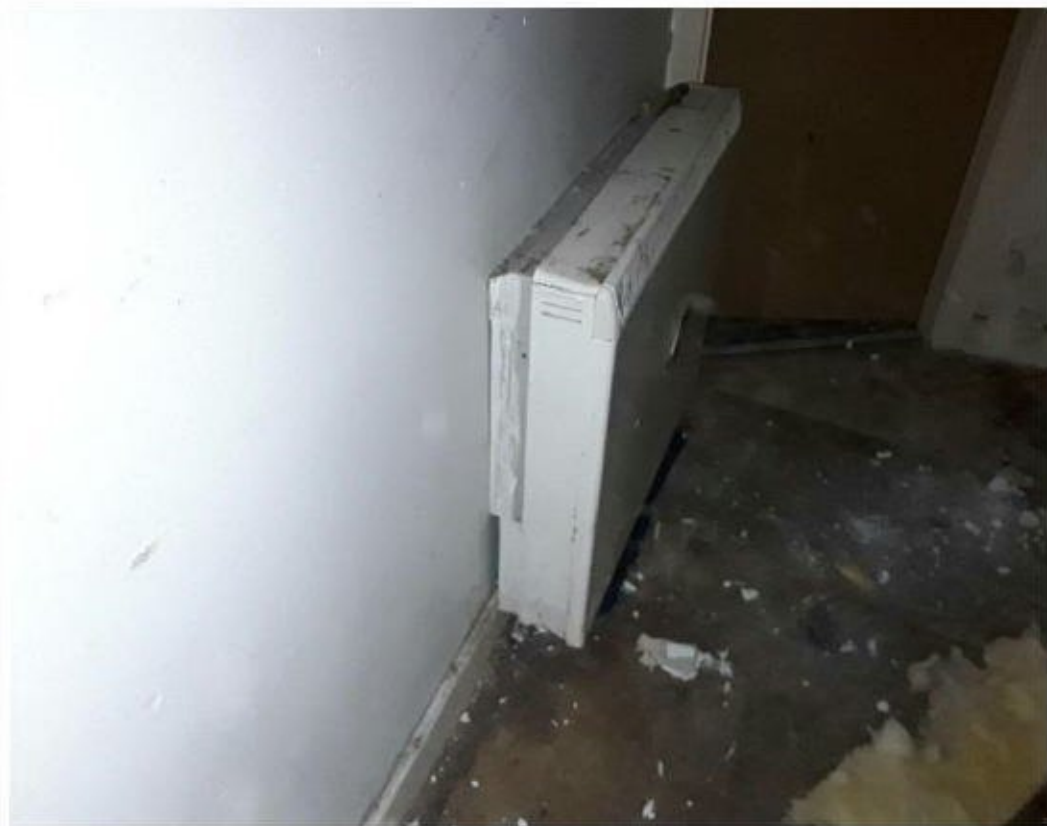
<b>Item:</b>	Asbestos Textile within electric heater			
<b>Asbestos Content:</b>	<b>Result Based on:</b>			
Chrysotile	Presumed			
<b>Sample Analysed By:</b>	Not applicable	<b>Extent:</b>	1 metres	
<b>Comments:</b> Presumed due to no safe access, live and connected

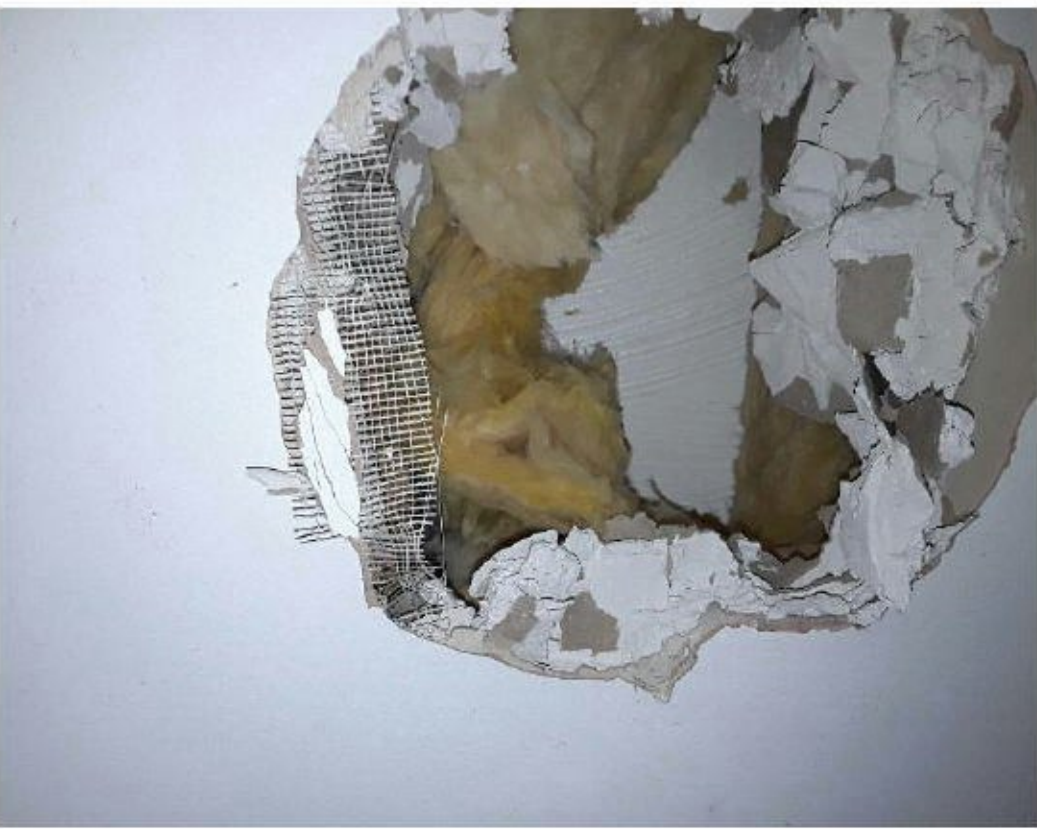
<b>Item:</b>	Textured coating to plasterboard ceiling			
<b>Asbestos Content:</b>	<b>Result Based on:</b>			
No Asbestos Detected	Analysis of sample using PLM			
<b>Sample Analysed By:</b> C Hay	<b>Extent:</b>	20 m <sup>2</sup>		
<b>Comments:</b> Visible beyond plaster to plasterboard ceiling

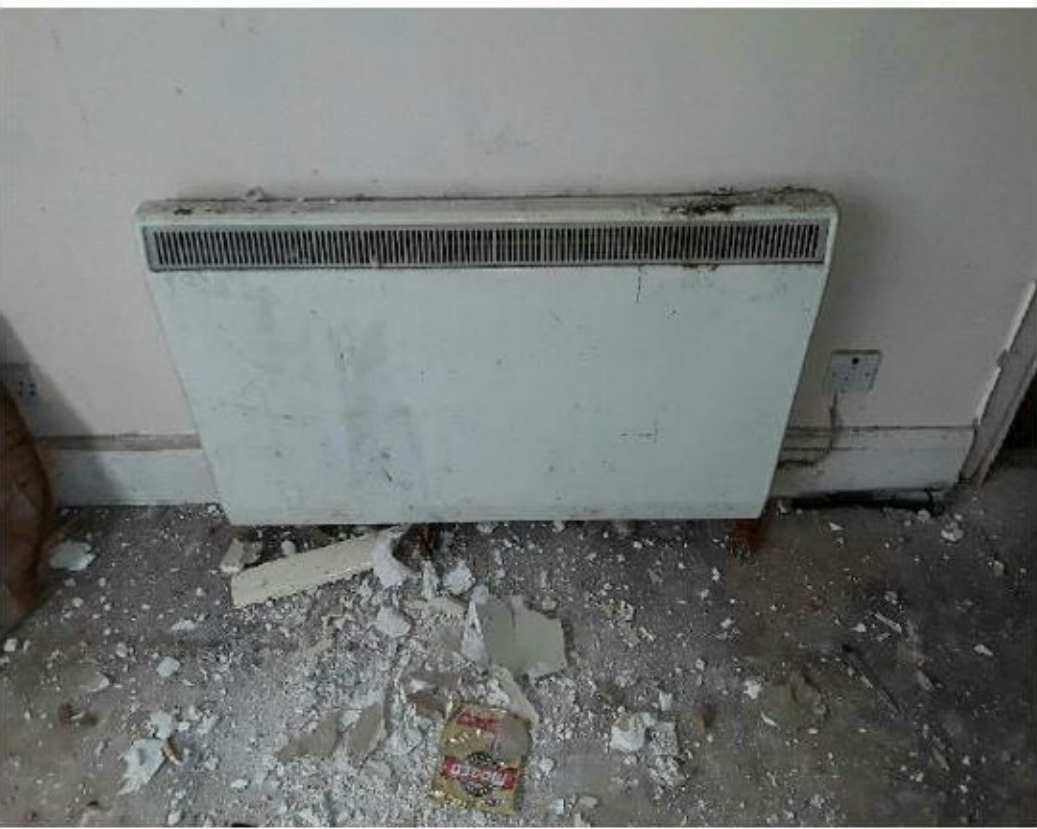
<b>Item:</b>	Asbestos Textile within electric heater				
<b>Asbestos Content:</b>	Result Based on:				
Chrysotile	Presumed				
<b>Sample Analysed By:</b>	Not applicable	<b>Extent:</b>	1 metres		
<b>Comments:</b> Presumed due to no safe access, live and connected

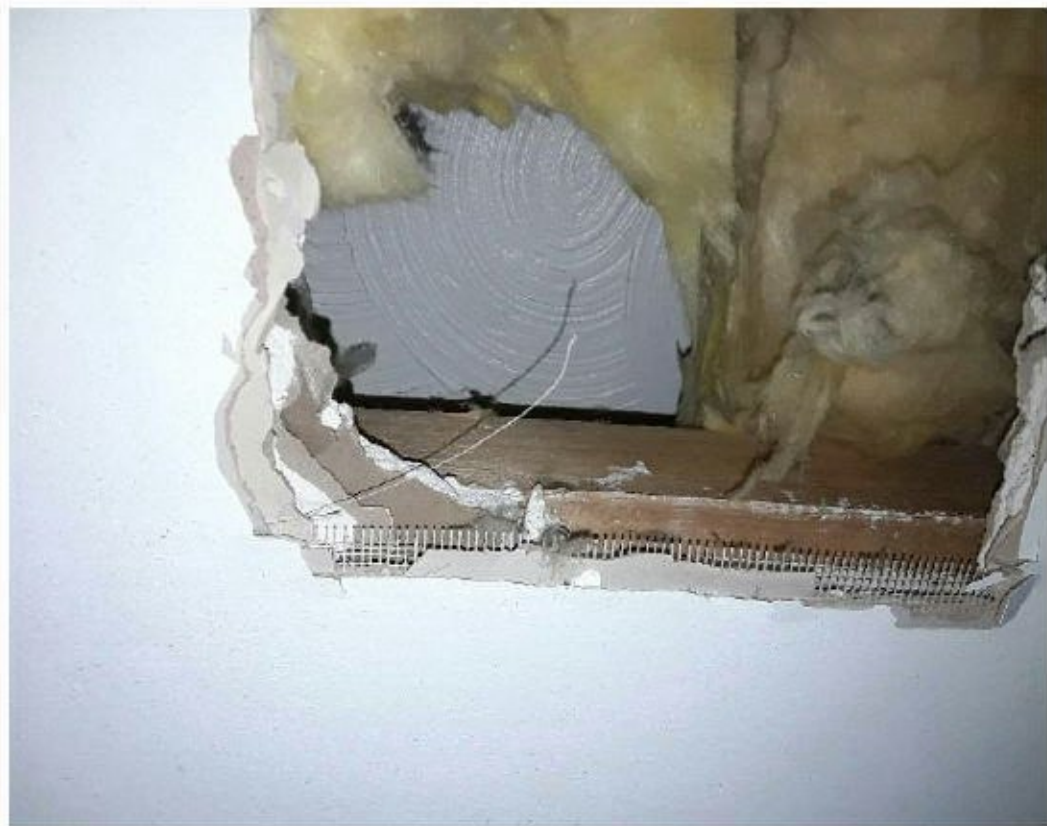
<b>Item:</b>	Textured coating to plasterboard ceiling			
<b>Asbestos Content:</b>	<b>Result Based on:</b>			
No Asbestos Detected	Analysis of sample using PLM			
<b>Sample Analysed By:</b>	C Hay	<b>Extent:</b>	6.5 m <sup>2</sup>	
<b>Comments:</b> Visible beyond plaster to plasterboard ceiling

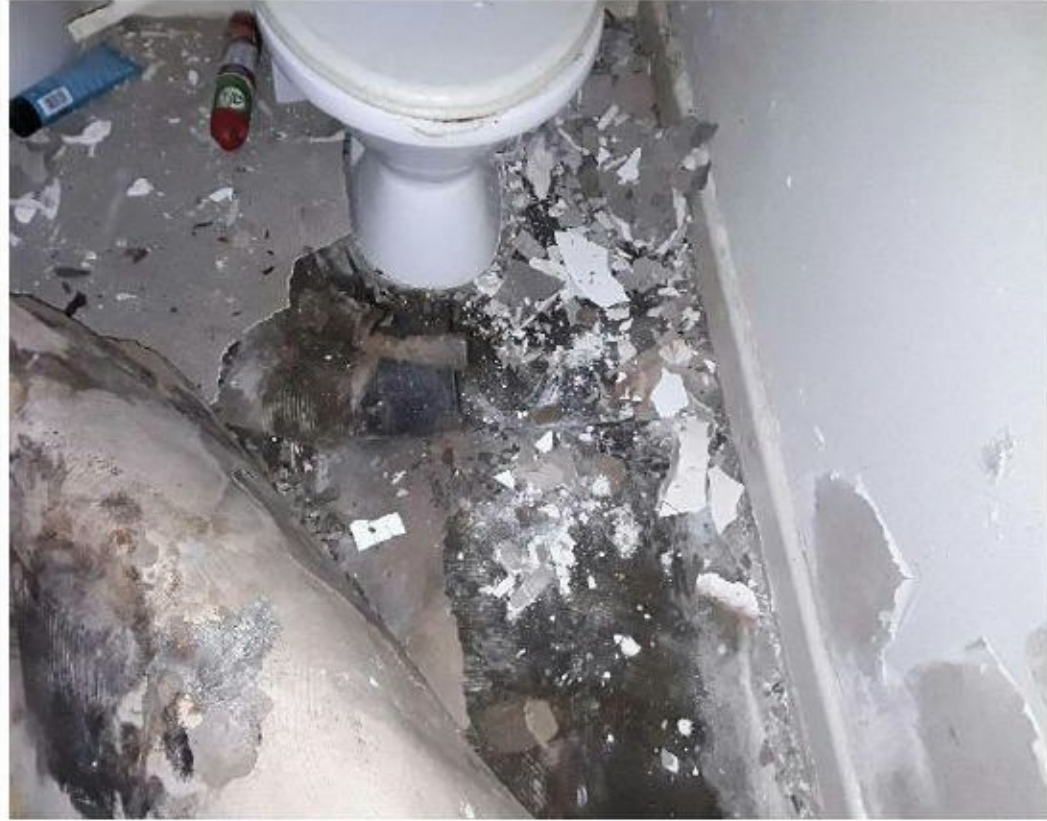
<b>Item:</b>	Textured coating debris to floor			
<b>Asbestos Content:</b>		<b>Result Based on:</b>		
No Asbestos Detected		Analysis of sample using PLM		
<b>Sample Analysed By:</b>	C Hay	<b>Extent:</b>	5 m <sup>2</sup>	
<b>Comments:</b> The debris is scattered across the room there it is recommended that remedial works are carried out.

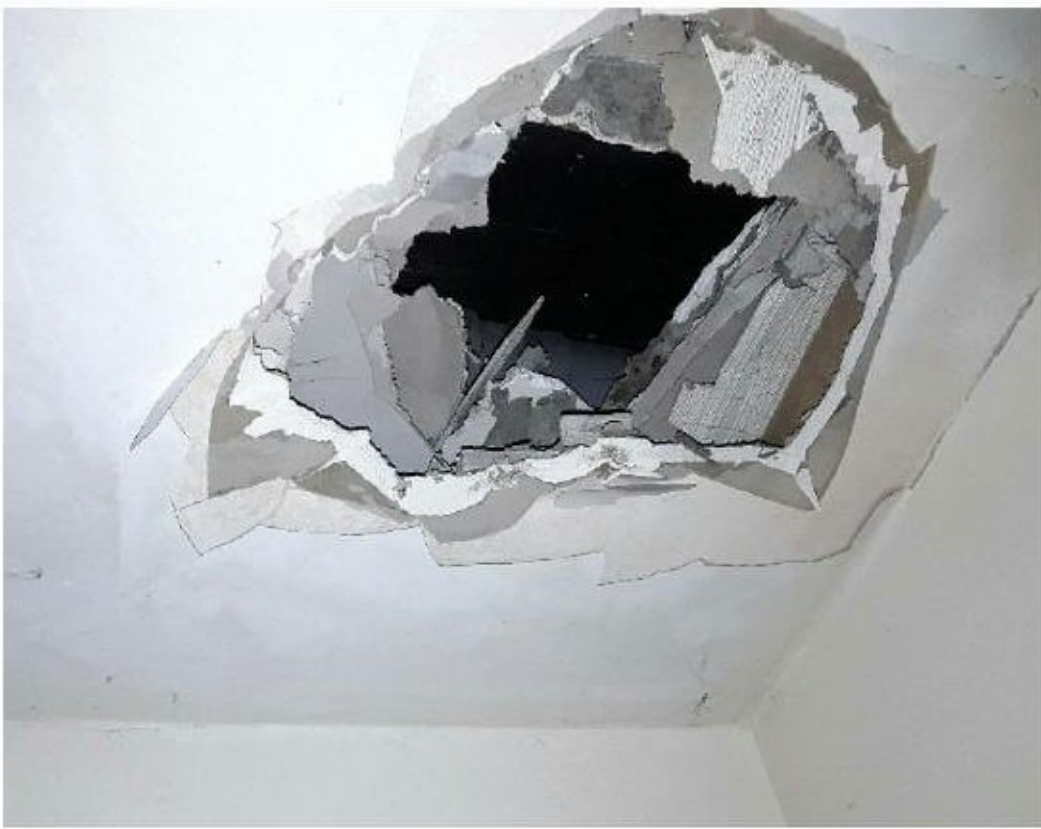
<b>Item:</b>	Textured coating to plasterboard ceiling			
<b>Asbestos Content:</b>		<b>Result Based on:</b>		
No Asbestos Detected		Analysis of sample using PLM		
<b>Sample Analysed By:</b>	C Hay	<b>Extent:</b>	5 m <sup>2</sup>	
<b>Comments:</b> The ceiling already had water damage

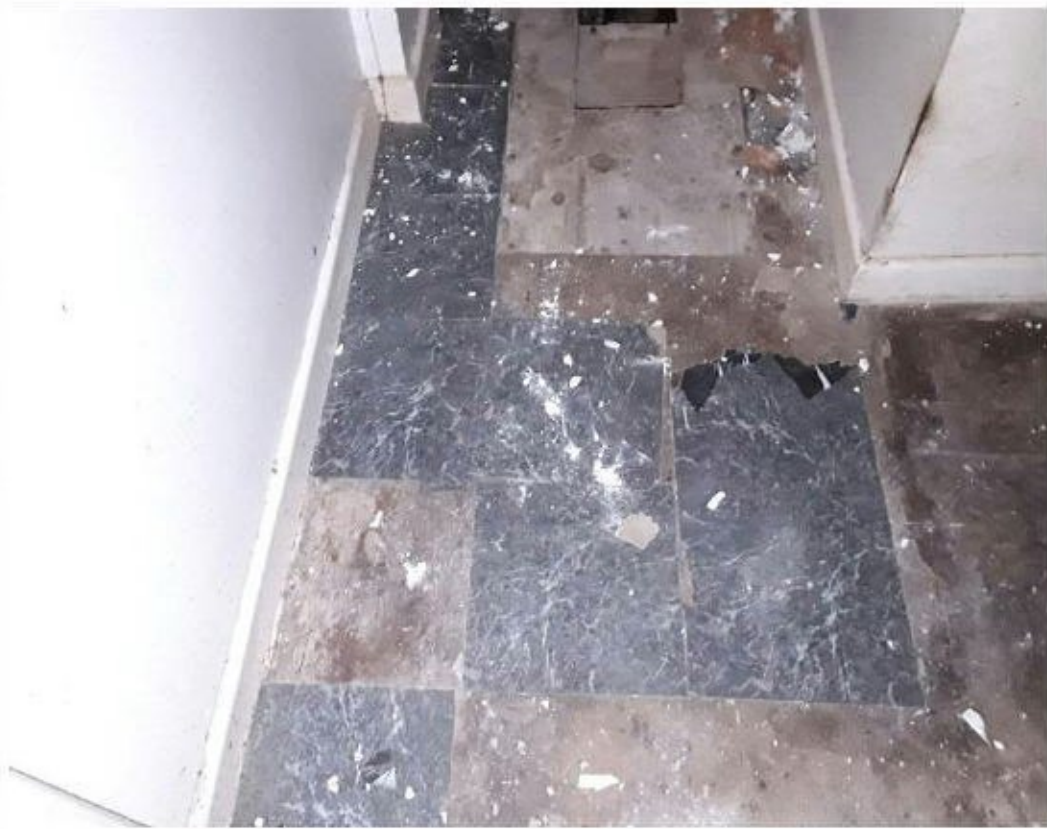
<b>Item:</b>	Vinyl floor tiles and adhesive to timber			
<b>Asbestos Content:</b>		<b>Result Based on:</b>		
No Asbestos Detected		Analysis of sample using PLM		
<b>Sample Analysed By:</b>	C Hay	<b>Extent:</b>	1 m <sup>2</sup>	
<b>Comments:</b> Present to a small section only

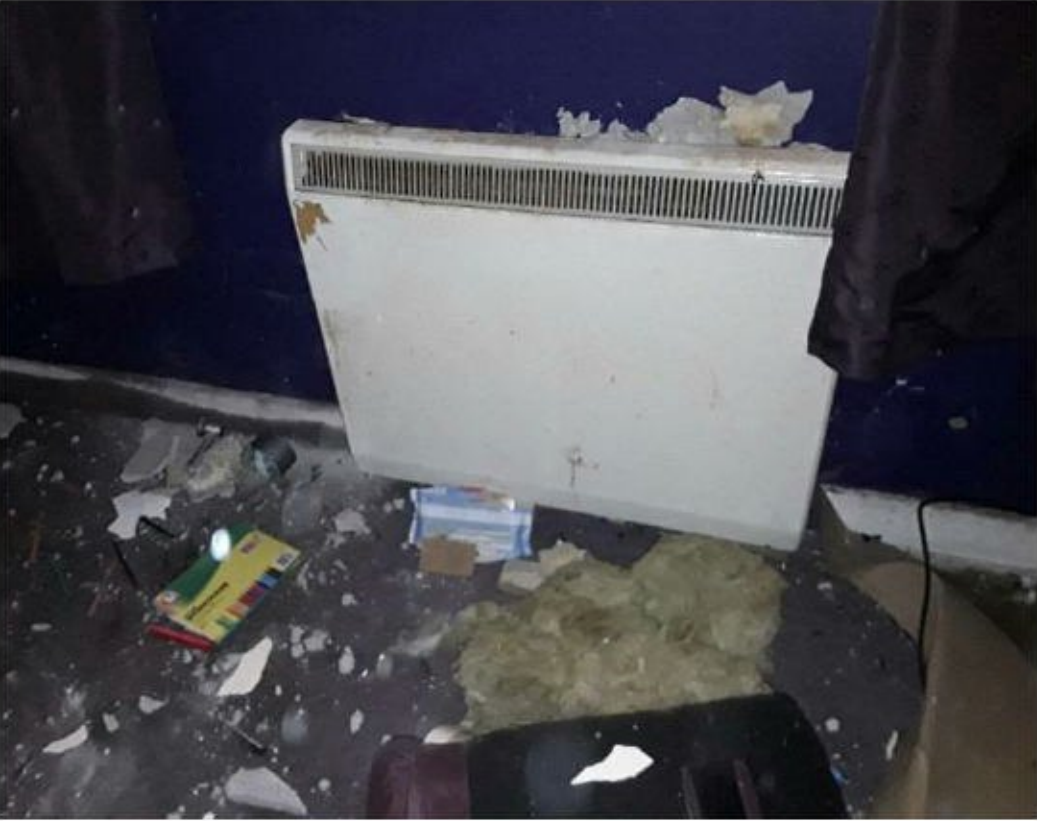
<b>Item:</b>	Asbestos Textile within electric heater				
<b>Asbestos Content:</b>	<b>Result Based on:</b>				
Chrysotile	Presumed				
<b>Sample Analysed By:</b>	Not applicable	<b>Extent:</b>	1 metres		
<b>Comments:</b> Presumed due to no safe access, live and connected

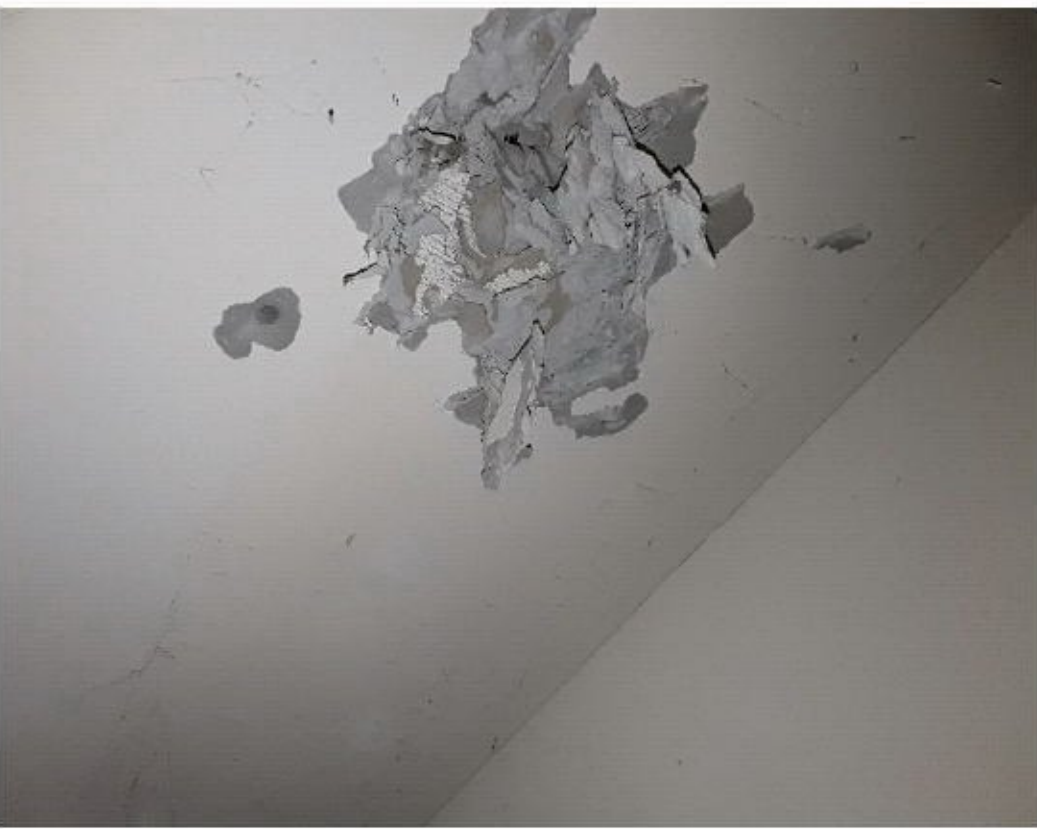
<b>Item:</b>	Textured coating to plasterboard ceiling			
<b>Asbestos Content:</b>		<b>Result Based on:</b>		
No Asbestos Detected		Analysis of sample using PLM		
<b>Sample Analysed By:</b>	C Hay	<b>Extent:</b>	3 m <sup>2</sup>	
<b>Comments:</b> Visible beyond plasterboard ceiling

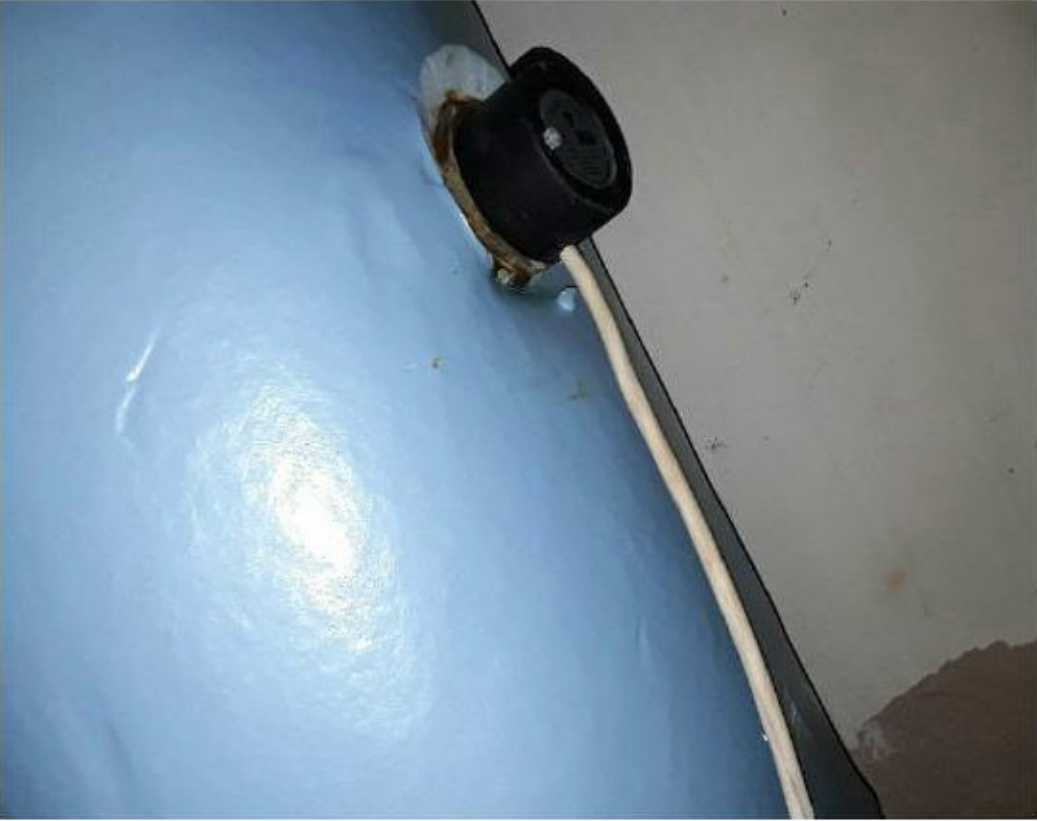
<b>Item:</b>	Gasket to cylinder			
<b>Asbestos Content:</b>		<b>Result Based on:</b>		
No Asbestos Detected		Analysis of sample using PLM		
<b>Sample Analysed By:</b>	C Hay	<b>Extent:</b>	2 units	
<b>Comments:</b>

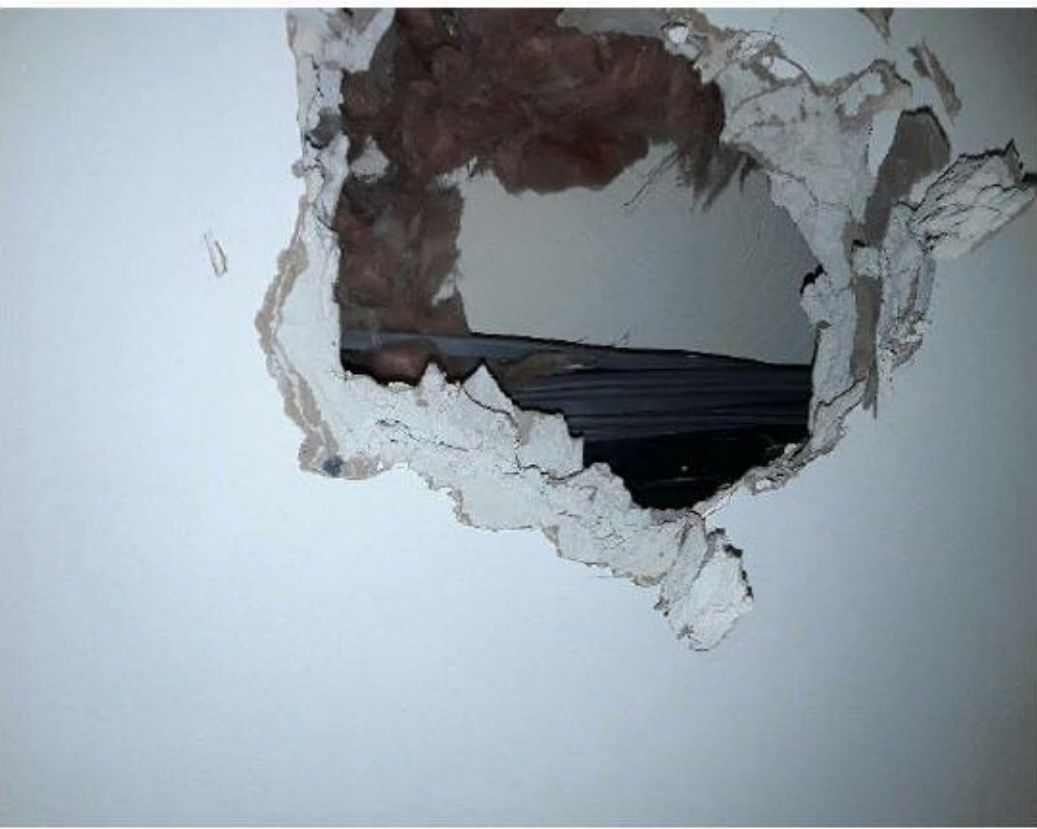
<b>Item:</b>	Textured coating to plasterboard ceiling			
<b>Asbestos Content:</b>		<b>Result Based on:</b>		
No Asbestos Detected		Analysis of sample using PLM		
<b>Sample Analysed By:</b>	C Hay	<b>Extent:</b>	8 m <sup>2</sup>	
<b>Comments:</b> Visible beyond plasterboard ceiling

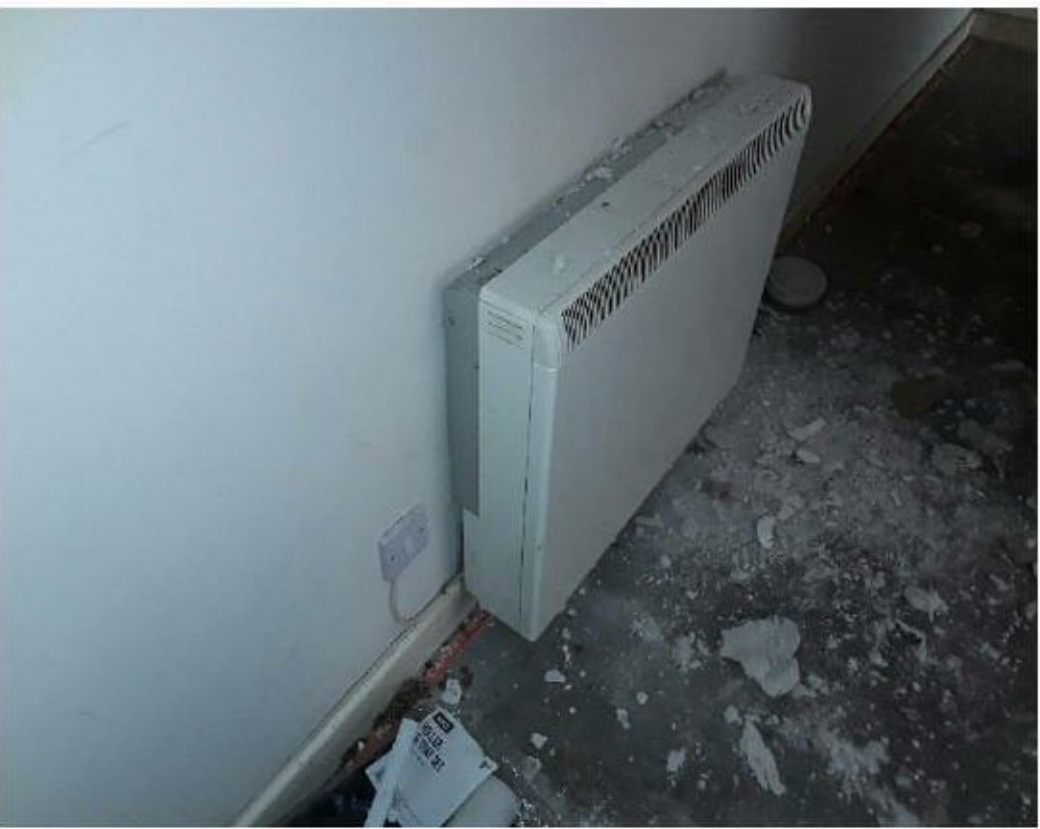
<b>Item:</b>	Asbestos Textile within electric heater				
<b>Asbestos Content:</b>	Result Based on:				
Chrysotile	Presumed				
<b>Sample Analysed By:</b>	Not applicable	<b>Extent:</b>	1 metres		
<b>Comments:</b> Presumed due to no safe access, live and connected
