**Report No.:** J177345 V2  
**Nature of Work:** Demolition Survey  
**Issue Date:** 12/01/2021  
**Client Name:** Regenda Homes  
Commutation Plaza, 1 Commutation Row, Islington, Liverpool,  
L3 8QF  
**Site Address:** Prospect Court (1-6), Rossall Road, Thornton-Cleveleys, FY5  
1HQ

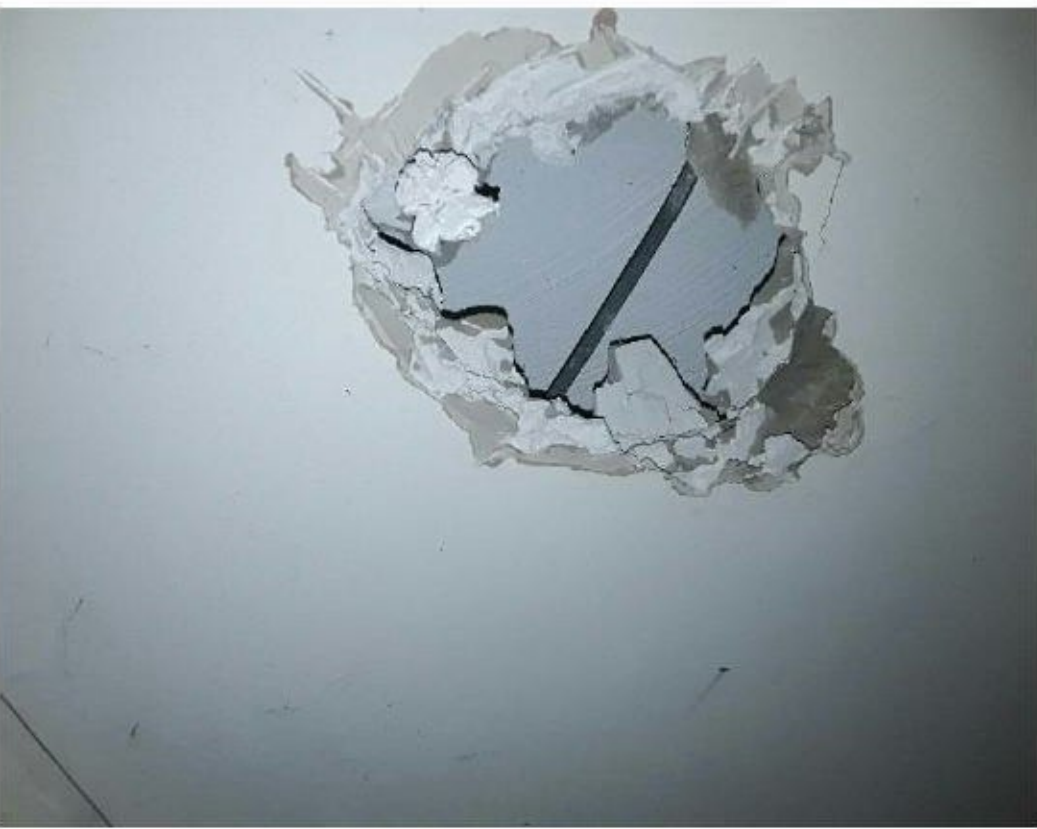
<b>Item:</b>	Textured coating to plasterboard ceiling			
<b>Asbestos Content:</b>		<b>Result Based on:</b>		
No Asbestos Detected		Analysis of sample using PLM		
<b>Sample Analysed By:</b>	C Hay	<b>Extent:</b>	2 m <sup>2</sup>	
<b>Comments:</b> Visible beyond plasterboard ceiling

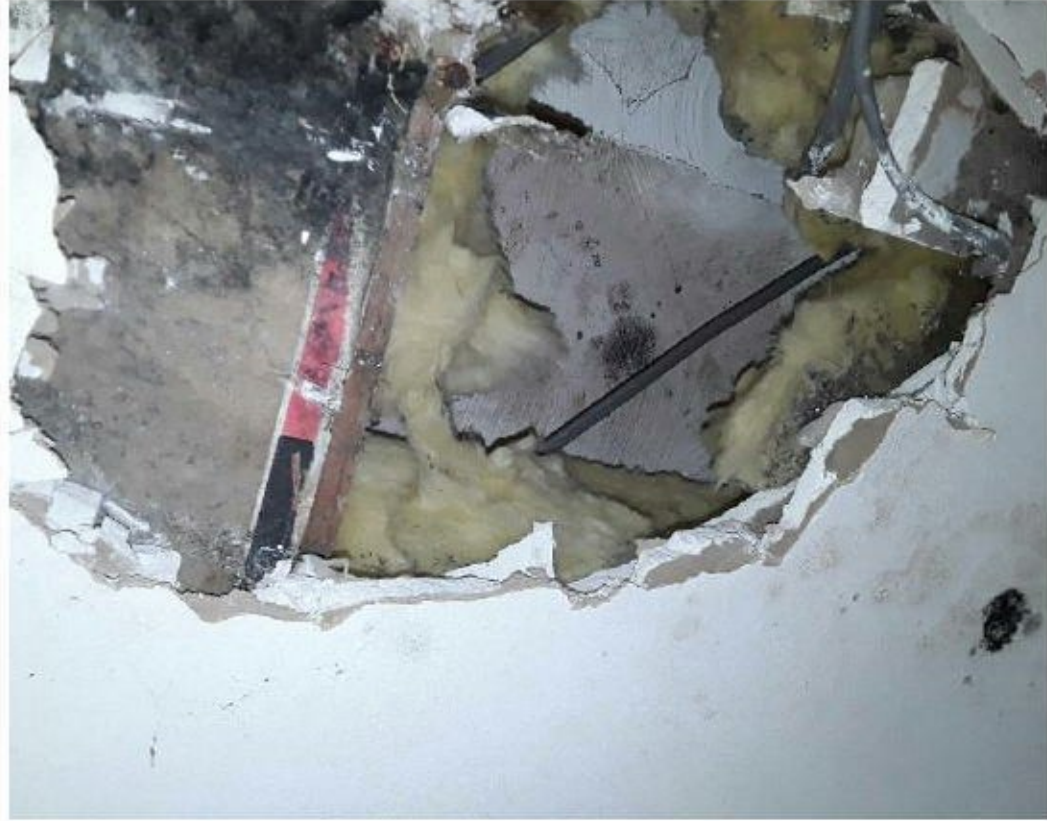
<b>Item:</b>	Textured coating to plasterboard ceiling				
<b>Asbestos Content:</b>		<b>Result Based on:</b>			
No Asbestos Detected		Analysis of sample using PLM			
<b>Sample Analysed By:</b>	C Hay	<b>Extent:</b>	16 m <sup>2</sup>		
<b>Comments:</b> Visible beyond plasterboard ceiling

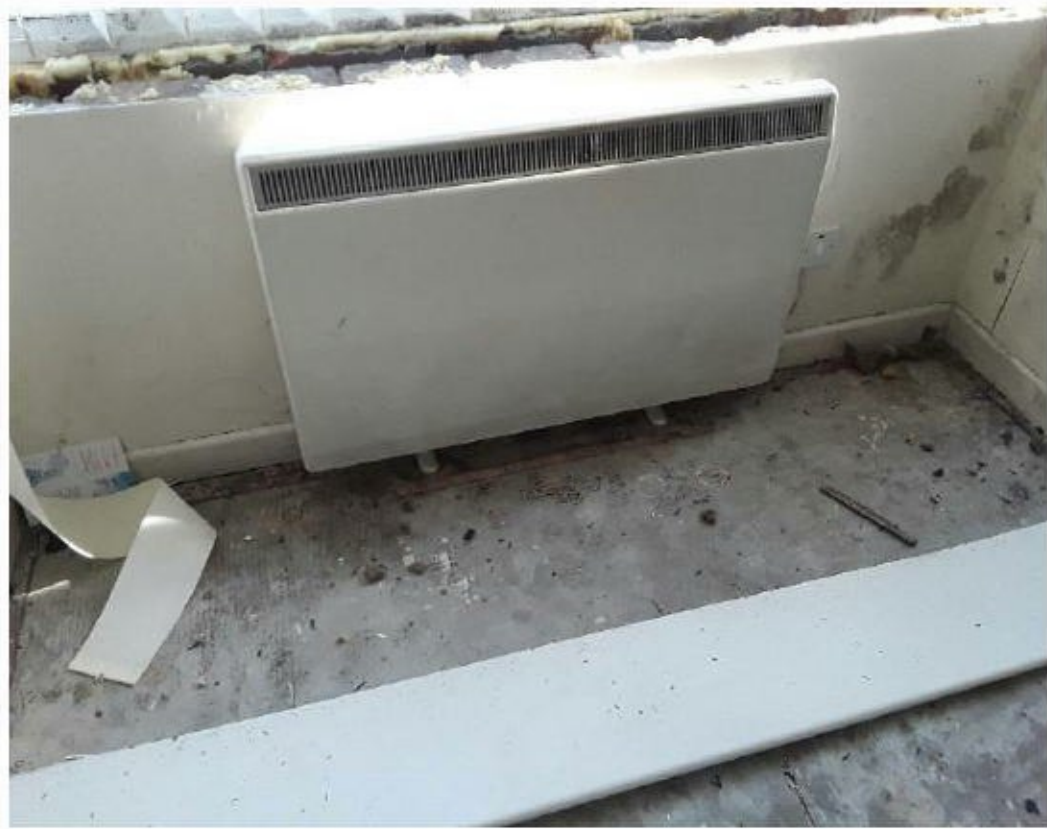
<b>Item:</b>	Asbestos Textile within electric heater			
<b>Asbestos Content:</b>	<b>Result Based on:</b>			
Chrysotile	Presumed			
<b>Sample Analysed By:</b>	Not applicable	<b>Extent:</b>	1 metres	
<b>Comments:</b> Presumed due to no safe access, live and connected

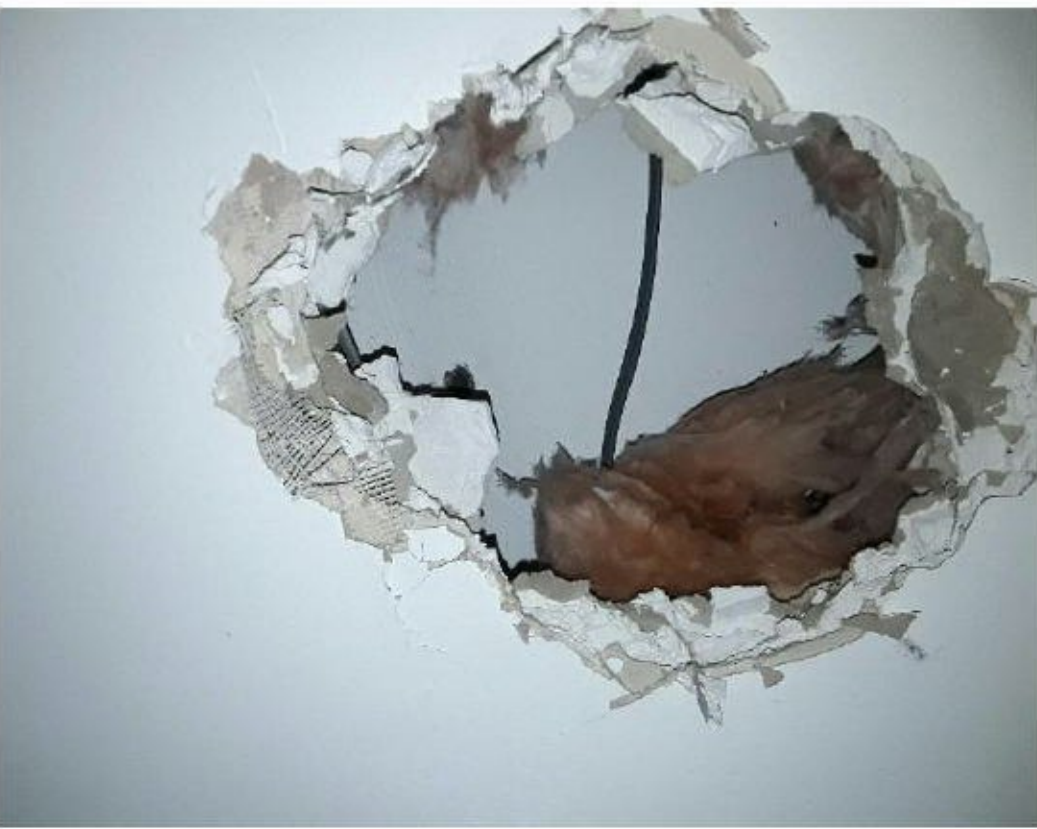
<b>Item:</b>	Textured coating to plasterboard ceiling			
<b>Asbestos Content:</b>		<b>Result Based on:</b>		
No Asbestos Detected		Analysis of sample using PLM		
<b>Sample Analysed By:</b>	C Hay	<b>Extent:</b>	5 m <sup>2</sup>	
<b>Comments:</b> Visible beyond plasterboard ceiling

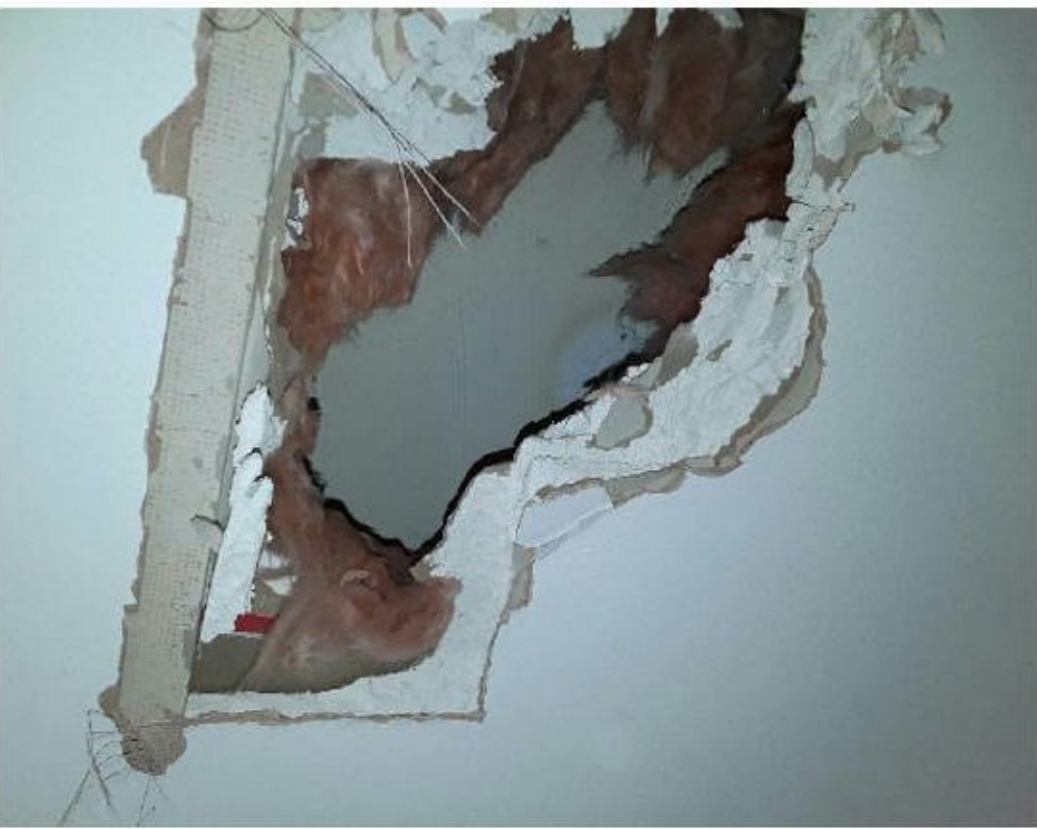
<b>Item:</b>	Textured coating to plasterboard ceiling			
<b>Asbestos Content:</b>		<b>Result Based on:</b>		
No Asbestos Detected		Analysis of sample using PLM		
<b>Sample Analysed By:</b>	C Hay	<b>Extent:</b>	10 m <sup>2</sup>	
<b>Comments:</b> Visible beyond plasterboard ceiling

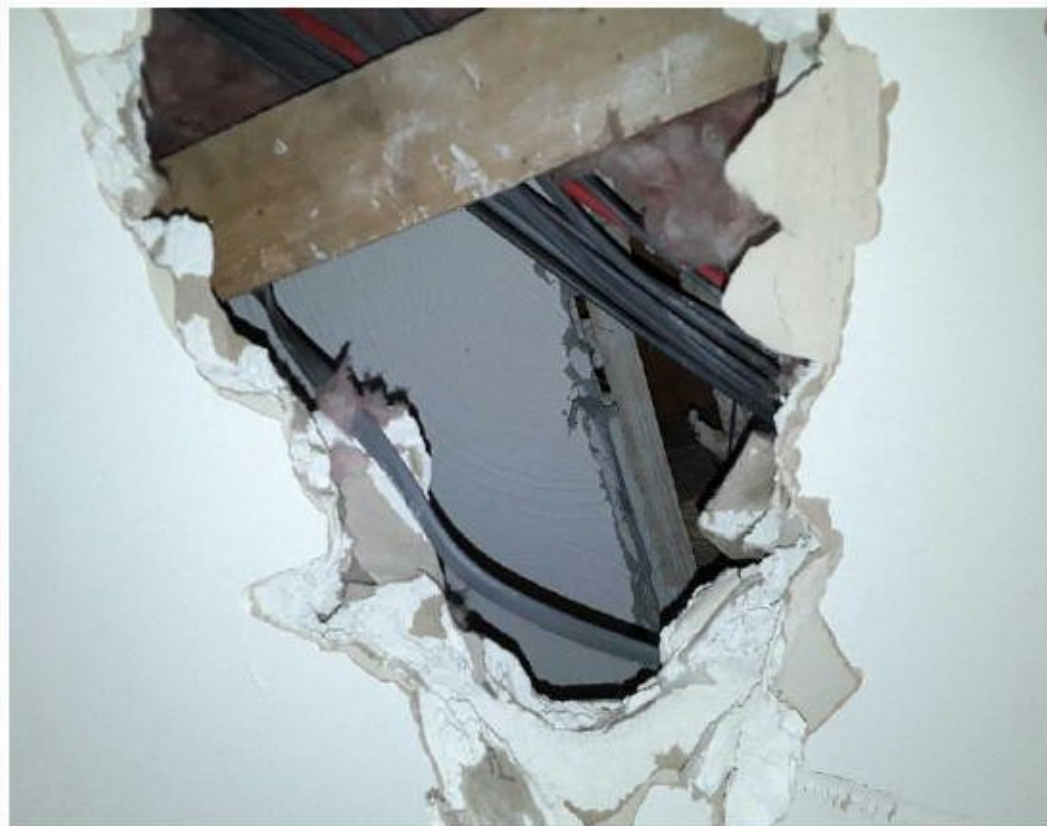
<b>Item:</b>	Textured coating to plasterboard ceiling				
<b>Asbestos Content:</b>		<b>Result Based on:</b>			
No Asbestos Detected		Analysis of sample using PLM			
<b>Sample Analysed By:</b>	C Hay	<b>Extent:</b>	17 m <sup>2</sup>		
<b>Comments:</b> Visible beyond plasterboard ceiling

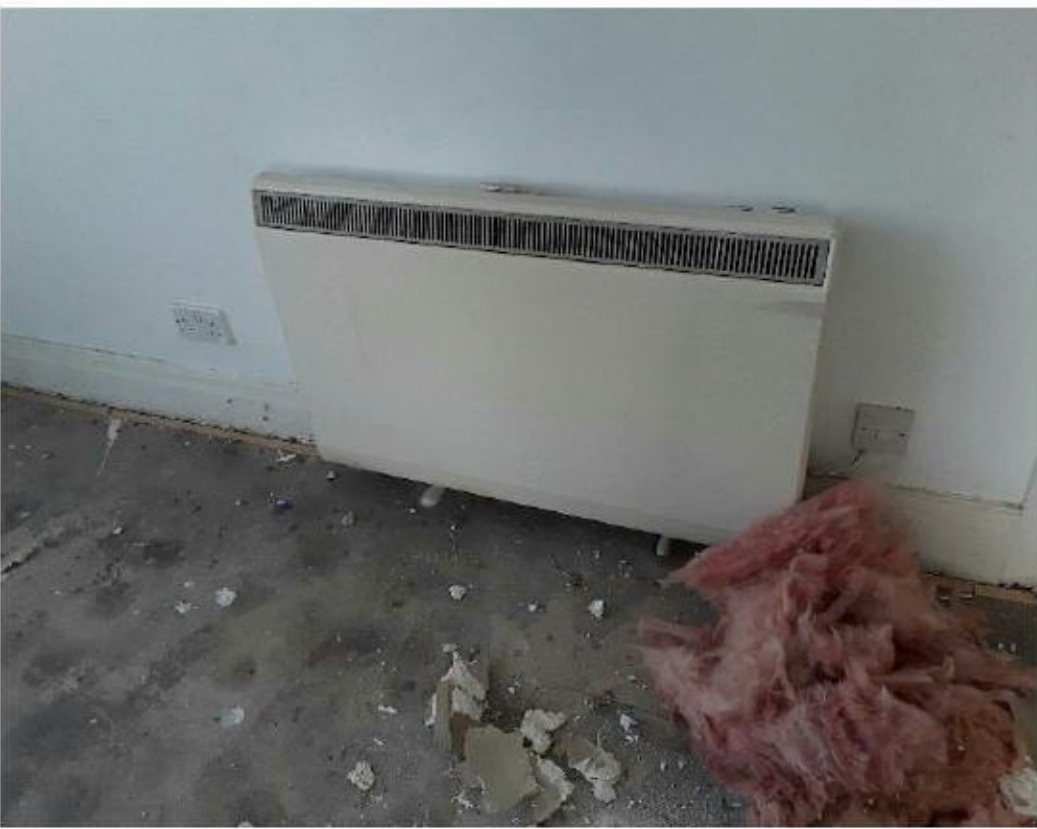
<b>Item:</b>	Asbestos Textile within electric heater			
<b>Asbestos Content:</b>	<b>Result Based on:</b>			
Chrysotile	Presumed			
<b>Sample Analysed By:</b>	Not applicable	<b>Extent:</b>	1 metres	
<b>Comments:</b> Presumed due to no safe access, live and connected

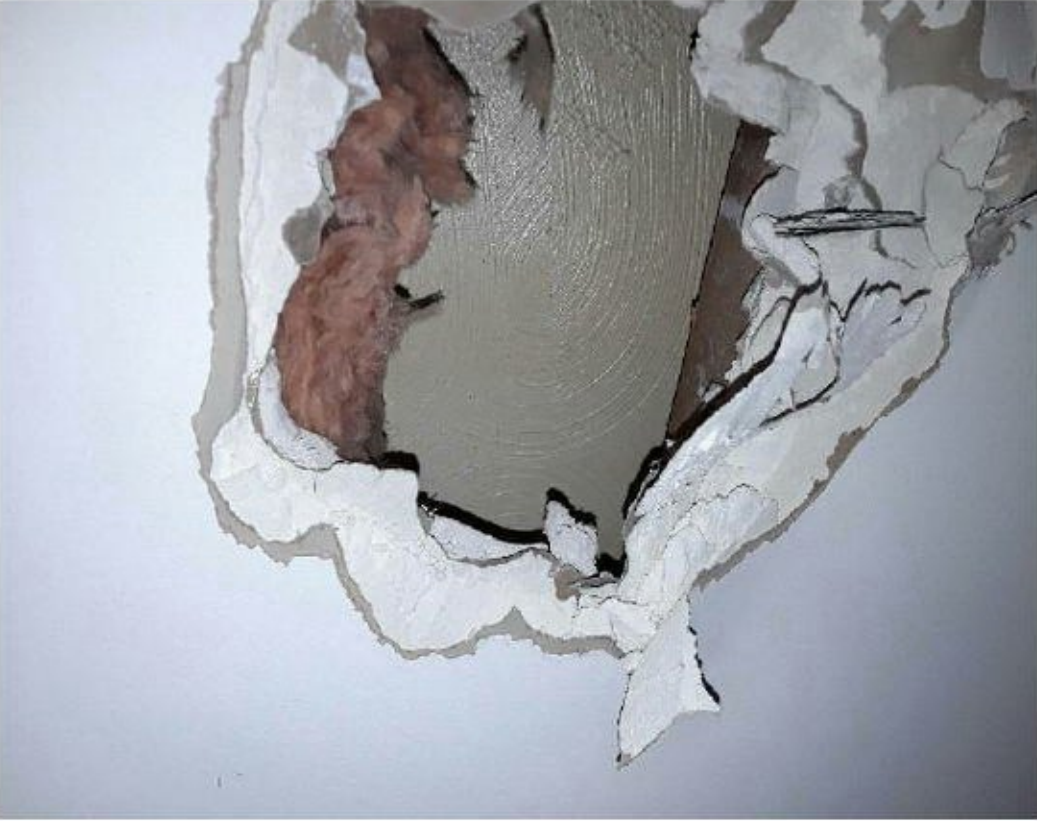
<b>Item:</b>	Textured coating to plasterboard ceiling			
<b>Asbestos Content:</b>		<b>Result Based on:</b>		
No Asbestos Detected		Analysis of sample using PLM		
<b>Sample Analysed By:</b>	C Hay	<b>Extent:</b>	9 m <sup>2</sup>	
<b>Comments:</b> Visible beyond plasterboard ceiling

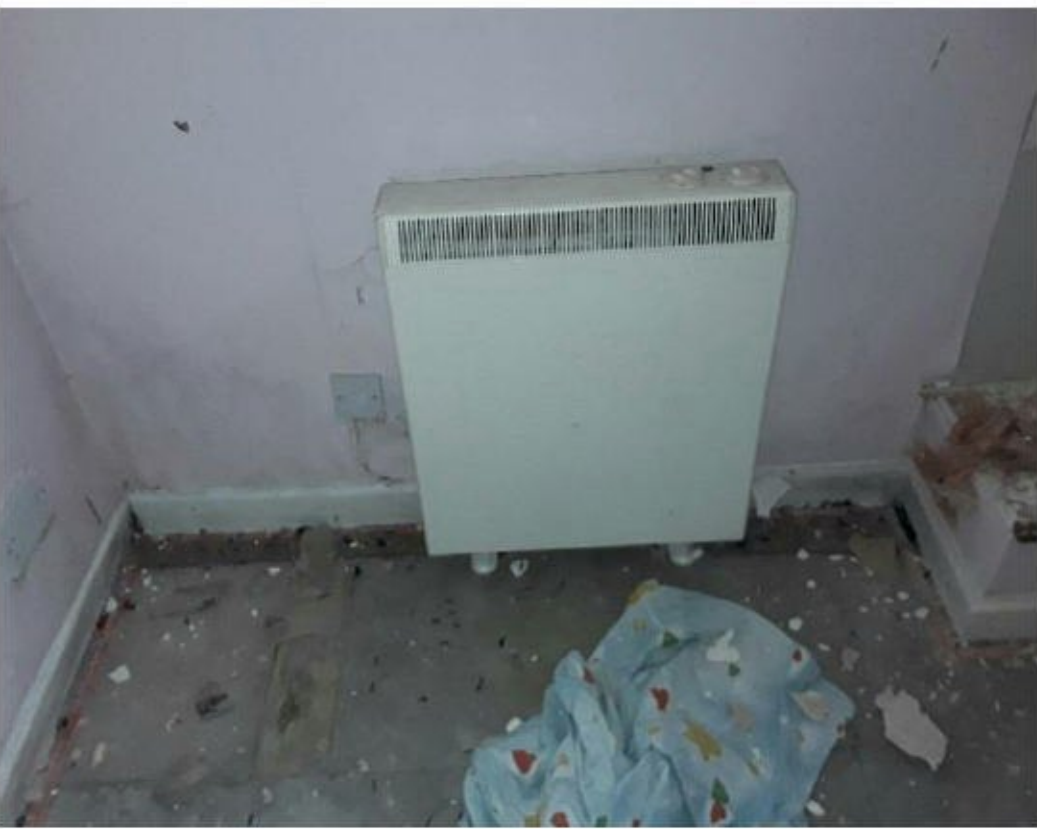
<b>Item:</b>	Asbestos Textile within electric heater			
<b>Asbestos Content:</b>	<b>Result Based on:</b>			
Chrysotile	Presumed			
<b>Sample Analysed By:</b>	Not applicable	<b>Extent:</b>	1 metres	
<b>Comments:</b> Presumed due to no safe access, live and connected

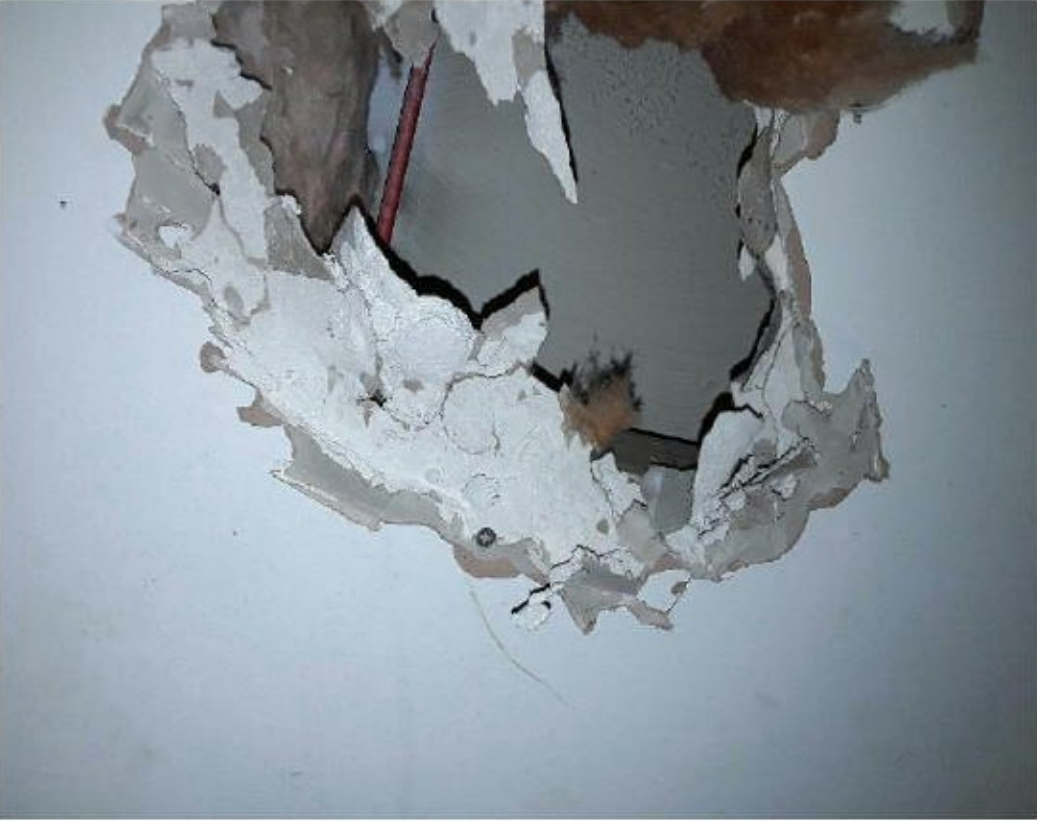
<b>Item:</b>	Textured coating to plasterboard ceiling			
<b>Asbestos Content:</b>		<b>Result Based on:</b>		
No Asbestos Detected		Analysis of sample using PLM		
<b>Sample Analysed By:</b>	C Hay	<b>Extent:</b>	3 m <sup>2</sup>	
<b>Comments:</b> Visible beyond plasterboard ceiling

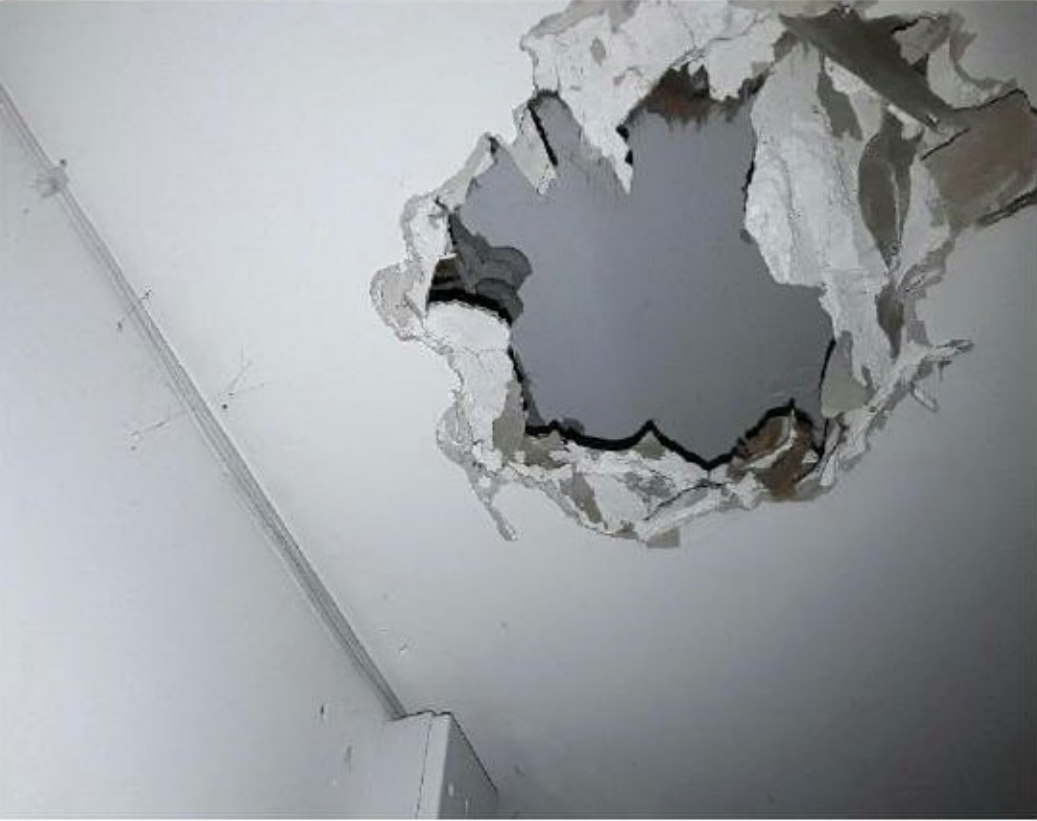
<b>Item:</b>	Textured coating to plasterboard ceiling			
<b>Asbestos Content:</b>		<b>Result Based on:</b>		
No Asbestos Detected		Strongly presumed		
<b>Sample Analysed By:</b>	Not applicable	<b>Extent:</b>	2 m <sup>2</sup>	
<b>Comments:</b> Visible beyond plasterboard ceiling

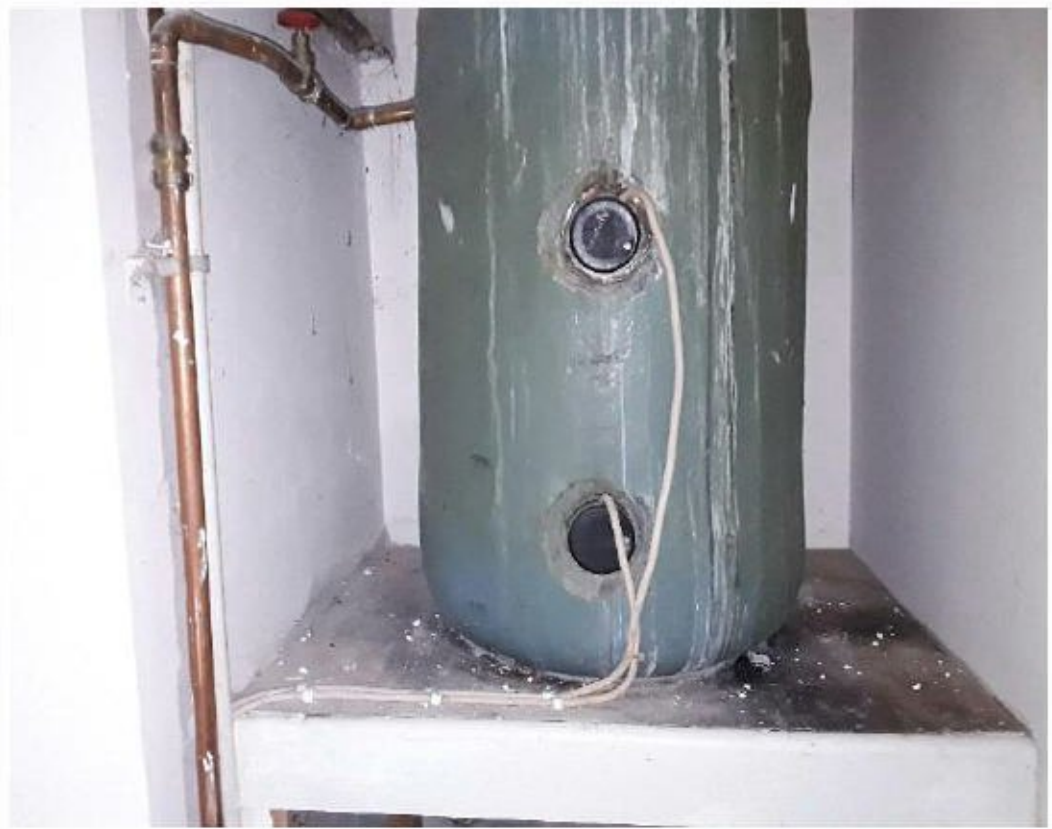
<b>Item:</b>	Gaskets to copper cylinder			
<b>Asbestos Content:</b>		<b>Result Based on:</b>		
No Asbestos Detected		Analysis of sample using PLM		
<b>Sample Analysed By:</b>	C Hay	<b>Extent:</b>	2 units	
<b>Comments:</b>

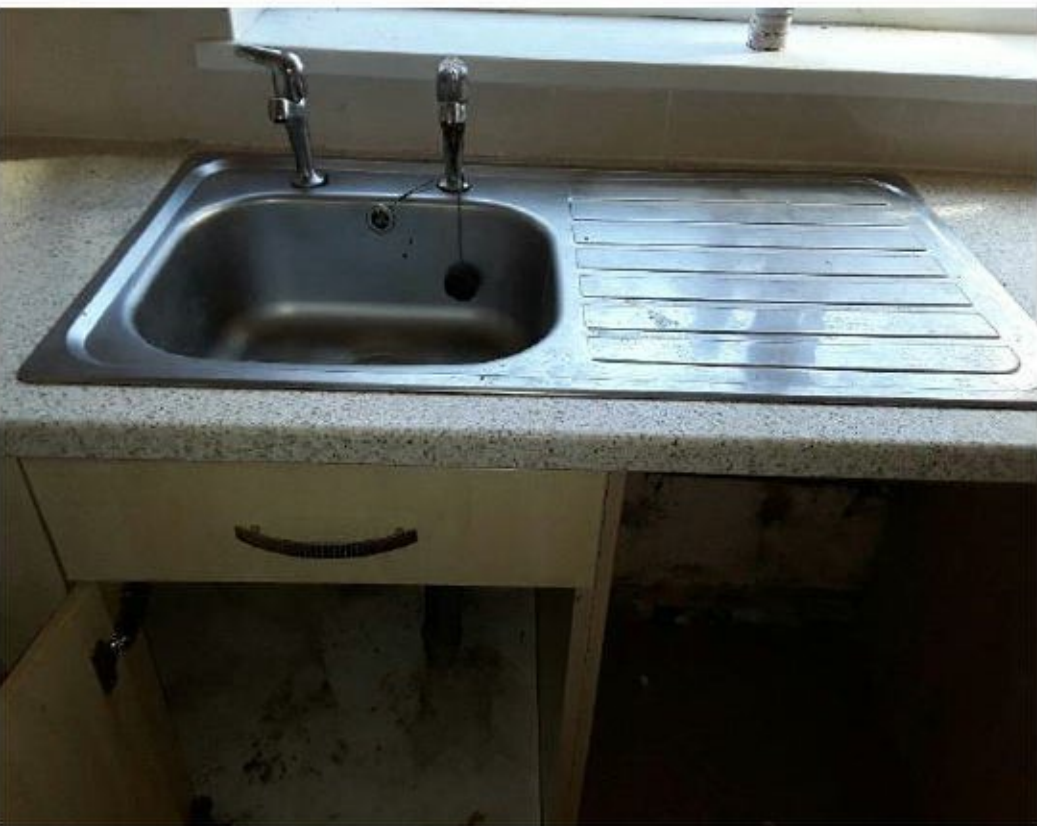
<b>Item:</b>	Bitumen sink pad				
<b>Asbestos Content:</b>	Result Based on:				
No Asbestos Detected	Analysis of sample using PLM				
<b>Sample Analysed By:</b>	C Hay	<b>Extent:</b>	1 unit		
<b>Comments:</b> Beneath bowl only

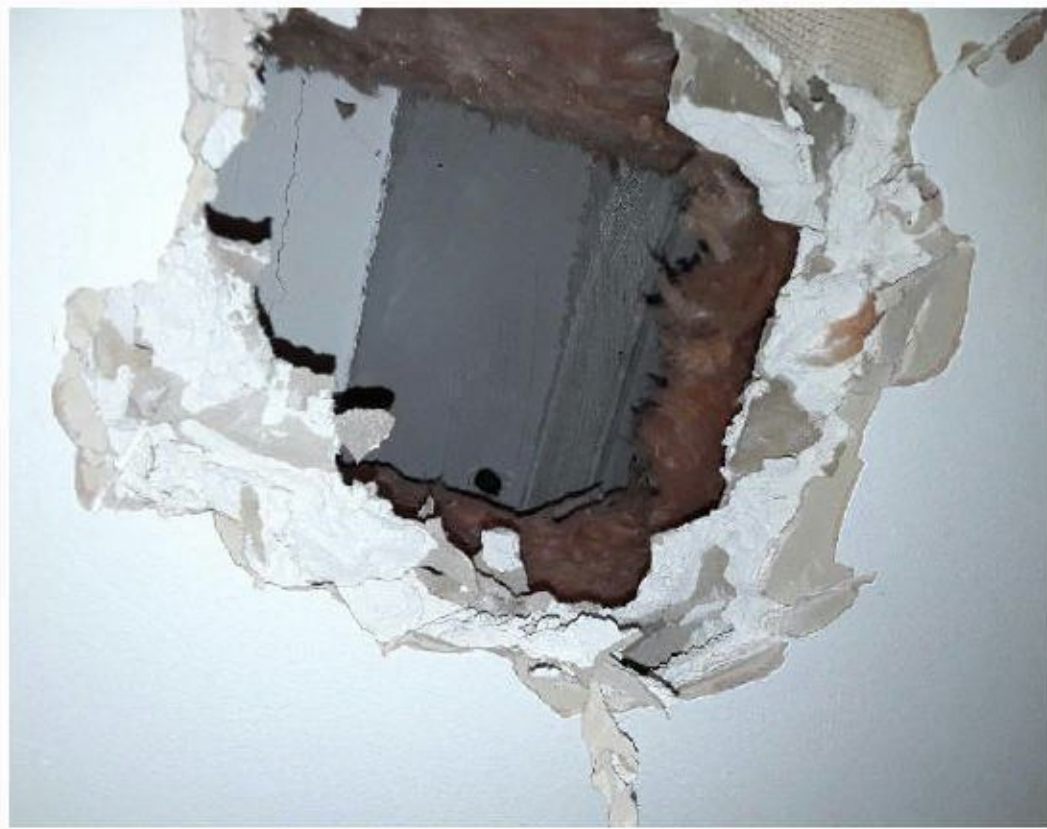
<b>Item:</b>	Textured coating to plasterboard ceiling			
<b>Asbestos Content:</b>		<b>Result Based on:</b>		
No Asbestos Detected		Analysis of sample using PLM		
<b>Sample Analysed By:</b>	C Hay	<b>Extent:</b>	16 m <sup>2</sup>	
<b>Comments:</b> Visible beyond plasterboard ceiling

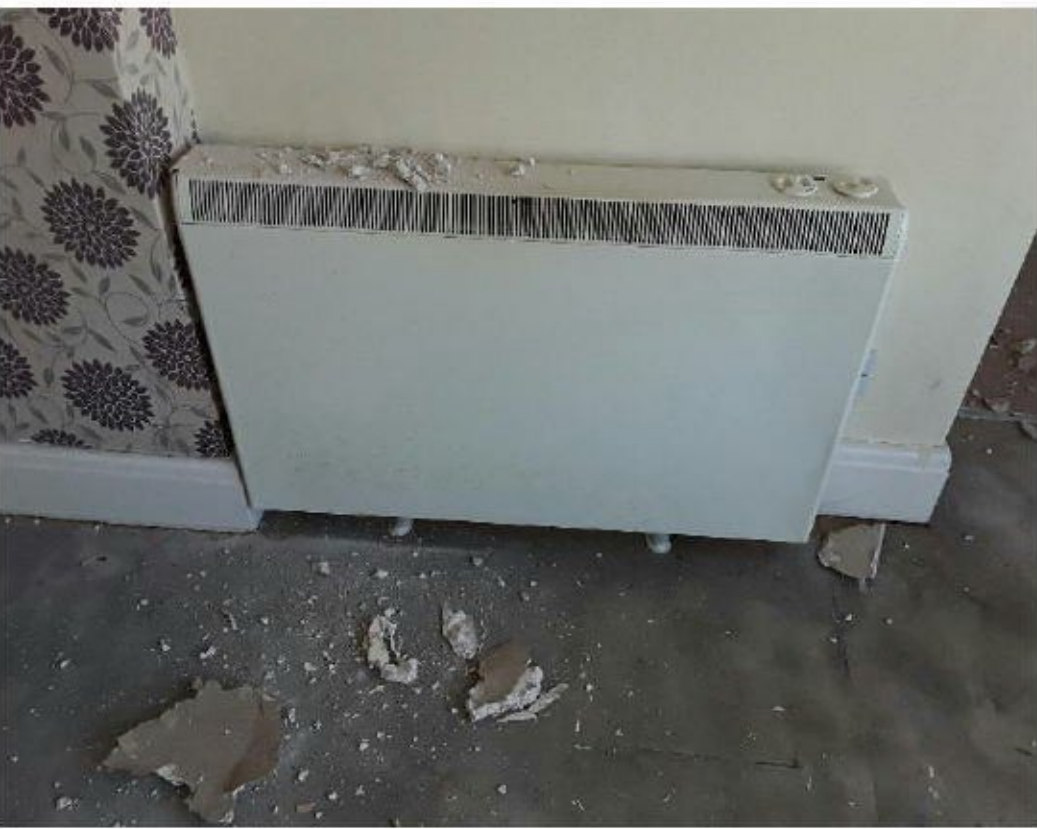
<b>Item:</b>	Asbestos Textile within electric heater			
<b>Asbestos Content:</b>	<b>Result Based on:</b>			
Chrysotile	Presumed			
<b>Sample Analysed By:</b>	Not applicable	<b>Extent:</b>	1 metres	
<b>Comments:</b> Presumed due to no safe access, live and connected

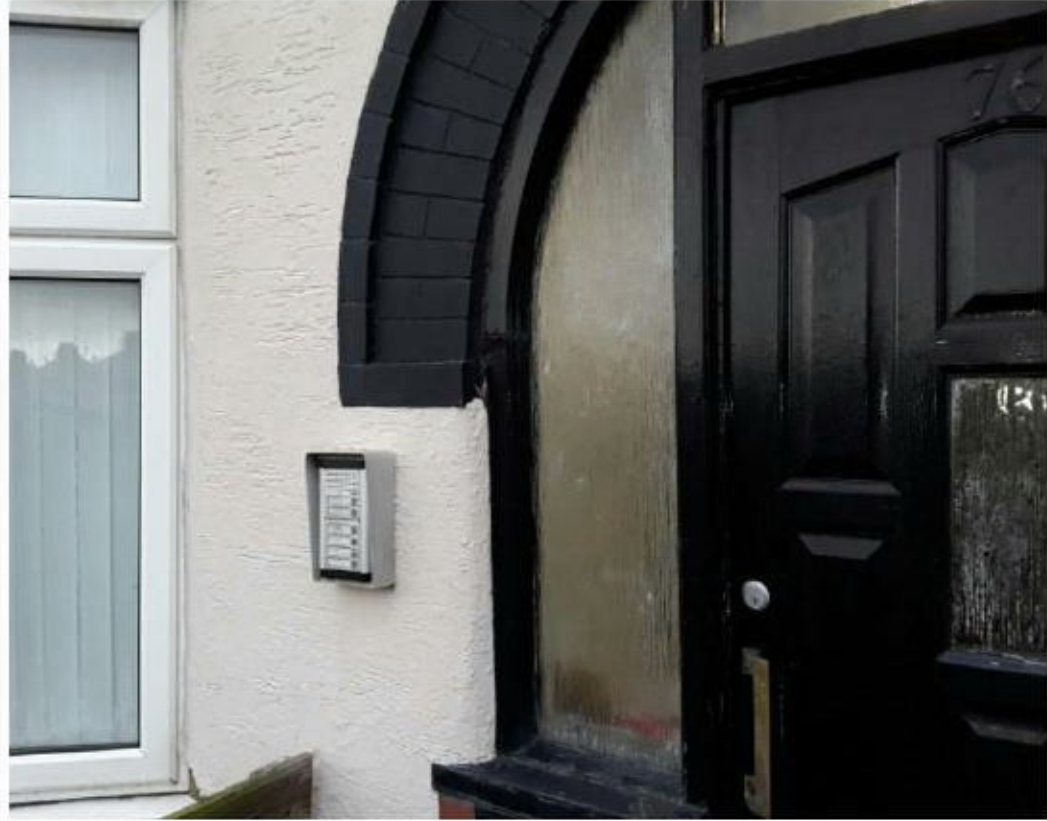
<b>Item:</b>	Mastic around timber door frame			
<b>Asbestos Content:</b>		<b>Result Based on:</b>		
No Asbestos Detected		Analysis of sample using PLM		
<b>Sample Analysed By:</b>	S Deasey-Jones	<b>Extent:</b>	6 linear metres	
<b>Comments:</b> Present to the main entrance door

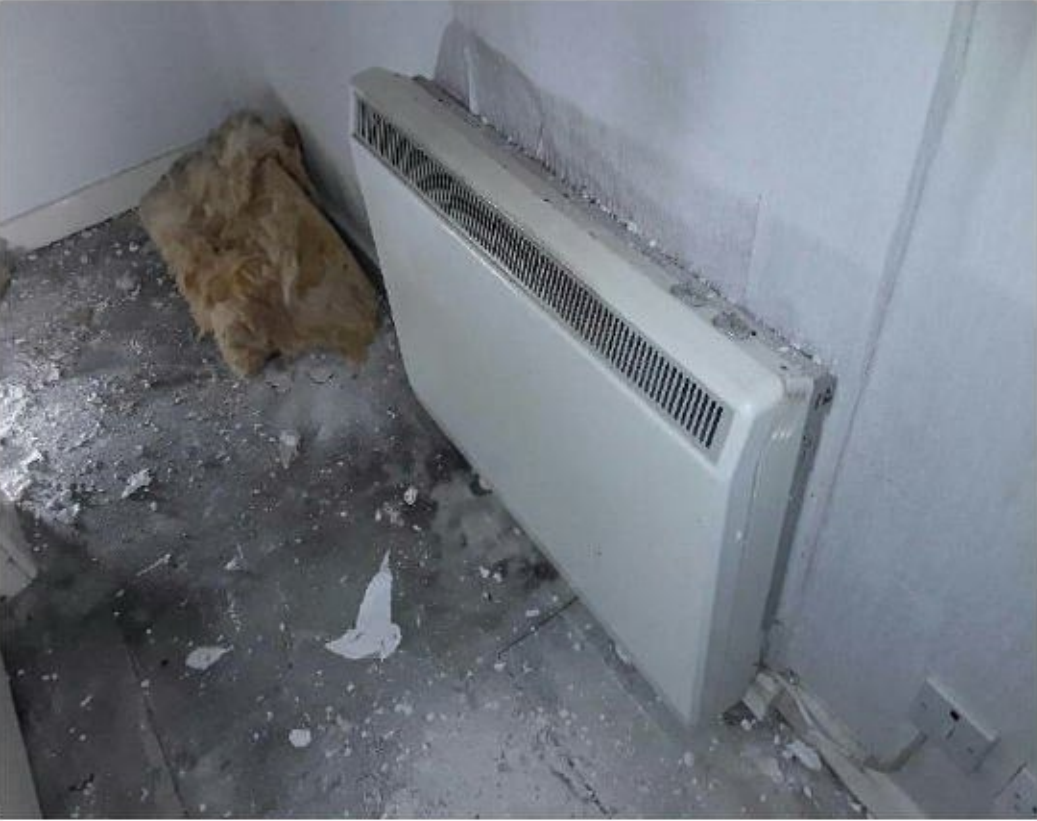
<b>Item:</b>	Asbestos Textile within electric heater			
<b>Asbestos Content:</b>	<b>Result Based on:</b>			
Chrysotile	Presumed			
<b>Sample Analysed By:</b>	Not applicable	<b>Extent:</b>	1 metres	
<b>Comments:</b> Presumed due to no safe access, live and connected

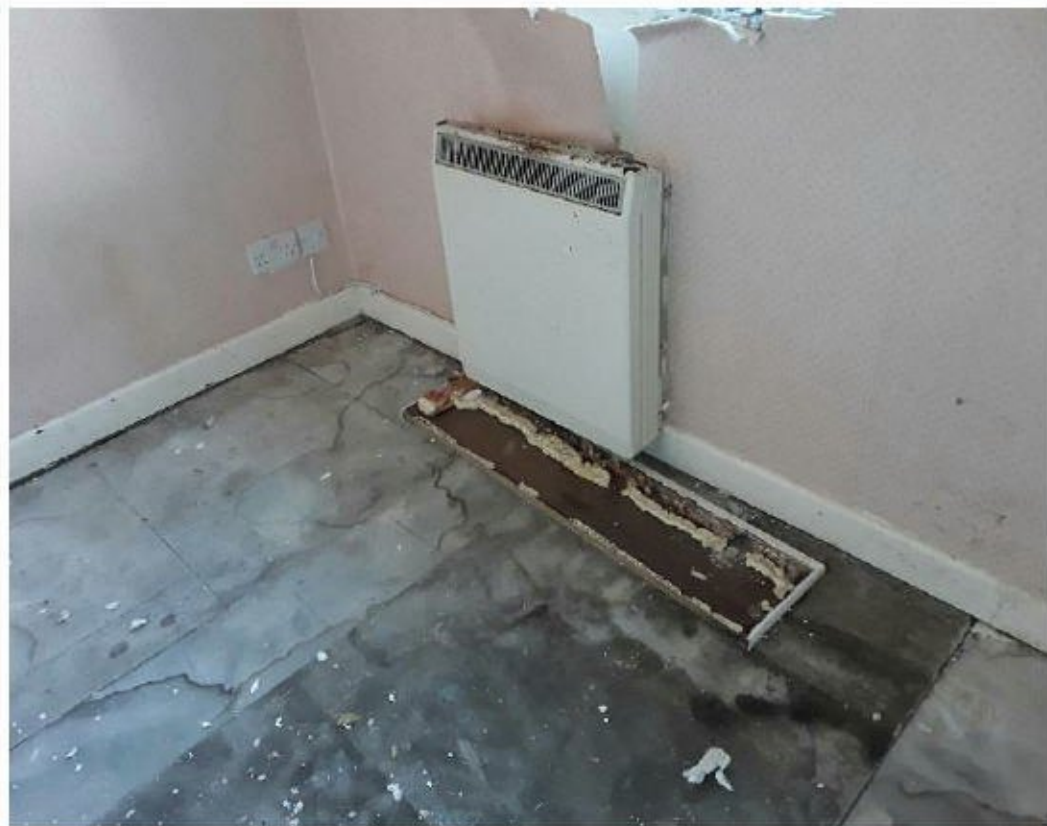
<b>Item:</b>	Asbestos Textile within electric heater			
<b>Asbestos Content:</b>	<b>Result Based on:</b>			
Chrysotile	Presumed			
<b>Sample Analysed By:</b>	Not applicable	<b>Extent:</b>	1 metres	
<b>Comments:</b> Presumed due to no safe access, live and connected

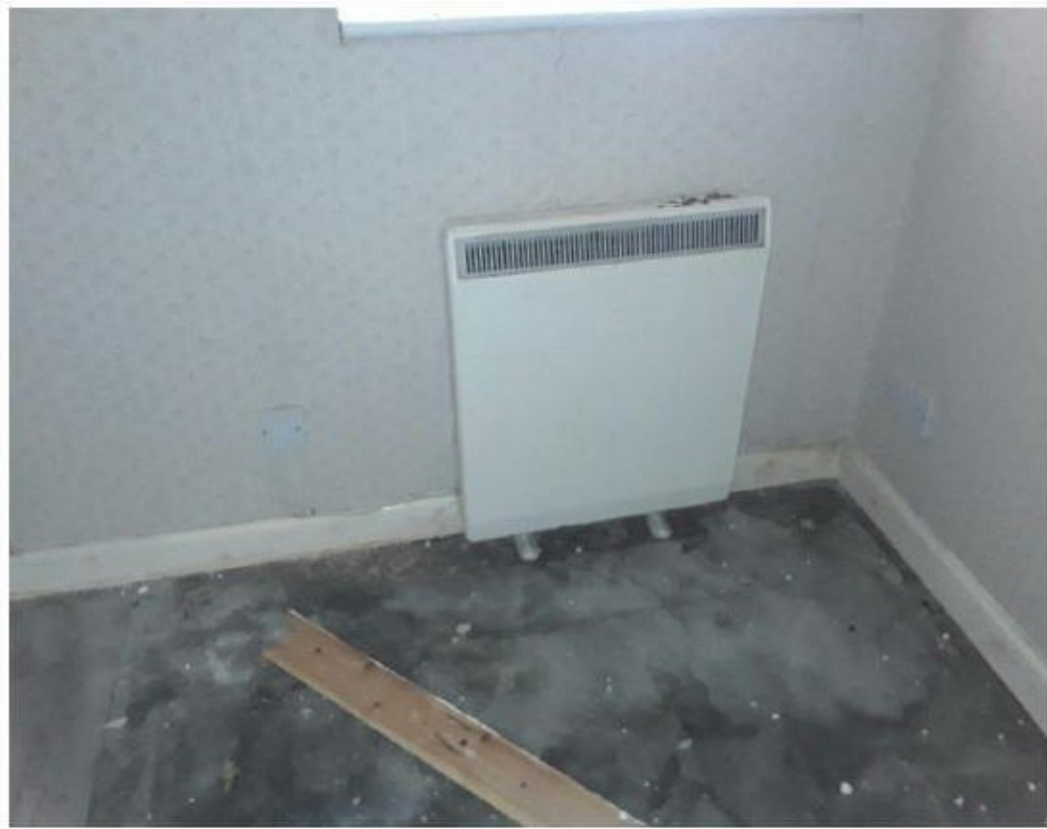
<b>Item:</b>	Asbestos Textile within electric heater			
<b>Asbestos Content:</b>	<b>Result Based on:</b>			
Chrysotile	Presumed			
<b>Sample Analysed By:</b>	Not applicable	<b>Extent:</b>	1 metres	
<b>Comments:</b> Presumed due to no safe access, live and connected

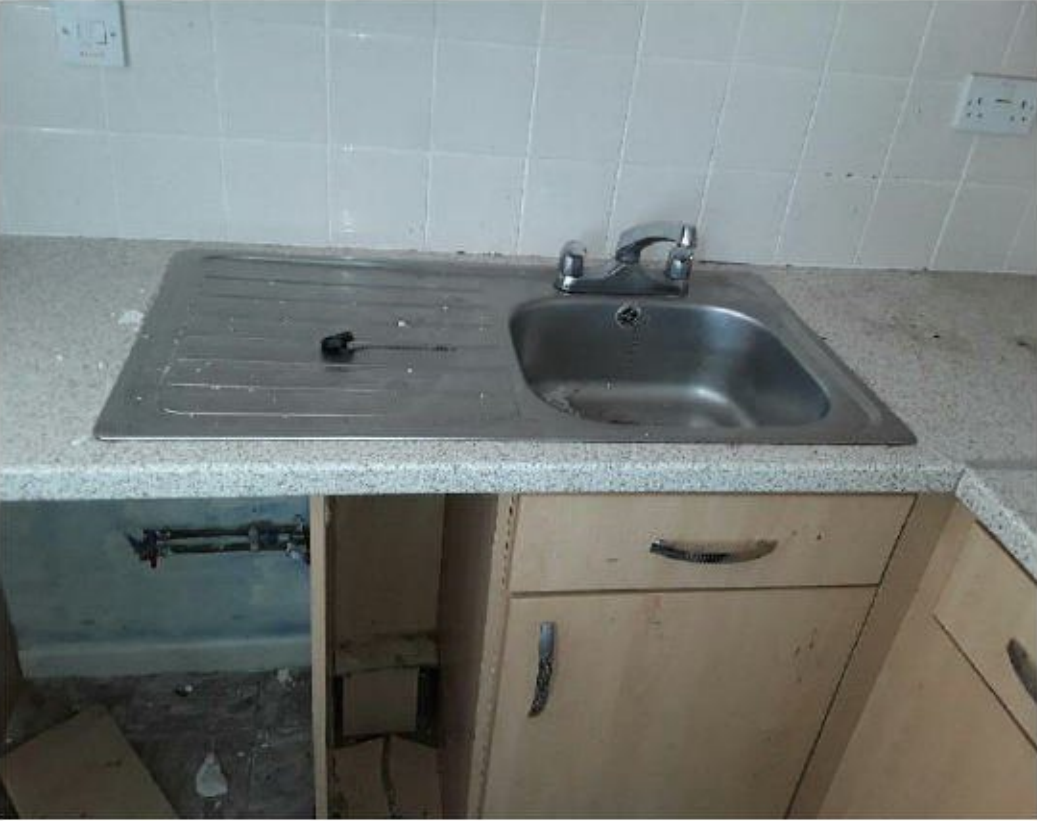
<b>Item:</b>	Bitumen sink pad			
<b>Asbestos Content:</b>	<b>Result Based on:</b>			
No Asbestos Detected	Analysis of sample using PLM			
<b>Sample Analysed By:</b>	C Hay	<b>Extent:</b>	1 unit	
<b>Comments:</b> Beneath bowl only

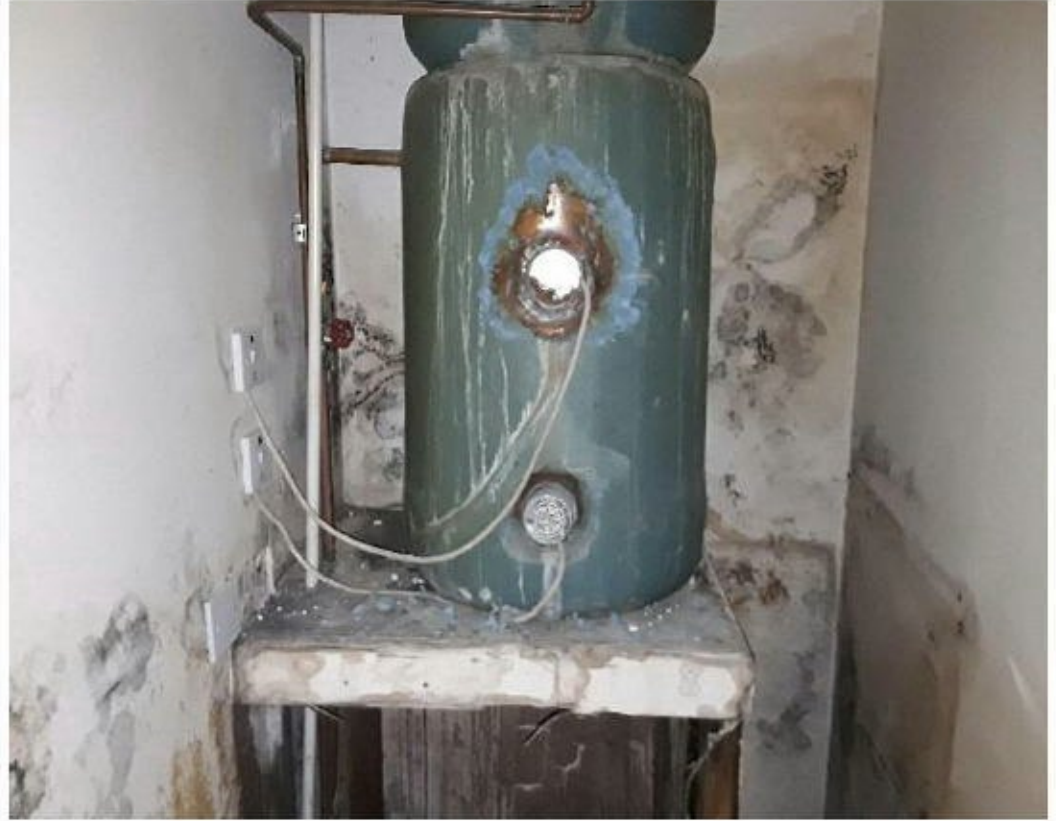
<b>Item:</b>	Gaskets to copper cylinder			
<b>Asbestos Content:</b>		<b>Result Based on:</b>		
No Asbestos Detected		Analysis of sample using PLM		
<b>Sample Analysed By:</b>	C Hay	<b>Extent:</b>	2 units	
<b>Comments:</b>

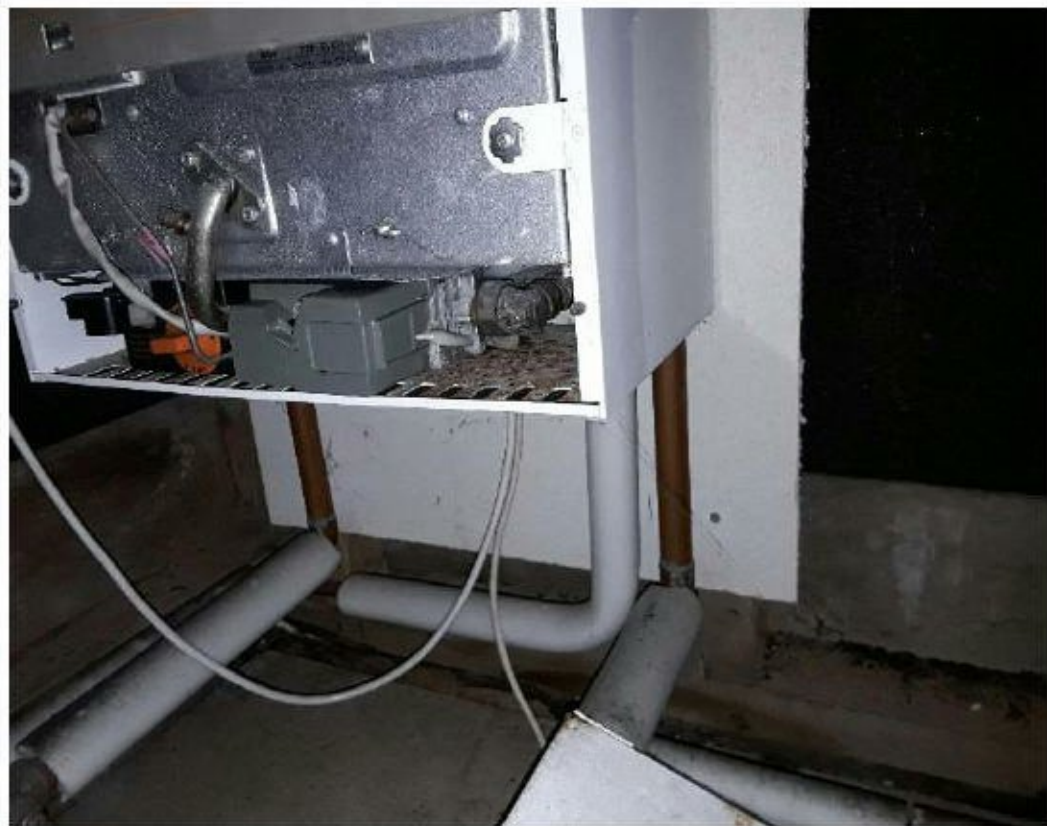
<b>Item:</b>	Insulating board panel to wall			
<b>Asbestos Content:</b>		<b>Result Based on:</b>		
No Asbestos Detected		Analysis of sample using PLM		
<b>Sample Analysed By:</b>	C Hay	<b>Extent:</b>	1 m <sup>2</sup>	
<b>Comments:</b> The insulating board panel appears to be modern and has been sampled to prove no asbestos is present.

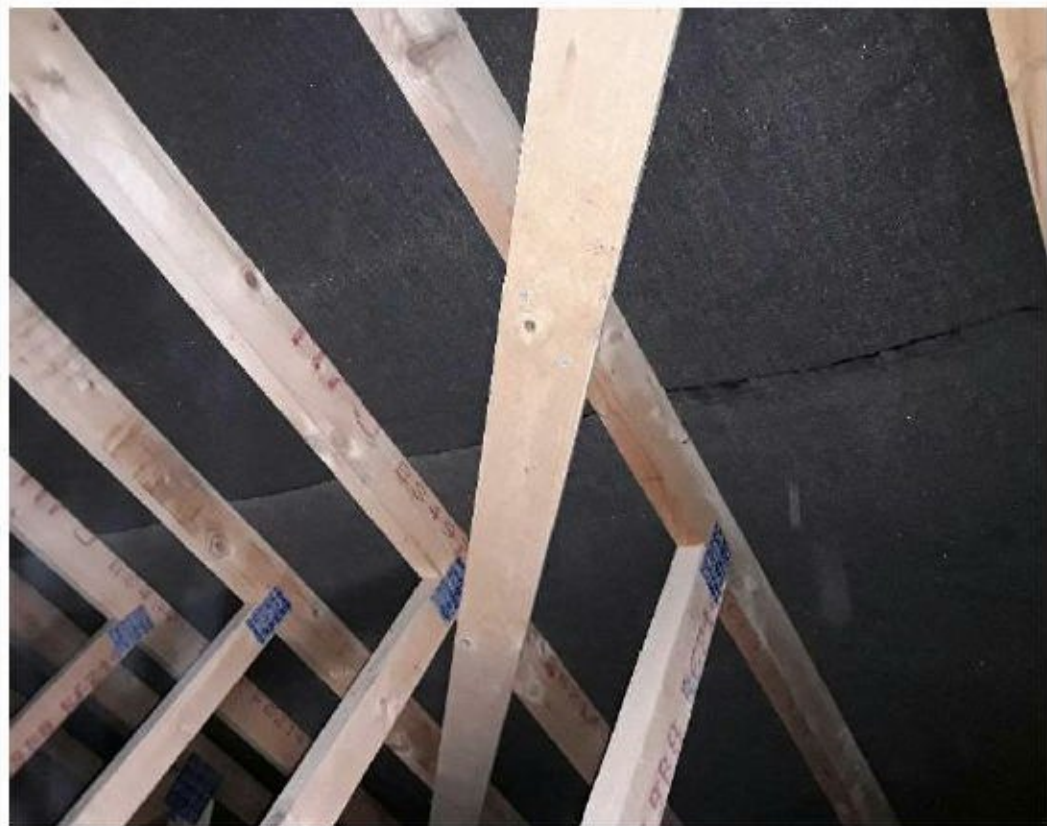
<b>Item:</b>	Bitumen roof sarking			
<b>Asbestos Content:</b>		<b>Result Based on:</b>		
No Asbestos Detected		Analysis of sample using PLM		
<b>Sample Analysed By:</b>	C Hay	<b>Extent:</b>	70 m <sup>2</sup>	
<b>Comments:</b> Present to the underside of a pitched roof

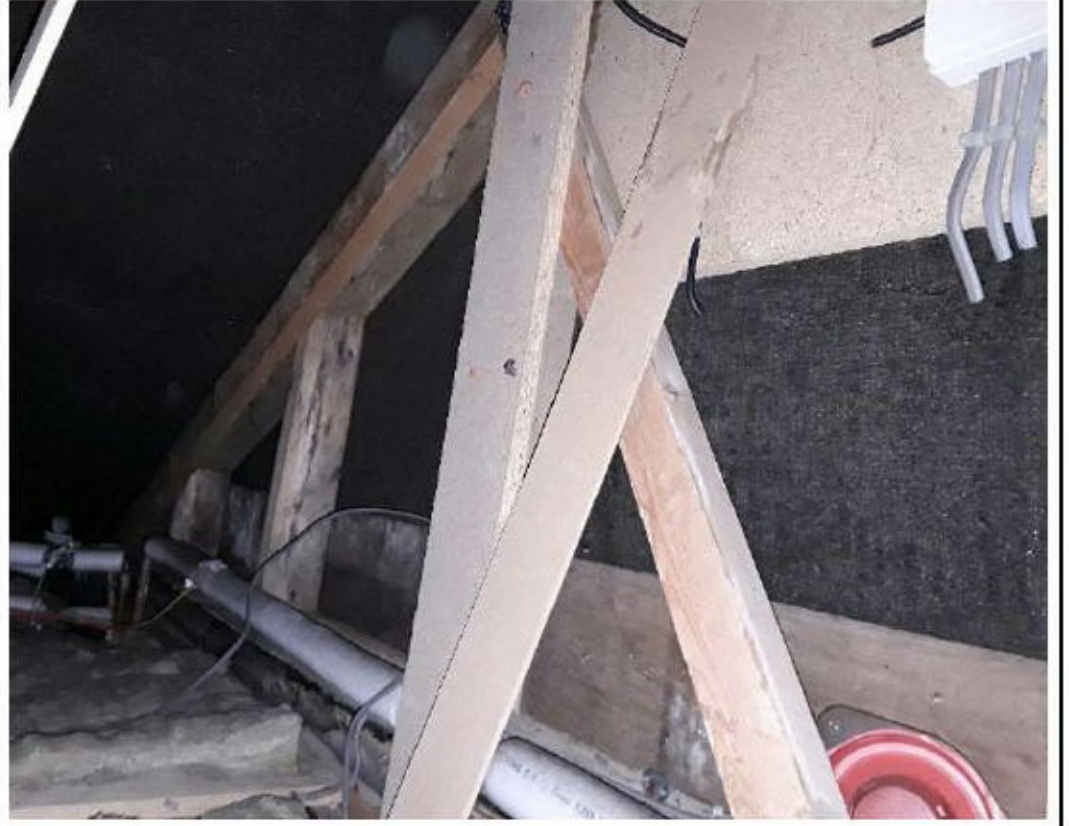
<b>Item:</b>	Bitumen felt lining to walls			
<b>Asbestos Content:</b>		<b>Result Based on:</b>		
No Asbestos Detected		Analysis of sample using PLM		
<b>Sample Analysed By:</b>	C Hay	<b>Extent:</b>	15 m <sup>2</sup>	
<b>Comments:</b>
