**Report No.:** J177345 V2  
**Nature of Work:** Demolition Survey  
**Issue Date:** 12/01/2021  
**Client Name:** Regenda Homes  
Commutation Plaza, 1 Commutation Row, Islington, Liverpool,  
L3 8QF  
**Site Address:** Prospect Court (1-6), Rossall Road, Thornton-Cleveleys, FY5  
1HQ

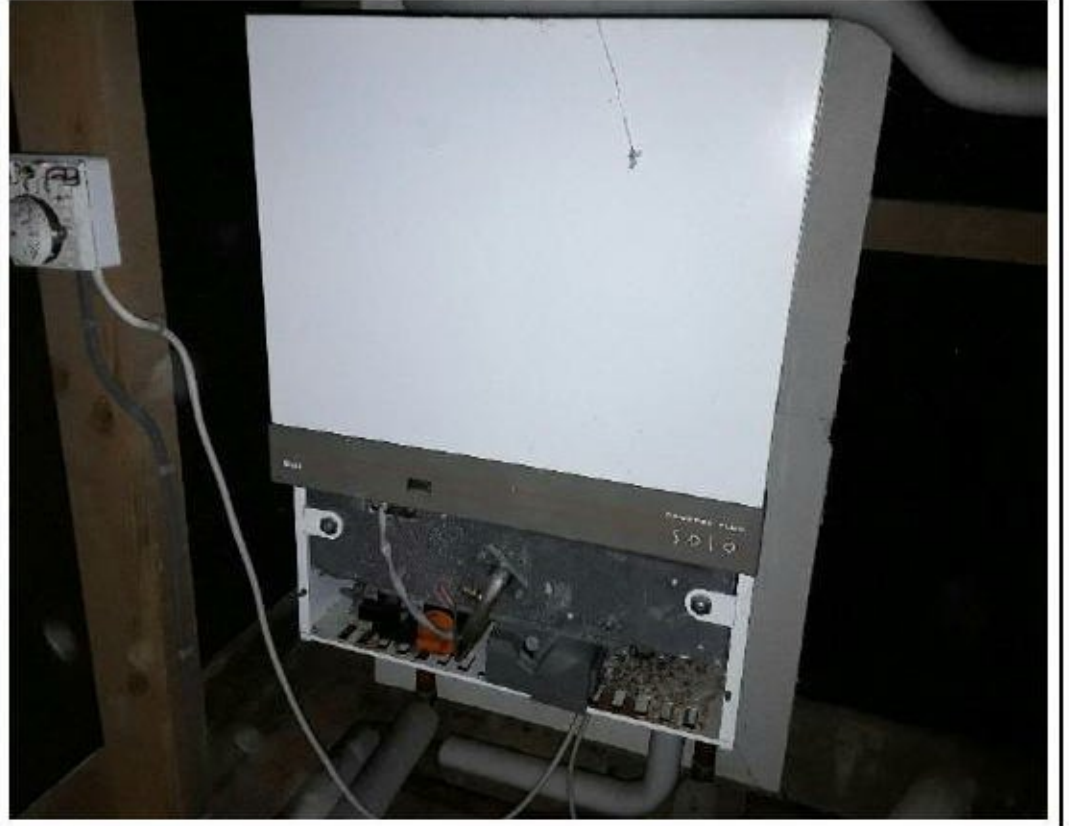
<b>Item:</b>	Asbestos Textile within boiler			
<b>Asbestos Content:</b>	<b>Result Based on:</b>			
Chrysotile	Presumed			
<b>Sample Analysed By:</b>	Not applicable	<b>Extent:</b>	1 metres	
<b>Comments:</b> Presumed due to no safe access, live and connected

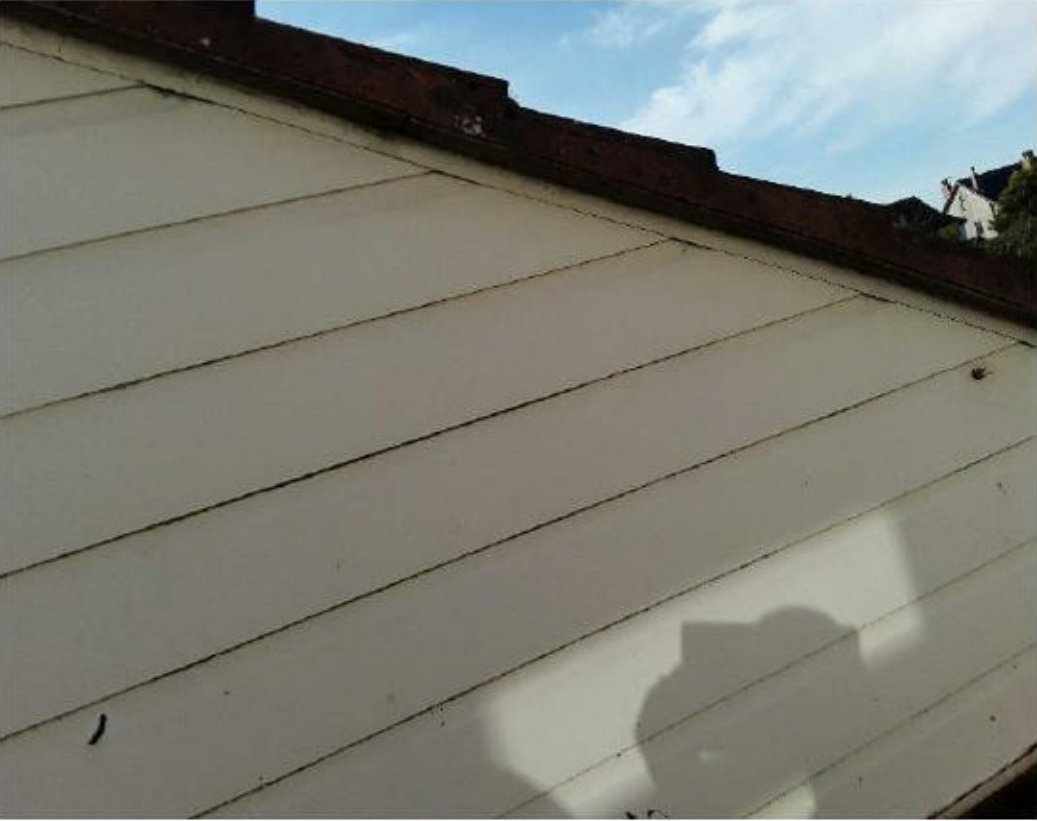
<b>Item:</b>	Cement undercloaking to roof verge			
<b>Asbestos Content:</b>		<b>Result Based on:</b>		
No Asbestos Detected		Analysis of sample using PLM		
<b>Sample Analysed By:</b>	C Hay	<b>Extent:</b>	6 linear metres	
<b>Comments:</b> Present to low level roof verge

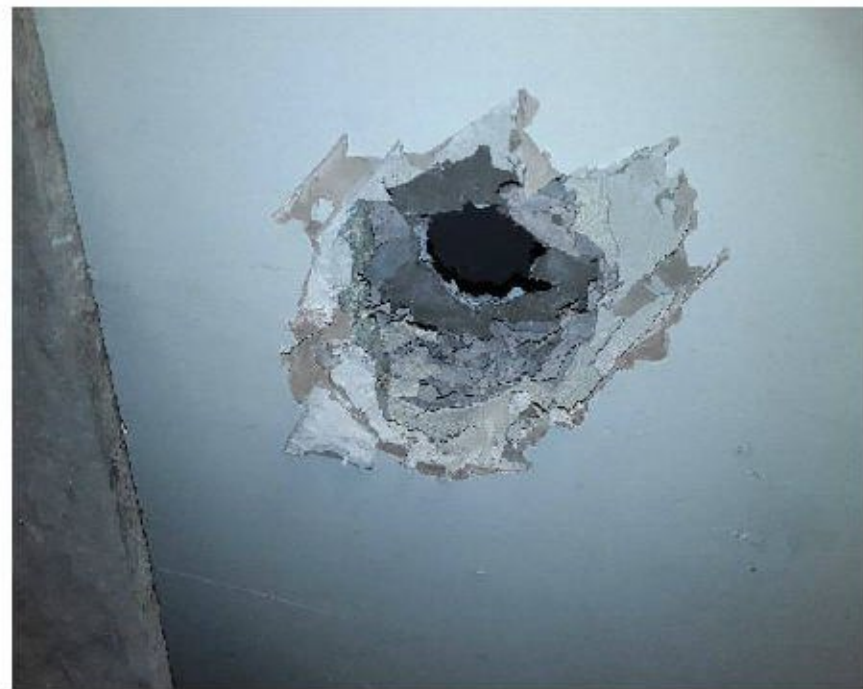
05 (03 Understairs Cupboard)  
Beyond timber floorboards

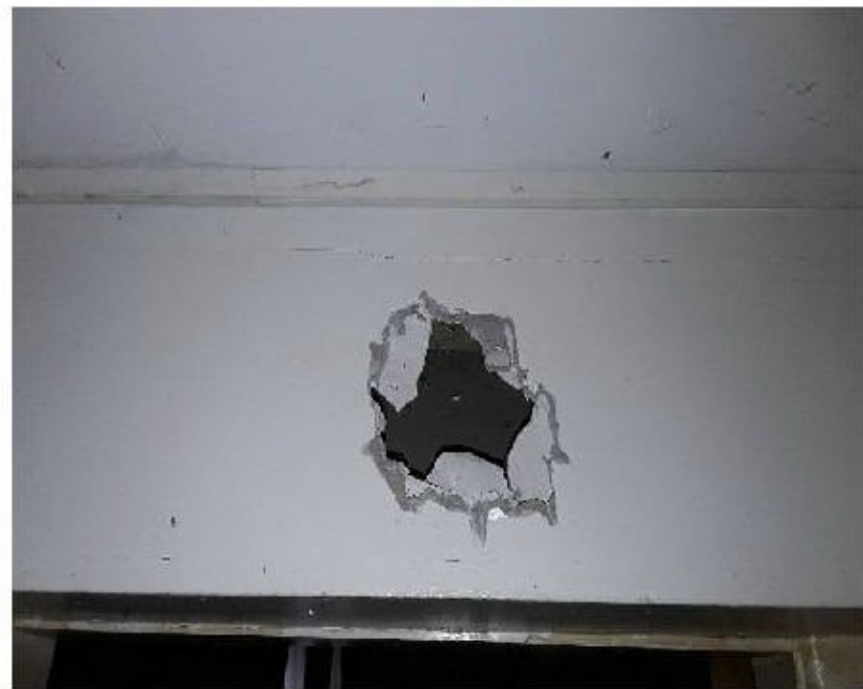
09 (06 Living Room) Beyond timber window sill
