**PROJECT:**  
 Greia House

**DRAWING TITLE:**  
 Photographic schedule of first floor

**SCALE:** As Shown @A1  
**DRAWING NO:** PS/04  
**REV:**

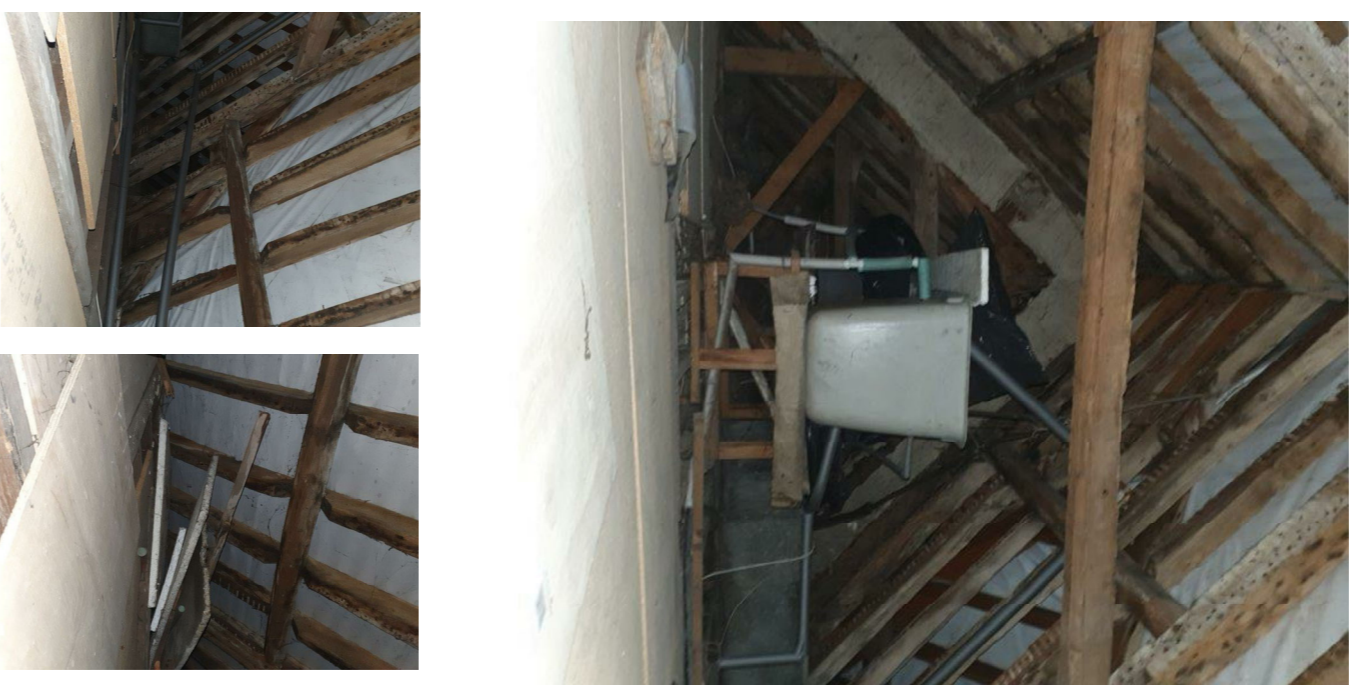
Attic space above Bedroom five cold water storage tanks in poor state with inadequate support

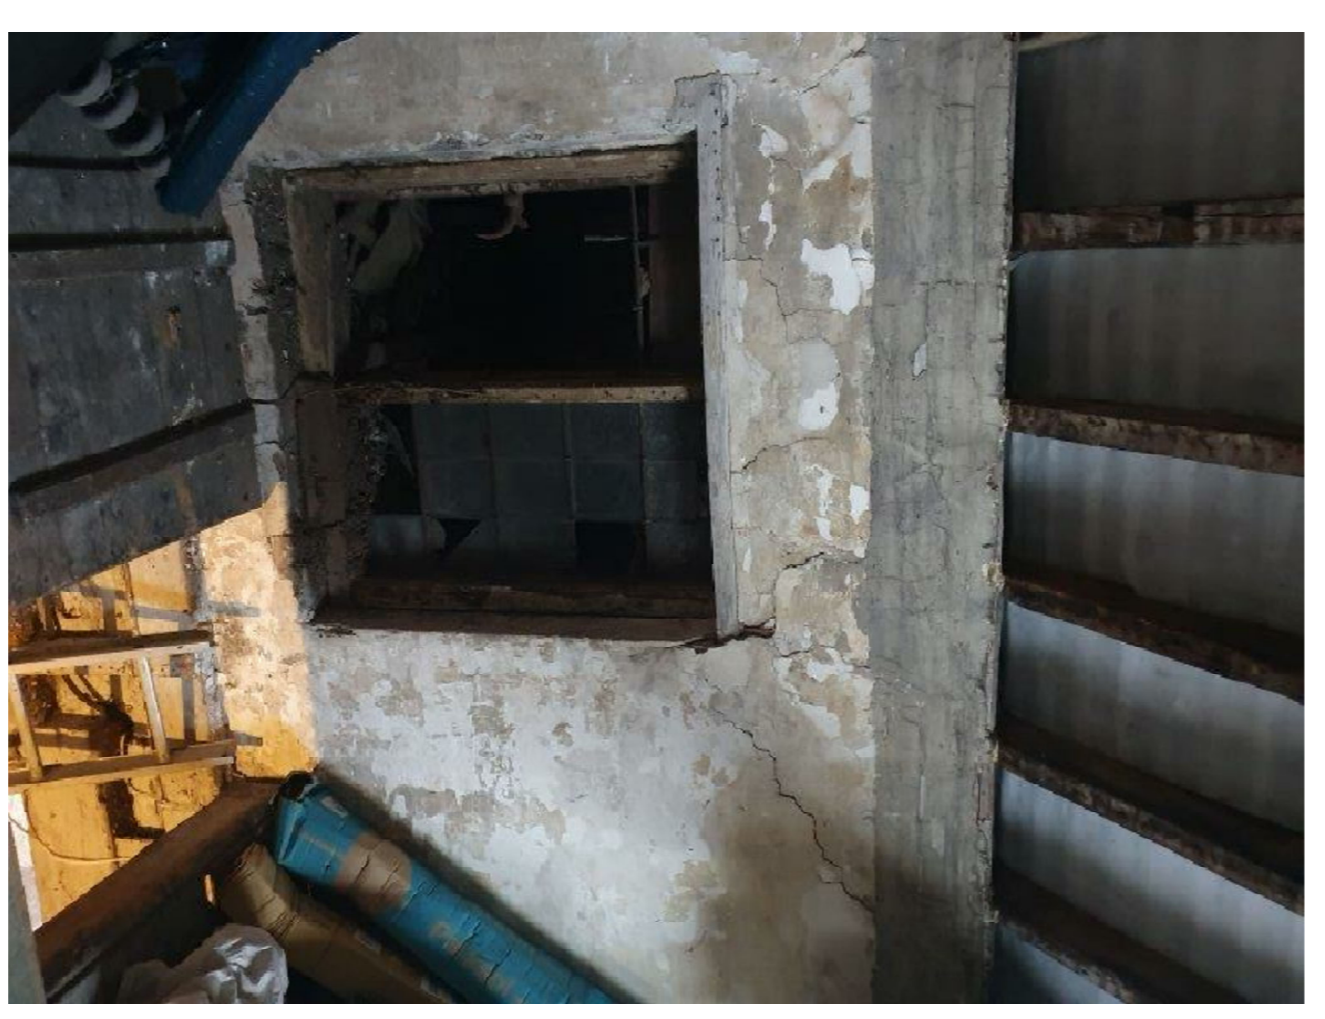
Structural crack internally - Front wall

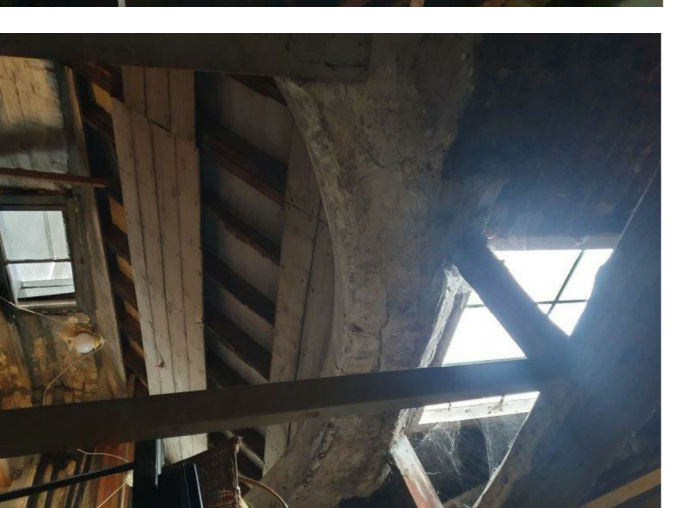
Gable above arch - poorly supported

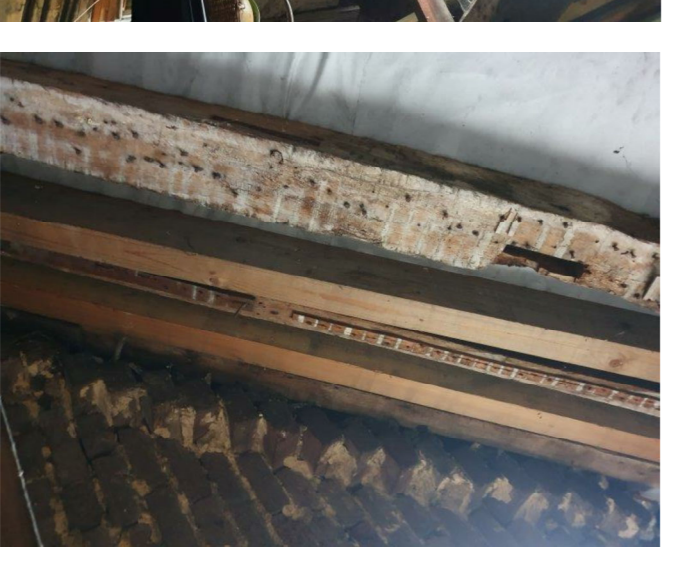
Gable above arch - poorly supported

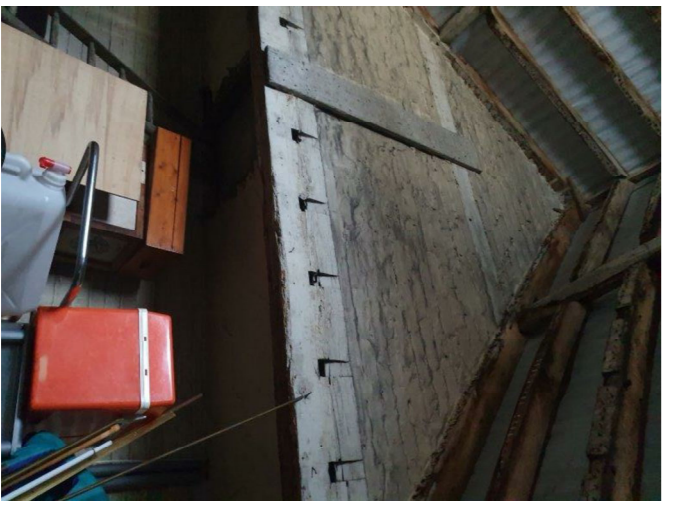
New timber introduced adjacent to gable

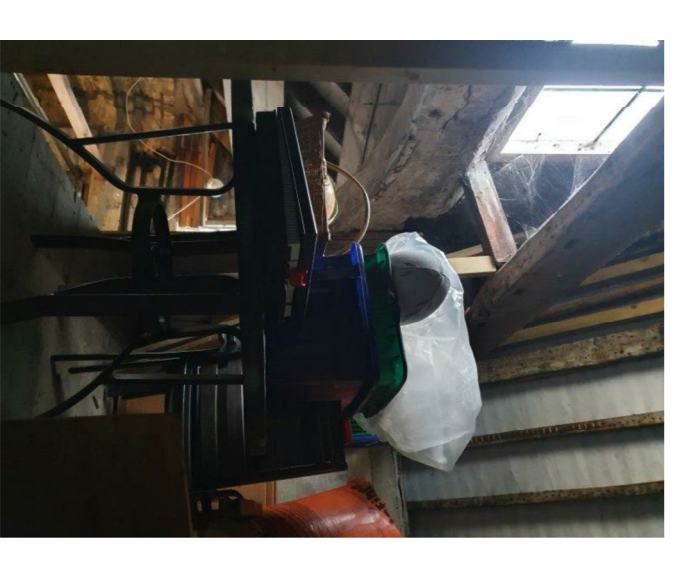
Check gable to bedroom five

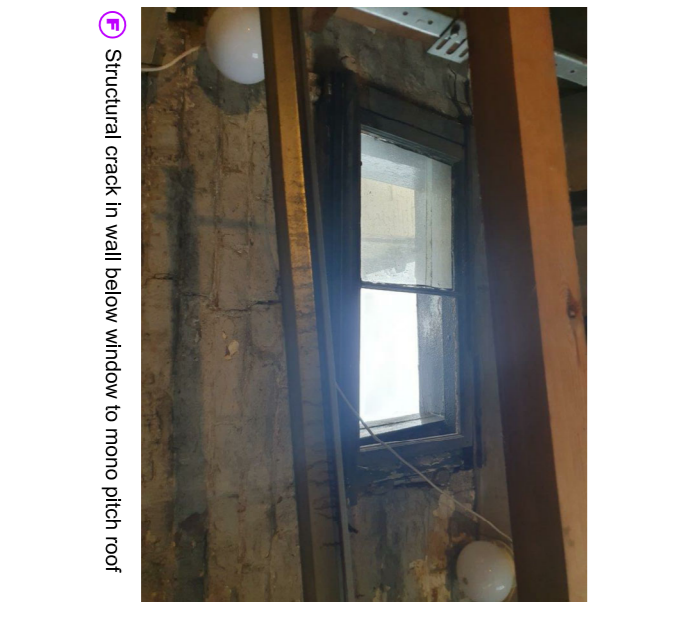
Arch supporting gable above

Structural crack in wall below window to mono pitch roof
