STRUCTURAL REPORT

Kitchen Garden Barn
Church Street
Wadenhoe
Peterborough
PE8 5TE

Your ref:
Our ref: 20095 Report
Date: 14th September 2020

Re: Limited Structural Report, Workshop Barn, Wadenhoe

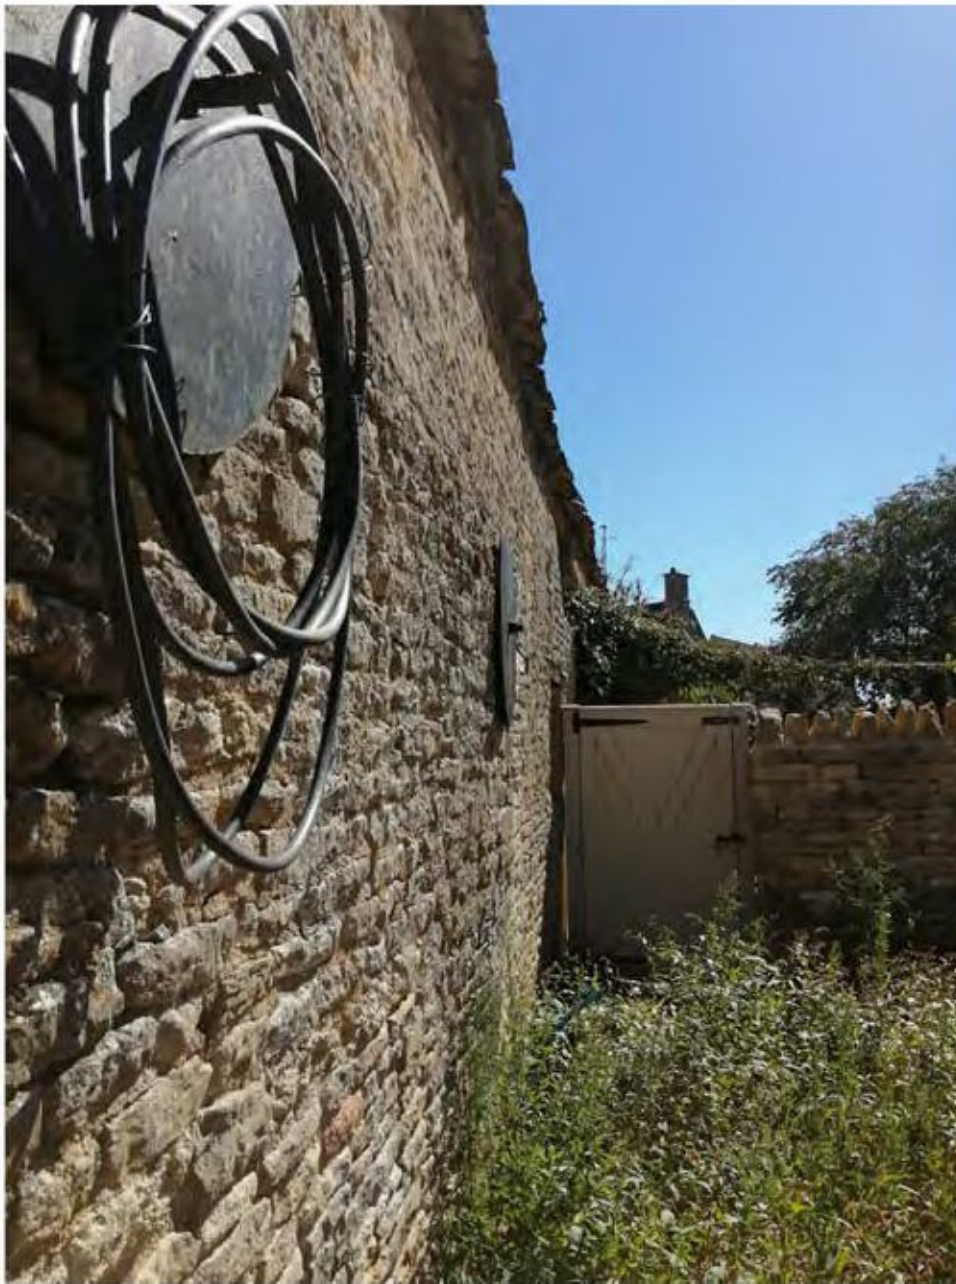
The south western flank wall has an inward lean and bellying of stonework at wallplate level (Plate 3).

Plate 3 Looking South West Along Flank Wall at Bellying Stonework at Wallplate Level

Attempts at arresting thrust in walls due to roof spread have been made by inserting 4 tie rods. This has not been wholly successful, leading to bellying of stonework.

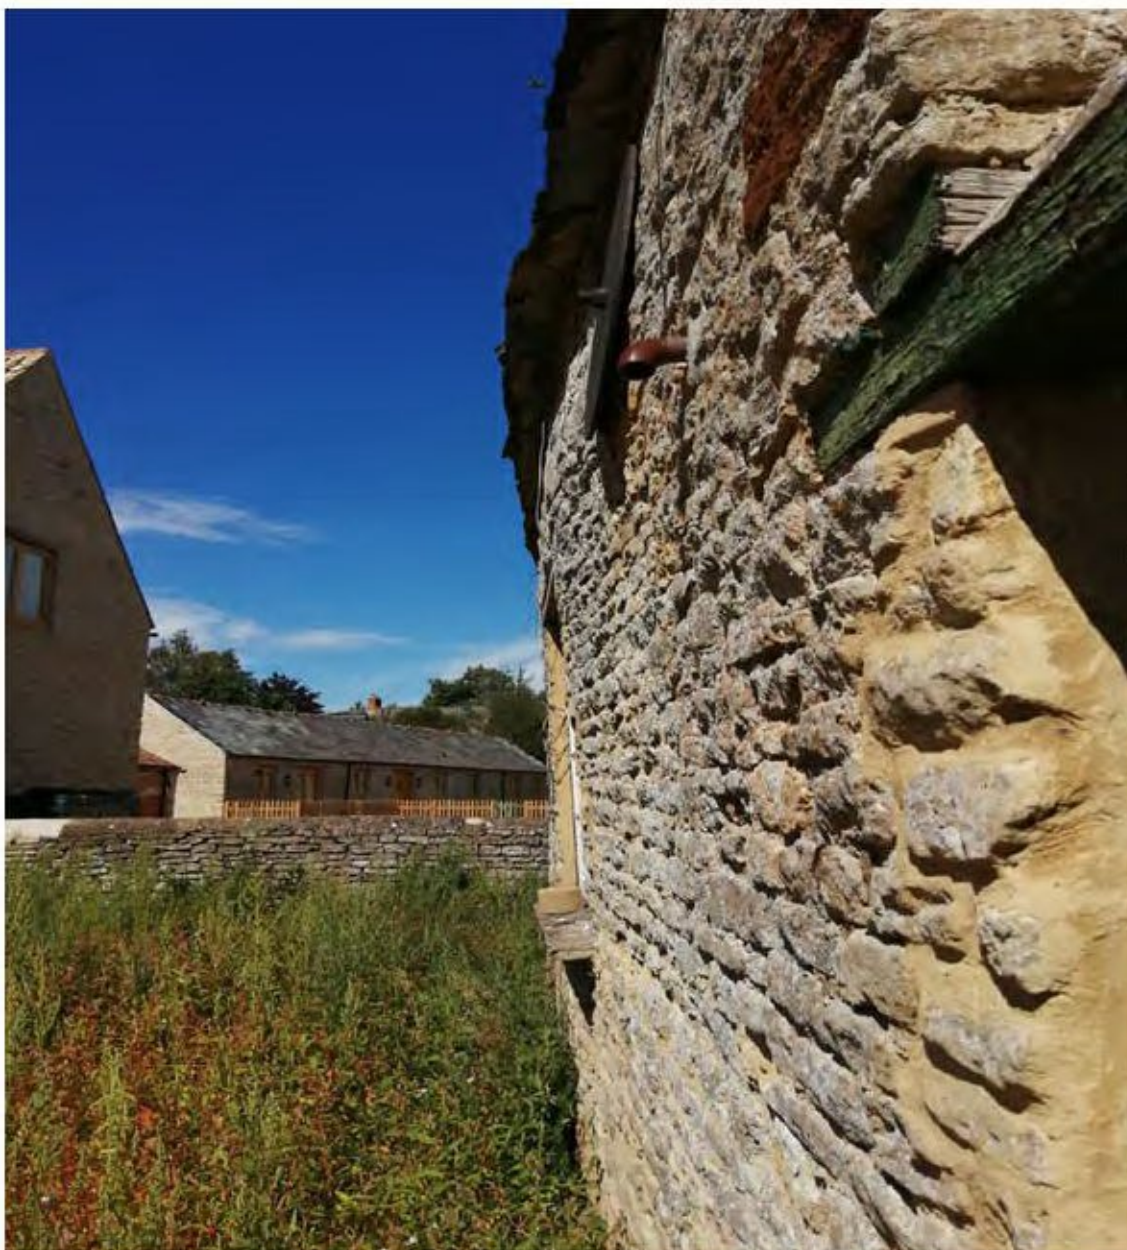
Similarly, further along to the north of this flank wall, the stonework is bellying outwards (Plate 4). Note the bulge is worse over the window opening to the workshop.

The bulging stonework above the window opening in the Western elevation wall to the Workshop should be taken down and rebuilt.

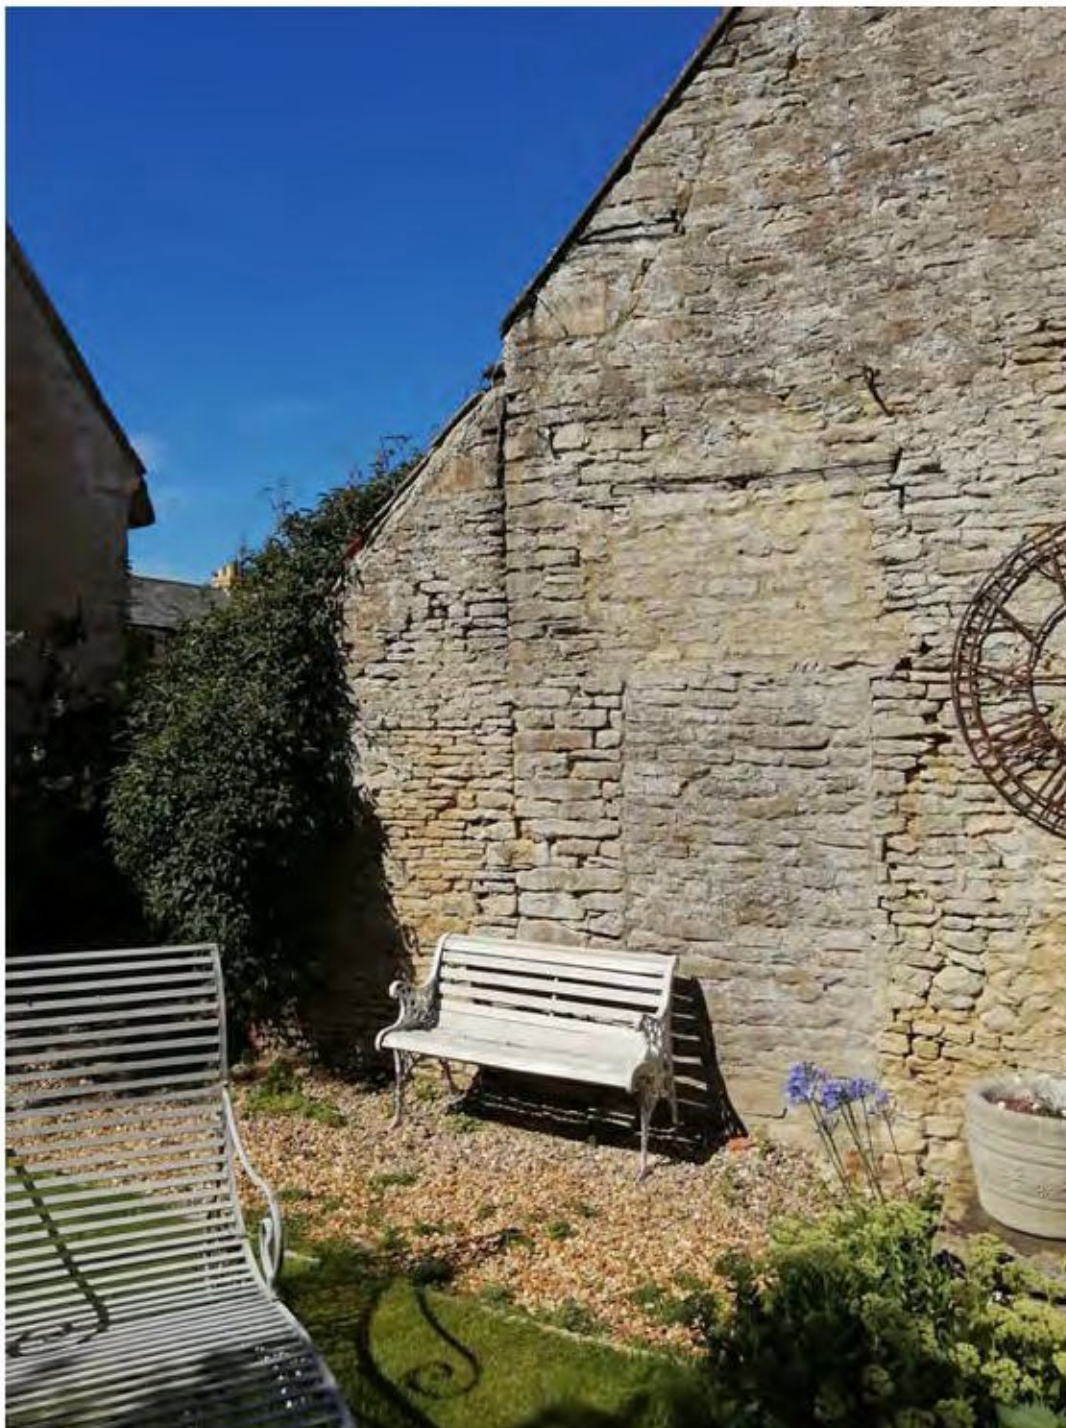
The south western gable elevation shows historic infilling of an original opening (Plate 6) and vertical cracking in the external stonework where bonding has been inadequate, leading to movement.

Plate 6 Looking North at Cracking to Infill Panel in Southern Gable Elevation

Stonework and brickwork should be stitched together with Helifix bars where vertical and diagonal cracking exists. A drawing should be marked up by a structural engineer to identify these locations. Stitching to be carried out strictly in accordance with manufacturers guidelines and instructions.

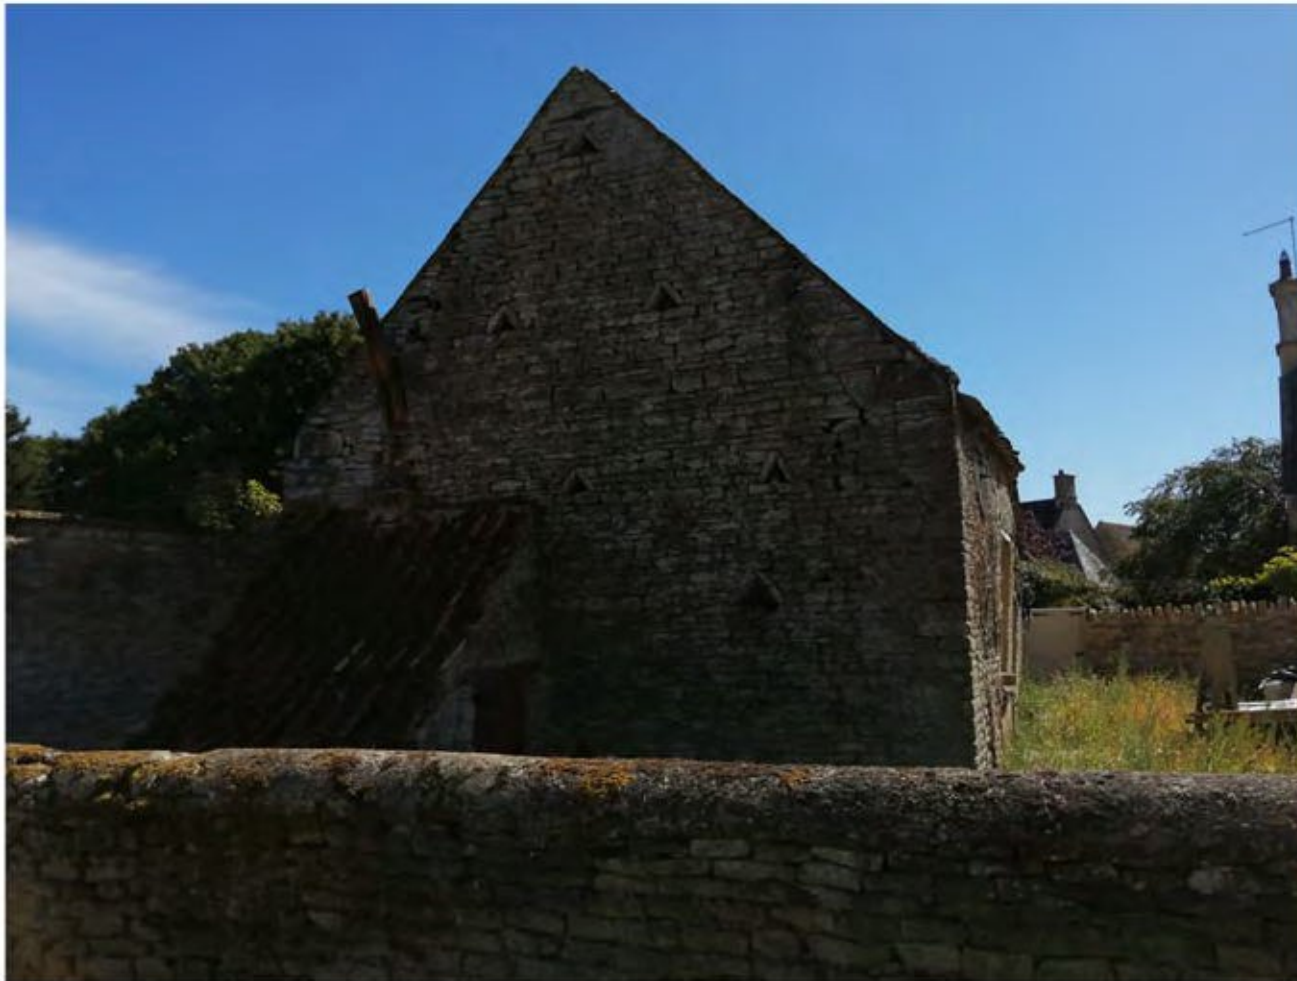
The north east gable end has vertical and diagonal cracking where it intersects with the eastern flank wall (Plate 7). Note the mortar joints are also weathered.

Plate 7 Looking South at Cracking in North East Gable End

Weathered stonework should be repointed throughout in a lime mix as approved by Listed Building Consent.

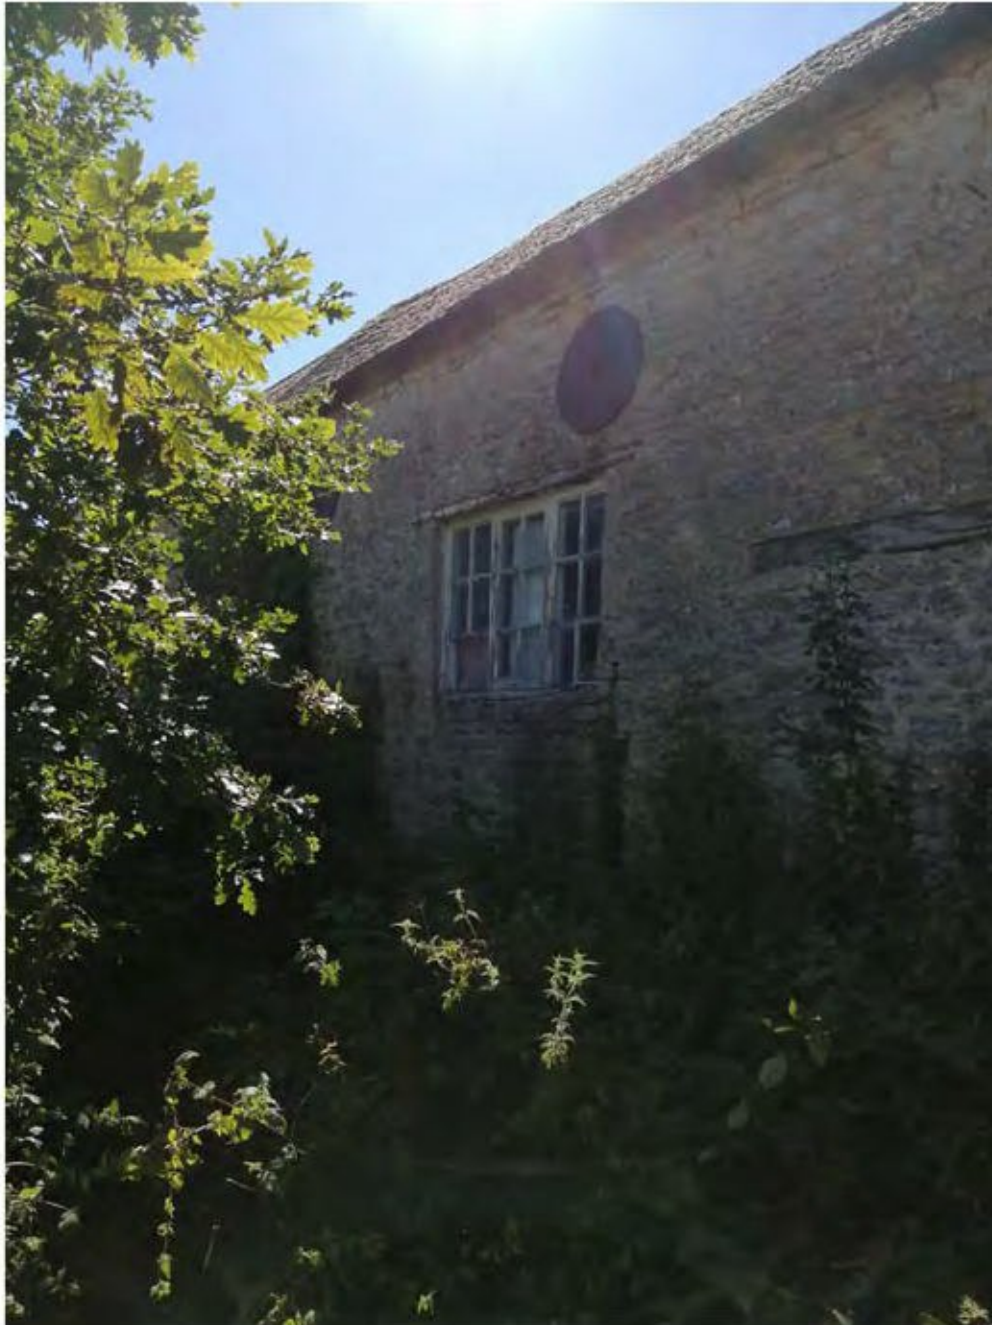
Lintels over most window and door openings are weathered and likely rotten (Plate 9). It can be seen that the window frames are beyond economic repair.

Plate 9 Looking South West Along Eastern Elevation at Poor Timberwork to Windows and Supporting Lintel Above

Lintels have been allowed to deteriorate due to water ingress as a direct result of no rainwater goods.

All damaged/ ineffective lintels should be removed and replaced with hardwood lintels designed by a structural engineer.

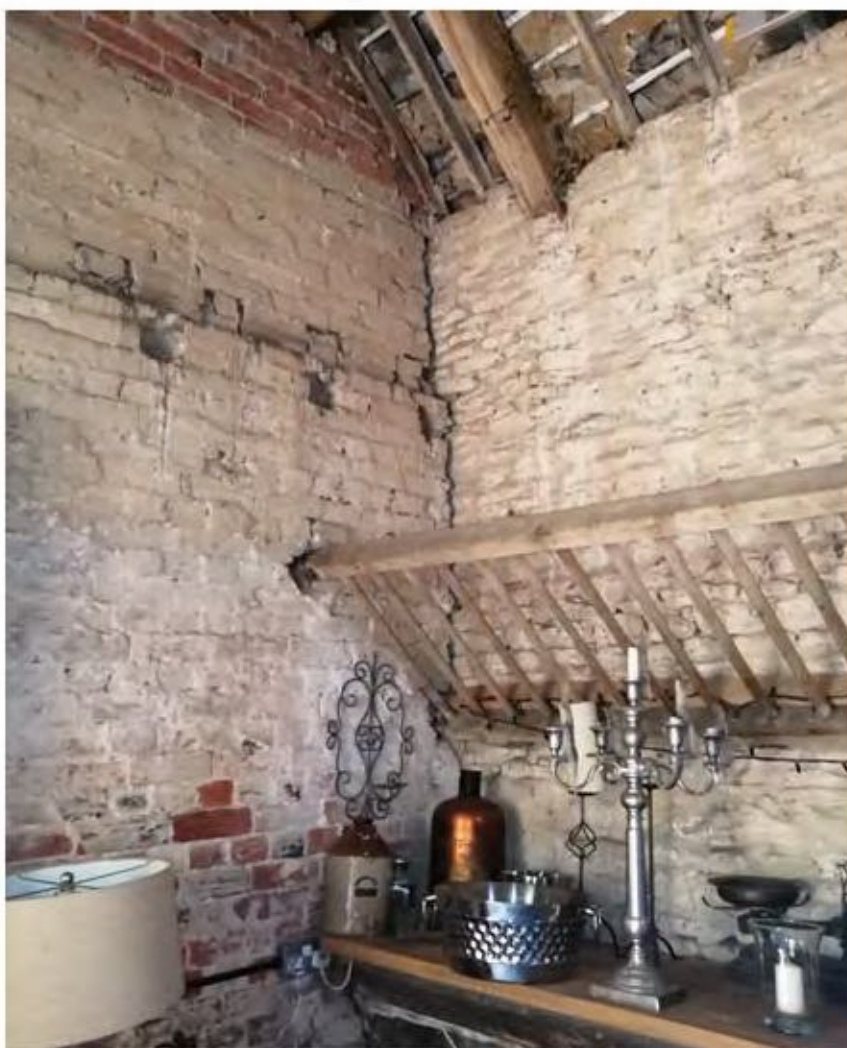
There are vertical cracks between the west flank and internal cross walls at the southernmost gable elevation (Plate 10). Similarly, cracks exist in the cross wall abutting the western elevation wall

Plate 10 Looking East at Vertical Cracks Between Eastern Flank Wall & Cross Wall

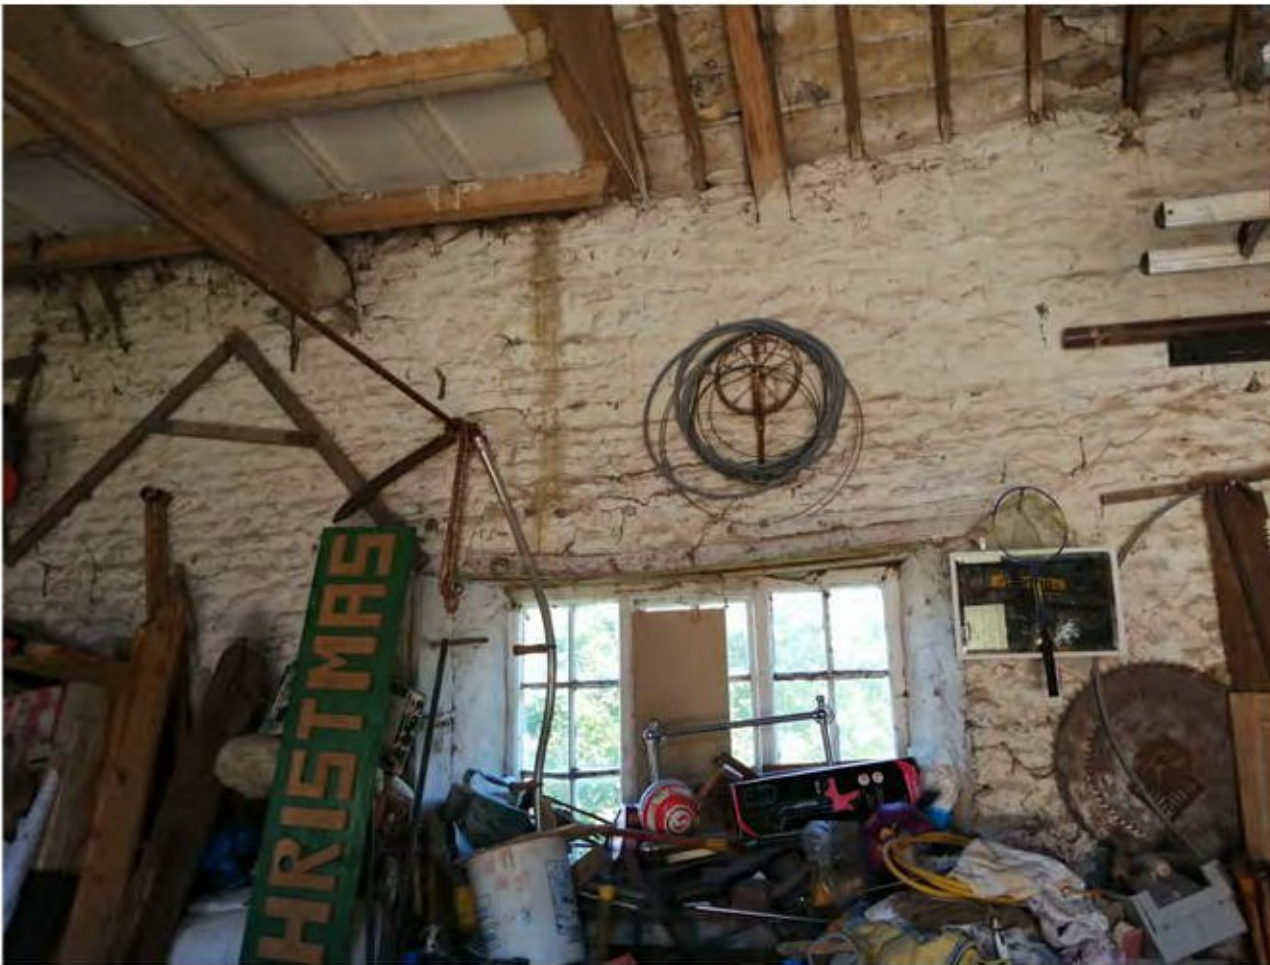
The lintel over the window opening in the eastern elevation wall to the workshop is deflecting excessively (Plate 12). The opening is supporting a truss above.

Plate 12 Looking East at Deflecting Lintel in Workshop Eastern Elevation Opening
