# STRUCTURAL REPORT

Kitchen Garden Barn  
Church Street  
Wadenhoe  
Peterborough  
PE8 5TE

Re: Limited Structural Report, Workshop Barn, Wadenhoe

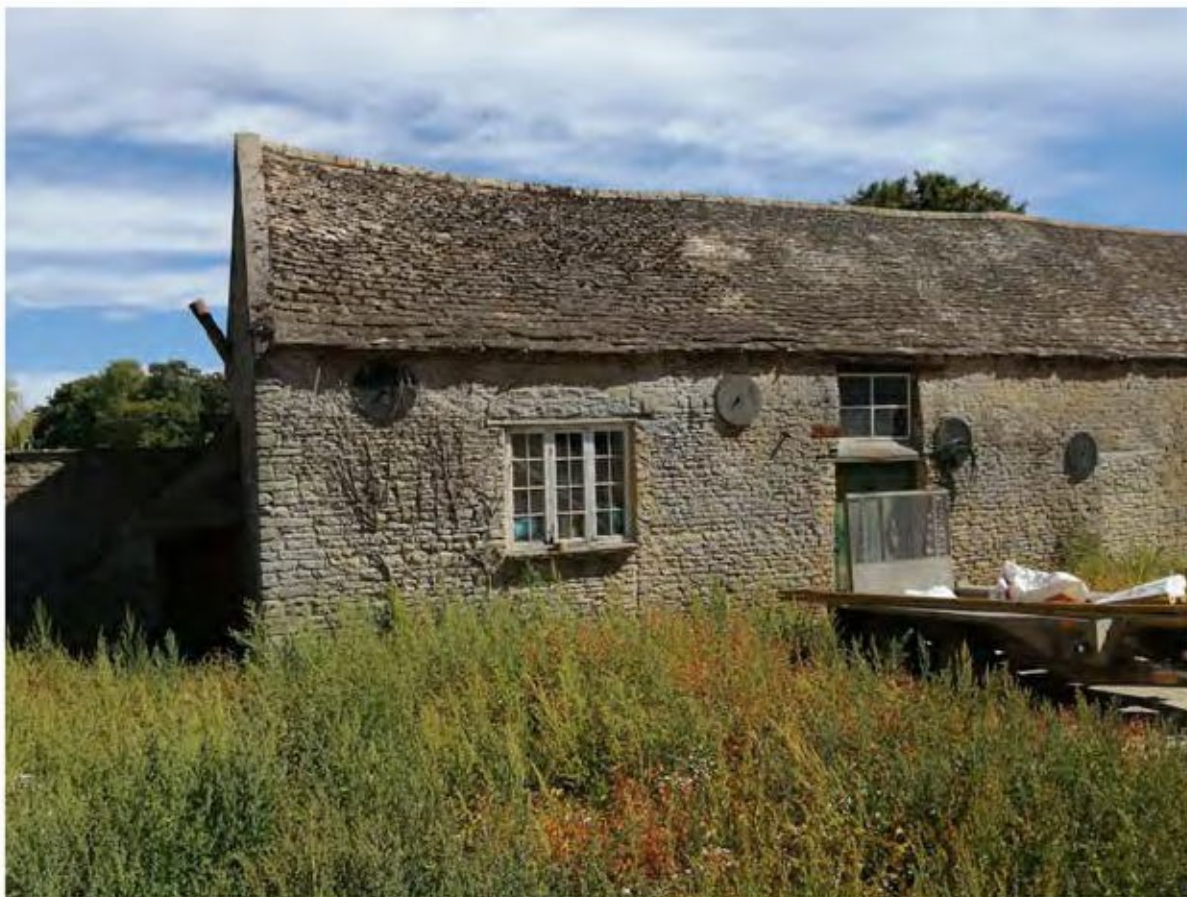
The general ridge line of the roof has undulations, suggesting undersized timber roof members (Plate 1) Tie rods have been added at some point in the past to resist roof spread, possibly as a consequence of the undersized roof members.

Plate 1 Looking East at West Elevation  
Indicating Undulating Roof Line & Tie Rods

Attempts at arresting thrust in walls due to roof spread have been made by inserting 4 tie rods. This has not been wholly successful, leading to bellying of stonework.

Any damaged or decayed timberwork should be replaced with similar section sizes. Similarly, damaged or missing roof slates and timber battens due to corroded pegs/ nails should be inspected and replaced as necessary by an experienced roofing contractor.

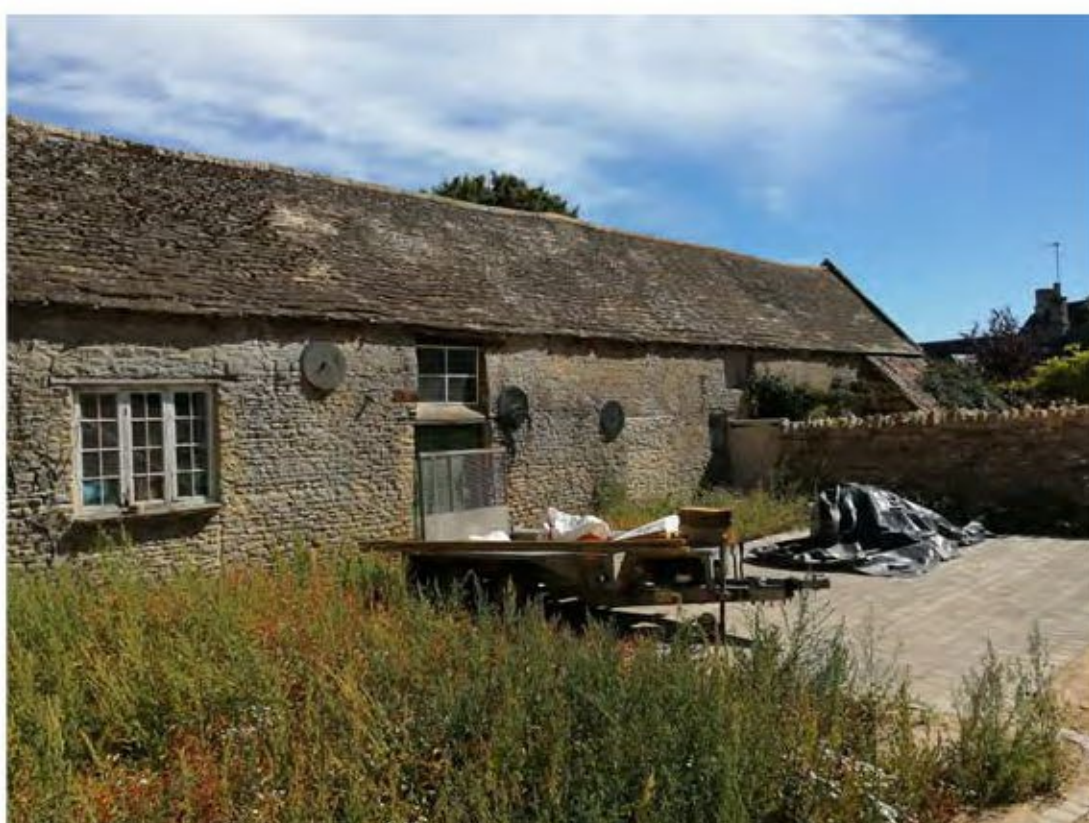
A number of original door and window openings have been blocked up with stonework over the years (Plate 2). Some re-pointing work can also be seen present in the external stonework.

Plate 2 Looking South East Along Barn

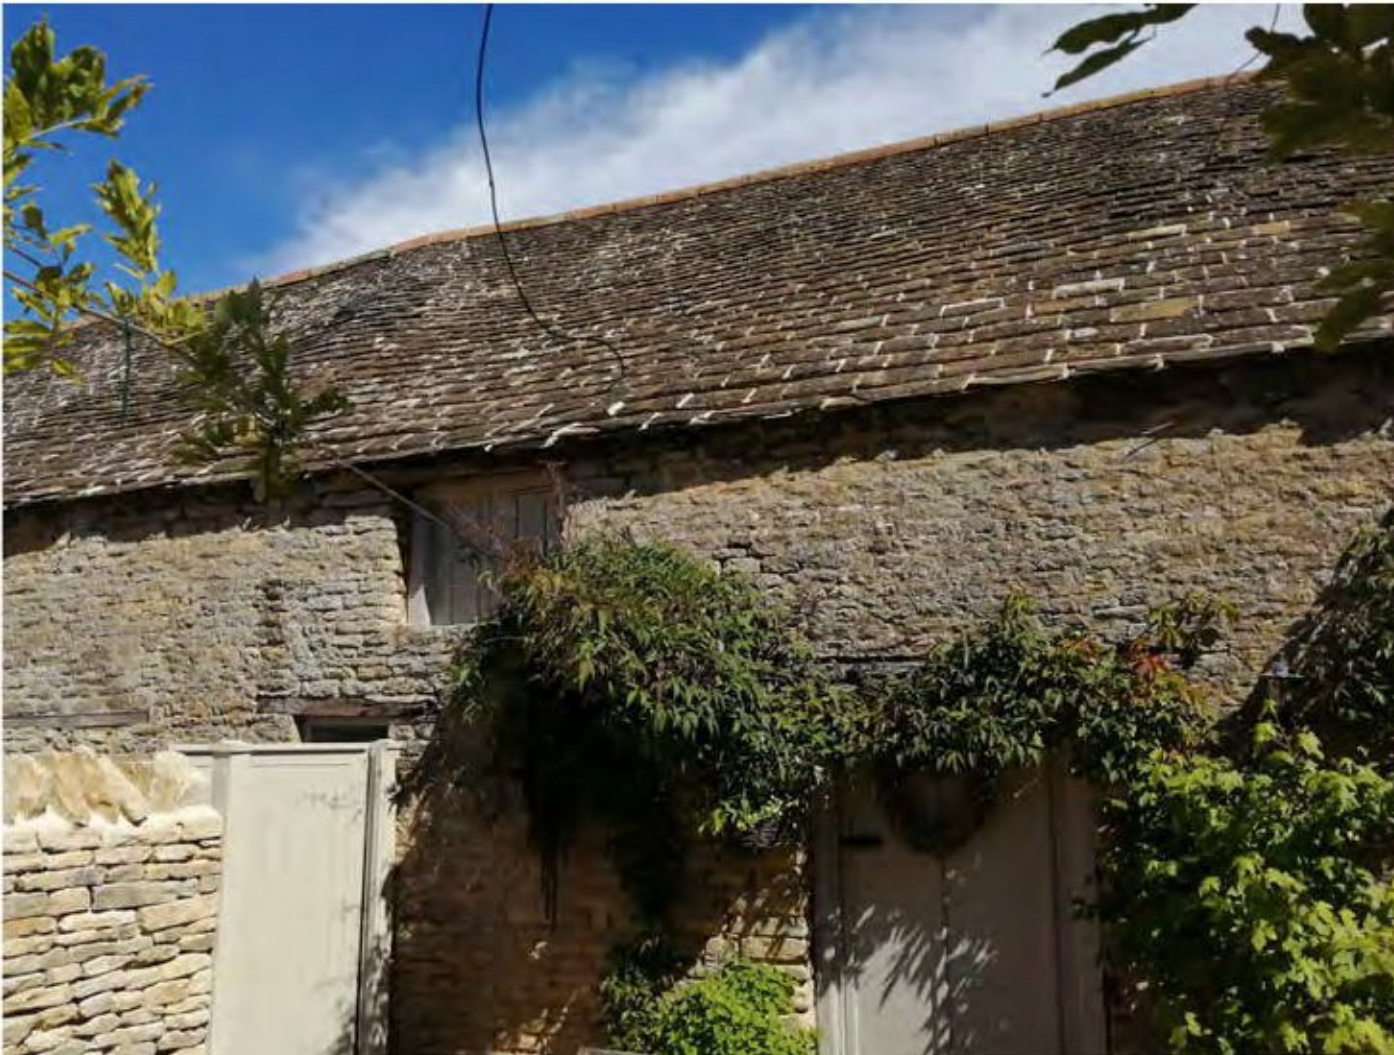
There are no rainwater gutters to the western flank elevation meaning all rainwater disperses onto the ground level (Plate 5)

Plate 5 Looking East at Roof Structure With no Rainwater Goods Present

Rainwater goods are missing throughout and as a consequence, weathering has taken effect on external stonework and external ground levels.

We recommend that gutters and downpipes be provided as a matter of urgency to prevent further damage to stonework and lintels.

A suitable number of downpipes and diameter of guttering should be provided to suit the expected flow of rainwater calculable to the surface area of the roof. This should be discharged into a relevant number of soakaways, a minimum of 5m from the building.

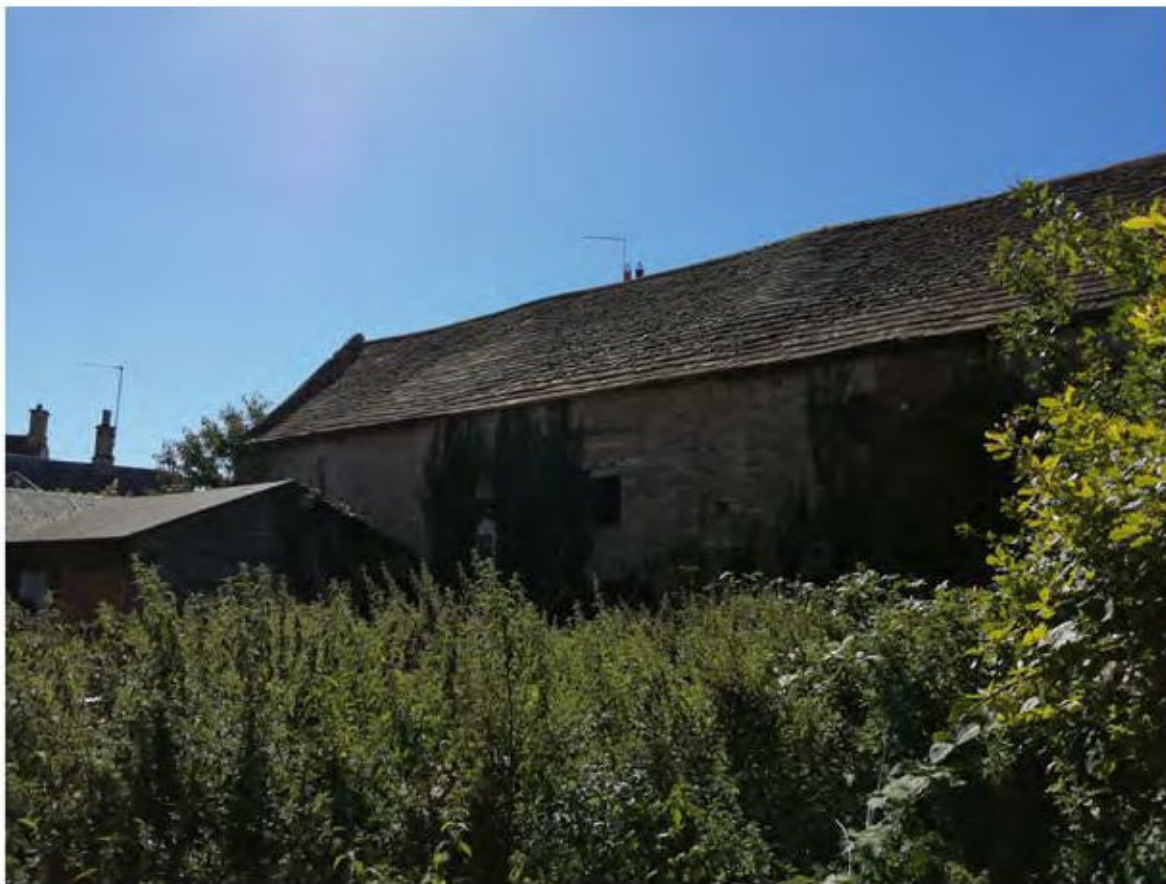
The eastern flank wall abuts a garden area which is overgrown. Ivy can be seen growing up the side of the stonework in places (Plate 8).

Plate 8 Looking West at Undergrowth Abutting and Growing Up East Facing Flank Wall

Some localised repair work has been undertaken to the collyweston slate roof in the past in the east facing roof (Plate 8). The unevenness in the roof structure, particularly at ridge level can also be seen in Plate 8, so too the tie rods which correspond with the western flank wall.

Roofing repairs are likely to take the form of an ongoing project due to the costly nature of replacing collyweston slates.

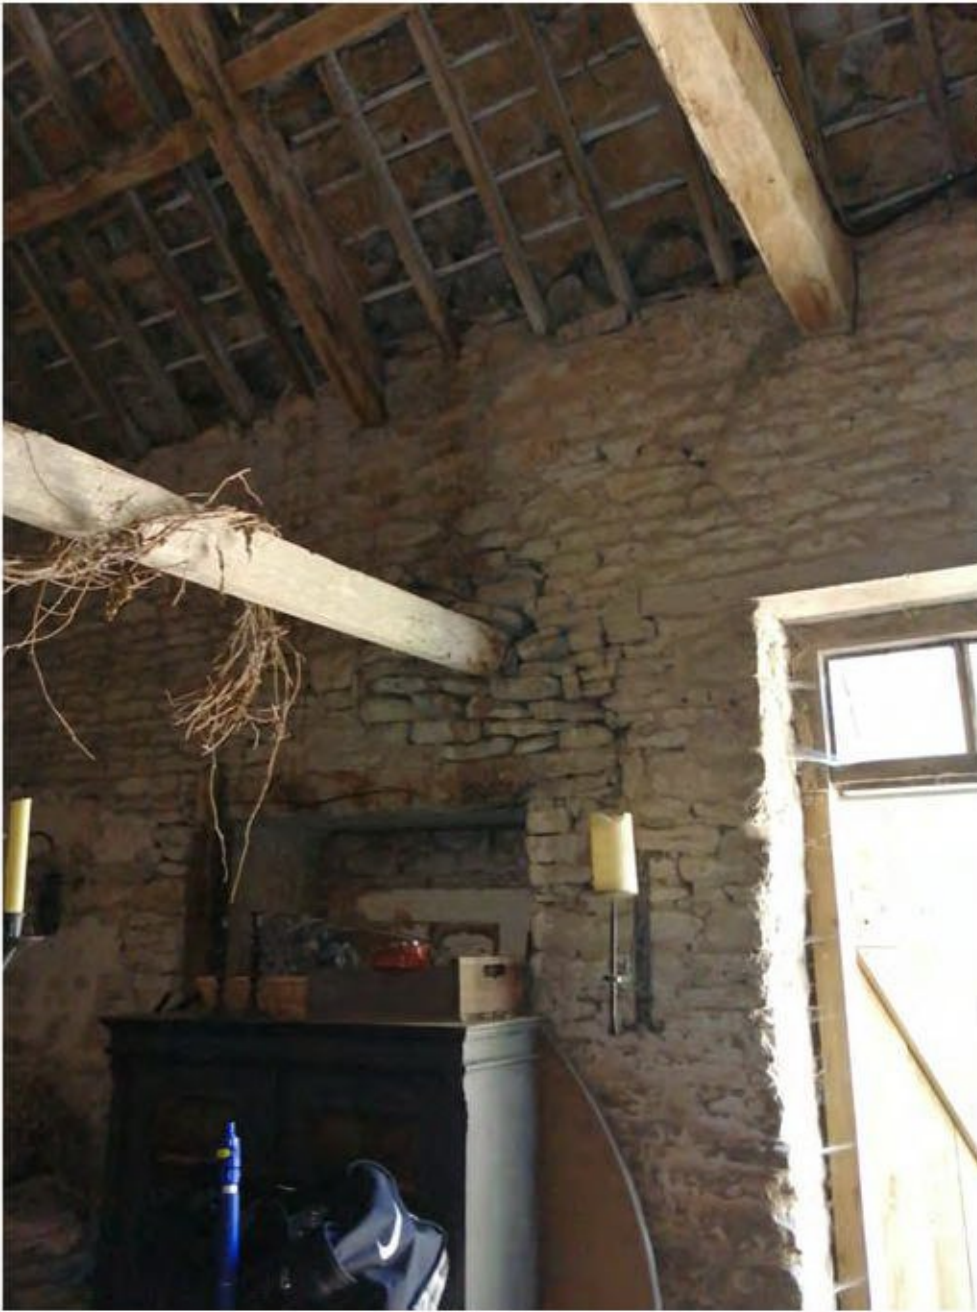
Weathering to the internal stonework is evident around the horizontal tie member to the southernmost section of barn (Plate 11).

Plate 11 Looking West at Weathering Around Horizontal Tie Beam

Weathered stonework should be repointed throughout in a lime mix as approved by Listed Building Consent.

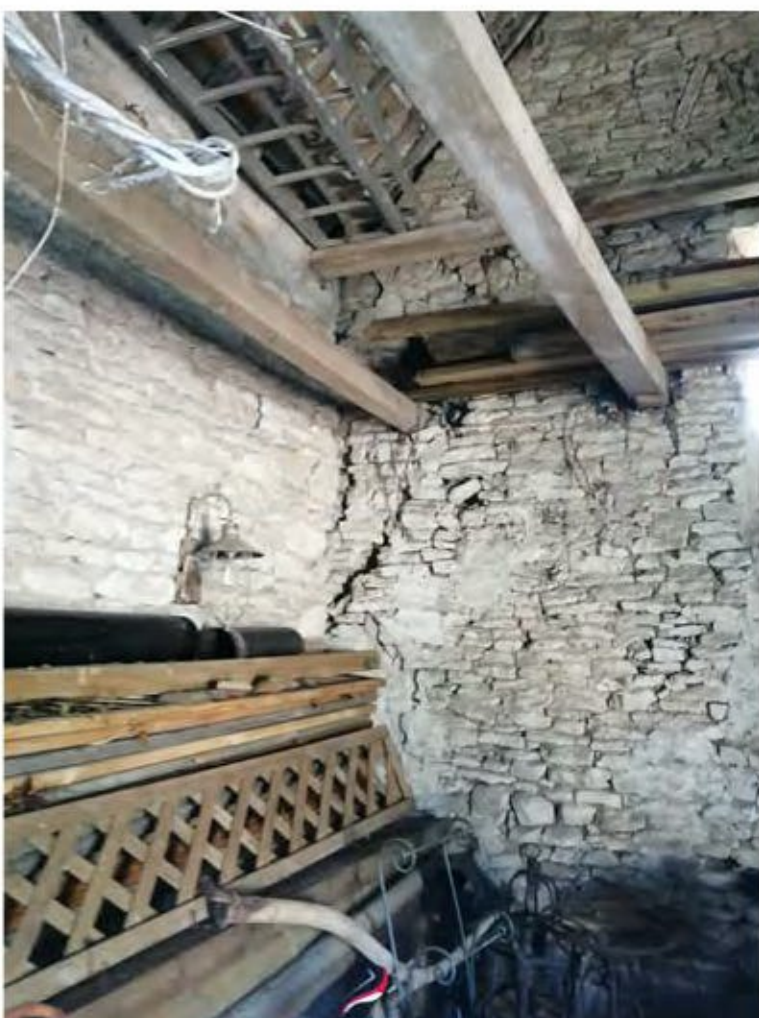
Vertical and diagonal cracking can be seen in the southernmost gable wall where intersecting with east and west flank walls (Plate 12).

Plate 12 Looking South at Internal Gable Wall Where Cracking Exists Where Intersecting with Eastern Flank Wall

Stonework and brickwork should be stitched together with Helifix bars where vertical and diagonal cracking exists. A drawing should be marked up by a structural engineer to identify these locations. Stitching to be carried out strictly in accordance with manufacturers guidelines and instructions.

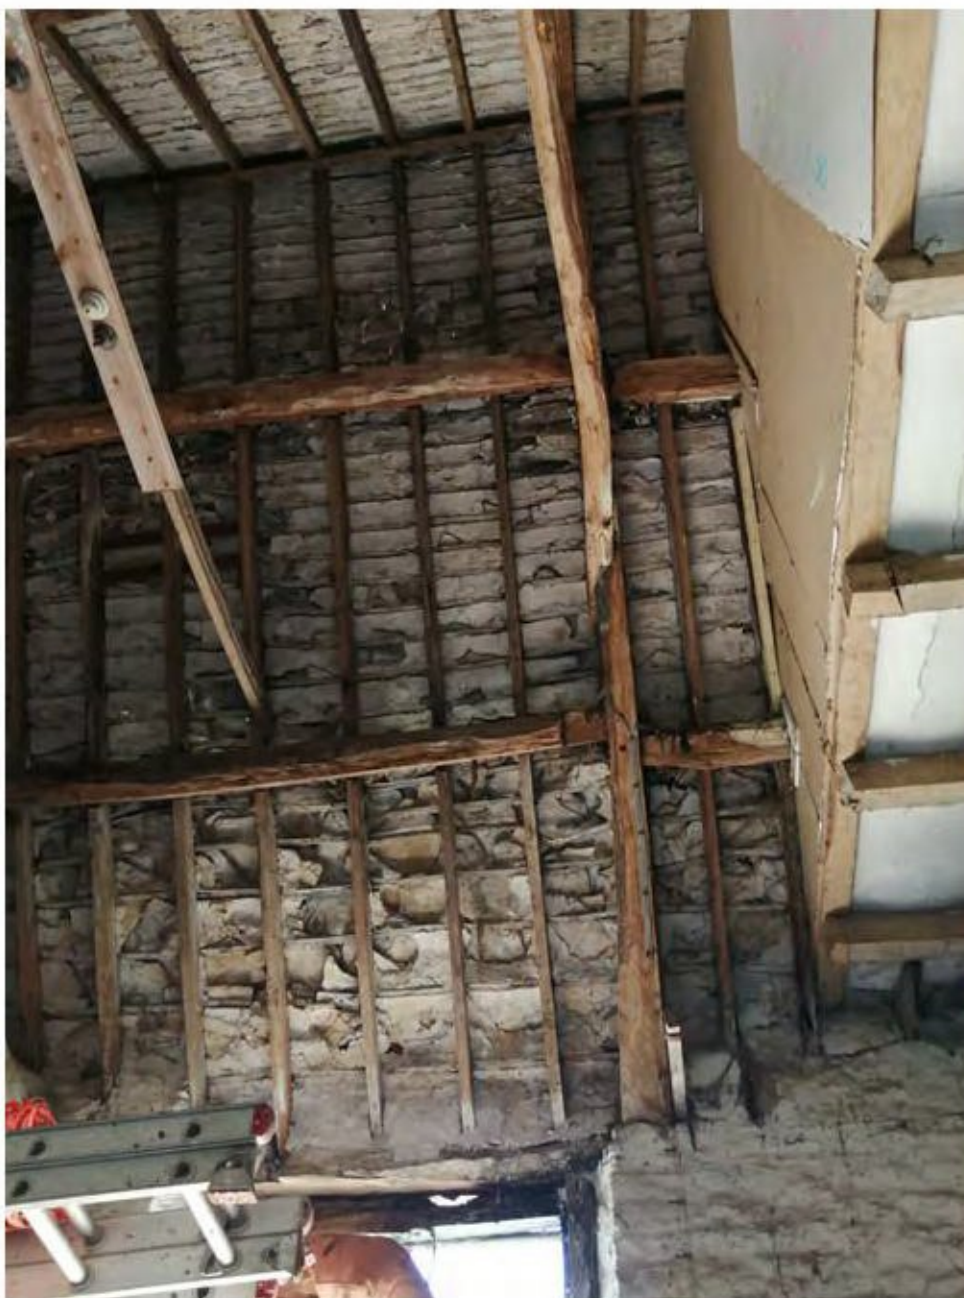
Roof timbers above the Workshop appear a mix of original and replacement members (Plate 13).

Plate 13 Looking at Roof Structure above Workshop

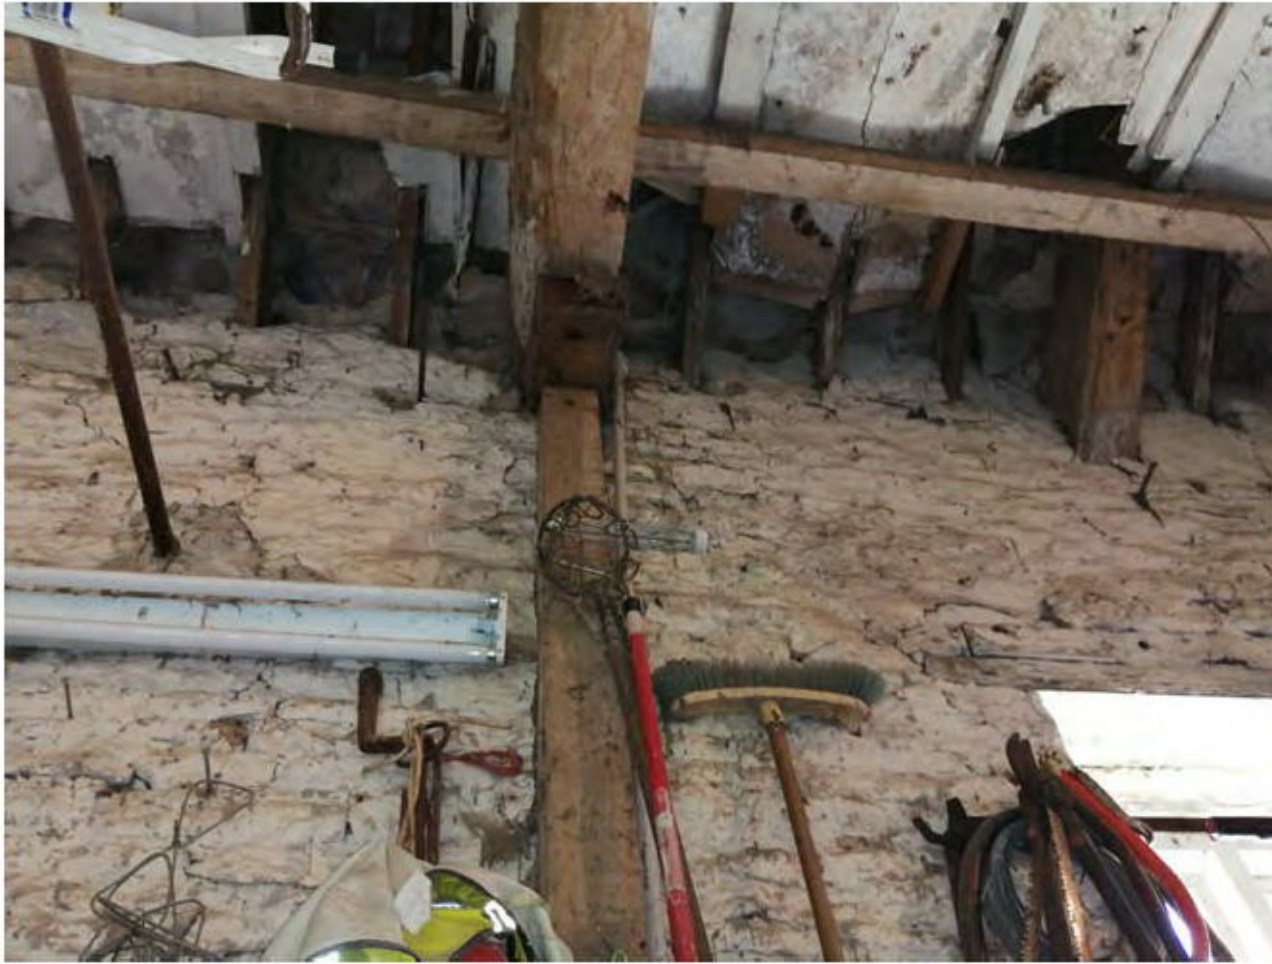
The truss to the Workshop has lost its bearing to the westernmost elevation (Plate 14) due to the (likely) ongoing movement of the roof and walls.

Plate 14 Looking at Reduced Bearing to Truss to Workshop

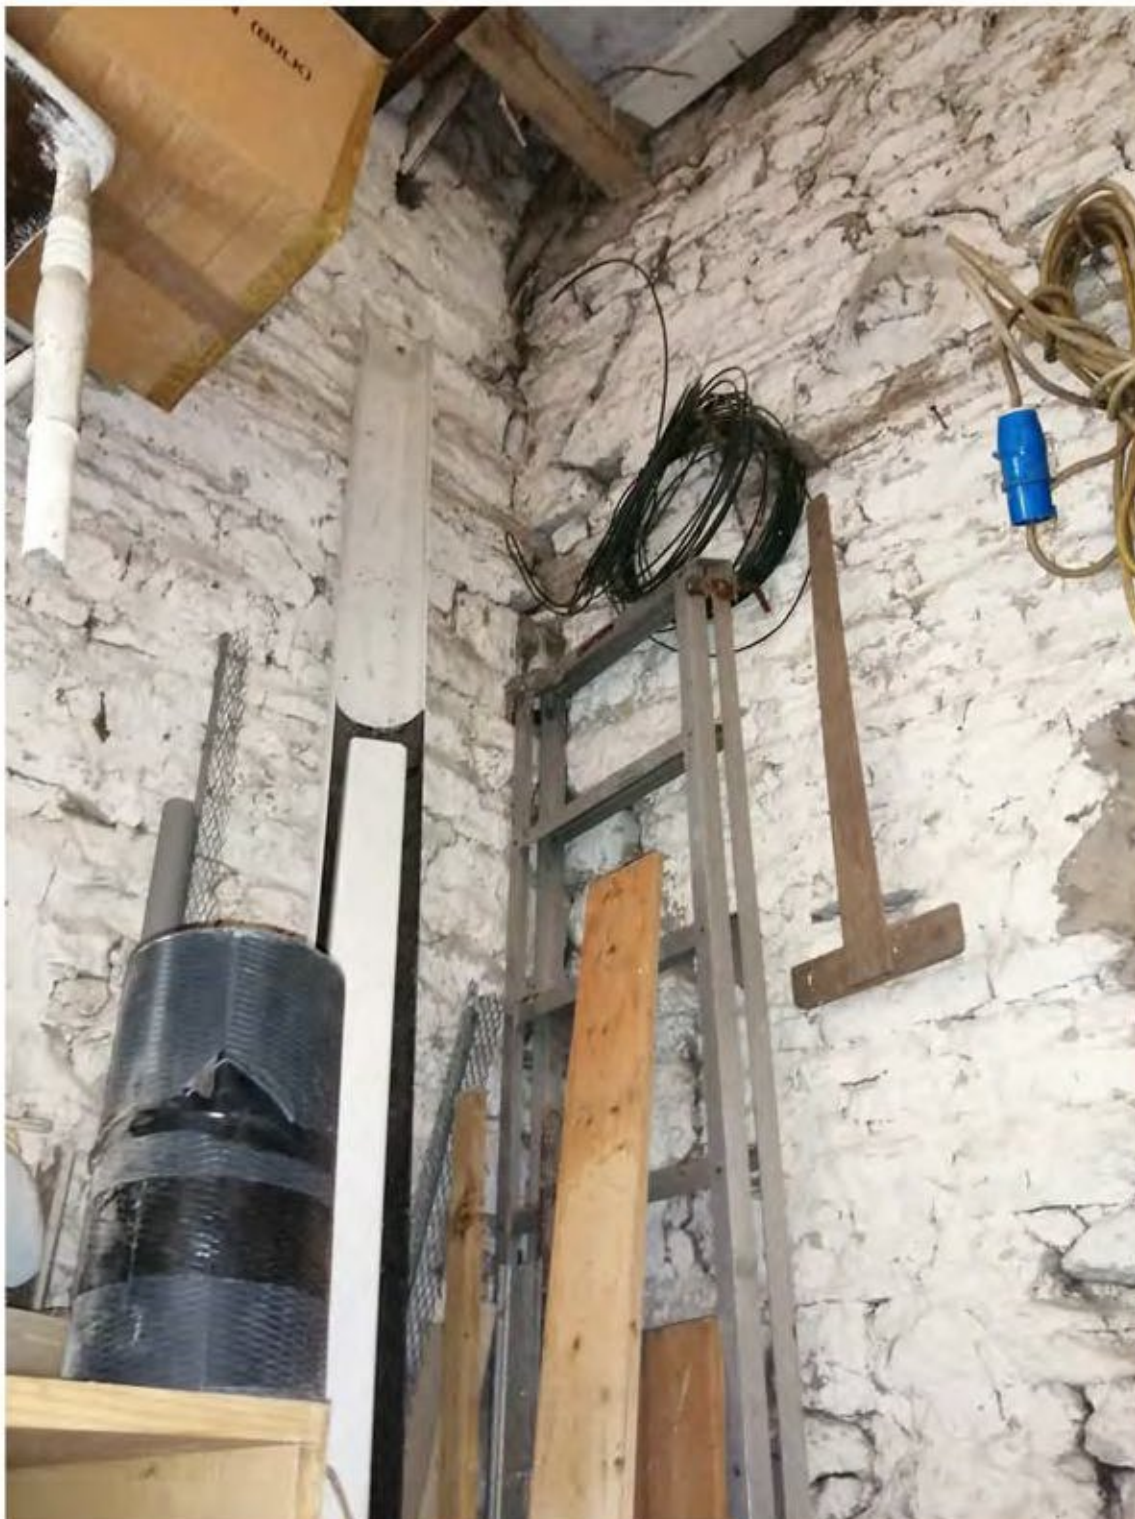
Vertical and diagonal cracks are visible to the northernmost gable elevation wall (Plate 15), corresponding with those evident externally and indicated previously in Plate 7.

Plate 15 Looking North West at Vertical & Diagonal Cracking to Stonework
