**LBC
Survey**

DATE:
22/07/21

Address: 38 Main Street,
Newtongrange, Edinburgh,
EH22 4LH

Client requests installation of double glazing by replacing existing sashes on a like-for-like basis with new sashes, custom fitted with 14mm IGU's. Existing cases (window boxes) to be retained and refurbished.

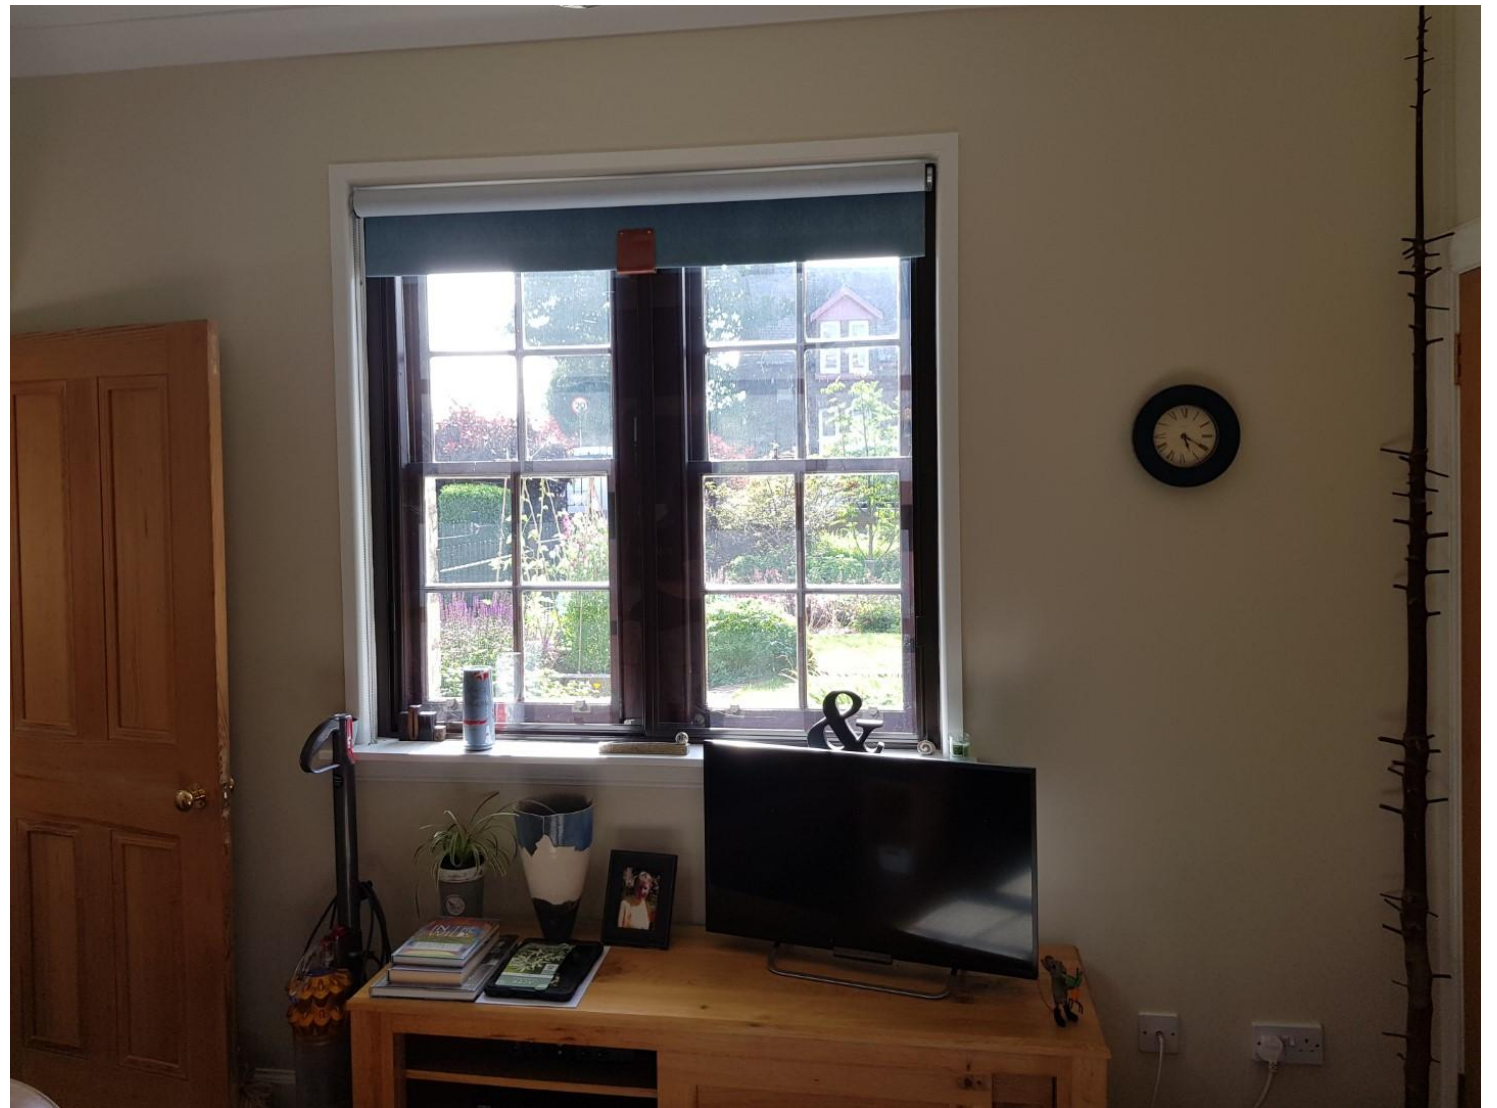
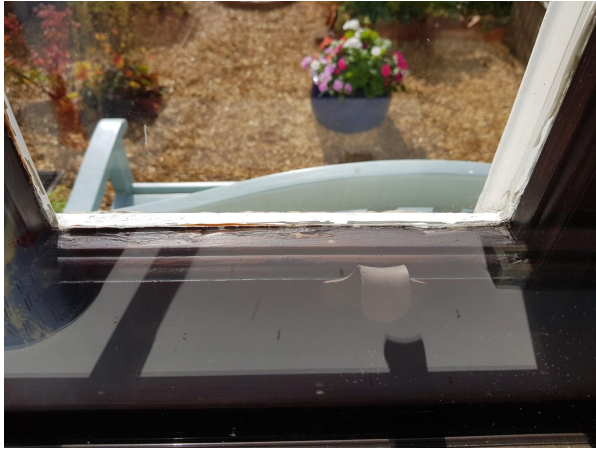
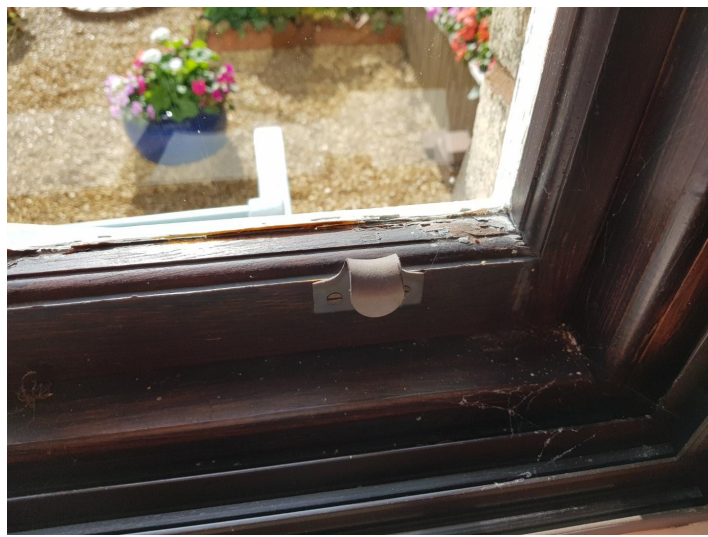
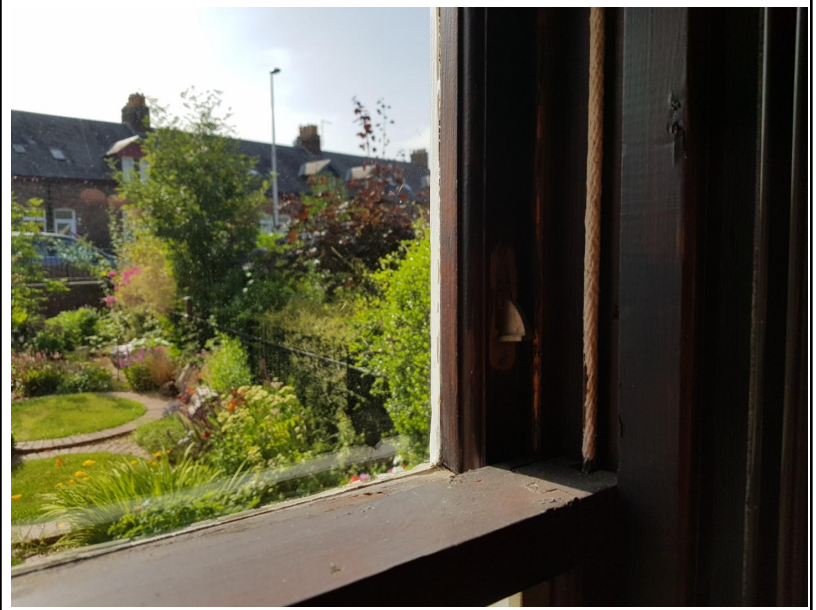
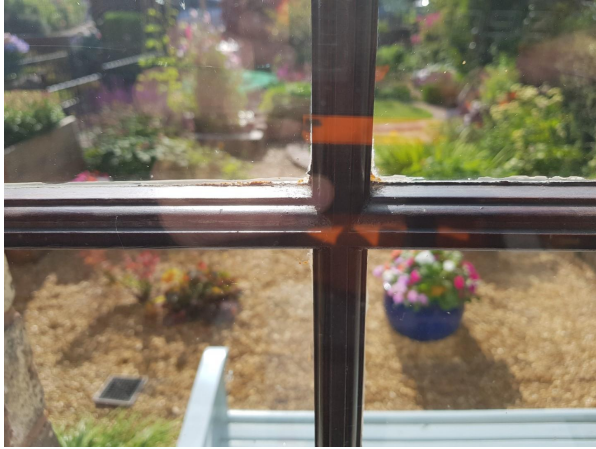
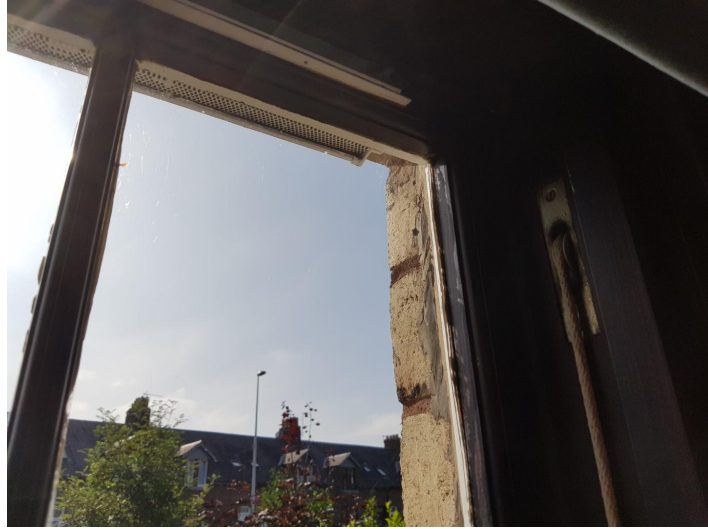
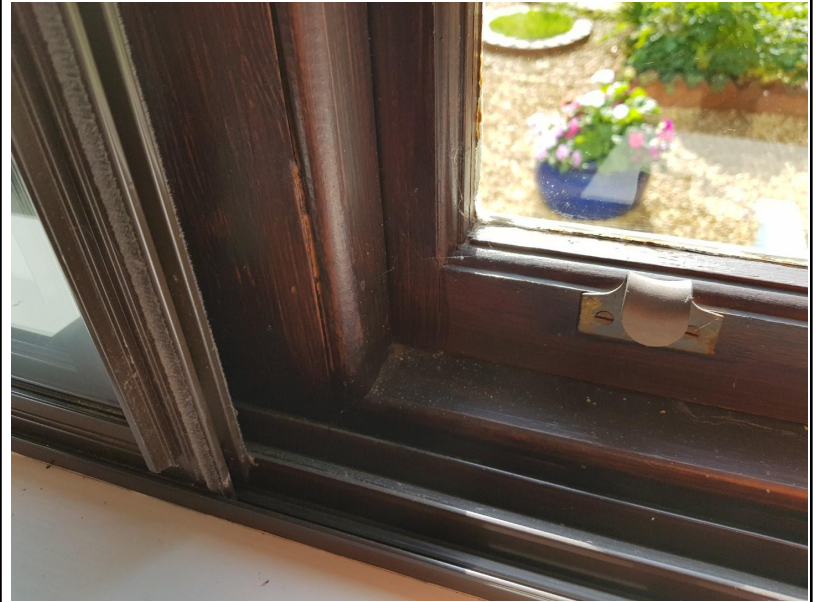
W1, W2 - Living Room
Currently 4 over 4 style sash and case

- Condensation damage to horizontal rails
- Cracking of paint along glue lines of mortise and tenon joinery indicative of excessive movement.
- Signs of joint failure to lower mortise and tenon joinery
- Paint shedding along horizontal mid rails indicative of underlying moisture penetration.
- Expect more underlying damage to be revealed on paint removal.
- Existing astragals unsuitable to house 14mm IGU's

** New cill required

**Secondary Glazing to be removed

**Existing Case to be Retained and refurbished

** Patch repairs likely required to lower portions of existing case.

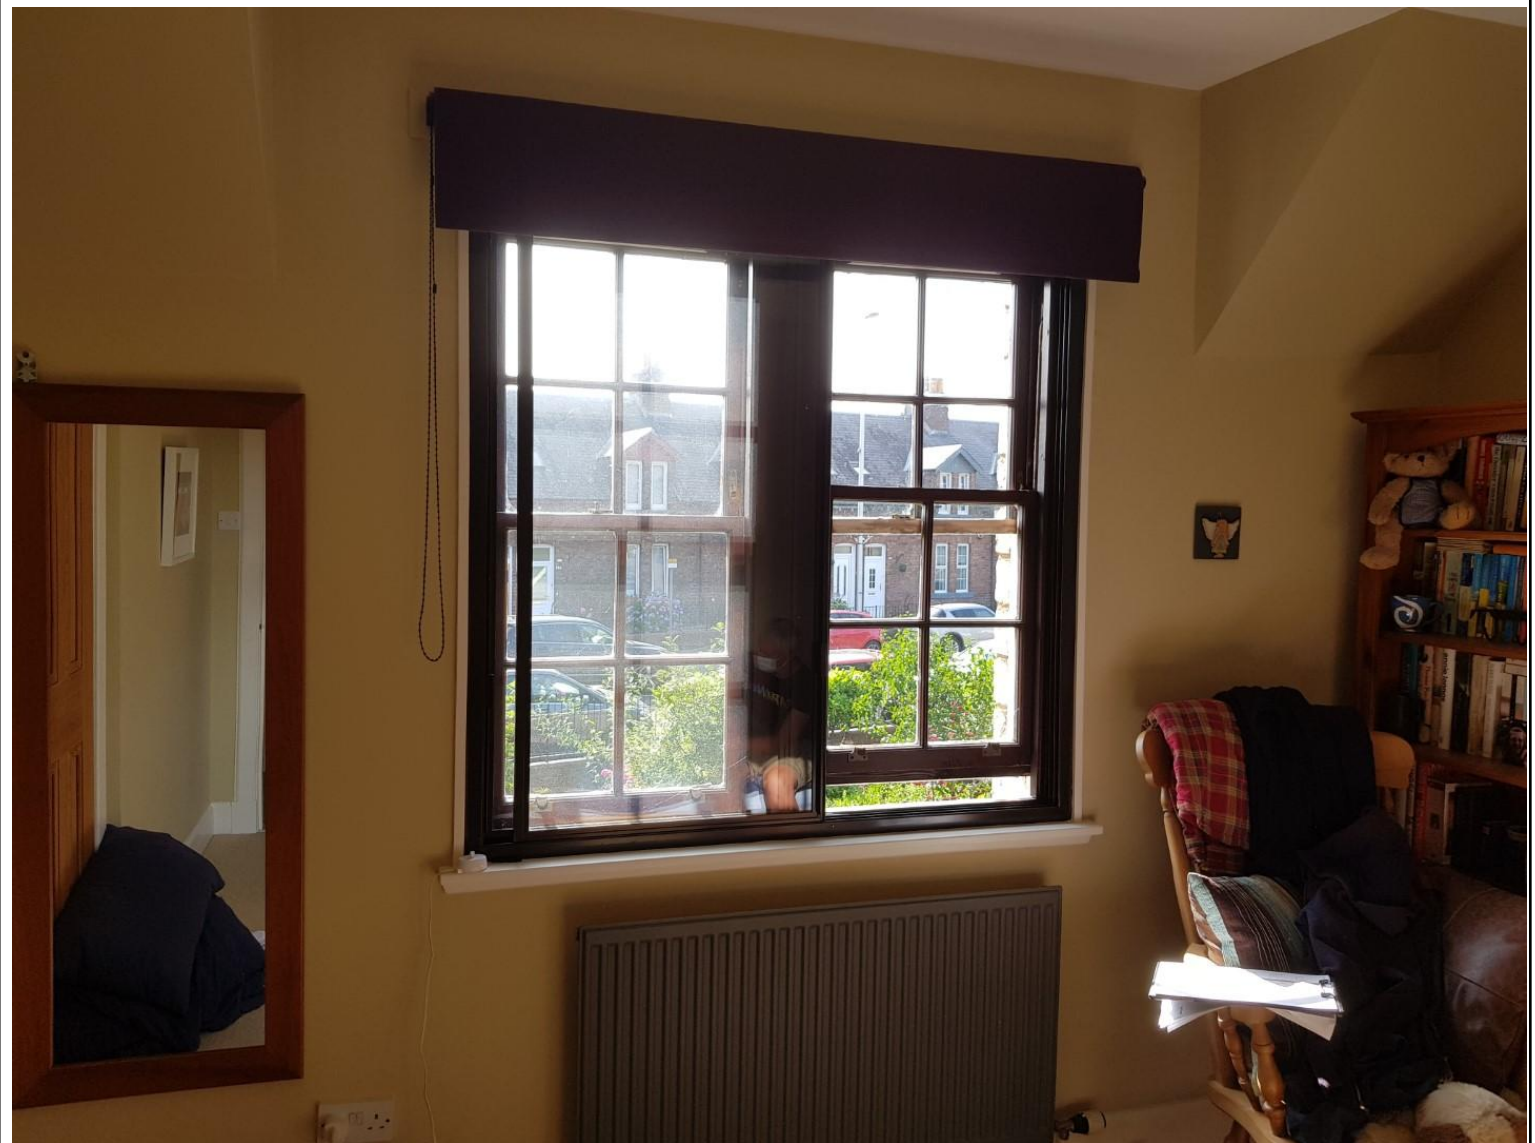
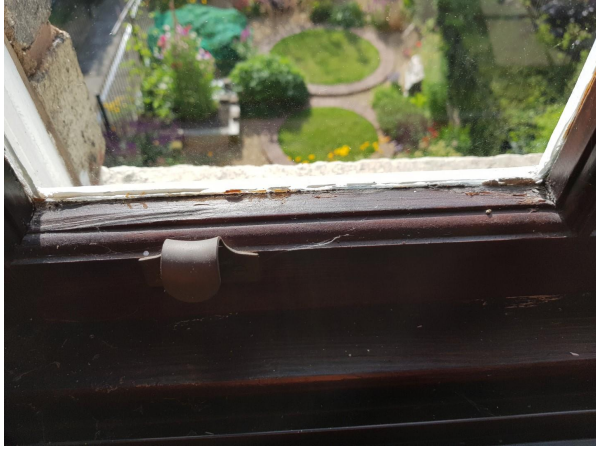
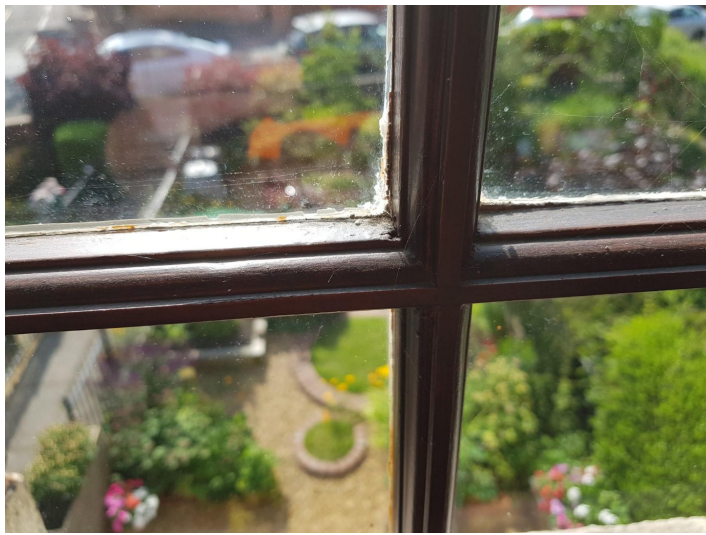
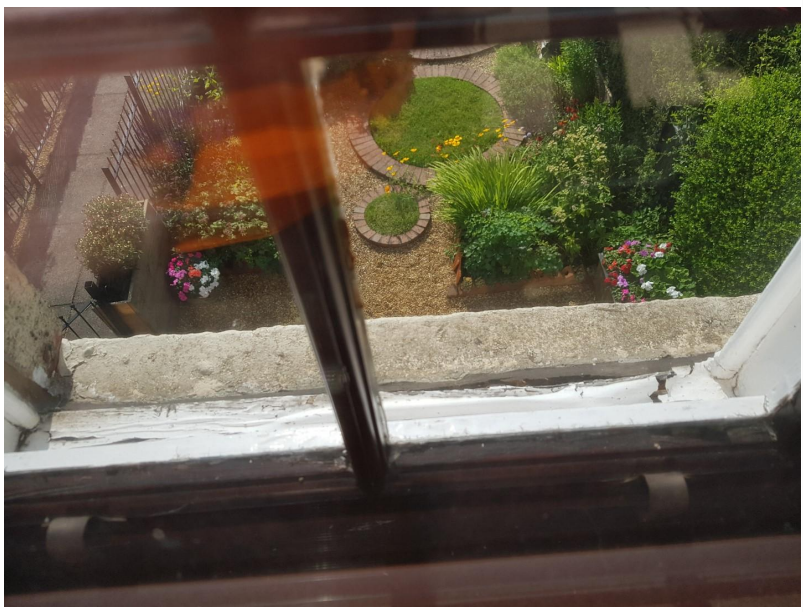
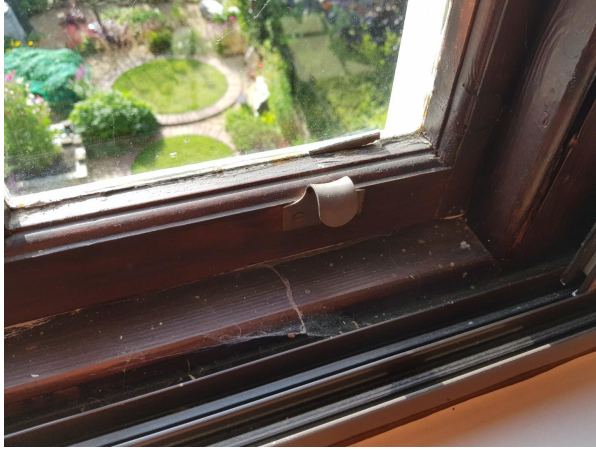
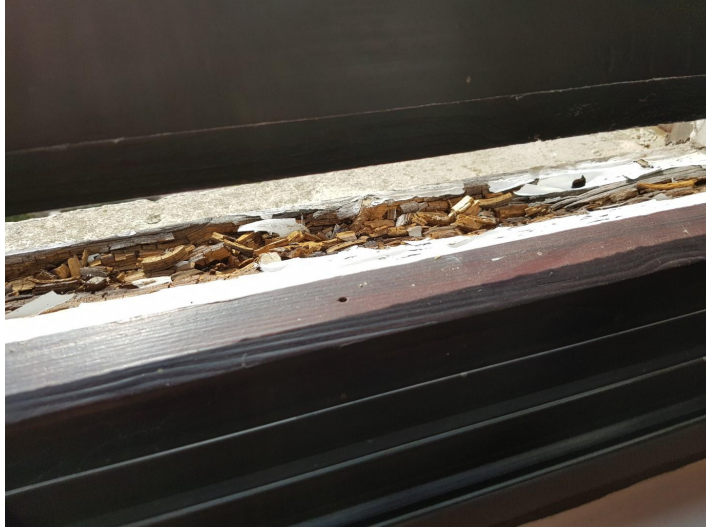
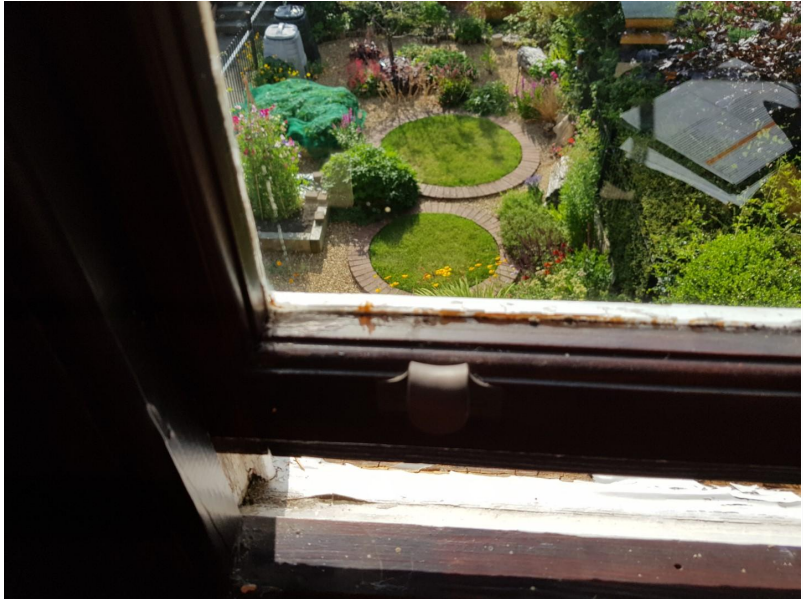
W3, W4 - Front Bed
Currently 4 over 4 style sash and case

- Condensation damage to horizontal rails
- Cracking of paint along glue lines of mortise and tenon joinery indicative of excessive movement.
- Signs of joint failure to lower mortise and tenon joinery
- Paint shedding along horizontal mid rails indicative of underlying moisture penetration.
- Water penetration of lower rail of bottom sashes.
- Expect more underlying damage to be revealed on paint removal.
- Existing astragals unsuitable to house 14mm IGU's

** New cill required

**Secondary Glazing to be removed

**Existing Case to be Retained and refurbished

** Patch repairs likely required to lower portions of existing case.

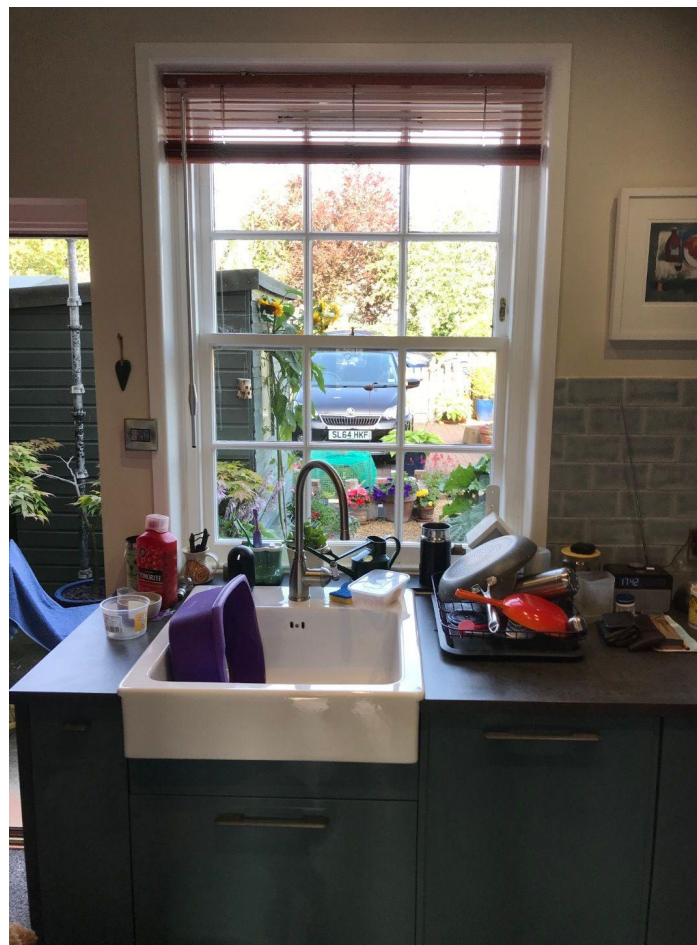
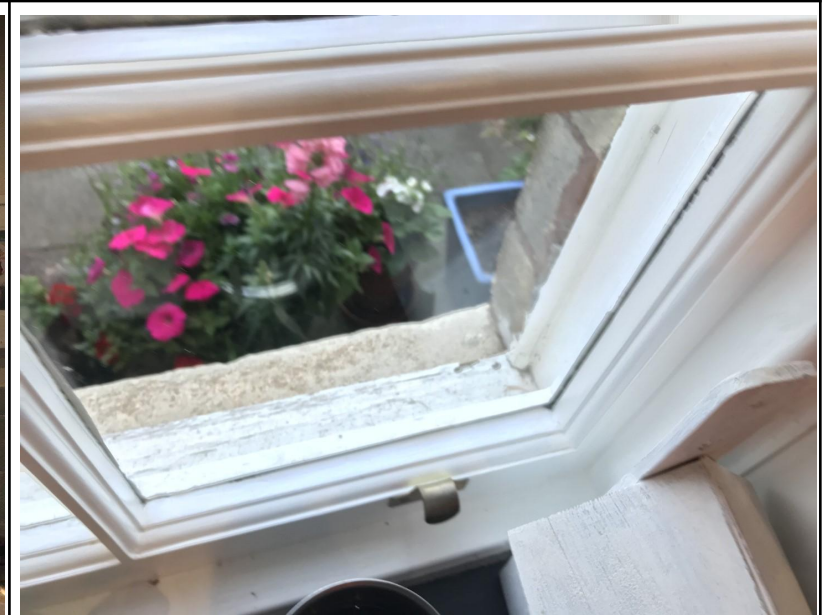
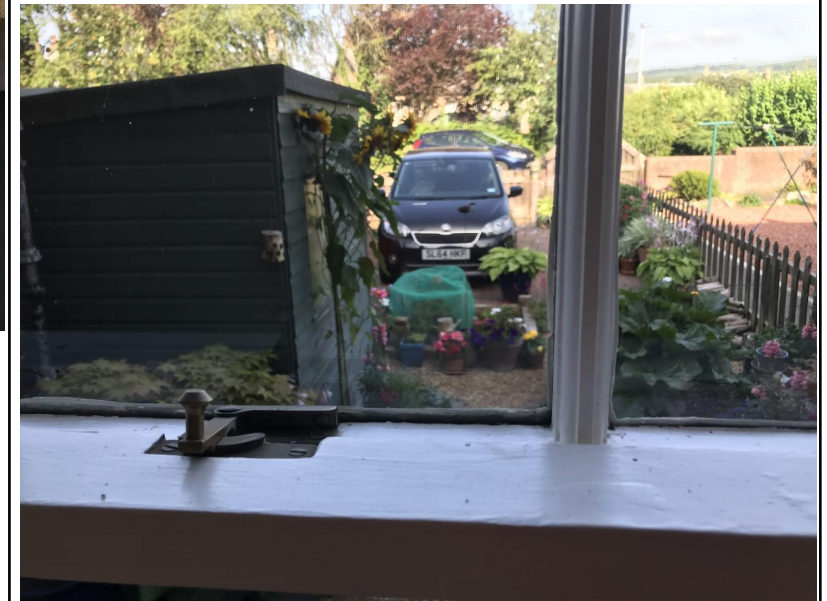
W5 - Kitchen Left
Currently 6 over 6 style sash and case

- Window seems to be in reasonable condition except excessive rot/weathering on cill
- Window recently painted shut and inoperable,
- Mid rail misalignment
- Windows look to be non original with clearly defined moulding detail and lack of overpainting and previous repair works.
- Existing astragals unsuitable to house 14mm IGU's

** New cill required

**Existing Case to be Retained and refurbished

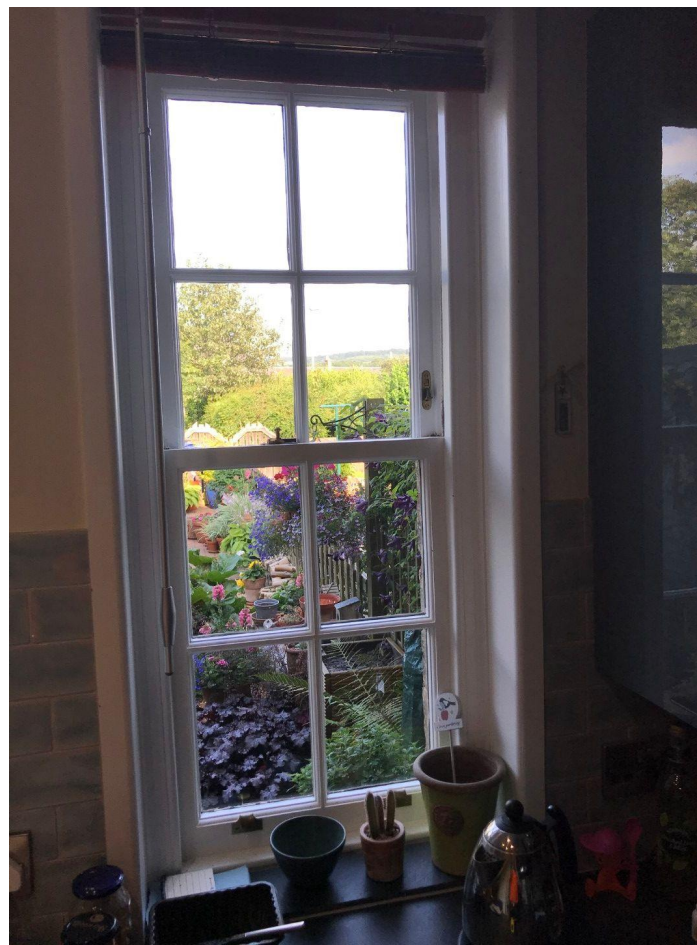
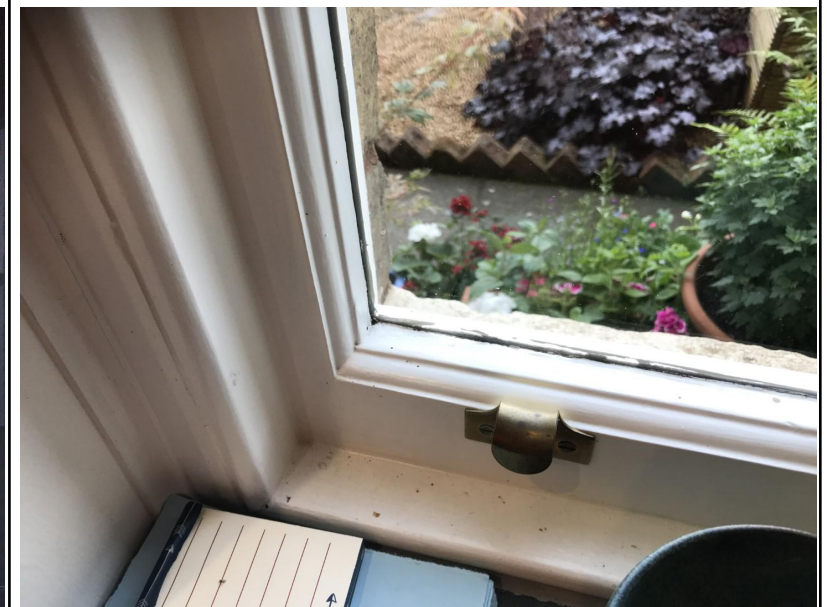
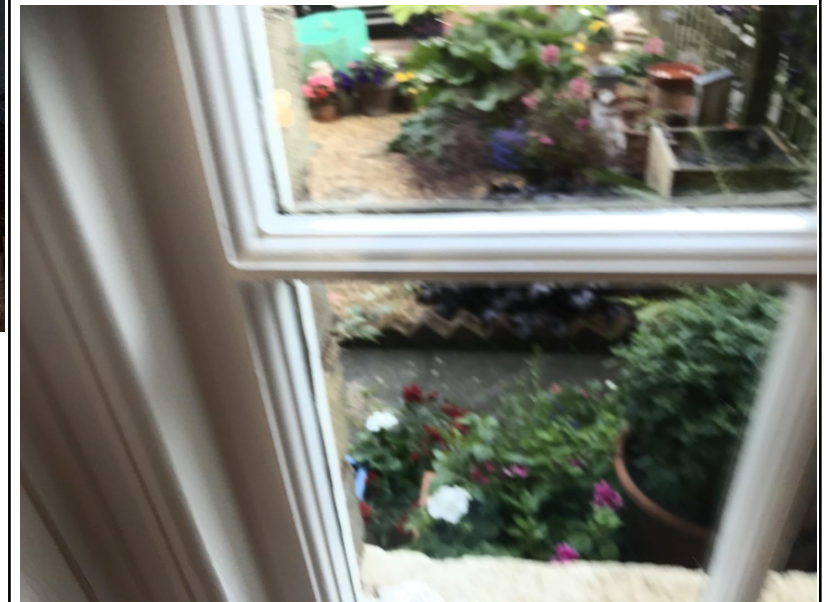
W6 - Kitchen Right

- Similar condition to window 5 due to being in a more sheltered elevation
- Window recently painted shut and inoperable,
- Windows look to be non original with clearly defined moulding detail and lack of overpainting and previous repair works.
- Existing astragals unsuitable to house 14mm IGU's

**Existing Case to be Retained and refurbished

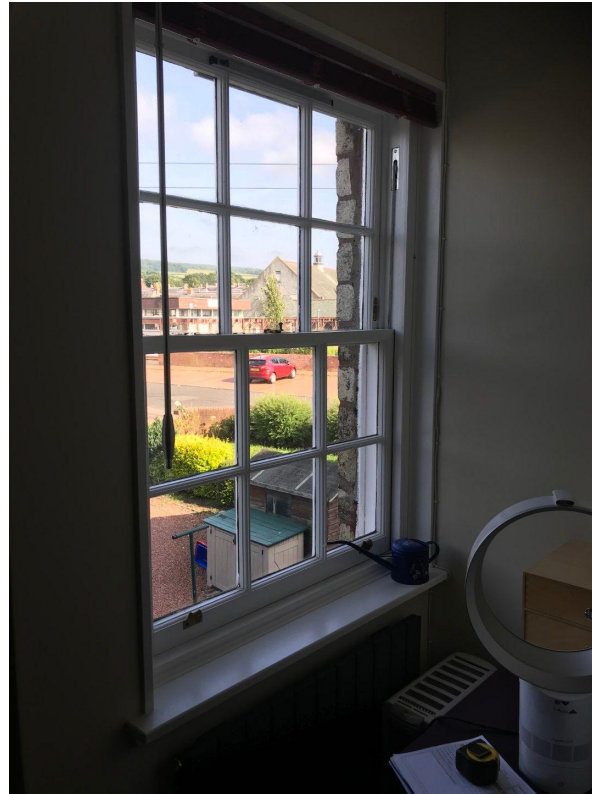
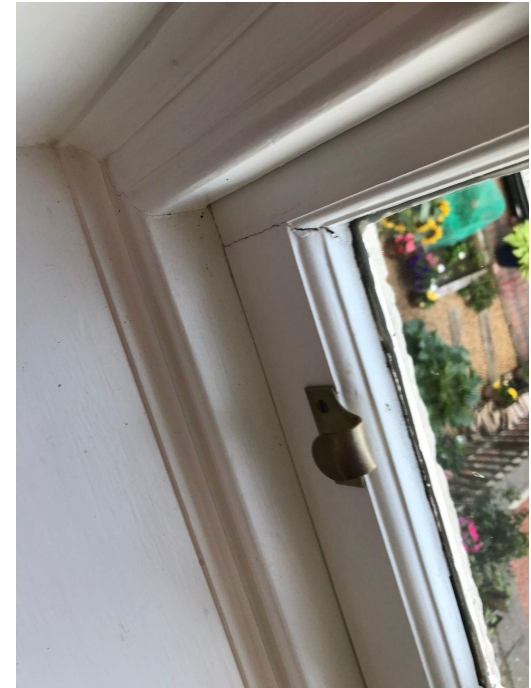
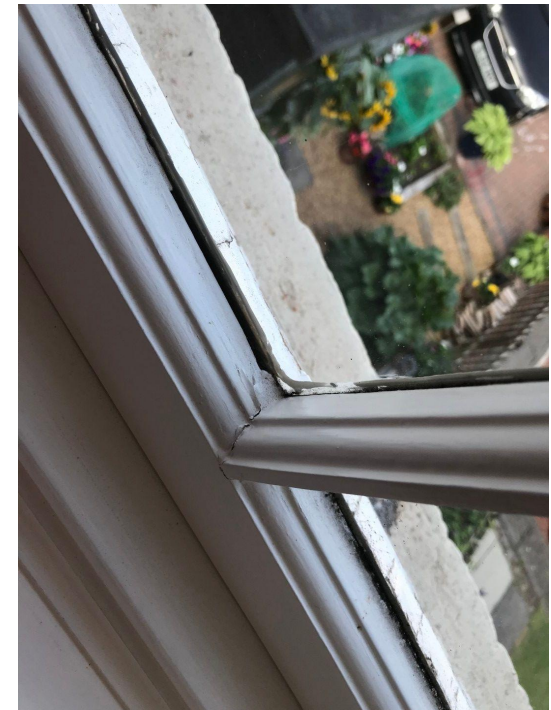
W7 - Rear Bed

- Window recently painted shut and inoperable.
- Paint cracking at astragal joins indicative of excessive shrinkage and swelling of timber and onset loosening of joins.
- Windows look to be non original with clearly defined moulding detail and lack of overpainting and previous repair works.
- Existing astragals unsuitable to house 14mm IGU's

**Existing Case to be Retained and refurbished

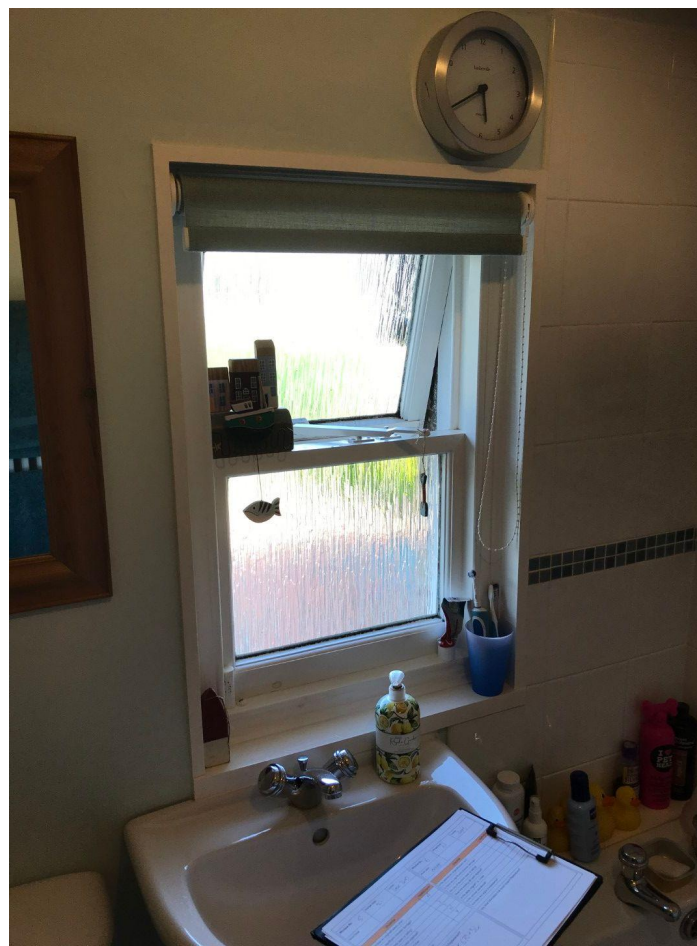
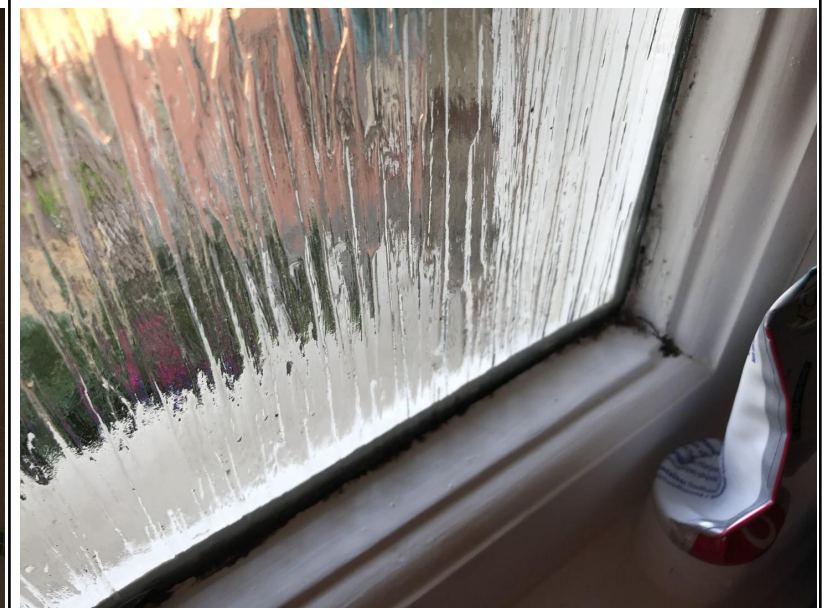
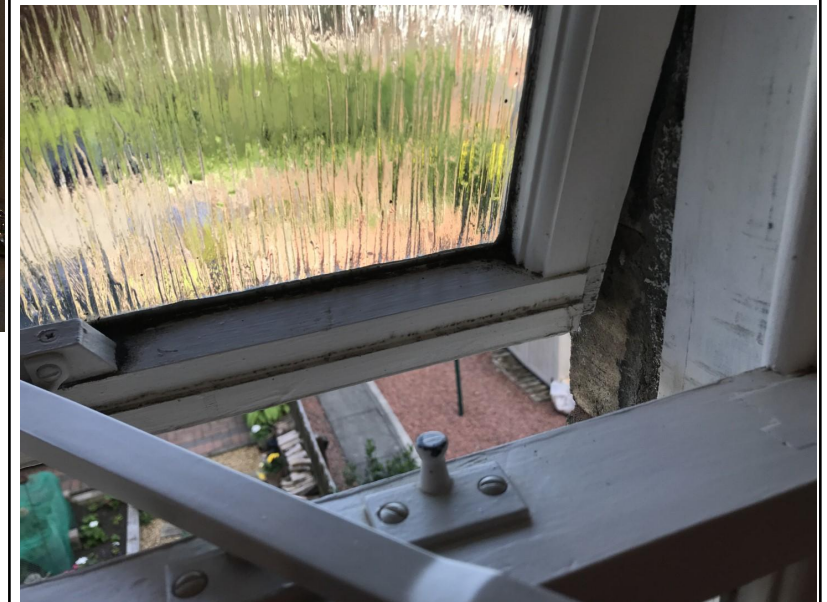
W8 - Bathroom

- Paint cracking at astragal joins indicative of excessive shrinkage and swelling of timber and onset loosening of joins.
- Condensation damage to lower rails mainly due to location in bathroom

**Existing Case to be Retained and refurbished
