ENVISION AESC UK BATTERY PLANT, SITE ACCESS, IAMP ONE, SUNDERLAND

STAGE 1 ROAD SAFETY AUDIT

Client/Project owner	Envision AESC UK Ltd
Project	Envision AESC UK Battery Plant, Site Access, IAMP ONE, Sunderland
Study	Stage 1 Road Safety Audit
Type of document	Final Report
Date	29/06/2021
File name	Envision Site Access, IAMP ONE, Sunderland – S1 RSA
Reference number	GB01T21B34/RSA/001
Number of pages	14

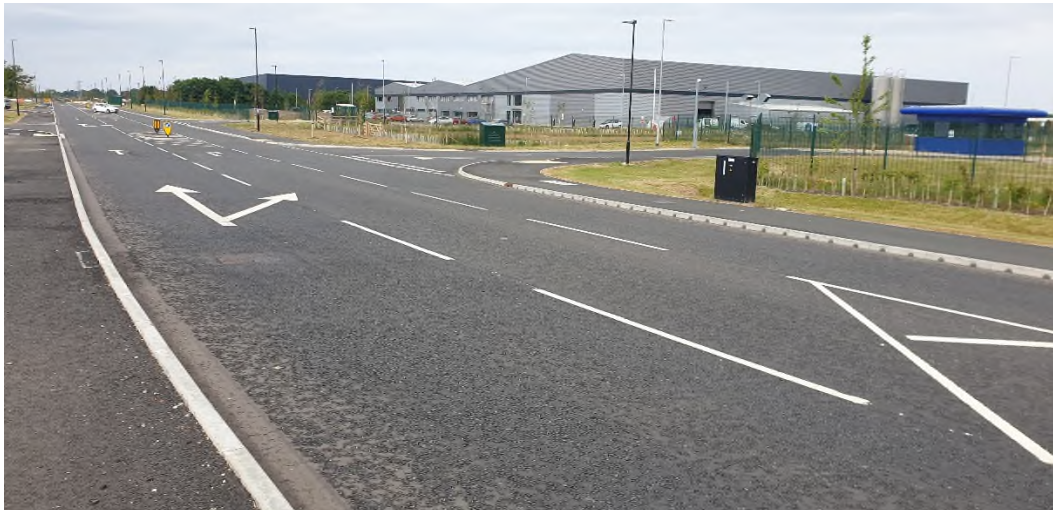
3.1.1 Problem: – 1 Tie in to existing road layout.

Summary: Right turning lane appears to overlap adjacent right turning lane, risk of side swipe and/or head-on collisions.

The drawings show the provision of a new right turning lane will be provided to access the new development. The right turning lane shown is approximately 55m long and appears to overlap the right turning lane for the existing access located to the east of the new site access (See photo below of existing right turn). The drawings do not show the exiting right turning lane or how the new road markings will be tied into the existing road markings. In addition, HGVs were observed pulling into the central hatching to access the existing right turn lane. If the road markings are not correctly provided this will increase the risk of vehicles entering both right turning lanes too early increasing the risk of side swipe and/or head-on collisions.

It is recommended that the drawings show how the new road markings will tie in with the existing road markings to ensure a safe layout is provided at the start of both right turning lanes and that auto-tracking is undertaken to demonstrate that large vehicles can safely undertake this manoeuvre.

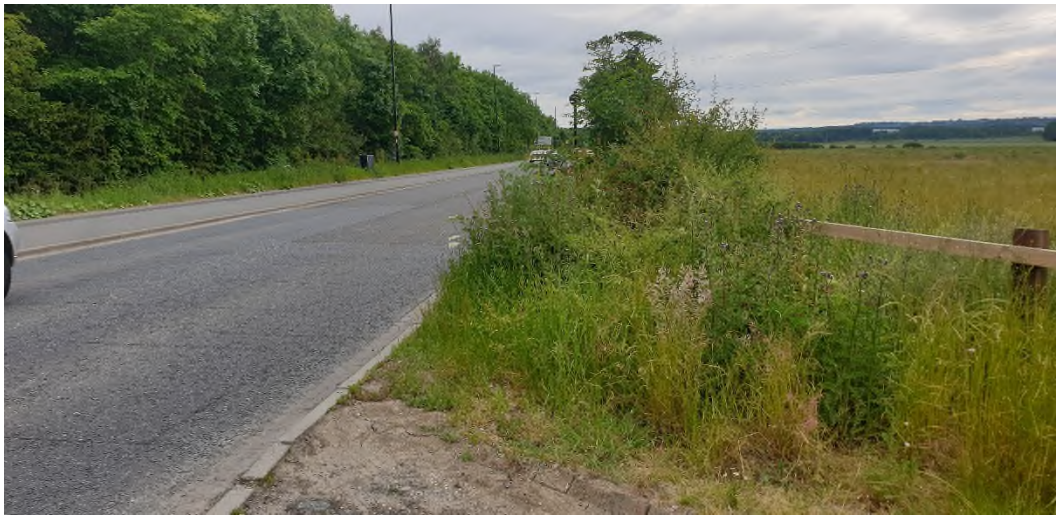
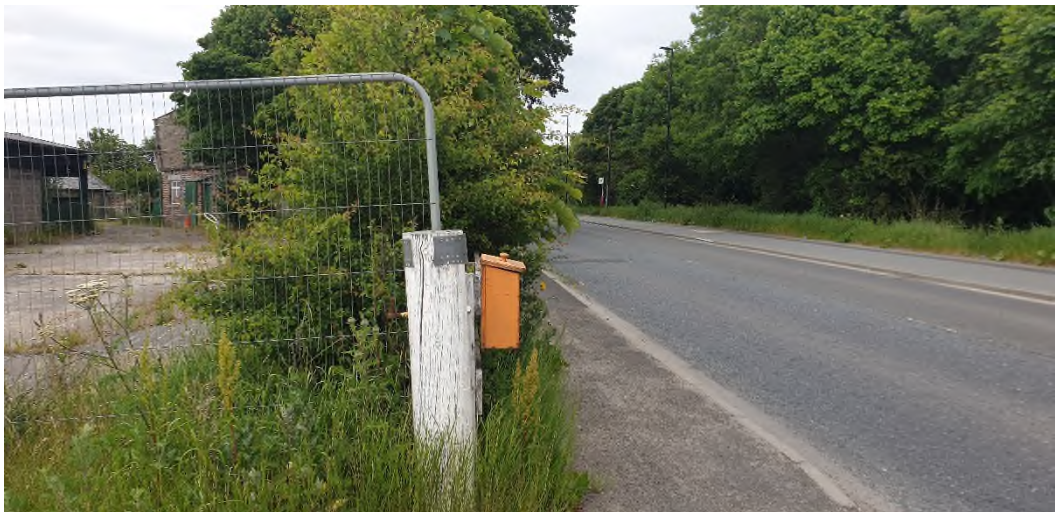
3.1.4 Problem: – 4 A1290 Emergency access visibility.

Summary: Visibility obstructed by existing vegetation within verge areas.

The proposed emergency access onto the A1290 has poor visibility due to the overgrown verge areas (See photos below of visibility from existing access point).. If visibility is obstructed this will increase the risk of a vehicle leaving the emergency access pulling into the path of a vehicle increasing the risk of side swipe collisions.

It is recommended that a suitable and permanent visibility splay is provided at the emergency access.

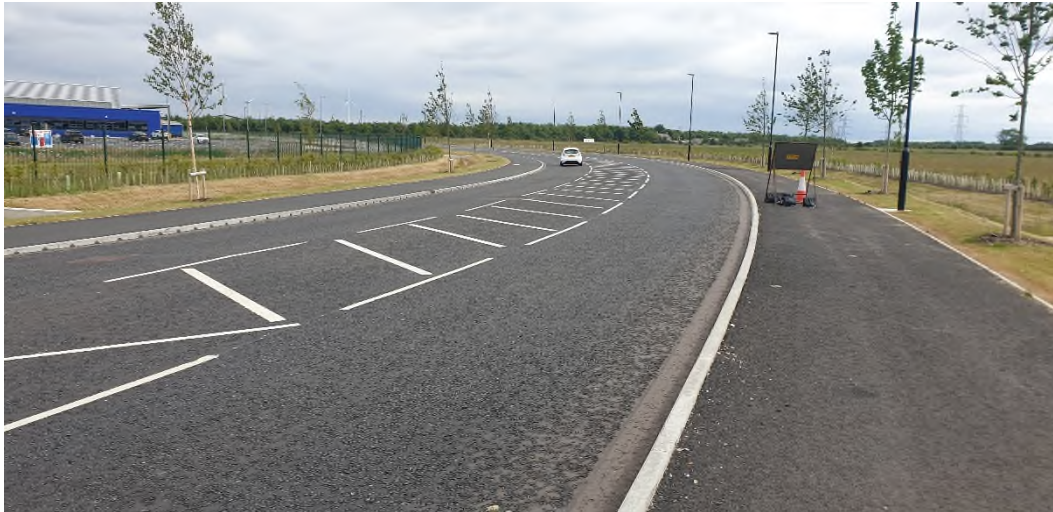
3.1.5 Problem: – 5 IAMP Spine Road.

Summary: No signage to warn shared footway/cycleway, increased risk of collisions and conflicts between pedestrians and cyclists.

There is a shared footway / cycleway that runs along the southern side of the A1290 which has signage to inform both pedestrians and cyclists that the route is shared. However, as you enter the IAMP Spine Road there is no signage to inform either pedestrians or cyclists if the footways are shared routes (See photo below of existing footway). This lack of signage on the IAMP Spine Road will increase the risk of collisions and conflicts between pedestrians and cyclists using the route.

It is recommended that signage is provided along the IAMP Spine Road to indicate who is allowed to use the routes.
