Old Stables, Medhurst Farm, Pootings Road,
Kent, TN8 6SF

Structural Survey Report

Report No. J9194 R 001

11 February 2021

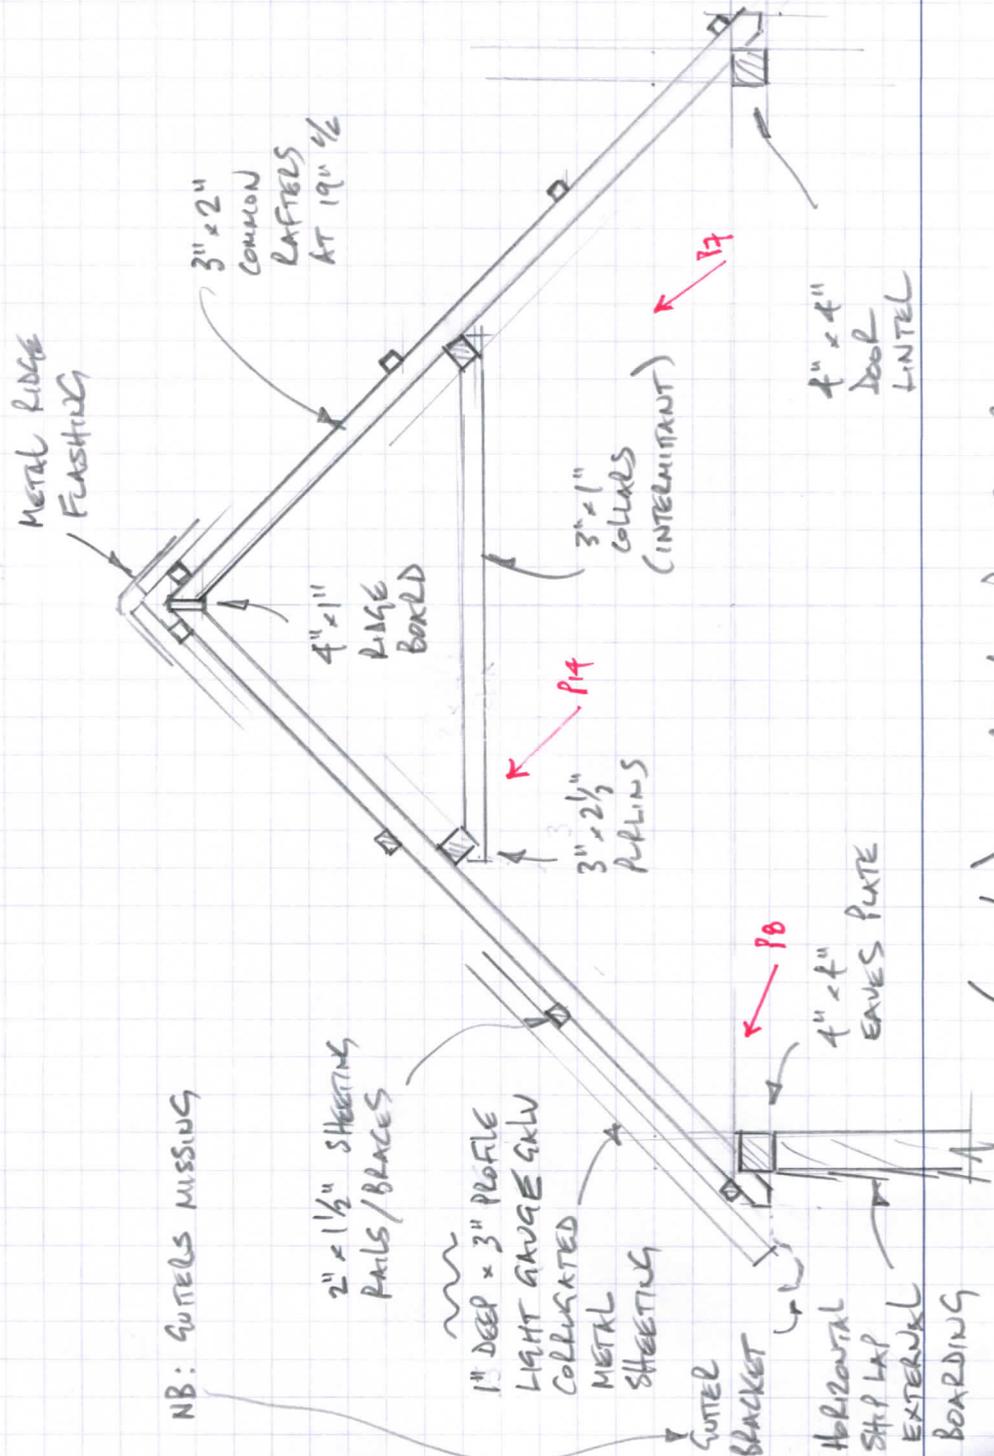
(105/1) Timber Roof Cross Section

There is evidence in the form of remaining metal brackets that the building's roof once had eaves gutters, but these are no longer present.

NB: GUTTERS MISSING

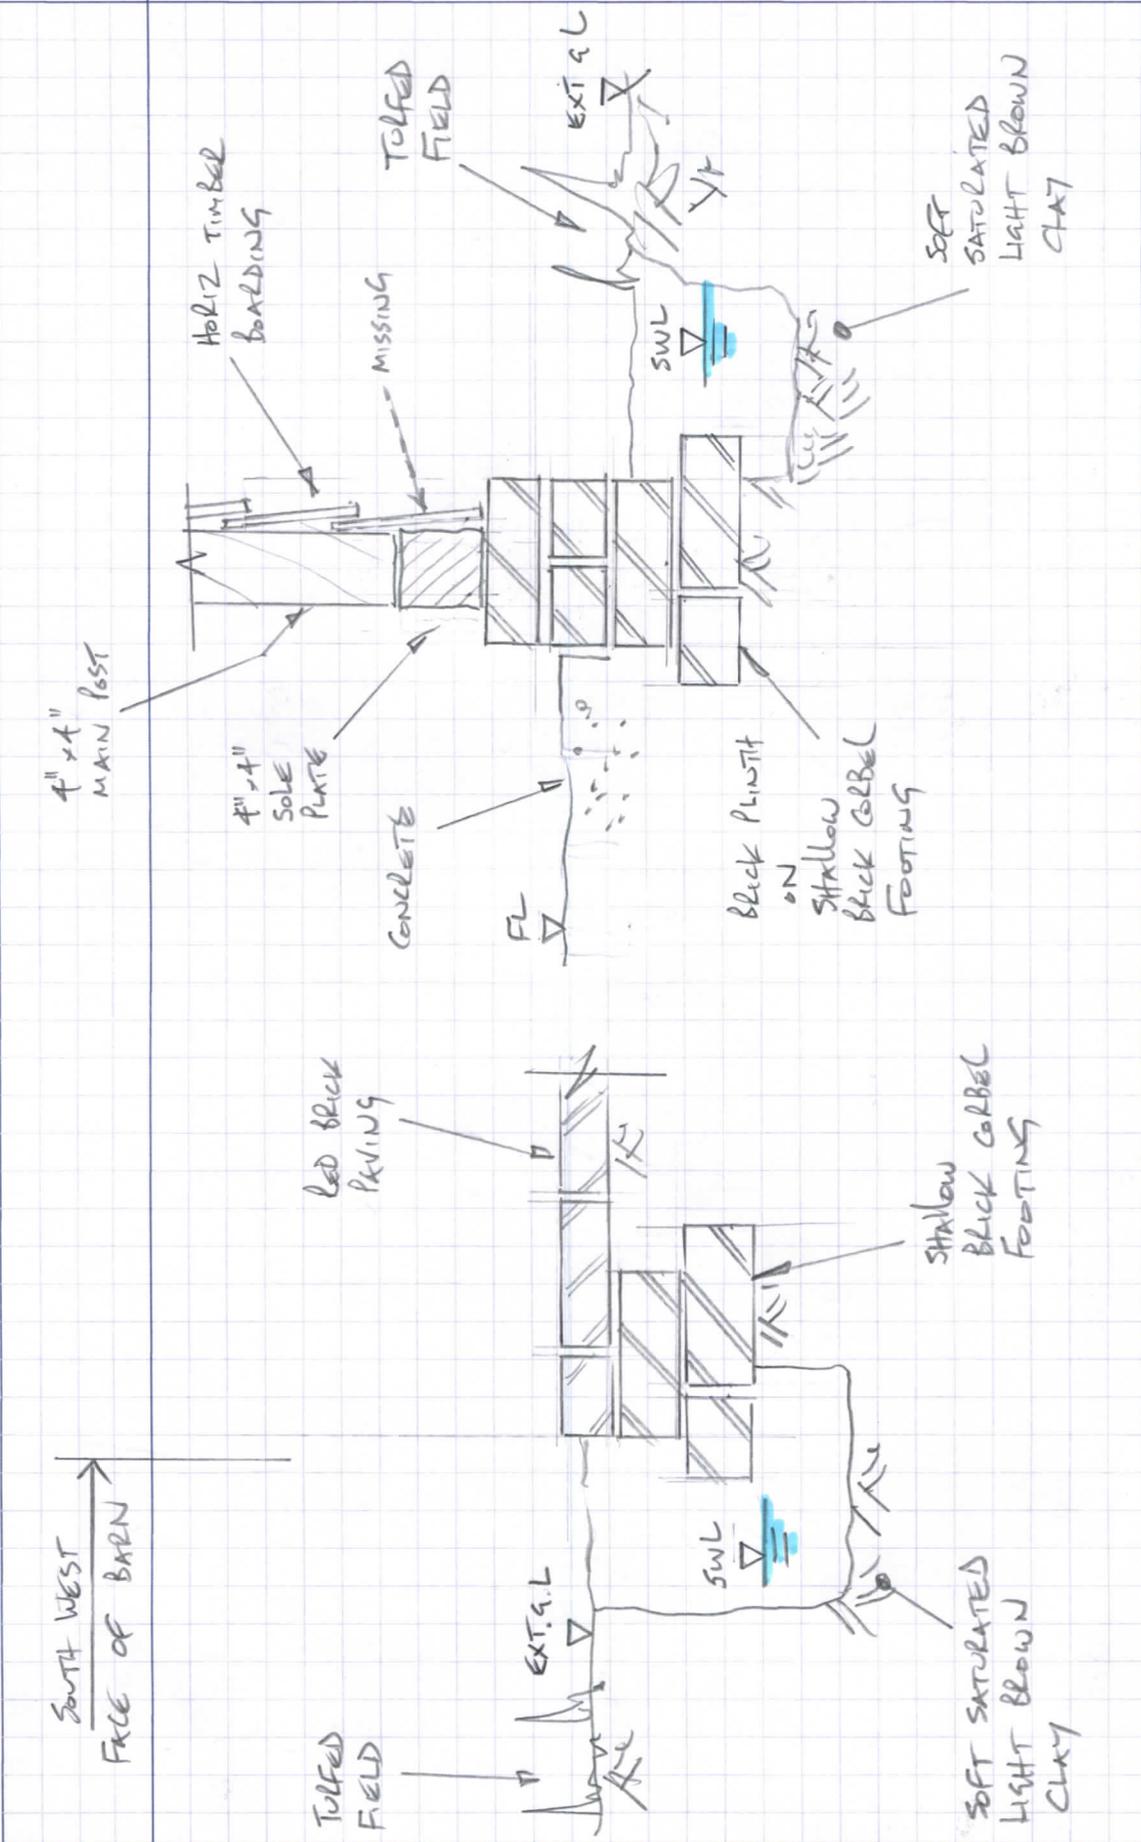
Soil samples taken from the trial pit excavations comprised a soft, saturated, brown, silty Clay, which appear to be weathered upper layers of the Weald Clay. The results of two trial pit investigations are shown on sketches J9194 SK101 & SK107 and on photographs P14 & P15. As is typical for agricultural buildings of this age, the building's existing foundations comprise shallow brick corbels.

SECTION 2-2 AT TRIAL PIT 2
 (NORTH EAST SIDE)
 SEE P15

SECTION 1-1 AT TRIAL PIT 1
 (SOUTH WEST SIDE)
 SEE P14

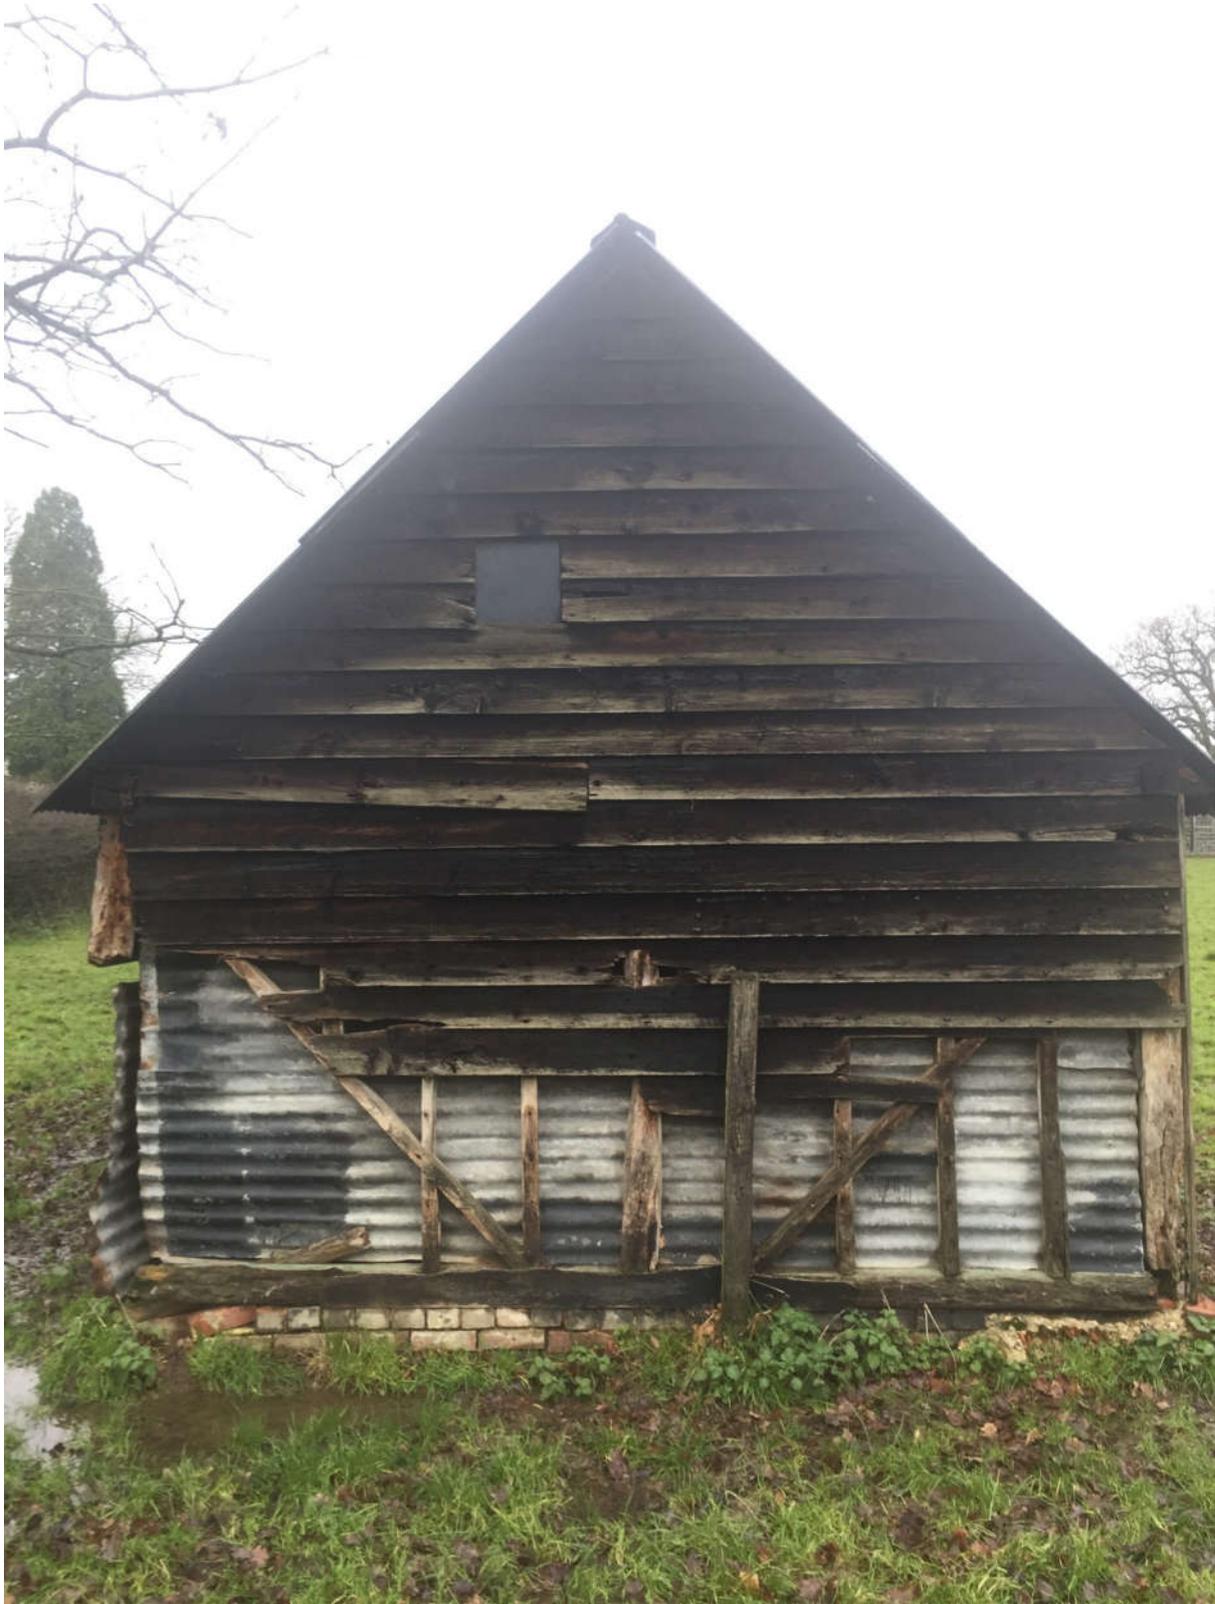
Photograph P2

The main timber wall posts are generally damp near their bases and are extensively decayed with signs of wet rot and insect attack. This is due to posts being in direct contact with the damp sole plates. At the South East corner of the building the main timber post is missing. *The main timber wall posts timber would need to be repaired or replaced as part of any proposed conversion works from agricultural to residential use.*

South East elevation.

(Note missing horizontal board cladding, and missing post/infill studs at SE corner).

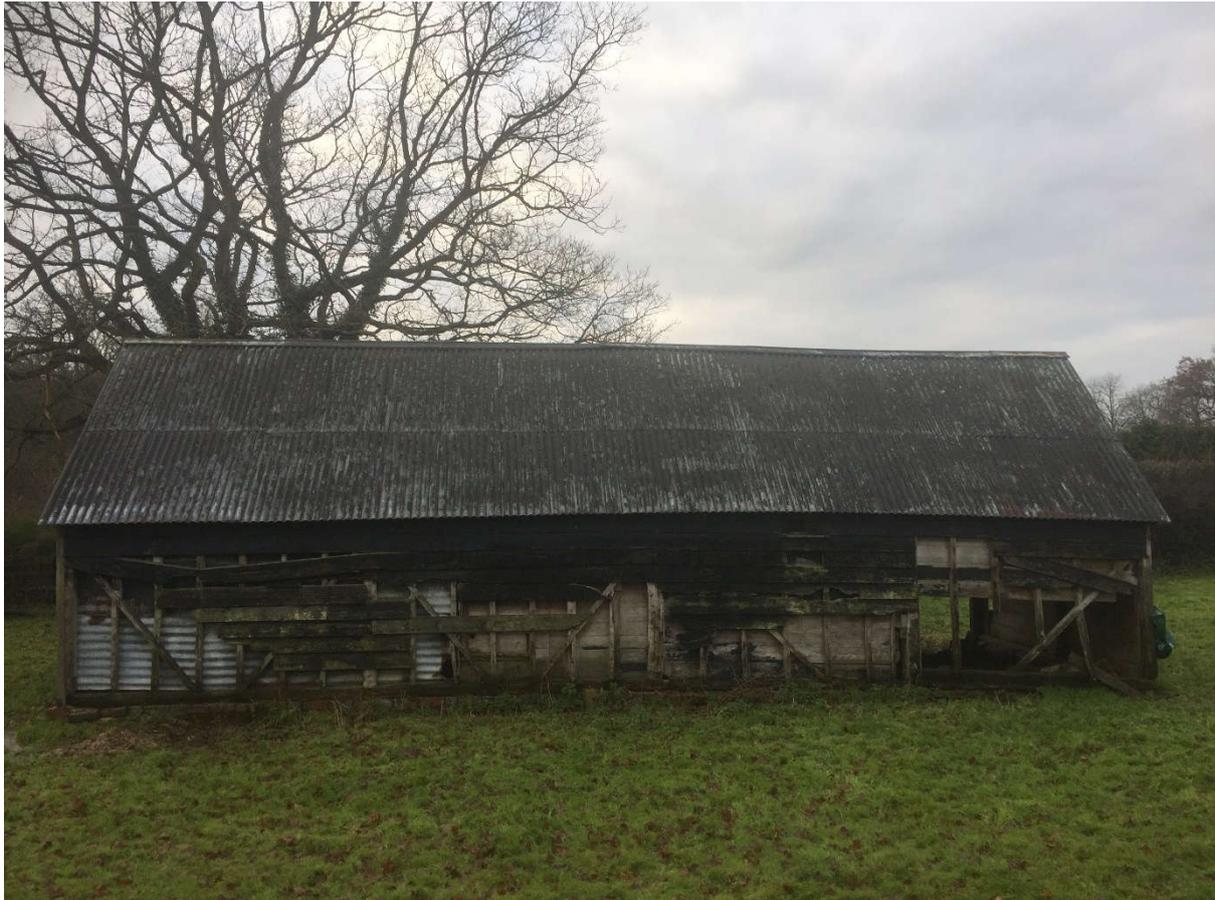
Photograph P3

The external horizontal timber ship lap wall cladding is extensively damaged and missing. This is probably due to a combination of age, nail corrosion, impact damage and wind damage. *The timber cladding would need to be fully repaired or replaced as part of any proposed conversion works from agricultural to residential use.*

North East elevation.

(Note missing horizontal board cladding, and damaged wall infill panel at NWcorner).

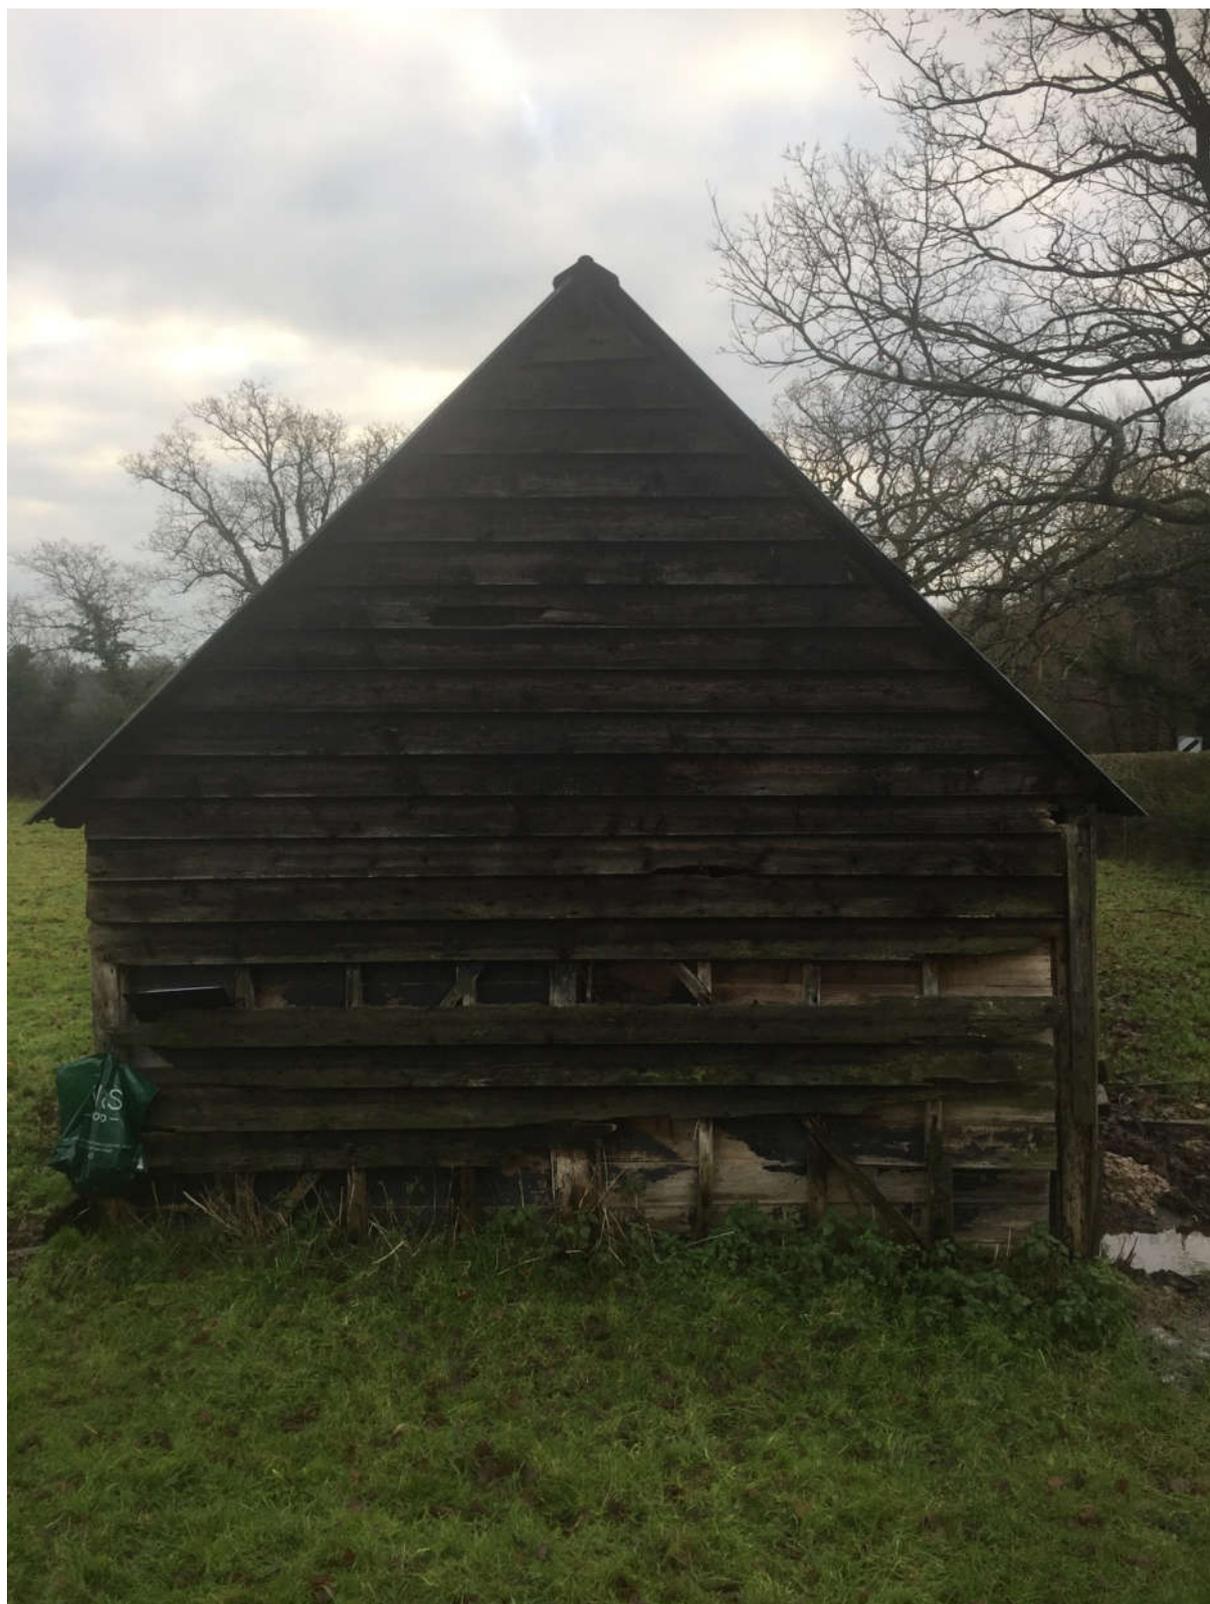
Photograph P4

North West elevation.

(Note missing horizontal board cladding).

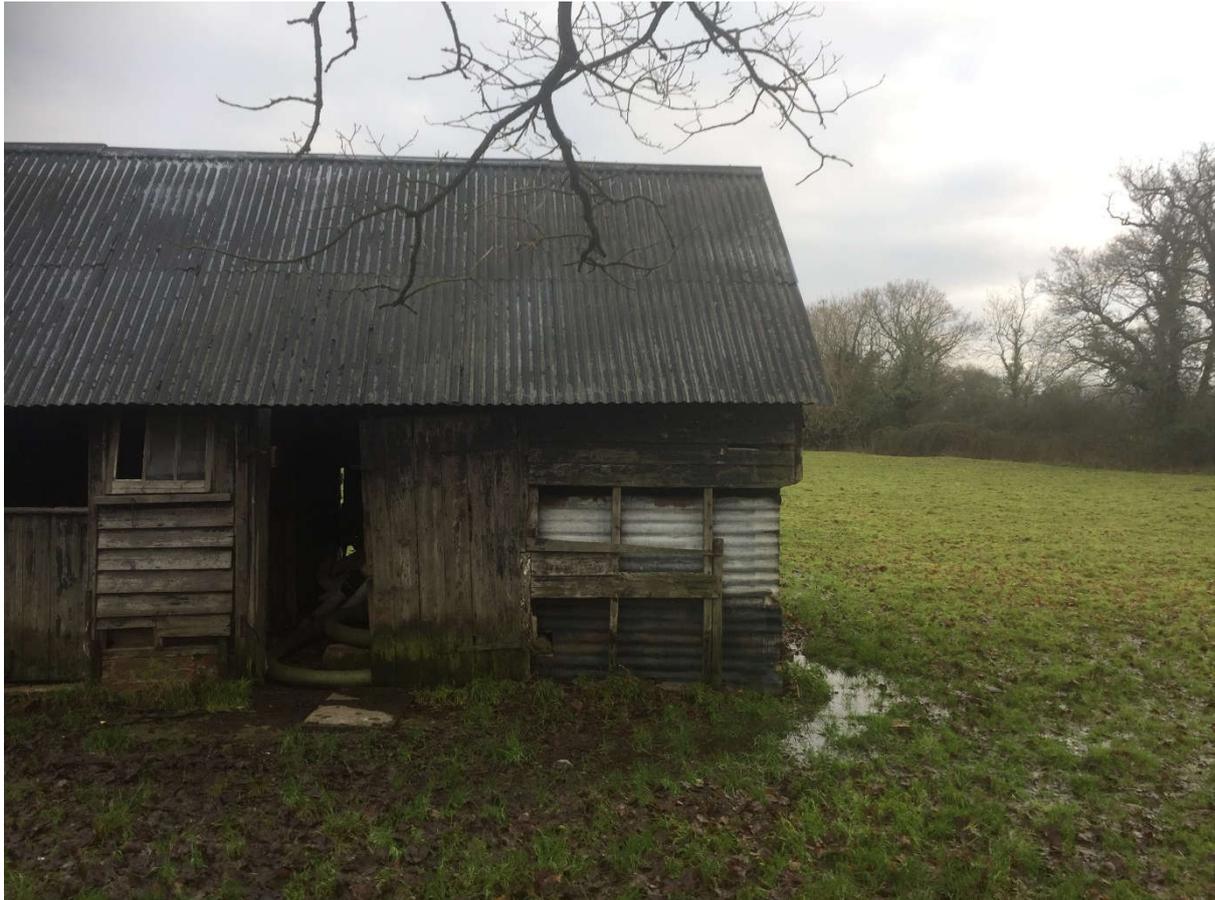
Photograph P6

South West elevation (2).

(Note missing horizontal board cladding, and missing post at SE corner).

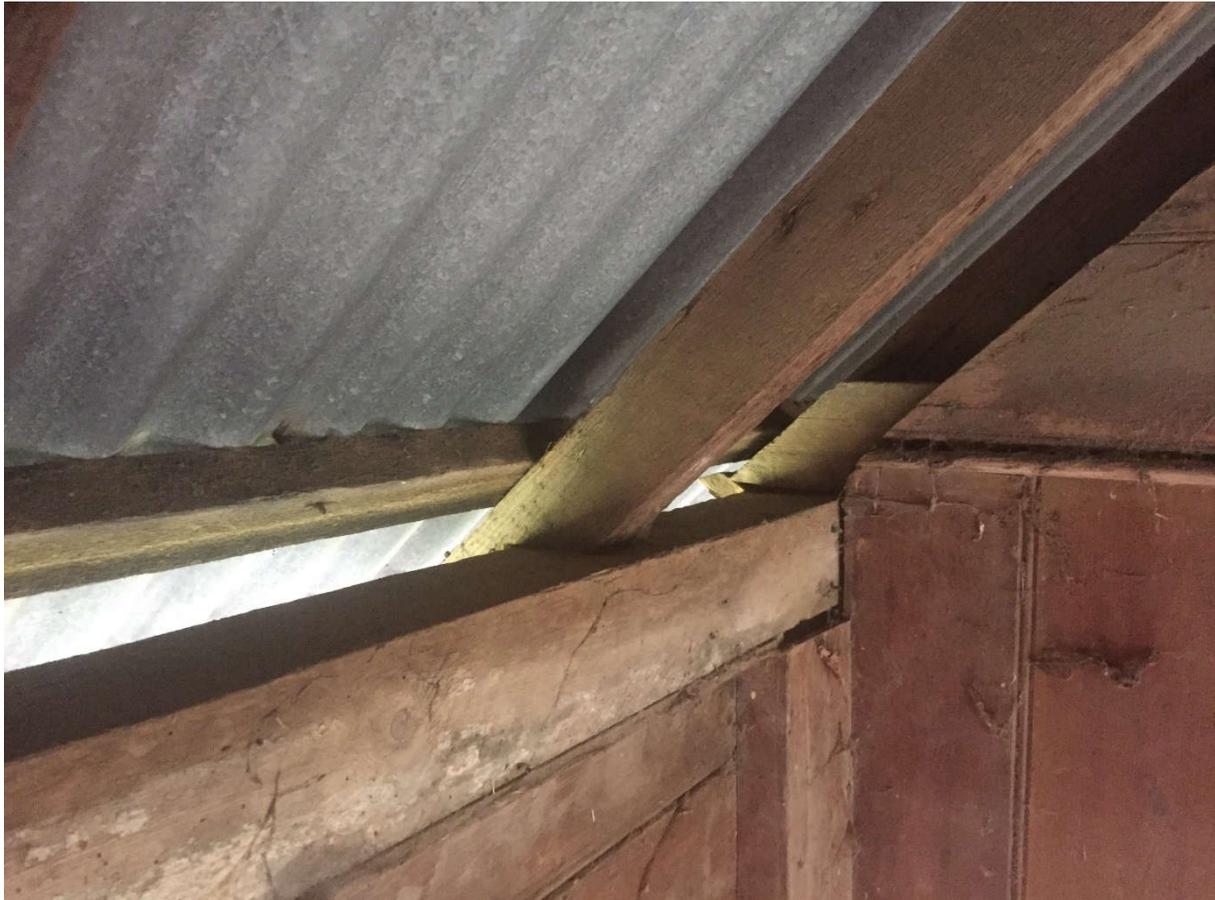
Photograph P8

Eaves plate and common rafter.

(Eaves plate and roof structure in relatively good condition).

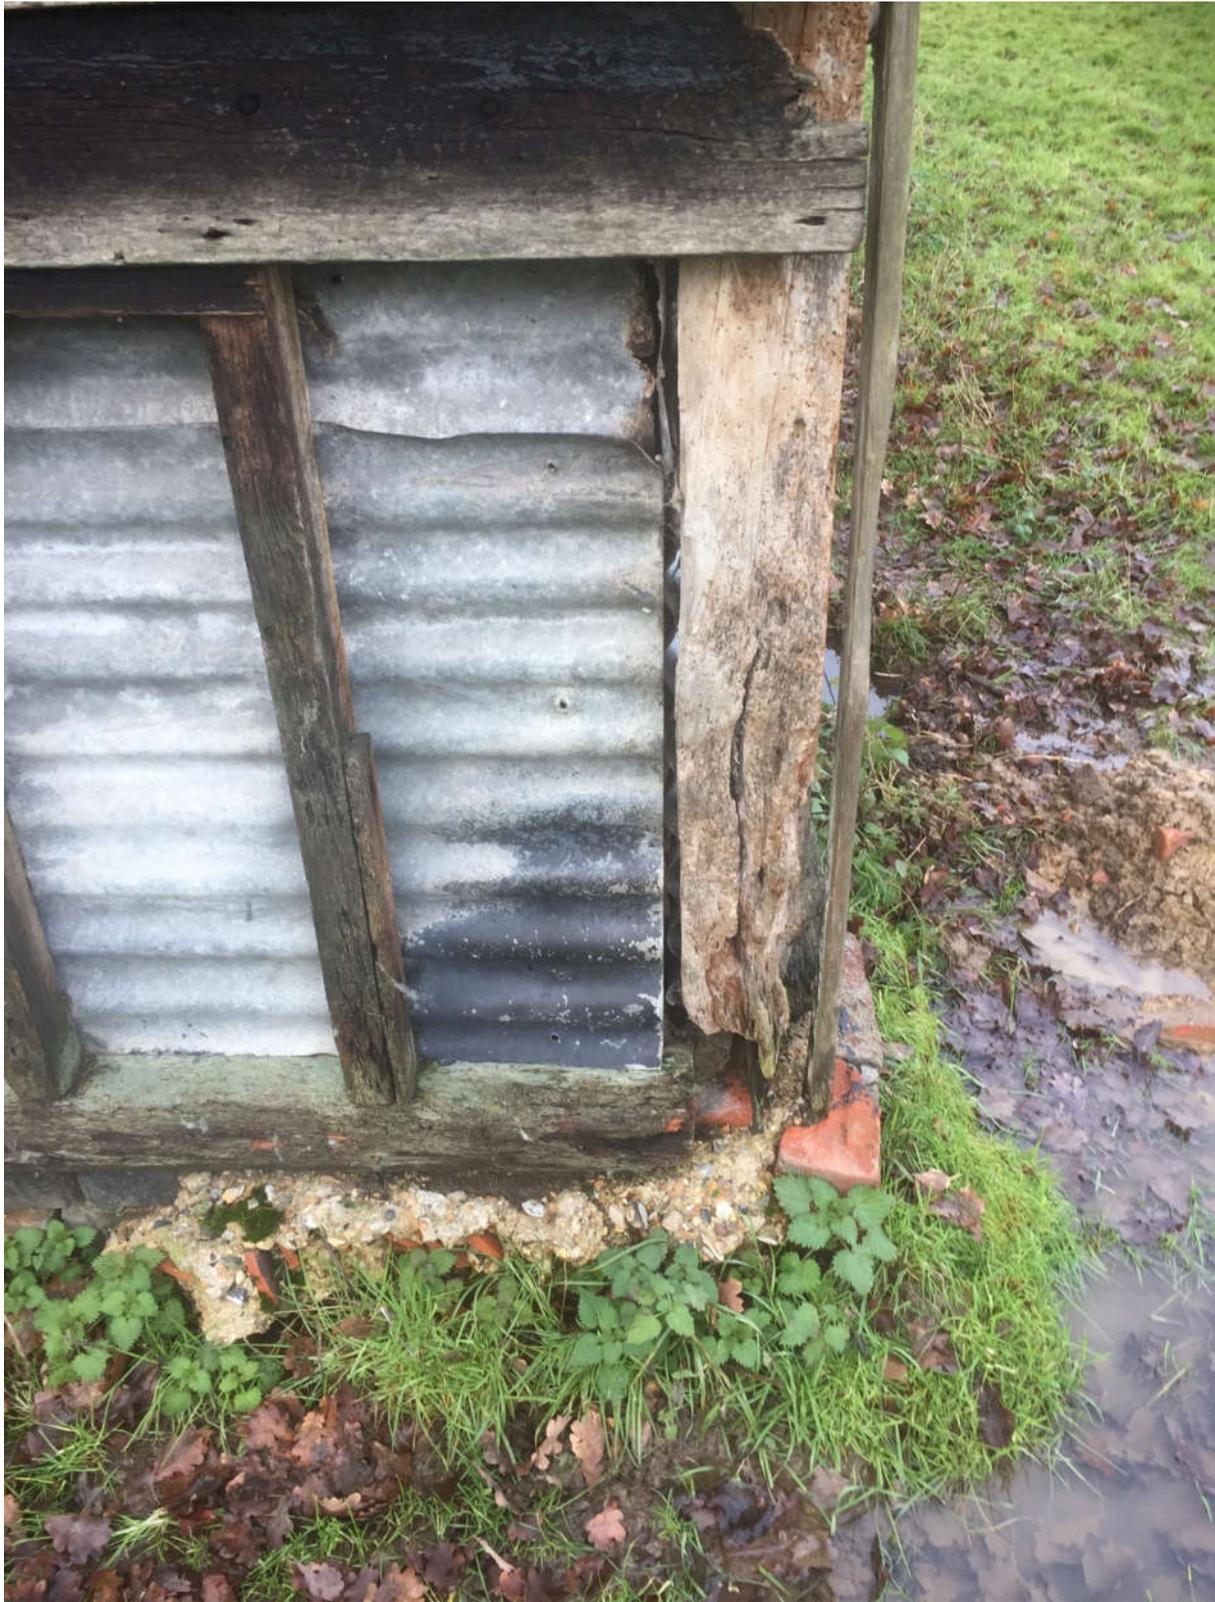
Typical decay of sole plate and bottoms of main posts and infill wall panel studs.

The timber sole plate generally saturated and is extensively decayed with signs of wet rot and insect attack. This is due to lack of DPC and the sole plate being in close proximity with the saturated ground. *The timber sole plate would need to be replaced as part of any proposed conversion works from agricultural to residential use.*

The timber infill wall panels studs and braces are generally damp near their bases and are extensively decayed with signs of wet rot and insect attack. This is due to panels being in direct contact with the damp sole plates. *The timber wall infill panels would need to be repaired or replaced as part of any proposed conversion works from agricultural to residential use.*

Photograph P12

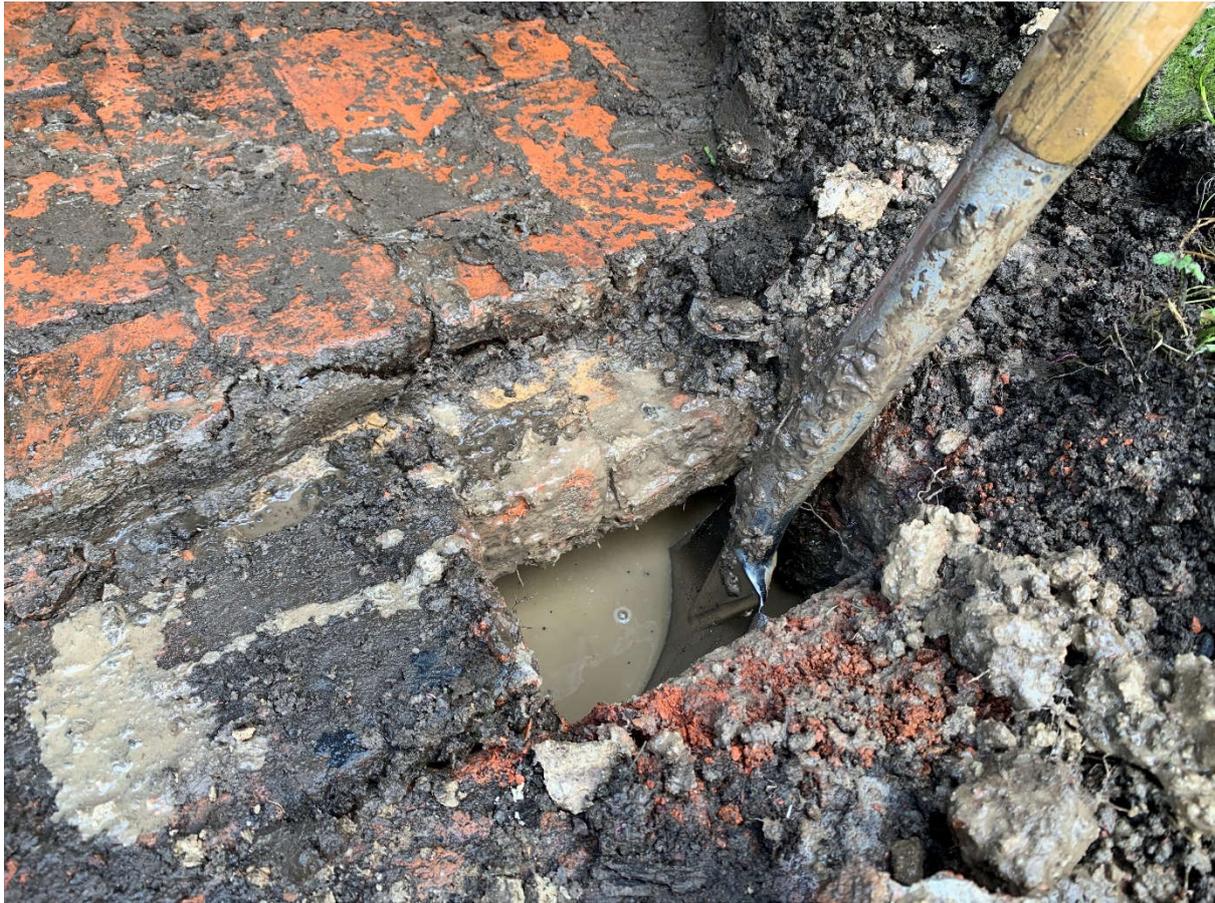
Photograph P14

The internal ground floor surfaces are generally cold and saturated. This is due to lack of DPM and the paving being in direct contact with the saturated ground. *The ground floor would need to be replaced with a suspended or insulated floor as part of any proposed conversion works from agricultural to residential use.*

Trial Pit TP1.

(Note standing water and red brick floor paving).

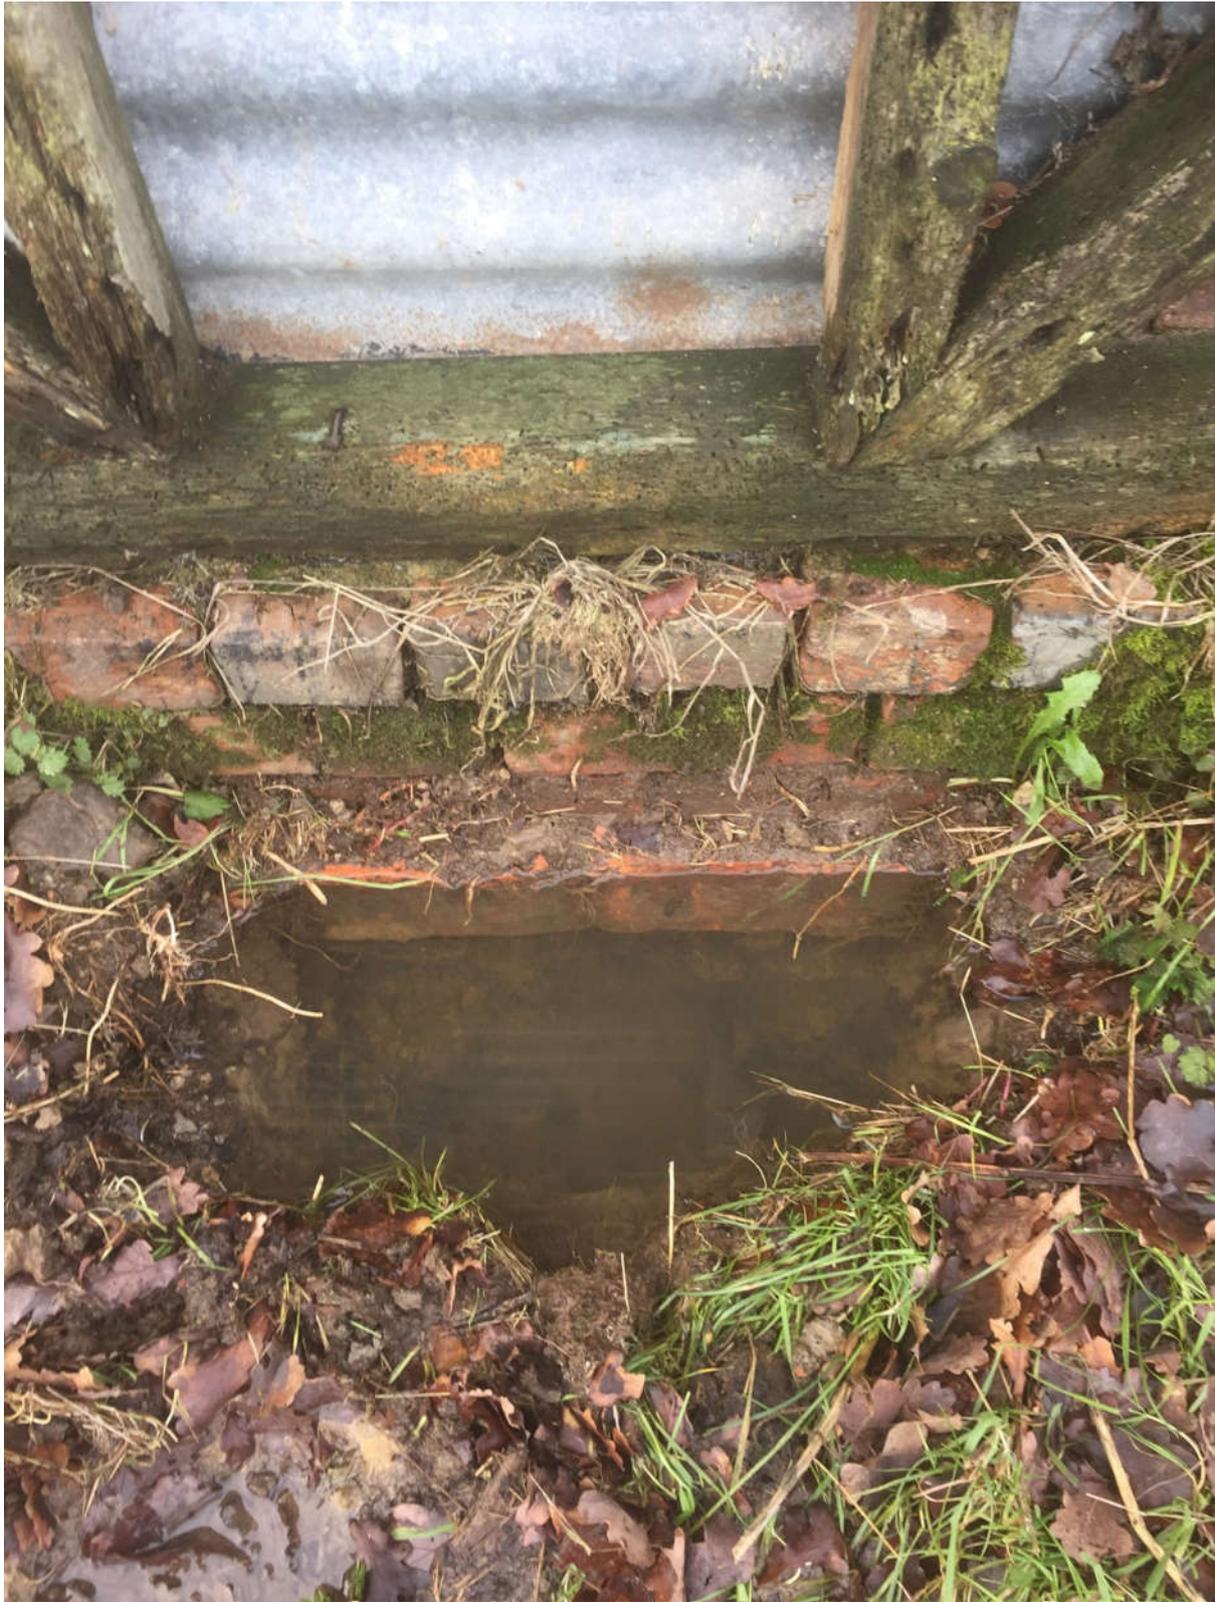
Photograph P15

Trial Pit TP2.

(Note standing water and decay of sole plate and bottom of wall infill panel studs/braces).
