STRUCTURAL INSPECTION REPORT
ON
REDUNDANT BARN AT
BODRAWL BUNGALOW
ST. PINNOCK, LISKEARD, CORNWALL, PL14 4QT
FOR
MR H KNAPMAN
MAY 2021

- 1.1 Property Barn at Bodrawl Bungalow
St Pinnock
Liskeard
Cornwall PL14 4QT
- 1.2 Brief To inspect and report on the structural aspects of the barn
- 1.3 Inspection The property was inspected M D Foulkes
PhD, CEng, MICE on Friday 21st
May 2021.

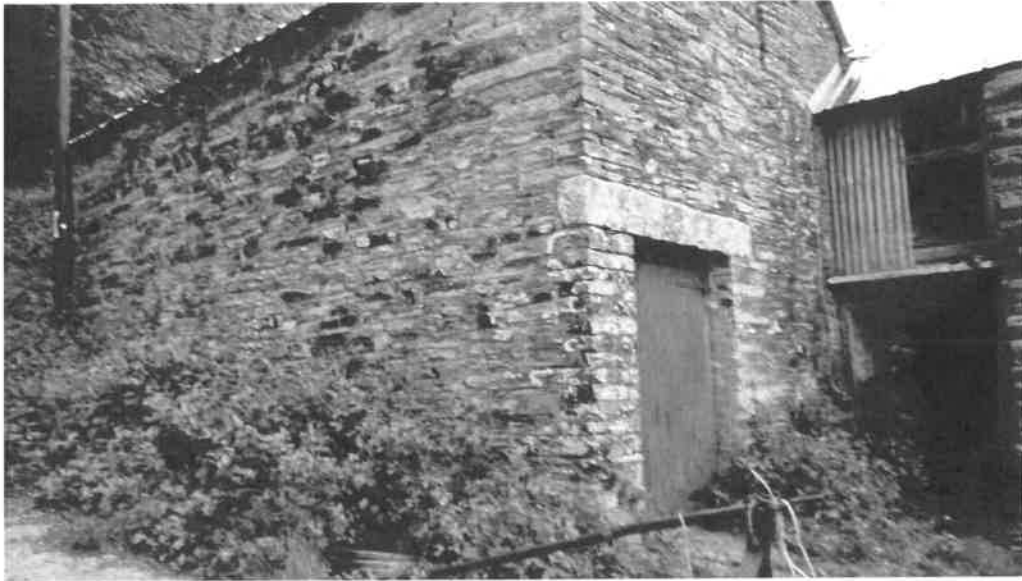
2.4 The lintel over the large door opening to the south elevation, shown in Photograph 1, is formed from granite and is a feature of the barn. The lintels over the remaining window and door openings are formed from timber.

Photograph 1 South and west elevations

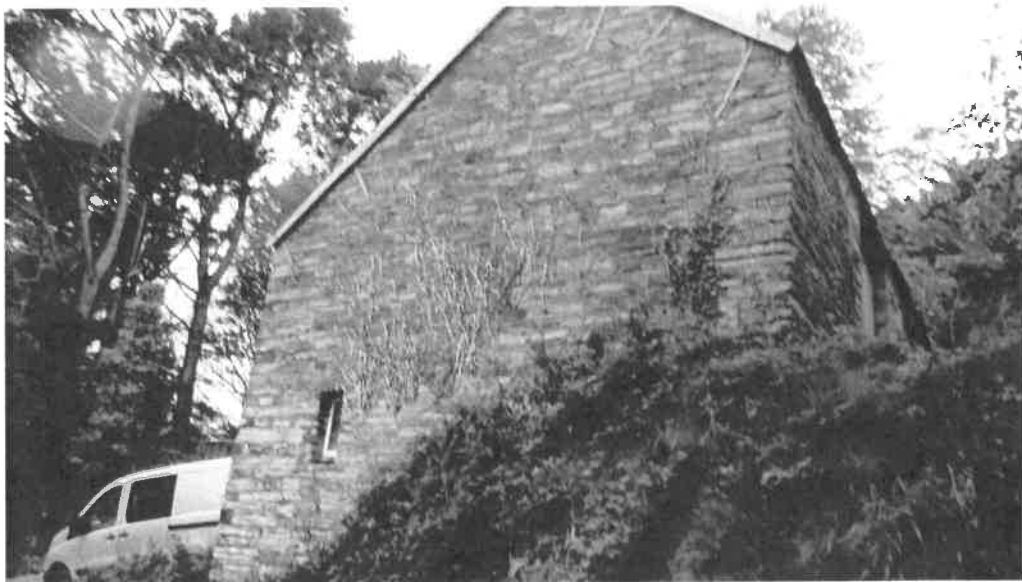
Photograph 2 South gable end wall

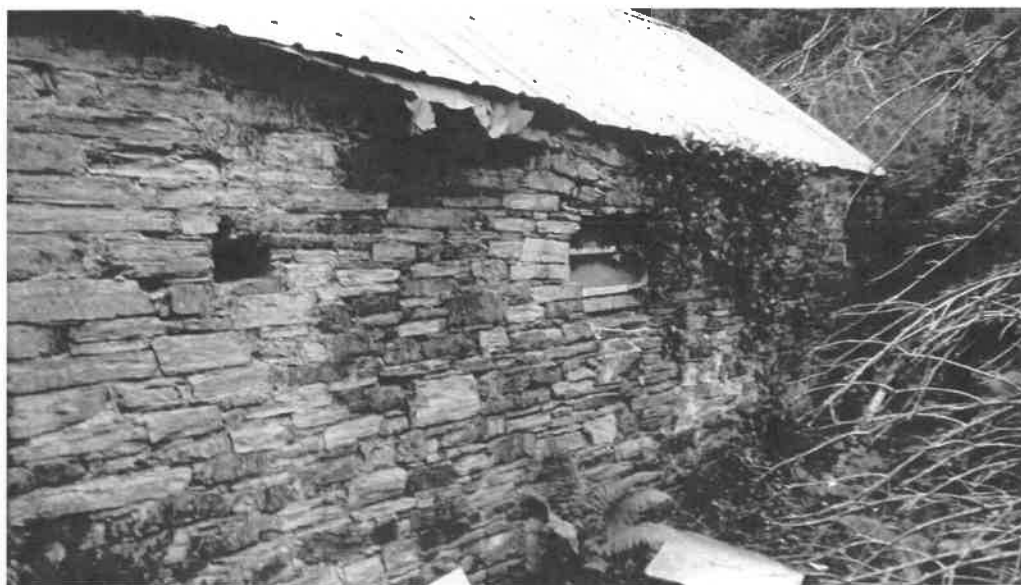
The failure of a lintel over a window opening in the upper floor of the west elevation, shown in Photograph 5, will require a replacement lintel followed by a small local area of re-building.

Photograph 5 Stonework to the east elevation flank wall above first floor level

3.3 The granite lintel over the doorway is performing satisfactorily. However it is recommended that the timber lintels be replaced with a combination of timber lintels supplemented with a 150mm dp precast concrete lintels internally.

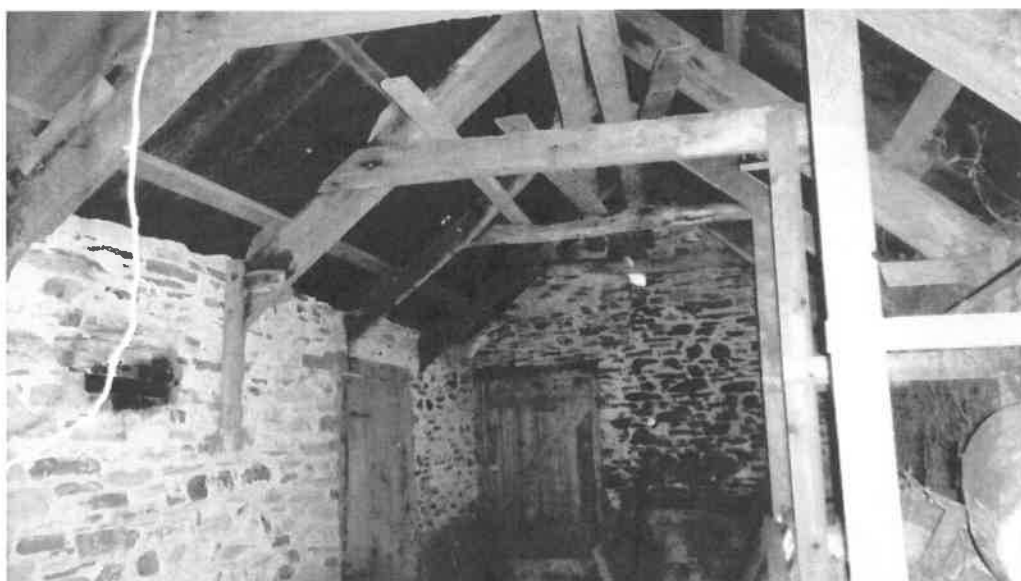
3.4 The roof trusses appear to be a reasonable condition. However the length of the primary rafters below the level of the ties exceeds that permitted by Section A of the Building Regulations which would require the majority of the trusses to be replaced or kept as features as part of a re-configured roof structure

In the event that any trusses are consider for re-use they should be closely inspected for rot where they embedded into the stonework.

Photograph 6 Roof trusses

The existing steel sheet cladding should be stripped and rotten common rafters and purlins replaced.

Thereafter the roof should be felted and reclad using natural slates.

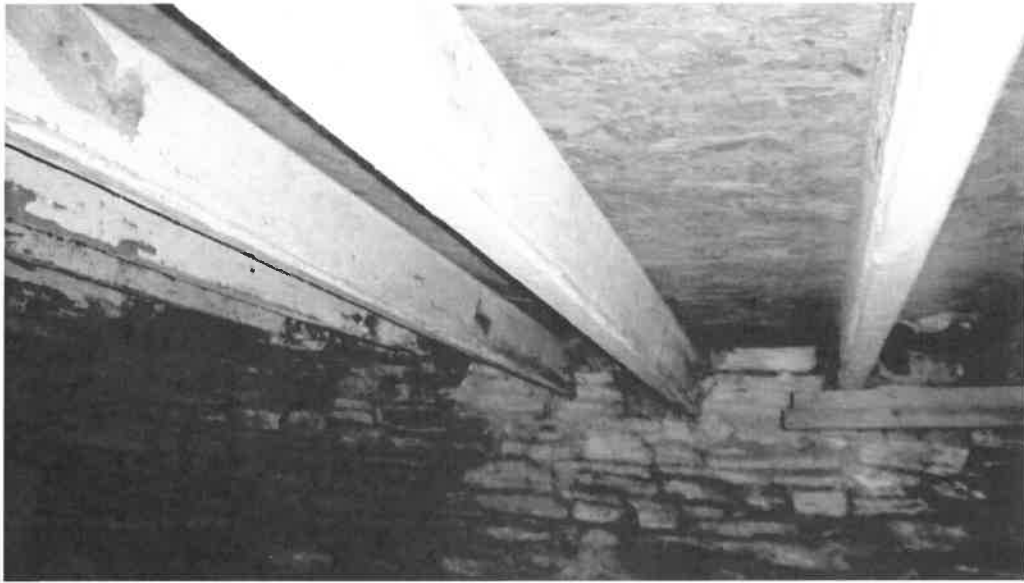
2.5 The first floor is constructed from 175 x 50 timber joists at about 500mm centres as shown in Photograph 3.

Photograph 3 First floor joists

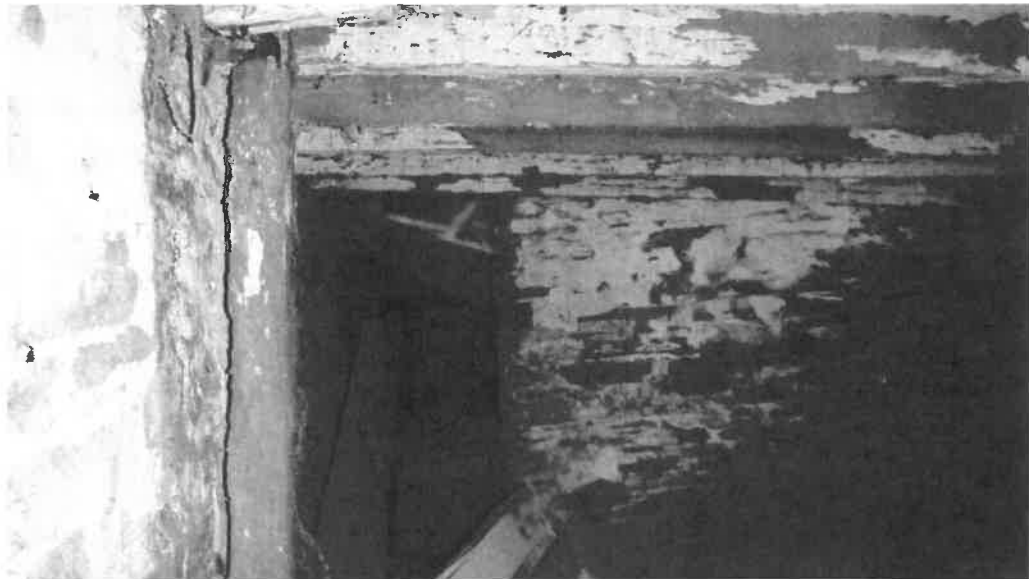
Photograph 4 Internal stone wall at ground floor level

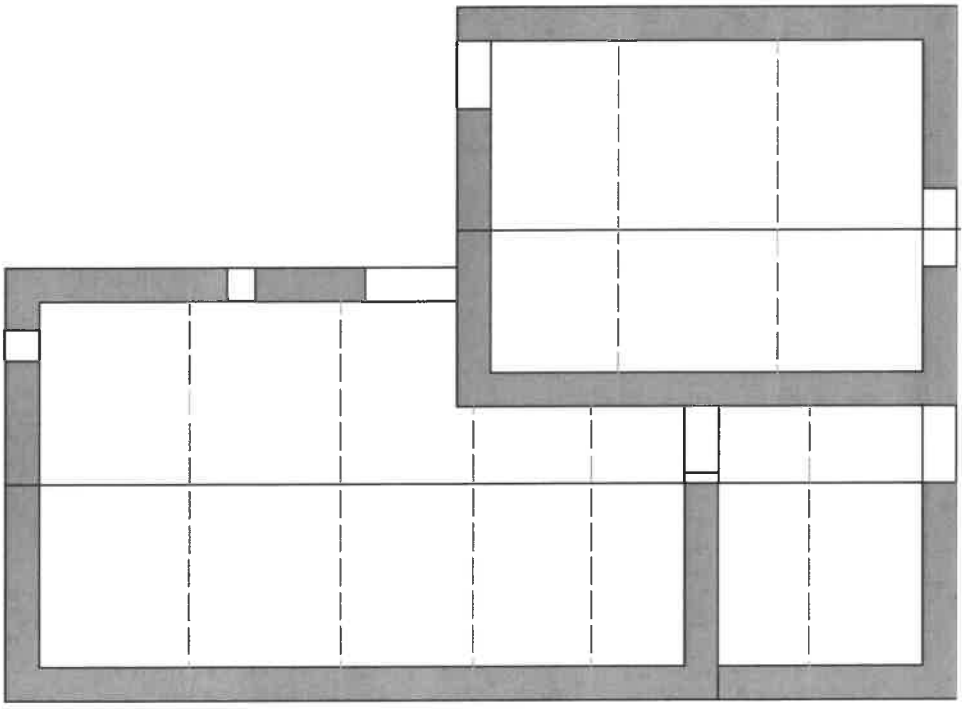
Plan on First Floor
Ground Floor layout Similar

The layout of the barn is shown on Architects Drawing number 3949 and attached sketch SC_844. It comprises two rectangular sections which are staggered as shown on the plan. Its over exterior length is approximately 12500mm and exterior width at its north is approximately 9000mm.

2.5 The roof structure is formed from elevated tie trusses from rough hewn timbers. The ties to the trusses are raised to various heights above the eaves reflecting the irregular configuration of the barn. The approximate location of the trusses is shown on the attached drawing SC_844.
