Sarah Wright
Brook Farmhouse
Colchester Main Road
Alresford
Essex CO7 8AP

Existing & Proposed
Elevation Drawing

Number
2106WR

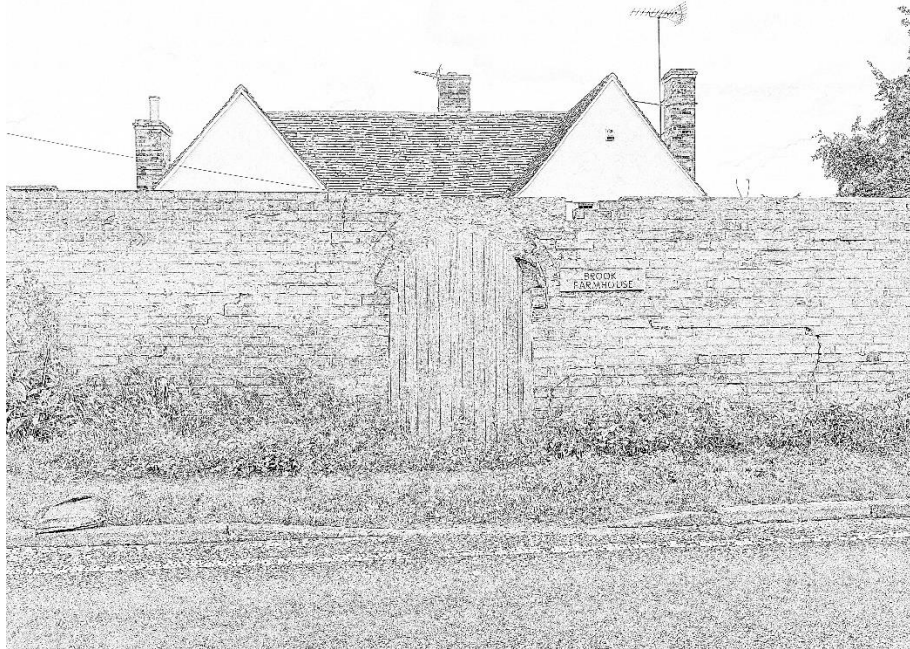
Existing Boundary Wall

Top section of round arch lintel collapsed due to ground movement

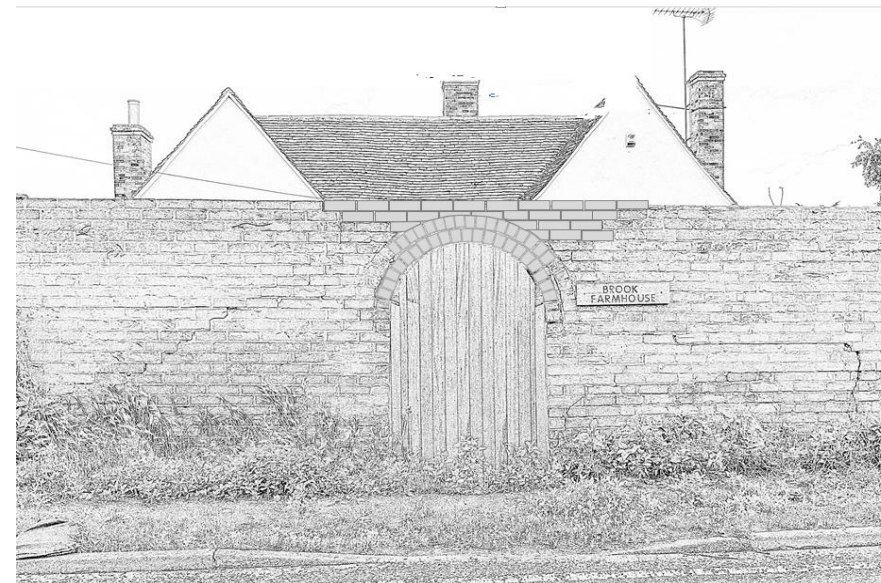
Proposed Repair

Some crack repairs and repointing required to adjacent section of the boundary wall

Clean off and reuse as many of the old bricks as possible.

Only suitable sourced replacement bricks to match existing to be used where needed.

Bricks to be bonded with lime mortar
