Arboricultural impact assessment

26 Oakley Wood Road
Bishops Tachbrook
CV33 9RW

Report number H 052

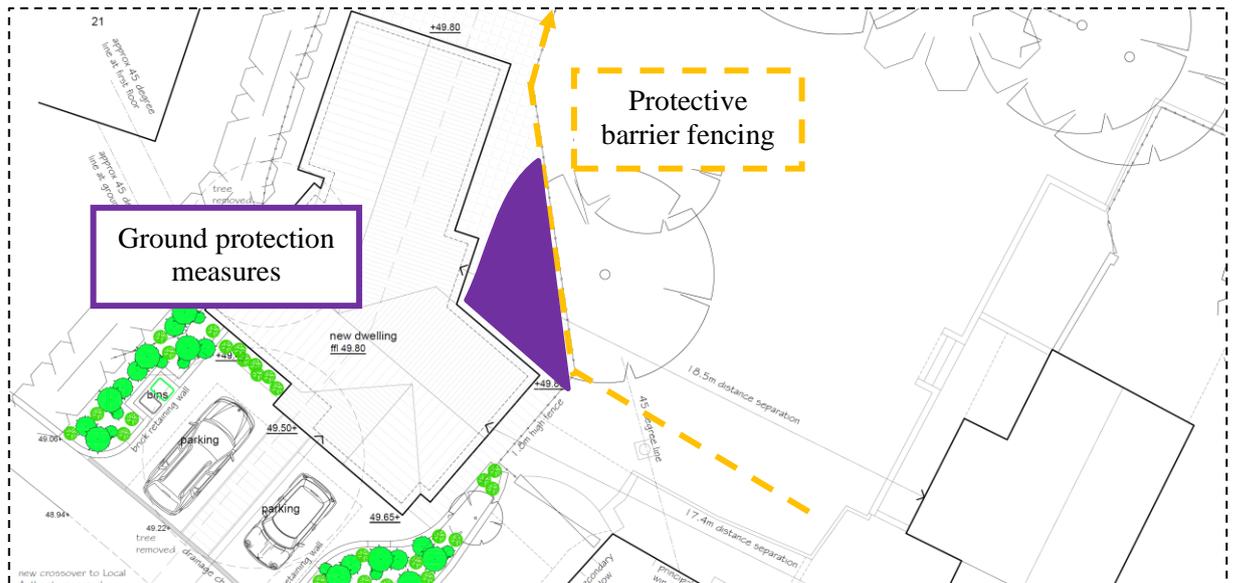
- 5.5 Tree protection measures, as described in Exclusion, will be required, the suggested alignment of the protective barrier fencing is indicated below. In addition, ground protection measures as described in Prevention will be required in the area as shown below.

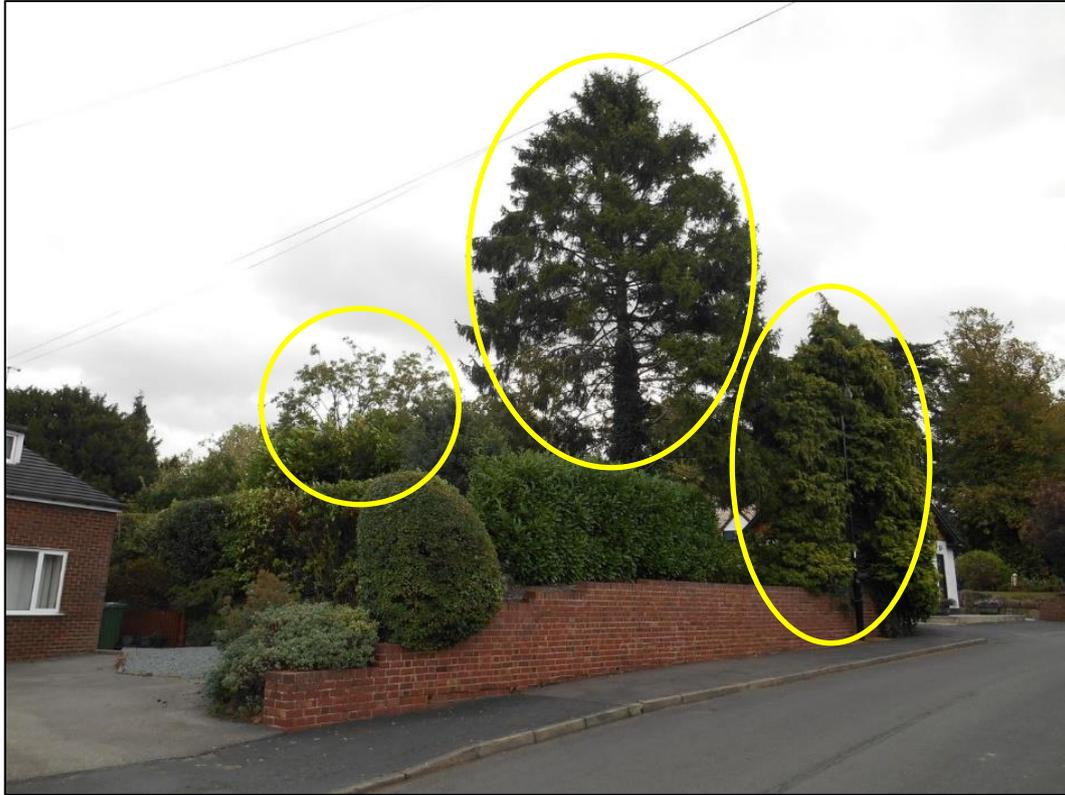
- 4.3 The four exotic alien conifers sat above a retaining wall and were significant in the local street scene, but they did not make a positive contribution in either visual or ecological terms.

- 4.4 The mountain ash was on the western boundary and was in apparently poor condition with very little leaf cover, the whole tree appeared to have been swamped by the vigorous laurel.

- 5.1 The four exotic conifers provided a mass of yellow-green foliage in the street scene, but the tree species are not locally native, and the angular Norway spruce and brooding mass of the Leyland cypress were not considered to be attractive, and so together they had a negative impact upon the local amenity.

- 5.2 The mountain ash tree appeared to be in poor condition and of poor form, the tree provided very little public amenity.
- 5.3 We are of the opinion that there should be no objection to the removal of the four exotic conifers and the mountain ash to facilitate the development. To provide some mitigation for their loss new tree planting will be provided in strategic locations to be determined on site along the eastern boundary fence to the rear of the proposed dwelling. Species that are suitable for a small garden should be considered, a list of such species is presented in Tree Species Selection for Green Infrastructure published by the Trees & Design Action Group.

The exotic conifers and mountain ash that are proposed for removal

- 7.1 We recommend that:
- 7.1.1 the four exotic conifers are not considered to be a constraint,
 - 7.1.2 the mountain ash is not considered to be a constraint,
 - 7.1.3 the five trees be removed to facilitate the development,
 - 7.1.4 new trees be planted in the season after the completion of the development to mitigate for the loss of the five trees, the species to be suitable for a small garden,
 - 7.1.5 specific control measures to prevent avoidable harm to be agreed once the development proposal has been finalised.

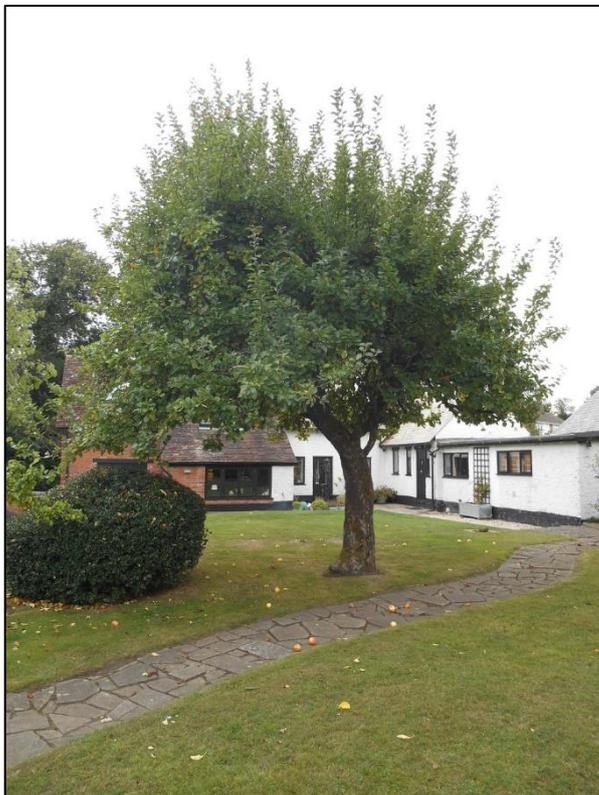
- 4.5 A mature apple tree was identified for retention in the rear garden of 26 Oakley Wood Road and will require protection from avoidable harm during the development. The tree had a stem diameter of approximately 450 mm, and so the radius of its root protection area was 5.4 m.

- 5.4 The retained apple tree’s RPA will extend across the property boundary toward the new dwelling and so suitable control measures will be required to prevent avoidable harm to the tree, see Tree roots and the RPA in Appendix 1.

The apple tree that is to be retained

- 5.6 To allow for the permanent boundary fence to be erected the apple tree's crown may well require selective lifting, see The stem and crown: the protective barrier fencing may as well be erected along the boundary for the duration of the development and then replaced by the permanent fence.
- 5.7 Consideration will need to be given to the siting of secure storage areas and welfare facilities; depending upon their location further control measures may be required to prevent avoidable harm to retained trees, either by exclusion or prevention.
