BoKlok Housing UK Limited

Hoodlands, Harry Stoke
*Geotechnical And Geoenvironmental
Interpretive Report*

Revision 2

July, 2021

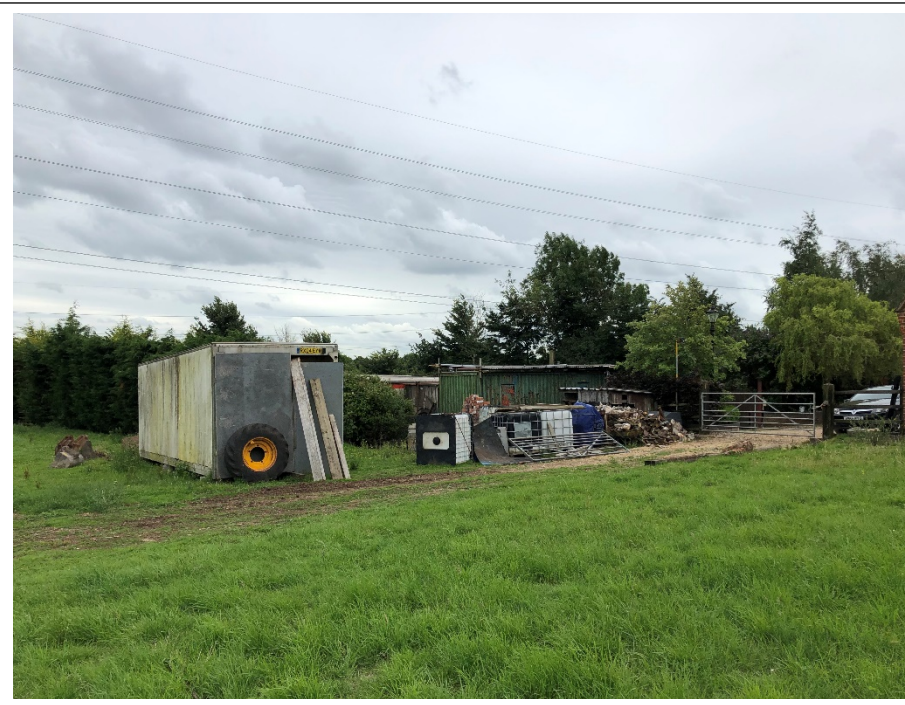
Photograph 1 – Looking south-east towards the storage area, showing the access route into the field.

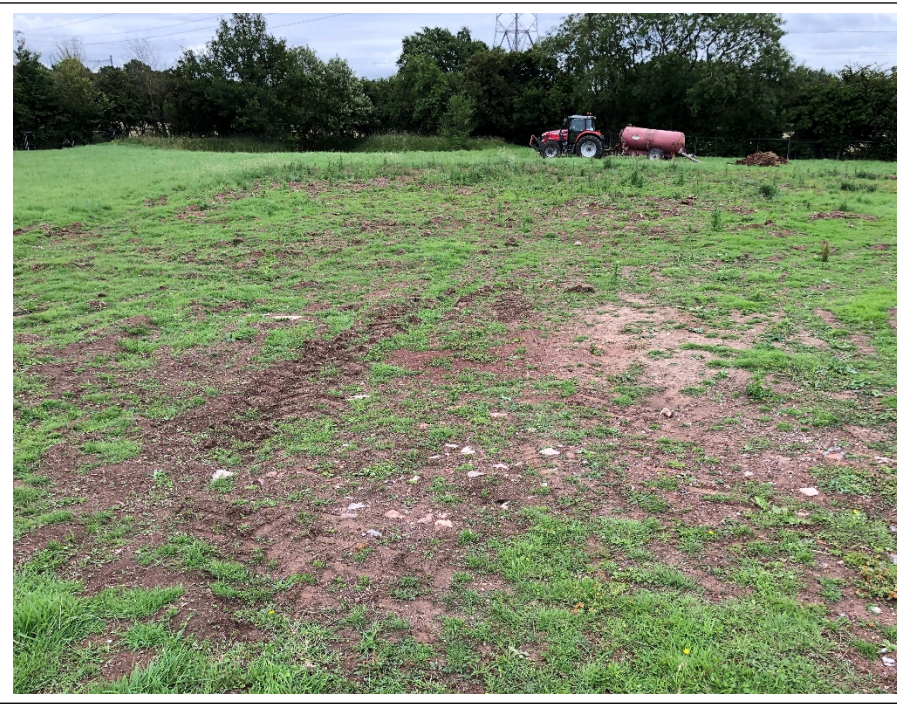
*Agricultural land use* – since the earliest historical maps, the majority of the site has comprised agricultural land. The rough hummocky ground noted may be as a consequence of this historical land use;
-

Photograph 2 – Looking east, showing hummocked area towards the centre of the site.

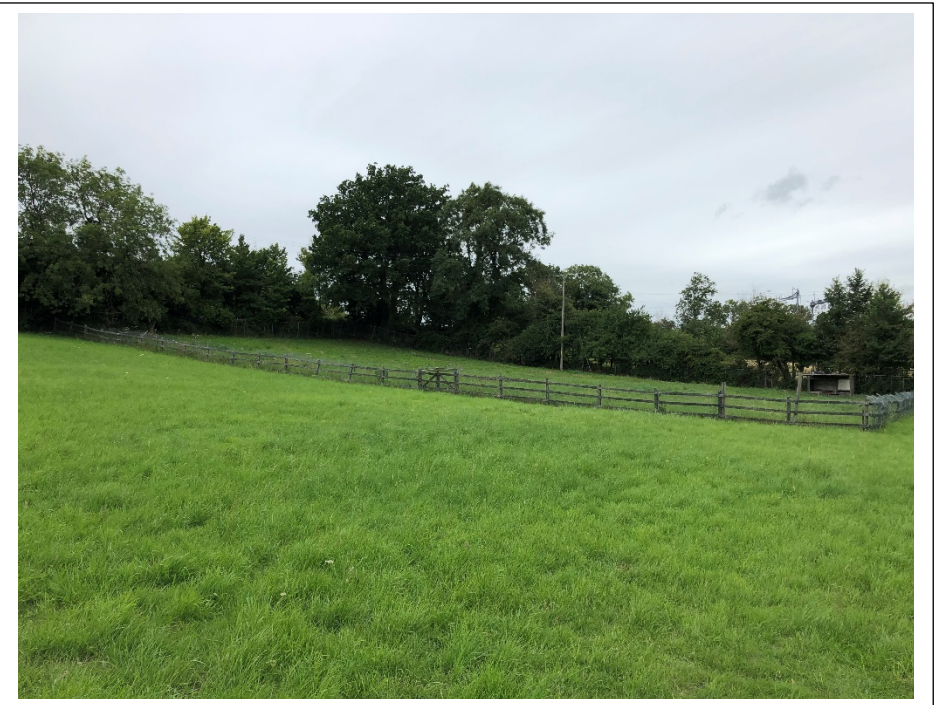
Photograph 3 – Looking north-west, showing the fenced paddock area.

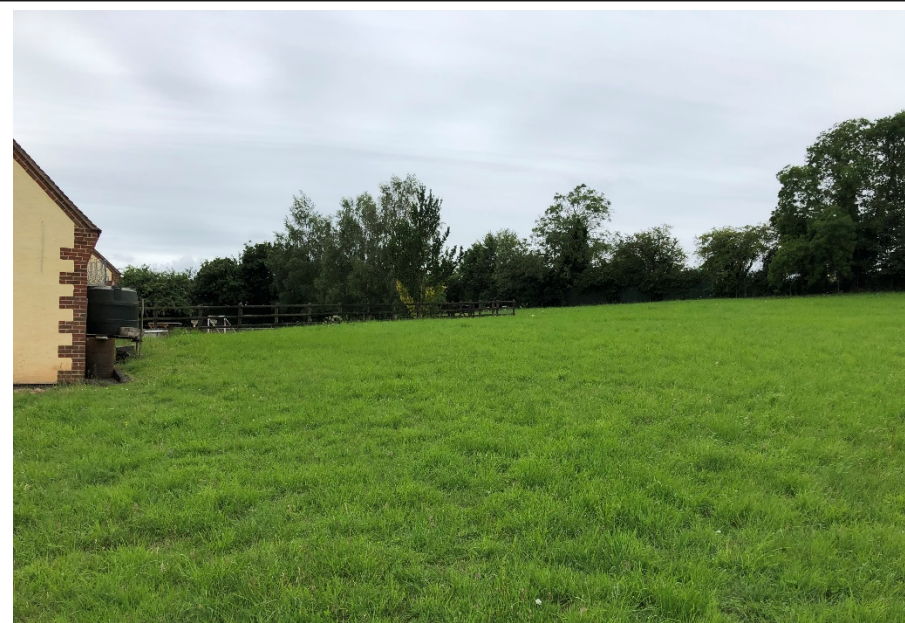
Photograph 4 – Looking south-west, showing the private residents, garden, and field area beyond.

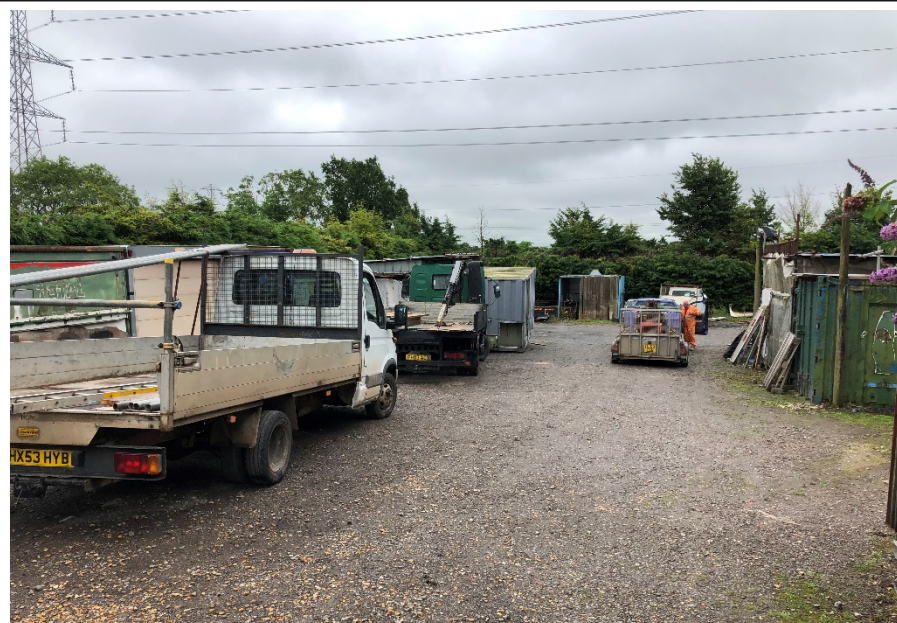
Photograph 5 – Looking east from the entrance to the storage area.

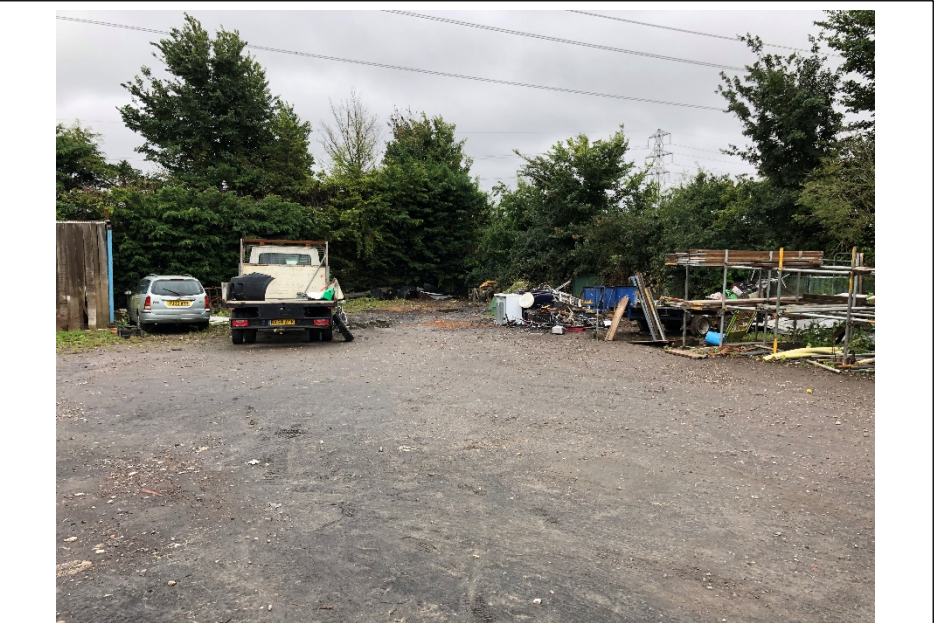
Photograph 6 – Looking south-east, showing an additional view of the storage area.

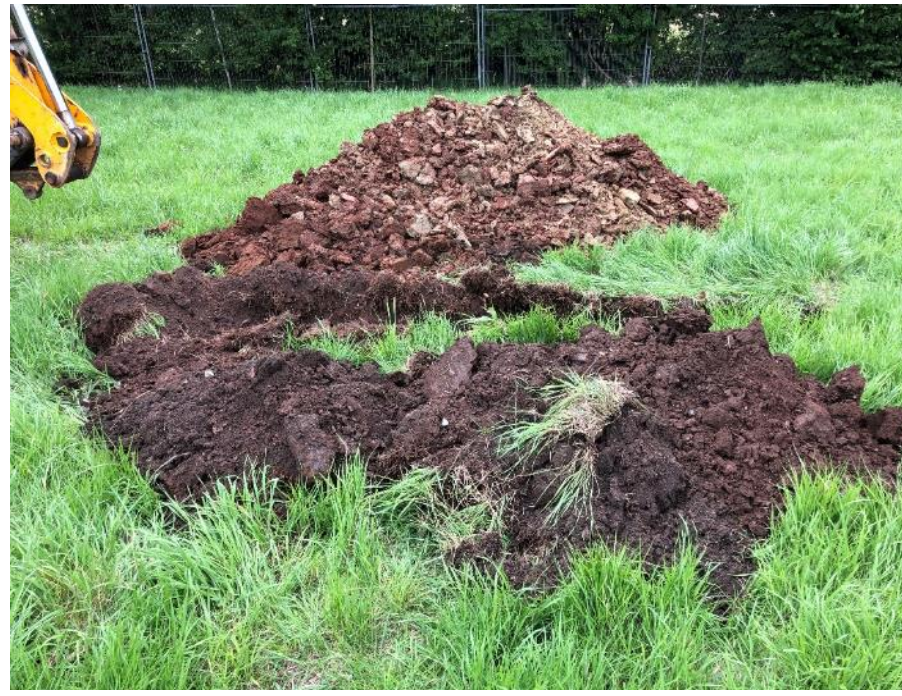
Photograph 1 – Displaying arisings at SA01, Topsoil and Made Ground (near side) along with the underlying Mercia Mudstone Group (far side).

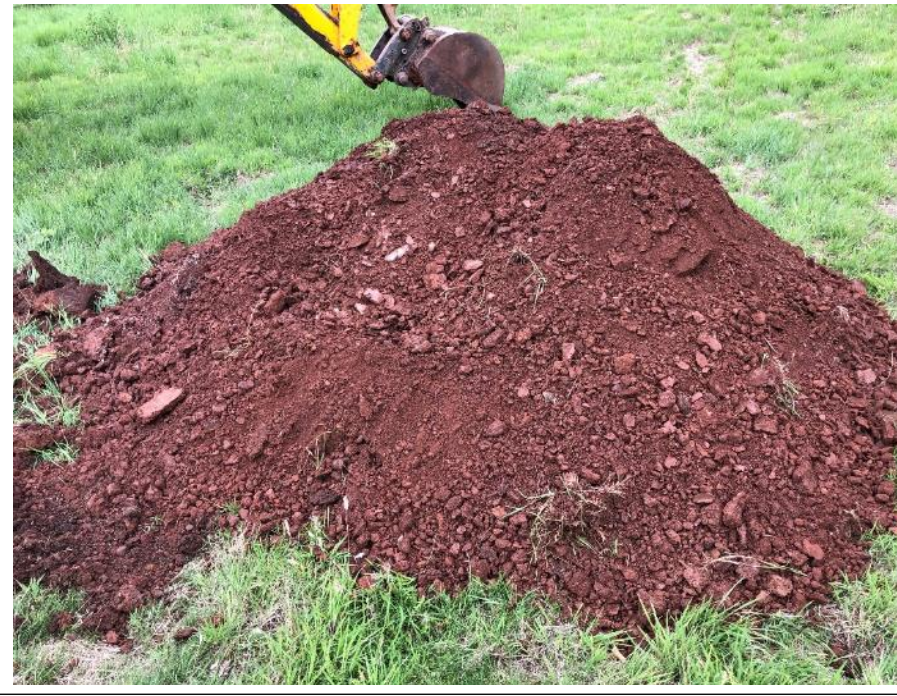
Photograph 2 – Displaying the underlying Mercia Mudstone Group excavated from TP01.

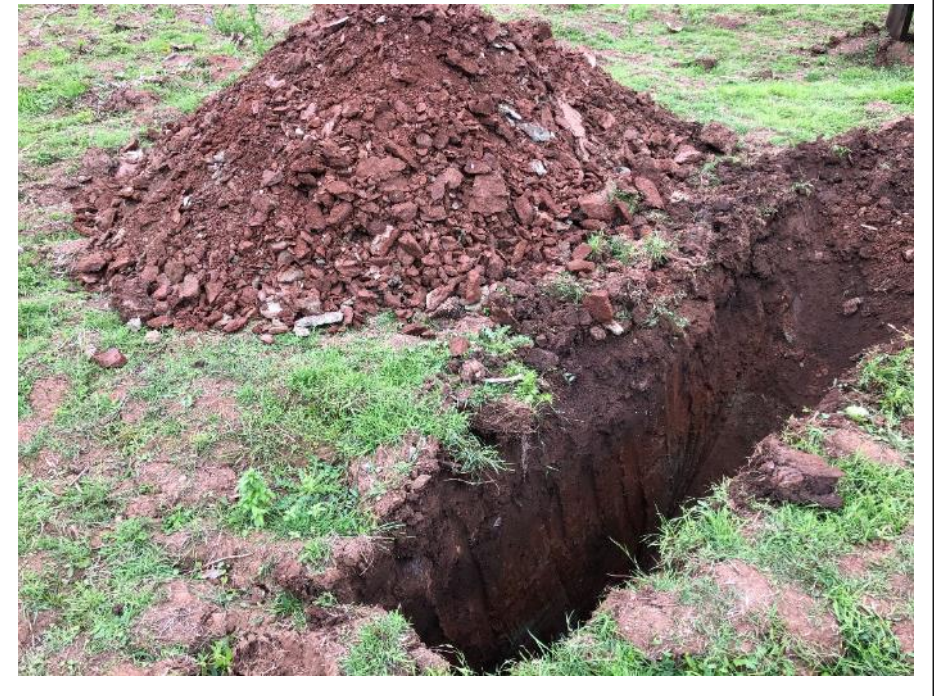
Photograph 3 – Displaying arisings (Mercia Mudstone Group) and trial pit of TP03 located, within the hummocked area in the centre of the site.

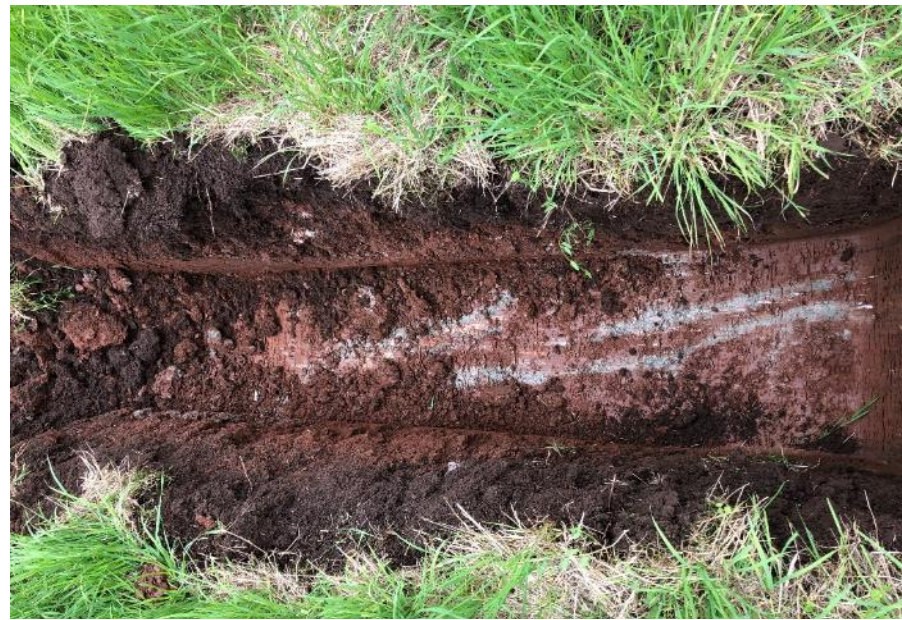
Photograph 4 – Displaying the in-situ shallow Mercia Mudstone Group, taken from TP04.

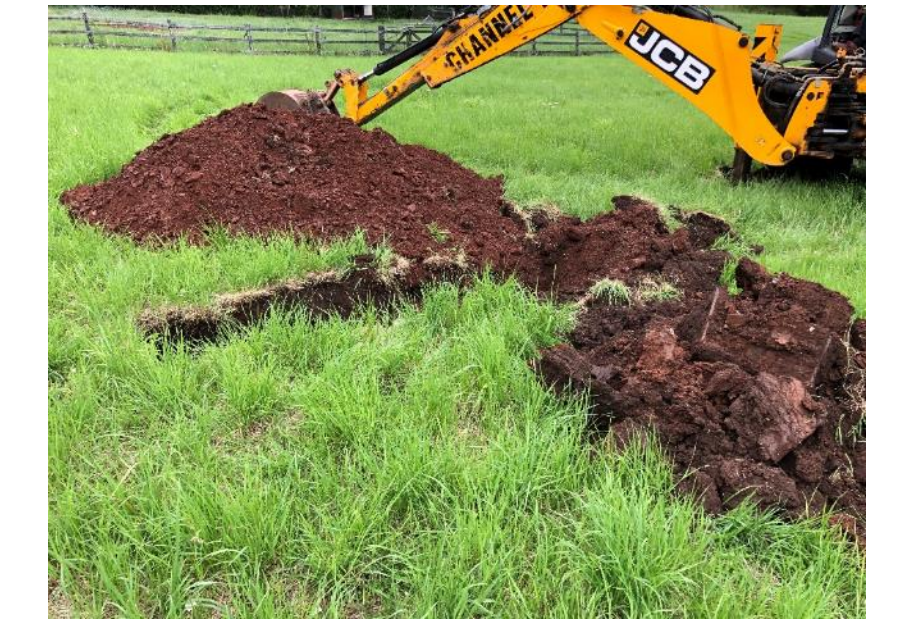
Photograph 5 – Displaying the arisings excavated from TP04, showing Topsoil (on the left) and the Mercia Mudstone Group (right).

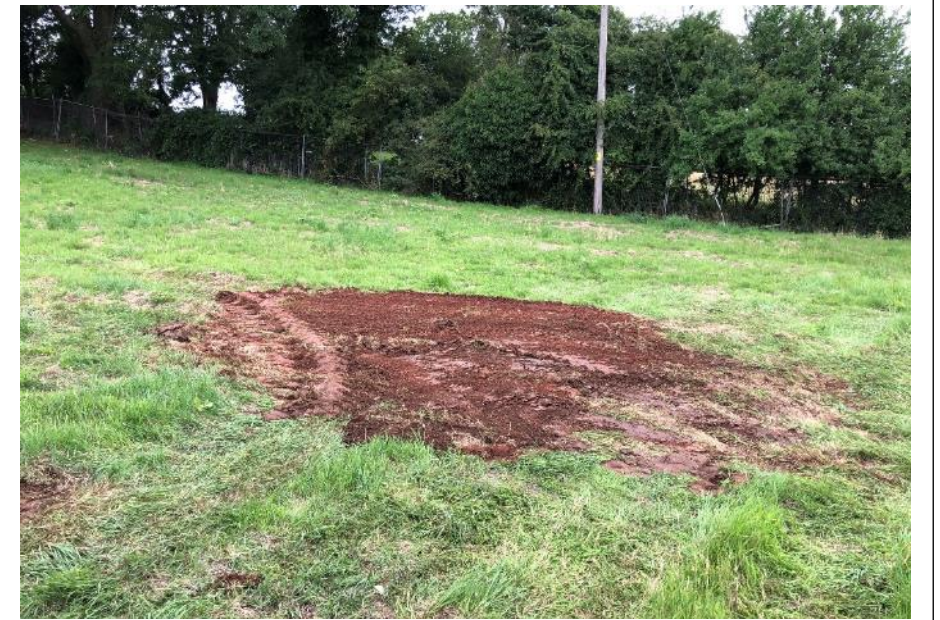
Photograph 6 – Showing an example of how all trial pit excavations were backfilled, taken from TP01.
