## STRUCTURAL APPRAISAL

PROPOSED CONVERSION OF BARN TO A DWELLING AT  
SOUTHOLT HALL BARN, SOUTHOLT, EYE, IP23 7TN

On behalf of Mark and Trudie Beckham

Version V1 – 18<sup>th</sup> December 2020

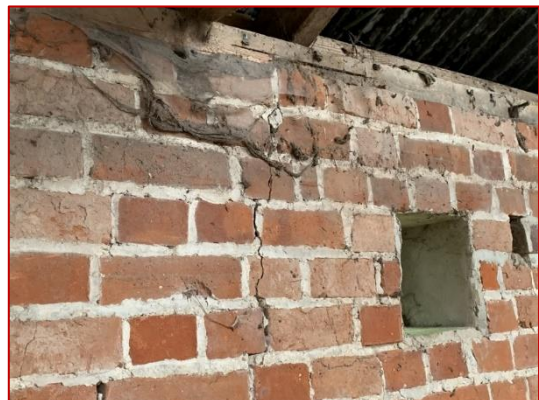
Photo 24: Cracking in Masonry to East Wing

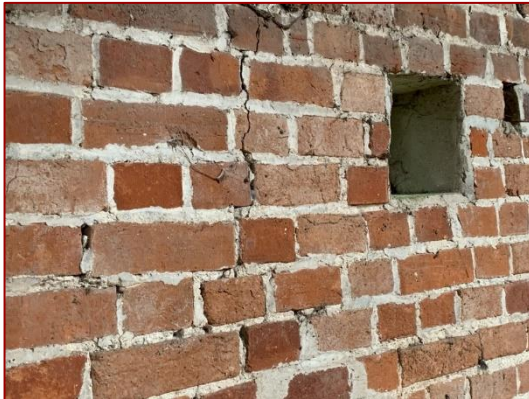
Photo 25: Cracking in masonry to East Wing

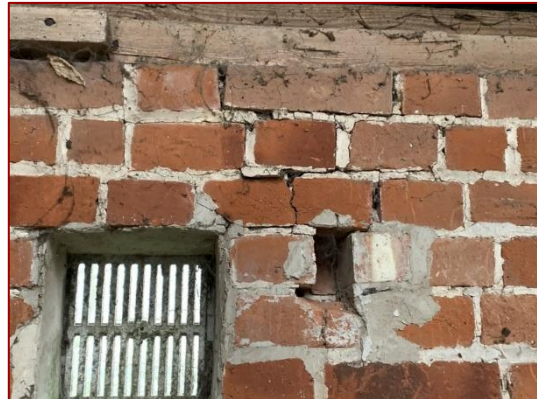
Photo 26: Cracking in Masonry to East Wing

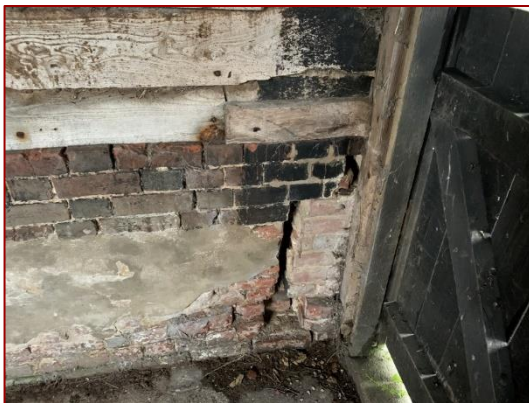
Photo 27: Separation of Western Gable Plinth from Northern Plinth to principal barn

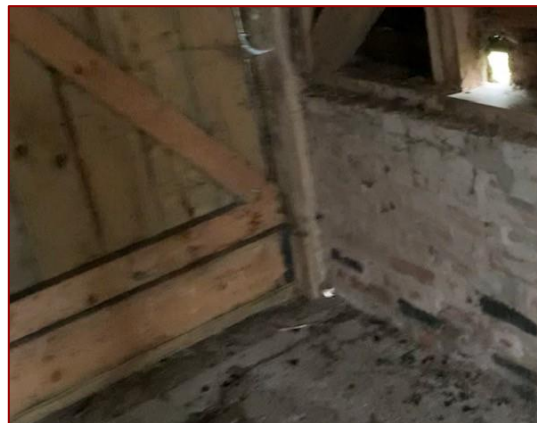
There is a loss of junction between the studs and the sole plate where the concrete encasement occurs. The framework is built off a masonry plinth which has displaced laterally and rotated. It has been rendered on the internal face with a cement-based render. This has resulted in deterioration of the brickwork below. There is cracking in the render indicative of further lateral movement, the suitability of the plinth for retention in the scheme is subject to removing the render and assessing the condition of the underlying brickwork.

Photo 30: Northern porch plinth

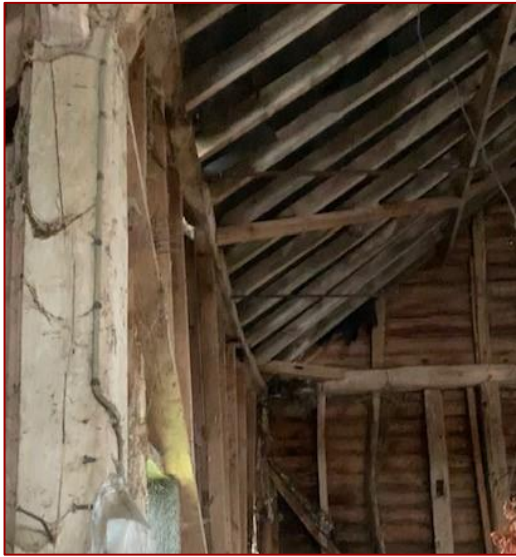
At first floor level at the western end of the north elevation the eaves level wall plate is displaying significant lateral displacement and additional steel tie rods have been introduced to prevent further lateral movement and deterioration of the frame. The remaining studs appear to be in reasonable condition and with formalisation of the lateral ties the framing can be retained as part of a proposed conversion. There has been water ingress in both corners at high level which has resulted in deterioration of the integral diagonal brace and some movement in the timber joints. Central to the north elevation is the principal framework to the entrance porch which appears to be in reasonable condition. There are solid timber haunches forming the principal connections. There is some slippage of the joint in the wall plate above the western haunch and this has been repaired in an adhoc fashion with a modern timber coach-screwed to the face of the timberwork. There is displacement of approximately 40mm at this junction.

Photo 31: View along north elevation along principal barn showing lateral displacement

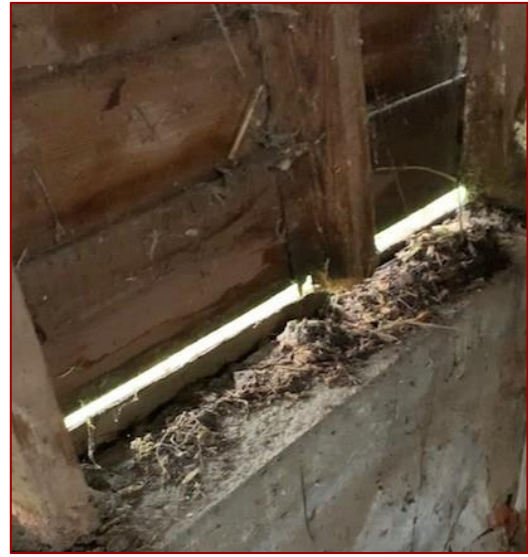
replaced in the past with a central and corner principal post still remaining as original. The sole plate is exposed from the porch to the central timber post and is in an acceptable condition. The sole plate towards the eastern corner has been encased in concrete and the condition is therefore assumed to be poor.

Photo 32: View of concrete encasement to timber wall plate

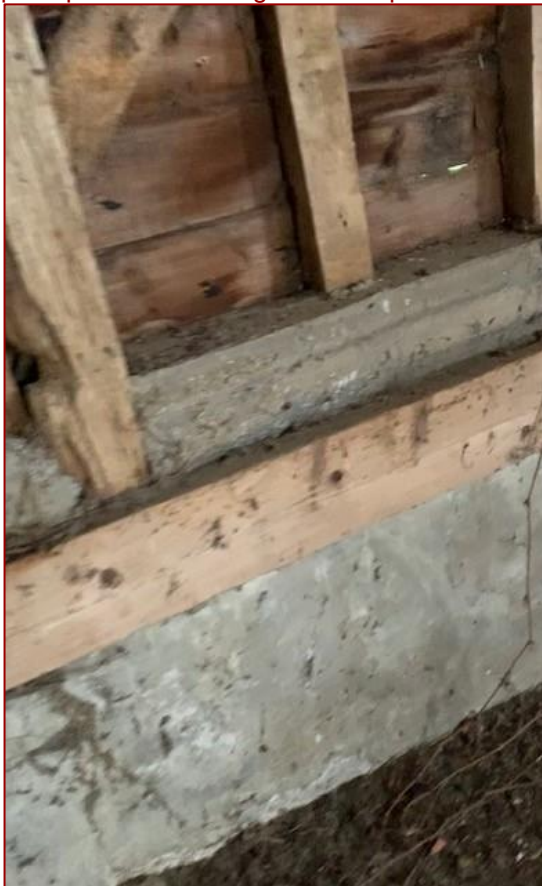
The internal face of the masonry plinth has been rendered in a cement-based render. The render is cracking and there is sign of lateral displacement of the plinth. The render would need to be carefully removed and the plinth repaired. The extent of repairs would be subject to investigation works. It is possible that the deterioration of the brickwork behind the render will be significant and therefore sections of plinth may need to be rebuilt.

Photo 33: View of rendered plinth and concrete encasement to wall plate on east elevation

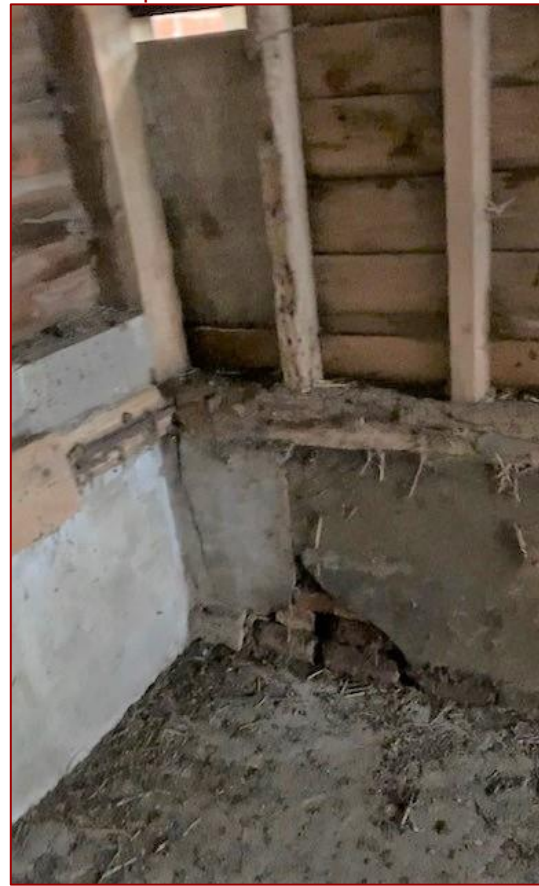
Photo 34: Separation of eastern plinth from southern plinth to main barn

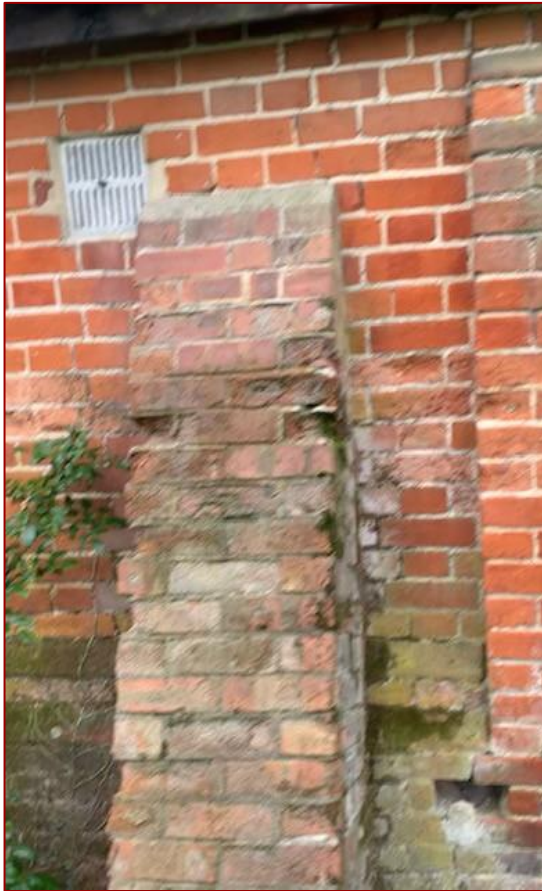
Photo 35: View of buttress to east elevation of east wing.
