**General structural appraisal report on**

Redundant barns  
Treraven  
St Clether  
Launceston  
Cornwall  
PL15 8PX

**Ref: 11018\_TF\_20**

27.08.20

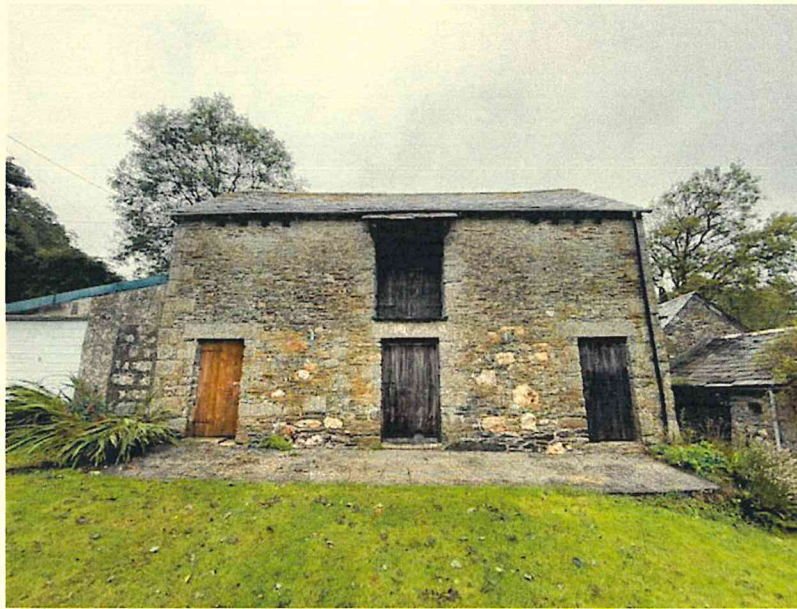
Photograph 1 – Front elevation of barn I

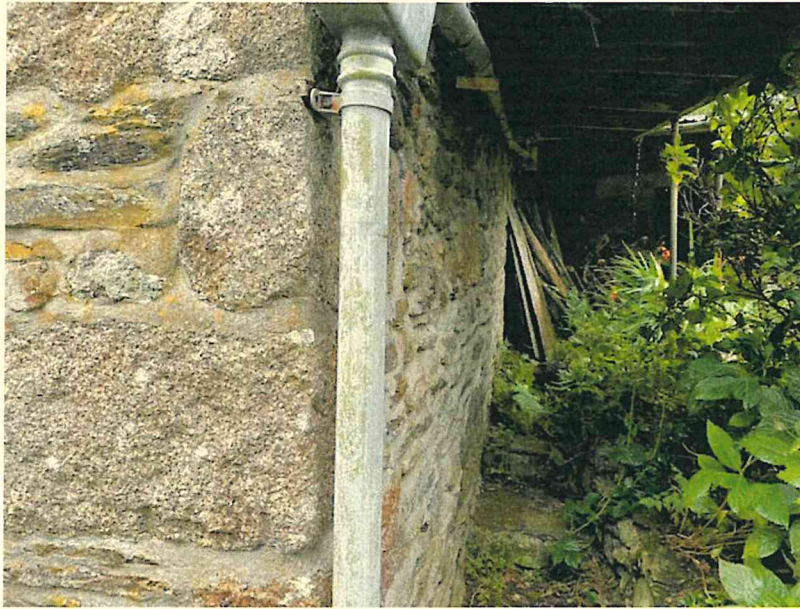
The stone walls throughout are generally straight and true with little sign of significant movement. Some outward bowing of the lower extents of the stone wall at the north end of the rear flank wall was recorded however together with a fine vertically propagating crack on the inner face of the stone.

There is no obvious causation to this movement. Noting the inner face of the wall appears less affected, and that the movement accords with position of a rainwater down pipe, it is possible water has caused the movement. Moisture ingress can result in a 'sumping' of the rubble core and associated lateral pressure on the outer facing stone. Minor settlement in the wall locally due to saturation of the ground below the wall may also be contributing factor.

Photograph 2 – Isolated lateral movement of stonework at rear corner.

The extent of the movement is not considered to be of significant structural concern at present although it should be monitored. Improvements should be made to the flashing where the rear roof abutment meets the stone here. The rainwater goods too should be checked and confirmed as functioning adequately.

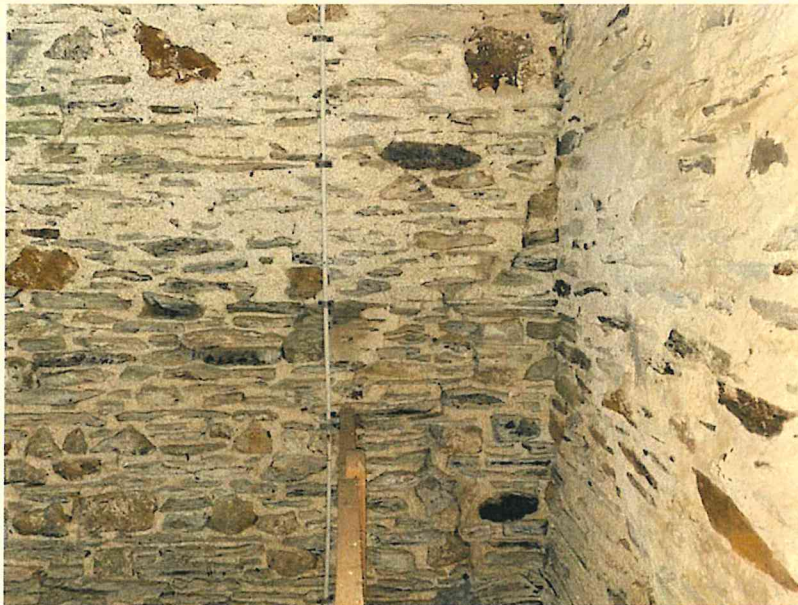
Photograph 3 – Stepped vertical cracking on inside face of wall at rear corner.

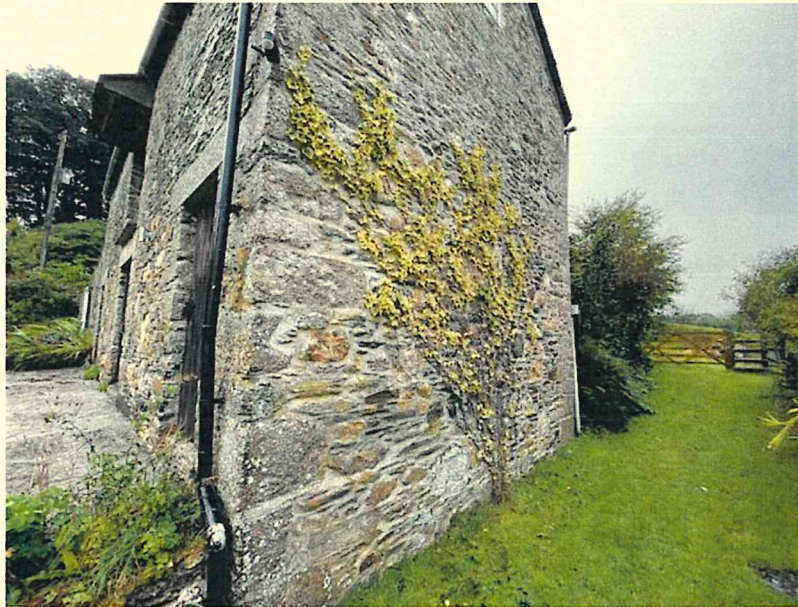
1.2 The pointing to the external envelope consists a mix of original coarse slaked lime mortar and later cement. The cement pointing appears generally restricted to the northern end of the building. Whilst it is generally accepted that cement pointing is not suitable for application on mass stone walls, it would appear to be a relatively recent addition and its current condition appears good. Erosion of the original mortar by the climbing foliage growth on the gable wall may had led to this repointing work. The original lime mortar elsewhere appears to be in generally fair condition.

Photograph 4 – Later cement based pointing and foliage growth again gable.

The climbing foliage on the gable should be cut off at its base and allowed to die back before being removed completely. It is suggested the bedding joints of the stonework are ranged over and, where deemed to be required, racked out and repointed using a suitable natural hydraulic lime (NHL) mortar. Further advice in respect to any repointing work should be sought from a suitably experienced stone mason or lime mortar specialist such as the Cornish Lime Company (01208 79779).

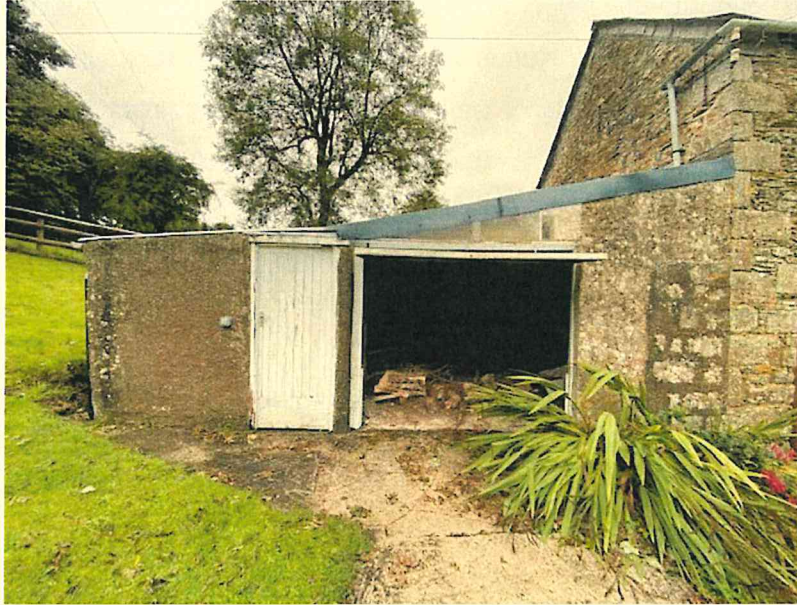
Photograph 5 – Front garage door opening and single door opening into plant room

The block walls were found to be in generally good order with no significant signs of structural movement.

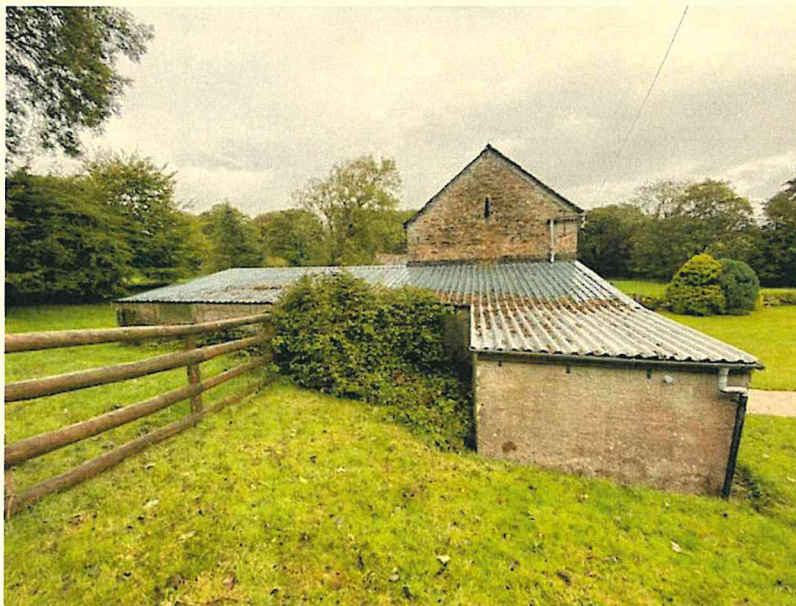
Photograph 6 – Side elevations of later concrete blockwork extensions.

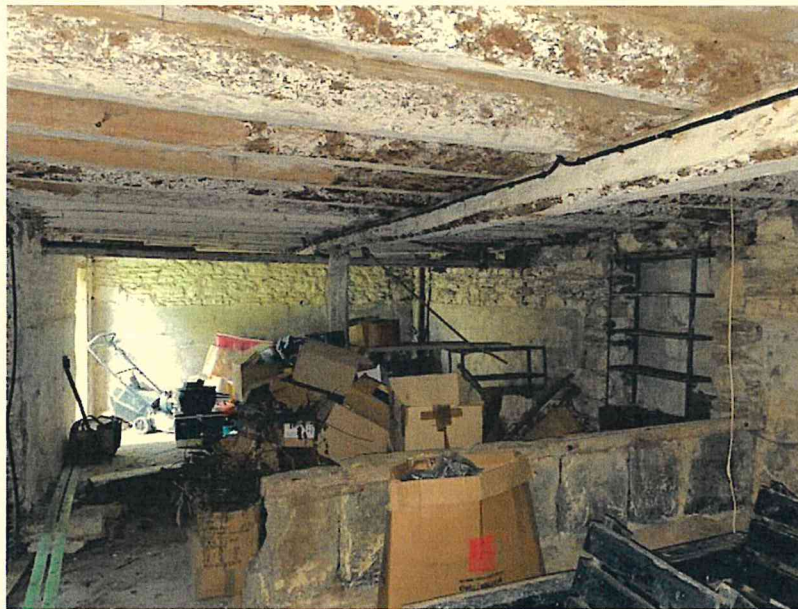
2.1 The floor within the original barn is formed from a series of roughhewn timber joists measuring in the order of 150-170mm by 100mm. The joists are typically spaced at between 450mm and 500mm centres down the length of the building. There is a single lateral beam running below the mid span of the joists. Whilst this timber tapers at its ends it broadly measures 140mm by 100mm in section. It is supported around its midspan on a circa 150mm square timber post. The timber joists are generally in fair condition for their age, however, some significant rot was recorded at their bearings where they extend into the thickness of the supporting walls. This rot is particularly pronounced at the rear western bearings; where some joists have compressed on their lower face and dropped considerably.

Photograph 7 – Timber floor joists to first floor of original barn.

Regardless of their condition it is suggested the existing joists would be undersized if subject to calculation in accordance with typical domestic floor loads. Upon conversion of the barn therefore strengthening will be required. The rotten joist ends will require repairing and an adequate form of intermediate support provided. This could either take the form of new internal load bearing walls, or, a new arrangement of supporting beams and posts. Alternatively consideration could be given to complete replacement of the floor joists. In this scenario it should be possible to design the new joists to span independently between the front and rear flank walls, if desired.

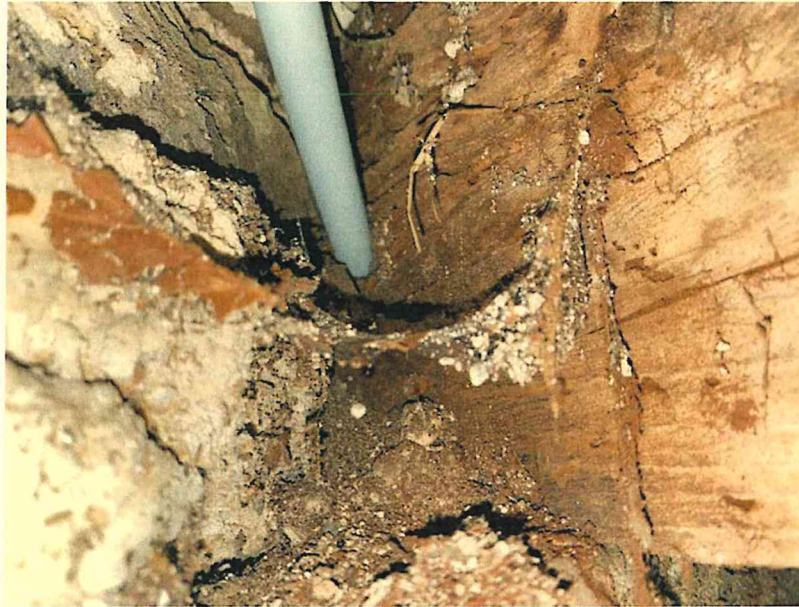
Photograph 8 – Rotten joist end at bearing on rear wall.

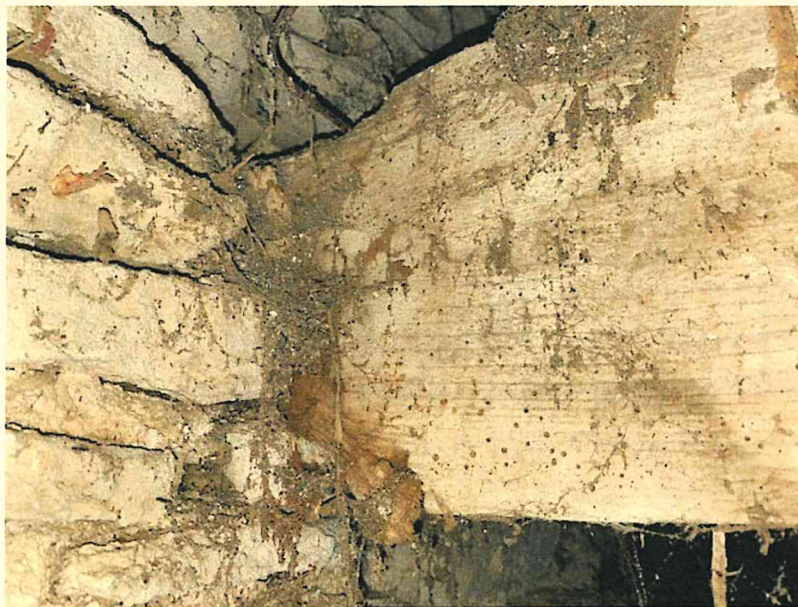
Photograph 9 – Local displacement in joist end at rotten bearing.

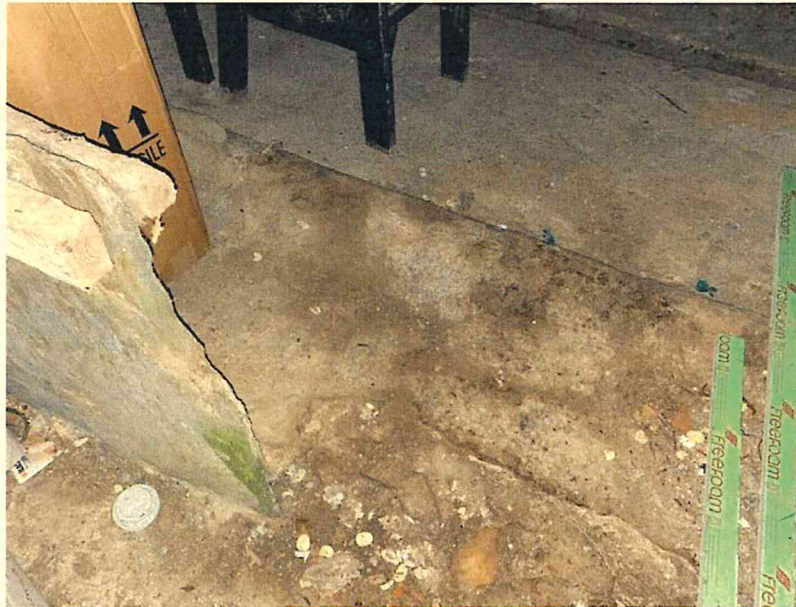
2.2 The ground floors within both the original stone barn and later block extensions are typically cast concrete slabs. The thickness of the slabs and their specification is unknown.

Photograph 10 – Example of ground floor construction..

The ground floor will evidently require relaying as a ground bearing concrete floor slab. Due to the surrounding ground levels, depending on the level of this slab thickenings may be required against the existing stone walls. It should be noted that the extent to which the existing stone walls extend below ground level is unknown. Although it is considered unlikely in this instance, if new floors are required below the level of the existing stonework then underpinning locally may be required.

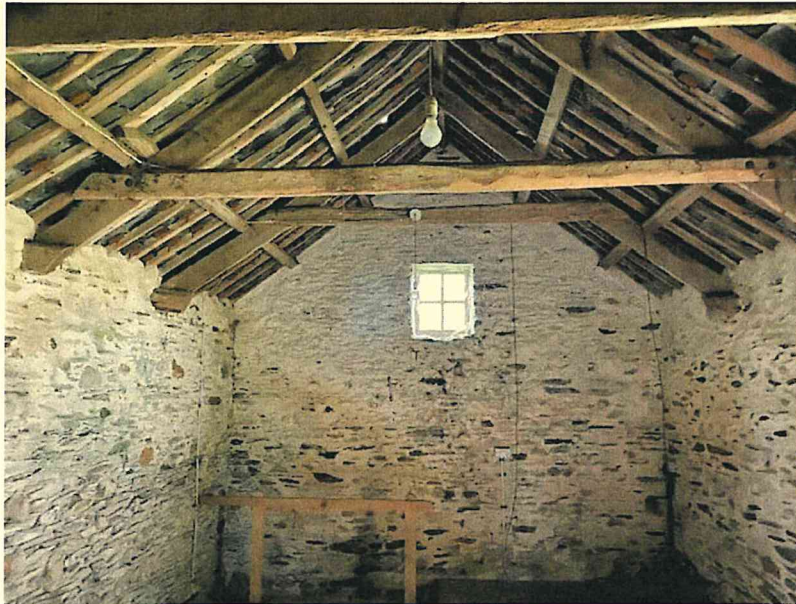
3.1 The roof over the original barn consists of five raised tie 'A' frame trusses, purlins and common rafters. The trusses are formed from approximately 75 x 200mm roughhewn timbers with lateral ties set at circa 700mm above eaves level. It would appear that the ties have been cut and latterly raised from their original position at some point in the past, presumably to improve the clear headroom at this level. The purlins measure some 70 x 100mm and there are two to each pitch and a single ridge member. Rafters span between the purlins and measure in the order of 50/60 x 80mm lain flat and spaced at around 250mm centres throughout. The roof appears largely original. It is clad with slate externally. Whilst some slipped slates are apparent, a large number appear to have been retrospectively secured to the rafters and purlins via glued foam pads.

Photograph 11 – Raised A frame truss and purlin roof structure.

The roof structure is in fair order for its age and is considered to be serviceable at present. Upon conversion it is likely the roof slates will need to be stripped and most, if not all, of the rafters replaced as a result. It should be possible to retain the purlins and principle trusses however; subject to further assessment by calculation in accordance with any new loads placed upon the fabric, such as plasterboard, insulation, services and alike.

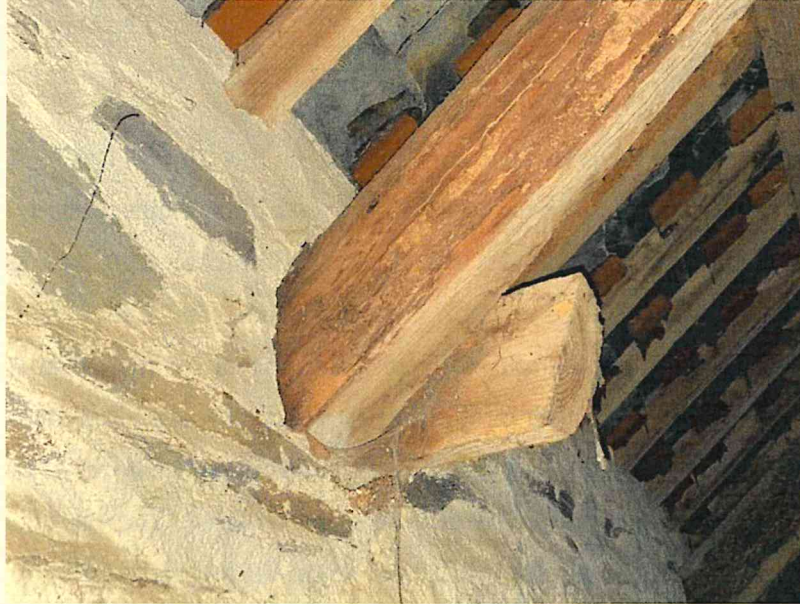
Photograph 12 – Original timber collar tie at eaves level cut off.

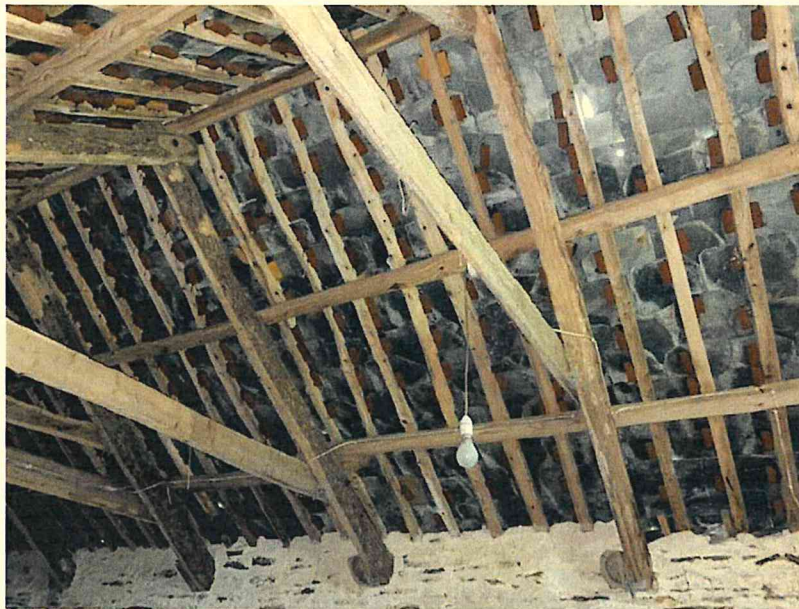
Photograph 13 – Common rafters glued to foam blocks and purlins.

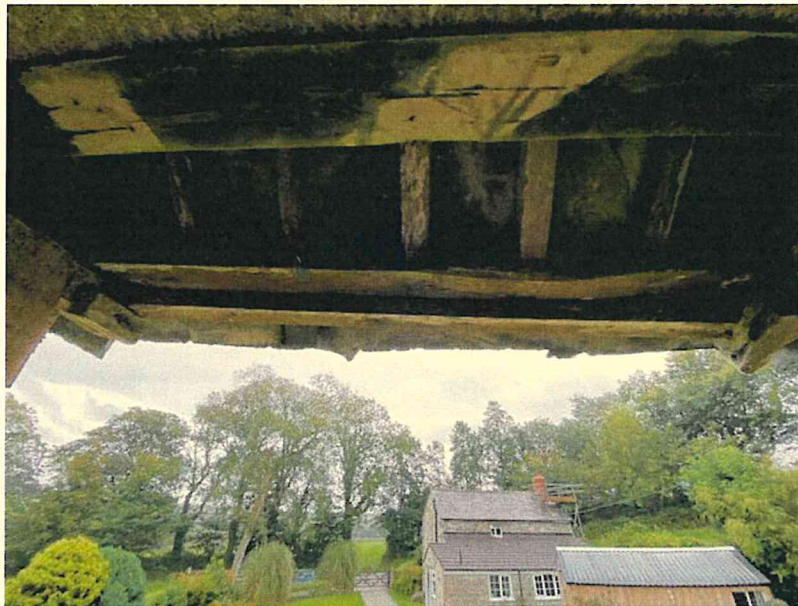
Photograph 14 – Underside of hayloft canopy roof structure.

The front canopy is in fair condition and appears serviceable at present. Some repairs will be required to the timber members but largely it is considered the existing arrangement should be suitable for re slating and retention upon conversion of the building if required.

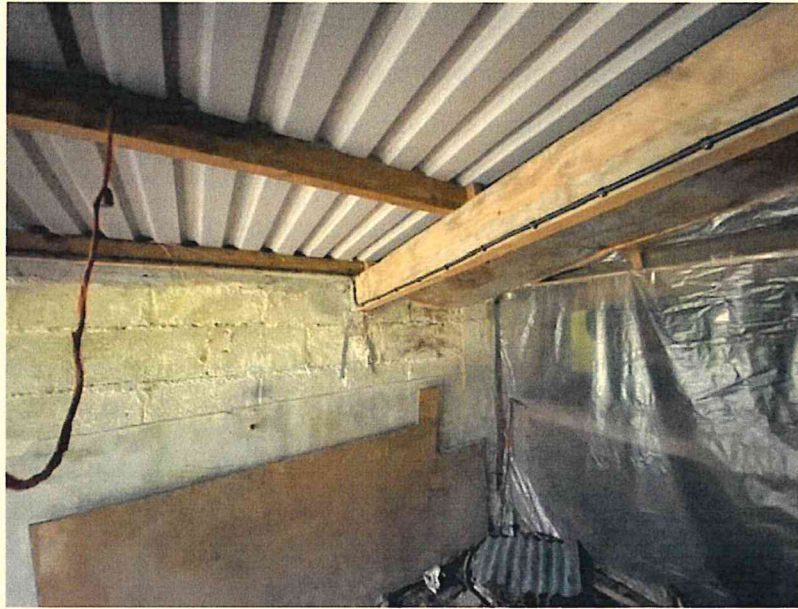
Photograph 15 – Single principal timber rafter supporting corrugated sheet covering in garage.

The roof structures to the garage and plant room appear serviceable at present and free from and significant signs of structural movement. If they are to be subject to additional loads as part of any conversion then formal calculations should be undertaken to prove their capacity. The roof to the open fronted store area is in poor condition. It would be difficult to justify its retention and it is suggested it is replaced as required.

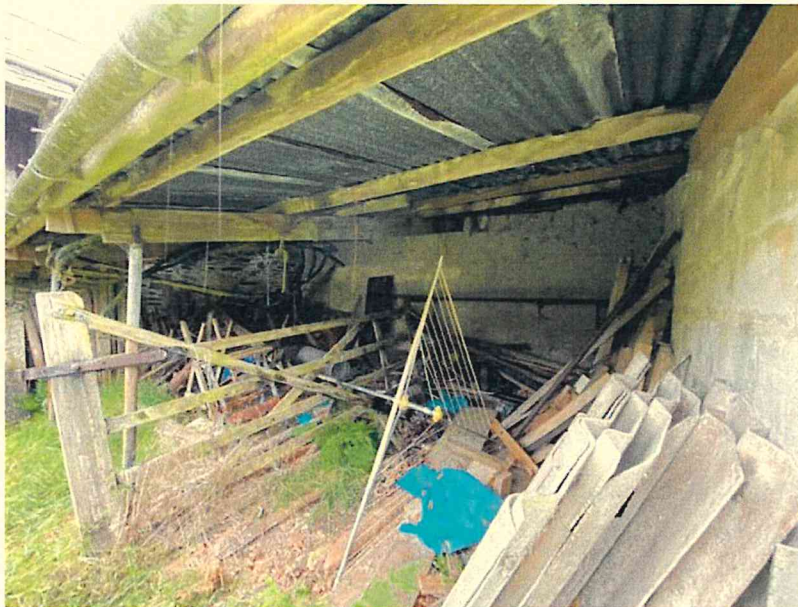
Photograph 16 – Open fronted section of roof structure at rear.

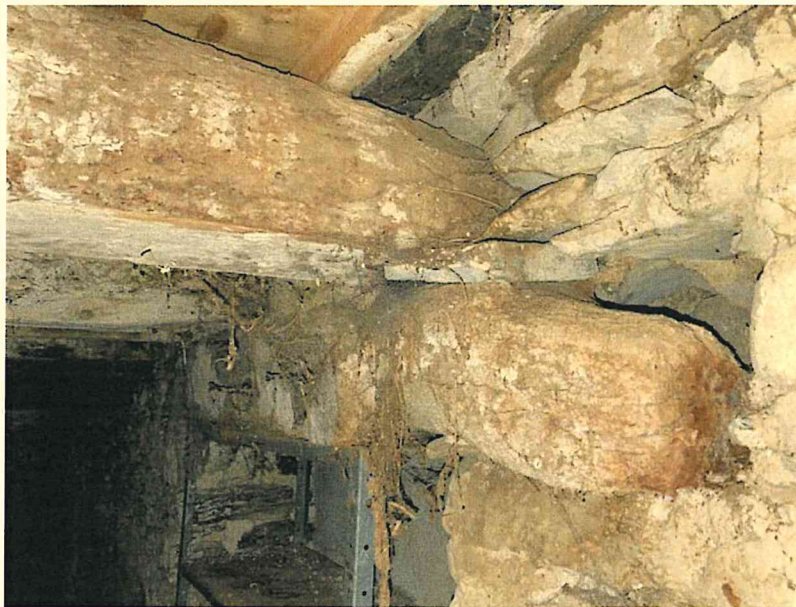
To the rear ground floor elevation there is a single 1.5m wide door opening which has been blocked up in the past with dense concrete blockwork. The inner timber lintel here is suffering from rot and have dropped and rotated at its bearing. This has caused reciprocal movement in the supported floor structure locally.

Photograph 17 – Displacement of lintel over rear ground floor door opening.

The lintels over this opening should be replaced or the opening should be re blocked up across the full width of the original stone wall using dense concrete block tied to the stonework up its height with stainless steel wall starters both sides.

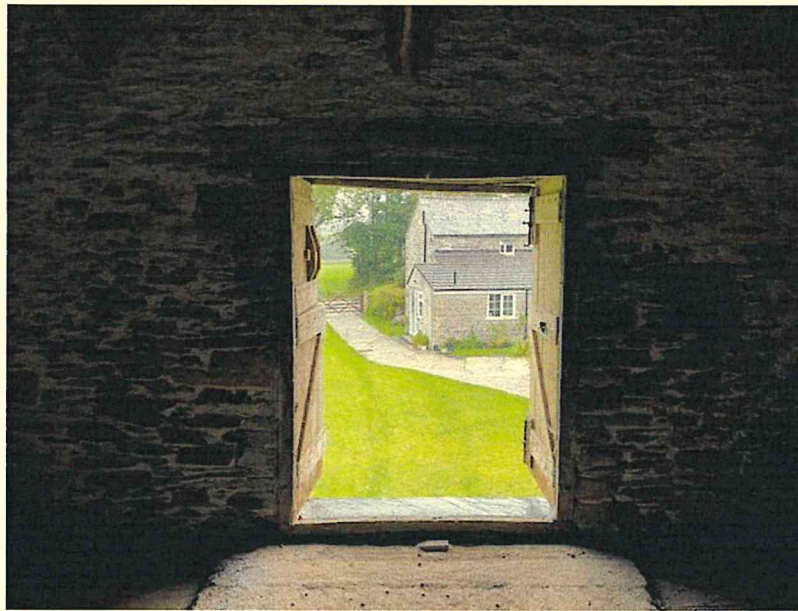
Photograph 18 – View on front hay loft door opening at first floor level with timber lintel over.

These lintels appear to be functioning adequately over these openings at present.

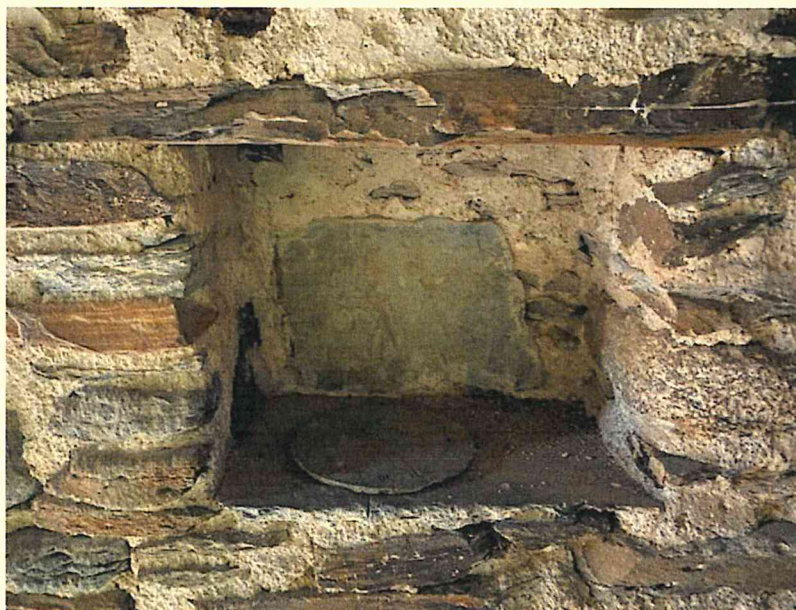
Photograph 19 – Alcove to right side of door opening with stone lintel locally over.

Using stone over openings of such narrow aperture is a traditional detail and each appears to be functioning adequately at present.

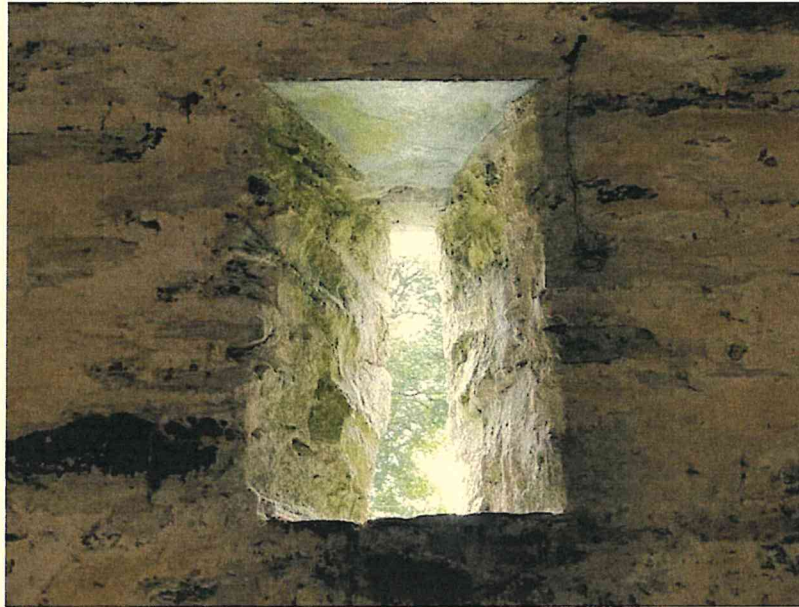
Photograph 20 – Arrow slit window opening at high level on gable with stone lintel over.

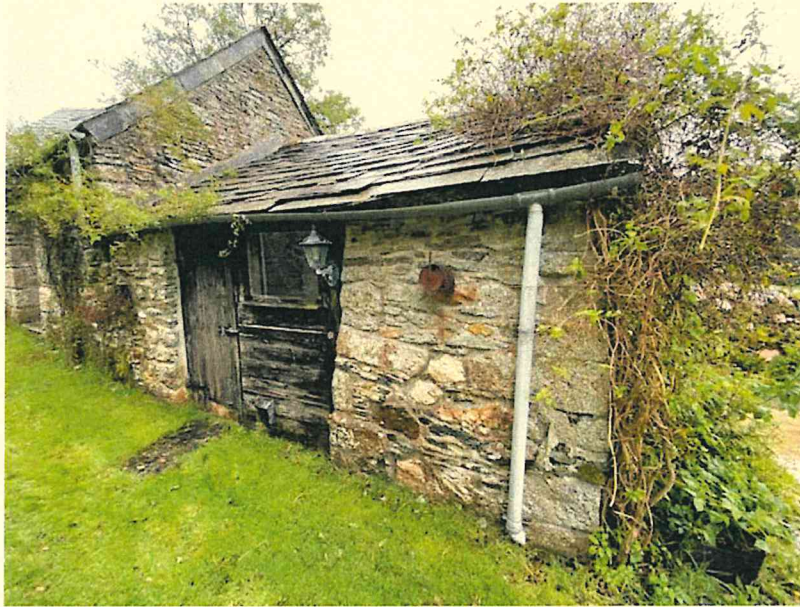
6.1 The original walls to Barn I consist approximately 500mm thick rubble stone. The barn as a whole is split into two parts. The eastern part having a lower roof profile and adjoining the gable of what is likely to be the original extents of the building. The front and rear flank walls to both sections exhibit lateral movement.

Photograph 21 – Front flank wall of eastern section of barn II.

The primary causation behind the movement can almost certainly be associated with defects in the roof structures of the building. Some general patching up and local rebuilding of the stone has been undertaken, much of which using cement mortar. It is suggested further repairs are required to the walls. They should be ranged over and any loose stones replaced or unstable sections rebuilt. The bedding joints too should be raked out where eroded or defective and repointed with a suitable lime mortar.

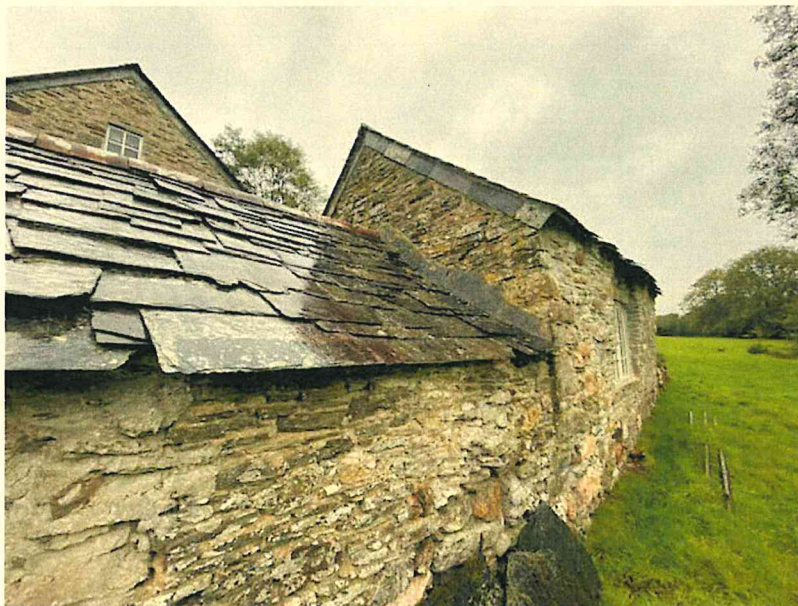
Photograph 22 – Rear flank wall elevations of barn II.

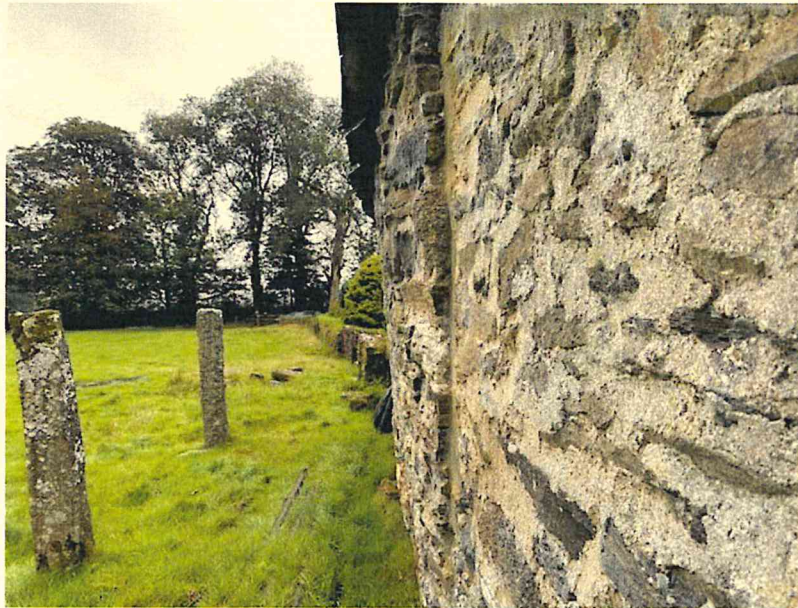
Photograph 23 – Extent of outward displacement on western end rear flank wall.

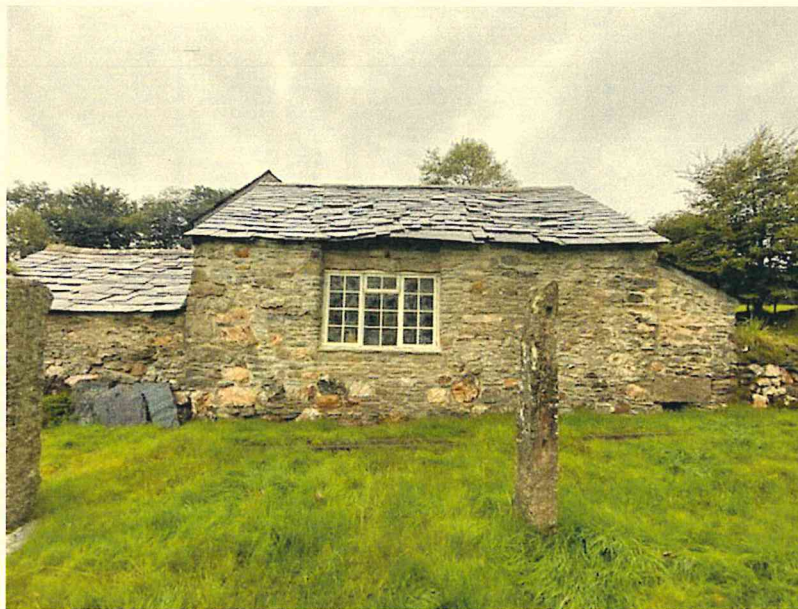
Photograph 24 – Rear elevation at western end of barn.

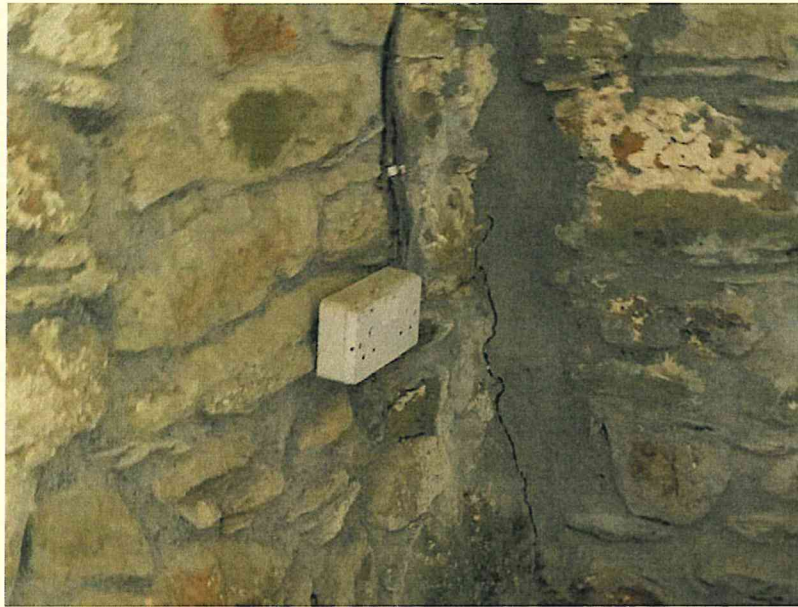
6.2 The outward movement of the walls has caused cracking on the internal face of the stone work and typically at the junctions between the flank and gable wall panels. These cracks have been filled in the past with cement. Some re opening of the cracks has occurred in areas suggesting the movement may be progressive.

Photograph 25 – Internal cracking at flank to gable wall return, filled with cement, reopening.

It is suggested the cracks are stitched and the walls rebounded using a stainless steel helical tie bars or sock anchors. The exact specification of this work is beyond the scope of this report but reference may be made to typical repair details as published by 'Helifix', or similar.

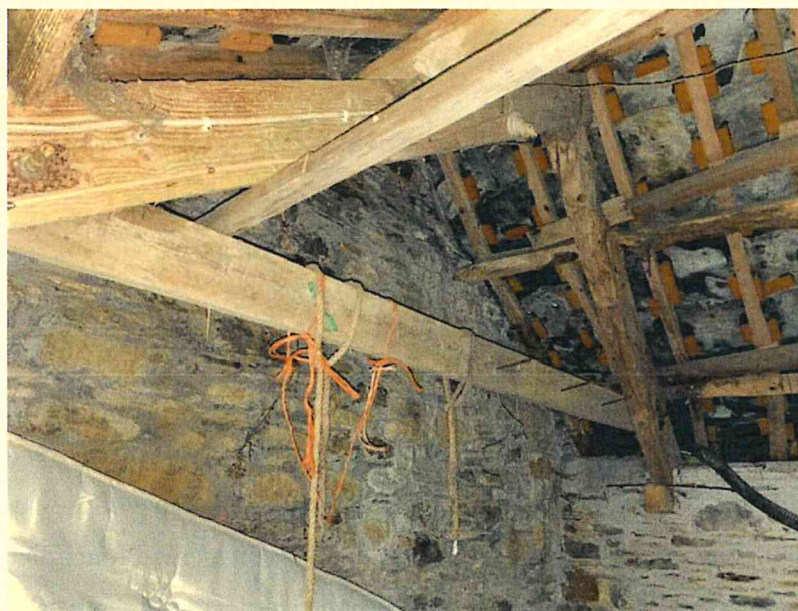
8.1 The roof over the eastern section of the barn is formed from three raised tie 'A' frame trusses, purlins and rafters. It is apparent ties of the trusses have been cut and raised at some point in the past. They are now at circa 300mm above eaves level. The trusses are formed from 75 x 180mm timbers. The purlins are approximately 50 x 100mm with 50mm square common rafters over at 250-400mm centres. The roof supports a cladding of slate externally. The trusses have raked over toward the east gable and there is significant undulation in the roof profile when viewed externally. One of the trusses appears to be a later addition and is set close to the side of the eastern most truss; presumably to provide additional support. These two trusses have had their bearings modified on the southern side with new spliced timbers and galvanized straps. Both are now supported here on light weight timber window framing set adjacent to the entrance door. There is significant water ingress locally.

Photograph 26 - Truss structure to eastern end of barn.

The modifications to the trusses is ad hoc and their bearing on the window framing structurally questionable. It is suggested additional props are provided below the truss bearings and the roof weathered in to prevent further movement, or local collapse. Generally the fabric of the roof here is in poor condition and it is suggested it will require complete replacement upon conversion of the building. Consideration could be given to the use of a ridge beam here to alleviate lateral pressure from the heads of the flanking wall panels.

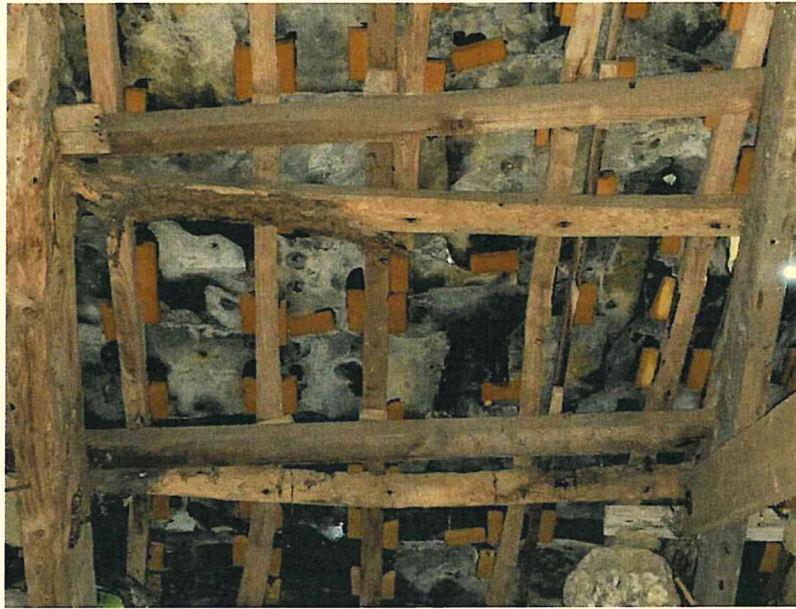
Photograph 27 – Purlins with common rafters and later foam pad fixings.

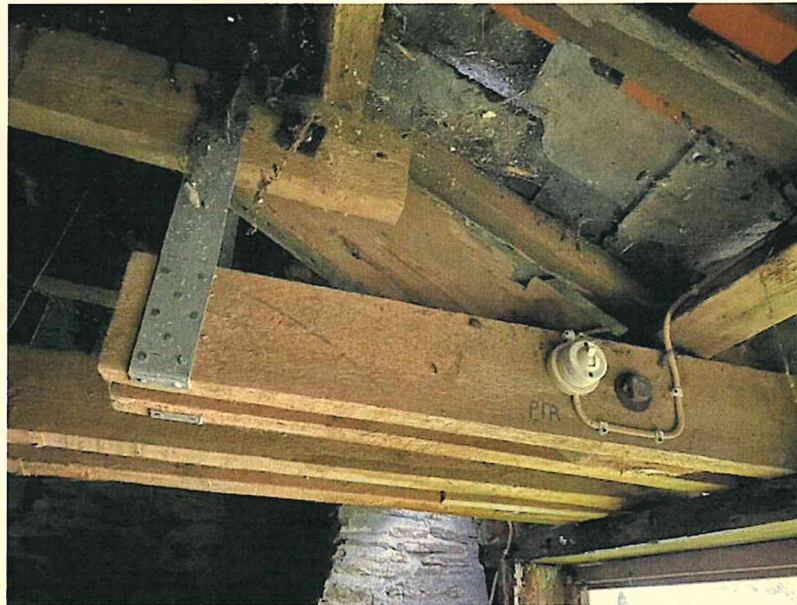
Photograph 28 – Ad hoc timber and bracket repairs to truss bearing on front elevation.

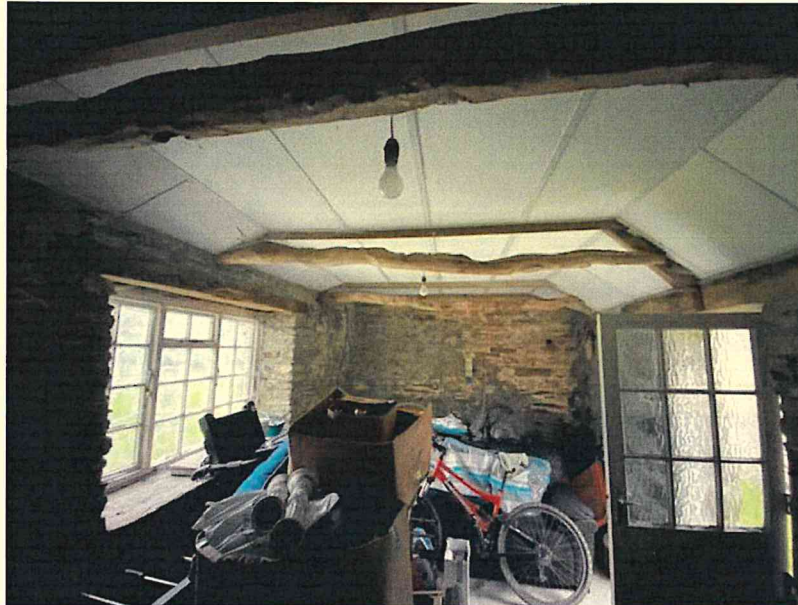
8.2 The roof over the western section of the barn has been partially enclosed by boarding. What appears to be three original timber ties of the trusses are exposed below the boarding level. There are partially exposed planed soft wood timbers above the ties which appear, perhaps, to have been installed to repair the original roof; the extent of this work however could not be confirmed.

Photograph 29 – Internal view on ceiling boarded roof structure to west end of barn.

The boarding enclosing the roof needs to be removed in order to confirm if the existing roof structure is viable for retention. On the basis of the apparent condition of the original ties, and the apparent continuation of movement in the walls, it is suggested likely to the roof will also need complete replacement in this area. Here again consideration could be given to the use of a ridge beam in replacement of the existing to alleviate lateral pressure from the heads of the flanking wall panels.

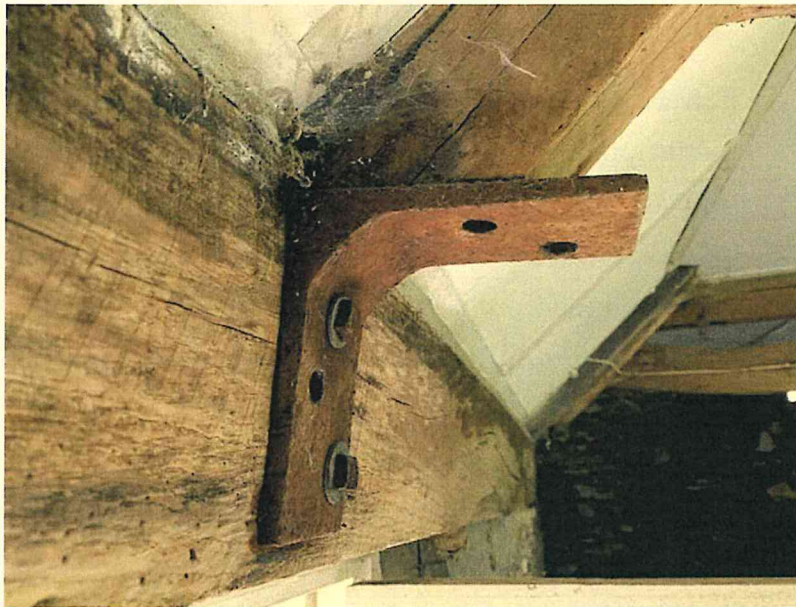
Photograph 30 – Equal angle steel supporting truss blade bearing on timber lintel over entrance door.

The lintels over these openings appear to be functioning adequately at present.
