**PRELIMINARY ENVIRONMENTAL
INTRUSIVE SITE INVESTIGATION
REPORT**

**Former Isolation Hospital and
Council Depot,
Main Road,
Dovercourt**

**REC Report 50398/report 2.1
October 2006**

Prepared for
Tendring District Council
Town Hall
Station Road
Clacton-on-Sea
CO15 1SE

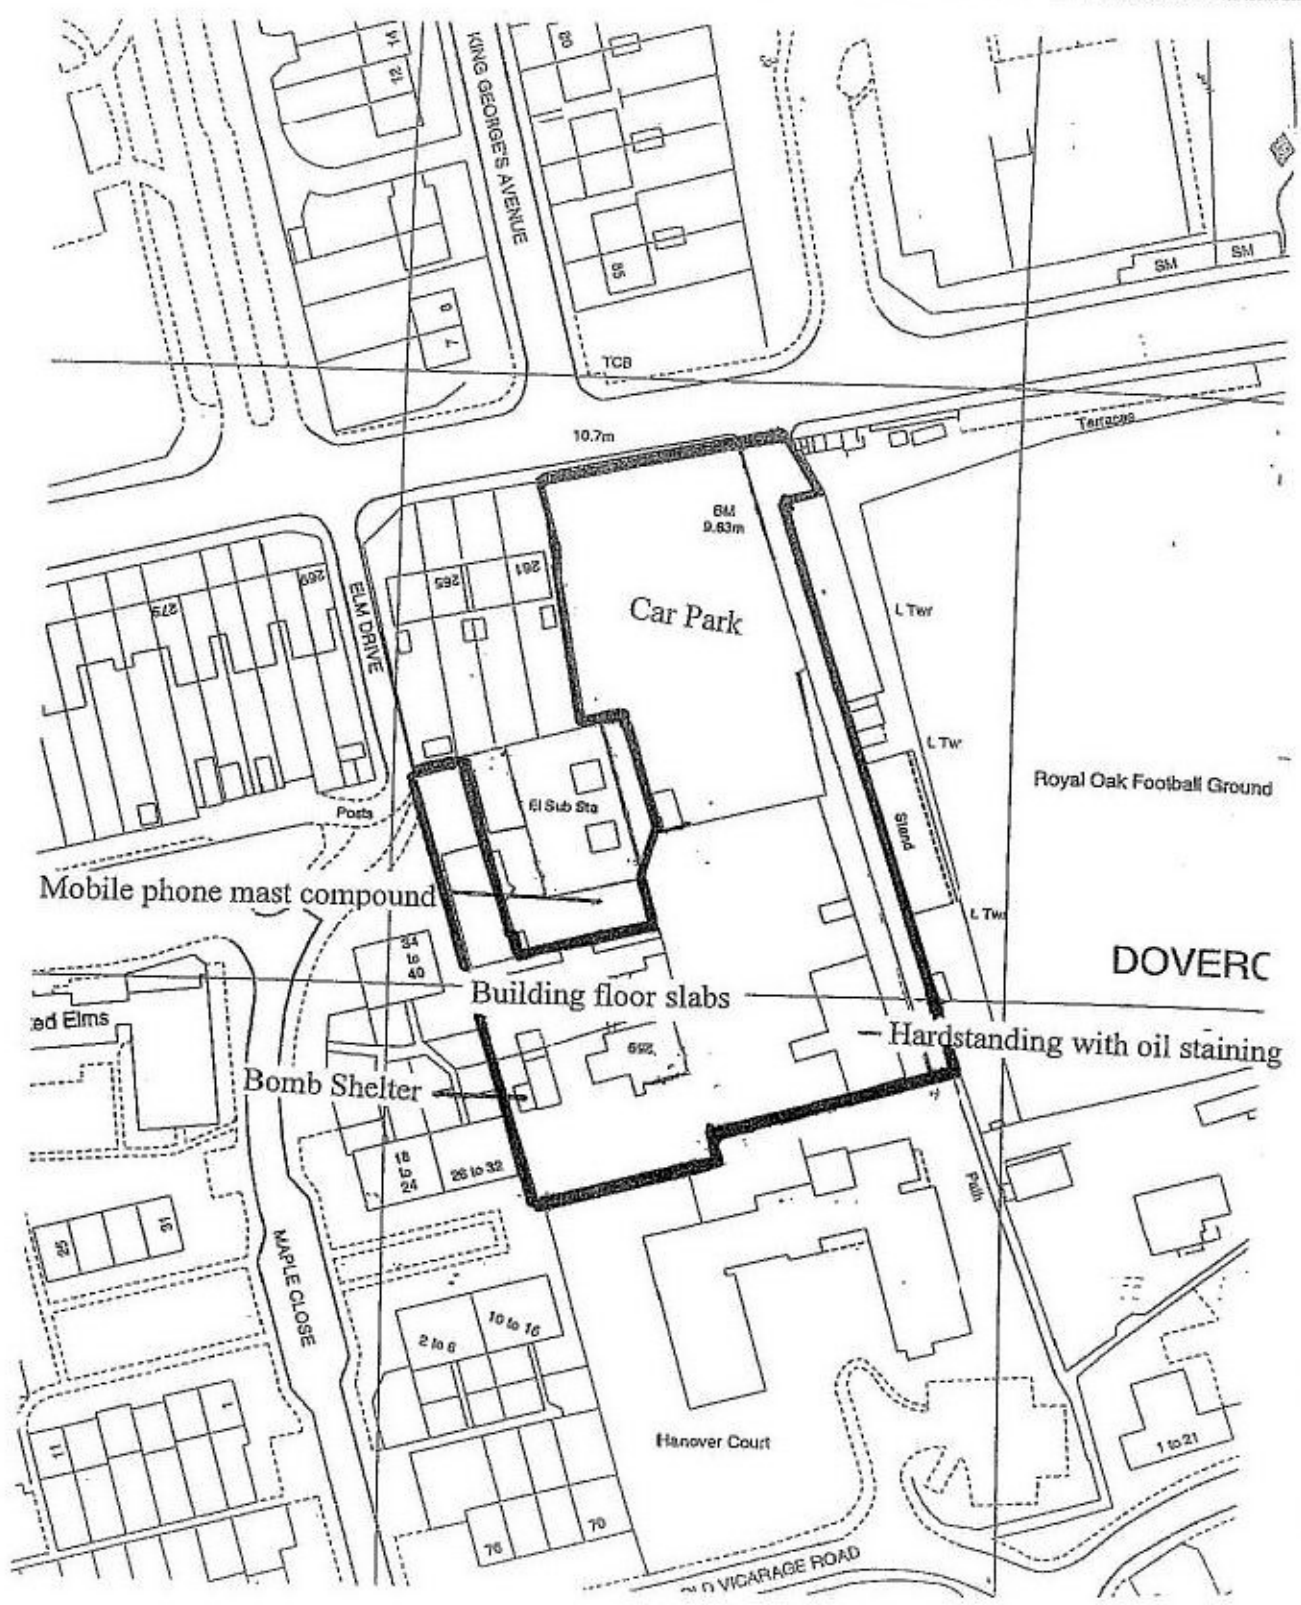
During the site walk-over no above ground or underground storage tanks or chemical storage were identified. No visual or olfactory evidence of contamination was noted during the site walkover, except for the staining of the former floor slab adjacent to the eastern boundary.

The locations of the potential sources of contamination are presented in Figure 2.

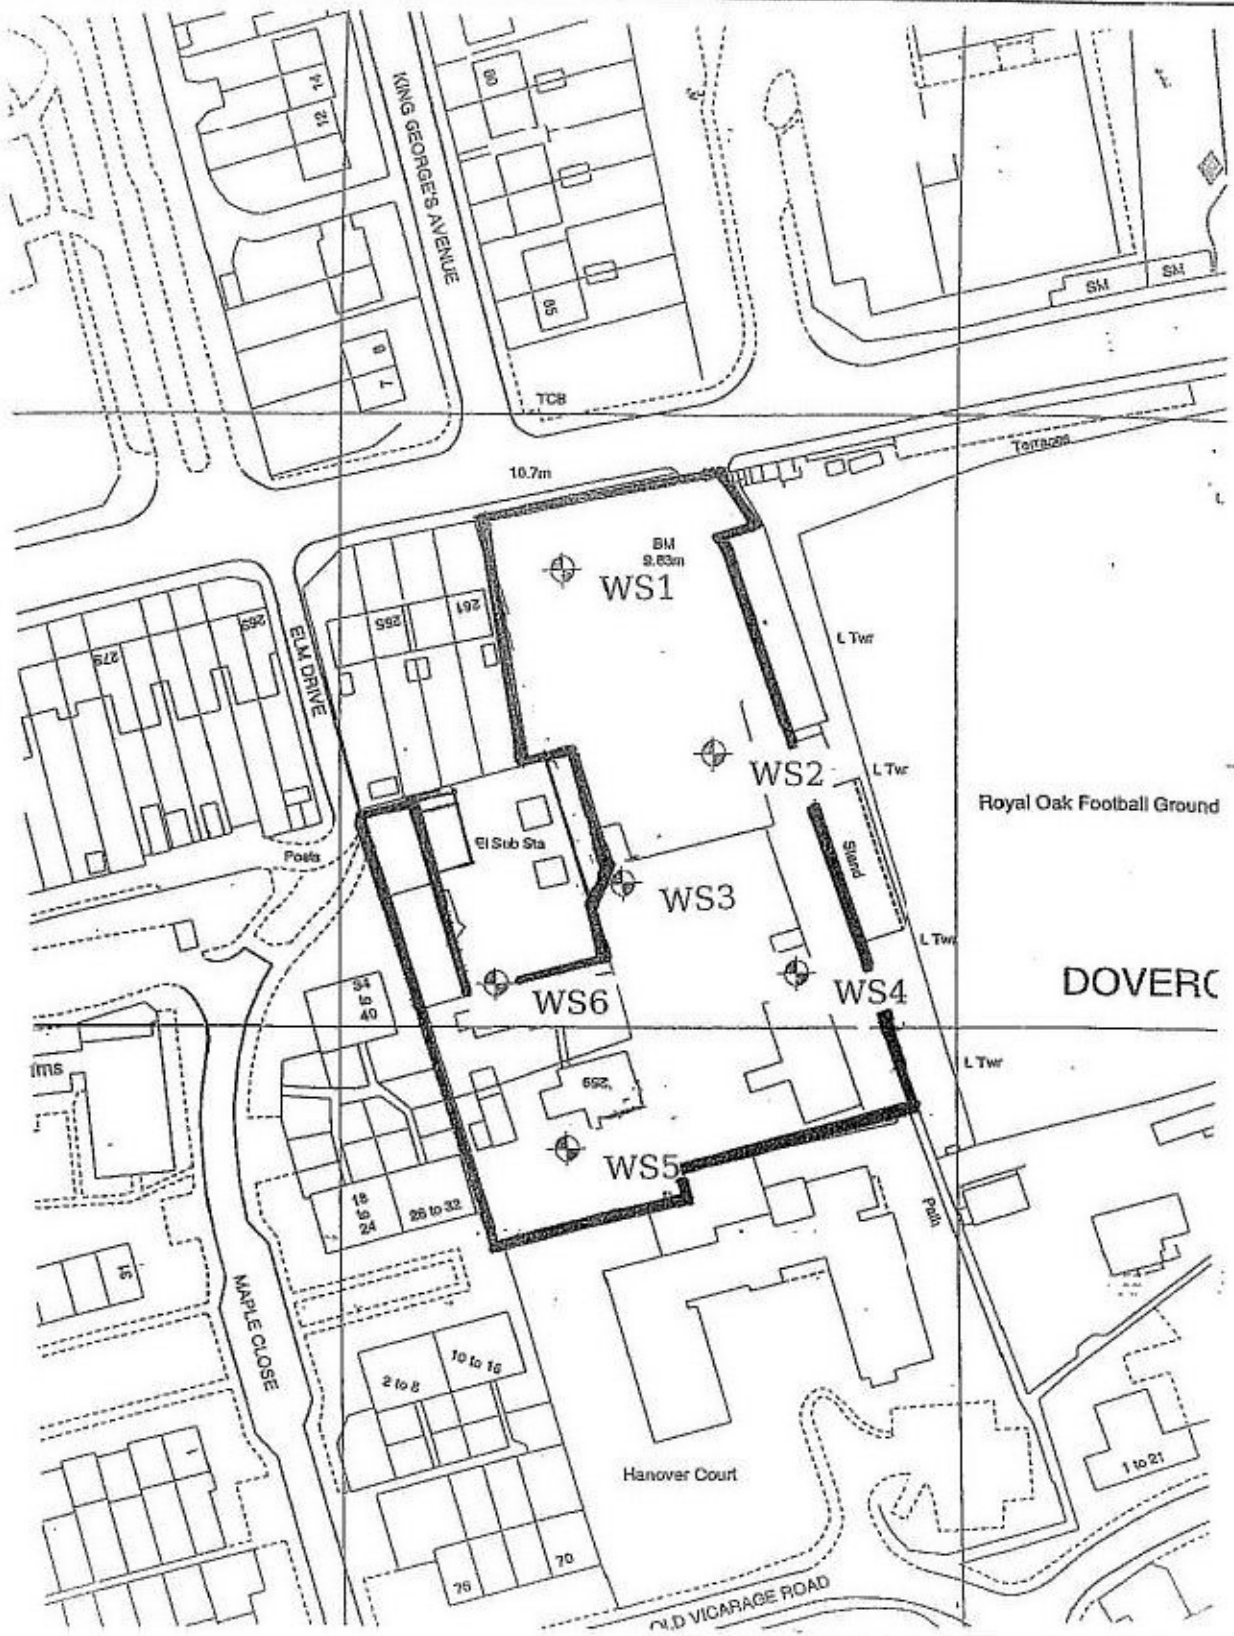
Six intrusive holes were drilled by window sampler on 20th September 2006 to a maximum depth of 3.0m below surface. The sample locations were determined to provide a general assessment of the ground quality beneath the site and the following potential source areas. The sampling locations are illustrated in Figure 3.

WS1 and WS2 – Assessment of made ground beneath the car park and disposal of ash from the hospital;

WS3 – Assessment of contamination originating from the transformer station and of made ground;

WS4 – Assessment of contamination originating from the diesel tank;

WS5 and WS6 – Assessment of made ground and historical use of the site.

From the results of the investigation it is recommended that the demolition material identified in WS5, together with any other material identified during the development of the site should be remediated if there area is to form soft landscaping or private gardens. Remediation should consist of the excavation to the base of the demolition material and removal from site. Excavated soils should be disposed of to site licensed to accept this type of material. Other solutions may be the provision of a barrier of clean inert soils to ensure sufficient capping of the material is provided.
