**The Thatched Cottage,
Bradfield,
Essex**

Historic Building Record

May 2021

The Thatched Cottage, Wix Road, Bradfield, Essex

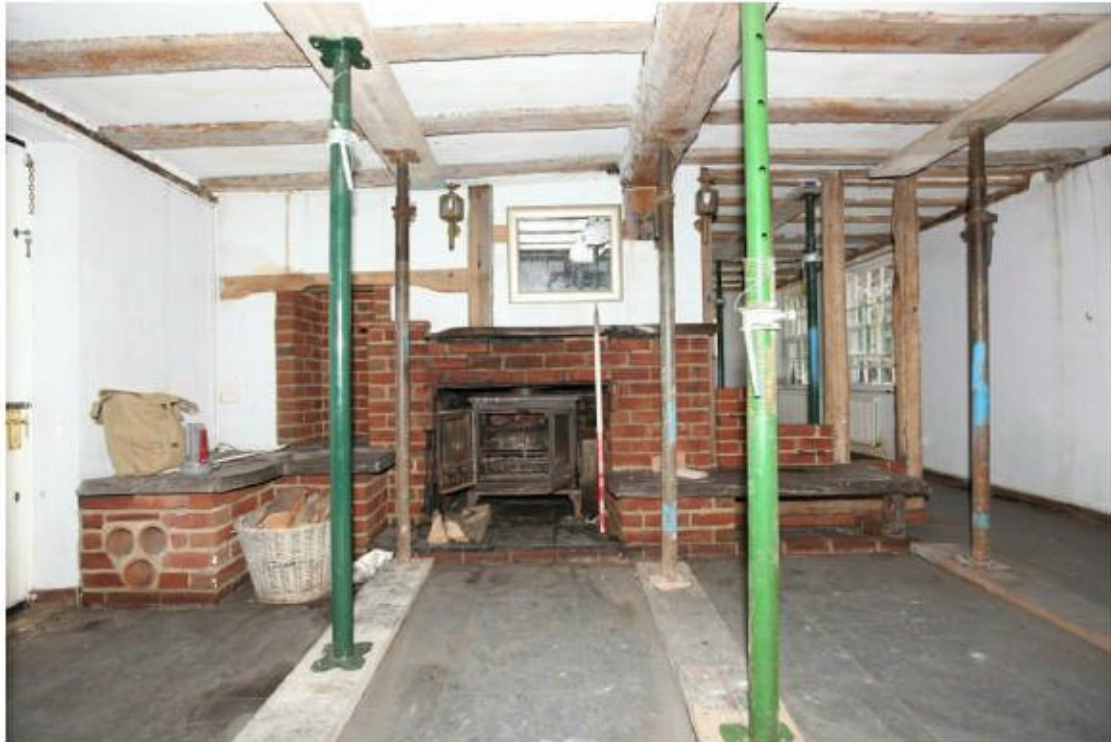
Illus. 7. The south-eastern wall of the central hall showing the 20th century brick fireplace and wood-burning stove in the original chimney with a gap in the later studwork for a connecting door to the parlour on the extreme right. The recess on the left appears to represent part of the original fireplace.

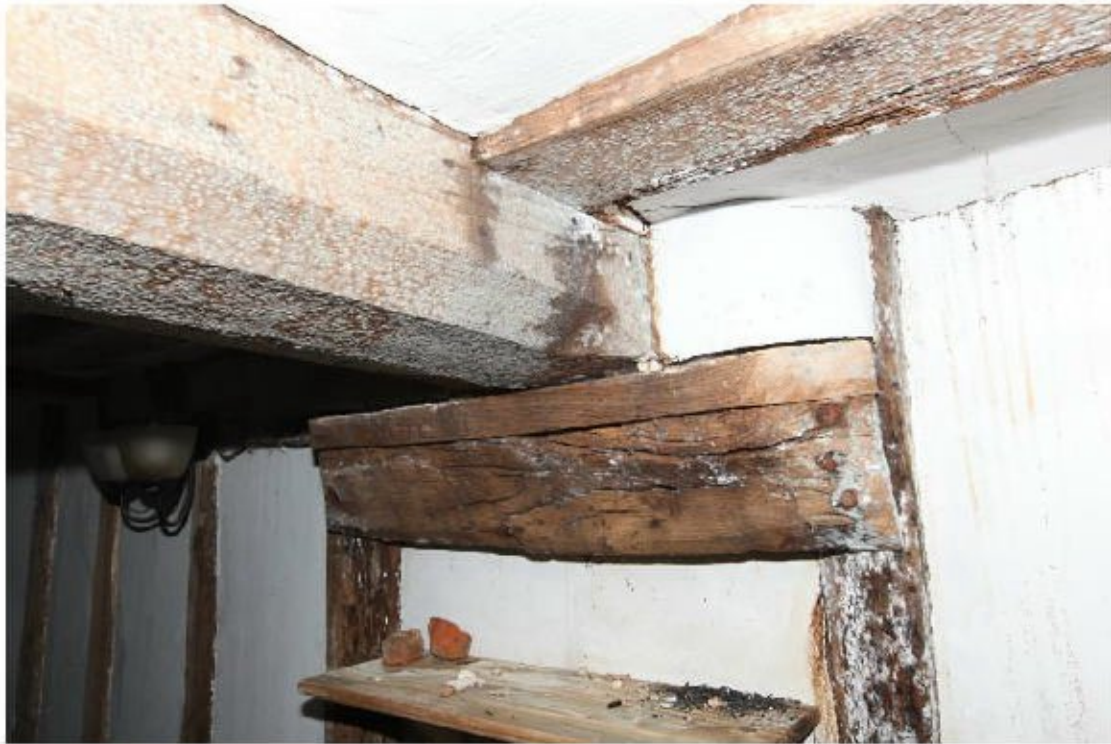
Illus. 11. A detail of the neatly chamfered axial joist of the hall ceiling supported by a short rail nailed to the original central studs of the north-western wall. This method of attachment, coupled with the lack of original first-floor doors to the hall chamber, indicates that the ceiling is a later insertion into an open hall.

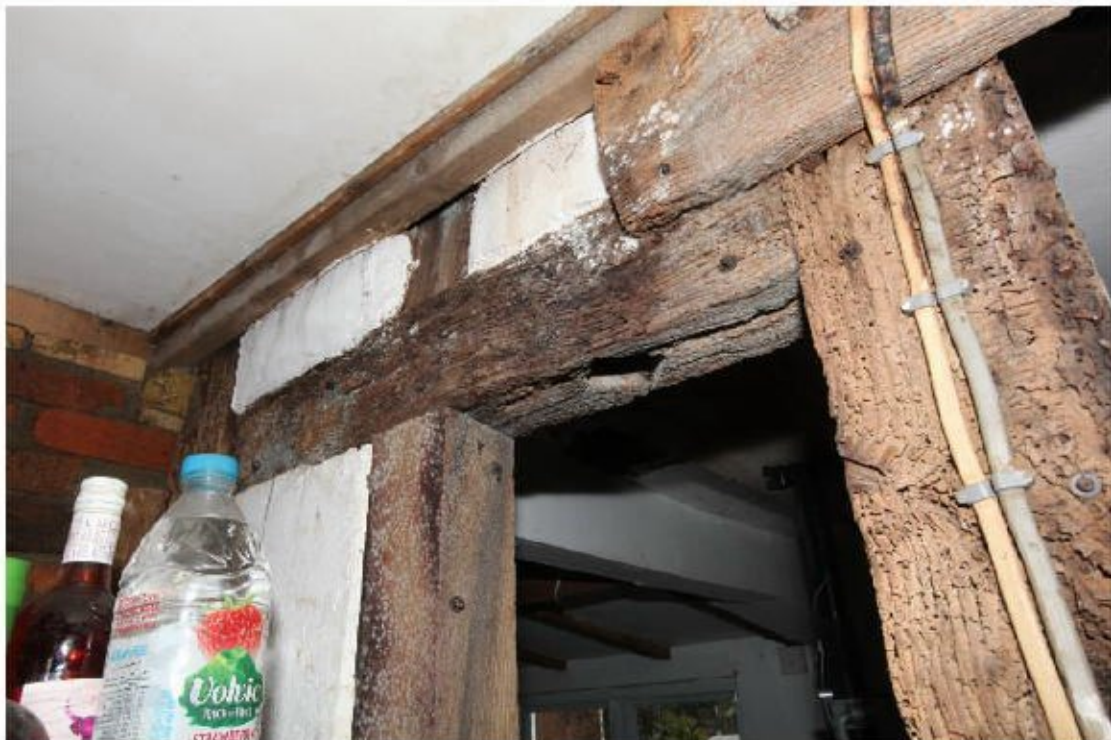
Illus. 20. A detail of the original window lintel in the rear wall of the parlour showing one of three empty mortices for diamond mullions. The nailed stud in the centre is a later insertion that blocks the window. Each mullion was 5.75 cm square (2.25 inches).

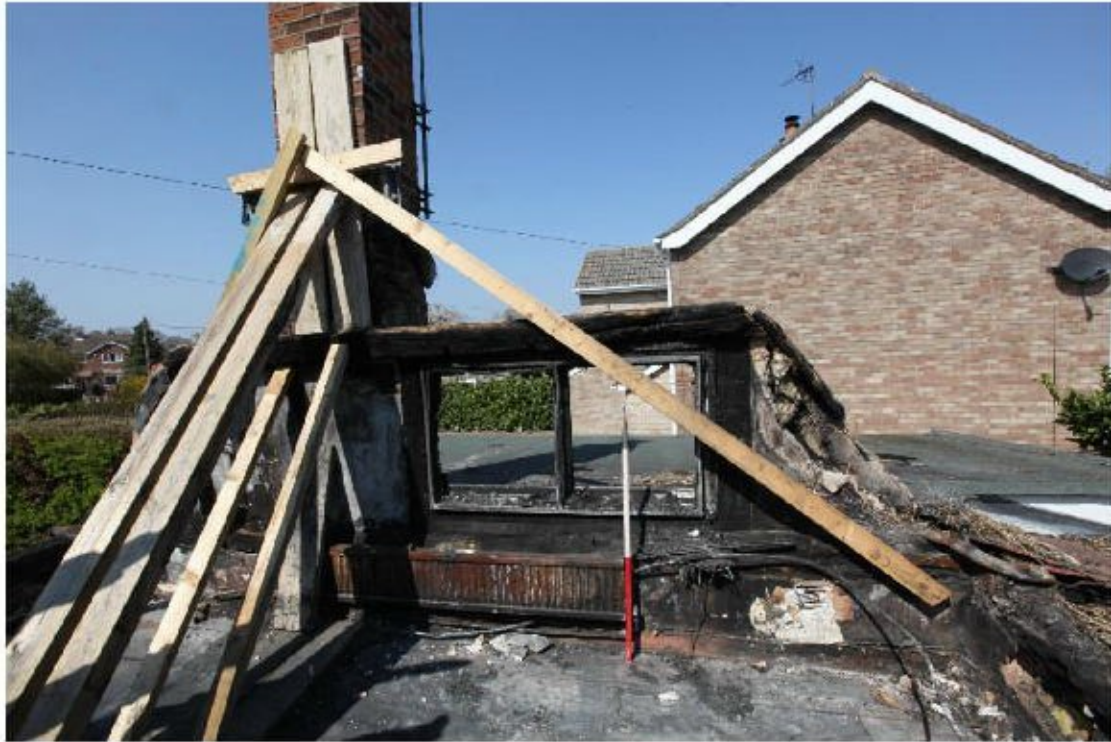
Illus. 23. The half-hipped north-western internal gable with evidence of an original window to the right of its centre in the underside of the upper tie-beam. The principal tie-beam is intact but largely hidden and any original studwork beneath is concealed by modern plasterboard. This gable is reconstructed in figure 16.

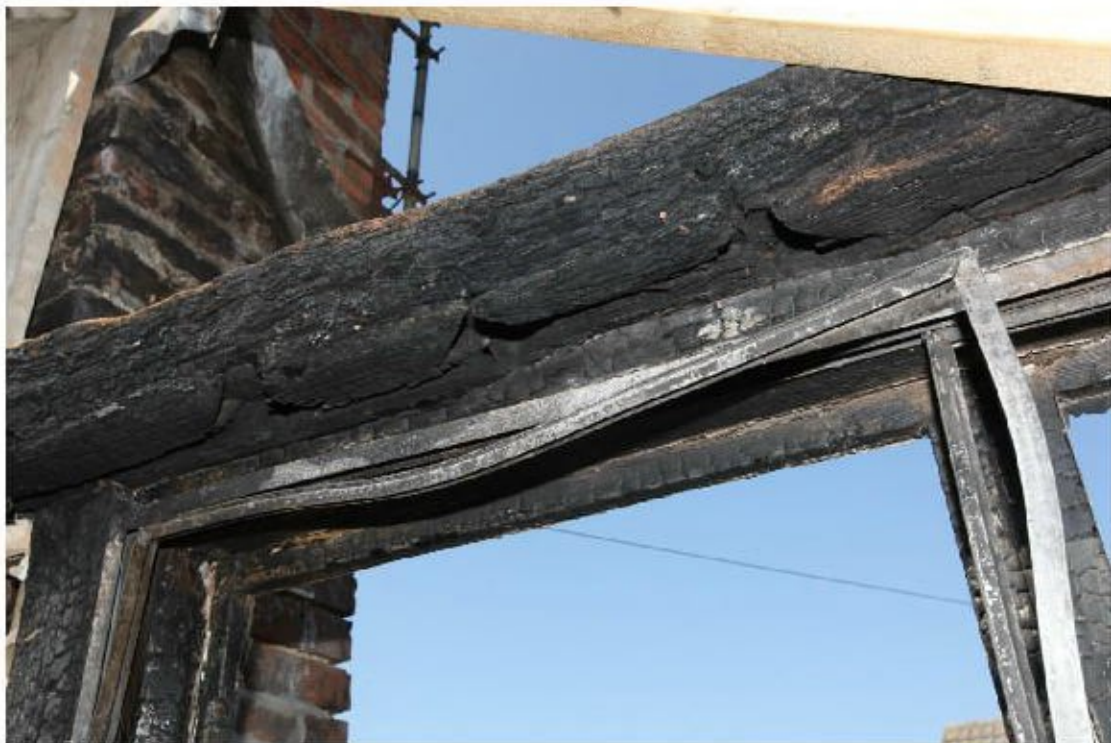
Illus. 24. A detail of the upper tie-beam of the north-western internal gable (illus. 23) showing empty mortices for three diamond window mullions with a groove for an internally sliding shutter.

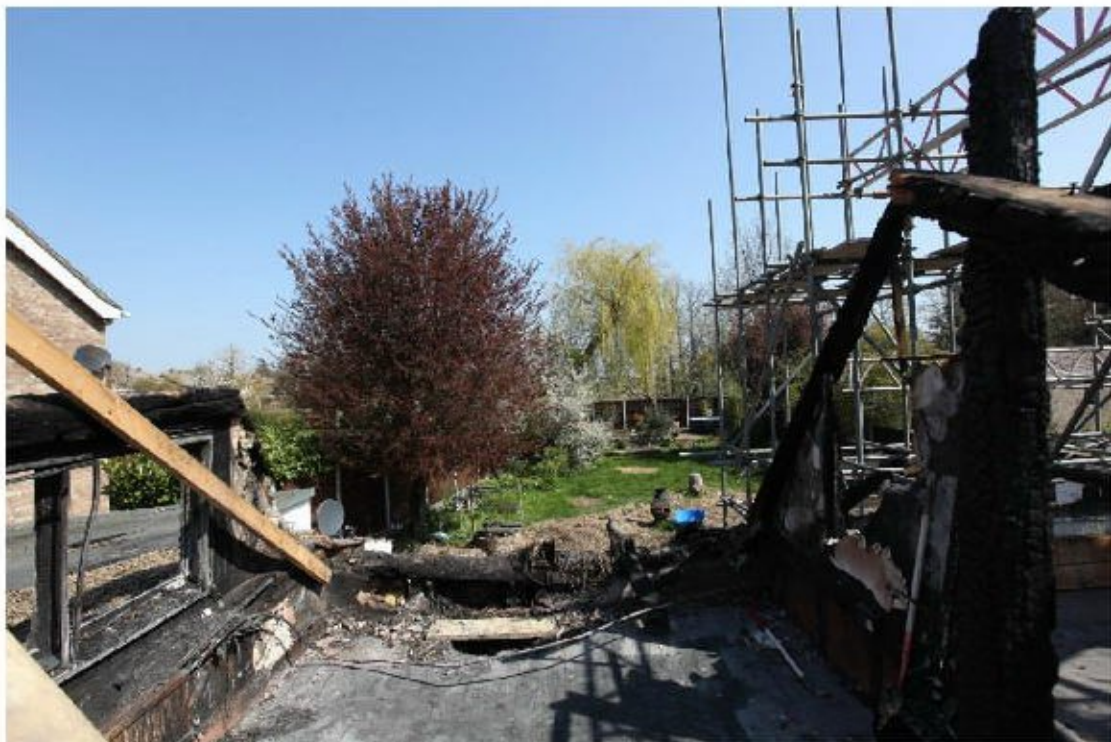
Illus. 26. The north-western chamber from the south-west showing the charred but intact rear roof-plate hidden by plasterboard and modern iron straps.

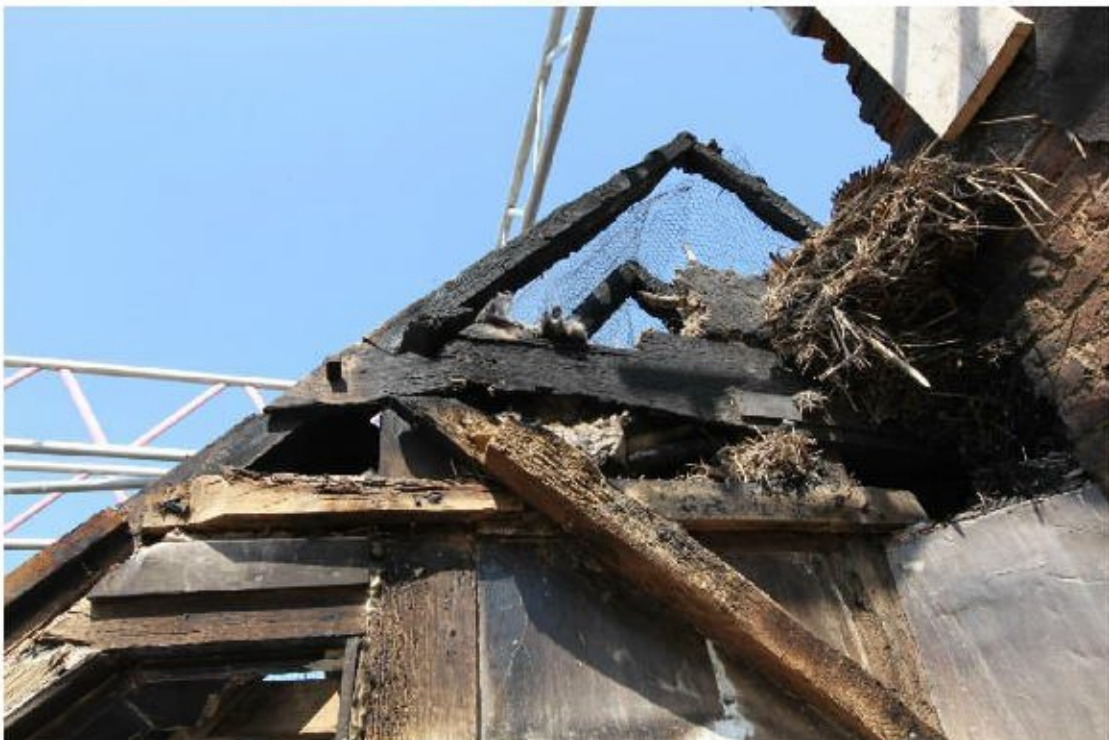
Illus. 32. A detail of the single remaining truss of the probably original clasped-purlin roof structure with pegged collars but no evidence of wind-braces (to the left of the chimney in illustration 31). Despite the lack of wind-braces this roof is consistent with the late-16th century date indicated by the wall framing, particularly as the collar is dovetailed rather than simply lapped. The nailed lower collars held the later ceiling.

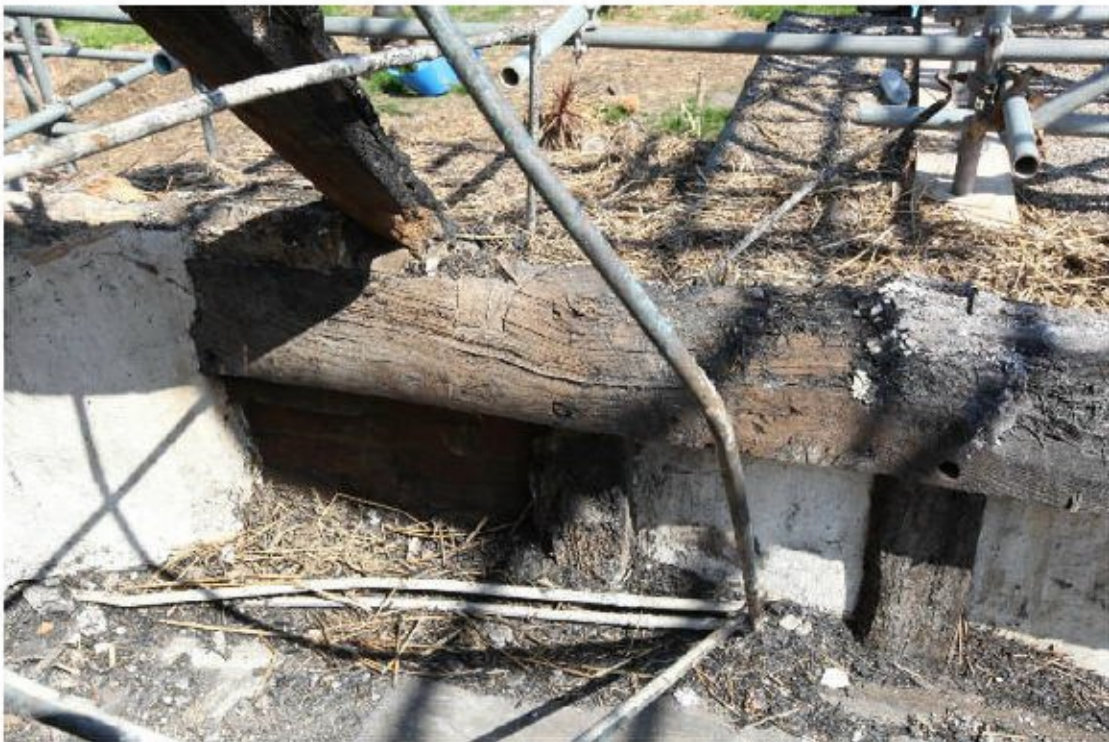
Illus. 36. A detail of the rear roof-plate in the south-eastern chamber showing a plaster-filled original dovetail joint for a missing tie-beam that formed a 1.1 m wide bay for the original chimney and corresponds with another in the front plate.
