STRUCTURAL REPORT

Conversion of redundant farm buildings to form a single dwelling

Field House Farm

30 April 2021

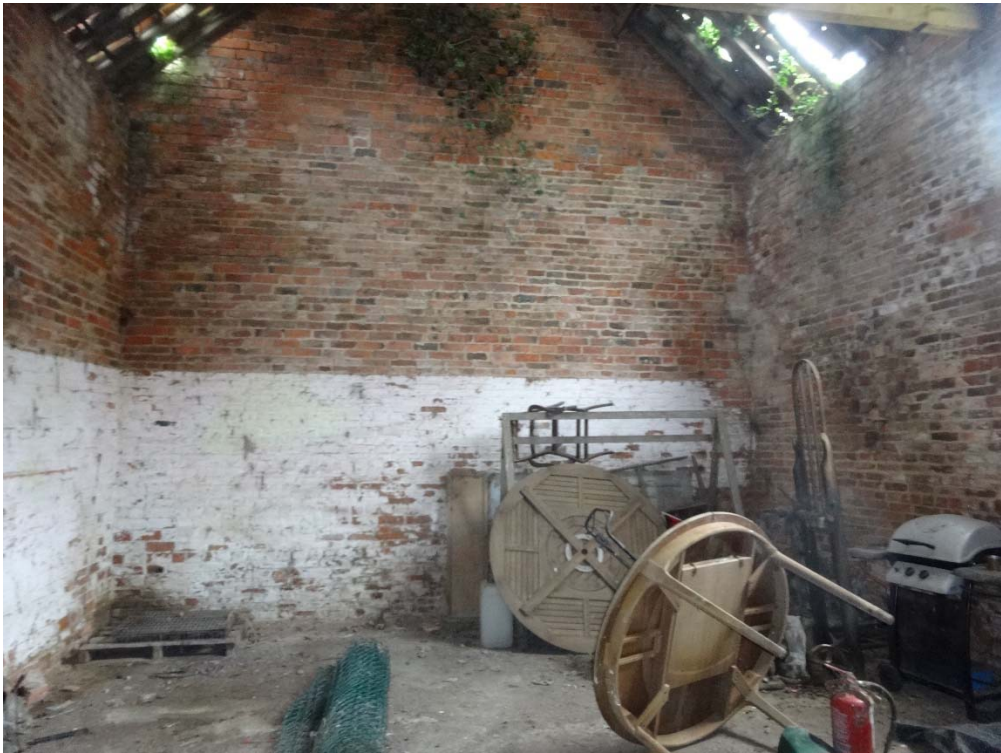
Internally the wall is well mortared and pointed and shows no signs of structural damage.

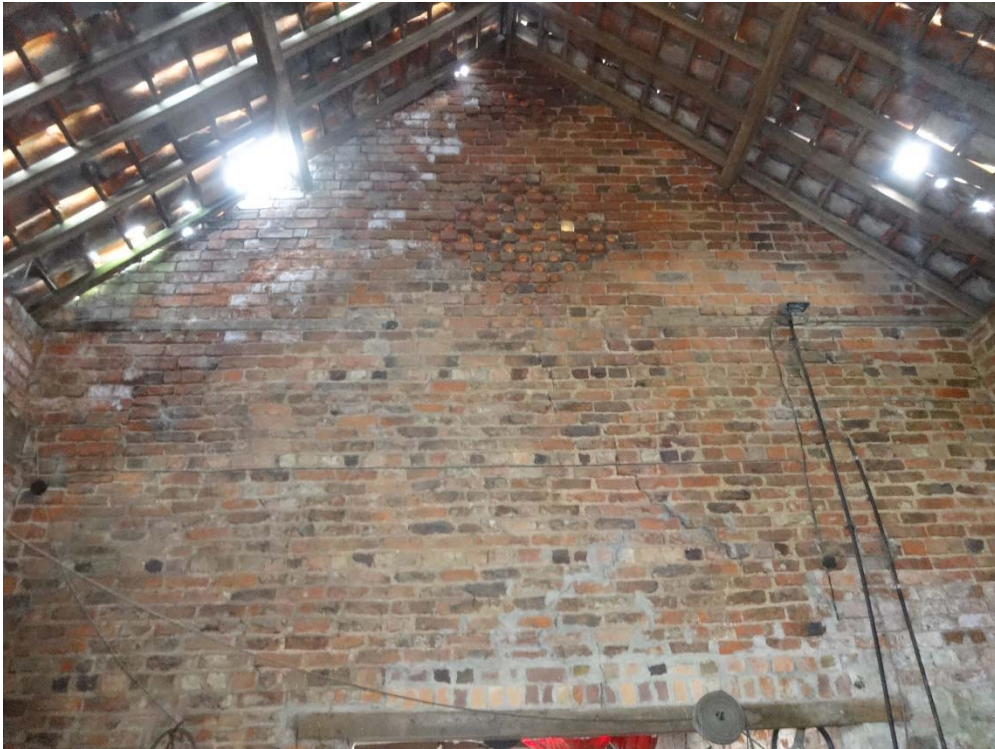
The northerly gable brickwork is shown above internally.

It is evident that the timber lintel over the opening which gives access from the two storey area to the single storey area has over its life deflected. This is shown by the repaired brickwork. There is a subsequent diagonal crack rising from the rise hand side rising up towards the ridge level.

The structural repairs are straight forward, steel lintels should be provided to the inner supporting leaf in place of existing timbers.

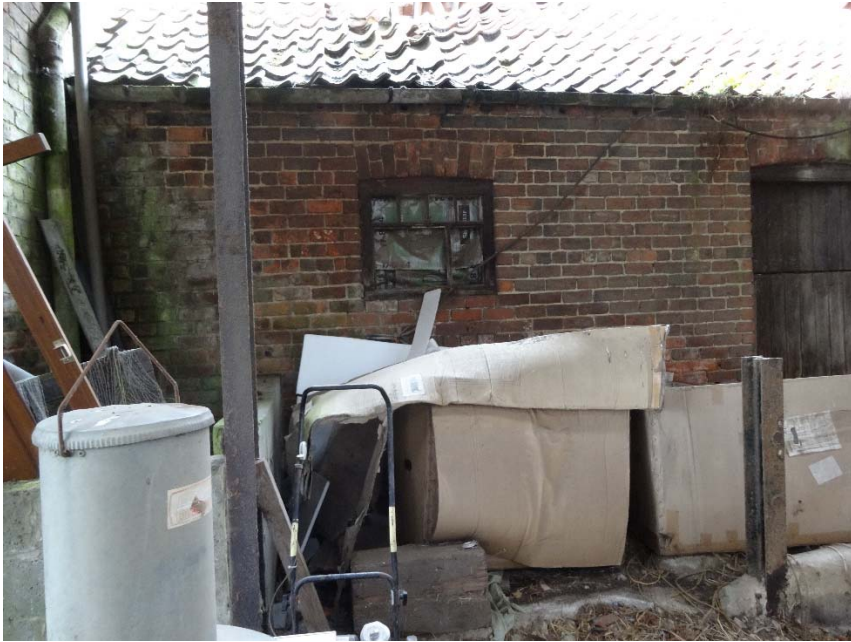
Note the window and door head brick arches all appear to be in good condition with no signs of fracture cracks.

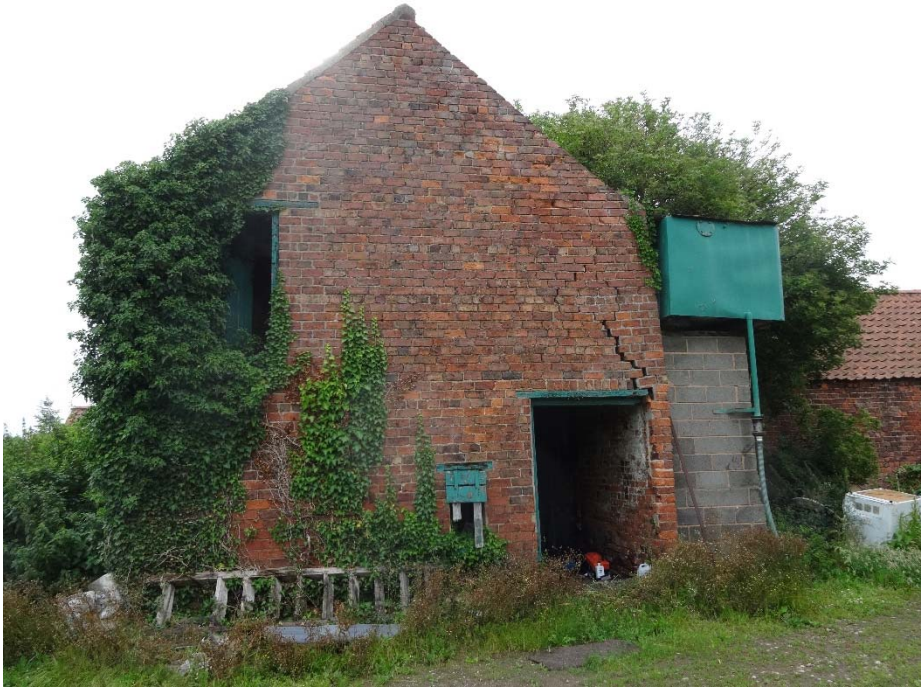
This picture shows the worst crack and piece of structural damage on the whole of the building. It can be quite clearly seen that door has been placed in the corner and hence there is no strength in the wall over the height of the door. That combined with the timber lintel creates a weak form of construction and as a consequence it has failed as would be expected.

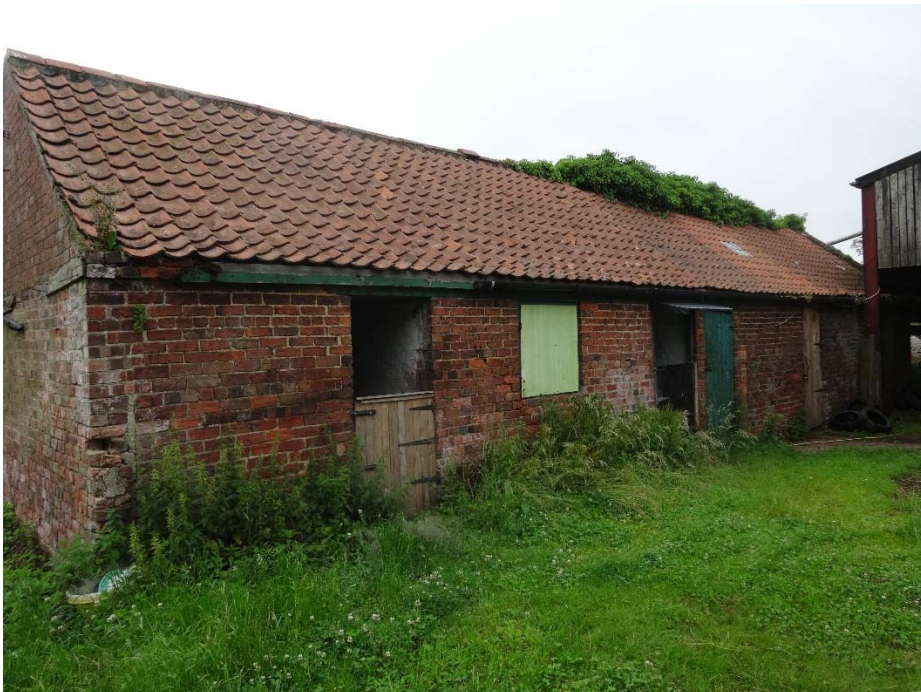
The stable block is in good condition. Note the straightness of the ridge.
