**From:** [Jan Willis](#)  
**To:** [Marc Lee](#)  
**Subject:** RE: Jewson Cringleford Wall  
**Date:** 18 August 2020 18:54:27  
**Attachments:** [image003.png](#)  
[IPW Report on Boundary Wall July 2020 Jewson Cringleton Norwich.pdf](#)

Please find attached marked up photographs explaining the situation at Cringleford along with my opinions on possible courses of action below.

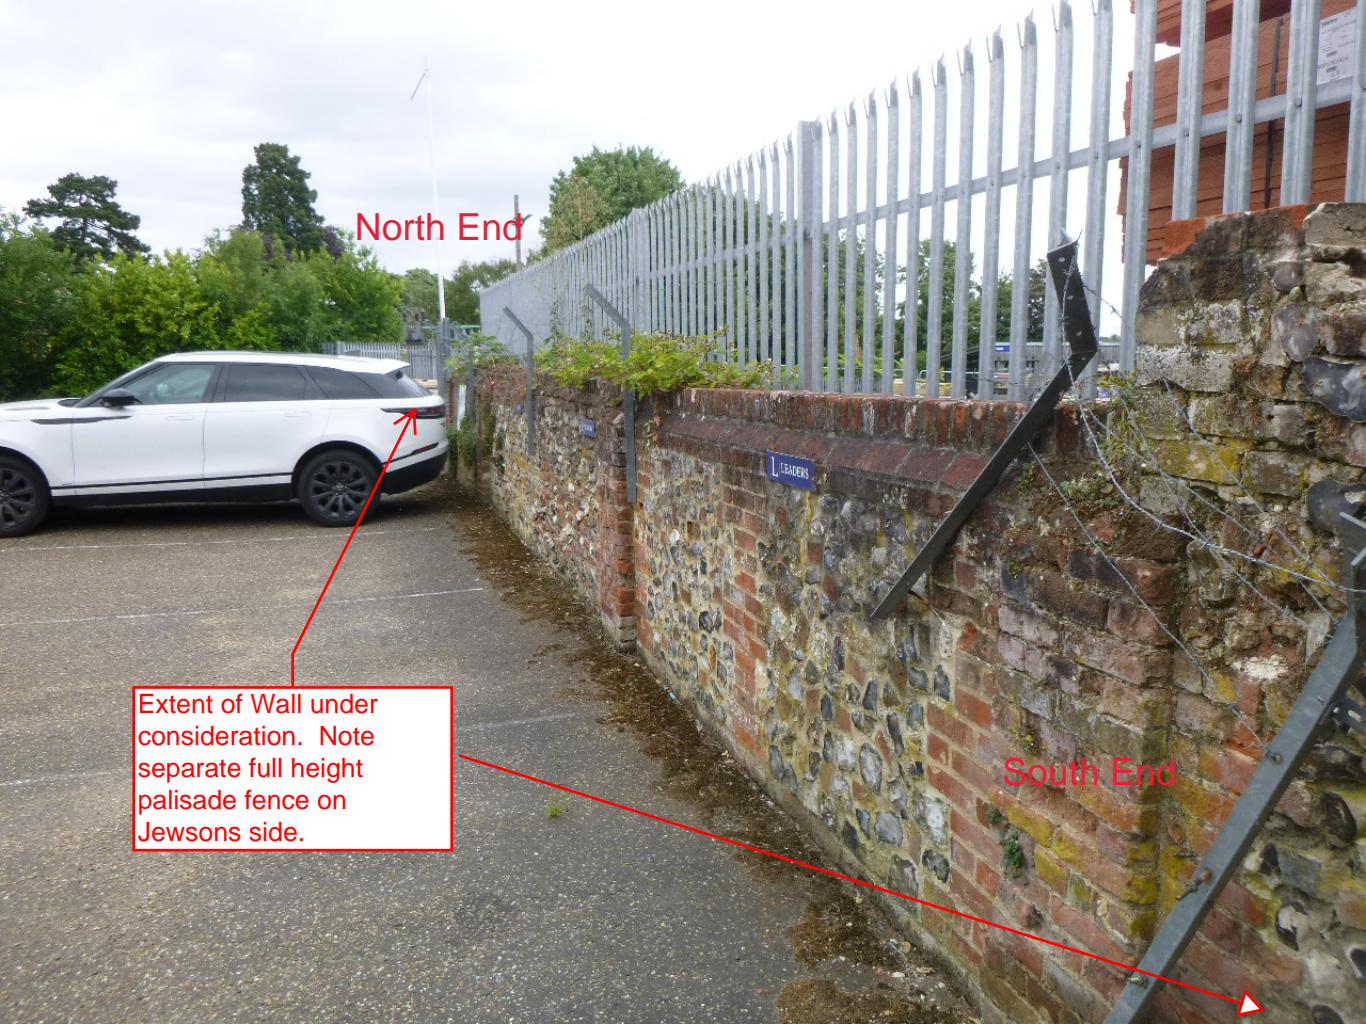
North End

South End

Extent of Wall under consideration. Note separate full height palisade fence on Jewsons side.

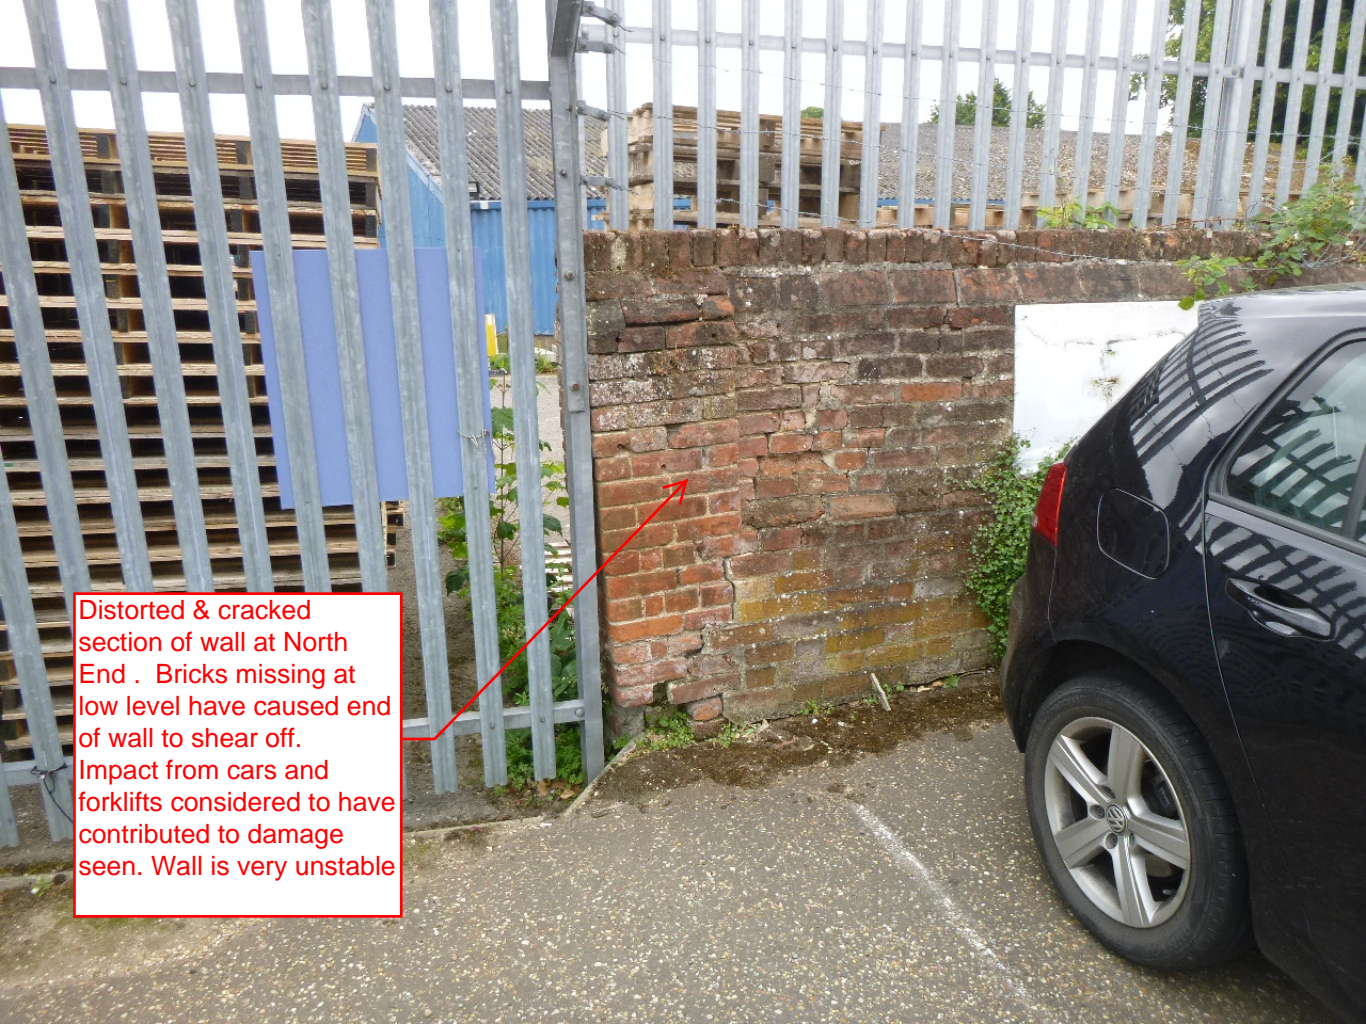
Distorted & cracked section of wall at North End . Bricks missing at low level have caused end of wall to shear off. Impact from cars and forklifts considered to have contributed to damage seen. Wall is very unstable

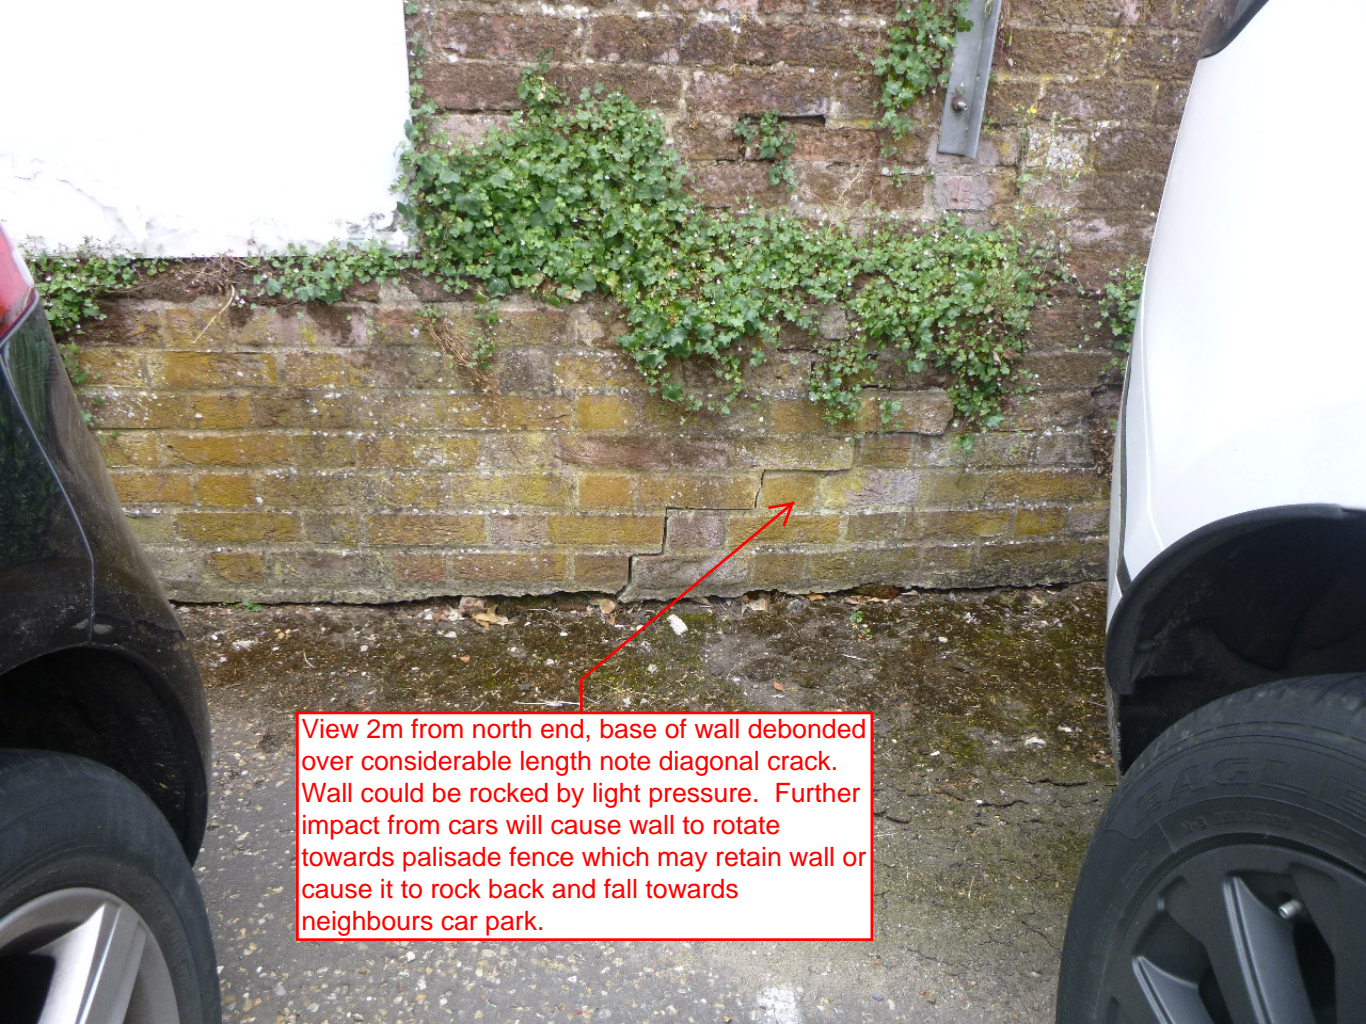
View 2m from north end, base of wall debonded over considerable length, note diagonal crack. Wall could be rocked by light pressure. Further impact from cars will cause wall to rotate towards palisade fence which may retain wall or cause it to rock back and fall towards neighbours car park.

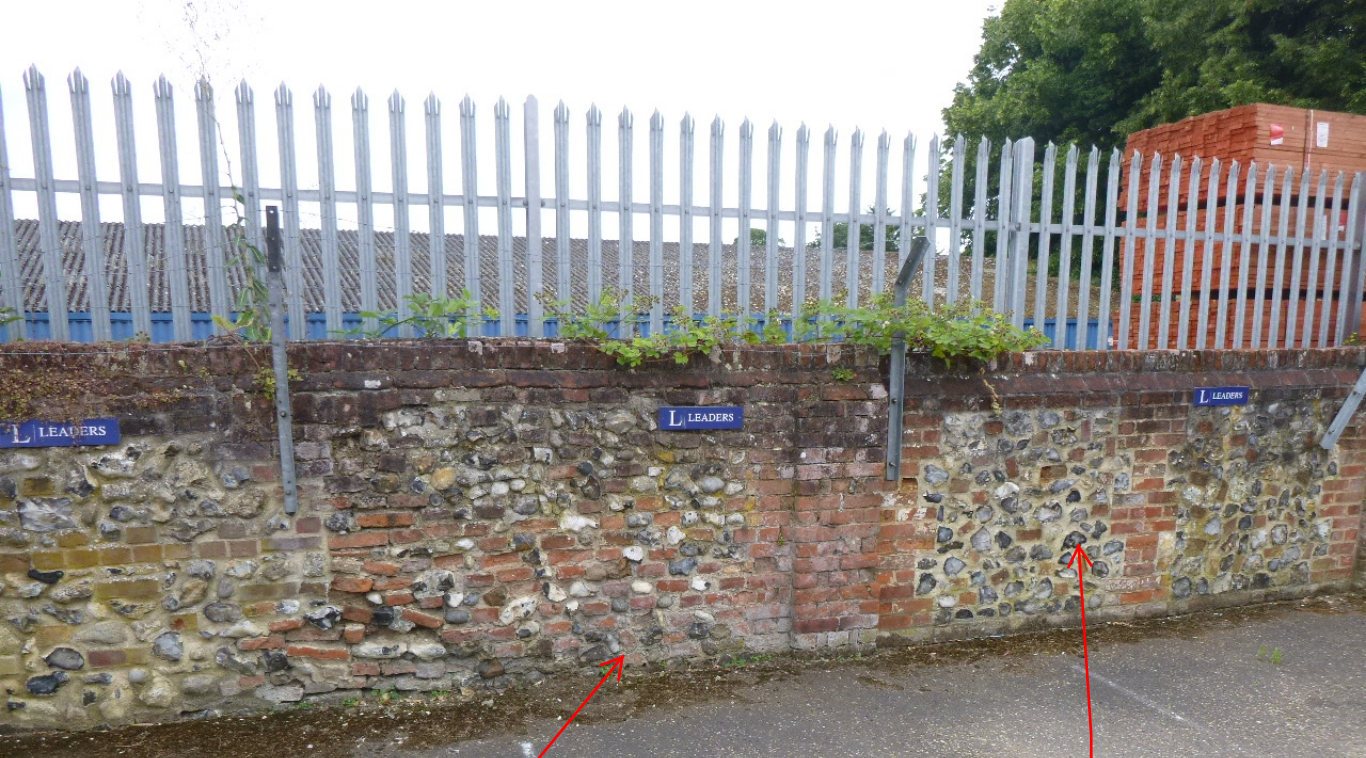
Unstable wall from this point. At base of wall bottom bed broken wall rocks when lightly pushed.

Only section of wall found to be stable. Recently rebuilt.

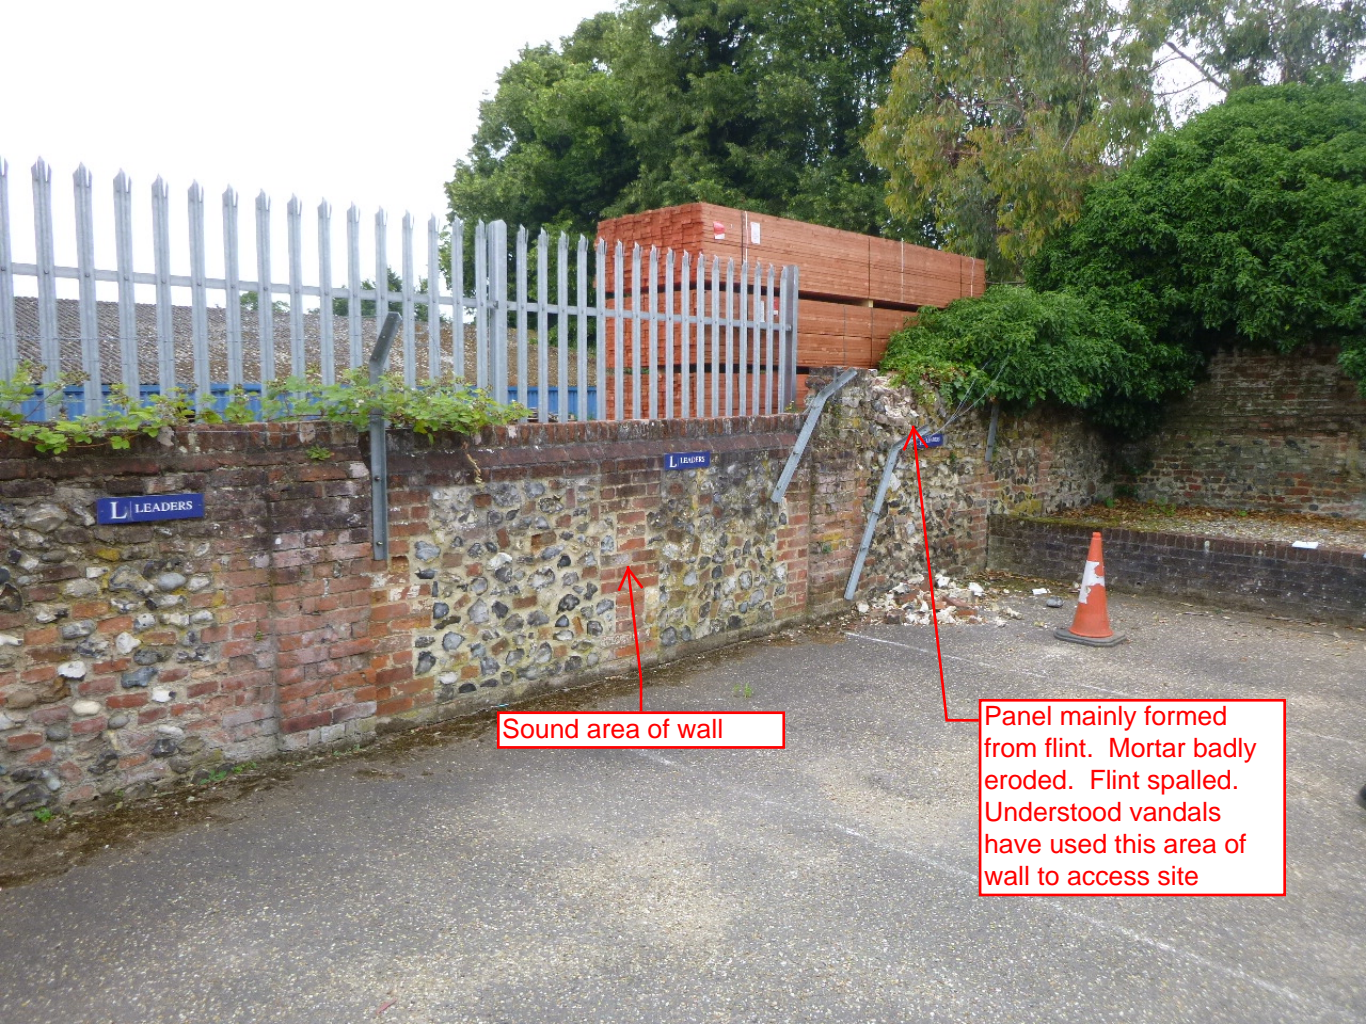
Sound area of wall

Panel mainly formed from flint. Mortar badly eroded. Flint spalled. Understood vandals have used this area of wall to access site

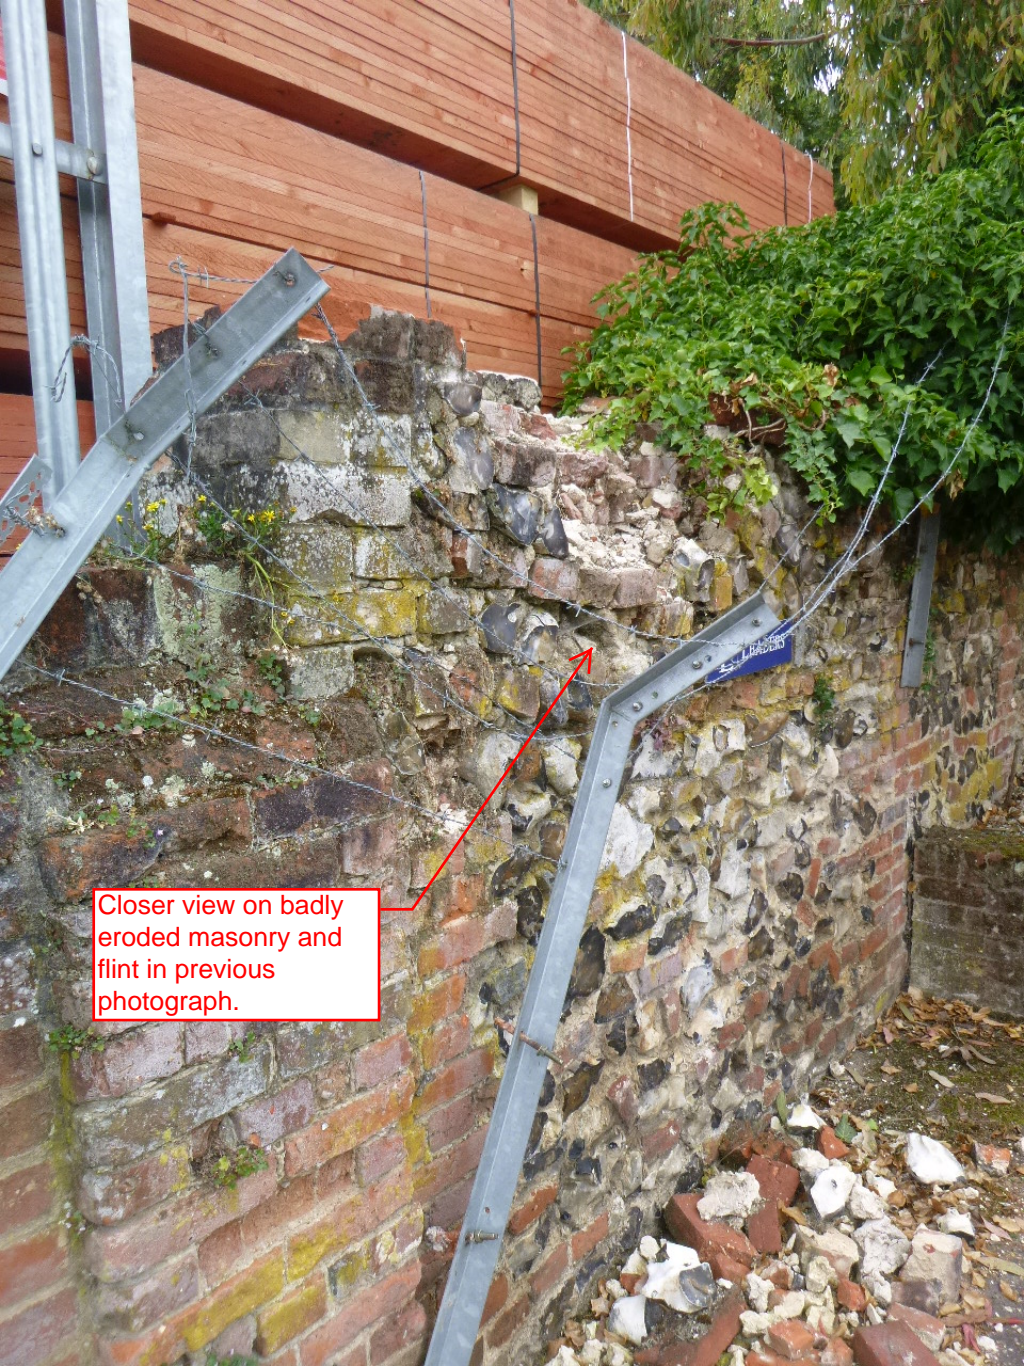
Closer view on badly eroded masonry and flint in previous photograph.

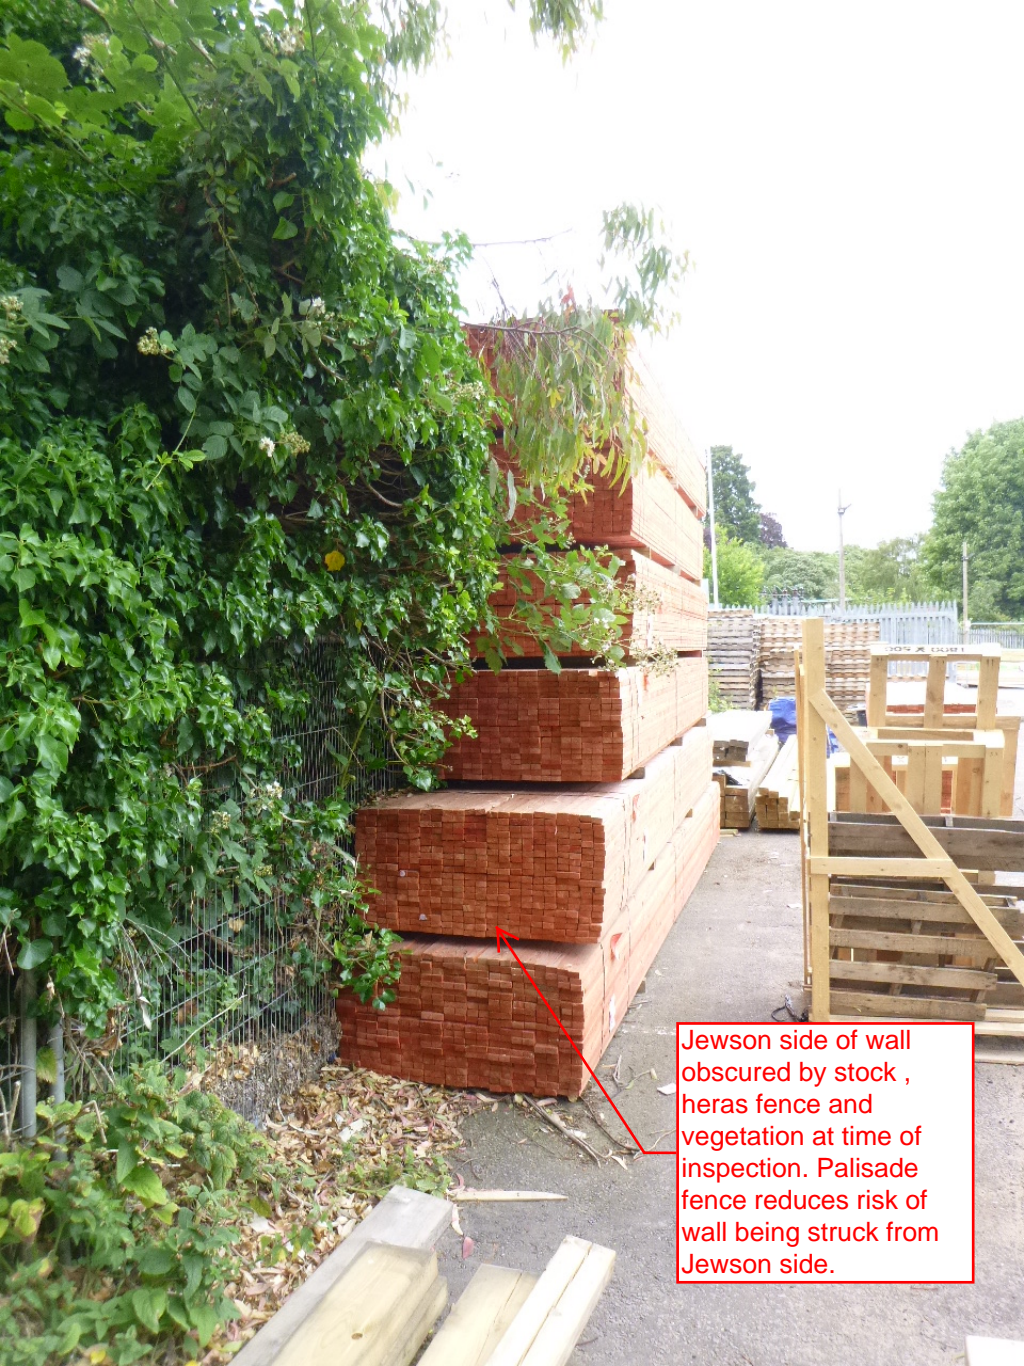
Jewson side of wall obscured by stock , heras fence and vegetation at time of inspection. Palisade fence reduces risk of wall being struck from Jewson side.
