**Schedule of Condition
of Windows and Doors**

**Inglenook Cote,
House Lane,
Romaldkirk,
Barnard Castle,
DL12 9EH**

June 2021

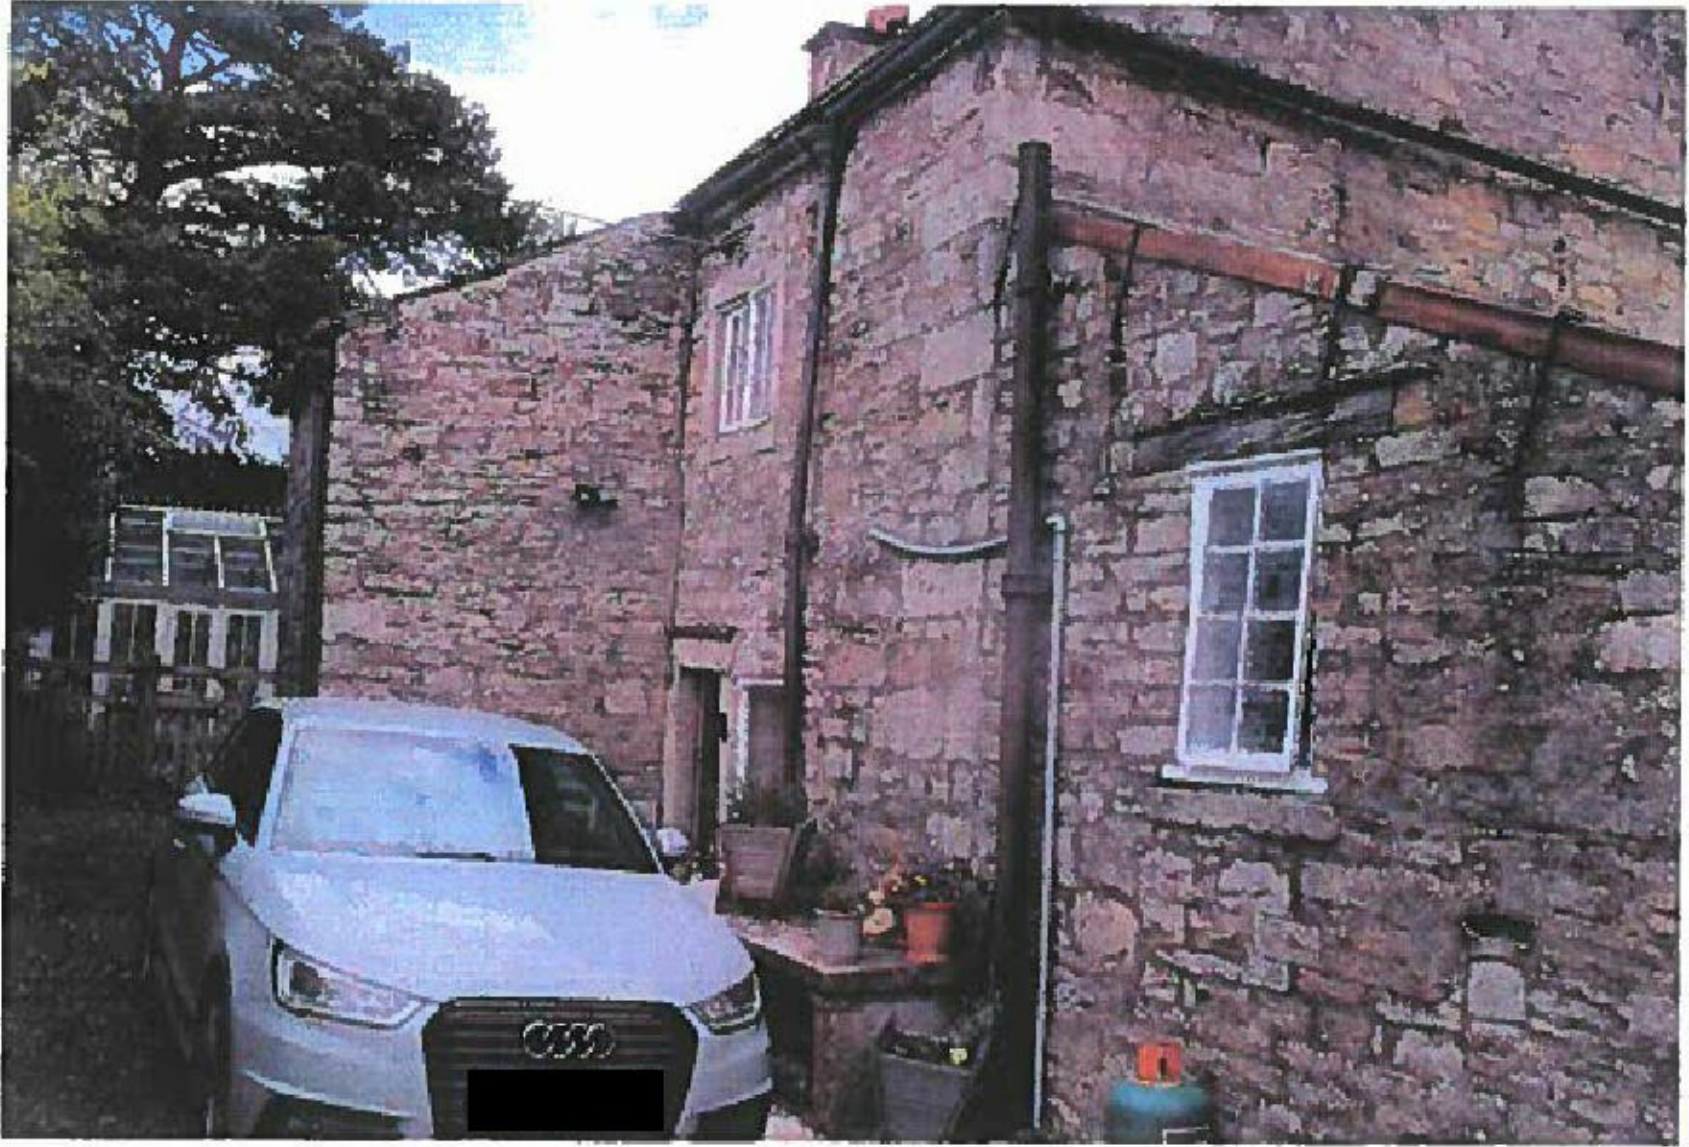
①

Photograph 1	General view of Rear Elevation
Photograph 2	General view of Front Elevation
Photograph 3	Typical window defects noted to Front Elevation
Photograph 4	Typical window defects noted to Front Elevation
Photograph 5	Typical window defects noted to Rear Elevation
Photograph 6	Typical window defects noted to Rear Elevation
Photograph 7	Typical window defects noted to Rear Elevation
Photograph 8	Typical window defects noted to Rear Elevation
Photograph 9	Typical window defects noted to Rear Elevation
Photograph 10	Typical window defects noted to Rear Elevation
