Technical Note

Project: Forge Farm Barn Conversions
Subject: Structural Assessment
Ref: B2021_094/ECSL/TN/001
Date: 01/06/2021

Introduction

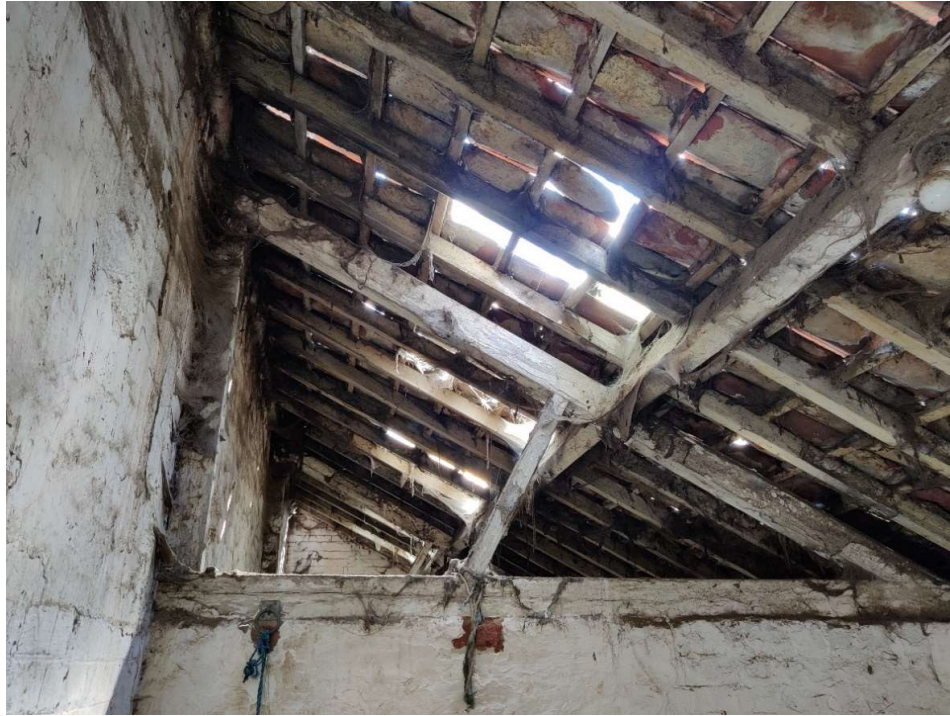
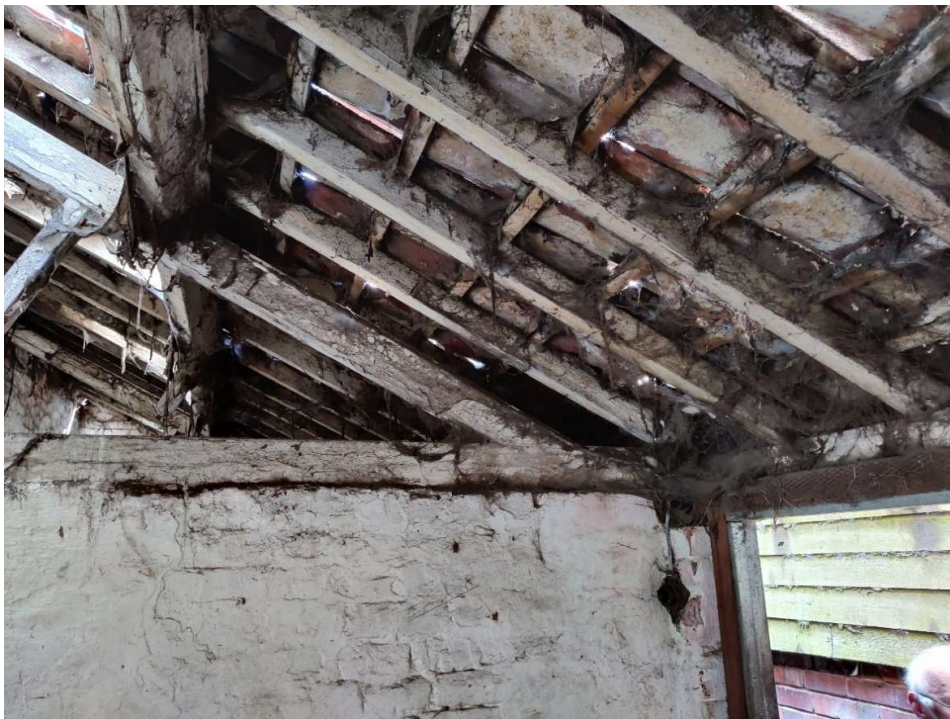
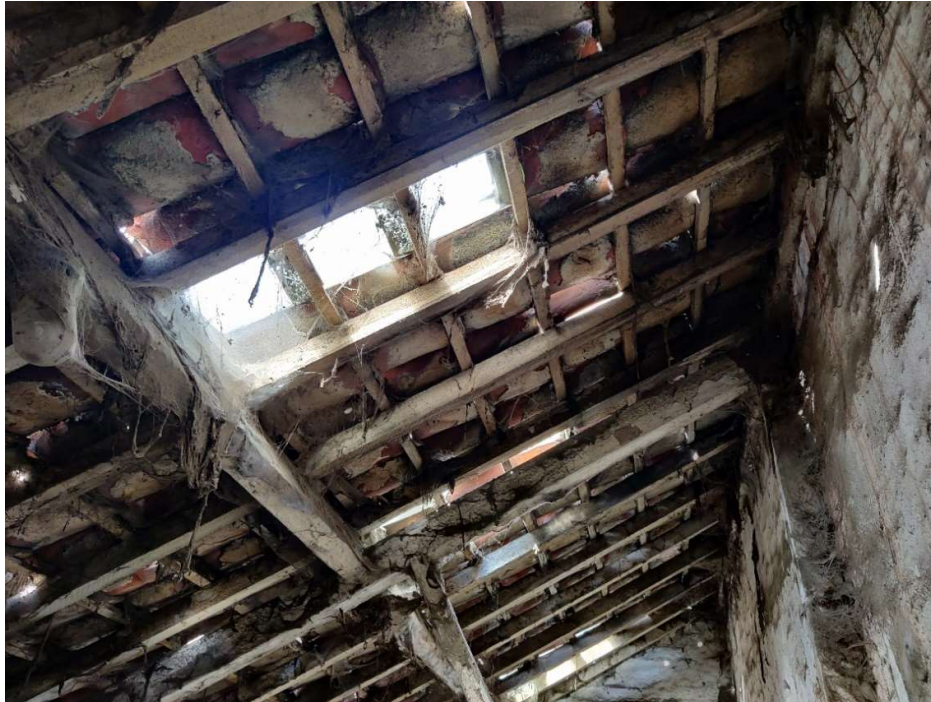
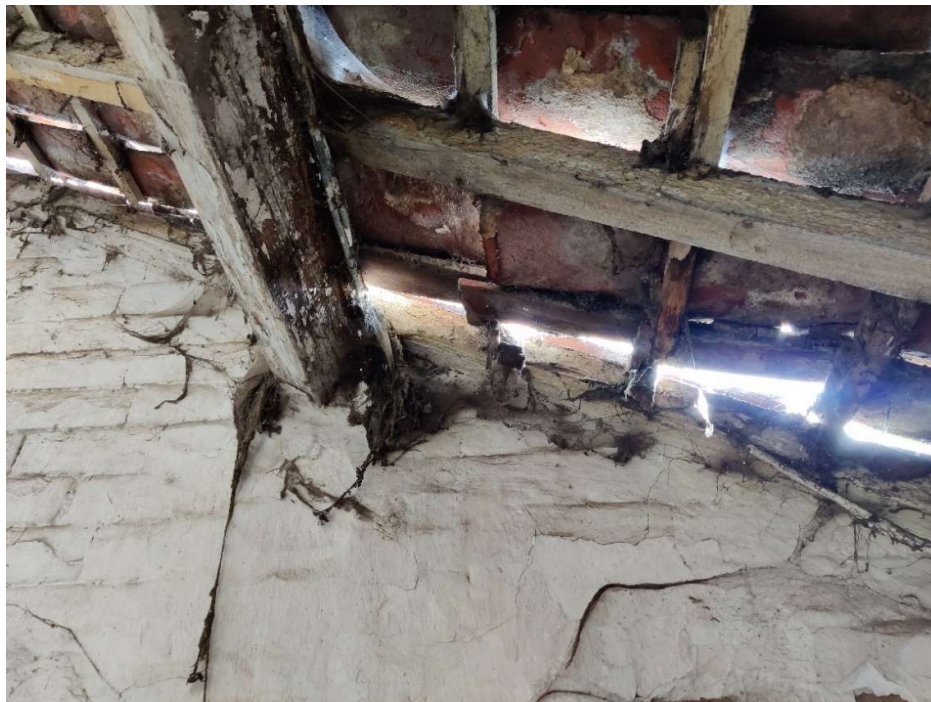
The roof structure has a substantial number of missing tiles throughout, which has resulted in the structural timber being exposed to external weathering for some time. Whilst the timber trusses and purlin elements appear to be supporting what is left of the roof, without too much distortion, there are several members that have appeared to suffer from rot due to being

exposed for so long. There will undoubtedly also be wet rot issues that are uncovered once the existing tiles are lifted to repair the roof covering.

The plans for this area suggest that the internal walls are to be removed, to allow better flow to the dwelling. However, currently the internal masonry walls appear to be supporting the timber frames above. In their current condition, even if the bottom cords are supported off the external walls, it would be unlikely that these frames would be suitable to support the existing roof structure once repaired.

The roof Structure in this area will need to be replaced with a suitable timber frame arrangement, with supporting purlin over, to replicate the existing arrangement.

Once the roof tiles have been removed the condition of the existing timber from above can be assessed in more detail. There may be rafters, etc that can be reused for the roof repair, which would be beneficial to the historic repair required.

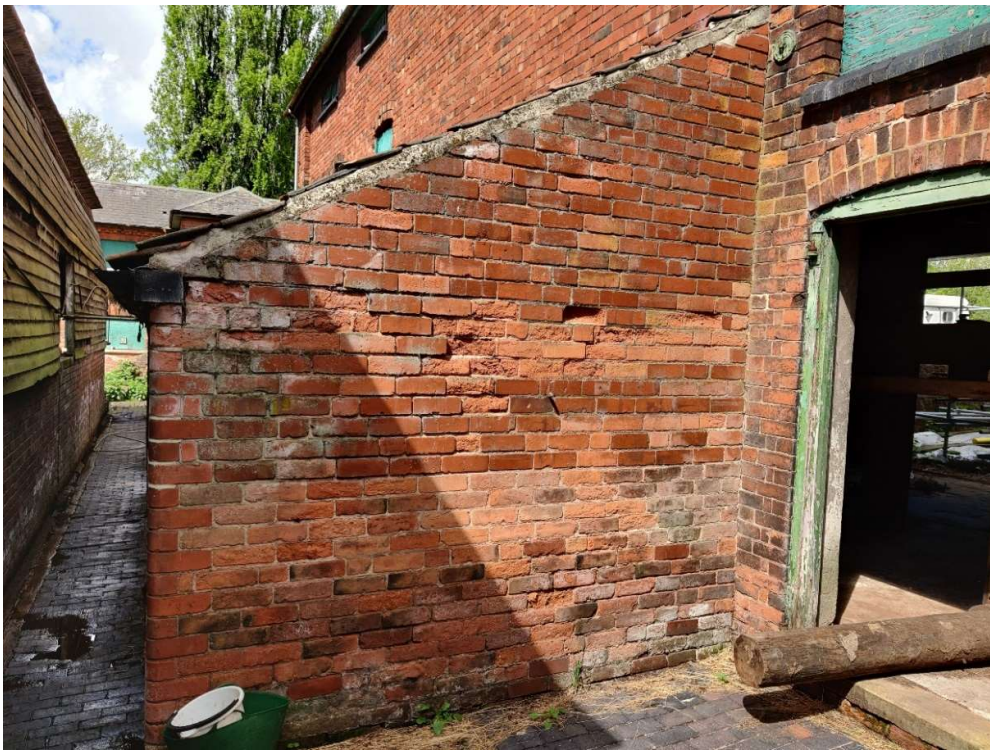
The brickwork looked to be in reasonable condition, there are brickwork faces that have blown away, and some loose mortar in places. We would suggest all loose mortar be removed from the walls and repointed. Where excessive brickwork damage to faces has occurred, these bricks should be replaced with suitable replacement bricks to suit the existing brickwork era. Although no cracks were noted, it would typically be advised that any cracks be assessed individually for issues. In some cases there may be a requirement to add brickwork reinforcement into the mortar repair to restrain the wall from further cracking, or to add additional strength back to the existing cracked wall. Typically, this would be done using a helifix crack stitching HeliBar installed to manufacturer's guidance to suit the wall construction and character of the structure.

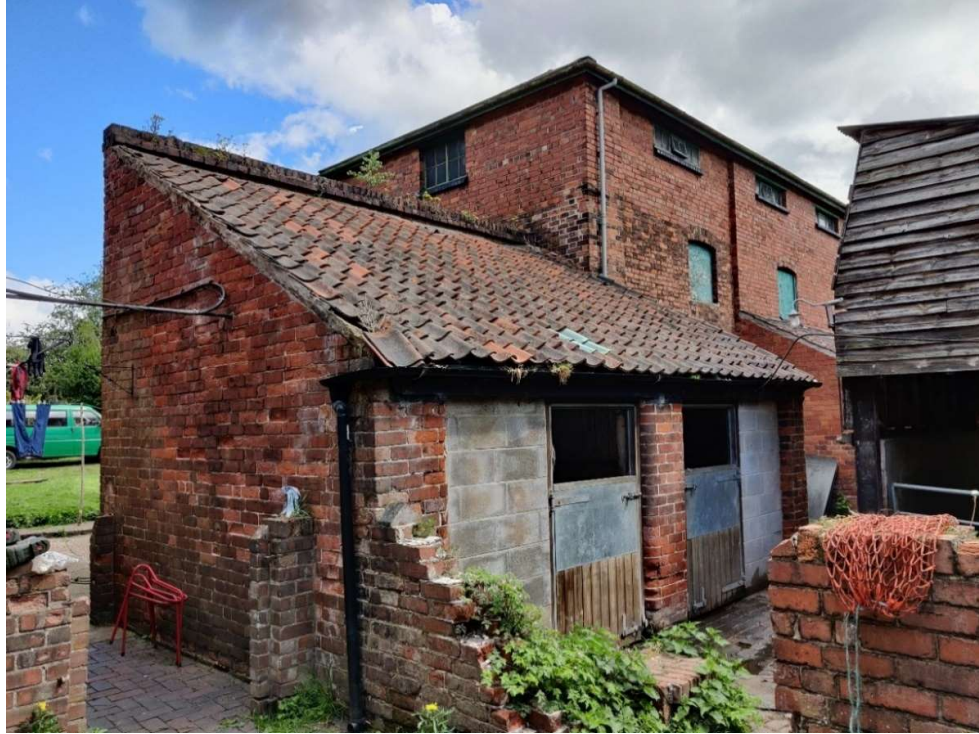
Parts of the stables have been adapted over the years, with the addition of Blockwork infill panels between larger openings. It is unlikely that these would have any historic structural

requirements, however, the existing timber lintels will need to be assess once properly uncovered. It is likely that these will need replacing to suit the proposed plans to have these openings restored, to house glazed windows/screens. In the event these lintels need replacing, they will need to be replaced for a like for like timber lintel, designed to current standards and loadings for the proposals.

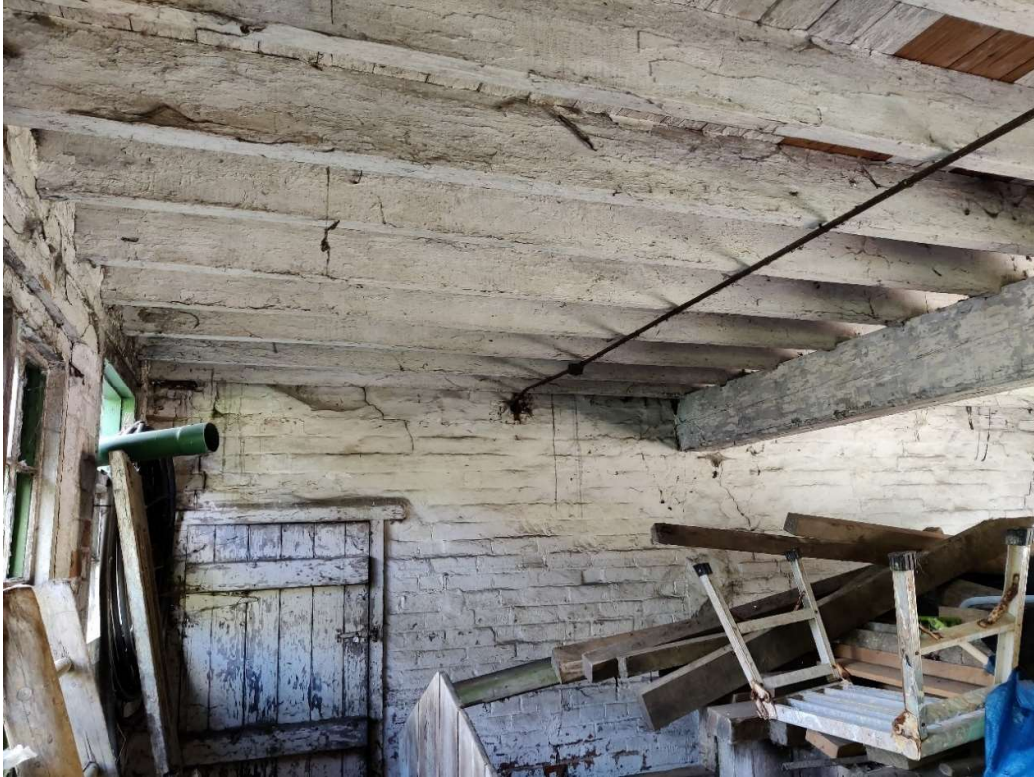
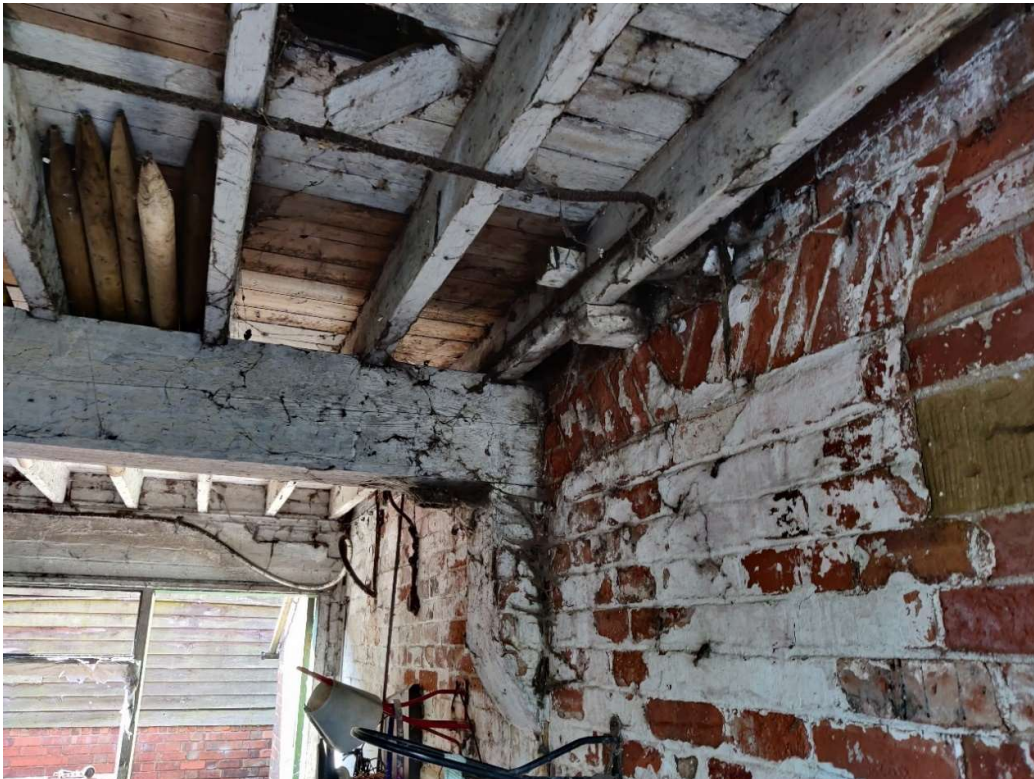
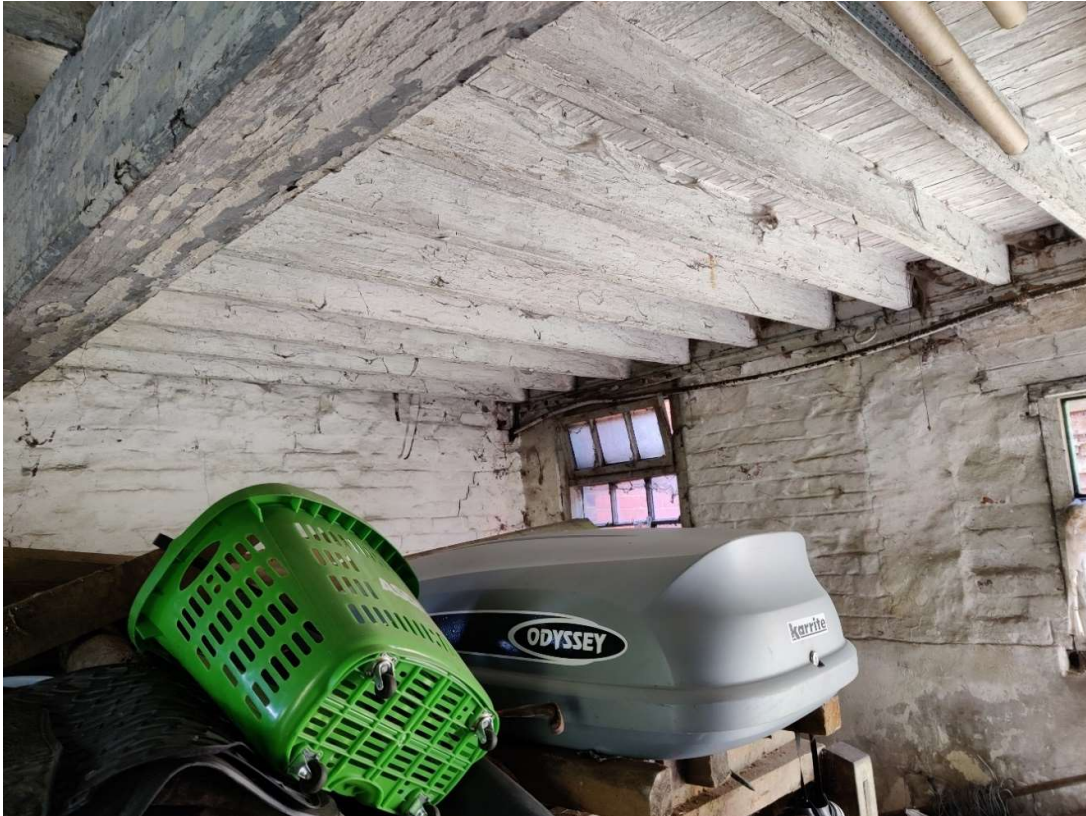
First Floor Timber floor structure over proposed dining area has been subject to moisture and condensation, there are signs of rot in places, but overall condition is difficult to determine with painted finish over.

Client is currently assessing floor levels in this structure to provide a more even distribution across the 3 storeys for the final design, therefore this floor structure may need to be lowered to achieve this.

As the existing joist is quite deep in this area, the designers should note that existing window levels in areas are already close to the underside of the joist, so careful planning in this area may be required, along with possibly assess window requirements.

The main floor beam across the middle of the floor joist spans is also bearing onto a masonry thickening in the wall. If this element were to be lowered to allow the floor levels to be reduced, the bearing of the beam would need to be reviewed by the structural engineer.

It would be advised that the main floor beam and joist are stripped back to good material and reused if possible. The beam and floor joist appear to be oversized for the loading that will be applied in the domestic usage proposed. So, there will be some tolerance to remove material. This should be reassessed by the structural engineer appointed to carry out any structural designs required. A minimum joist size should be calculated.

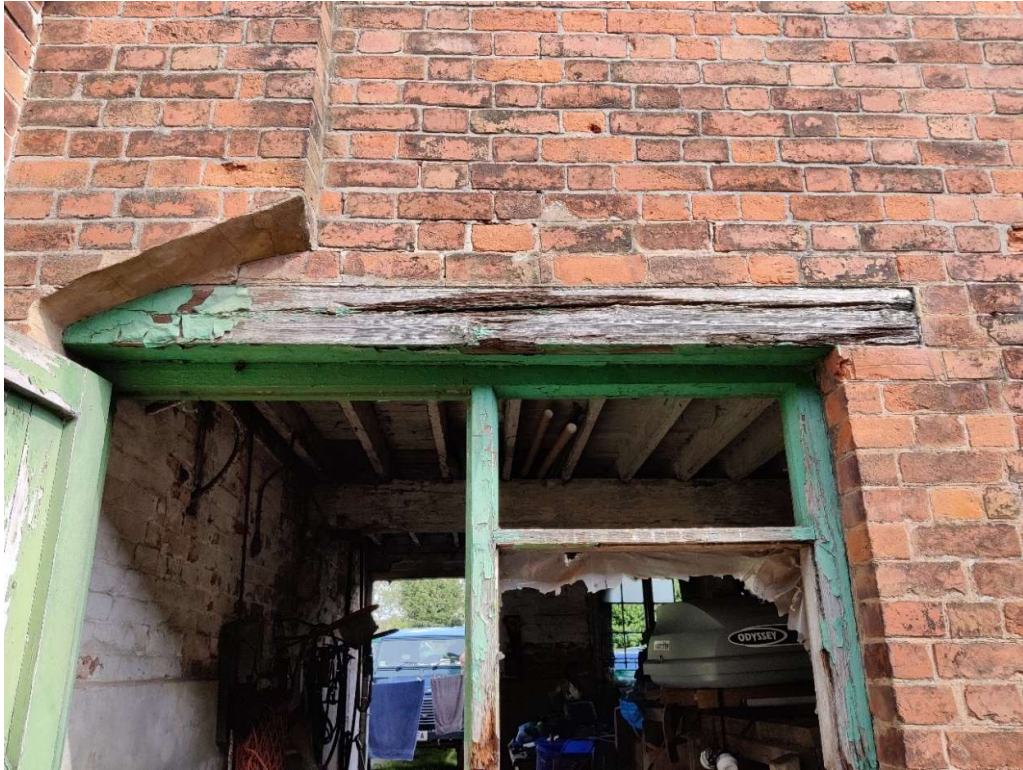
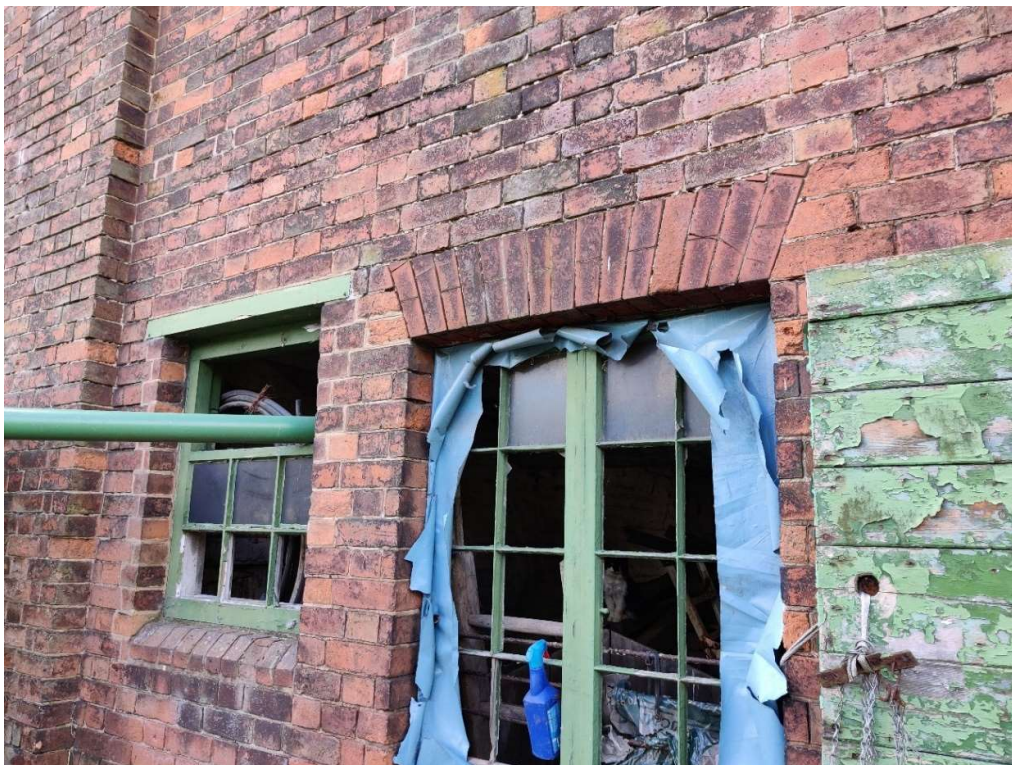
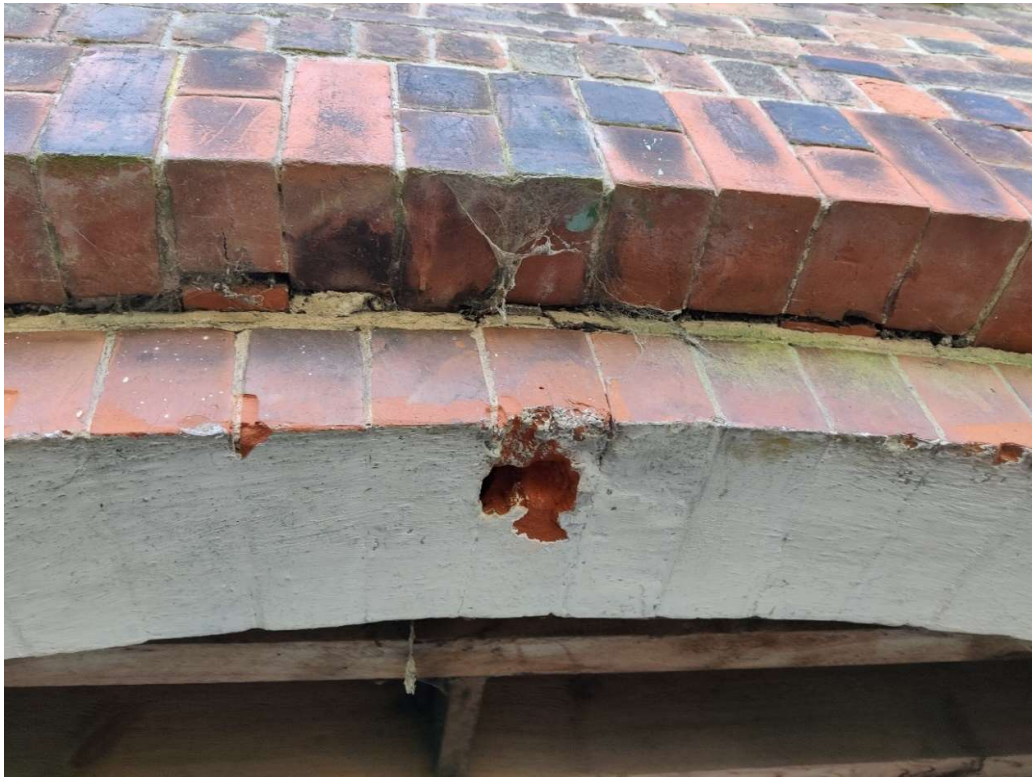
Lintels over existing windows have been formed using both Brickwork and timber in places. Where brickwork has been used, there does not seem to be any structural issues, or cracking that would look to be a potential future issue.

Timber lintels in places look to be structurally sound, whereas in other areas rot has taken affect and these would need to be replaced with a like for like replacement. Some internal lintels were not accessible at the time of visit, it is suggested each lintel is assessed individually once the works begin onsite.

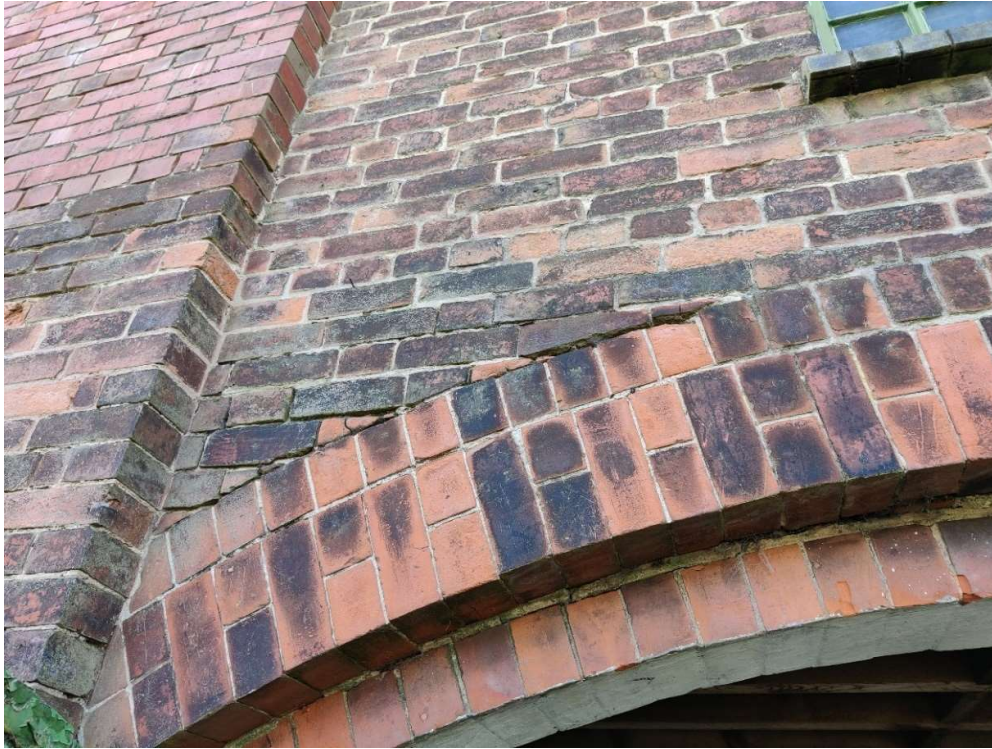
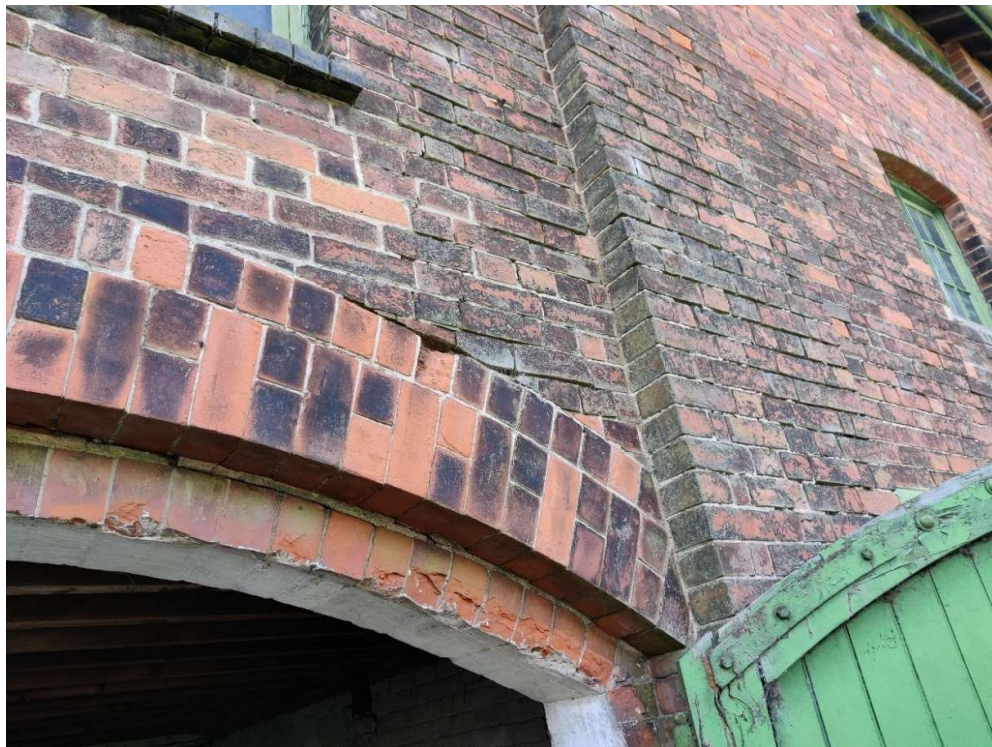
Large arched opening to the rear of plot 1, is generally in good condition, with no signs of cracking to suggest movement or future issues. However, there is a single brick at the head of the arch that is missing a large section of material. It is advisable that this is repaired at the time of the conversion to ensure no future issues arise. It is likely that this brick will continue to

There are a few areas of brickwork above the arch with blown faces and missing mortar. Where excessive amounts of material are missing, or several bricks in close proximity are damaged, these bricks should be replaced with bricks to suit the age of the structure. It would also be advised to clean out the joints of any loose mortar between brickwork where loose and damaged and repoint to suit the rest of the structure.

decay and collapse of the first string of bricks in the arch may occur. This would need to be done by an experienced masonry craftsman with experience of working with arched brickwork. Temporary propping will be required to provide support once the damaged brick is removed.

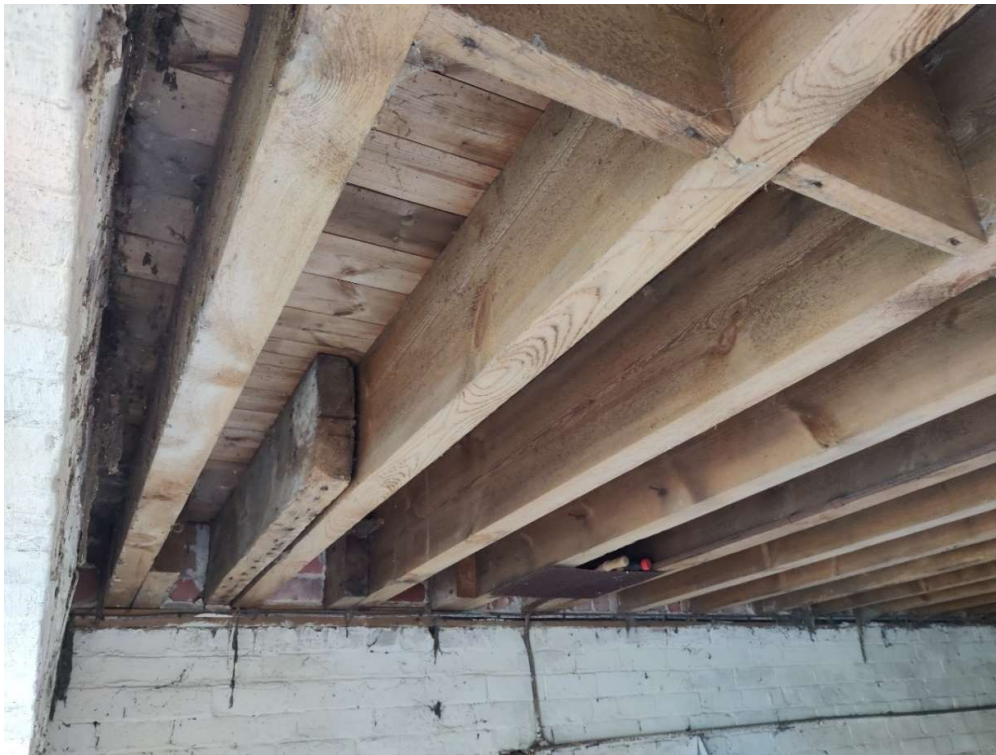
The first-floor joist over the proposed lounge area appears to be in very good condition throughout, with no visible issues noted from the underside. As noted previously, this floor may need to be lowered to accommodate floor level adjustments to suit the proposed usage. In this case these joists should be able to be reused.

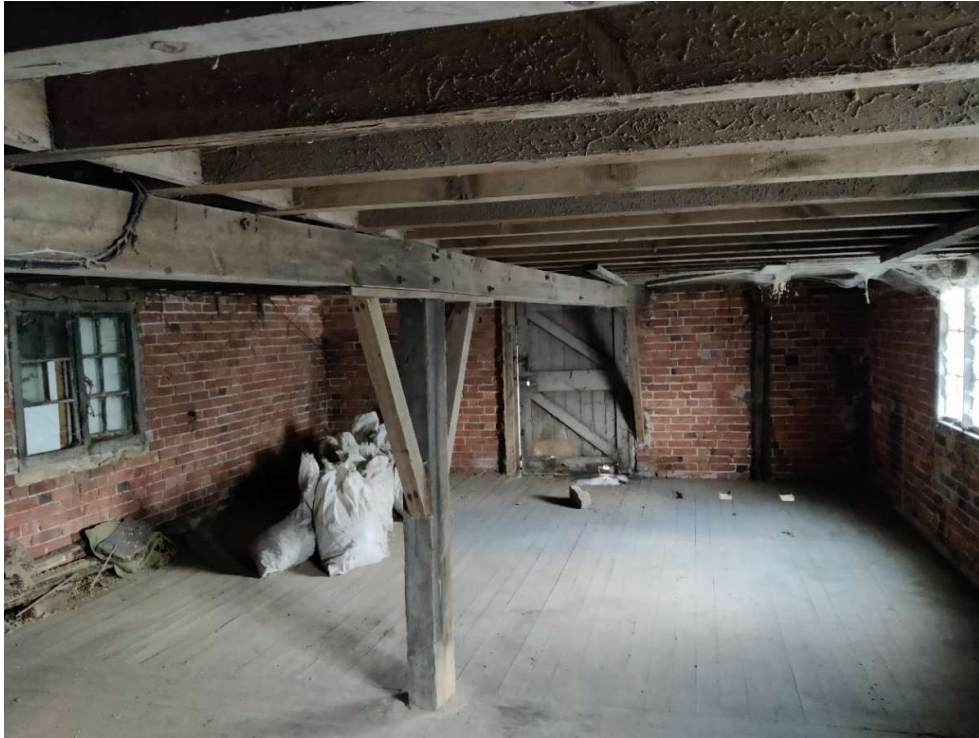
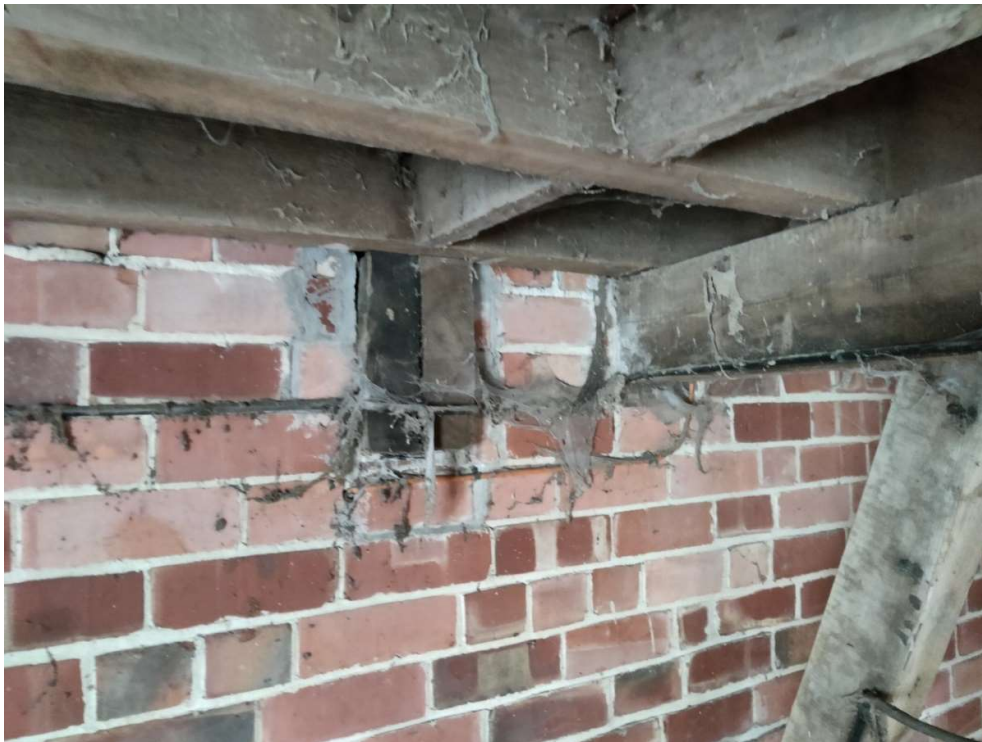
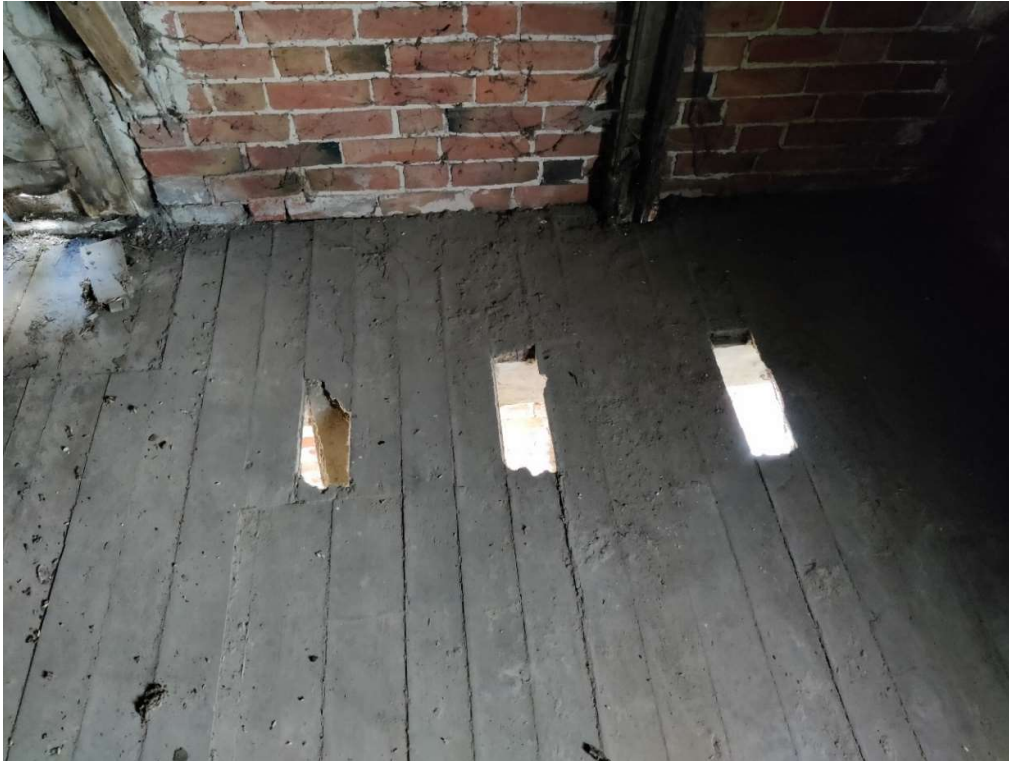
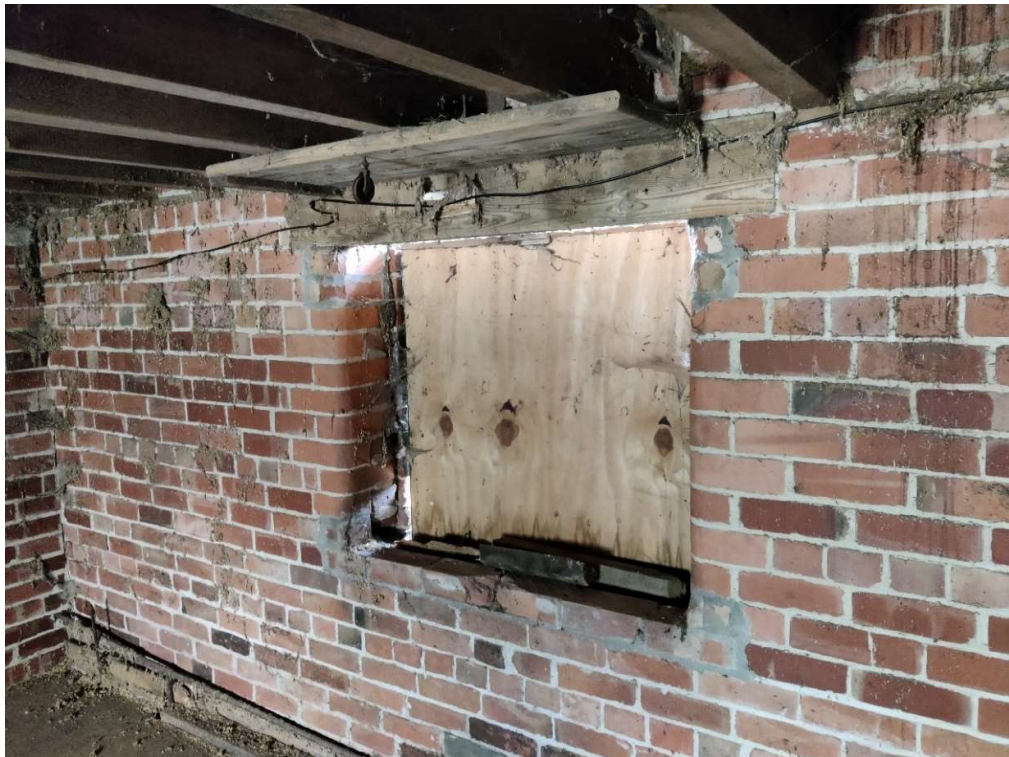
At first floor level the floorboards below generally look to be in good condition. However, there are some areas of damaged boards that will need to be lifted and replaced with new items. On removing damaged boards, the top of the joist below should be further assessed

Floor joist and beams over the first-floor level forming the second floor, look to be in good condition, with no visible signs of rot or damage from the underside.

Timber lintels also seem to be in good overall condition, however, once works begin and the areas cleaned, these elements should be inspected further to ensure their condition is as appears.

Brickwork internal also seems to be in good condition, with only minor areas showing damage/blown brickwork faces. However, once works begins and the walls are cleaned up, if any issues are uncovered these areas will require further assessment.

to check for further damage and rot. If rot is found in these locations, it may be a good option to lift further boards to inspect the joist below beyond the damaged areas. From the views below, the area above the proposed dining area may be the worst affected, with the joist above the proposed lounge looking to be in much better condition, and most likely replaced at some point not too long ago.

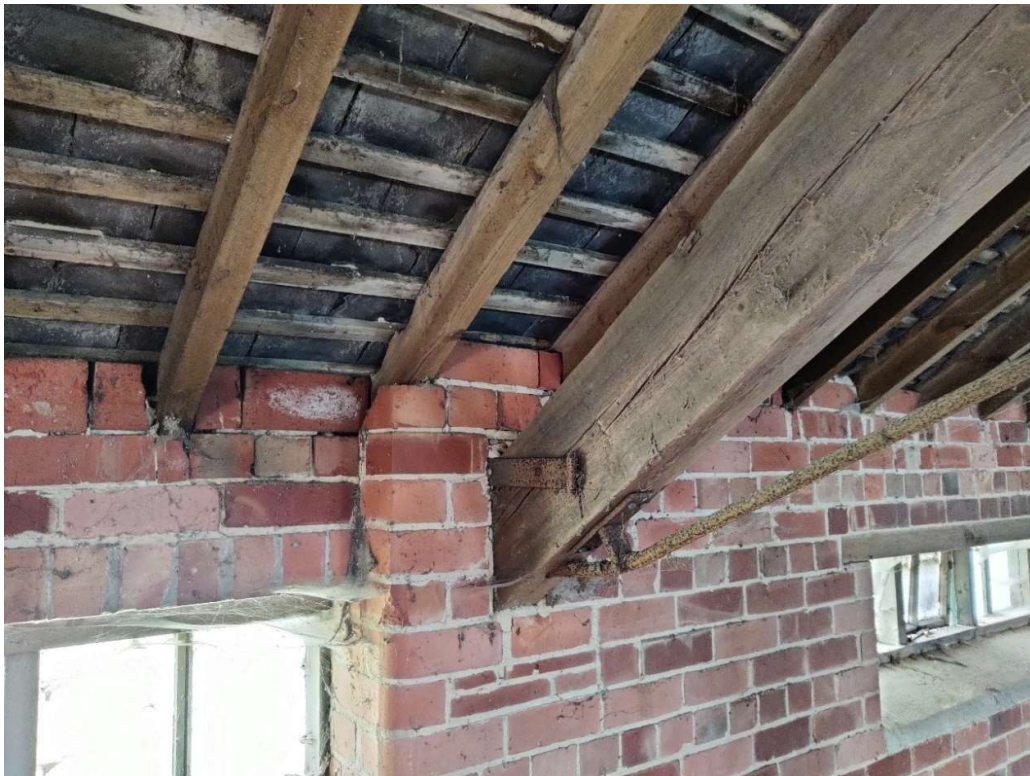
At second floor level, there are visible loose/cracked brickwork around timber roof rafters, these should be replaced with suitable bricks, noting that brickwork sizing is typically larger than current standard brickwork sizing in the UK, therefore traditional brickwork units will need to be sources where spare bricks from the property cannot be found or reused for the repair.

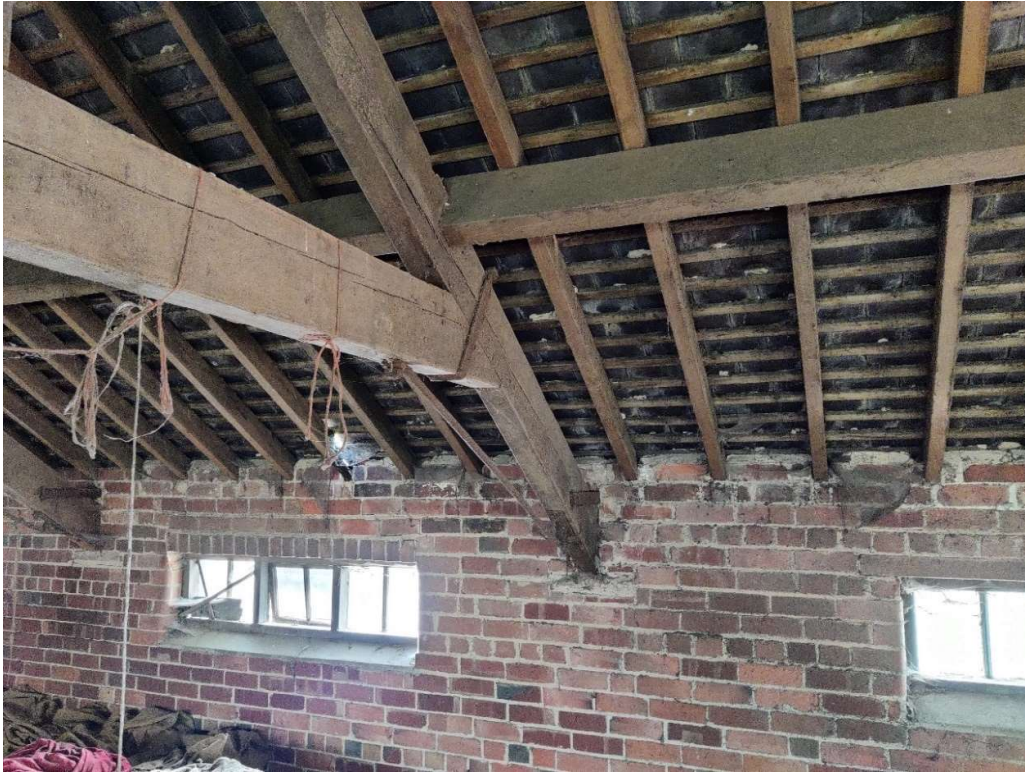
Typically, the Roof trusses seem to be in good condition, once works on site begin, these should be cleaned down and double checked for damp, rot and any damage not visible from below. If damaged areas are found in isolation, these may still be able to be used in the final build, however they will need to be checked individually with structural calculations to assess minimum structural capacity is still achieved for the applied roof loadings.

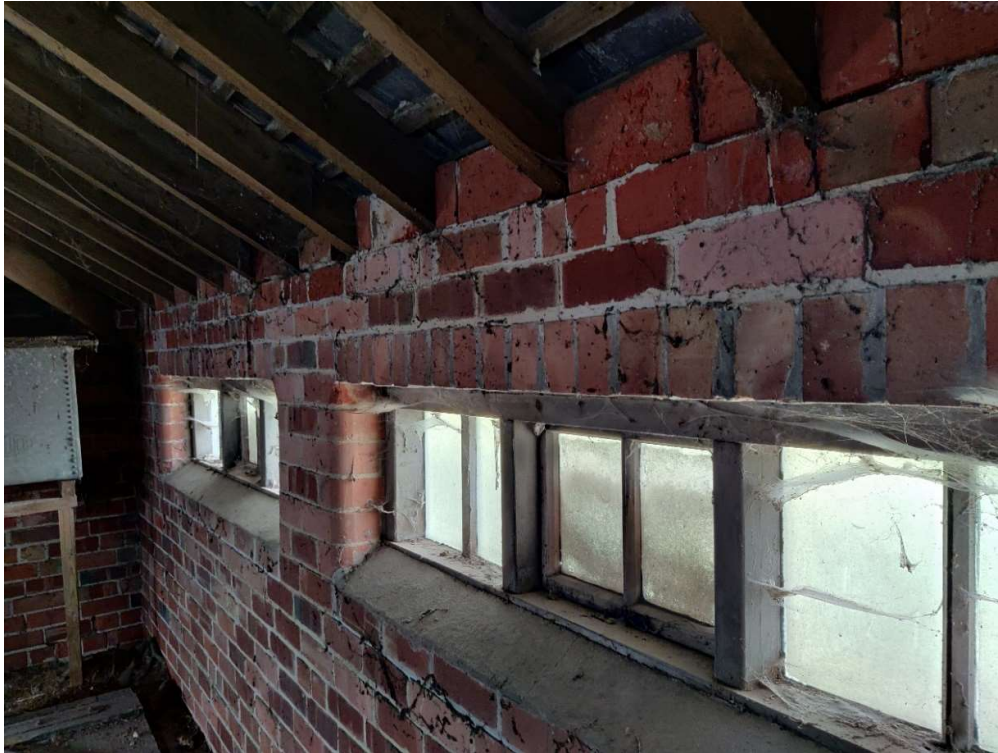
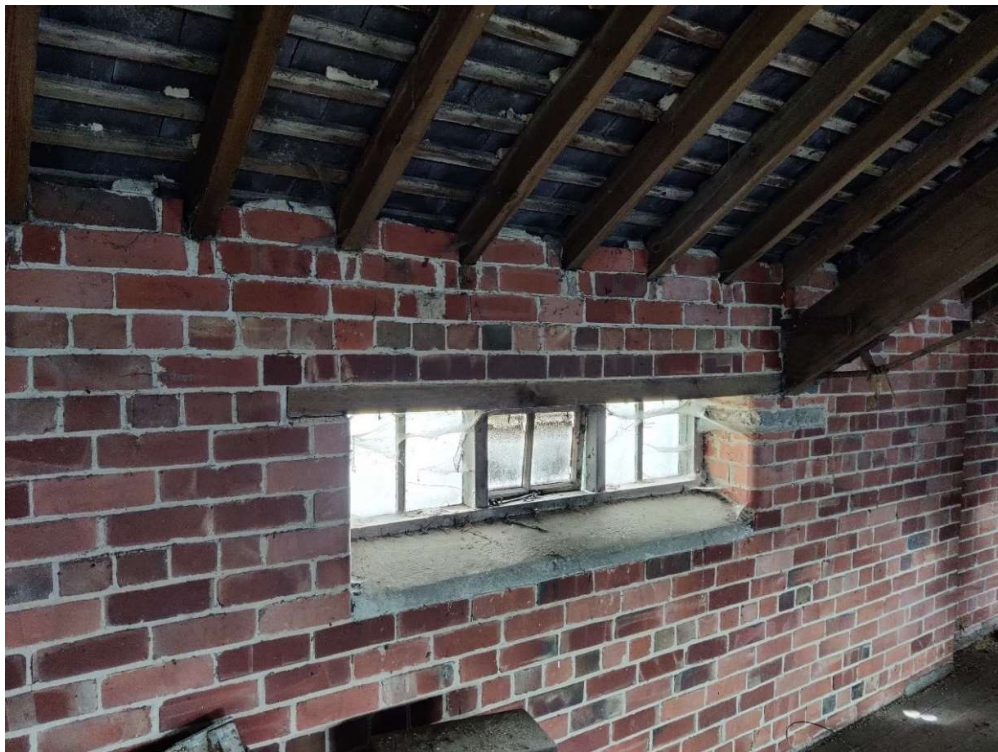
There appears to be concrete lintels over some windows and no lintels over others. The concrete lintels are not from the original build, so will have been added, most likely due to masonry movement over the window openings. Whilst no cracking or movement was noticed in these areas, it may occur later in the building life and if lintels can not be added for historic heritage reasons, then alternative measure may be worth investigating to ensure

The timber window frames will be providing support in the current form. However, with more frequent opening of windows, once the dwelling is in use, the strengthening over the window should be reviewed to ensure future issues do not arise where lintels are not present.

later issues do not occur. Helifix HeliBar or similar masonry bed joint reinforcement can be utilised here. This works well with the additional strengthening being hidden from view and keeping appearances as close to existing as possible.

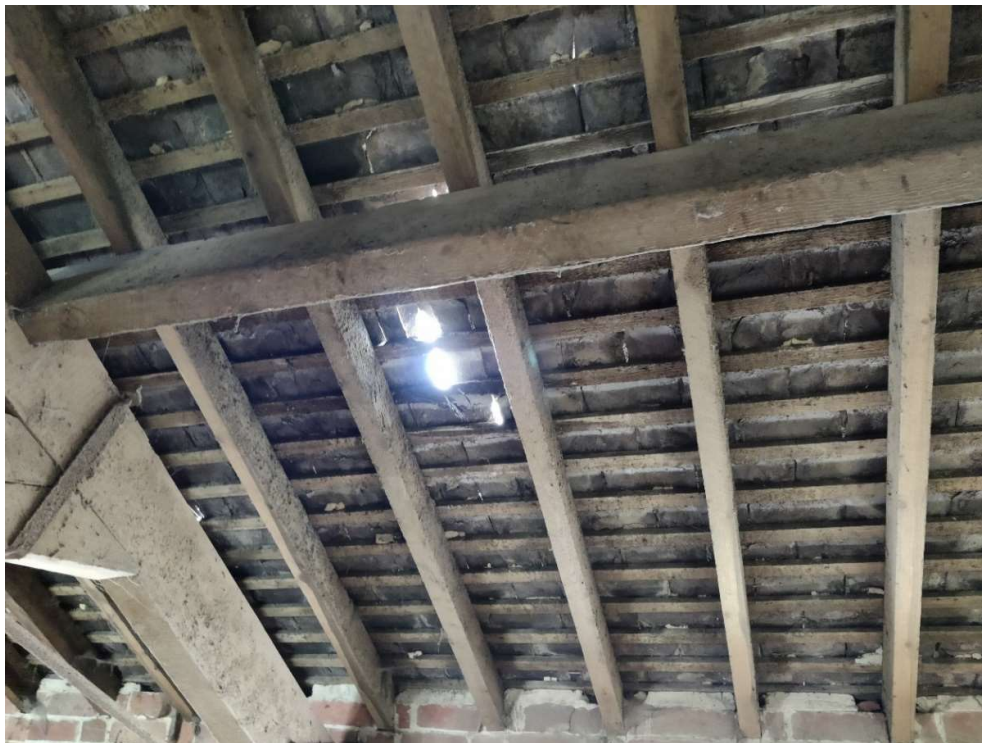
Roof covering missing throughout the roof structure, these would need to be replaced. With the extent of missing tiles and movement of tiles, along with rot and damage to binder timbers. It would be best to completely relay the roof coverings. This would also allow further inspection of the roof timber rafters, purlins and trusses from the top, where water damage/rot is most likely to occur.

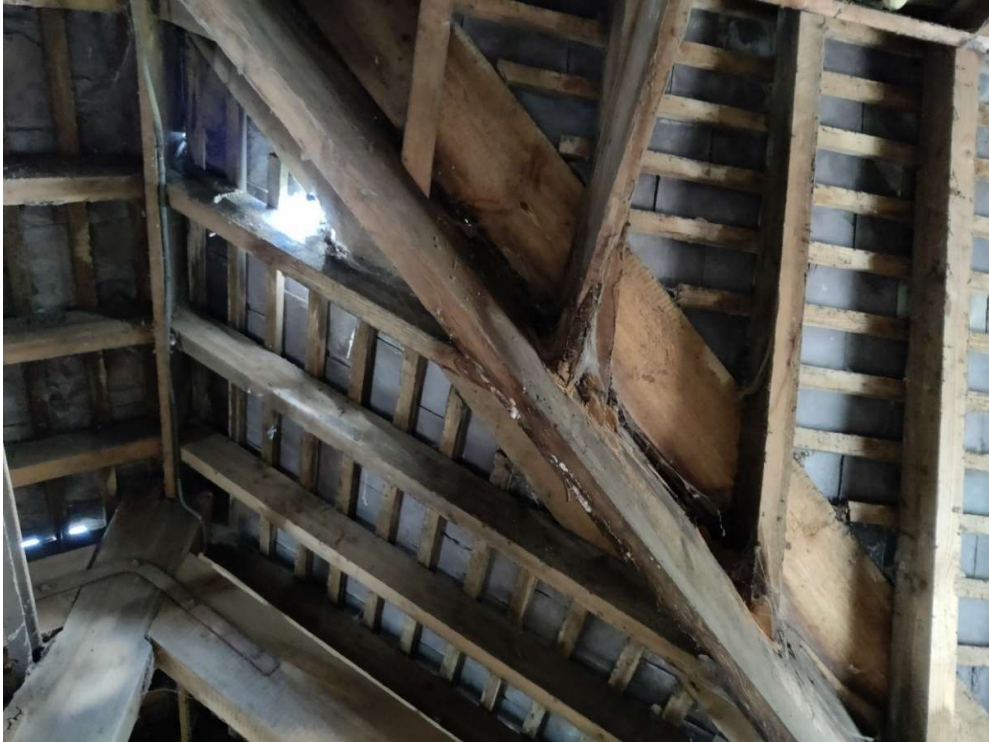
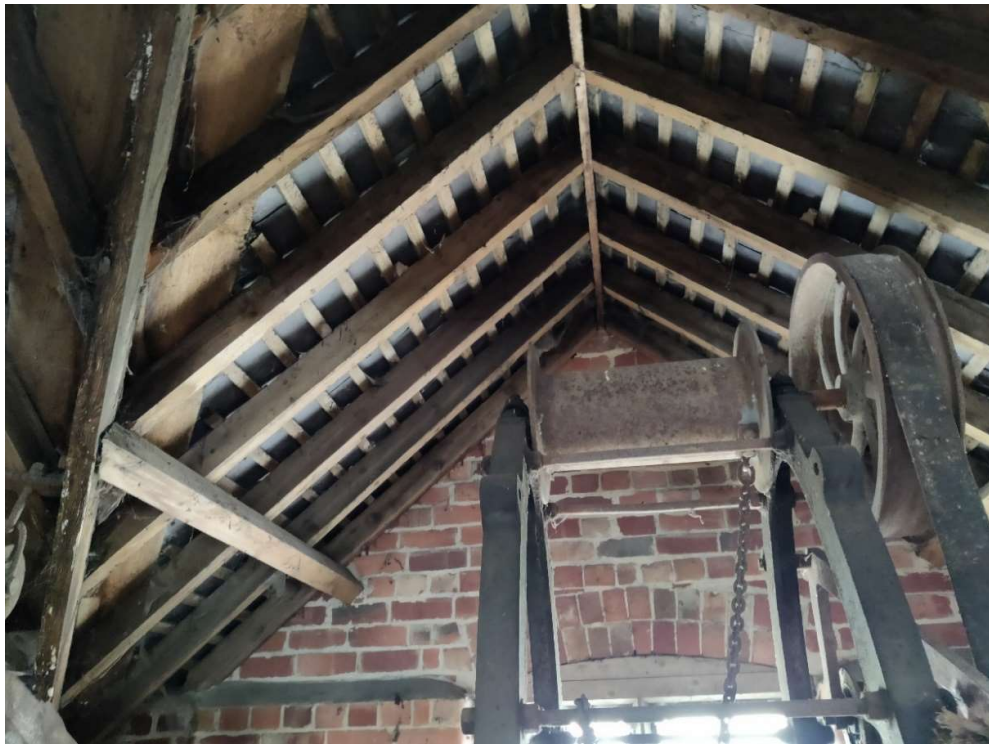
Generally, the Roof structure in this area is as noted for Plots 1, as currently it is the same building with no separation, therefore all points noted for that area are also relevant for plot 2. However, where the existing Dormer/hipped roof extension is present, there is Rot present

to all timber members forming the valleys on both sides of the dormer. These elements would need to be replaced in full with like for like timber elements. Whilst the area is uncovered, it would also be advisable to assess all other timber elements uncovered to better assess for rot, damp, or any other invisible damage from below.
