Technical Note

Project: Forge Farm Barn Conversions
Subject: Structural Assessment
Ref: B2021_094/ECSL/TN/001
Date: 01/06/2021

Introduction

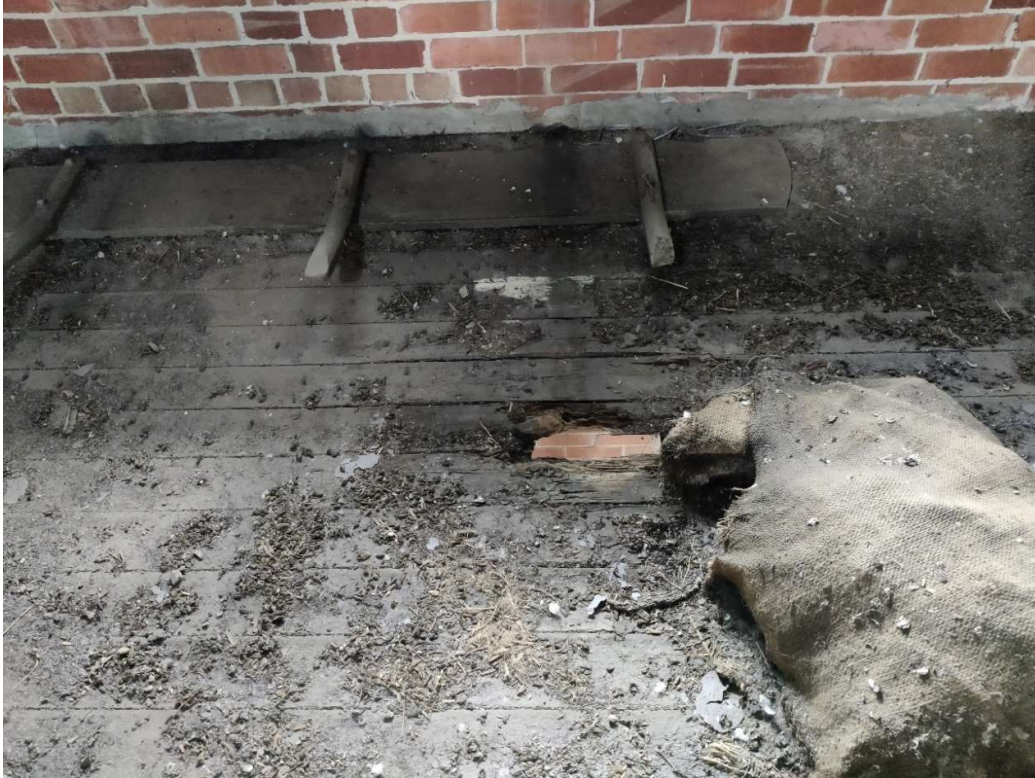
Areas of damage to Floorboards. These will need to be replaced with like for like boards. Whilst removing boards, joist under to be further assessed for damage.

Where holes in the roof structure have formed it is typical for the floors directly below to be the worst affected. This can transfer all the way down to the ground floor level. Therefore once works begin and the structure is cleaned up and starting to be stripped. It is advisable to review holes and the areas directly below them for further damage from water and weather.

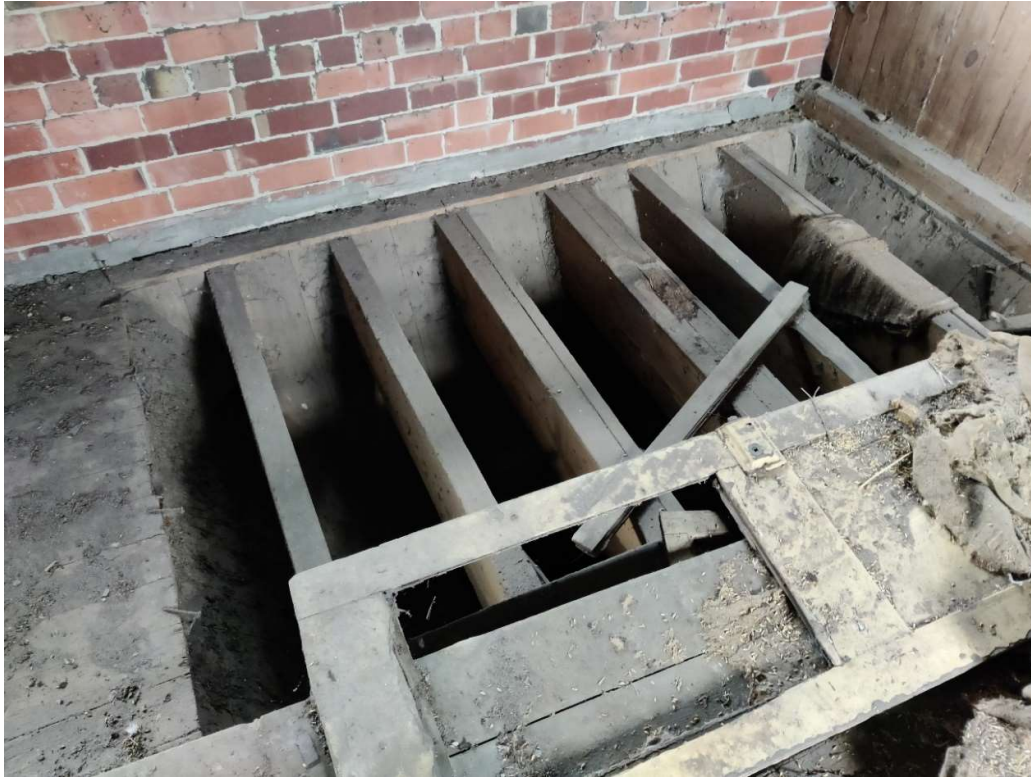
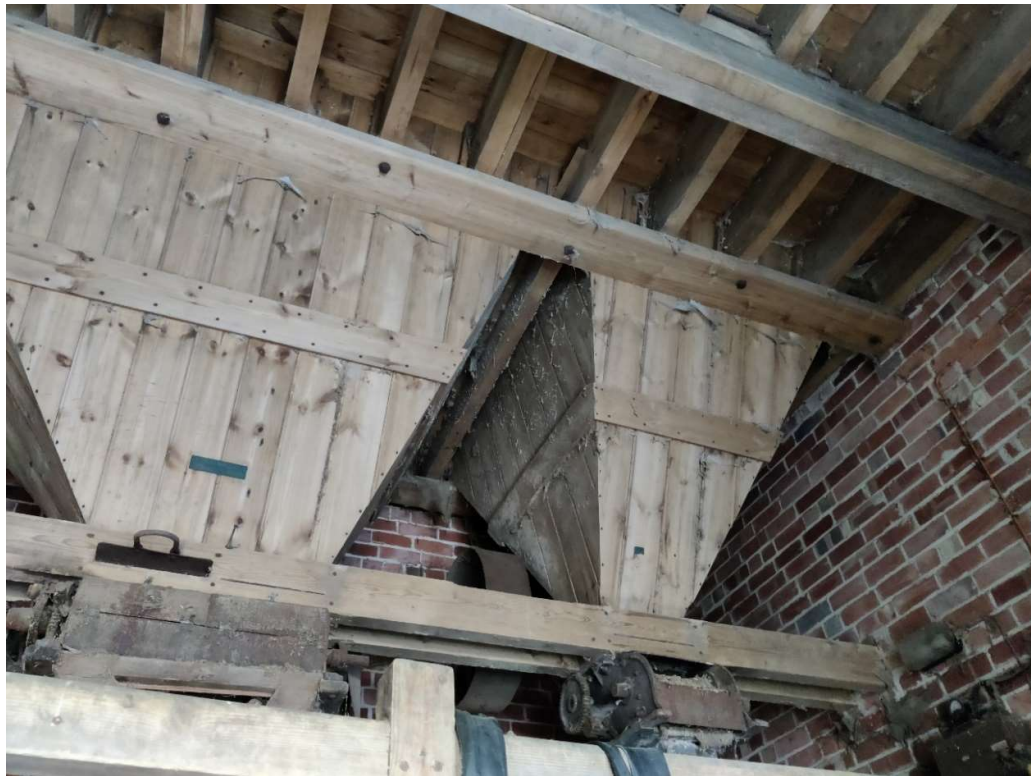
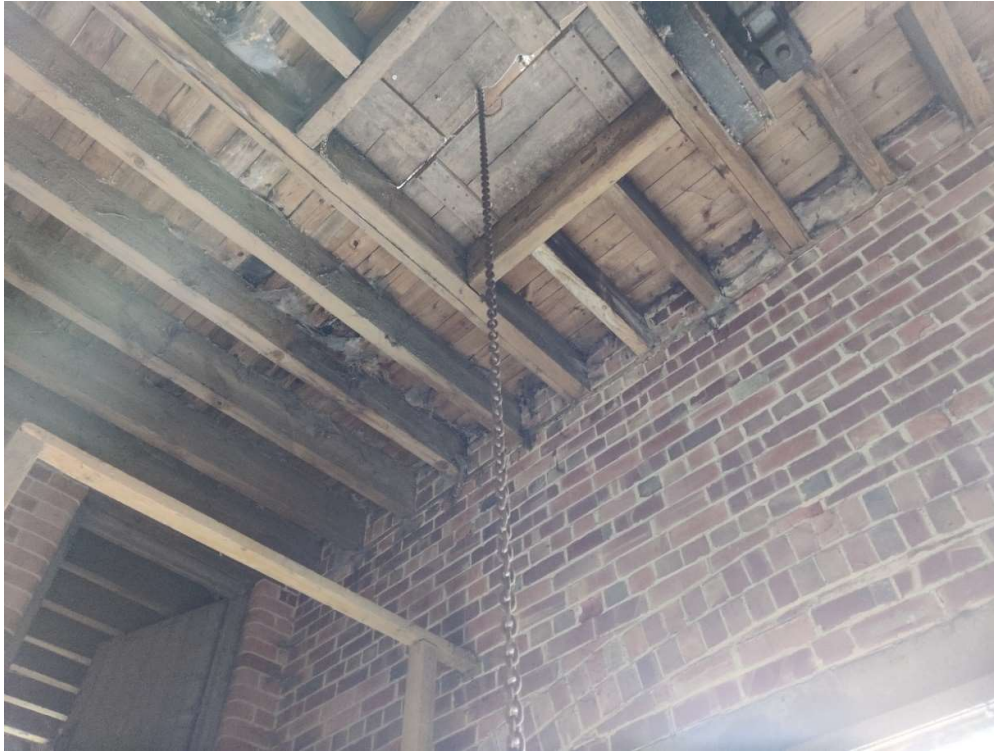
Existing farming structure and trap door within floor at second floor level is to be removed and infilled with new floor joist and boarding to structural engineer's design, and to suit existing floor structure around. Existing timber floor trimmers forming the holes, should be checked for the new loading to ensure structurally sound. All joints and connections should be reviewed on site also to ensure these are adequate and meet required standards.

Masonry condition in these areas is consistent with that noted for plot 1 assessments. Therefore, recommended further works and assessment are expected to be as required for plot 1 throughout Plot 2 also.

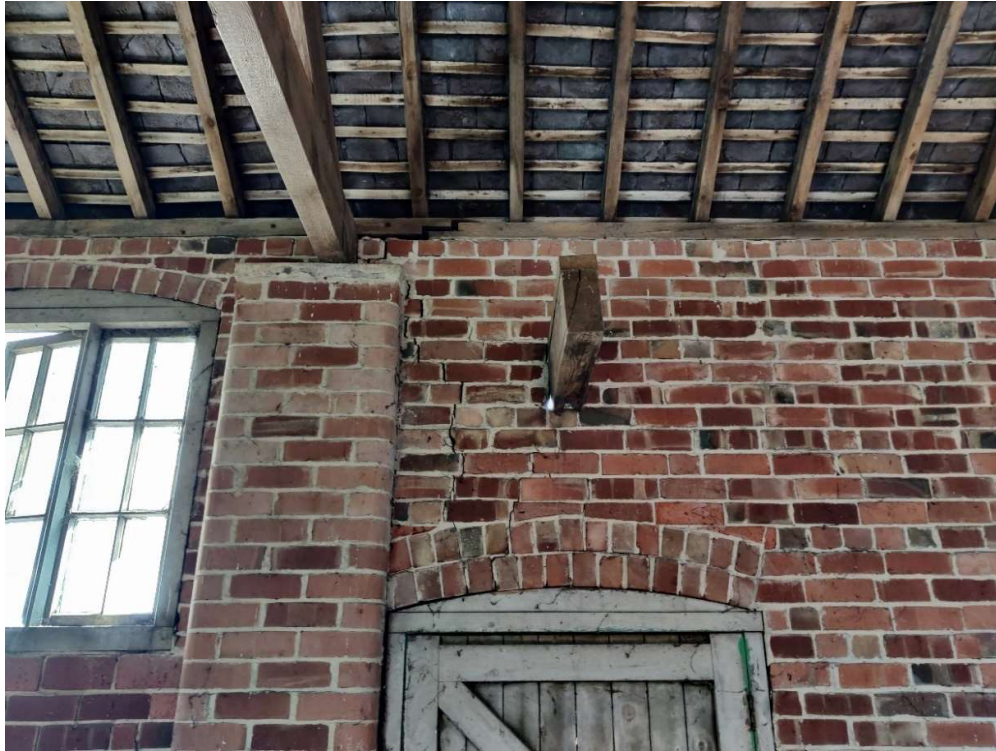
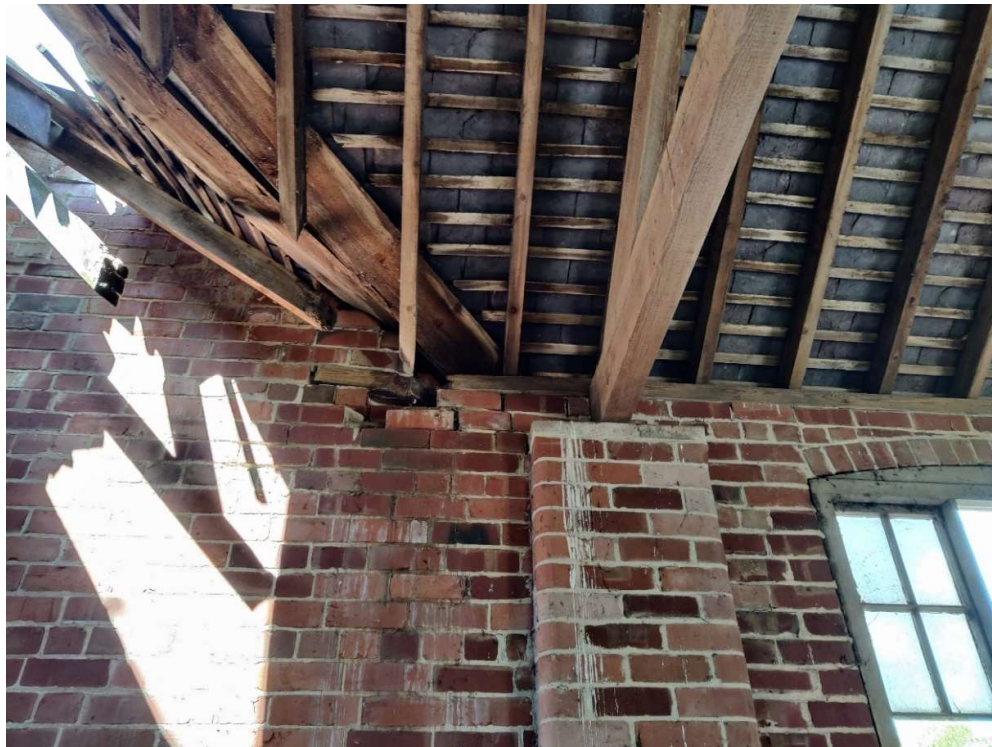
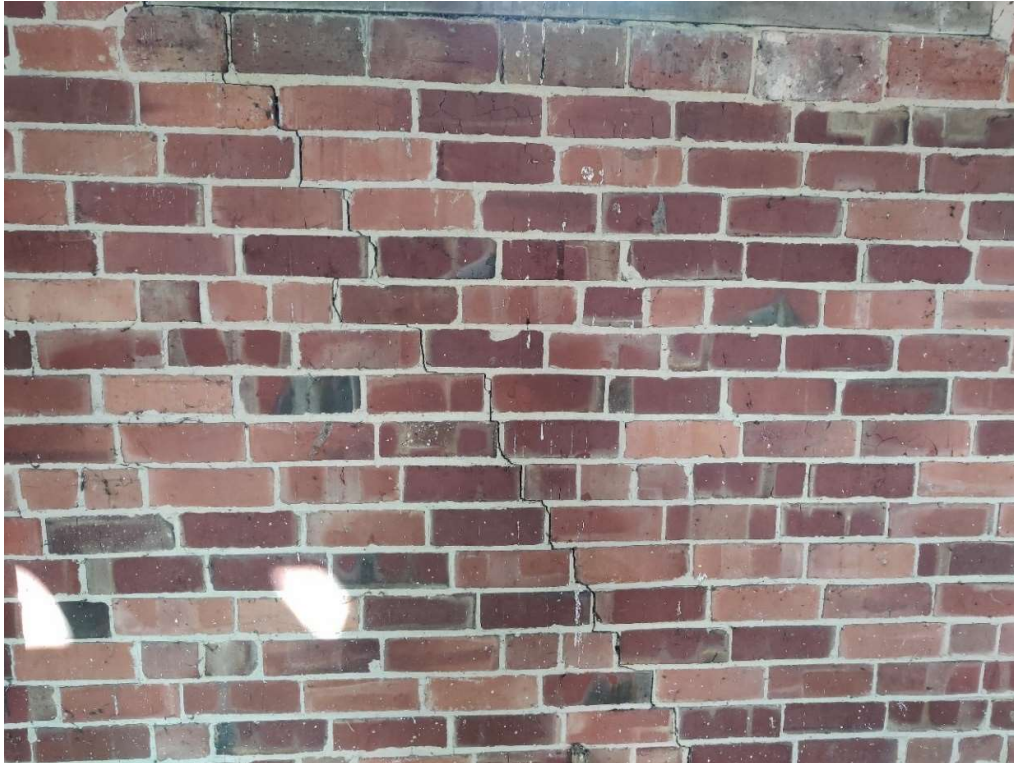
Masonry condition within the barn to the north east of the site, forming plot 2 is generally in good condition structurally. However, there are a few areas that will require repair. Firstly, the area above the door pictured above to the east elevation has substantial cracking, over it and up to roof level around the masonry pier. Has there does not seem to be any movement around the door or arched frame around the door, this is likely to have been caused by water ingress and frost. The timber wall plate has also shown signs of movement. There does not appear to be any visible cracking from the outside elevation, so appears to be internally only. The repair for this area would require all loose material to be removed. Helifix HeliBar or similar bed joint reinforcement would be recommended to ensure additional strengthening within the joints and ensure good key to the existing brickwork. This would need to be undertaken with care over the arched brickwork opening to ensure it does not collapse. Further temporary propping may be required if brickwork needs to be removed and rebuilt on closer inspection.

Similarly, the masonry on the west elevation where the roof valley meets the wall plate, there are several loose bricks that would need to be cleaned up and re-laid. A section of wall plate in this area is rotten, therefore this should also be replaced for a like for like timber section. Careful consideration between engineer and builder should be undertaken to ensure the correct length of wall plate be replaced, to ensure further parts of the roof are not affected.

Cracking to the window directly below this area is likely due to trapped water and frost. Cracking is generally small. As noted previously the repair here would be Helifix Helibar crack stitching and repointing.

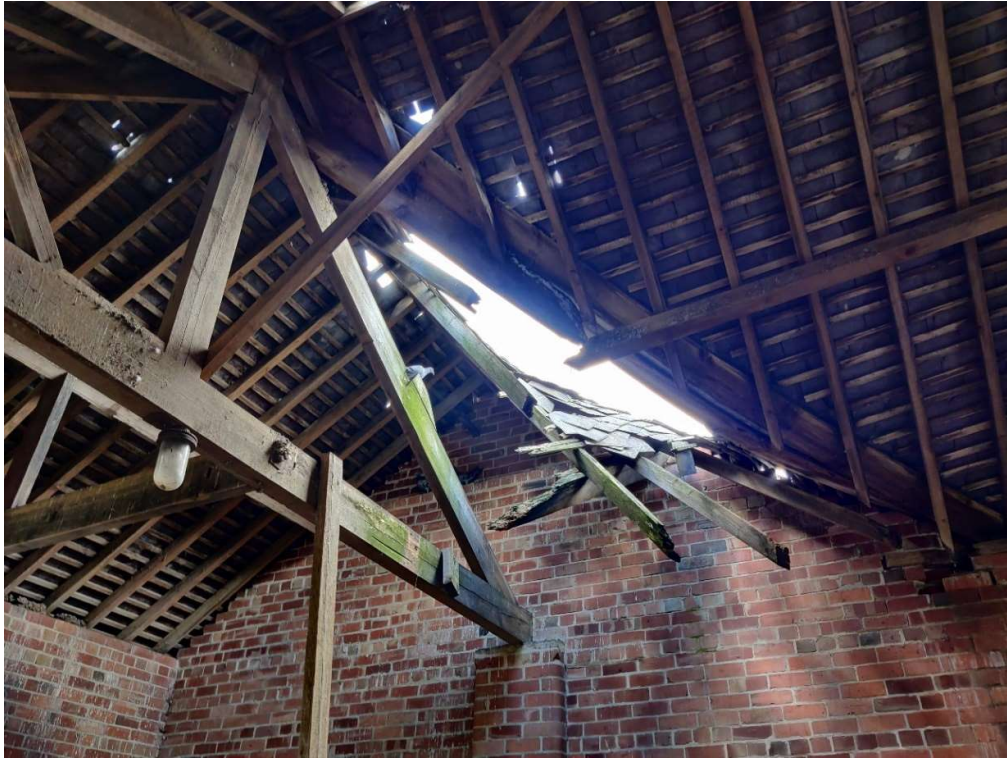
Roof structure substantially damaged in this area. All roof rafters, binders, purlins, coverings etc will need to be replaced with like for like timbers, designed and specified by appointed structural engineer.

The King Post truss looks to have minimal damage but is likely to be damp due to the exposure, therefore further assessments will need to be done to check the condition once access is available. Visually, there is a missing member to the truss internally and as shown in the picture there are signs of damp on the surface. It is likely that some of this truss may need to be replaced to unsure it can support the new roof over. But many of the existing timbers in the truss look to be solid from this view.

All timbers forming the valley in the roof will need to be replaced, this includes binders, joist and purlins. It is unclear if the remaining timbers on either side of the hole can be reused, as the collapse of this section of roof will have likely caused damage to any timbers not already rotten.

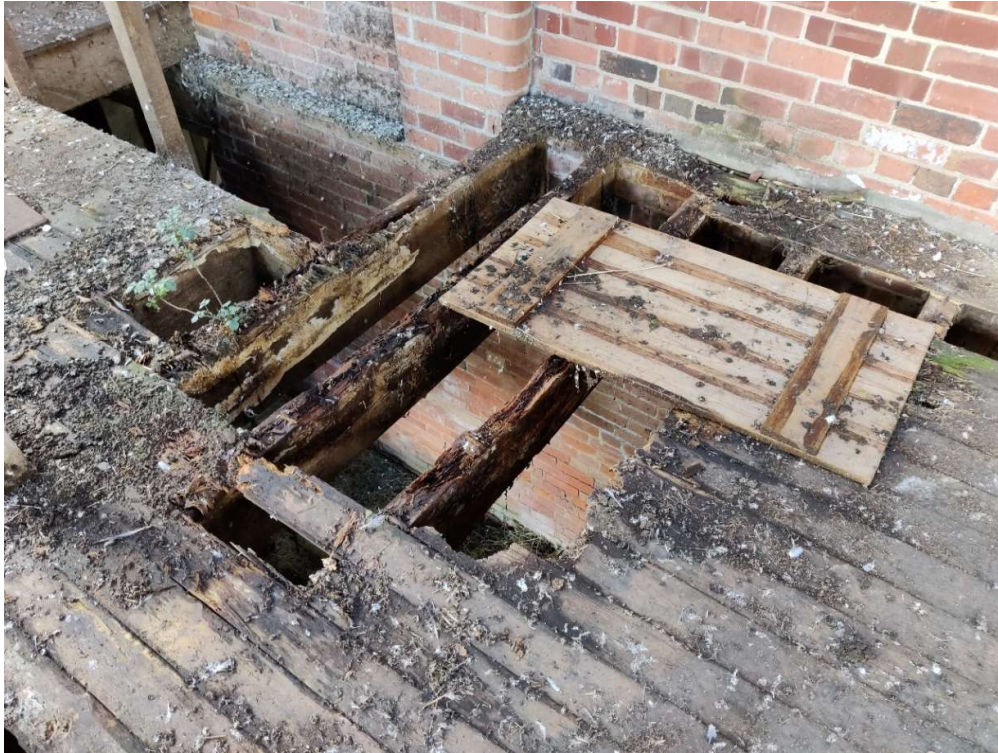
Timber Floor is generally structurally sound, however, directly below the hole in the roof, the floor structure is severely rot damaged, and will need to be stripped to assess the extent and replaced like for like.

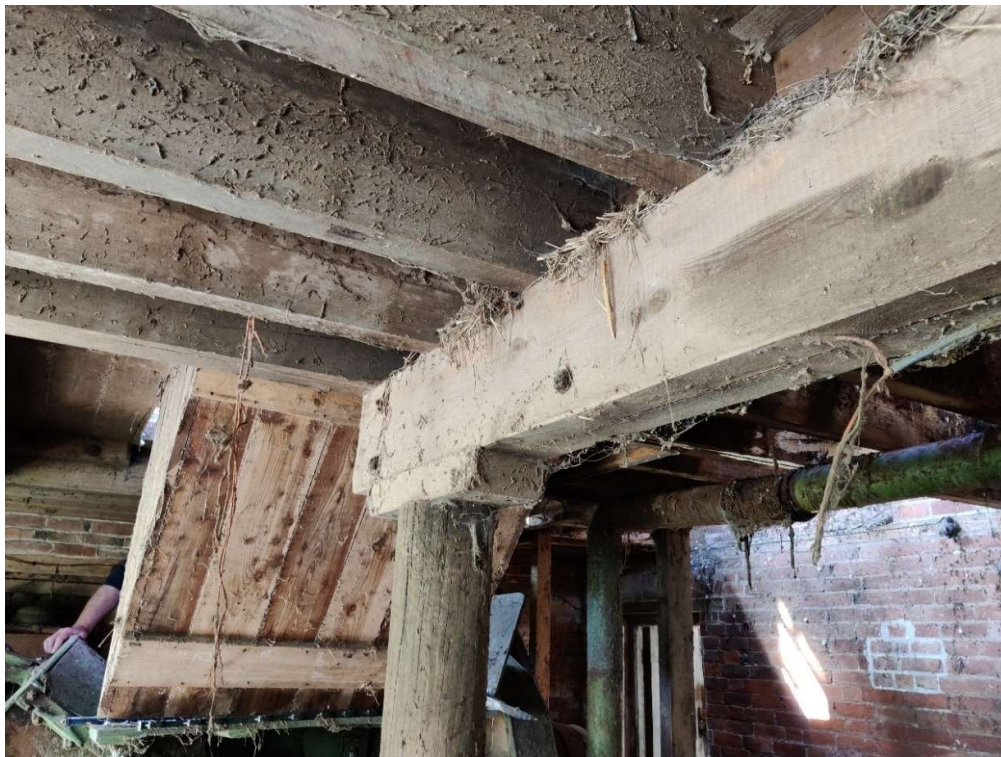
Adjacent to the large area of rotten floor timber is an existing opening within the floor with timber structures used as part of the old farm. This will need to be completely removed and replaced with new flooring to match the existing. Note that the column and beam structure currently supporting the first-floor structure stops at this point. The support of the new proposed floor joist in this area will need to be assessed by the Structural engineer for the new layout and loadings. With potentially new beams/support required.

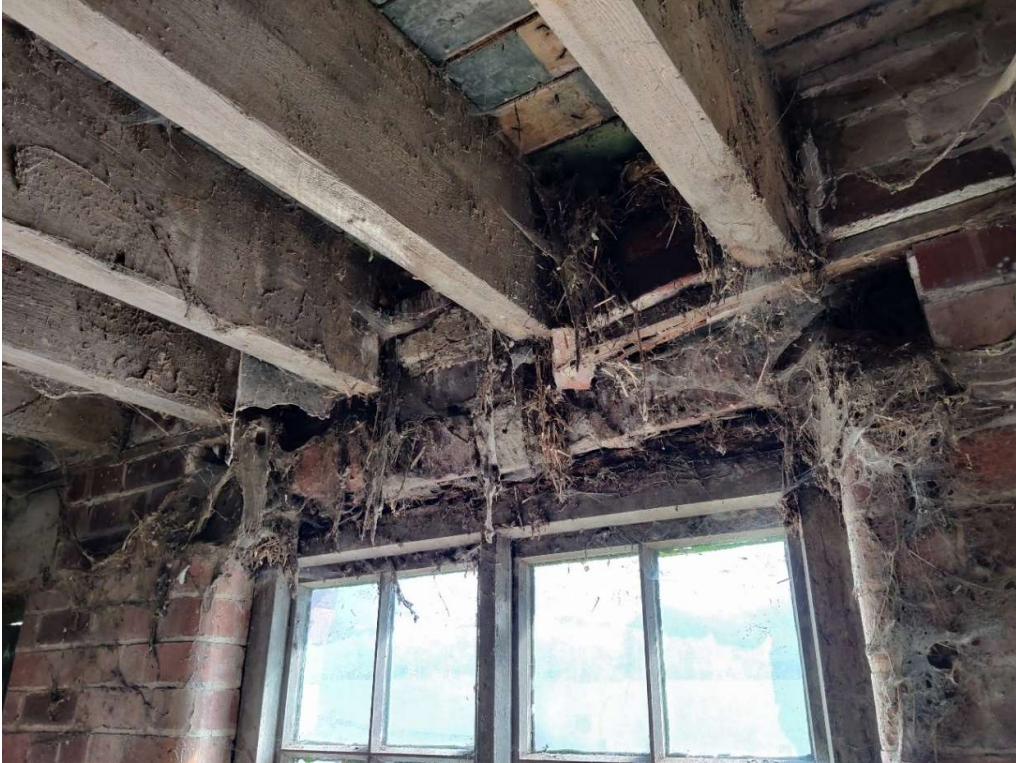
Typically, Lintels in this section of the property seem to be structurally sound. However, the timber lintel over the window above is rotten and will need to be replaced. It is possible that this lintel may have caused some of the cracking through movement to the wall above, but is unlikely to be the main cause.

The lintel will need to be replaced with a suitable lintel designed by the structural engineer to support the floor joist loadings over. This should ideally be a like for like timber lintel to match the existing structure.

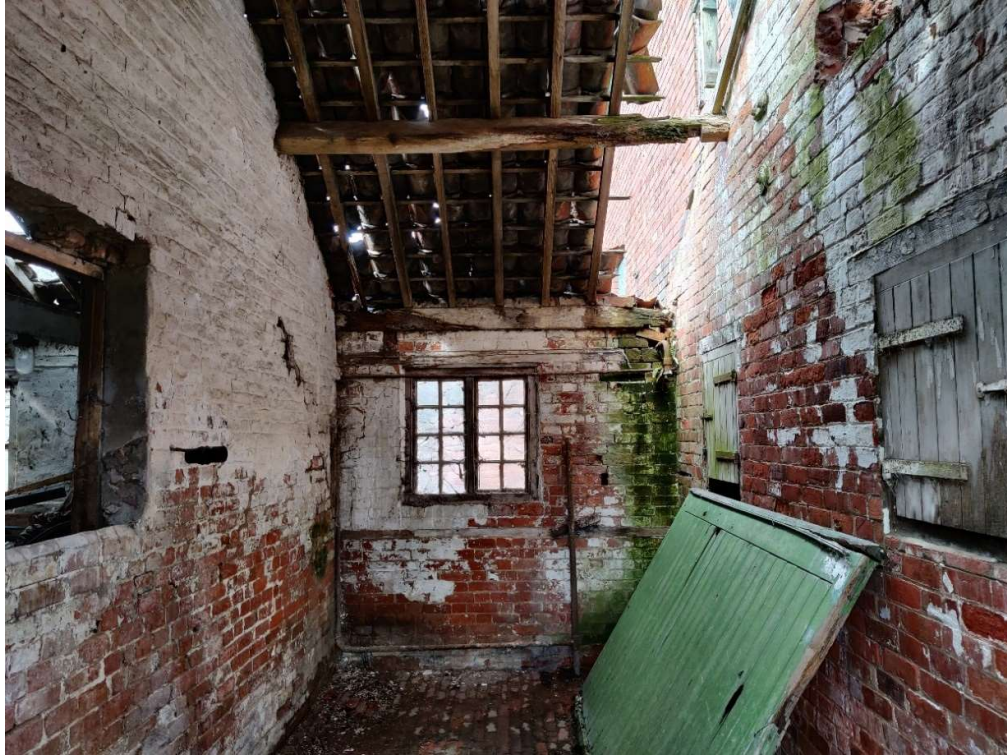
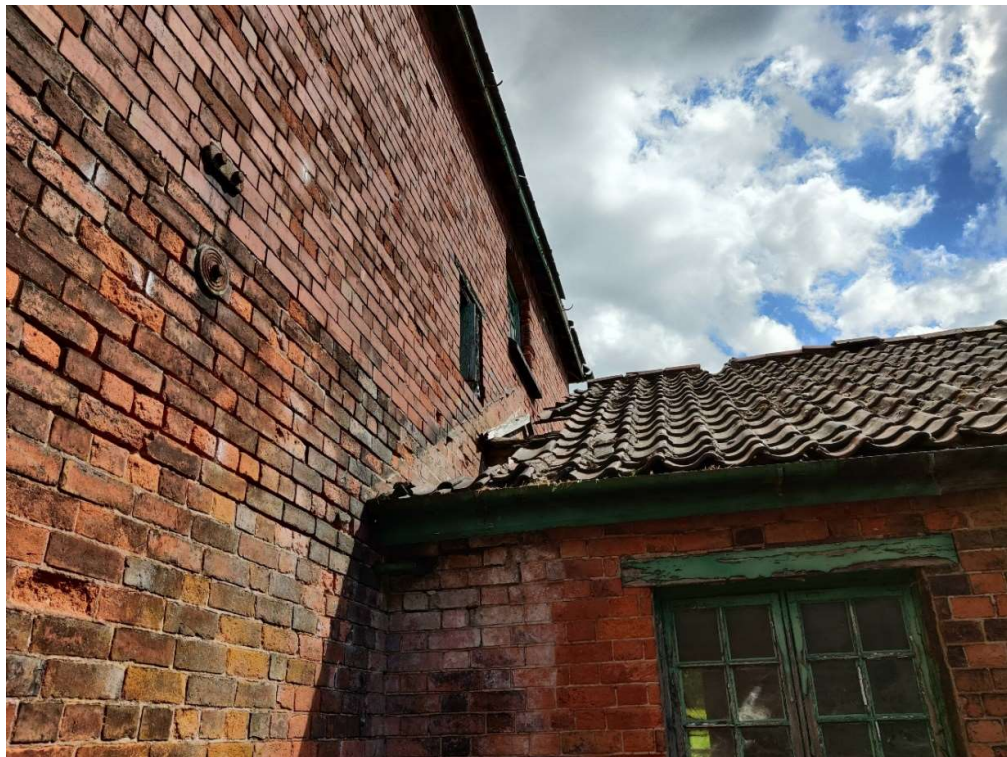
Roof severely damaged and rotten where adjoined to plot 2 elevation. Roof structure to be completely replaced in this area to replicate the existing roof throughout plot 3. Structural support to purlins from plot 2 party/external wall.

Masonry adjoining plot 2 wall also damaged and not fully connected to wall to provide adequate restraint. Most of the issues seem to be internally, as from the outside view of this area the masonry does not seem to be damaged or cracking. Therefore, removing loose bricks and mortar and rebuilding should be adequate. In the event more than 20% of the height of the wall needs to be removed, it would be advised to also install some form of masonry tie within the mortar joint to provide additional fixity between the two walls.

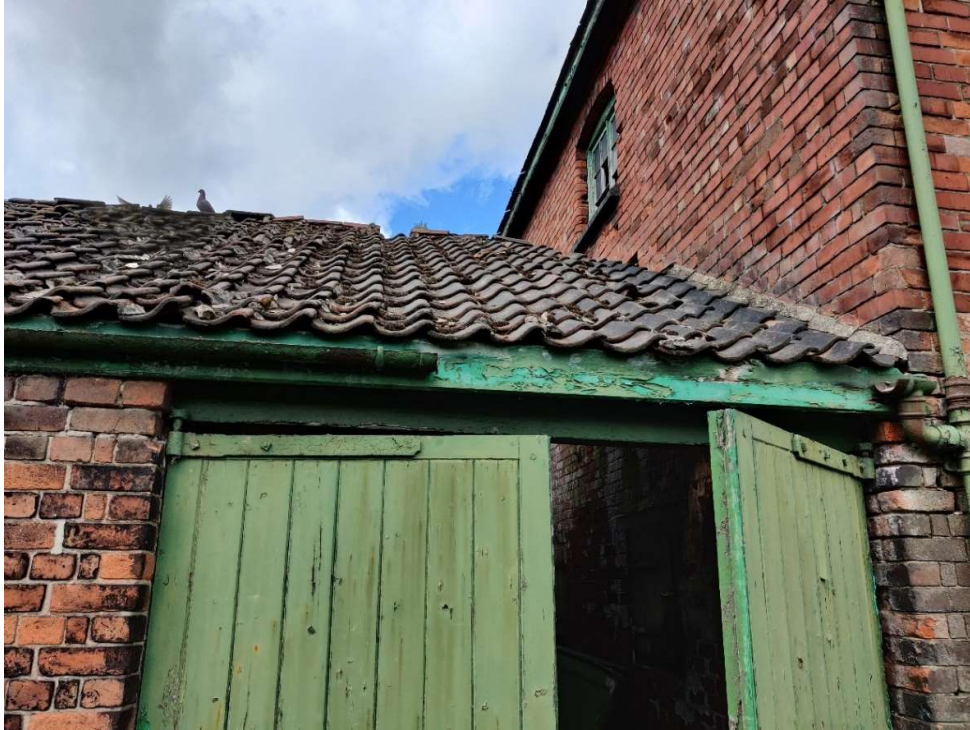
Existing Timber lintel showing signs of rot. This will need to be replaced with a suitably sized timber lintel to support the roof structure over. Also note missing mortar joints and potentially loose brickwork to either side at the top of the opening. All loose material to be removed and rebuilt and pointed.

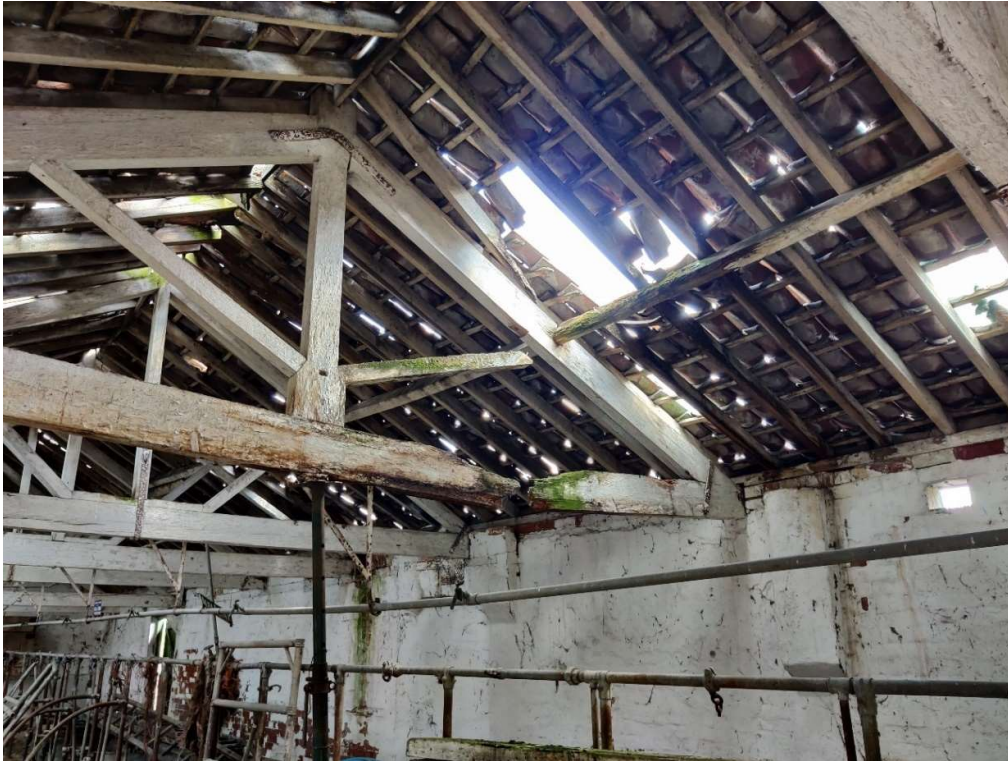
Roof within main area of plot 3 has substantial number of holes within the roof covering, causing issues with purlins, joist, and trusses where directly exposed and beyond in some cases. Most noticeable area is pictures above where the bottom chord of the king post truss has rotted all the way through and broke into two sections. This has most likely also caused the internal member to become disjointed. This truss will need to be replaced with a like for like replacement, designed for the proposed loadings by the structural engineer. Roof purlin and rafters in this area will also need to be completely replaced were rotten.

From a visual inspection from Ground level the remaining king trusses seem fine, with only minor defects, however, these would need to be reassessed once the roof covering is removed to ensure there is not any damp, rot or hidden damage from above.

Some minor removal of rotten material may be acceptable in the final build, but further assessment will need to be carried out by the structural engineer, to ensure a minimum cross-sectional area of each member of the truss is calculated for the proposed loading.

Due to the failure of the bottom chord member of the above truss. The external wall to the west elevation has been pushed out substantially. Due to the level of movement and cracking along the middle of the wall in this area, we would suggest carefully removing the brickwork along the affected area, to allow it to be rebuilt using the existing masonry as much as possible. This will ensure no future issue with movement once the roof structure is repaired.

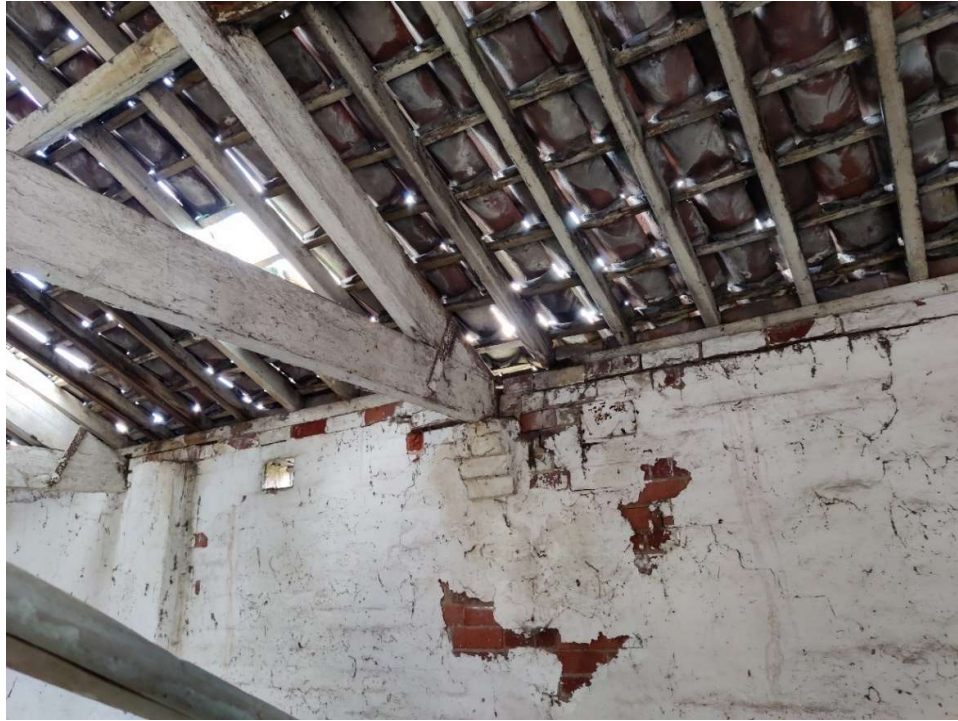
Elsewhere there are several areas of loose brickwork and missing mortar, mostly at the head of the wall in areas supporting the roof trusses. These areas should have any loose elements removed and cleaned up to allow them to be reused in the reconstruction of the wall and pointed afterwards.

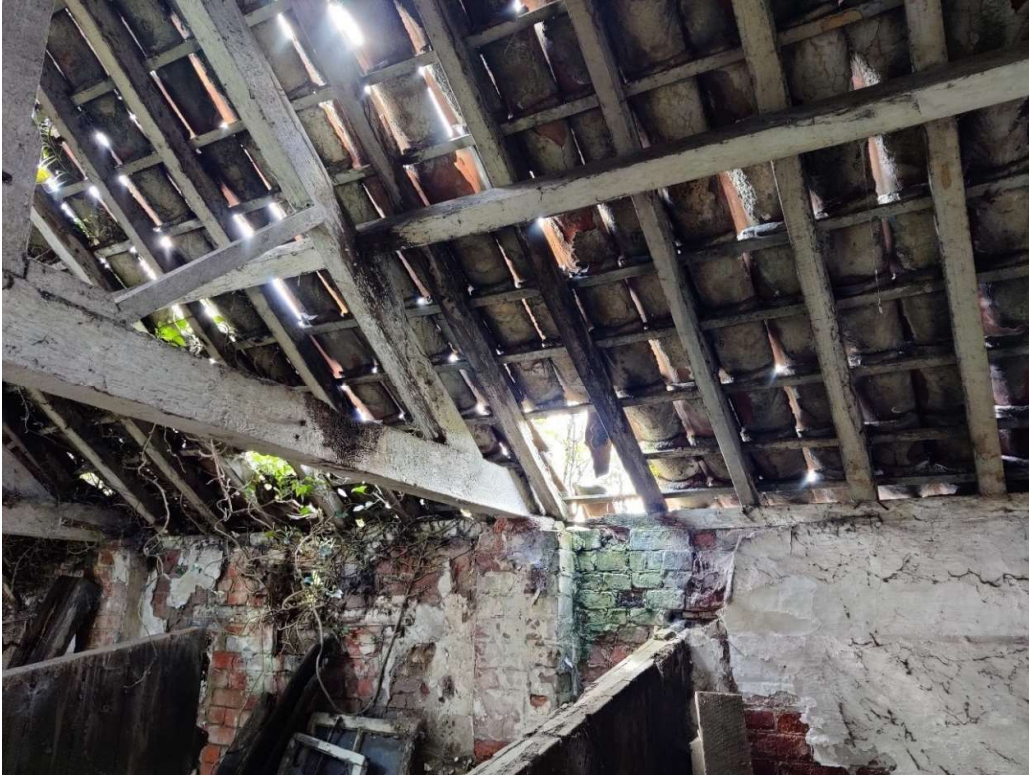
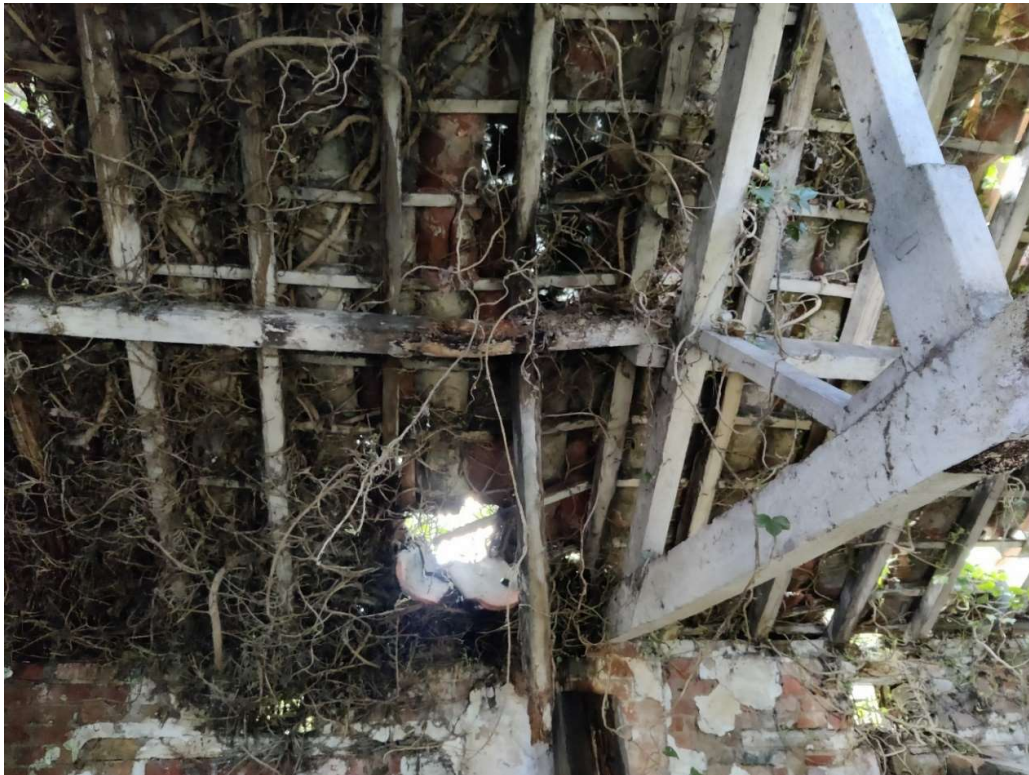
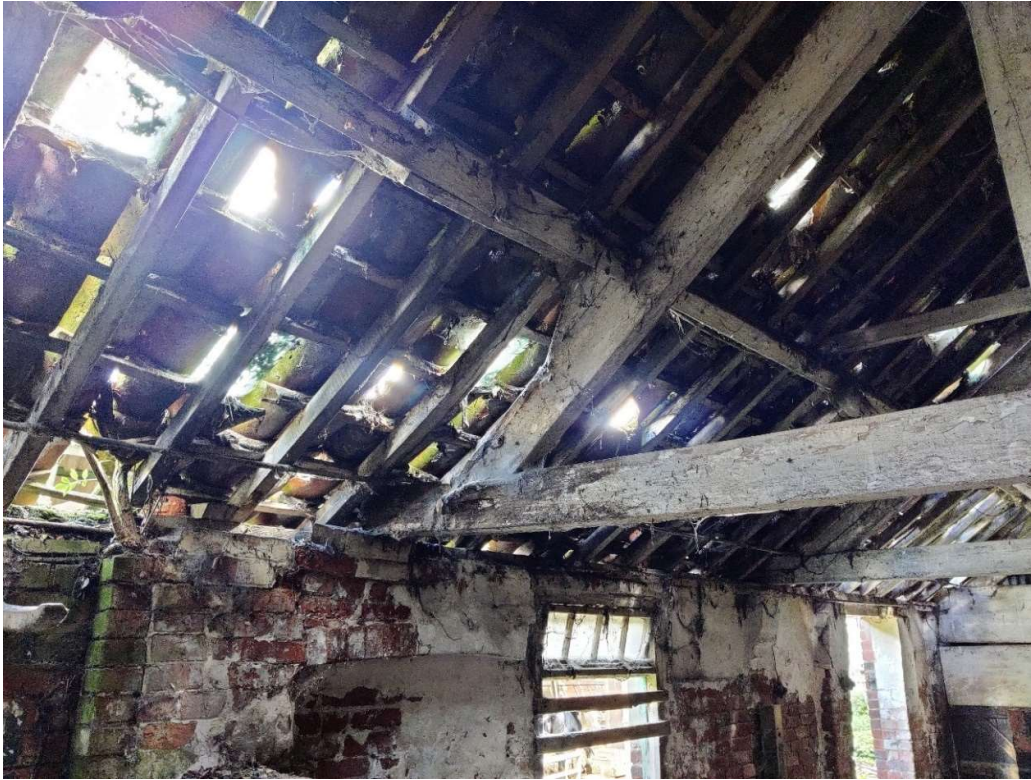
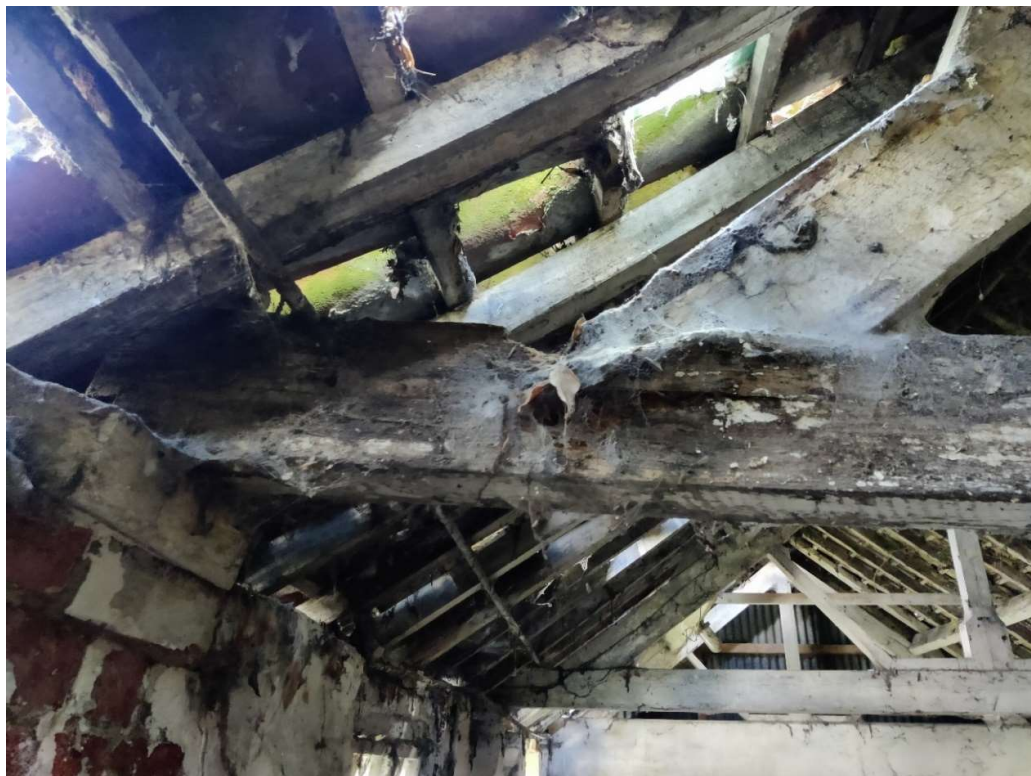
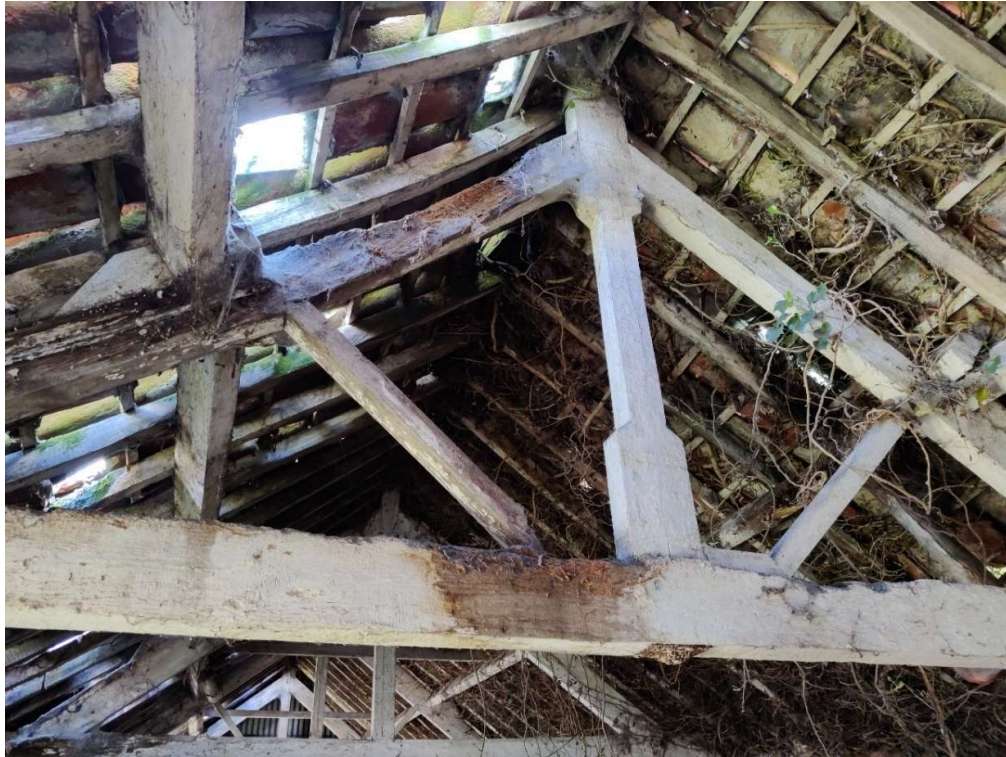
The roof in plot 4 is in the worst condition overall, with much of the roof missing coverings. Several of the king post trusses have severe rot and will need to be replaced. Purlins member between trusses in several areas are also rotten, along with roof rafters and binders. Once the roof covering is fully removed the king post trusses that appear ok from ground level can be properly checked for rot, damp, and damage. Where the damaged timber trusses are found, king post trusses replicating the existing trusses would be ideally used, potentially where possible reusing existing timber that remain in usable condition.

Due to the damage to the roof structure, movement has occurred at the head of some of the walls causing brickwork to become loose and leaning. Where this is the case, all leaning and damaged brickwork is to be carefully removed and rebuilt using the existing brickwork wherever possible. It is also likely that the timber wall plates will also need to be replaced due to rot throughout.

Masonry internally below the top section of walls, does not look substantially damaged. However, there are lot of obstructions, including tree roots growing around the wall that have likely caused damaged. All growth will need to be fully removed from the wall to allow proper inspection. It is highly likely that some rebuilding will need to be undertaken, and at a minimum repair of loose bricks and pointing. In this case the existing brickwork should be reused wherever possible.

Timber lintels to several windows are also rotten and will need to be replaced with similar timber lintel ideally, to structural engineer's design to suit new loading requirements.

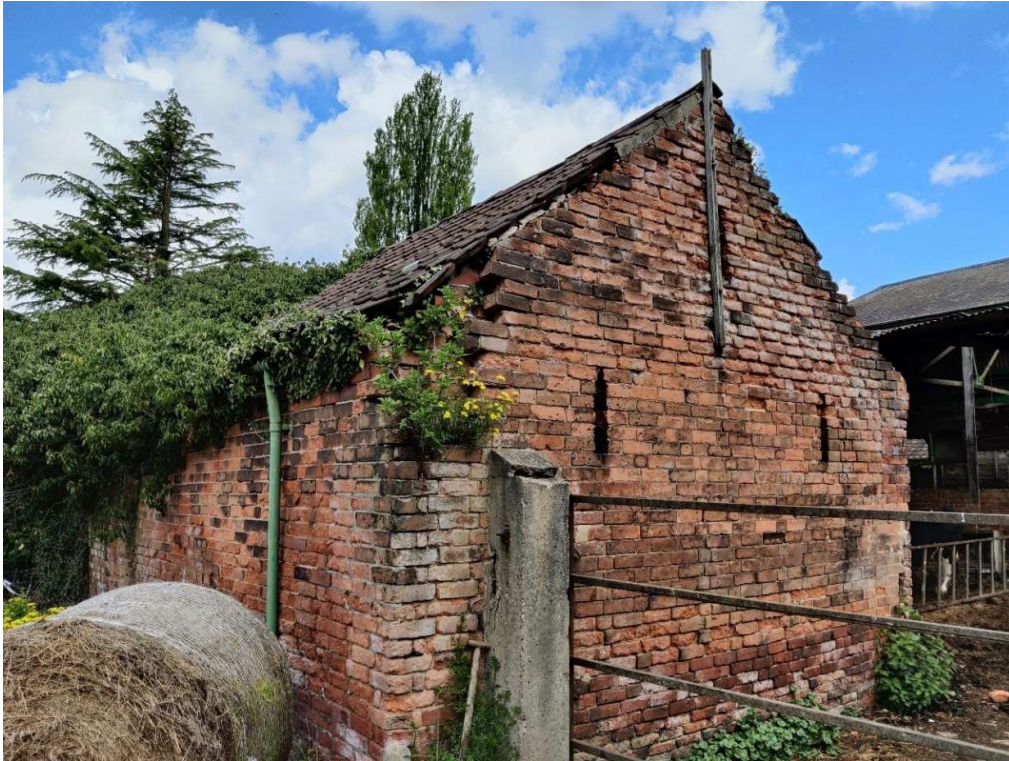
External Brickwork visible beyond the tree growth will require repair in places. Most noticeably the southeast corner of the structure where there are several missing bricks that would need to be rebuilt. Brickwork with Blown faces generally will need to be replaced where excessive, as shown in the picture above. Several areas of the wall require repointing, loose material should be removed where found.

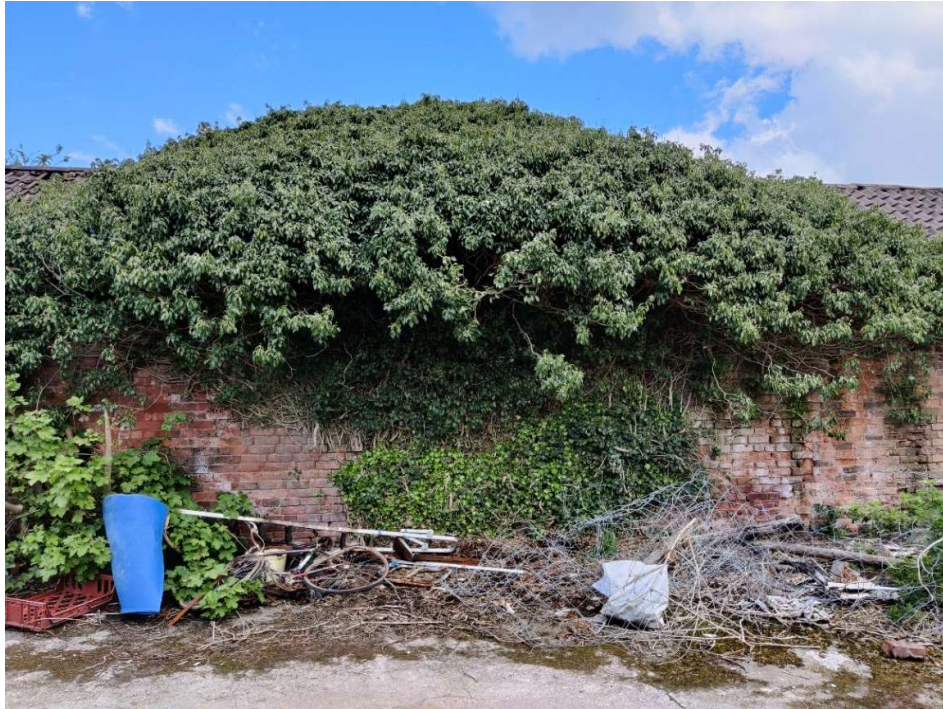
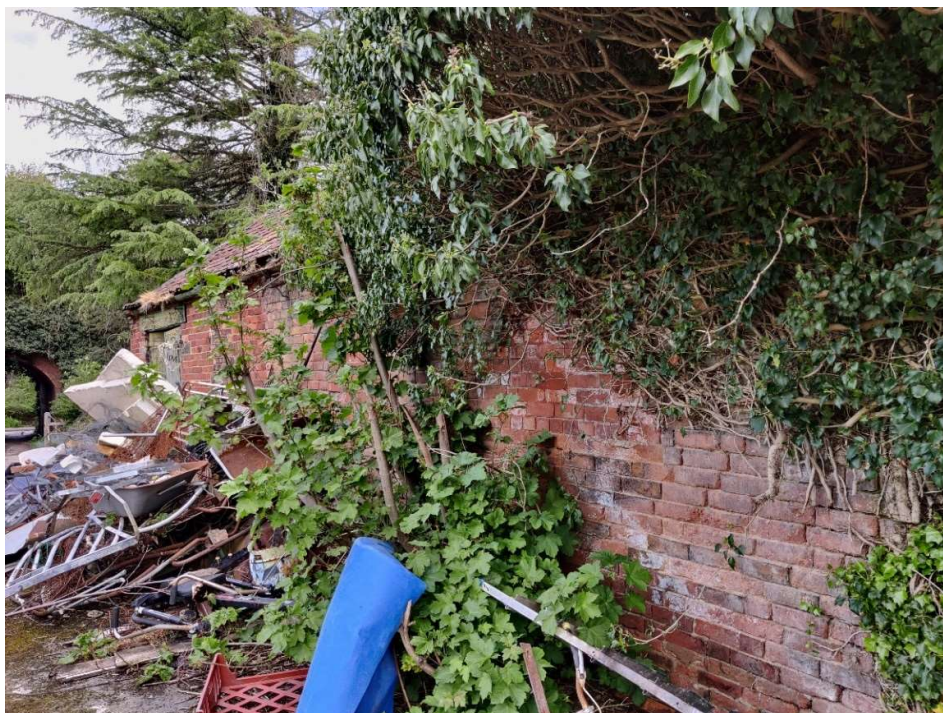
Vegetation to south face of plot 4 is extensive, as noted for the internal assessment, damage is difficult to determine without the removal of vegetation. But it is very likely that at least loose bricks, minor cracking, and missing mortar will be present. This should be repaired where possible using the existing brickwork, and repointed. Any excessive cracks should be repaired using Helifix HeliBar as noted previously. If walls have been caused to lean up to approx. 100mm (assuming wall thickness of 225mm), then it is also likely that the wall will need to be rebuilt in these places to ensure future structural stability is maintained.

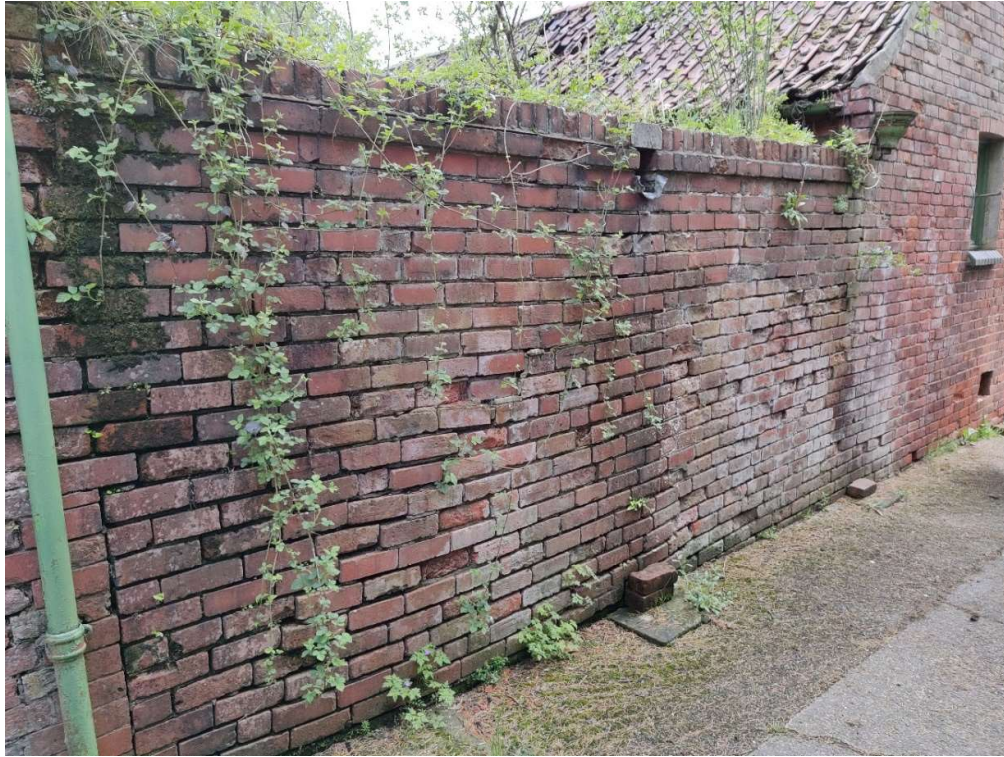
Existing wall to rear of Pig Sty is leaning. If this is less than 100mm, assuming a 225mm thick wall. Then it may be possible to strengthen the wall using Helifix HeliBar or similar bed joint reinforcement within the mortar and then repointed. However, as this wall is to form part of the plot 4 structure, and supporting of the new roof over. It would be a better option to rebuild using the existing brickwork. All vegetation will need to be removed.

It would also be advisable that the foundations of this wall be assessed before applying vertical loadings, as part of the proposed plans for this area.
