Technical Note

Project: Forge Farm Barn Conversions
Subject: Structural Assessment
Ref: B2021_094/ECSL/TN/001
Date: 01/06/2021

Introduction

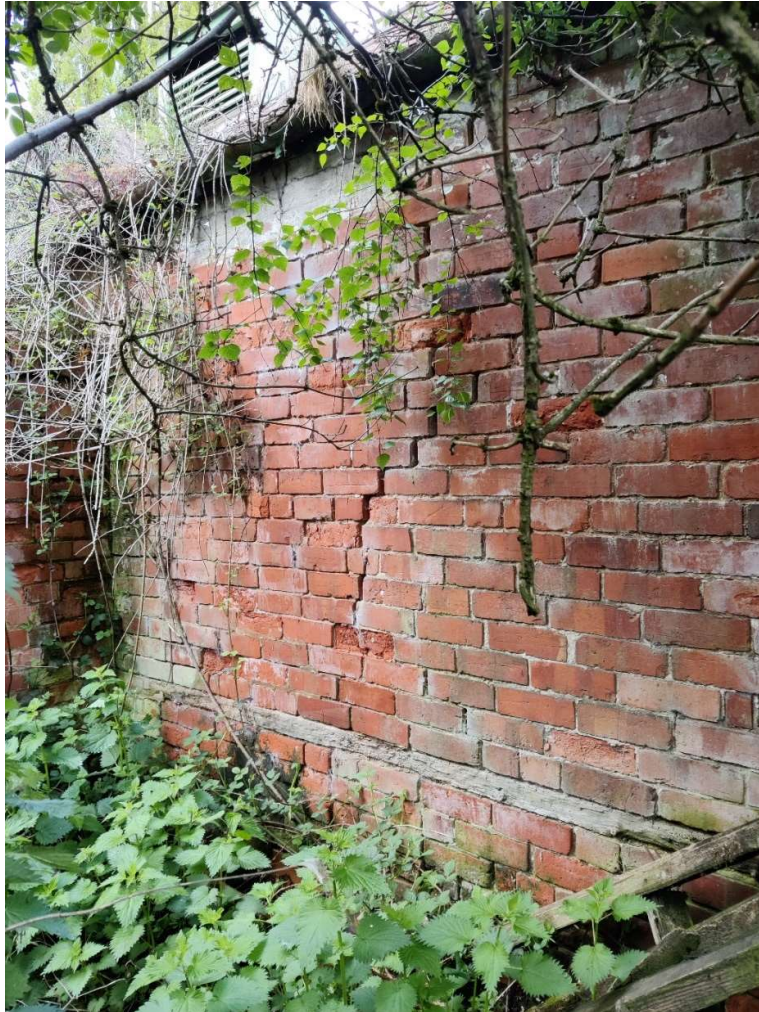
Cracking to external side of barn north of pig sty. Internal face not visible due to plaster or similar finish. However, if cracking was present internally it would likely have also cracked this finish. Therefore, suggest crack repair using Helifix HeliBar as previously and repointing to external side only. All vegetation to be removed and wall to be rechecked for further hidden damage.

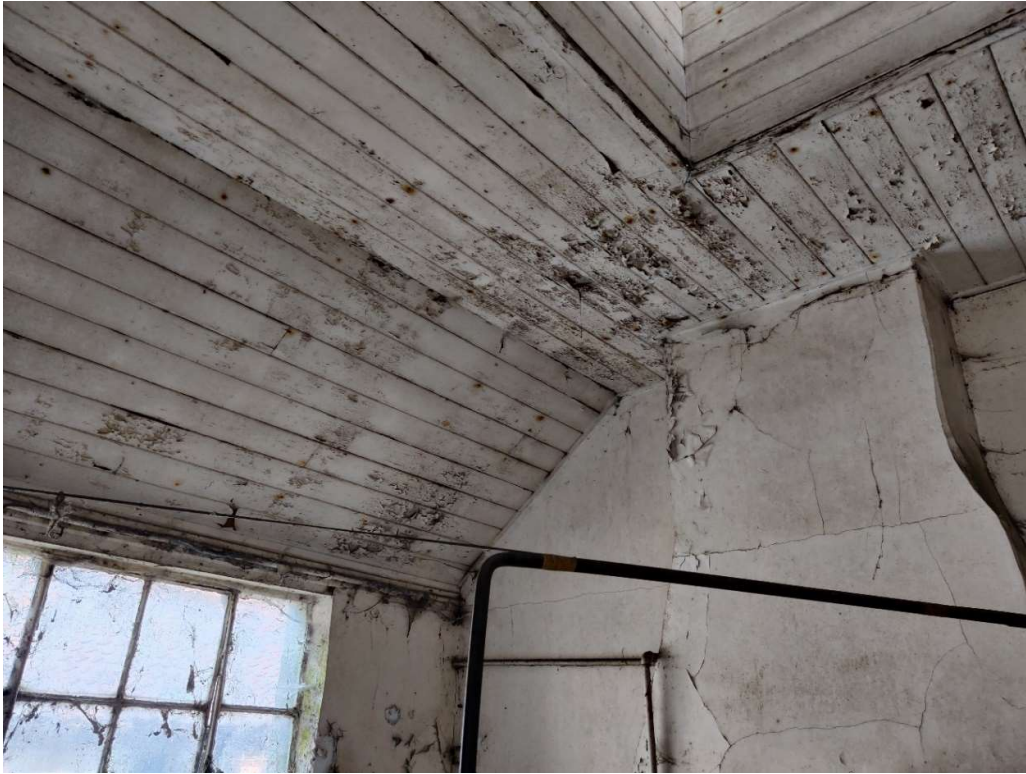
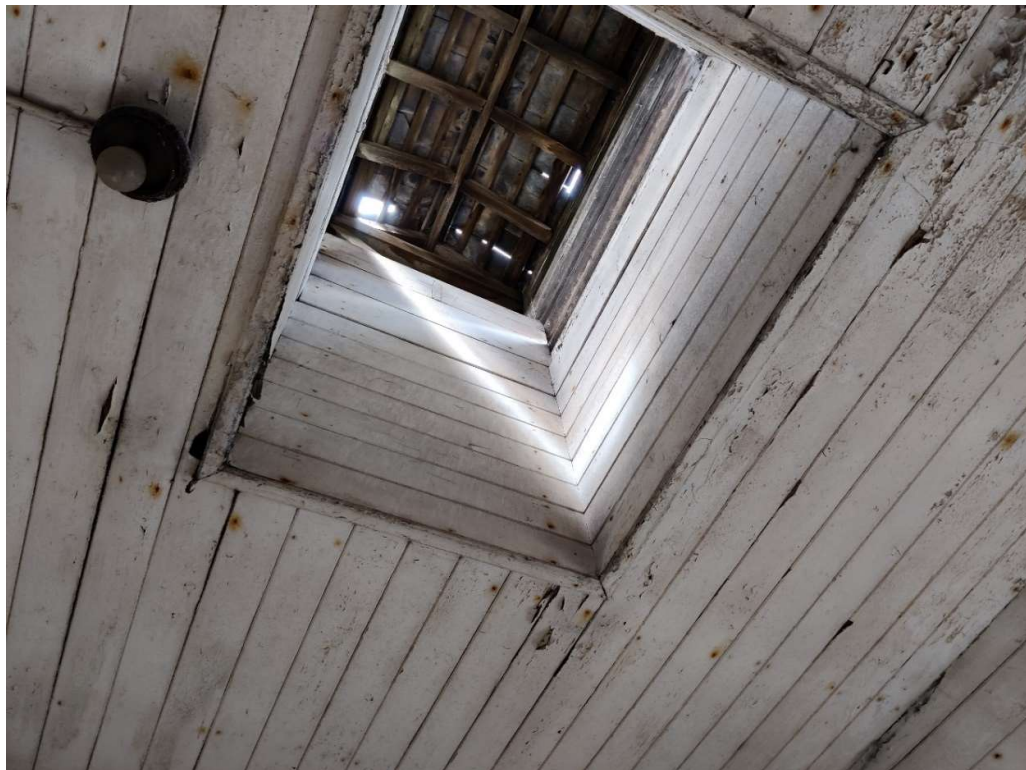
Roof within barn has been covered with timber throughout. However, daylight is present through the joint that suggest the roof construction over is in similar condition to the other barns. Where there is an access hole it is visible that there are holes within the roof covering and will therefore require further work. Once the timber finish is removed, measures similar to

that pointed out elsewhere on the site should be adopted. If in doubt, then a structural engineer should be appointed to review further and advise.
