Tree Survey Recommendations

Client: Concord College
 Site: Main Site

Llanerch Arboriculture

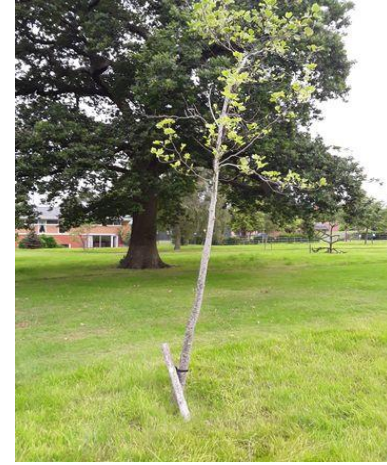
Ref	Species	Location	Survey Notes	Work Recommendations	Priority	Photo	Photo
T412	Leyland Cypress (Cupressocyparis leylandii X)	In shrub bed area between path and wall	Fair Form Tight fork evident at 9m, it does appear to be in the process of slow failure. It does not appear to be adapting to this fault. Previous work recommended to this tree has not been undertaken and should be programmed	Reduce height of tree by at least 4m to reduce loading at failing tight fork. Tree marked with YELLOW paint	3 Months	No Photo.	
T319	Italian Cypress (Cupressus sempervirens)	Centre of unmown grassed area	Good Form, has a lean because slightly unstable in the ground	Re-firm stake and tree making sure tree is vertical	3 Months	No Photo.	
T331	Tulip Tree (Liriodendron tulipifera)	On edge of unmowed grass area	Good Form, struggling to stabilise and is rocking in the ground. Tree needs stabilising otherwise it will not establish and maybe die.	Re-stabilise the tree using multiple stakes and strapping and apply basal woodchip mulch to improve immediate rooting environment. Support post marked with YELLOW paint	3 Months

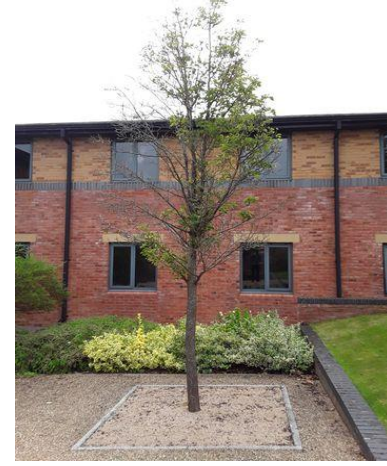
T362	Pear x5 (Pyrus sp.)	Group of 5 trees in a line by residential block	Good Form Notably two trees in hard surfacing not as vigorous or large, one in hard surfacing nearest grass has fire blight & needs removing, tree still remains and is 50% dead	Remove tree with fireblight, and replace with new tree.	3 Months

Fireblight infection	
T456	Pedunculate Oak (Quercus robur)	In rear garden by tree house	Good Form, has a split hung up branch at 10m height, facing house Adjacent landowner has cut low hanging branches Minor deadwood in crown.	Remove split hung up branch at 10m. Remove all dead branches from the crown	3 Months	No Photo.

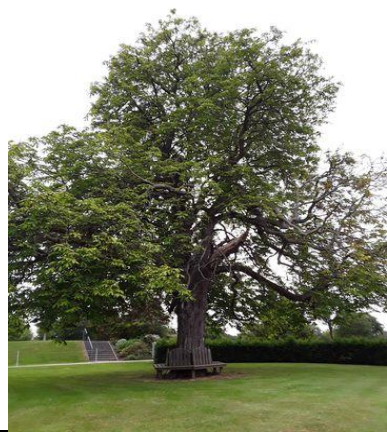
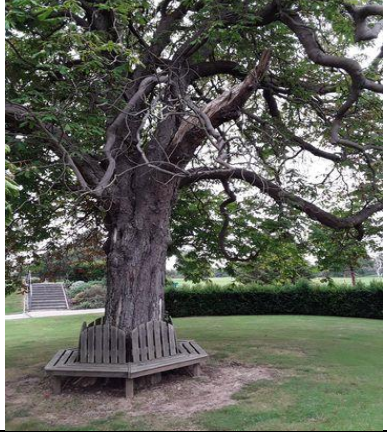
Ref	Species	Location	Survey Notes	Work Recommendations	Priority	Photo	Photo
T391	Horse Chestnut (Aesculus hippocastanum)	Large tree on grassed area with bench around trunk	Long arching limbs previously reduced, but bleeding canker has really impacted. Large area of dead bark throughout crown on all limbs and main stem. Only surface decay developing, but vigour has dropped significantly since last inspection. If tree had not been reduced, removal would have been already recommended. Large diameter limb dailed at 4.5m other large limbs are dying back. No fungus evident, but the loss of the large limb and the continued decline, and relatively high risk target, makes retention of this tree no longer feasible.	Fell to ground level	6 Months

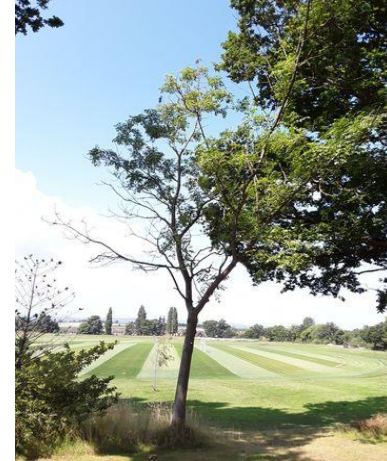
T122	Common Ash (Fraxinus excelsior)	Adjacent to old boundary	Crown Lifted in past Good Form Struggling, has Chalara Ash dieback on over half of the crown (crown health <50%). Tree is not dead but becomes more hazardous as it declines.	Fell to ground level, tree marked with ORANGE paint	1 Year

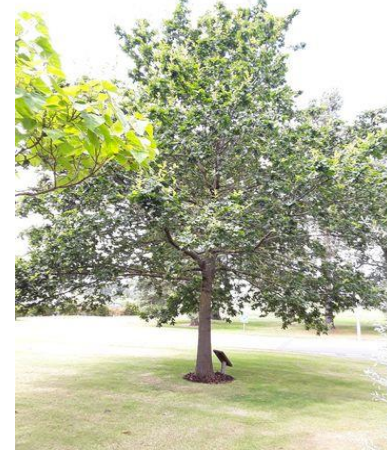
T200	Pedunculate Oak (Quercus robur)	On grassed area	Crown Lifted in past, branch tips are low Good Form, commemorative tree for Our Lady of Sion	Crown lift branch tips to 2.5m all round. Pruning cuts to be kept to less than 100mm diameter. Tree marked with YELLOW paint	1 Year

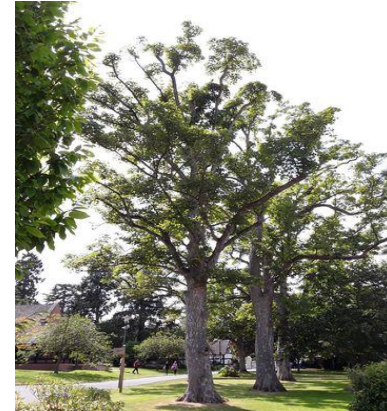
T234	Sycamore (Acer pseudoplatanus)	On large grassed area near car park, part of large group	Crown has been reduced since last inspection and any dead branches removed. It is unclear as to the specification for the work, although the resulting crown shape is good. The remaining crown is reasonably good although there are some signs of the decline of some small branches. Previously vigour was stabilising with some growth on long laterals following mulch application a few years ago. Improvement of vigour has slowed, tree may start declining by next survey, hence the rerecommendation of woodchip application.	Application of mulch spread as evenly as practicable to a depth of 75 mm over an area of 3 metres diameter with the tree at the centre. The mulch shall comprise of wood chips & leaves which have been composted for at least 6 months and shall not be piled against the bark of the tree. Tree marked with YELLOW paint	1 Year

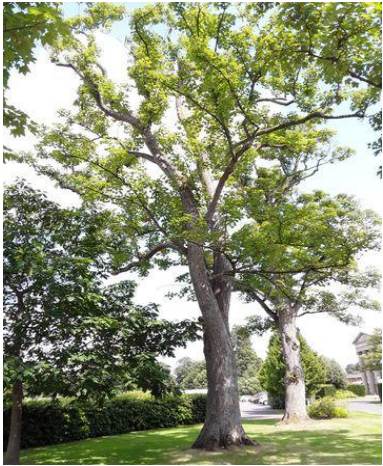
Ref	Species	Location	Survey Notes	Work Recommendations	Priority	Photo	Photo
T235	Sycamore (Acer pseudoplatanus)	On large grassed area, part of large group	Crown has been sensitively reduced since last inspection and any dead branches removed. The remaining crown is reasonably good although there are some signs of the decline of some small branches Previously vigour was stabilising with some growth on long laterals following mulch application a few years ago. Improvement of vigour has slowed, tree may start declining by next survey, hence the re-recommendation of woodchip application.	Remove all major deadwood (>80mm dia) & stubs from throughout crown. Application of mulch spread as evenly as practicable to a depth of 75 mm over an area of 3 metres diameter with the tree at the centre. The mulch shall comprise of wood chips & leaves which have been composted for at least 6 months and shall not be piled against the bark of the tree. Tree marked with YELLOW paint	1 Year

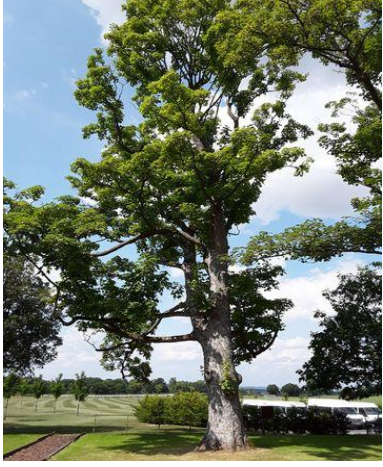
July 2021	
T237	Sycamore (Acer pseudoplatanus)	On large grassed area, part of large group	Crown has been reduced since last inspection and any dead branches removed. The remaining crown is reasonably good although there are some signs of the decline of some small branches high up in the crown. Previously vigour was stabilising with some growth on long laterals following mulch application a few years ago. Improvement of vigour has slowed, tree may start declining by next survey, hence the rerecommendation of woodchip application. This is probably the best of the 4 trees.	Application of mulch spread as evenly as practicable to a depth of 75 mm over an area of 3 metres diameter with the tree at the centre. The mulch shall comprise of wood chips & leaves which have been composted for at least 6 months and shall not be piled against the bark of the tree.	1 Year

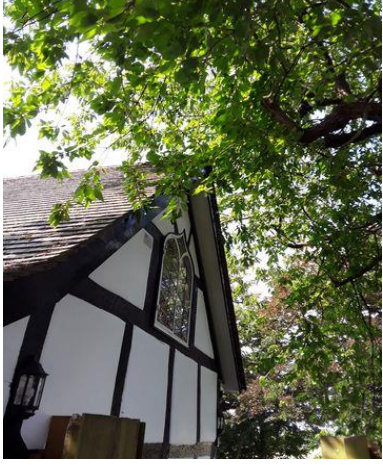
July 2021	
T247	Cherry (Prunus sp. (Cherries))	To the side of the lodge, just inside the garden	Crown Lifted in past Fair Form, pruned away from the building previously, but this has regrown. Some bacterial canker infection on main stem	Crown reduce to clear building by 2.0m.	1 Year

Branches touching	
T415	Cherry (Prunus sp. (Cherries))	On grassed area near wall & tutorial classroom	Good Form Has bacterial canker infection, notably on a few lower scaffold limbs. Branch tips touching adjacent tutorial room	Crown reduce to clear building by 2.0m. Pruning cut(s) should be less than 100mm diameter . Tree marked with YELLOW paint	1 Year

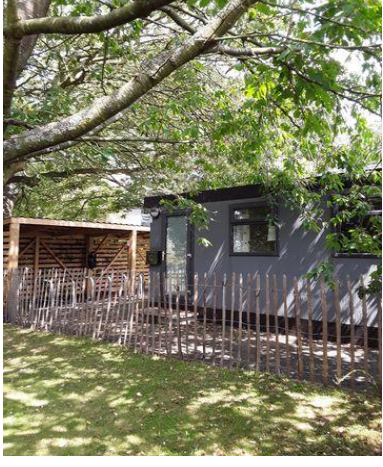
Branches touching building

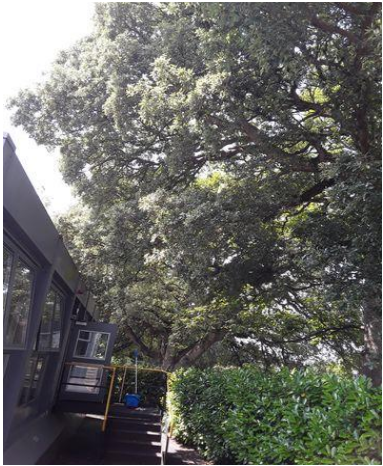
Ref	Species	Location	Survey Notes	Work Recommendations	Priority	Photo	Photo
T417	Oak 'Fulhamensis' (Quercus sp.)	On edge of small shrubbed area, near 2 demountable classrooms	Crown Lifted in past Fair Form, has had limbs selectively reduced which has helped prevent any limb failure. One branch tip is resting on classroom roof	Crown reduce to clear building by 2.0m. Pruning cut(s) should be less than 100mm diameter. Tree marked with YELLOW paint	1 Year

Branch of building july 21	
T428	Oak (Quercus sp.)	Group of 3 large trees on grassed area near sportshall	Trees in group struggling possibly due to ground compaction. Trees have been dead wooded previously, but are producing significant deadwood again. One mature tree previously felled because of decay. Mulching application may help these trees, otherwise they will continue to decline. One tree has had chainsaw removal of burr growth, one flush cut has been created, this will hopefully not become an issue for the tree	Apply woodchip mulch spread as evenly as practicable to a depth of 100mm and in a semi-circle with a diameter of up to 3m from the stems. Fresh or composted woodchip from briadkeaved trees should be used. DO NOT USE BARK UNLESS COMPOSTED FOR AT LEAST 12 MONTHS	1 Year

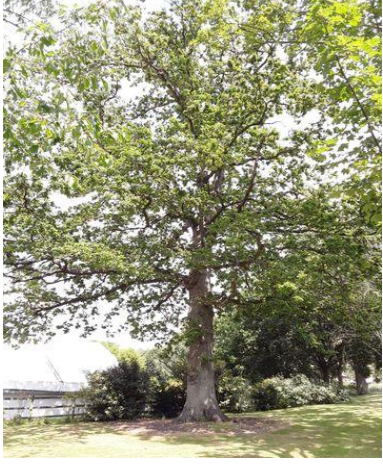
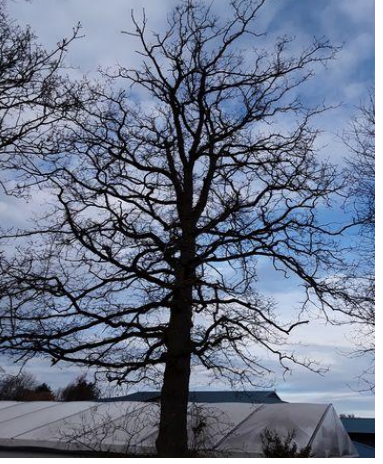
T433	Pedunculate Oak (Quercus robur)	On grassed area next to new sportshall	Crown Lifted in past Good Form, tree mulched with woodchip in past 36 months. Dead branches developing, mostly small but at least 3 larger diameter dead branches in the crown. It is unclear if the crown health is improving as there are some patches of good growth in the crown, but other parts deadwood has developed. The larger dead branches are going to have to be removed, the branches are still in situ from the previous survey	Remove all major deadwood (>80mm dia) & stubs from throughout crown. Tree marked with YELLOW paint	1 Year

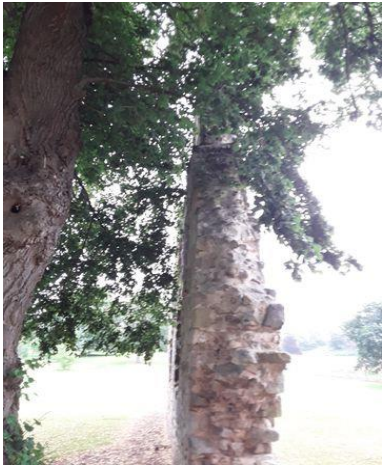
Ref	Species	Location	Survey Notes	Work Recommendations	Priority	Photo	Photo
T286	Common Lime (Tilia x vulgaris)	On grassed area directly adjacent to ruin	Crown Lifted in past Good form Some small branches touching Tithe Barn ruin, this needs pruning back to avoid damage occurring	Crown reduce to clear tithe barn ruin by approximately 2.0m.	1 Year

Branch contact	
T297	Oriental Plane (Platanus orientalis)	On edge of unmown grassed area behind building	Fair Form, low branching beginning to develop into crown, low branches are beginning to spoil form, remedial formative pruning appropriate	Crown lift to 1.2m all round. This will prevent a weak form developing. Branches are marked with YELLOW paint	1 Year	No Photo.	
T491	Oak (Quercus sp.)	In boundary hedge near road	Crown Lifted in past Good Form, branches over road are becoming a minor obstruction with impact on branch tips evident	Crown lift lower branch tips to 5.5m over road. Remove only small diameter branches or reduce the length of others. Tree marked with YELLOW paint	1 Year	No Photo.

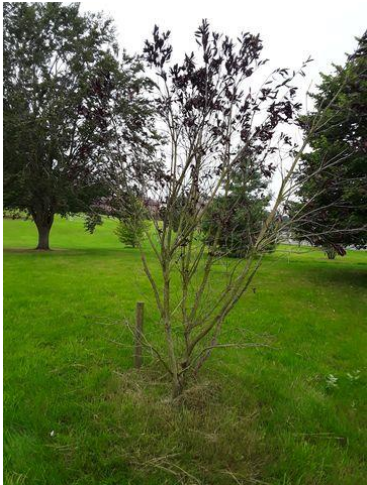
Ref	Species	Location	Survey Notes	Work Recommendations	Priority	Photo	Photo
T302	Strawberry tree (Arbutus unedo)	On grassed area near Wellingtonia	Good Form, evidence of bark damage at 1m above ground, possibly mammal damage. Tree has died since last inspection	Fell to ground level	1 Year

Dead tree	
T360	Horse Chestnut (Aesculus hippocastanum)	Young tree on grassed area by residential block	Good Form Bleeding canker on main stem, appears to be girdling main stem. Tree is struggling and is 50% dead. Not unsafe but unsightly and has limited life expectancy	Fell to ground level	1 Year

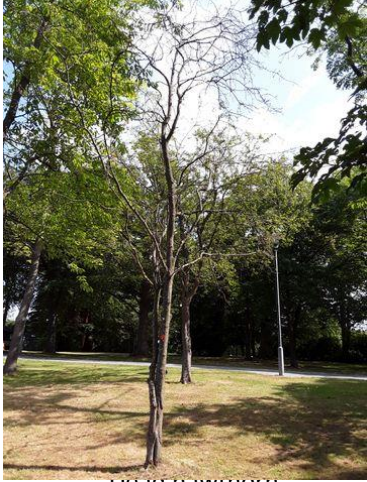
July 21	
T125	Mixed Species Group (Group, mixed species)	Group of 17 trees growing between 2 large Oak trees	Crown Lifted in past Fair Form The remaining Sycamore tree is poorly formed as it is growing from old previously felled stump. The other Sycamores have been felled. The single Ash in the group has advancing Chalara Ash dieback infection although crown health is greater than 50%. Dead Hawthorn in centre of group	Fell to ground level single Hawthorn in centre of group, marked with ORANGE paint	1 Year

Dead hawthorn

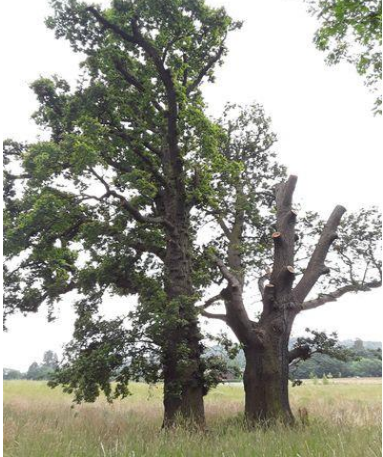
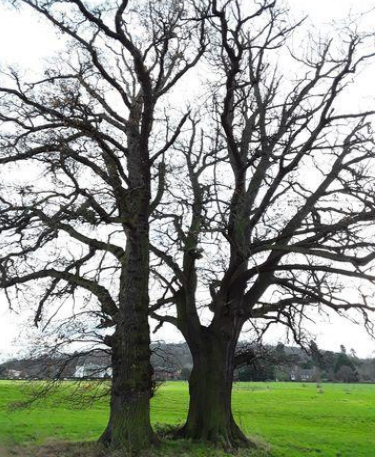
T523	Pedunculate Oak (Quercus robur)	In field, 8m from garden boundaries, 2 closely growing trees	<p>Southern tree is dying back quite rapidly, mulching may help this tree. There are numerous areas of bleeding exudate on the southern side of the main stem suggesting the tree has acute Oak decline. This tree has been heavily pollarded and reduced and unfortunately no mulch has been applied around the base. This tree has been left one sided and this work may result in this tree dying rapidly as opposed to steady retrenching which could create a much lower crown. The northern tree has also been reduced but to a much more sympathetic level. As previously noted there is no target for deadwood or any other hazardous limbs and with Oak trees dead limbs can safely remain in the crown for decades. If the trees are desired to be retained as long term features then it is important that the application of woodchip mulch is undertaken as recommended.</p> <p>Northerly tree had small fruiting body of Meripulus between structural root facing properties in 2016, nothing in 2017, 2018, 2020 or 2021. The southerly tree has bleeding exudate on main stem, 19 active lesions on southern side between 0.6m & 2.0m. Good sounding hammer around the bases of both trees suggests little current impact from Meripulus</p>	Application of mulch spread as evenly as practicable to a depth of 75 mm over an area of 2 metres diameter with the trees at the centre. The mulch shall comprise of wood chips & leaves which have been composted for at least 6 months and shall not be piled against the bark of the tree.	1 Year

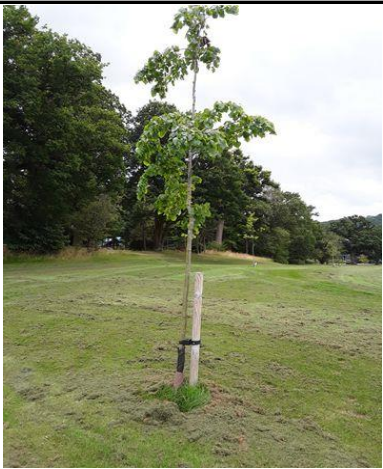
Ref	Species	Location	Survey Notes	Work Recommendations	Priority	Photo	Photo
T783	Mixed Species Group (Group, mixed species)	Informal grouping of young trees on sportsfield	Good Form None of the trees have any basal weed control, this should be created using woodchip mulch, one Scots Pine is really struggling to establish 1x Oak is dead. The Oaks are quite thin trees, and may not establish properly. A few of the support ties are heavily restricting the stems causing damage. A number have been cut during the inspection as leaving these will cause the trees to fail at that point.	Application of mulch spread as evenly as practicable to a depth of 75 mm over an area of 1 metre diameter with the tree at the centre. The mulch shall comprise of wood chips & leaves which have been composted for at least 6 months and shall not be piled against the bark of the tree.	1 Year	No Photo.	
T790	Mixed Species Group x7 (Group, mixed species)	Spaced out group of young trees on edge of sportsfield	Grass growth to base of trees, will aid establishment if a weed free mulch ring is applied. All have strimmer guards around base to prevent maintenance damage	Application of mulch spread as evenly as practicable to a depth of 75 mm over an area of 1 metre diameter with the tree at the centre. The mulch shall comprise of wood chips & leaves which have been composted for at least 6 months and shall not be piled against the bark of the tree.	1 Year

No mulch ring
