**A Phase I and Phase II Geoenvironmental and Geotechnical Report for
East Cambridgeshire District Council.**

Address: Mepal Outdoor Centre, Iretons Way, Mepal, CB6 2BA

Date: 21st June 2021

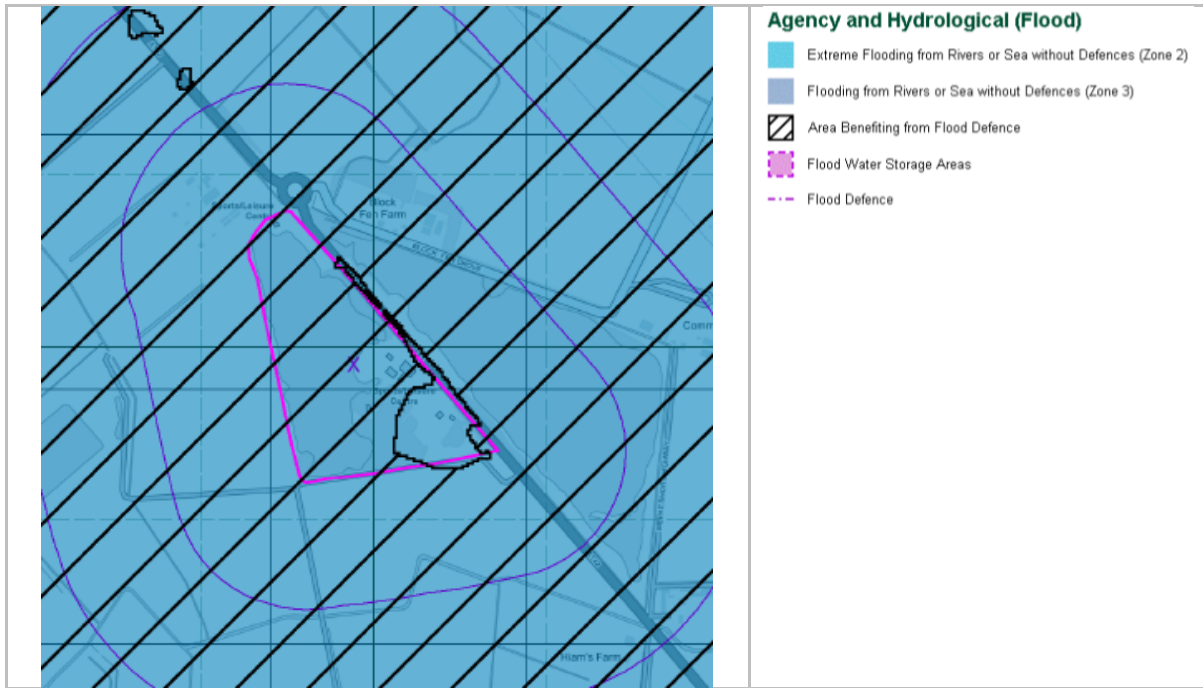
Figure 11. Map of Flood Risk Zones

The site is within Flood Zone 3 land which is at very high risk of flooding (Figure 11). However, the site does benefit from flood defences.

If areas of impermeable surfaces such as buildings, roads etc. are constructed on a greenfield site, a surface water management system designed in accordance with the principles of Sustainable Urban Drainage Schemes (SUDS) will be required.

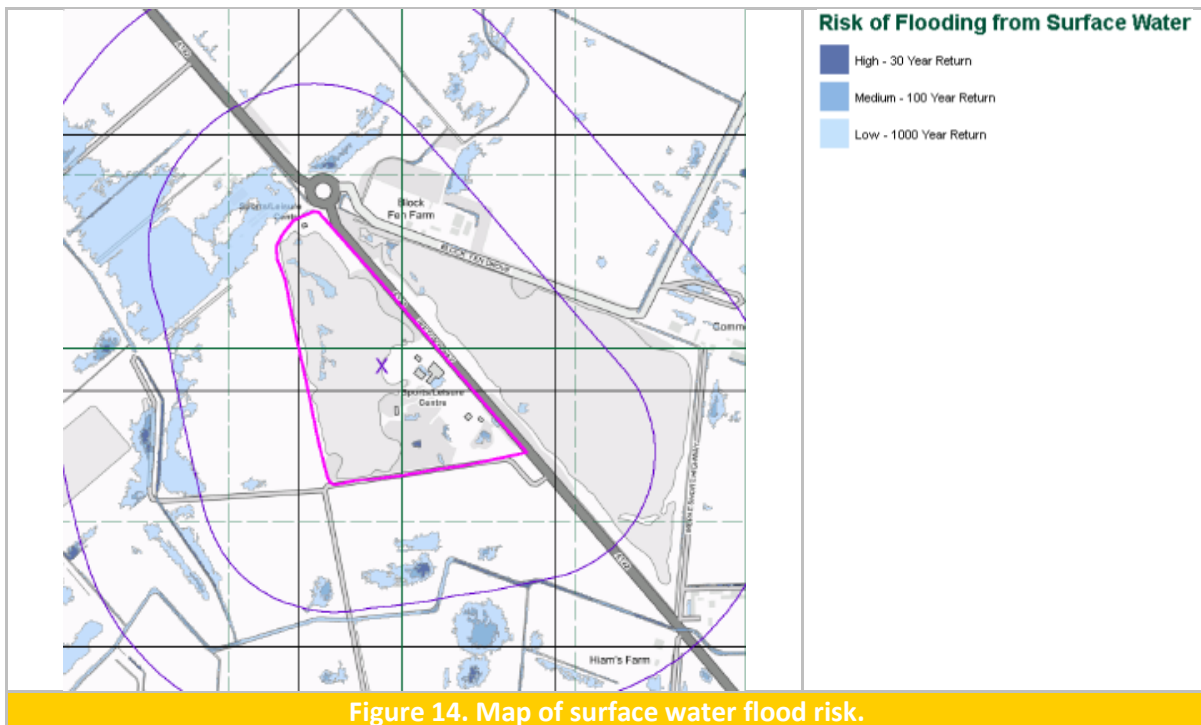
There are several areas, as shown in Figure 14 below, which are liable to surface water flooding on the raised area of land in the south-eastern corner of the site. Any works which might increase the risk of flooding on or off site need to be identified and the risks assessed and mitigated using a suitable SUDS compliant approach.

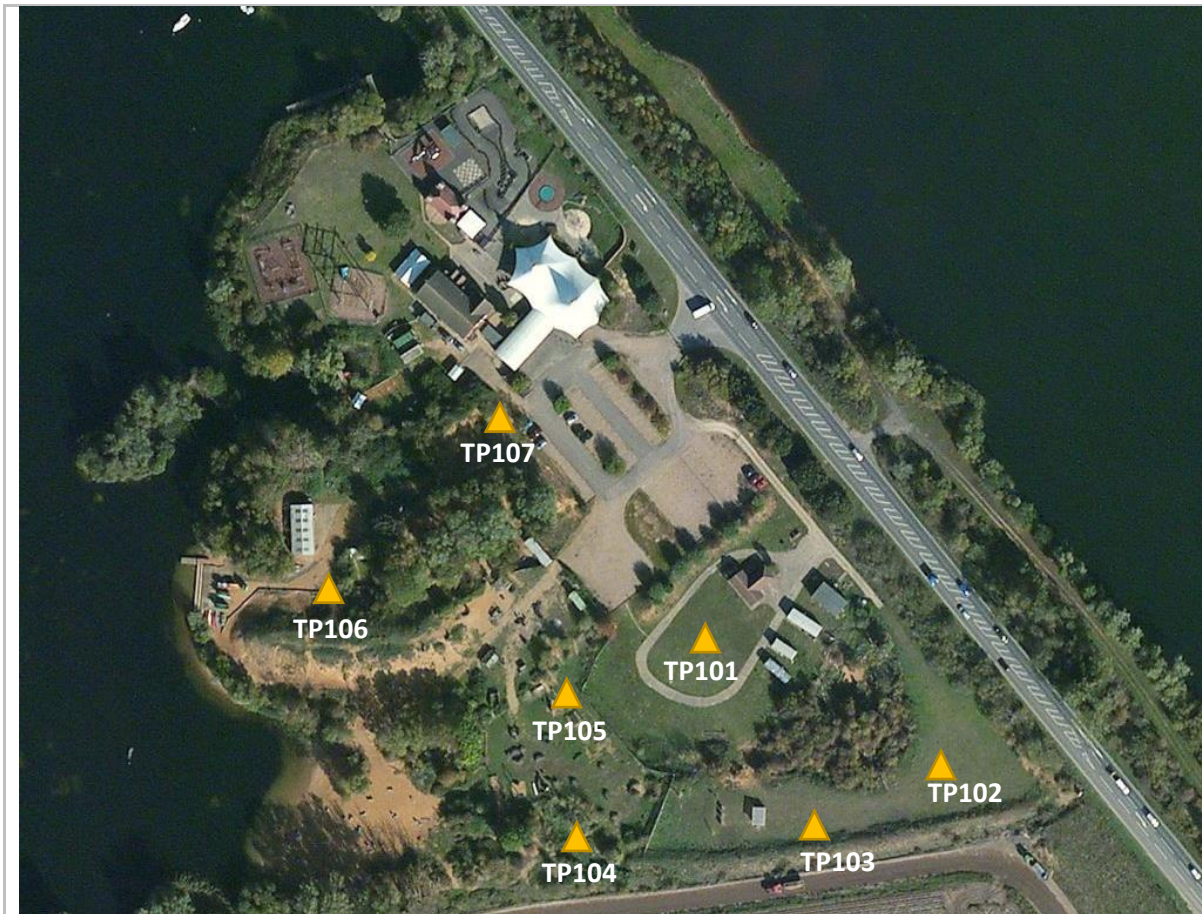
Figure 15. Exploratory Hole Location Plan

The trial pits were excavated at the approximate locations shown below in Figure 15, to maximum depths of 3.3m. In some areas of the site it was difficult to achieve target depths due to the instability of the made ground soils which comprised loose sand.

During the excavation of the trial pits, evidence of significant trench instability was observed within the loose and poorly compacted made ground soils.

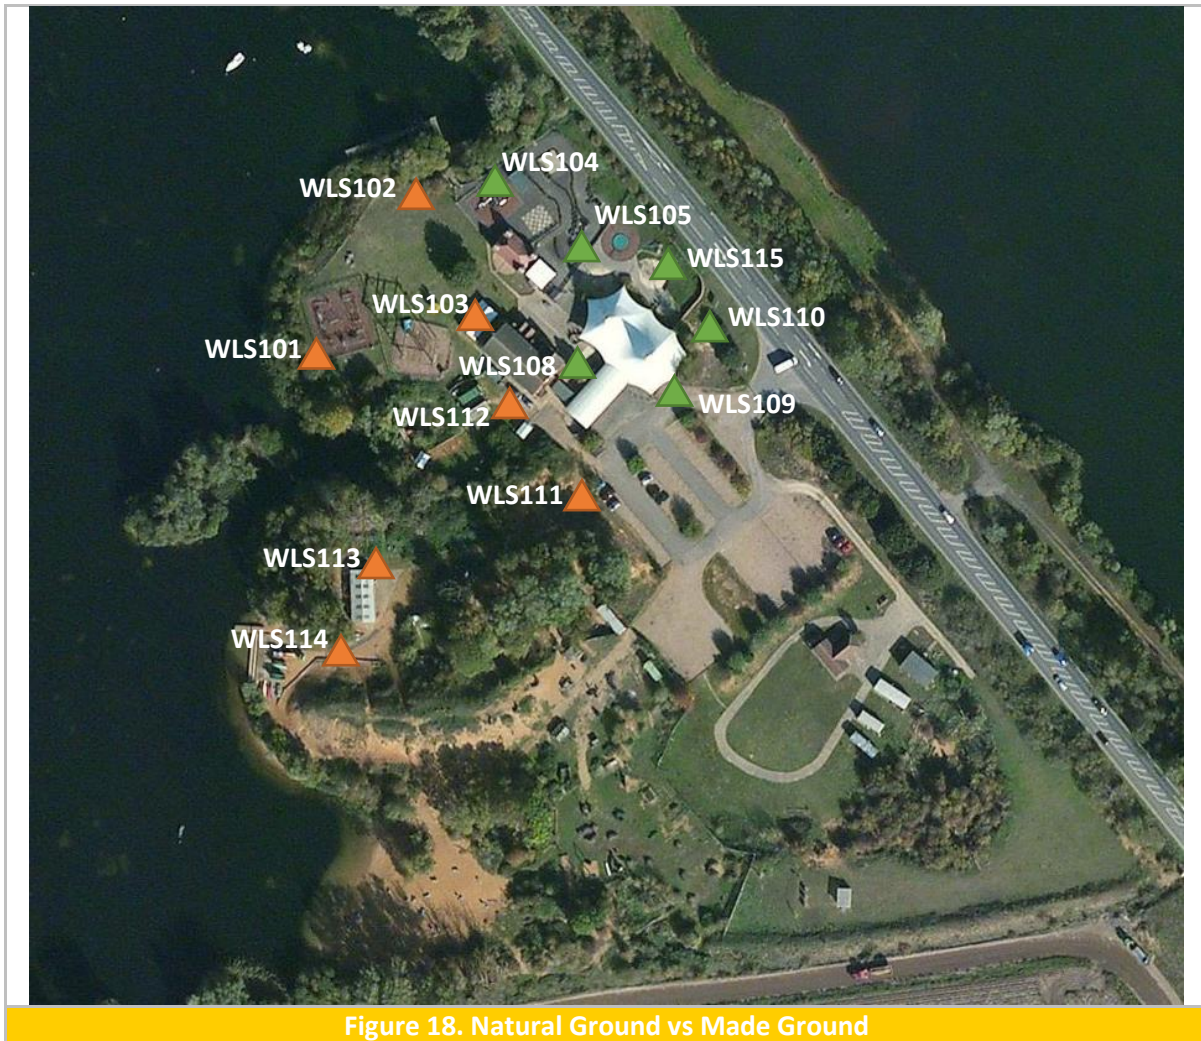
Figure 18. Natural Ground vs Made Ground

The approximate extent of the natural ground as shown in Figure 18 below, has been found to be very limited and would severely restrict the placement of a new building on site in areas to achieve a traditional foundation solution versus a piled foundation solution. In addition, any new crematorium would need to be placed 50 yards back from the highway (45.7m) which effectively pushes the proposed building off the natural soils and back onto the made ground soil.

Natural ground, which was found to be generally loose to medium dense based on insitu test results has been recorded in the green triangles whereas made ground, which was generally loose to very loose has been recorded in orange triangles.

Due to the variable nature of the ground conditions encountered on site traditional spread load foundations are not considered to be appropriate. Recommendations have been given to consider the use of a piled foundation solution or ground improvement techniques such as dynamic/vibro compaction of the made ground soils.
