Colin Chapman
Plym Roofing

SEMERDON MANOR EX22 6RL

Chimney Issues

Wednesday, 28 October 2020

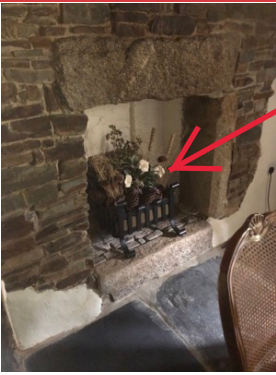
ISSUE 1

There is a fireplace at ground level served by the chimney which is no longer in use for open fires.

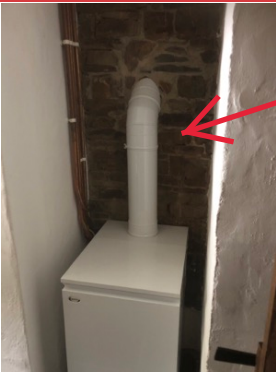
ISSUE 2

The the rear of the fireplace in a utility room. There is a boiler with a flue, which utilises one of the chimney chambers for extraction from the boiler.

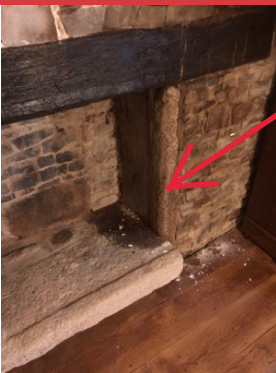
ISSUE 3

There is another fireplace served by the chimney in an upper bedroom. This fireplace shows obvious signs of water ingress.

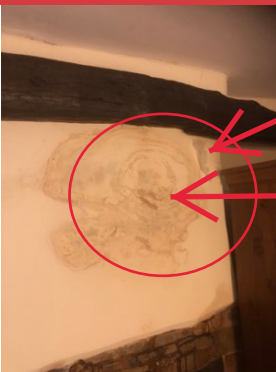
ISSUE 4

There is also a large damp patch on the chimney breast plaster, where paint has flaked off the wall. I noticed the plaster used beneath the paintwork was gypsum. This plaster does not breath. I was lead to believe a listed building officer advised on the works and would have thought at the very least lime plaster which does breath would have been used in this instance as it complies with listed building consent and it the appropriate material to be used on this property.

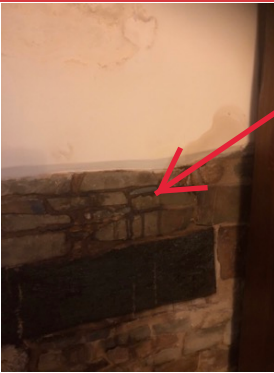
ISSUE 5

The chimney is heavily saturated with water and it can be seen running into the joints of the stonework internally.

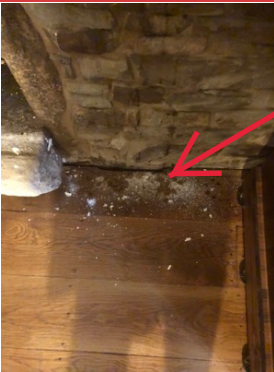
ISSUE 6

Paint and plaster has dropped off the wall due to the ingress and a fur deposit has formed around defects on the plastered walls.

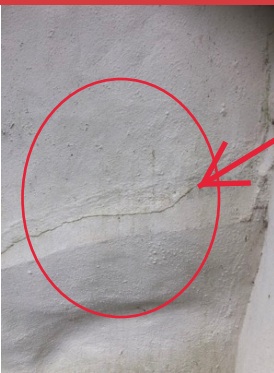
ISSUE 7

When I began my inspection outside the first thing I noticed was a crack in the external gable end wall plaster. I carried out a tap test to the plaster and parts of the render are hollow indicating it is blown and has detached itself from the wall.

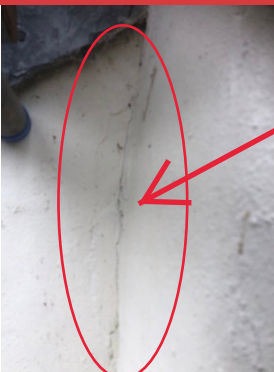
ISSUE 8

The crack continues up the wall at the abutment with the chimney stack to the underside of the slate verge detail.

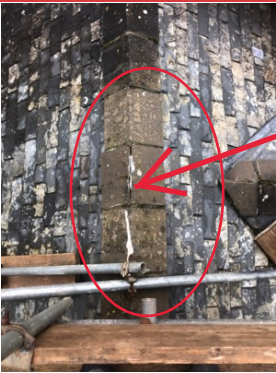
ISSUE 9

The first observation I made when on the roof was two cracked ridge tiles which someone has attempted to make watertight by applying silicone to the defects. These ridges will need to be replaced in order to protect the integrity of the roof.

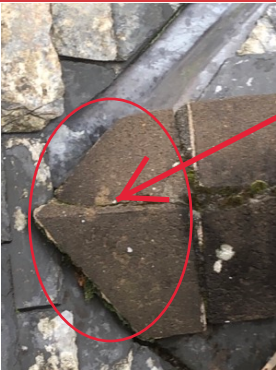
ISSUE 10

There is a small roof on the rear elevation with two lead valleys. There are also some broken ridges at the apex of the valley which need to be replaced.

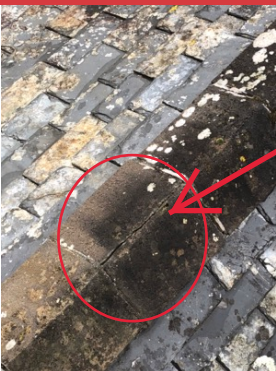
ISSUE 11

Another broken ridge on the rear elevation.

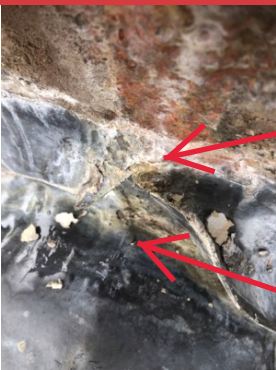
ISSUE 12

When I inspected the chimney above the area of ingress the first thing I noticed was the large deposits of calcium carbonate running out of the chimney. Stalactites have formed where calcite has run out of the chimney due to water mixing with minerals in the mortar.

There is a lead saddle at the apex of the ridge which has been welded correctly to form a watertight seal.

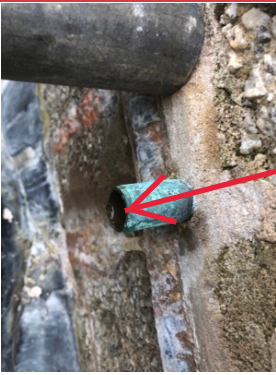
ISSUE 13

The chimney had a series of copper pipes installed to it acting as weep holes to discharge water out of the stack. There are 3 pipes on two faces of the chimney and 1 pipe on the opposite two faces. All pipes were dripping with water while I was present.

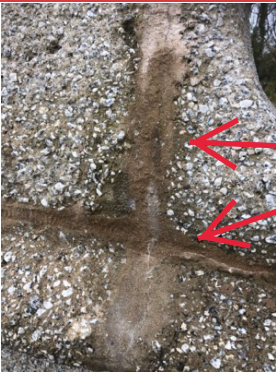
ISSUE 14

Looking at the granite stone and mortar joints on the chimney, they appeared to be absorbing a great deal of moisture. It was not raining during my survey nor has it been raining since the early hours and yet at 11.00am the stone and joints were still showing a lot of moisture content.

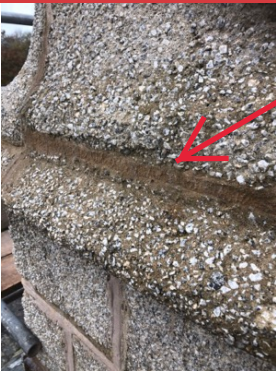
ISSUE 15

Stones and joints still very damp.

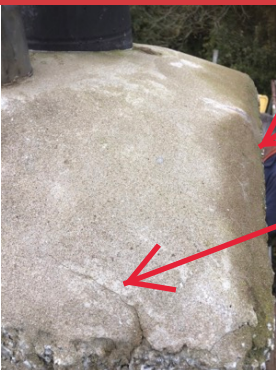
ISSUE 16

There was a new flaunch installed when the chimney was rebuilt. The flaunch already shows signs of cracks in the render and is very damp in places. I am unsure if an additive was allowed to be used in the mortar mix to protect the flaunch during harsh cold weather.

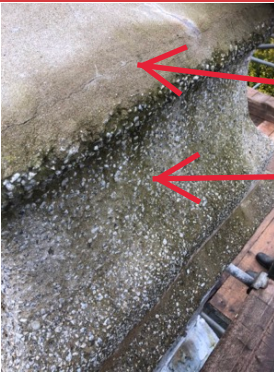
ISSUE 17

Looking at a different face of the chimney and flaunch, a visible crack can be seen running through the flaunch leaving the surrounding mortar damp. The granite stone below this defect is very wet.

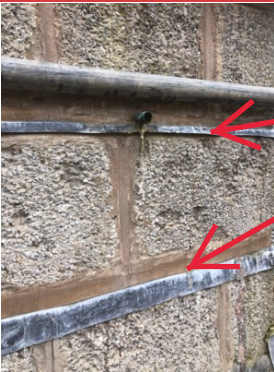
ISSUE 18

There are two lead trays installed to the chimney. The trays should be a continuous piece of lead which spans the full width of the chimney. They should incorporate an upstand where it meets the flue. The upstand should be a minimum of 50mm high to keep moisture which collects on the tray from seeping over the top of the upstand, down onto the stones below. The problem with this chimney is there is only one flue serving the boiler leaving the the other chamber to serve what was an open fire place in the bedroom, this is now redundant. The burning question is; was an upstand created for this chamber or was lead simply cut to shape of the chamber leaving the chimney exposed to water ingress. Is the upstand high enough.

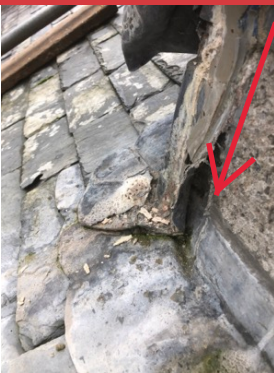
ISSUE 19

I peeled back the lead flashings to gain a better understanding of the installation process. As a general rule of thumb lead sheet association guidelines stipulate the lead tray should be positioned 150mm above the lowest point of the front chimney flashing where possible. The lead should then be dressed down over the front flashing and turned up to form a tray on the remaining three sides thus forming a catchment trays which drains off one side. The lead tray is no-where near the required measurement here.

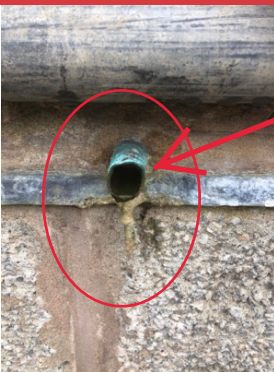
ISSUE 20

All copper pipe weep holes were discharging water during my survey so the chimney must has a considerable amount of water build-up across the trays.

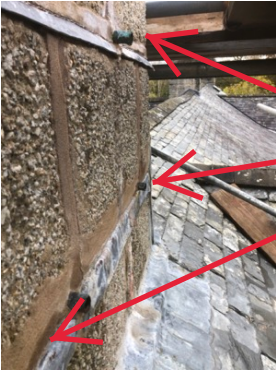
ISSUE 21

As mentioned above 2 sides of the chimney are served by three copper pipe weep holes. Two pipes are installed above the lower tray and one pipe is installed above the upper tray. Water and damp can was seen coming from each pipe with calcite build-up forming stains on the roof.

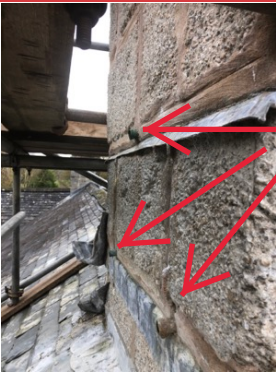
ISSUE 22

The opposite side of the chimney showing the other three pipes.

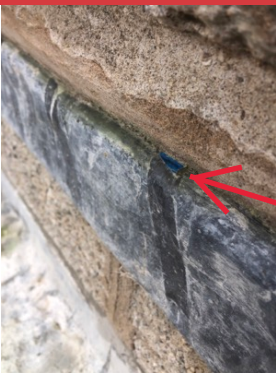
ISSUE 23

One of the concern I have with the lead trays is the selection of the code of lead for the task.

The recommended lead to use for chimneys is either Code 4 or 5 lead. Selection is determined by the weight of the chimney above the lead trays. Too much weight and the tray will become punctured. Code 4 lead is more often used for small brickwork chimney which do not have much load bearing weight. Code 5 trays are for more substantial chimneys, which have a lot of weight and mass. The code of lead used for the trays on this chimney are Code 4 this is indicated by the blue tape still left on the lead.

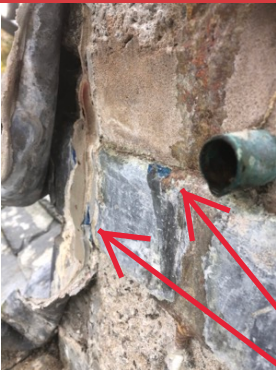
ISSUE 24

I would expect the lead trays on this chimney to be Code 5 to cope with the heavy weight of the granite stone. The lead trays should also be painted on both surfaces with bitumen paint to prevent corrosion from mortar. I could see no traces of bitumen used on these trays.

Blue tape indicates Code 4 lead used for trays. I would have expected Code 5 to be employed for a heavy chimney such as this.

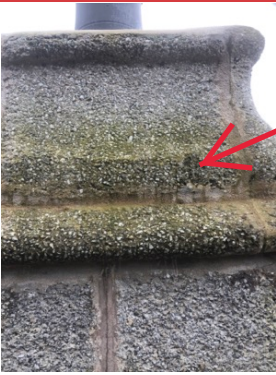
ISSUE 25

Image of moisture build-up in top architectural stones of the chimney.

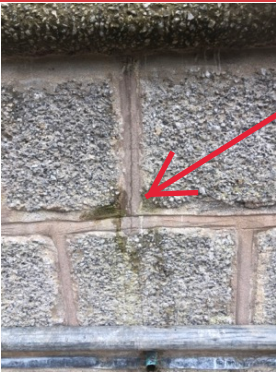
ISSUE 26

Moisture coming out at the base of the stones below the moulding in the image above.

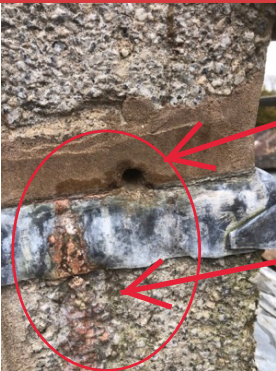
ISSUE 27

I drilled a hole in one of the mortar joints to try and determine if this was a continuous lead tray or just a flashing which had been installed. To be fair the lead did appear to go right through the chimney as far as my drill bit would go. When I removed my drill bit water ran out of the hole and down the wall indicating a build-up of moisture sat on the tray. The worry has the moisture risen above the upstand of the tray around the flue and is there an upstand on the other chamber or has it been cut flush allowing water to penetrate through the cut lead and onto the stones below.

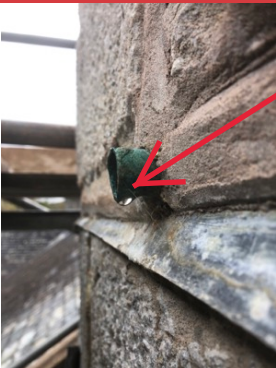
ISSUE 28

Image showing the water dripping out of copper pipes.

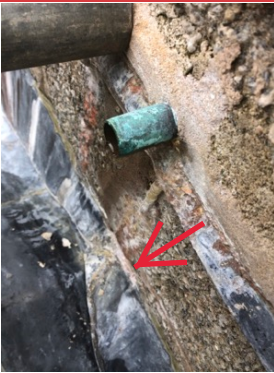
ISSUE 29

This image shows the lead DPC tray above the lowest front lead flashing. The tray should be positioned 150mm above the lowest flashing.

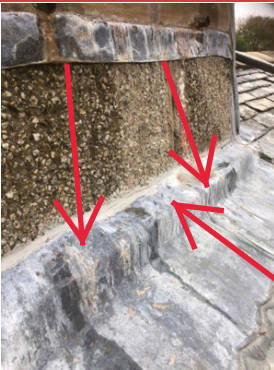
ISSUE 30

The front flashing is chased into the wall to a depth of 25mm. The tray above should protect the lower flashing and I would have expected the lead tray to have been extended down over the lower flashing here preventing any water penetration of the stone directly above the lower flashing.

lead installation should have been continued down to here

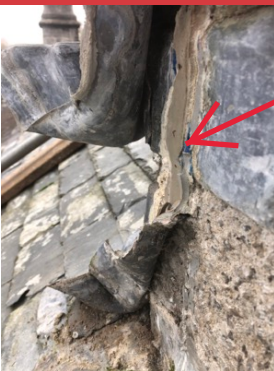
ISSUE 31

The side flashing where it lapps around the front of the chimney is also chased into the wall. This again sits below the lead tray and has had lead mastic applied in an attempt to make the corner watertight. This could have been avoided if lead tray had been dressed down over the flashing as mentioned in the previous issue.

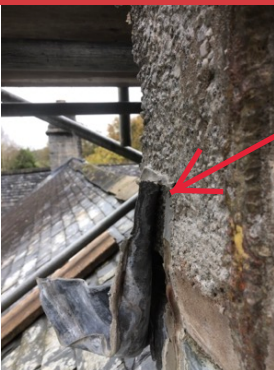
ISSUE 32

Image showing the side cover flashing barely chased into the wall.

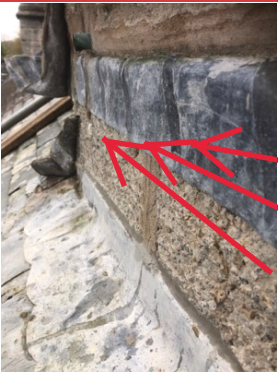
ISSUE 33

Water running out off the lower tray onto stones above the lower lead flashing. These stones sit above the lower lead flashing which is only chased 25mm into the wall so any water penetration of the stones leaves the lower flashing susceptible to ingress.

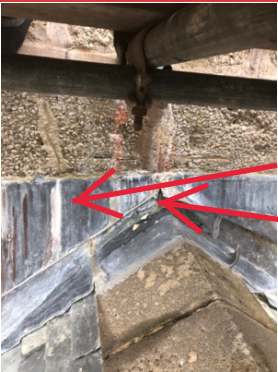
ISSUE 34

The lead at the side of the chimney above the ingress is installed correctly. Calcite deposits can be seen where water is seeping out off the lead tray. The problem is I am unable to determine the detail in the centre of the tray around the flue and chimney chamber, which is hidden by the stonework installed on top of it. I am also unable to determine if the stone work is too heavy for the Code 4 lead and has punctured it. Has bitumen been used to prevent corrosion from mortar to the tray.

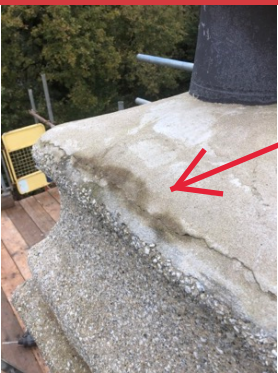
ISSUE 35

Another image showing defect in the flaunch with damp around the crack in the render. This problem will manifest in the winter when water trapped beneath the flaunch turns to ice during freeze thaw. The ice expands causing further issues in the future as problems with crack gets worse and more water enters the crack.

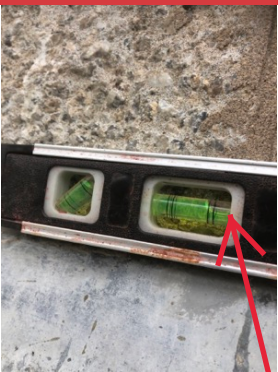
ISSUE 36

The ingress appears to be at the front left hand corner of the chimney looking at the property from the driveway. With trays being installed I would not expect to find damp penetrating the stoneworks and causing ingress below. However, when I do come across issues such as this and I suspect a defect with the lead trays, it is always a good indicator to see why the water is running to one side of the chimney only. I placed a spirit level on the stonework at the base of the chimney and the stoneworks runs out by about 20mm to the corner where the ingress is occurring. The mortar bed above this stone has then been adjusted to make level. Water finding its way down to the base stone will naturally run across the top of the stone if it is out of level so I suspect this is why only this corner of the chimney has an issue with ingress.

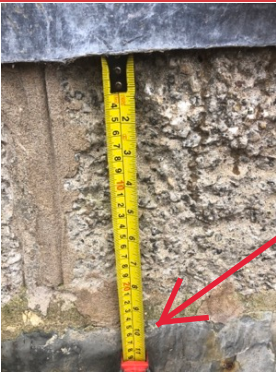
ISSUE 37

Tape shows the lower tray is 260mm above the lowest front flashing, recommended height is 150mm. This would be fine if the lead had been carried down over the lower lead flashing to form a block flashing, eliminating any possibility the stone it covers suffering from water penetration.

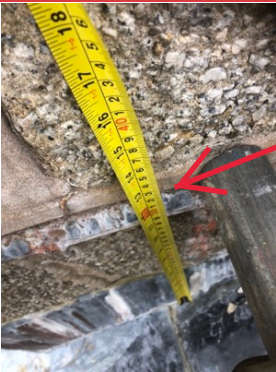
ISSUE 38

The secondary tray sits 390mm above the lower tray. This cannot be avoided when using large granite stones, however if the code of lead, the upstand around the flue, the upstand around the other chimney chamber and bitumen paint on lead to avoid corrosion have not been installed in the correct fashion, all of these elements can have an effect on the integrity of the chimney and can see the previous works carried out become compromised due to ingress.

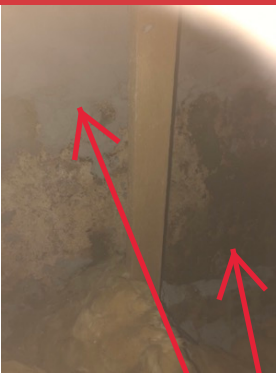
ISSUE 39

This image is not the best. Looking inside the loft space it was clear to see water running out of the stonework which forms the chimney. There has been a large amount of cement applied to the chimney just below the ridge line which I am not sure if it is Vandex. Vandex is a tanking solution which prevents water penetrating through cement work. There is a small stain on the cement work through a crack with the majority of the ingress below this. If Vandex has been used it is simply driving the water downwards. Again With a listed building officer overseeing these works I am surprised this product was allowed to be applied to the walls I would have expected to see lime plaster which is breathable. Either way this confirmed my suspicions there is something wrong with the lead trays as water is running into the property below the trays which indicates they have not been installed correctly.

Damp below cement applied to the stonework of the chimney.

Cement possibly Vandex
