ASBESTOS REFURBISHMENT SURVEY

Client	Twenty Five
Site	Lodge Farm, High Catton, York, North Yorkshire, YO41 1EW
Date started	23 Jun 2021
Date completed	23 Jun 2021
Date report issued	25 Jun 2021
Survey reference	J616986
Lead surveyor	Adam Martin
Assistant surveyor	N/A
UPRN	N/A

ASBESTOS SURVEY OF LODGE FARM, HIGH CATTON, YORK, NORTH YORKSHIRE

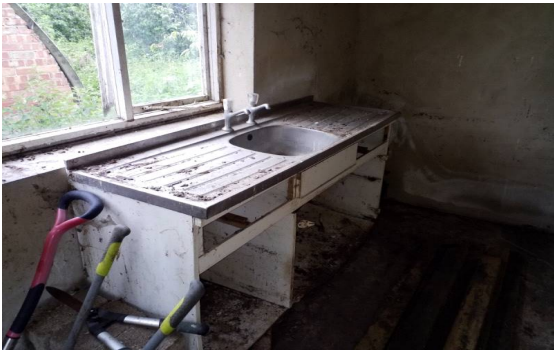
Item Reference	J616986 #2	
	Sample reference number	PC000743	
	Client name	Twenty Five	
	Site address	Lodge Farm, High Catton, York, North Yorkshire, YO41 1EW	
	Date surveyed	23/06/21	
	Date analysed	June 24 2021	
	Building	Lodge Farm, High Catton, York, North Yorkshire, YO41 1EW	
	Floor level	External	
	Room	Workshop	
	Position	To sink unit

Item Reference	Sample	Building	Floor	Room	Position	Item desc	Conclusion	Assessment scores			Risk code	
								Material	Priority	Total		
J616986 #2	PC000743	Lodge Farm, High Catton, York, North Yorkshire, YO41 1EW	External	Workshop	To sink unit	Bitumen pad	Chrysotile	3	5	8	Risk code E	 
								Very Low Material Risk				
Comments						Next reinspection	Extent	Recommended action			Action Timescale	Date action completed
						06/2022	3no.	Monitor and manage

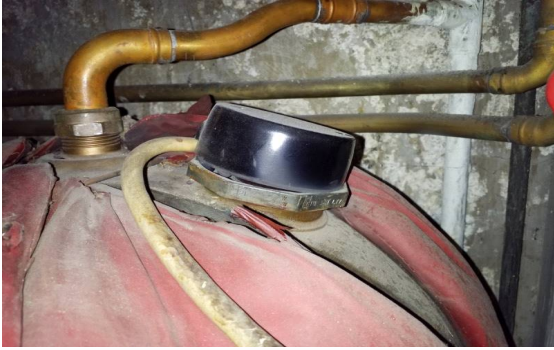
Item Reference	J616986 #11	
	Sample reference number	PC000748	
	Client name	Twenty Five	
	Site address	Lodge Farm, High Catton, York, North Yorkshire, YO41 1EW	
	Date surveyed	23/06/21	
	Date analysed	June 24 2021	
	Building	Lodge Farm, High Catton, York, North Yorkshire, YO41 1EW	
	Floor level	1st Floor	
	Room	Farmhouse - Toilet	
	Position	To thermostat on top of copper water tank

Item Reference	Sample	Building	Floor	Room	Position	Item desc	Conclusion	Assessment scores			Risk code	
								Material	Priority	Total		
J616986 #11	PC000748	Lodge Farm, High Catton, York, North Yorkshire, YO41 1EW	1st Floor	Farmhouse - Toilet	To thermostat on top of copper water tank	Gasket	Chrysotile	5	4	9	Risk code D	 
								Low Material Risk				
Comments						Next reinspection	Extent	Recommended action			Action Timescale	Date action completed
						06/2022	1no.	Monitor and manage

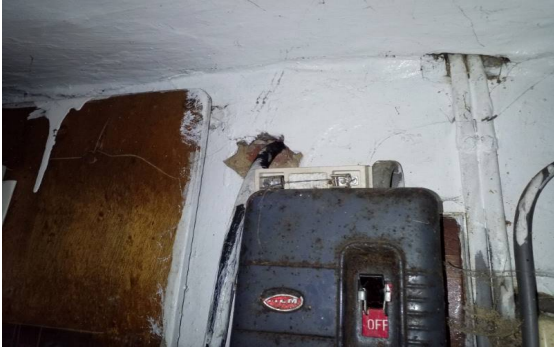
Item Reference	J616986 #19	
	Sample reference number	PC000752	
	Client name	Twenty Five	
	Site address	Lodge Farm, High Catton, York, North Yorkshire, YO41 1EW	
	Date surveyed	23/06/21	
	Date analysed	June 24 2021	
	Building	Lodge Farm, High Catton, York, North Yorkshire, YO41 1EW	
	Floor level	Ground Floor	
	Room	Farmhouse - Store	
	Position	Within loose fuse above electrics

Material	Priority	Total		
J616986 #19	PC000752	Lodge Farm, High Catton, York, North Yorkshire, YO41 1EW	Ground Floor	Farmhouse - Store	Within loose fuse above electrics	Flash guards	Chrysotile	6	5	11	Risk code E	
								Low Material Risk				
Comments						Next reinspection	Extent	Recommended action			Action Timescale	Date action completed
Flash guards are presumed to continue within live electrics						06/2022	1no.	Remove

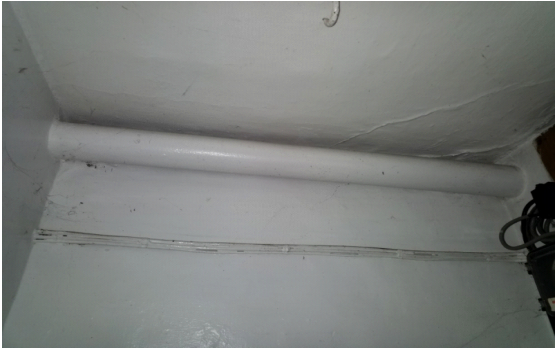
Item Reference	J616986 #22	
	Sample reference number	PC000753	
	Client name	Twenty Five	
	Site address	Lodge Farm, High Catton, York, North Yorkshire, YO41 1EW	
	Date surveyed	23/06/21	
	Date analysed	June 24 2021	
	Building	Lodge Farm, High Catton, York, North Yorkshire, YO41 1EW	
	Floor level	Ground Floor	
	Room	Farmhouse - Store	
	Position	To High level wall

Item Reference	Sample	Building	Floor	Room	Position	Item desc	Conclusion	Assessment scores			Risk code	 
								Material	Priority	Total		
J616986 #22	PC000753	Lodge Farm, High Catton, York, North Yorkshire, YO41 1EW	Ground Floor	Farmhouse - Store	To High level wall	Cement pipe	Chrysotile	4	5	9	Risk code E	
								Very Low Material Risk				
Comments						Next reinspection	Extent	Recommended action			Action Timescale	Date action completed
						06/2022	11m	Monitor and manage

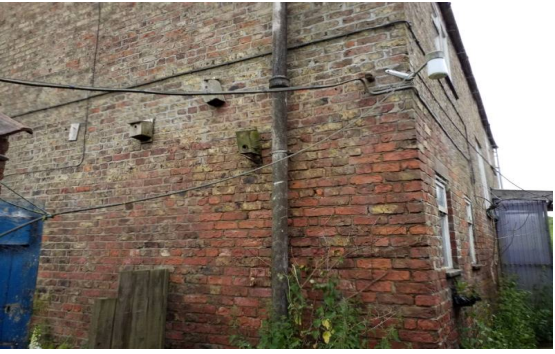
Item Reference	J616986 #34	
	Sample reference number	PC000755	
	Client name	Twenty Five	
	Site address	Lodge Farm, High Catton, York, North Yorkshire, YO41 1EW	
	Date surveyed	23/06/21	
	Date analysed	June 24 2021	
	Building	Lodge Farm, High Catton, York, North Yorkshire, YO41 1EW	
	Floor level	External	
	Room	Exterior of farmhouse	
	Position	To wall

Item Reference	Sample	Building	Floor	Room	Position	Item desc	Conclusion	Assessment scores			Risk code	
								Material	Priority	Total		
J616986 #34	PC000755	Lodge Farm, High Catton, York, North Yorkshire, YO41 1EW	External	Exterior of farmhouse	To wall	Cement pipe	Chrysotile	4	2	6	Risk code E	 
								Very Low Material Risk				
Comments						Next reinspection	Extent	Recommended action			Action Timescale	Date action completed
Continues into floor for unknown extent						06/2022	71m	Monitor and manage

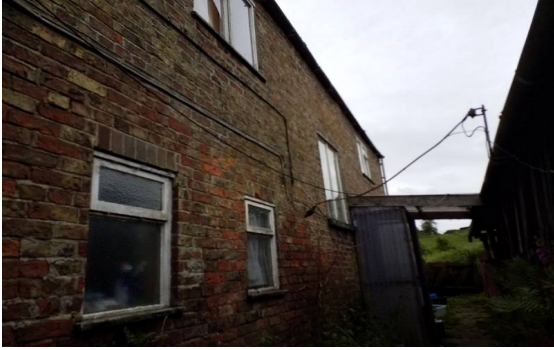
Item Reference	J616986 #35
		Sample reference number	PC000756
		Client name	Twenty Five
		Site address	Lodge Farm, High Catton, York, North Yorkshire, YO41 1EW
		Date surveyed	23/06/21
		Date analysed	June 24 2021
		Building	Lodge Farm, High Catton, York, North Yorkshire, YO41 1EW
		Floor level	External
		Room	Exterior of farmhouse
		Position	To wooden windows throughout ground floor and first floor.

Item Reference	Sample	Building	Floor	Room	Position	Item desc	Conclusion	Assessment scores			Risk code	
								Material	Priority	Total		
J616986 #35	PC000756	Lodge Farm, High Catton, York, North Yorkshire, YO41 1EW	External	Exterior of farmhouse	To wooden windows throughout ground floor and first floor.	Mastic	Chrysotile	3	2	5	Risk code E	 
								Very Low Material Risk				
Comments						Next reinspection	Extent	Recommended action			Action Timescale	Date action completed
						06/2022	451m	Monitor and manage

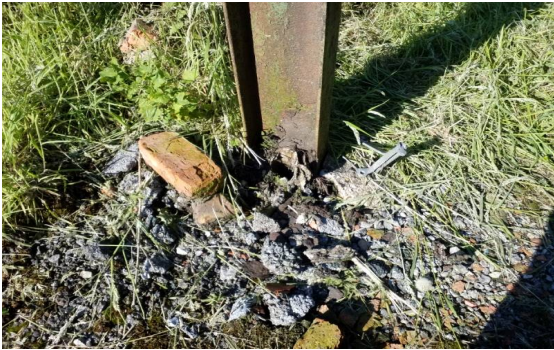
Item Reference	J616986 #36
		Sample reference number	PC000757
		Client name	Twenty Five
		Site address	Lodge Farm, High Catton, York, North Yorkshire, YO41 1EW
		Date surveyed	23/06/21
		Date analysed	June 24 2021
		Building	Lodge Farm, High Catton, York, North Yorkshire, YO41 1EW
		Floor level	External
		Room	Agricultural building 1
		Position	To floor adjacent steel column

Item Reference	Sample	Building	Floor	Room	Position	Item desc	Conclusion	Assessment scores			Risk code	
								Material	Priority	Total		
J616986 #36	PC000757	Lodge Farm, High Catton, York, North Yorkshire, YO41 1EW	External	Agricultural building 1	To floor adjacent steel column	Cement pipe	Chrysotile + Crocidolite	6	3	9	Risk code E	 
								Low Material Risk				
Comments						Next reinspection	Extent	Recommended action			Action Timescale	Date action completed
Continues into ground for unknown extent						06/2022	<1m	Monitor and manage

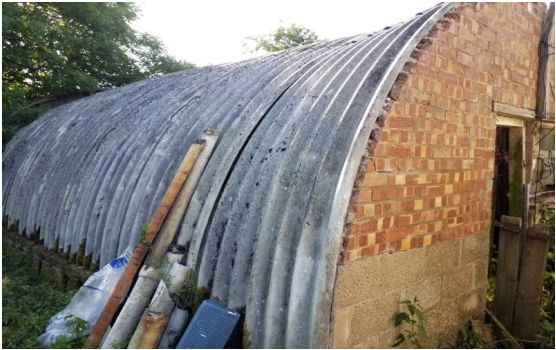
Item Reference	J616986 #37	
	Sample reference number	PC000758	
	Client name	Twenty Five	
	Site address	Lodge Farm, High Catton, York, North Yorkshire, YO41 1EW	
	Date surveyed	23/06/21	
	Date analysed	June 24 2021	
	Building	Lodge Farm, High Catton, York, North Yorkshire, YO41 1EW	
	Floor level	External	
	Room	Agricultural building 2	
	Position	To barrelled roof

Item Reference	Sample	Building	Floor	Room	Position	Item desc	Conclusion	Assessment scores			Risk code	 
								Material	Priority	Total		
J616986 #37	PC000758	Lodge Farm, High Catton, York, North Yorkshire, YO41 1EW	External	Agricultural building 2	To barrelled roof	Cement sheets	Chrysotile + Crocidolite	6	4	10	Risk code E	
								Low Material Risk				
Comments						Next reinspection	Extent	Recommended action			Action Timescale	Date action completed
						06/2022	100m²	Monitor and manage

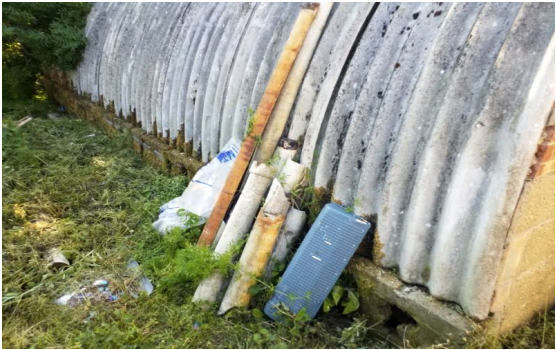
Item Reference	J616986 #38	
	Sample reference number	PC000759	
	Client name	Twenty Five	
	Site address	Lodge Farm, High Catton, York, North Yorkshire, YO41 1EW	
	Date surveyed	23/06/21	
	Date analysed	June 24 2021	
	Building	Lodge Farm, High Catton, York, North Yorkshire, YO41 1EW	
	Floor level	External	
	Room	Agricultural building 2	
	Position	Stacked up next to building

Item Reference	Sample	Building	Floor	Room	Position	Item desc	Conclusion	Assessment scores			Risk code	 
								Material	Priority	Total		
J616986 #38	PC000759	Lodge Farm, High Catton, York, North Yorkshire, YO41 1EW	External	Agricultural building 2	Stacked up next to building	Loose cement rainwater goods	Chrysotile	5	4	9	Risk code E	
								Low Material Risk				
Comments						Next reinspection	Extent	Recommended action			Action Timescale	Date action completed
						06/2022	121m	Remove

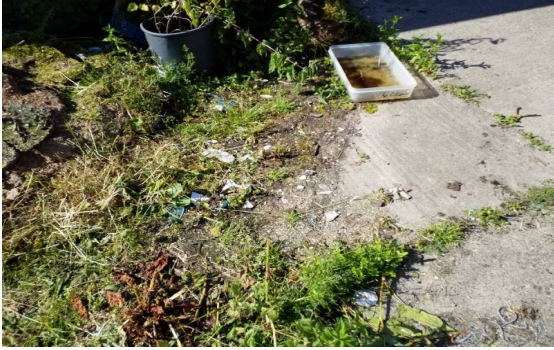
Item Reference	J616986 #39	
	Sample reference number	PC000760	
	Client name	Twenty Five	
	Site address	Lodge Farm, High Catton, York, North Yorkshire, YO41 1EW	
	Date surveyed	23/06/21	
	Date analysed	June 24 2021	
	Building	Lodge Farm, High Catton, York, North Yorkshire, YO41 1EW	
	Floor level	External	
	Room	External areas	
	Position	To floor adjacent to parking spaces

Material	Priority	Total		
J616986 #39	PC000760	Lodge Farm, High Catton, York, North Yorkshire, YO41 1EW	External	External areas	To floor adjacent to parking spaces	Cement debris	Chrysotile + Crocidolite	8	5	13	Risk code E	
							Medium Material Risk					
Comments						Next reinspection	Extent	Recommended action		Action Timescale	Date action completed	
Spread over site						06/2022	1m²	Remove

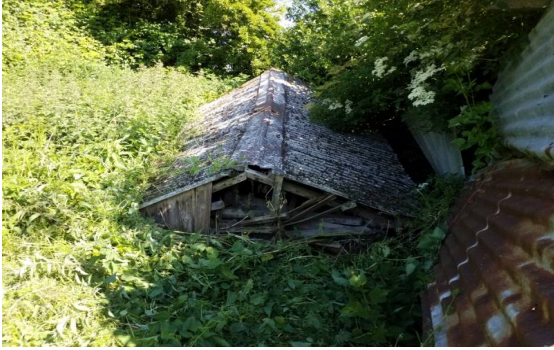
Item Reference	J616986 #47
		Sample reference number	PC000761
		Client name	Twenty Five
		Site address	Lodge Farm, High Catton, York, North Yorkshire, YO41 1EW
		Date surveyed	23/06/21
		Date analysed	June 24 2021
		Building	Lodge Farm, High Catton, York, North Yorkshire, YO41 1EW
		Floor level	External
		Room	Agricultural building 9
		Position	To collapsed roof

Item Reference	Sample	Building	Floor	Room	Position	Item desc	Conclusion	Assessment scores			Risk code	 
								Material	Priority	Total		
J616986 #47	PC000761	Lodge Farm, High Catton, York, North Yorkshire, YO41 1EW	External	Agricultural building 9	To collapsed roof	Cement sheets	Chrysotile	6	3	9	Risk code E	
								Low Material Risk				
Comments						Next reinspection	Extent	Recommended action			Action Timescale	Date action completed
						06/2022	30m ²	Remove

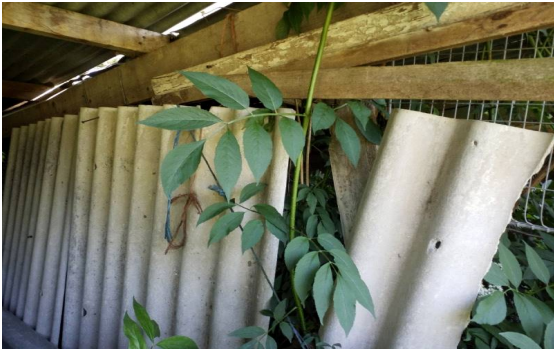
Item Reference	J616986 #48
		Sample reference number	PC000762
		Client name	Twenty Five
		Site address	Lodge Farm, High Catton, York, North Yorkshire, YO41 1EW
		Date surveyed	23/06/21
		Date analysed	June 24 2021
		Building	Lodge Farm, High Catton, York, North Yorkshire, YO41 1EW
		Floor level	External
		Room	Agricultural building 9
		Position	To internal walls

Item Reference	Sample	Building	Floor	Room	Position	Item desc	Conclusion	Assessment scores			Risk code	 
								Material	Priority	Total		
J616986 #48	PC000762	Lodge Farm, High Catton, York, North Yorkshire, YO41 1EW	External	Agricultural building 9	To internal walls	Cement sheets	Chrysotile	4	2	6	Risk code E	
								Very Low Material Risk				
Comments						Next reinspection	Extent	Recommended action			Action Timescale	Date action completed
						06/2022	16m²	Monitor and manage

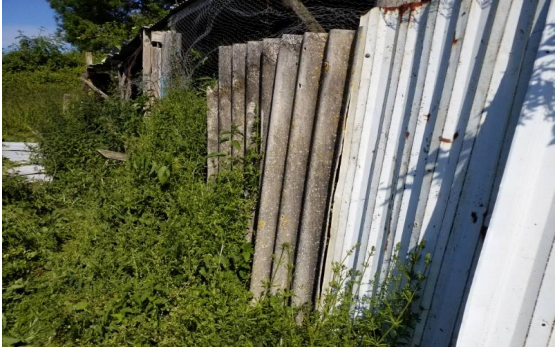
Item Reference	J616986 #49	
	Sample reference number	PC000763	
	Client name	Twenty Five	
	Site address	Lodge Farm, High Catton, York, North Yorkshire, YO41 1EW	
	Date surveyed	23/06/21	
	Date analysed	June 24 2021	
	Building	Lodge Farm, High Catton, York, North Yorkshire, YO41 1EW	
	Floor level	External	
	Room	Agricultural building 9	
	Position	To external walls

Item Reference	Sample	Building	Floor	Room	Position	Item desc	Conclusion	Assessment scores			Risk code	 
								Material	Priority	Total		
J616986 #49	PC000763	Lodge Farm, High Catton, York, North Yorkshire, YO41 1EW	External	Agricultural building 9	To external walls	Cement sheets	Chrysotile	4	3	7	Risk code E	
								Very Low Material Risk				
Comments						Next reinspection	Extent	Recommended action			Action Timescale	Date action completed
One panel seems to be within undergrowth inside building						06/2022	8m²	Monitor and manage

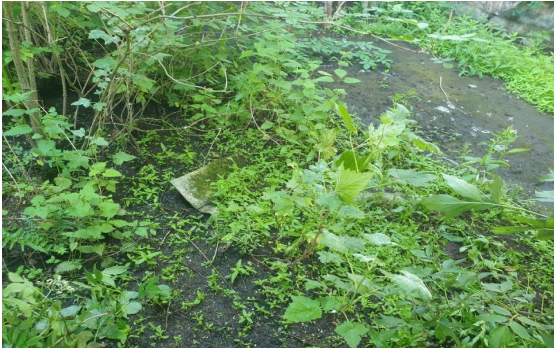
Item Reference	J616986 #54		
	Sample reference number	PC000765		
	Client name	Twenty Five		
	Site address	Lodge Farm, High Catton, York, North Yorkshire, YO41 1EW		
	Date surveyed	23/06/21		
	Date analysed	June 24 2021		
	Building	Lodge Farm, High Catton, York, North Yorkshire, YO41 1EW		
	Floor level	External		
	Room	Covered yard		
	Position	To floor to rear right hand side adjacent concrete ramp

Item Reference	Sample	Building	Floor	Room	Position	Item desc	Conclusion	Assessment scores			Risk code	 
								Material	Priority	Total		
J616986 #54	PC000765	Lodge Farm, High Catton, York, North Yorkshire, YO41 1EW	External	Covered yard	To floor to rear right hand side adjacent concrete ramp	Cement debris	Chrysotile + Crocidolite	8	4	12	Risk code E	
								Medium Material Risk				
Comments						Next reinspection	Extent	Recommended action			Action Timescale	Date action completed
Spread over unit						06/2022	1m ²	Remove
